ST. EDMUNDSBURY HOSPITAL, LUCAN, CO. DUBLIN

Volume 1 Part 2: Conservation Report -
Architectural Inventory, Condition Report & Appraisal

November 2023

Ref: 22037

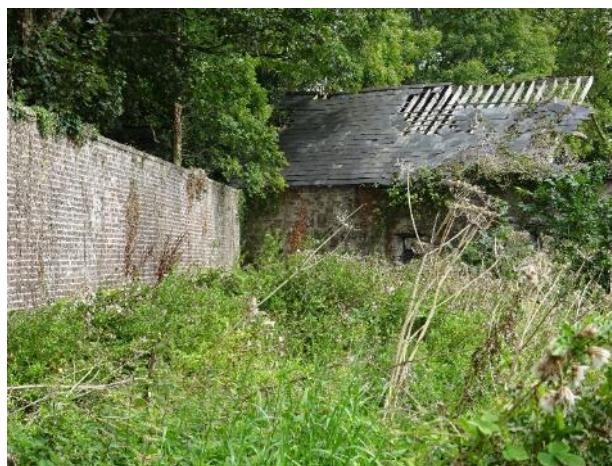
Description (materials, construction, location)	Double pitched slate roof.
Condition	Poor condition. The roof is generally missing, with just a small section remaining at the north end of the building. The timber trusses are in extremely poor condition.
Probable causes/consequences	Wear and tear. Water ingress over the years.
Recommended measures	Roof replacement.

Symptoms	Condition class (CC)	Urgency	Urgency class (UC)
Major symptoms	CC 3	Urgent and immediate	UC 3

Fig.4: Barn, remaining section of the roof at the north.

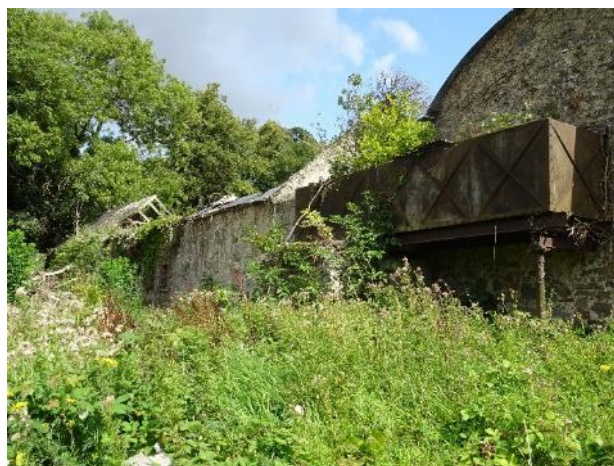
Description (materials, construction, location)	Rubble stone walls with roughcast lime render. Brick course at the top of the wall on the east elevation.
Condition	Generally the lime render has worn away, though small areas remain. Vegetation overgrowth: ivy Bituminous paint at the bottom section on the east elevation. Concrete render on the south elevation.

Modern concrete blocks infill beneath each window opening. This suggests that the original window openings were taller.
Probable causes/consequences	Wear and tear. Water ingress. Previous interventions. Risk of destabilisation and collapse.
Recommended measures	Remove vegetation. Carefully remove cement render and replace with lime render, in line with conservation specification. Carefully remove cement-based mortar and replace with lime mortar, in line with conservation specification. Remove bituminous paint. Rebuild brick course at the top of the wall on the east elevation in line with conservation specification. SE to inspect structural stability of the barn and make recommendations.

Fig.6: Barn, west elevation, lime render has fallen, vegetation overgrowth

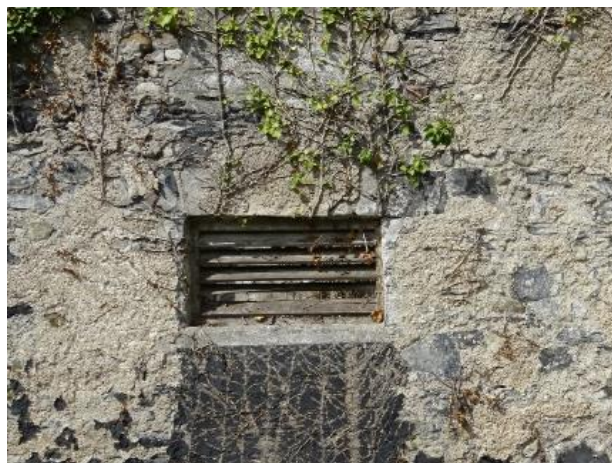
Description (materials, construction, location)	4 no. square-headed window openings with horizontal timber louvres on the east elevation. 6 no. square-headed window openings on the west elevation. 1 no. square-headed window opening with brick lintel on the south elevation.
Condition	Concrete bricks infill beneath the window opening on the east elevation suggests that original window openings were taller. Arrowslit window openings are blocked-up on the east and west elevations. Timber louvres are in poor condition.
Probable causes/consequences	Previous intervention. Wear and tear.
Recommended measures	Remove concrete block infill on the east elevation. Replace timber louvres.

Fig.9: Barn, east external elevation, square-headed window opening were altered as there are a brick infill underneath a concrete sill.

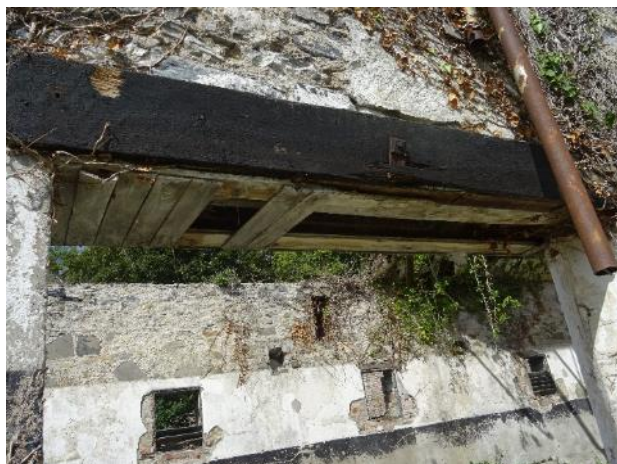
Fig.15: Barn, external east elevation, square-headed door opening with timber beam lintel.

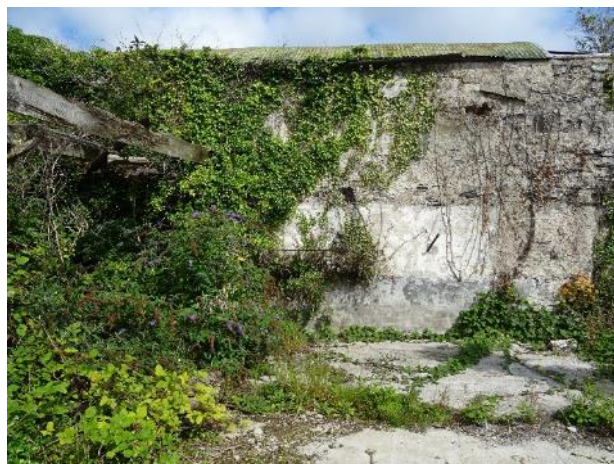
Fig.37: Coach House, west section, south elevation, cementitious render, vegetation overgrowth.

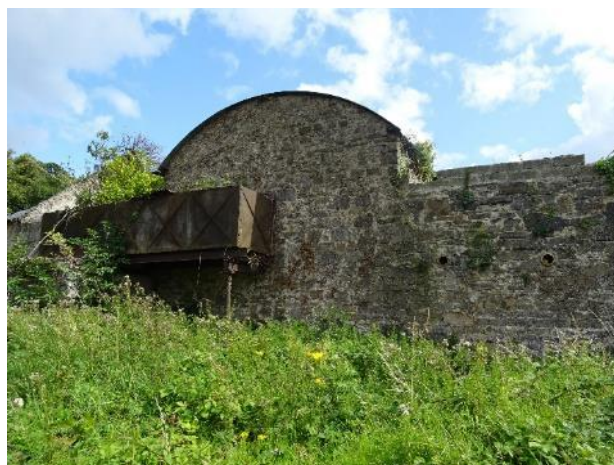
Fig.41: Coach House, west section, west elevation, the lime render has fallen.

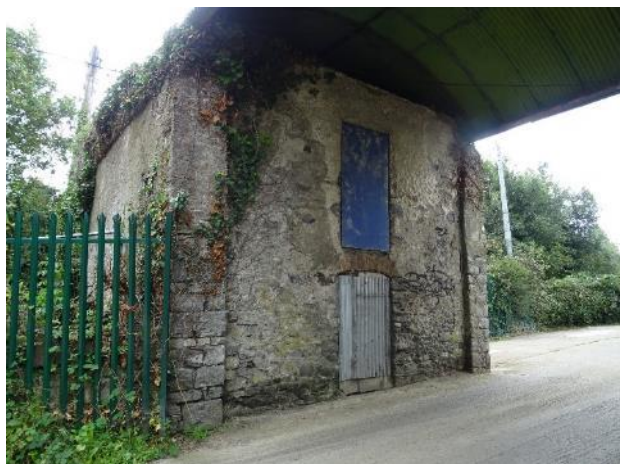
<p>Generally, the lime render has degraded. The vegetation is developing.</p> <p><u>East section, east elevation</u></p> <p>The lime render has fallen in some areas. There are open joints at the bottom section. Vegetation is developing at the section at the north. There is a crack on the south section.</p>
Probable causes/consequences	<p>Wear and tear.</p> <p>Water ingress.</p> <p>Previous interventions: timber beams and concrete slab.</p> <p>Risk of destabilization and collapse.</p>
Recommended measures	<p>Repoint open joints.</p> <p>Remove vegetation.</p> <p>Remove cement render.</p> <p>Remove modern fixings.</p> <p>Replace lime render.</p> <p>Remove graffiti.</p> <p>Structural engineer to inspect the cracks and the wall leaning and make recommendations.</p> <p>Conservation consultants to carry out a mortar analysis to specify mortar replacement.</p>

Fig.42: Coach House, east section, east elevation, vegetation overgrowth, lime render has fallen in some areas, open joint at the bottom section.
