# ASBESTOS REFURBISHMENT SURVEY REPORT

Carlow WWTP

Irish Water

| <b>Project Title</b> | 24535 Carlow WWTP Asbestos Survey |

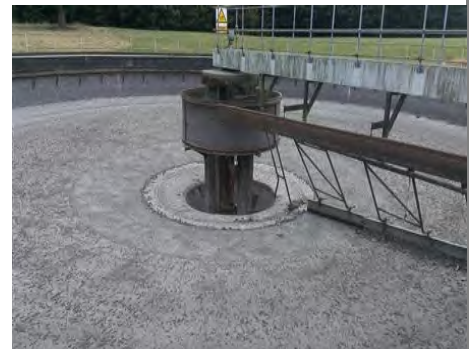
## Location Details 295158 No Asbestos Found

Building/Area : Storm Tank  
Room/Section : Construction  
Location :  
Description :  
Sample No. :  
Confirmation : --N\A--  
Access : Full Access  
Normal Use : External Plant Area  
Recommendations :  
Ceramic floor tiles, solid walls, plastered ceiling, electrical storage heater;

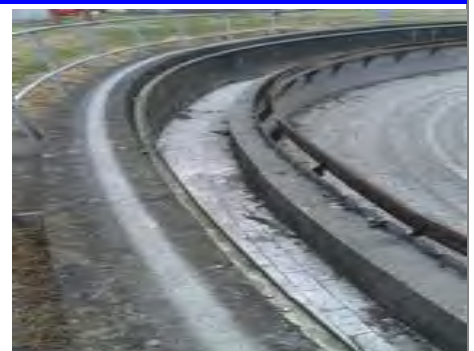
## Location Details 295159 No Asbestos Found

Building/Area : Storm Tank  
Room/Section : Construction  
Location :  
Description :  
Sample No. :  
Confirmation : --N\A--  
Access : Full Access  
Normal Use : External Plant Area  
Recommendations :  
Ceramic floor tiles, solid walls, plastered ceiling, electrical storage heater;

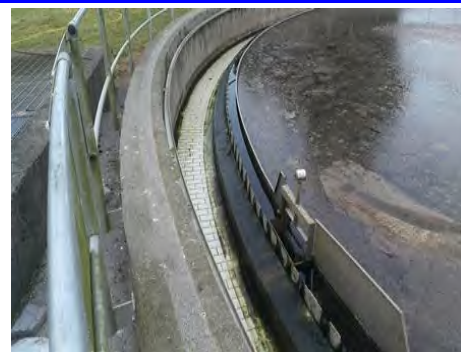
## Location Details 295155 No Asbestos Found

Building/Area : Clarifier No. 2  
Room/Section : Construction  
Location :  
Description :  
Sample No. :  
Confirmation : --N\A--  
Access : Full Access  
Normal Use : External Plant Area  
Recommendations :  
;

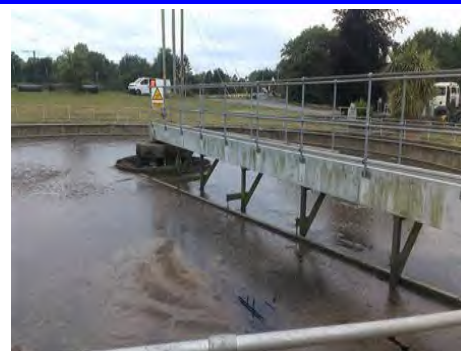
## Location Details 295156 No Asbestos Found

Building/Area : Clarifier No. 2  
Room/Section : Construction  
Location :  
Description :  
Sample No. :  
Confirmation : --N\A--  
Access : Full Access  
Normal Use : External Plant Area  
Recommendations :  
Ceramic floor tiles, solid walls, plastered ceiling, electrical storage heater;

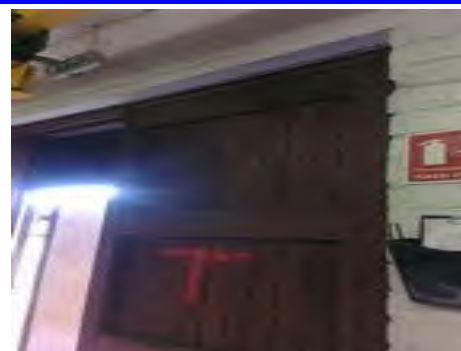
## Location Details 295129 No Asbestos Found

Building/Area : Air Blower Building  
Room/Section : Internal Areas  
Location : Doors  
Description :  
Sample No. :  
Confirmation : --N\A--  
Access : Full Access  
Normal Use : Plantroom Area  
Recommendations :  
timber doors and frame;

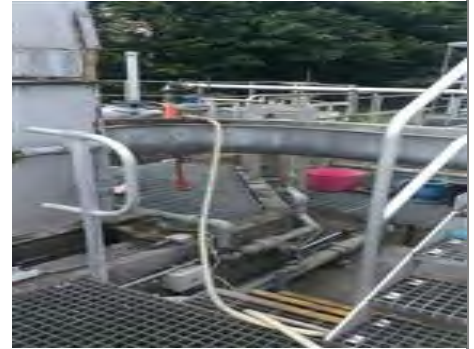
## Location Details 295130 No Asbestos Found

Building/Area : Inlet Works Area  
Room/Section : Construction  
Location :  
Description :  
Sample No. :  
Confirmation : --N\A--  
Access : Full Access  
Normal Use : External Plant Area  
Recommendations :  
Concrete base, machinery and tanks;

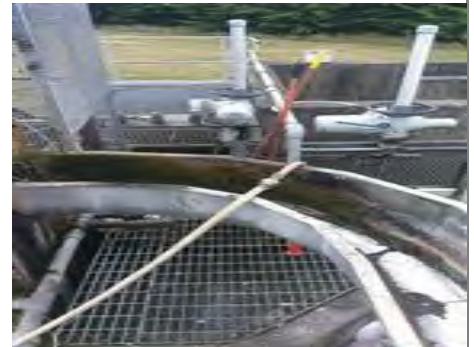
## Location Details 295131 No Asbestos Found

Building/Area : Inlet Works Area  
Room/Section : Construction  
Location :  
Description :  
Sample No. :  
Confirmation : --N\A--  
Access : Full Access  
Normal Use : External Plant Area  
Recommendations :  
Concrete base, machinery and tanks;

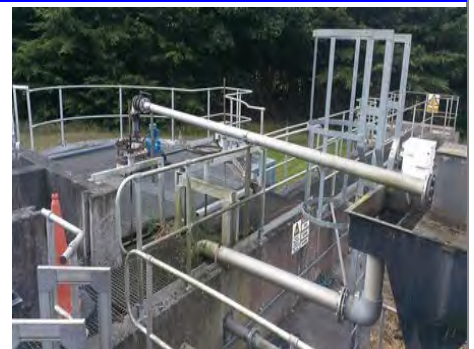
## Location Details 295132 No Asbestos Found

Building/Area : Inlet Works Area  
Room/Section : Construction  
Location :  
Description :  
Sample No. :  
Confirmation : --N\A--  
Access : Full Access  
Normal Use : External Plant Area  
Recommendations :  
Concrete base, machinery and tanks;

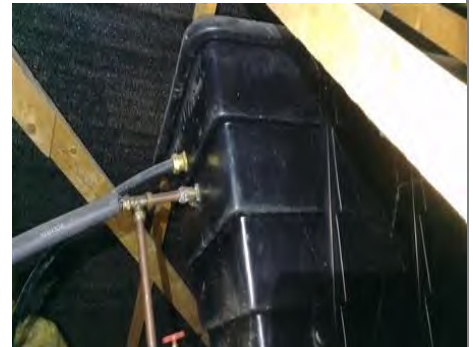
## Location Details 295111 No Asbestos Found

Building/Area : Administration Building  
Room/Section : Workshop  
Location : Attic  
Description :  
Sample No. :  
Confirmation : --N\A--  
Access : Full Access  
Normal Use : Office type use  
Recommendations :  
plastic water tanks, felt and timber roof, mmmf insulation;

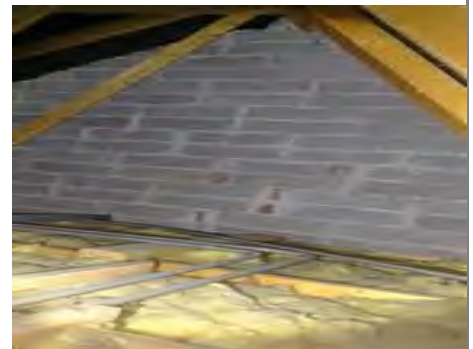
## Location Details 295112 No Asbestos Found

Building/Area : Administration Building  
Room/Section : Workshop  
Location : Attic  
Description :  
Sample No. :  
Confirmation : --N\A--  
Access : Full Access  
Normal Use : Office type use  
Recommendations :  
plastic water tanks, felt and timber roof, mmmf insulation;

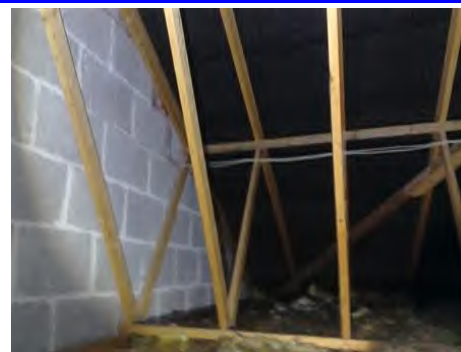
## Location Details 295113 No Asbestos Found

plastic water tanks, felt and timber roof, mmmf insulation;

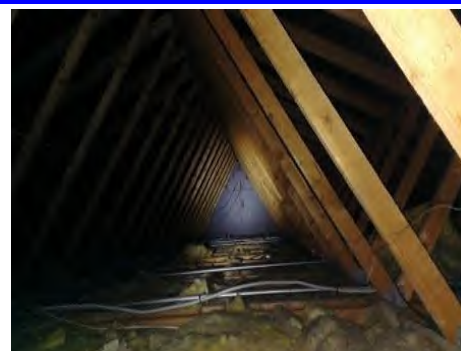
## Location Details 295114 No Asbestos Found

Building/Area : Administration Building  
Room/Section : Attic  
Location : Construction

plastic water tanks, felt and timber roof, mmmf insulation;

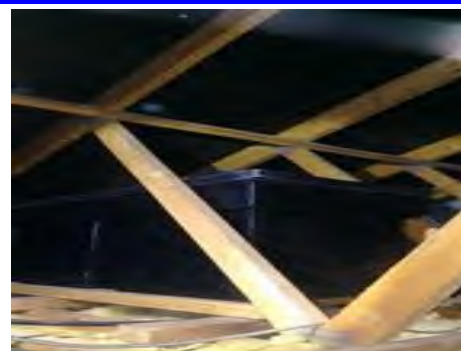
## Location Details 295115 No Asbestos Found

Building/Area : Administration Building  
Room/Section : Attic  
Location : Construction

plastic water tanks, felt and timber roof, mmmf insulation;

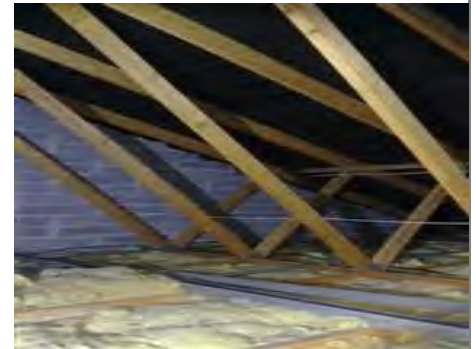
## Location Details 295116 No Asbestos Found

Building/Area : Administration Building  
Room/Section : Attic  
Location : Construction  
Description :  
Sample No. :  
Confirmation : --N\A--  
Access : Full Access  
Normal Use : Office type use  
Recommendations :  
plastic water tanks, felt and timber roof, mmmf insulation;

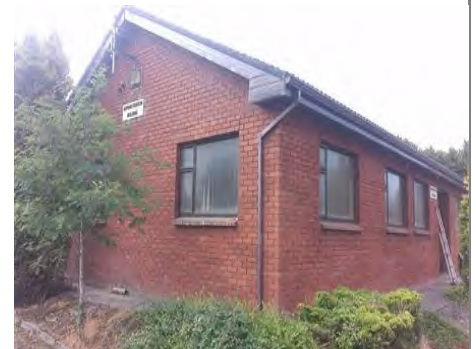
## Location Details 295117 No Asbestos Found

Building/Area : Administration Building  
Room/Section : External Areas  
Location : Construction  
Description :  
Sample No. :  
Confirmation : --N\A--  
Access : Full Access  
Normal Use : External  
Recommendations :  
Brick walls, aluminum windows, aluminum fascia, soffit and guttering, concrete tiles;

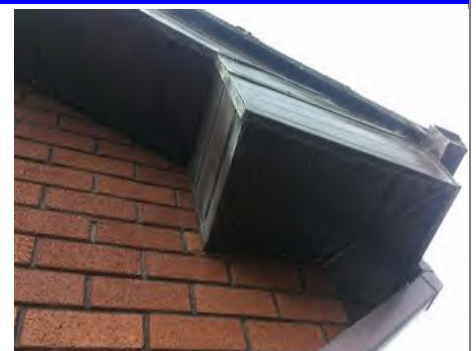
## Location Details 295118 No Asbestos Found

Building/Area : Administration Building  
Room/Section : External Areas  
Location : Construction  
Description :  
Sample No. :  
Confirmation : --N\A--  
Access : Full Access  
Normal Use : External  
Recommendations :  
Brick walls, aluminum windows, aluminum fascia, soffit and guttering, concrete tiles;

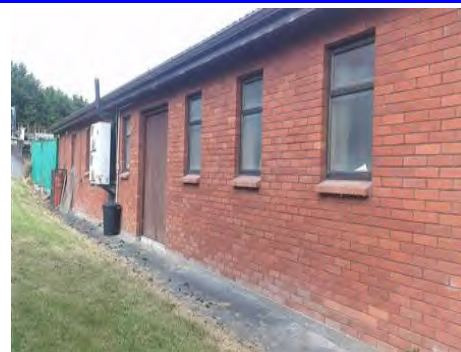
## Location Details 295119 No Asbestos Found

Brick walls, aluminum windows, aluminum fascia, soffit and guttering, concrete tiles;

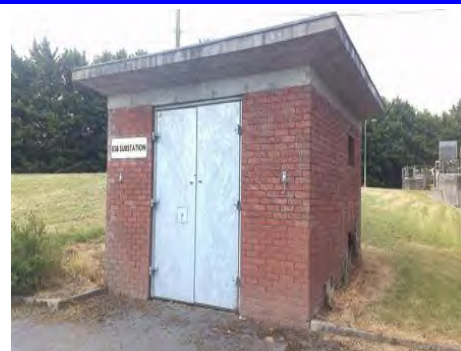
## Location Details 295120 No Asbestos Found

Building/Area : ESB Substation  
Room/Section : External Areas  
Location : Construction  
Description :  
Sample No. :  
Confirmation : --N\A--  
Access : Full Access  
Normal Use : External

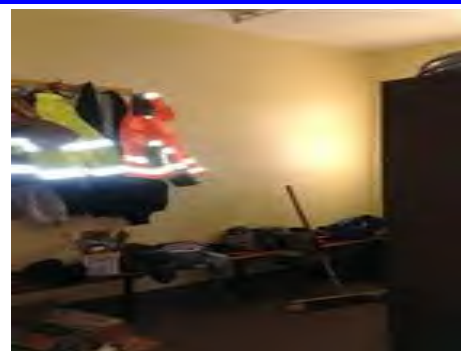
## Location Details 295099 No Asbestos Found

Building/Area : Administration Building  
Room/Section : Changing Room  
Location : Floor, walls, ceiling  
Description :  
Sample No. :  
Confirmation : --N\A--  
Access : Full Access  
Normal Use : Office type use

Ceramic tiles, solid walls, plastered ceiling, modern electrical heater;

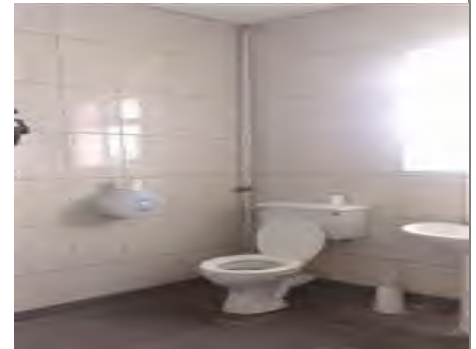
## Location Details 295100 No Asbestos Found

Building/Area : Administration Building  
Room/Section : Toilet  
Location : Floor, walls, ceiling  
Description :  
Sample No. :  
Confirmation : --N\A--  
Access : Full Access  
Normal Use : Office type use  
Recommendations :

Ceramic tiles, solid walls, plastered ceiling, modern electrical heater;

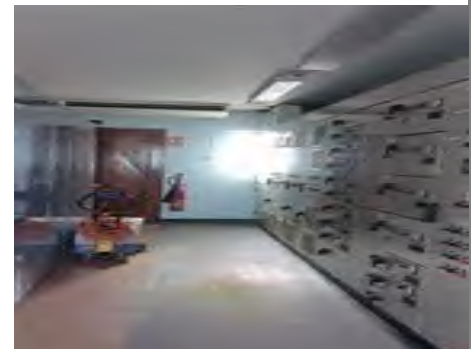
## Location Details 295101 No Asbestos Found

Building/Area : Administration Building  
Room/Section : Control Room.  
Location : Walls, ceiling  
Description :  
Sample No. :  
Confirmation : --N\A--  
Access : Full Access  
Normal Use : Office type use  
Recommendations :

Solid walls, plastered ceiling;

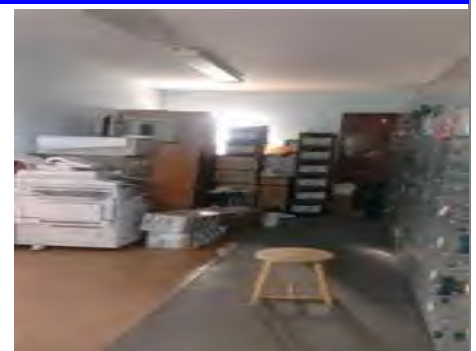
## Location Details 295102 No Asbestos Found

Building/Area : Administration Building  
Room/Section : Control Room.  
Location : Walls, ceiling  
Description :  
Sample No. :  
Confirmation : --N\A--  
Access : Full Access  
Normal Use : Office type use  
Recommendations :

Solid walls, plastered ceiling;

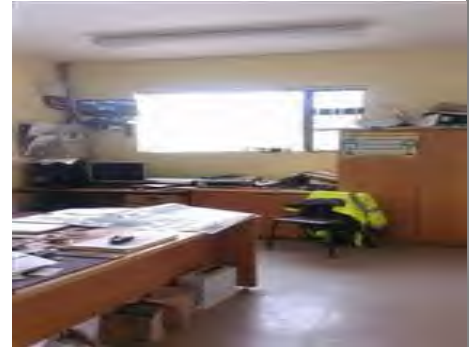
## Location Details 295103 No Asbestos Found

Building/Area : Administration Building  
Room/Section : Control Room Office  
Location : Walls, ceiling  
Description :  
Sample No. :  
Confirmation : --N\A--  
Access : Full Access  
Normal Use : Office type use  
Recommendations :  
Solid walls, plastered ceiling;

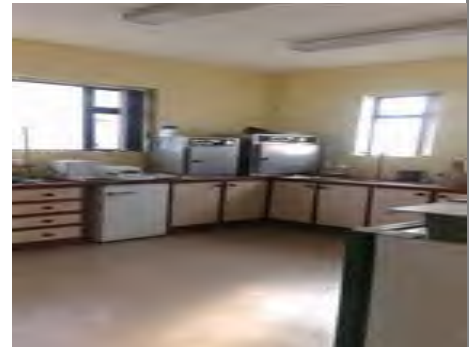
## Location Details 295104 No Asbestos Found

Building/Area : Administration Building  
Room/Section : Control Room Laboratory  
Location : Walls, ceiling  
Description :  
Sample No. :  
Confirmation : --N\A--  
Access : Full Access  
Normal Use : Office type use  
Recommendations :  
Solid walls, plastered ceiling;

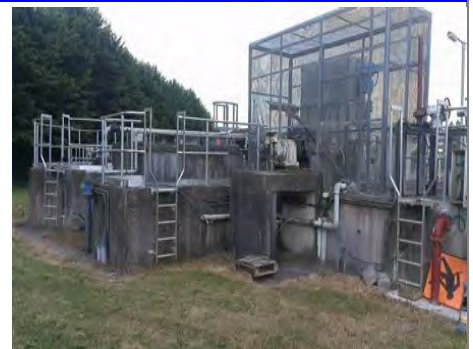
## Location Details 295134 No Asbestos Found

Building/Area : Inlet Works Area  
Room/Section : Construction  
Location : Gaskets  
Description :  
Sample No. :  
Confirmation : --N\A--  
Access : Full Access  
Normal Use : External Plant Area  
Recommendations :  
Rubber gaskets where visible;

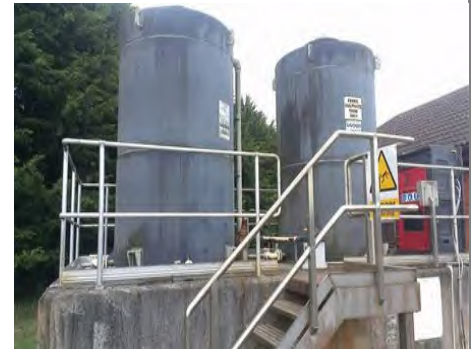
## Location Details 295135 No Asbestos Found

Building/Area : Ferric Dosing Area  
Room/Section : Construction  
Location :  
Description :  
Sample No. :  
Confirmation : --N\A--  
Access : Full Access  
Normal Use : External Plant Area  
Recommendations :  
modern units, concrete base;

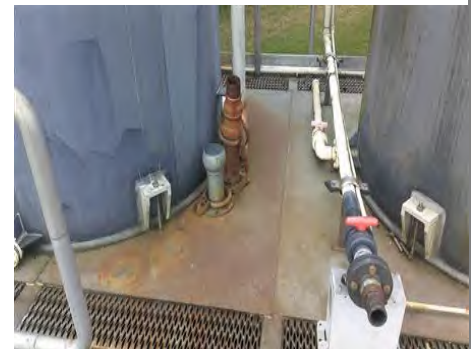
## Location Details 295136 No Asbestos Found

Building/Area : Ferric Dosing Area  
Room/Section : Construction  
Location :  
Description :  
Sample No. :  
Confirmation : --N\A--  
Access : Full Access  
Normal Use : External Plant Area  
Recommendations :  
modern units, concrete base;

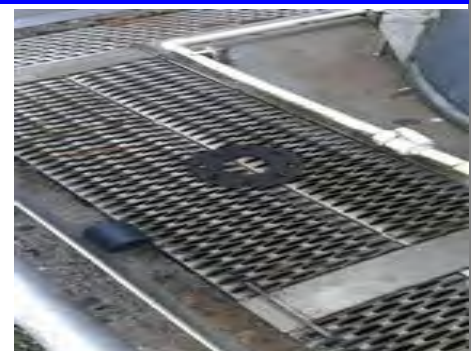
## Location Details 295137 No Asbestos Found

Building/Area : Ferric Dosing Area  
Room/Section : Construction  
Location :  
Description :  
Sample No. :  
Confirmation : --N\A--  
Access : Full Access  
Normal Use : External Plant Area  
Recommendations :  
modern units, concrete base;

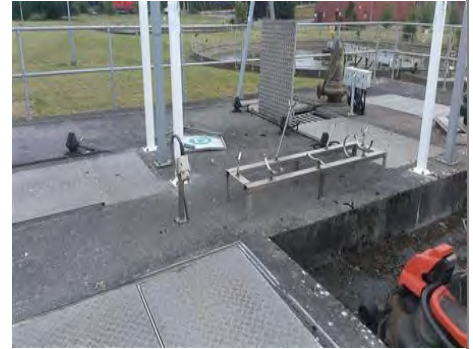
## Location Details 295138 No Asbestos Found

Building/Area : Sludge Return Tank  
Room/Section : Construction  
Location :  
Description :  
Sample No. :  
Confirmation : --N\A--  
Access : Full Access  
Normal Use : External Plant Area  
Recommendations :  
Concrete base, metal covers;

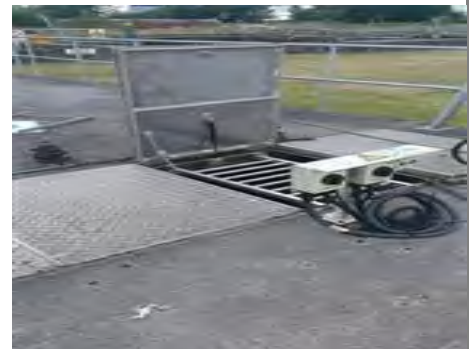
## Location Details 295139 No Asbestos Found

Building/Area : Sludge Return Tank  
Room/Section : Construction  
Location :  
Description :  
Sample No. :  
Confirmation : --N\A--  
Access : Full Access  
Normal Use : External Plant Area  
Recommendations :  
Concrete base, metal covers;

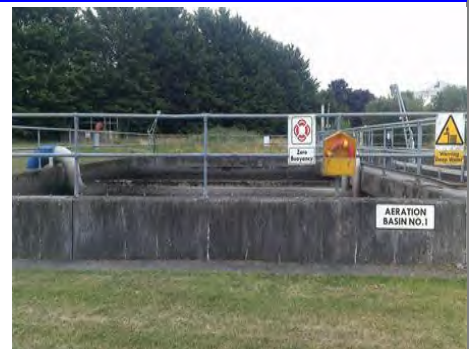
## Location Details 295140 No Asbestos Found

Building/Area : Aeration Basin No. 1, 2 and 3  
Room/Section : Construction  
Location :  
Description :  
Sample No. :  
Confirmation : --N\A--  
Access : Full Access  
Normal Use : External Plant Area  
Recommendations :  
Concrete tanks, metal pipe work for compressed air;

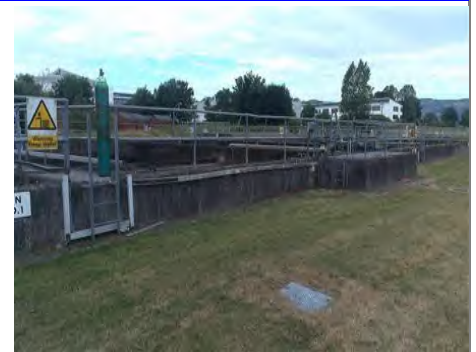
## Location Details 295141 No Asbestos Found

Building/Area : Aeration Basin No. 1, 2 and 3  
Room/Section : Construction  
Location :  
Description :  
Sample No. :  
Confirmation : --N\A--  
Access : Full Access  
Normal Use : External Plant Area  
Recommendations :  
Concrete tanks, metal pipe work for compressed air;

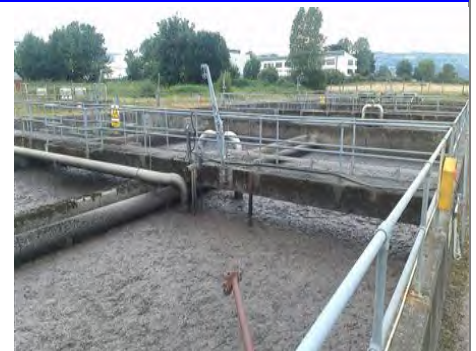
## Location Details 295142 No Asbestos Found

Building/Area : Aeration Basin No. 1, 2 and 3  
Room/Section : Construction  
Location :  
Description :  
Sample No. :  
Confirmation : --N\A--  
Access : Full Access  
Normal Use : External Plant Area  
Recommendations :  
Concrete tanks, metal pipe work for compressed air;

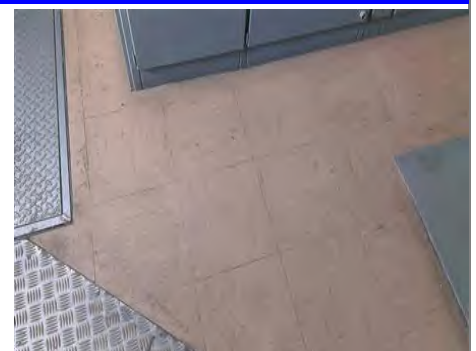
## Location Details 295108 No Asbestos Found

Building/Area : Administration Building  
Room/Section : Control Room  
Location : Floor  
Description : Tiles  
Sample No. : DKB20180626002  
Confirmation : Sample Taken  
Access : Full Access  
Normal Use : Office type use  
Recommendations :  
;

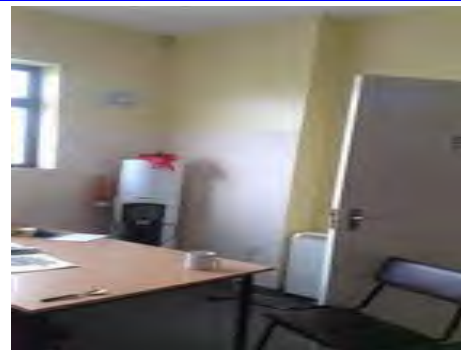
## Location Details 295095 No Asbestos Found

Ceramic floor tiles, solid walls, plastered ceiling, electrical storage heater;

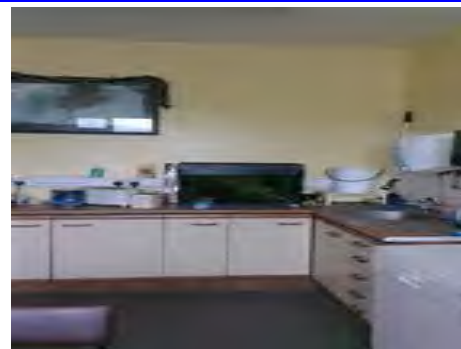
## Location Details 295096 No Asbestos Found

Building/Area : Administration Building  
Room/Section : Canteen  
Location : Floor, Walls, Ceiling

Ceramic floor tiles, solid walls, plastered ceiling, electrical storage heater;

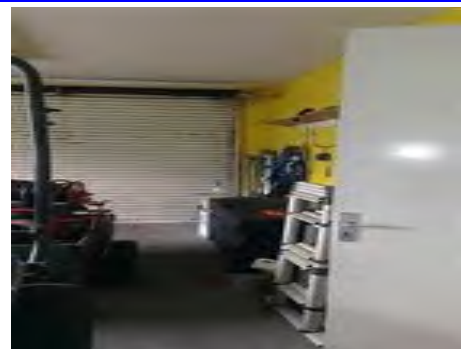
## Location Details 295097 No Asbestos Found

Building/Area : Administration Building  
Room/Section : Workshop  
Location : Floor, Walls

Solid floor, solid walls, light door;

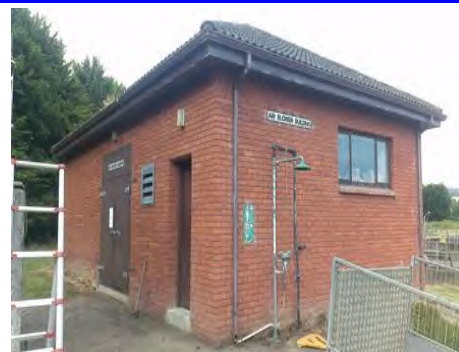
## Location Details 295122 No Asbestos Found

Brick walls, concrete roof tiles, aluminum guttering and fascia / soffit;

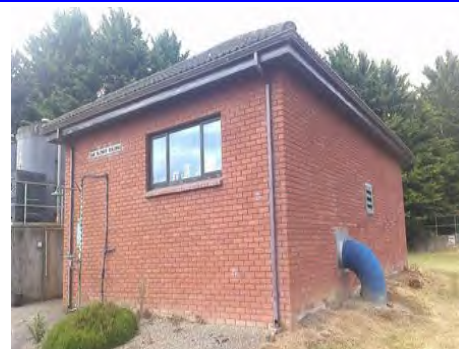
## Location Details 295123 No Asbestos Found

Building/Area : Air Blower Building  
Room/Section : External Areas  
Location : Construction  
Description :  
Sample No. :  
Confirmation : --N\A--  
Access : Full Access  
Normal Use : External

Brick walls, concrete roof tiles, aluminum guttering and fascia / soffit;

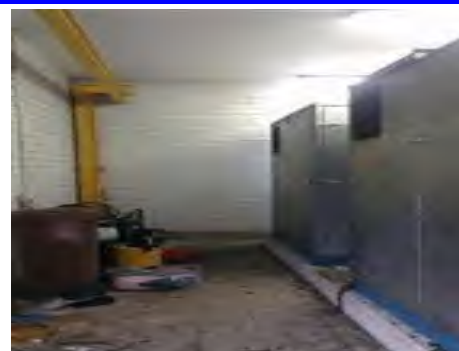
## Location Details 295124 No Asbestos Found

Building/Area : Air Blower Building  
Room/Section : Internal Areas  
Location : Floor, walls, ceiling  
Description :  
Sample No. :  
Confirmation : --N\A--  
Access : Full Access  
Normal Use : Plantroom Area

ceramic floor tiles, solid walls, plastered ceiling;

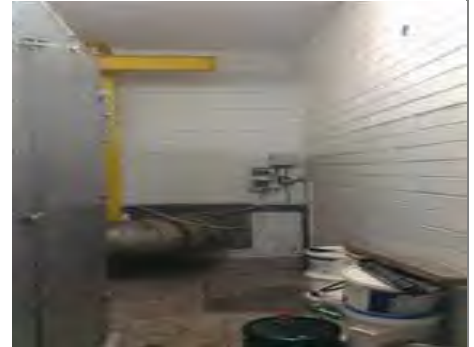
## Location Details 295125 No Asbestos Found

Building/Area : Air Blower Building  
Room/Section : Internal Areas  
Location : Floor, walls, ceiling  
Description :  
Sample No. :  
Confirmation : --N\A--  
Access : Full Access  
Normal Use : Plantroom Area  
Recommendations :  
ceramic floor tiles, solid walls, plastered ceiling;

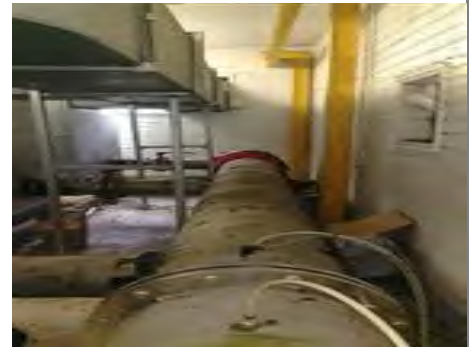
## Location Details 295126 No Asbestos Found

Building/Area : Air Blower Building  
Room/Section : Internal Areas  
Location : Floor, walls, ceiling  
Description :  
Sample No. :  
Confirmation : --N\A--  
Access : Full Access  
Normal Use : Plantroom Area  
Recommendations :  
ceramic floor tiles, solid walls, plastered ceiling;

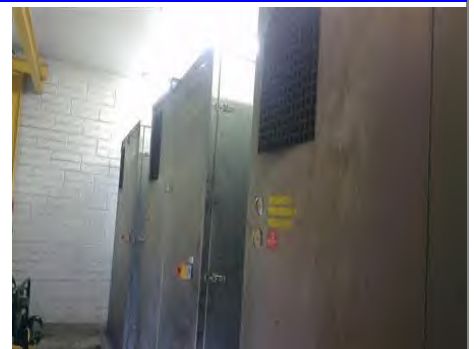
## Location Details 295127 No Asbestos Found

Building/Area : Air Blower Building  
Room/Section : Internal Areas  
Location : Equipment  
Description :  
Sample No. :  
Confirmation : --N\A--  
Access : Full Access  
Normal Use : Plantroom Area  
Recommendations :  
modern compressor equipment;

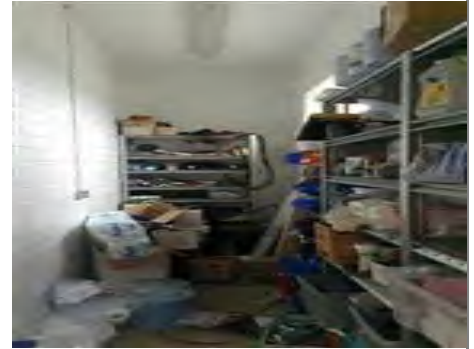
## Location Details 295182 No Asbestos Found

Building/Area : Air Blower Building  
Room/Section : Store Room  
Location : Floor, walls, ceiling  
Description :  
Sample No. :  
Confirmation : --N\A--  
Access : Full Access  
Normal Use : Store  
Recommendations :  
;

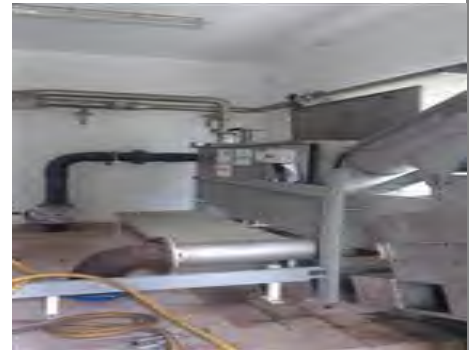
## Location Details 295183 No Asbestos Found

Building/Area : Storm Screen Building  
Room/Section : Screen Room  
Location : Floor, walls, ceiling  
Description :  
Sample No. :  
Confirmation : --N\A--  
Access : Full Access  
Normal Use : Store  
Recommendations :  
constructed in 2003;

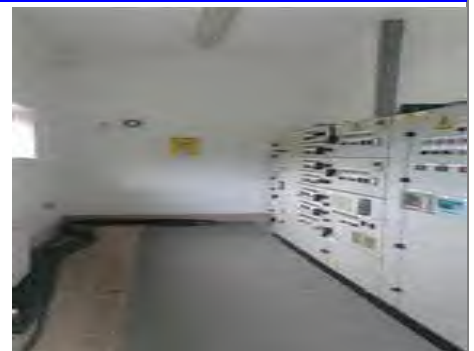
## Location Details 295184 No Asbestos Found

Building/Area : Storm Screen Building  
Room/Section : Electrical Room  
Location : Floor, walls, ceiling  
Description :  
Sample No. :  
Confirmation : --N\A--  
Access : Full Access  
Normal Use : Store  
Recommendations :  
constructed in 2003;

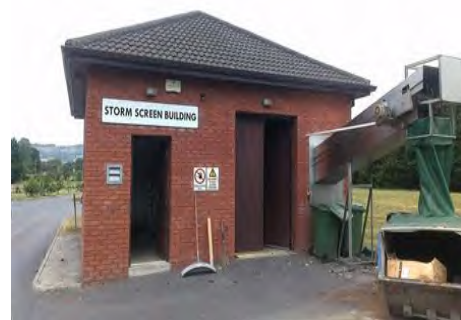
## Location Details 295185 No Asbestos Found

Building/Area : Storm Screen Building  
Room/Section : External Areas  
Location : Construction  
Description :  
Sample No. :  
Confirmation : --N\A--  
Access : Full Access  
Normal Use : External  
Recommendations :  
constructed in 2003;

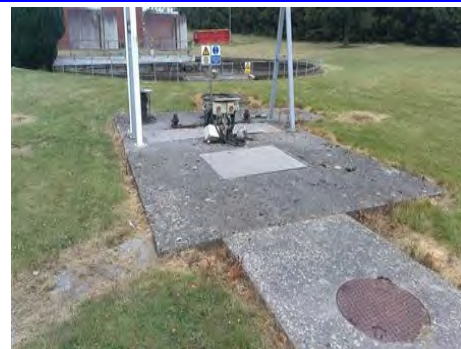
## Location Details 295186 No Asbestos Found

Building/Area : Raw Sludge Tank  
Room/Section : External Areas  
Location : Construction  
Description :  
Sample No. :  
Confirmation : --N\A--  
Access : Full Access  
Normal Use : External  
Recommendations :  
;

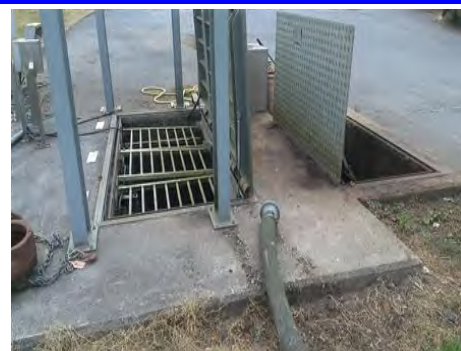
## Location Details 295187 No Asbestos Found

Building/Area : Raw Sludge Tank  
Room/Section : External Areas  
Location : Construction  
Description :  
Sample No. :  
Confirmation : --N\A--  
Access : Full Access  
Normal Use : External  
Recommendations :  
;

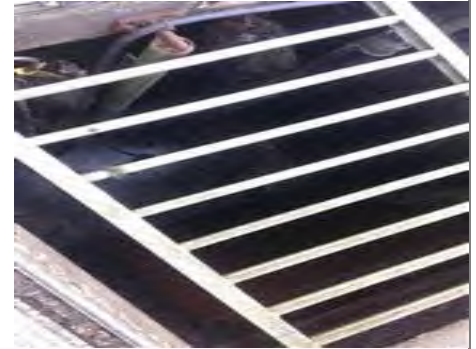
## Location Details 295188 No Asbestos Found

Building/Area : Raw Sludge Tank  
Room/Section : External Areas  
Location : Construction  
Description :  
Sample No. :  
Confirmation : --N\A--  
Access : Full Access  
Normal Use : External  
Recommendations :  
;
