# APPENDICES INDEX

## Appendix 7-1      GSI & TII Scoping responses with Hydro-G technical responses

**Re: Proposed extension of limestone quarry, Kilree, Sheastown, Bennettsbridge, Co Kilkenny**

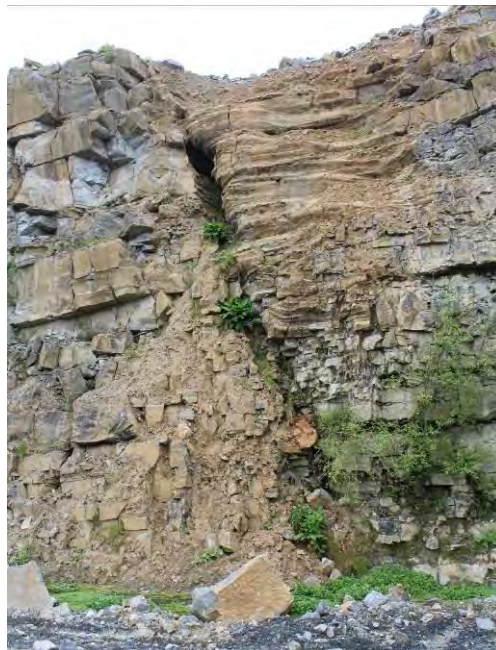
From visual observations the intact rock strength of the rock in the quarry is good. There are local areas of weathering to the East and South East of the quarry primarily in the upper benches. Structurally there is a large fault running close to West East through the middle of the quarry. This fault has a large persistence, an aperture of c.0.5m with a weathered clay/rock infill. The fault has a measured strike of 080° and a Dip of 80° South.

**Figure 4 The main West East trending fault**

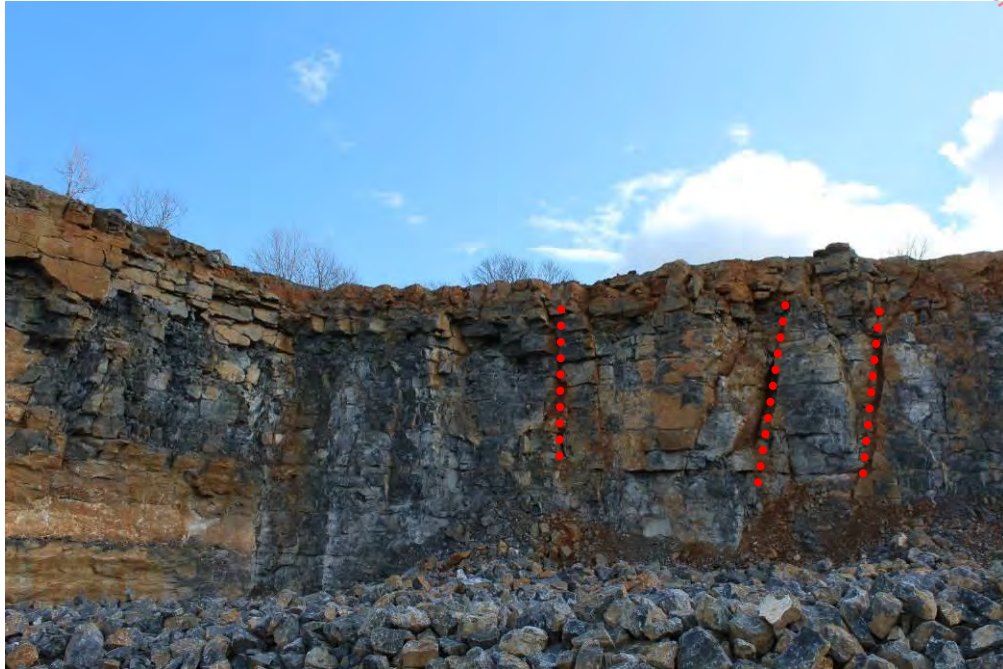
The primary joint set has an average orientation of 350° Strike and 85° Dip with a secondary joint set with an average orientation of 064° Strike and 82° Dip. The bedding within the rock is close to horizontal with a slight tendency in dipping to the East.

**Figure 5 The primary joint set (highlighted in red)**

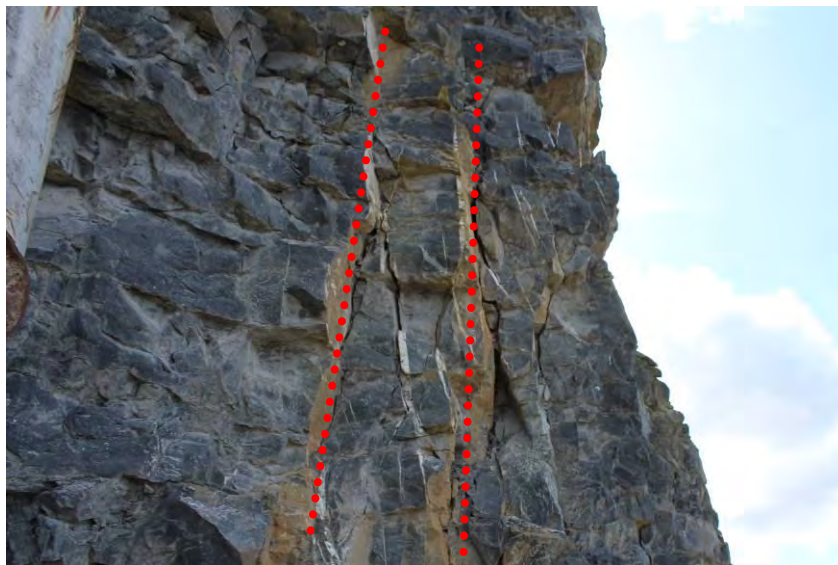
**Figure 6 The secondary joint set (highlighted in red)**

These orientations give a slight proclivity towards potential toppling failure in the western faces with more likely block failure in the northern, southern and eastern

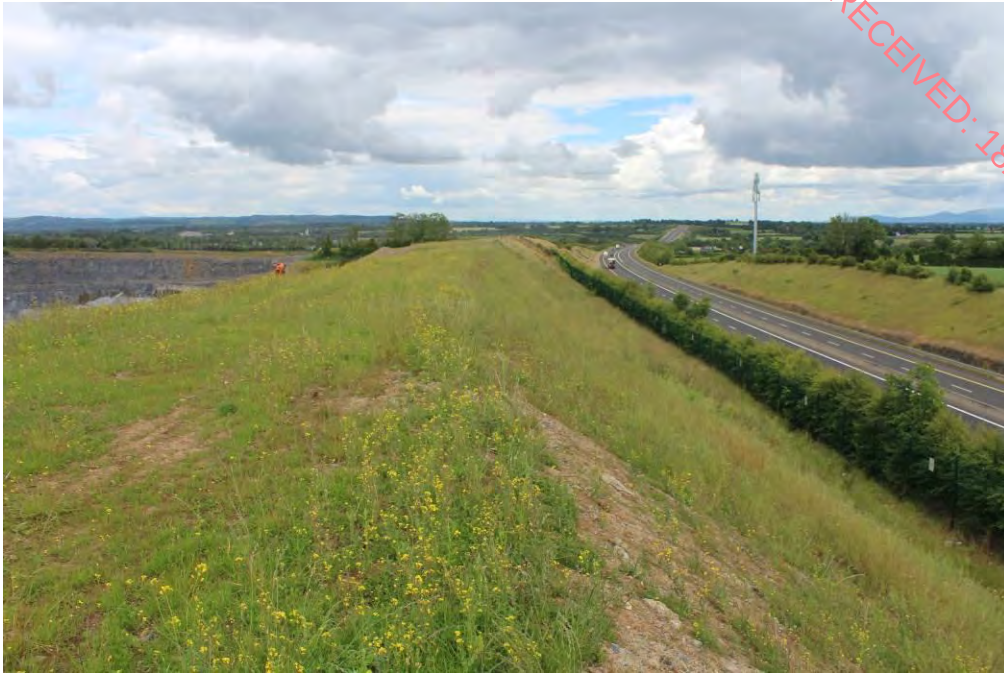
A notable new feature in the quarry is the stripped material from the south west extension that was placed and shaped into a bund running along the periphery of the quarry site to the south near the boundary with the M9 motorway. The stability of this was assessed in previous appraisal reports but will also be added to in this report now that the bund is complete.

**Figure 13 Bund running along southern boundary of the quarry**

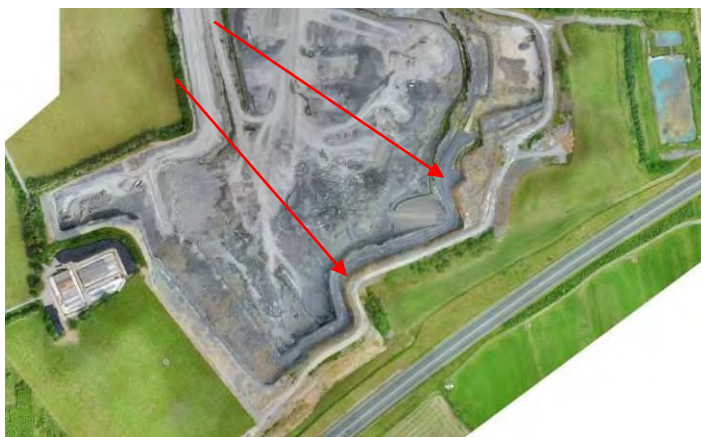
Although there is very little exposure of quarry personnel to the southern upper face there appears to be loose present particularly on the corner to the left of the interim ramp access and in some other weathered portions of the face. There is also signs of previous small failures from the southern upper face and although small could be a sign that a larger instability is developing or that the face stability overall is deteriorating.

**Figure 19 Areas where bund height should be increased**

It is recommended that the rockfall bund and exclusion zone be increase in size or that the area be shut off completely and access be granted on an individual risk assessed basis when needed. The bund and exclusion zone need particular attention around the two corners identified on the image below:

1. Increase and extend bund beneath the southern portion of the Eastern face particularly on the two corners identified in the assessment.

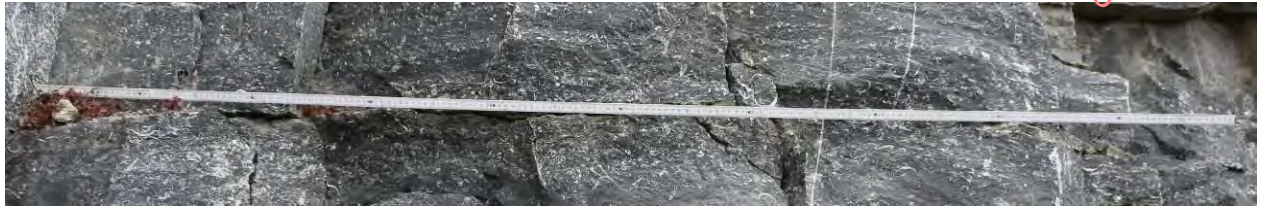
The measured RQD at two locations is 90 making it a competent rock however the development of large loose blocks is clear in the upper sections of the face. All discontinuities were dry on the day of the site visit and have a medium to high persistence, high roughness coefficient and low aperture.

**Figure 26 RQD of eastern upper face norther section**

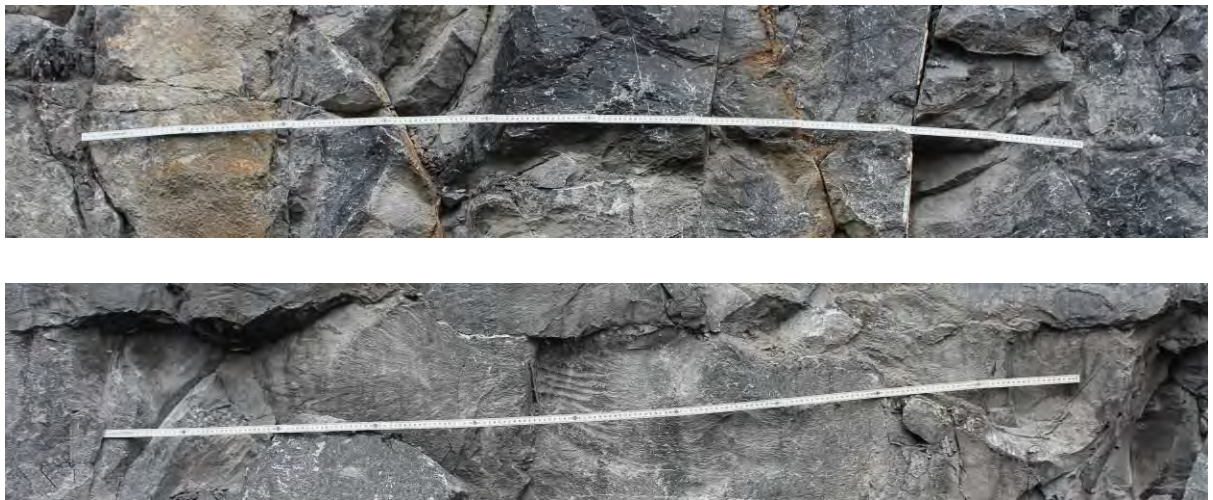
The measured RQD at two locations in the south western faces is 92 making it a very competent rock. All discontinuities were dry on the day of the site visit and have a medium to high persistence, high roughness coefficient and low aperture.

**Figure 32 Western Face RQD**

The only observable way in which that stability of the faces in the south west corner could be improved is the presence of overhangs at the very top of some of the faces.

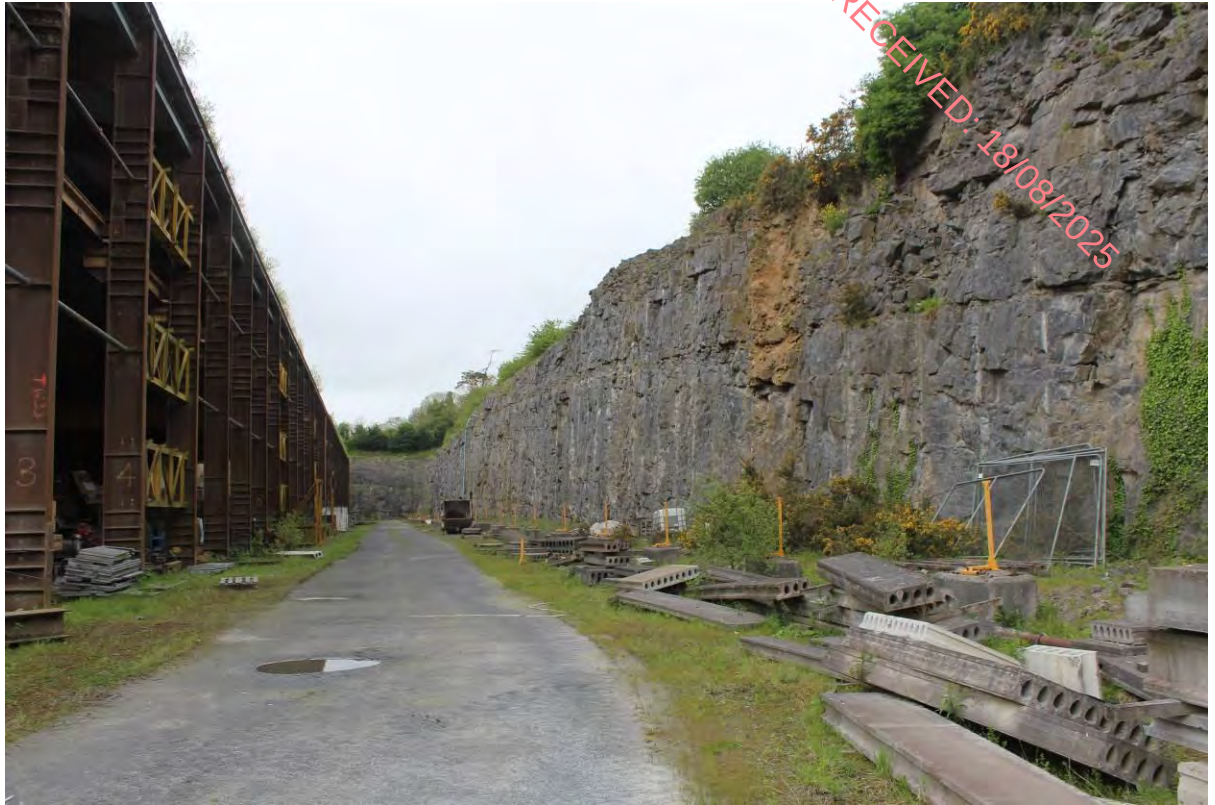
The upper section of the Northern face is located parallel to the pre-cast building in the north of the quarry. For the most part this face has been there for a long time and been stable for most of that period. There is a chained, signed and bunded exclusion zone at the base of this face

**Figure 34 Northern Upper face**

The measured RQD at two locations in the Northern faces is 92 making it a competent rock. All discontinuities were dry on the day of the site visit and have a medium to high persistence, high roughness coefficient and low aperture.

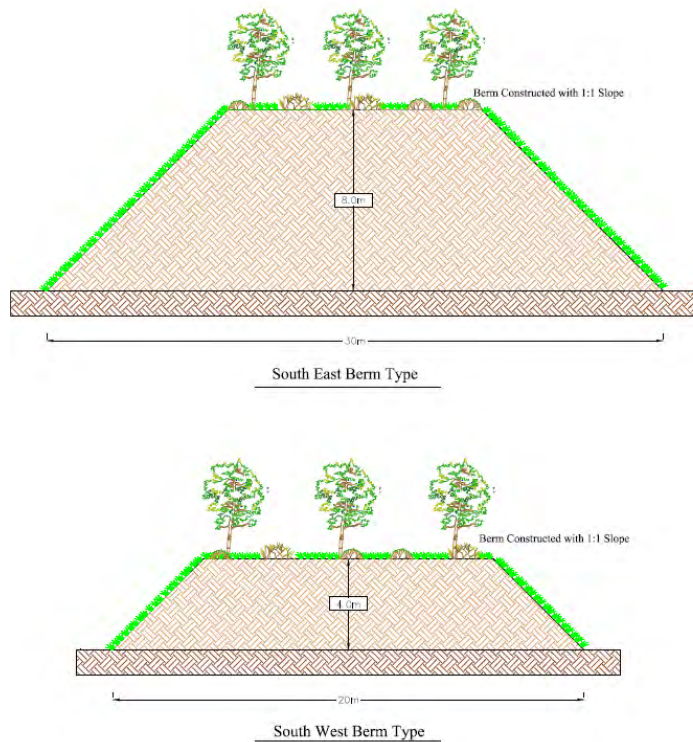
After construction the berm height was measure as being between 4.5m and 6.6m high with a slope angle of between 20.4° and 27° which complies with the design

submitted in the planning application and is shallow enough to be stable for this material type.

**Figure 39 Bund Design**

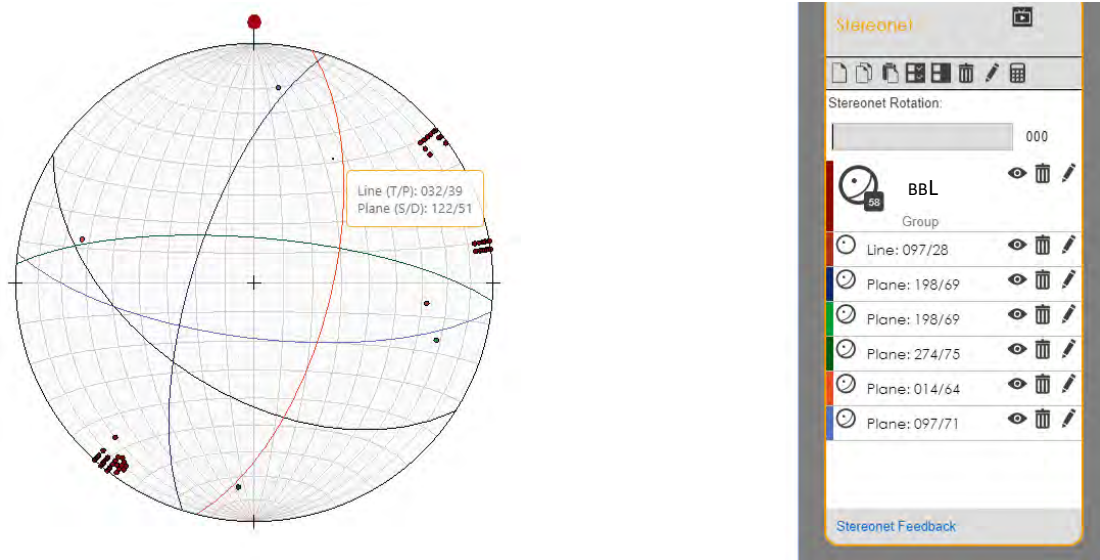
**Figure 43 Discontinuity pole analysis**

Analysis of the poles shows a propensity for toppling failure in the Eastern face. The northern and southern face is more likely to form larger wedge or planar failures however there is a clear potential larger failure directly observed in the Eastern face also.

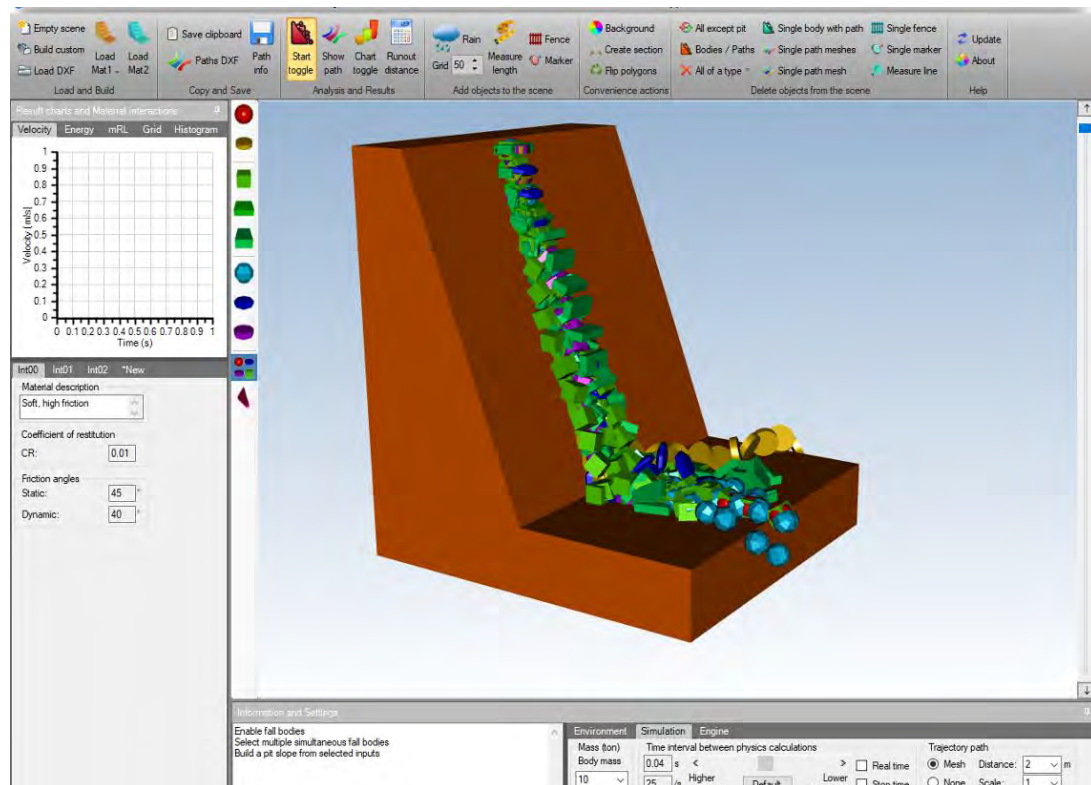
For the eastern face which was simulated as greater than 20m high with and without a rockfall bund 2m high for a number falls of various sizes (0.1T, 1 T and 10T). All rockfall simulations were arrested by the Rockfall bund meaning that this is an appropriate measure for mitigating against rockfalls in Bennetsbridge.

Figure 45 East face rockfall simulation without bund

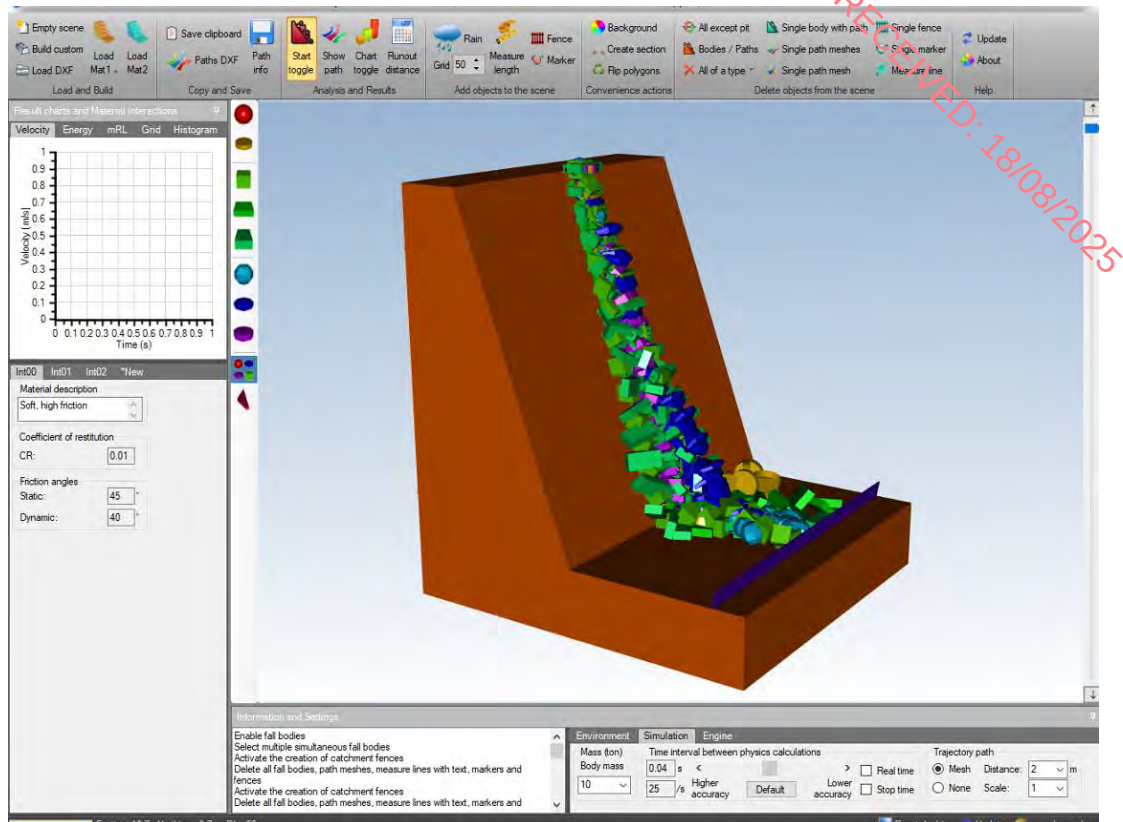
**Figure 46 East face rockfall simulation with 1.5m bund**

If the placement of the bund is an appropriate measure for the highest face in the quarry then it can be applied to the other faces with the same effectiveness. Given that all faces developed since 2016 have remained well below this height it is shown to be an effective means of protection in other areas of the quarry also.

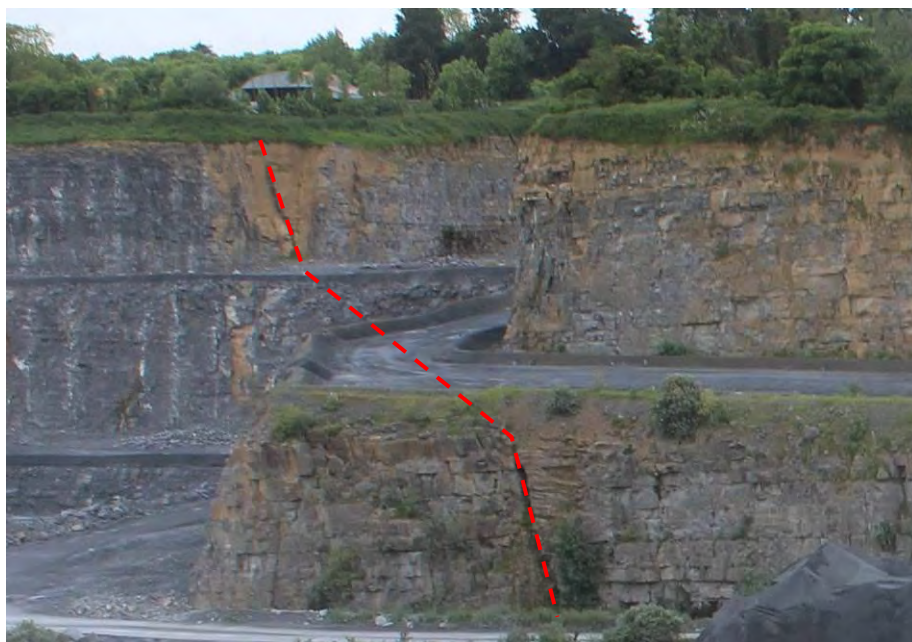
**Figure 4 The main West East trending fault (2024)**

From visual observations the intact rock strength of the rock in the quarry is good. There are local areas of weathering to the East and Southeast of the quarry primarily in the upper benches. Structurally there is a large fault running close to West East through the middle of the quarry. This fault has a large persistence, an aperture of between 0.5m and 2m depending on location with a weathered clay/rock infill. The fault has a measured strike of 080° and a Dip of 80° South.

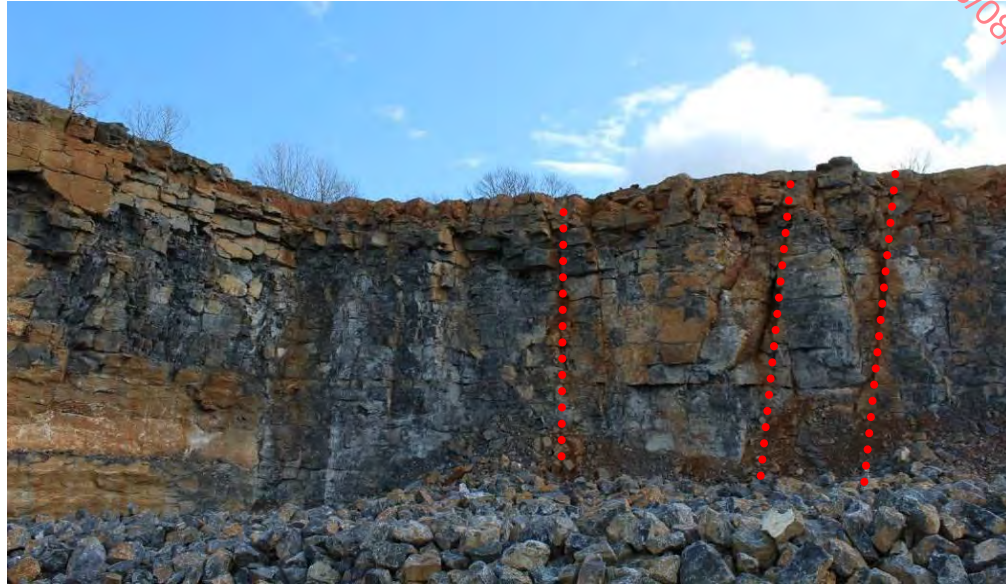
**Figure 5 The primary joint set (highlighted in red taken in 2020)**

The primary joint set has an average orientation of 350° Strike and 85° Dip with a secondary joint set with an average orientation of 064° Strike and 82° Dip. The bedding within the rock is close to horizontal with a slight tendency in dipping to the East.

These orientations give a slight proclivity towards potential toppling failure in the western faces with more likely block failure in the northern, southern and eastern faces. There is no obvious kinematically controlled hazards that are currently near any active portions of the quarry, but this will be discussed further in the geotechnical assessment section of this report.

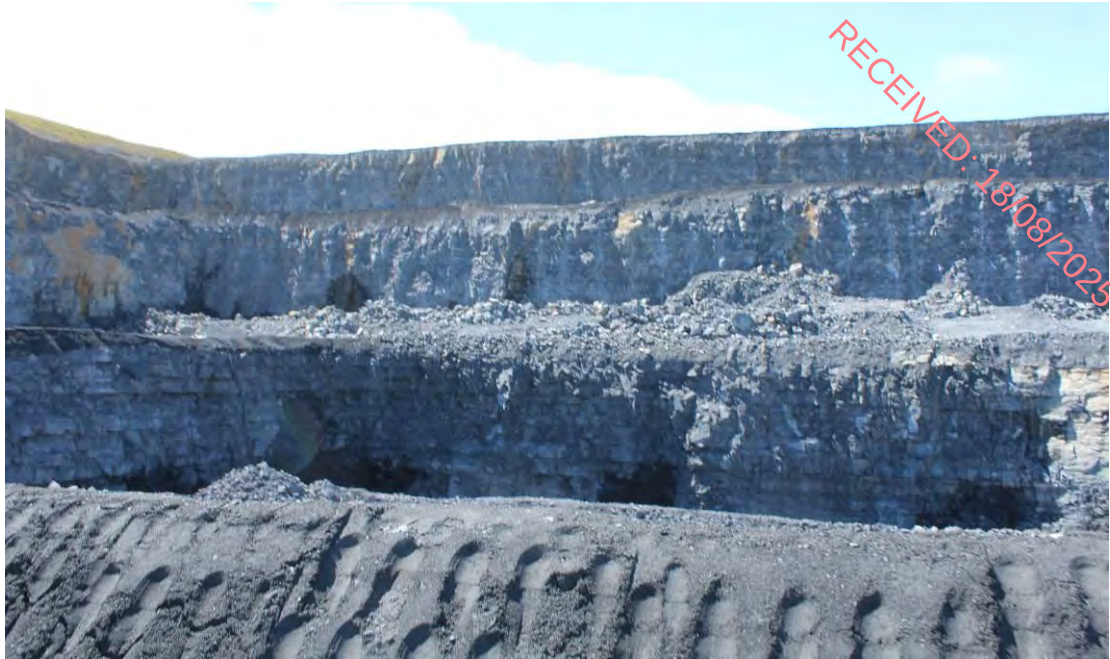
**Figure 9 Individual benches in the southern side of quarry all under 20m in height**

The quarry has been designed and operated to take cognisance of good practice and the 2008 regulations. As a result, a conscious effort has been made to keep individual bench heights below 20m and stand-off zones are present beneath all the currently active and old faces. The quarry operator has also instigated procedures where no unauthorised personnel are allowed anywhere near faces keeping most quarry activity far away from active faces.

There is a section of the East face that has left an overall face height in excess of 20m and therefore this can be considered to be a significant hazard.

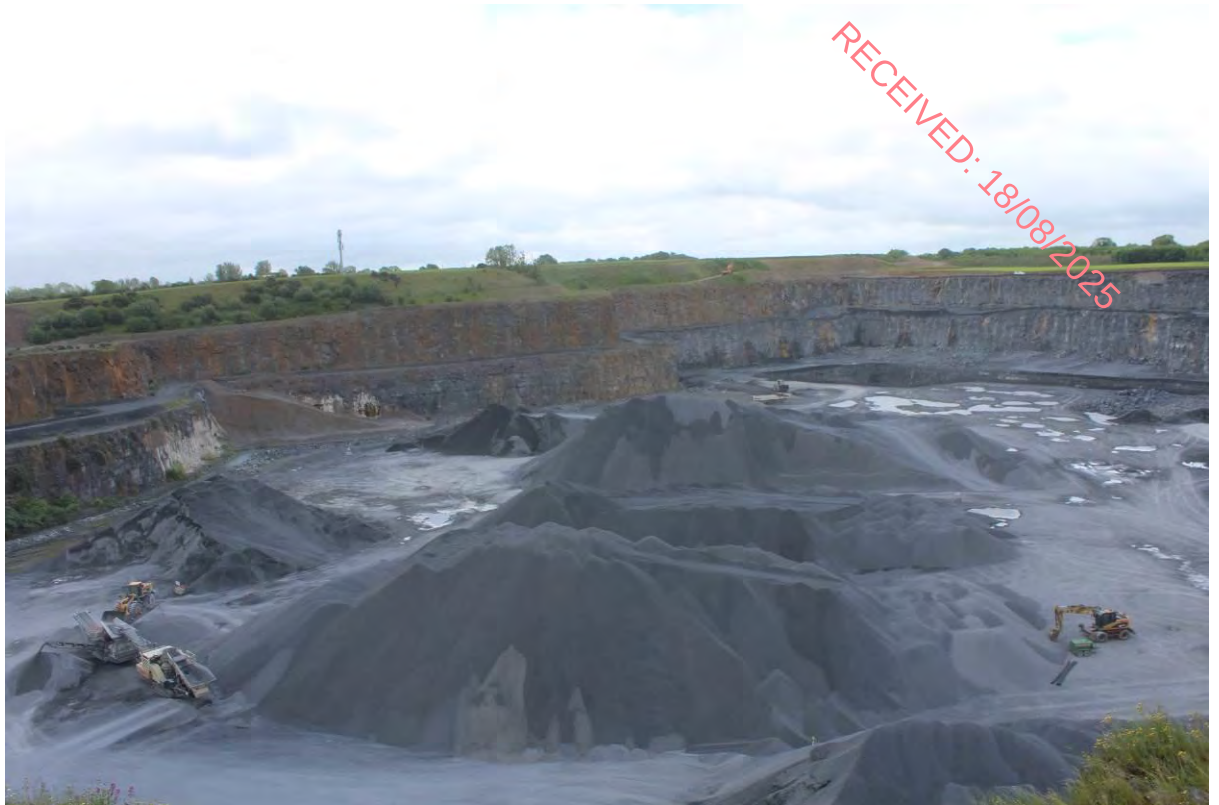
**Figure 11 Showing the stockpiles in BBL Quarry**

The stockpiles at the time of writing in Bennettsbridge Limestone quarry do not exceed any of the above specifications and can be considered stable. The individual stockpiles are below 20m in height, situated on level ground and well drained to the point where all stockpiles are located on dry ground with the quarry drainage system situated between the individual tips.

None of the stockpiles in Bennettsbridge Limestone quarry can be considered a significant hazard as part of the geotechnical appraisal.

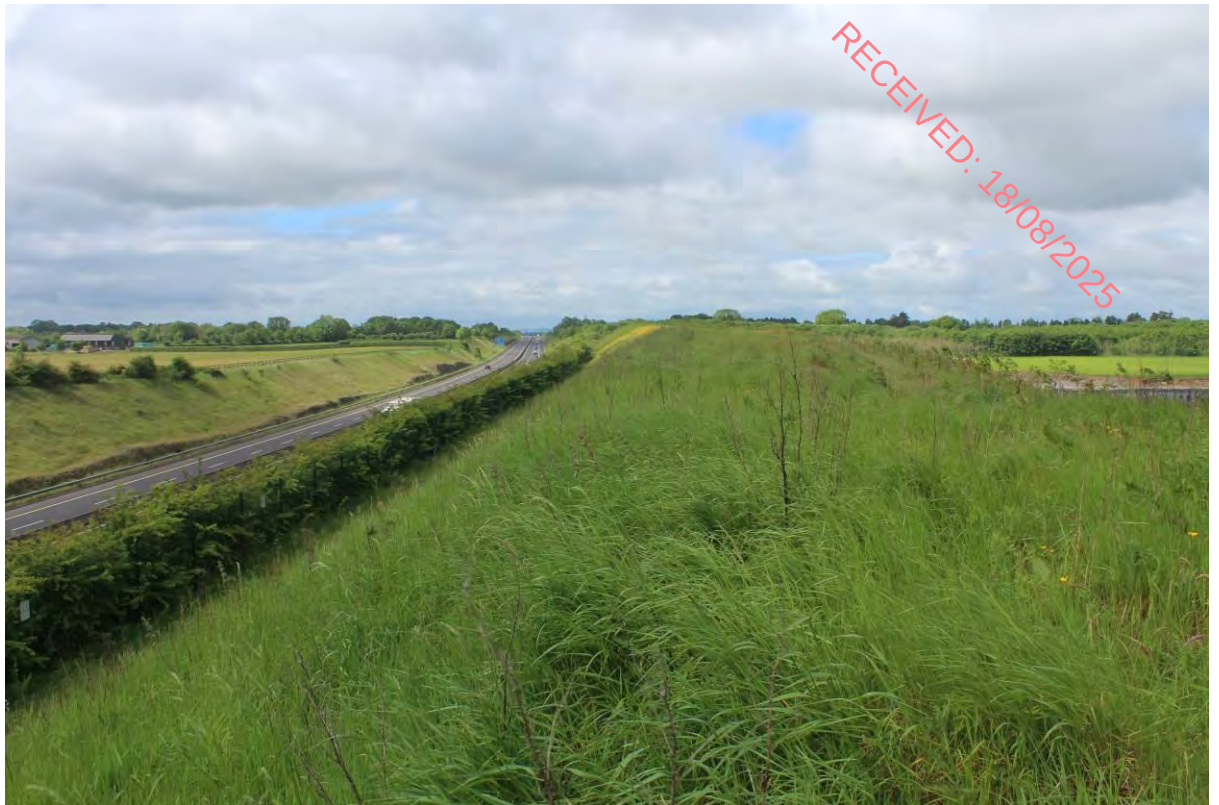
**Figure 12 Bund on southern side of quarry.**

In addition to the stockpiles there has been a significant amount of stripper material placed as a bund to the West of the quarry along the M9 motorway since 2020. The stability of this material was observed closely during construction and its current stability will be examined further in the assessment section of this report.

Since AMS last visit the bund there has been no further change to the bund and it remains stable. AMS has no further recommendation relating to the bund and it will be re- assessed during the next geotechnical assessment.

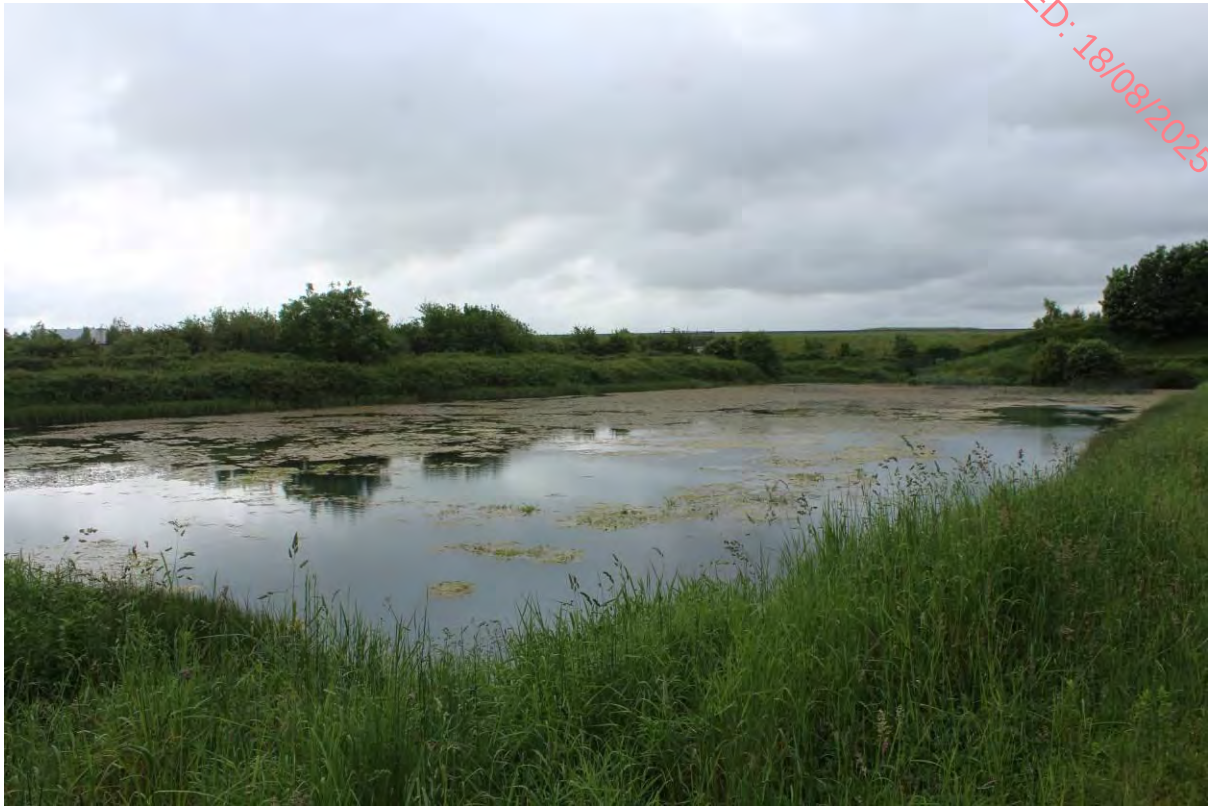
**Figure 14 Showing larger settlement lagoon**

The size, location and orientation of the land around the lagoon are all within the accepted guidelines of the regulation and can be considered not to contain any significant hazards as per the geotechnical appraisal.

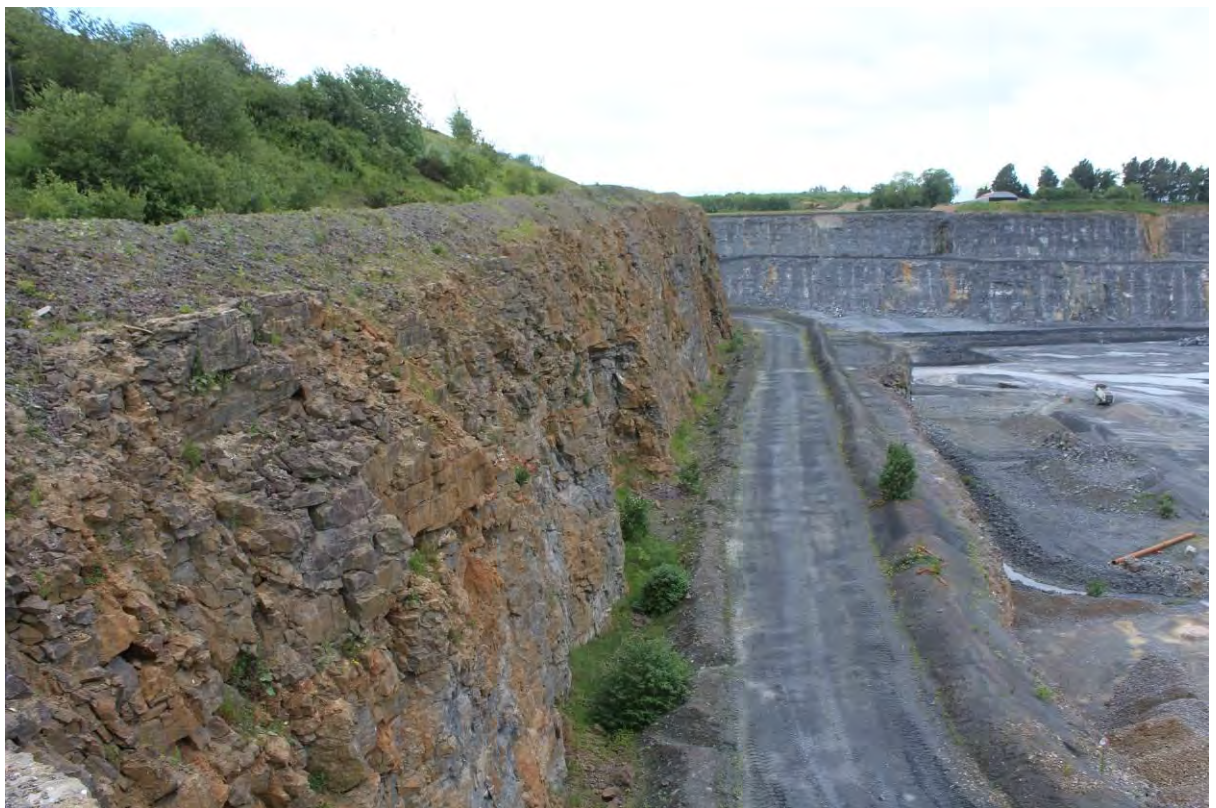
**Figure 16 Southern Upper Face**

An examination of the southern upper face shows a number of examples of loose rock at the top of the face. There is evidence of failure although mostly small in size. It is necessary to monitor the loose rock on this face and although there is little or no

Aside from the visible loose on this face the rock is generally in good condition. There is some localised weathering around the primary joints set but the measured RQD is 79%. All discontinuities were dry on the day of the site visit and have a medium to high persistence, high roughness coefficient and low aperture.

exposure of quarry personnel to these hazards in some cases the loose rock should be removed by using a rockbreaker sitting on top of a temporary ramp. In the interim it is necessary to limit access to this area except when absolutely necessary.

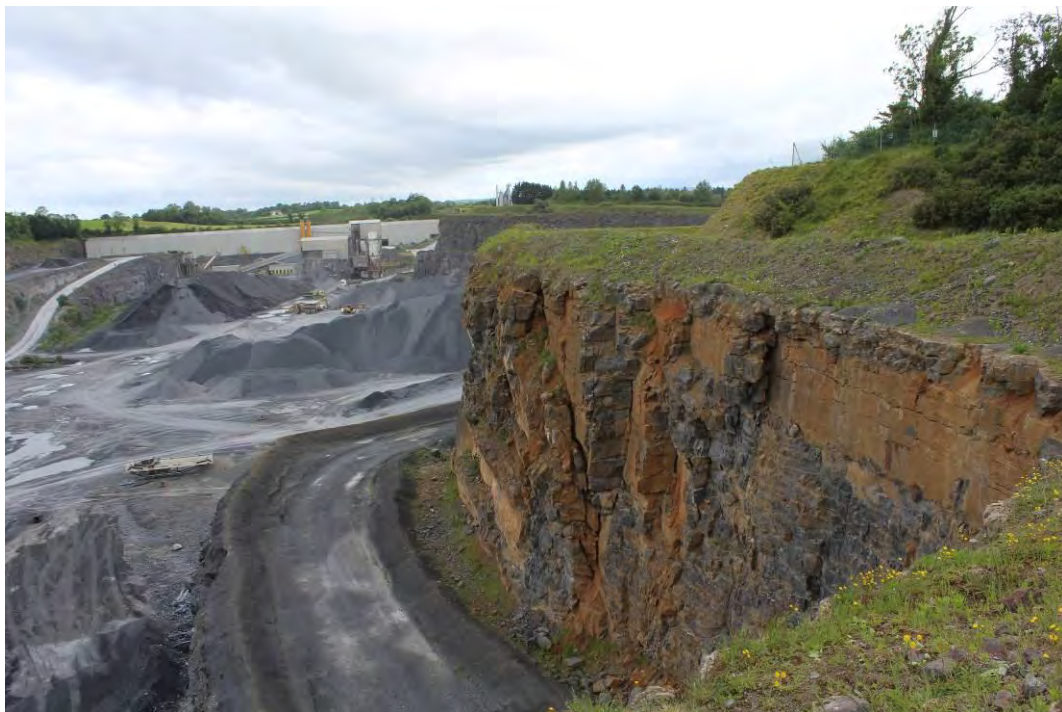
**Figure 18 Southern Upper Face Corner**

It was highlighted in the last assessment that the corners on the access road to the upper southern face had significant loose rock and that the bund in this area should be raised and extended. This work was completed.

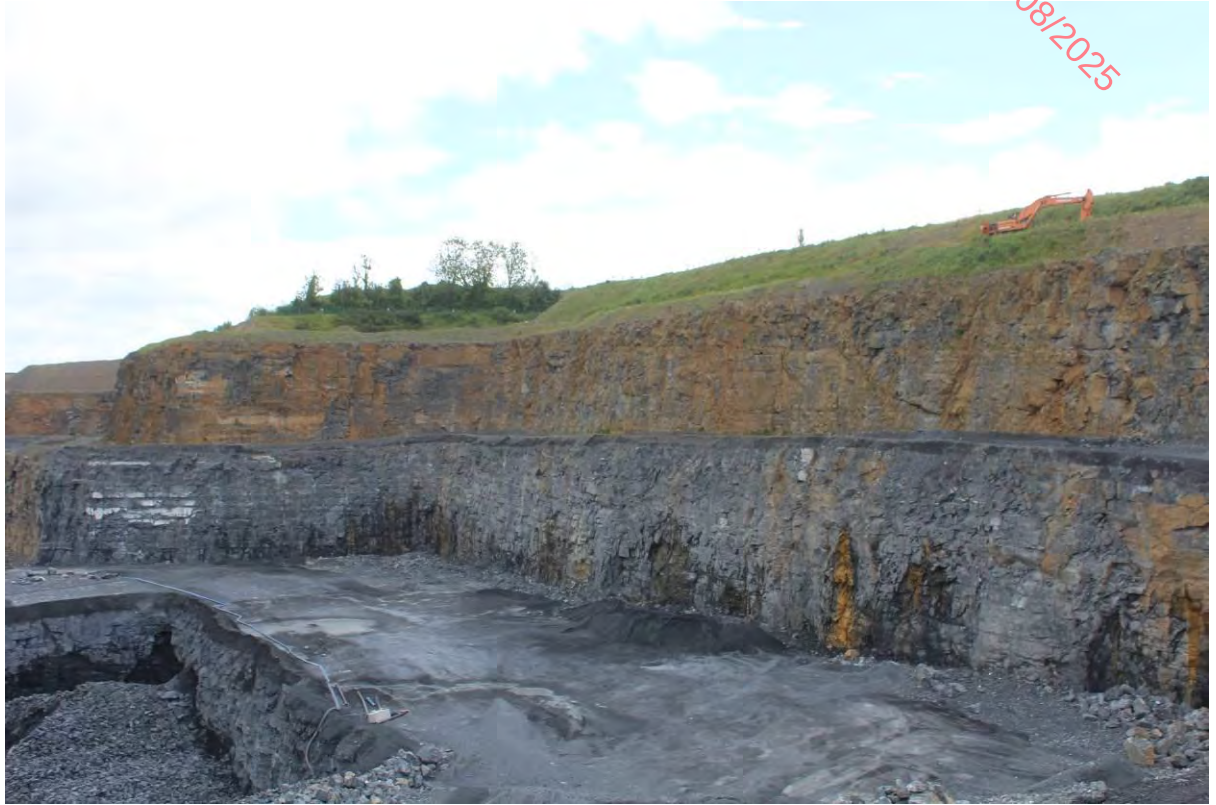
**Figure 19 Southern Lower face**

The southern middle face previously the lower face has not been developed since AMS last visit and remain intact, unweathered and has a good face profile.

AMS has no recommendations regarding the southern middle face.

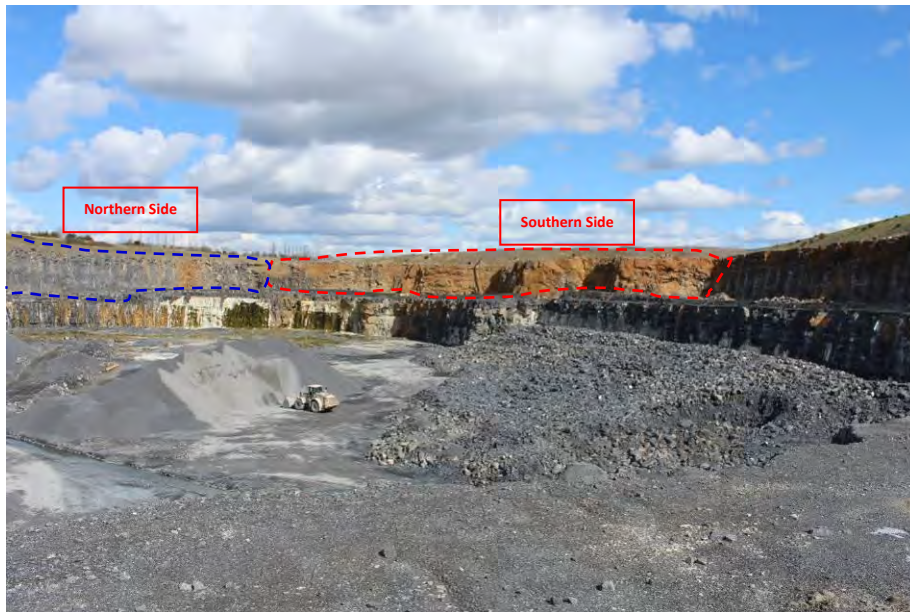
**Figure 20 Eastern Upper faces**

The Eastern upper face is essentially split into two distinct sections from a geotechnical perspective. The southern section highlighted in red in Figure 20 below is composed of a much more weathered rock as illustrated by the orange discoloration in the rock. The rock in this section of the quarry also has an increased dolomite content as it progresses towards neighbouring rock units. In general, this face remains unchanged since the 2016 assessment.

From previous assessments it was noted that the eastern upper face despite the noticeably increased degree of weathering is stable. Much like other faces there is a moderate amount of loose material in the upper sections of the face and some tension cracks at the top of the bench. Access near the face must be restricted in order to lower the risk of exposure.

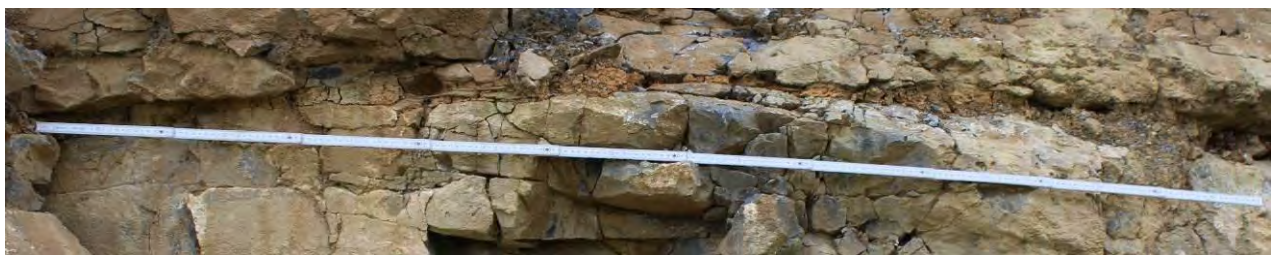
**Figure 22 RQD of weathered section of eastern upper face.**

The measured RQD at two locations is 49. All discontinuities were dry on the day of the site visit and have a medium to high persistence, high roughness coefficient and low aperture. This rock is much more subject to degradation over time and as such assessment should be conducted of this face on an annual basis to monitor this deterioration.

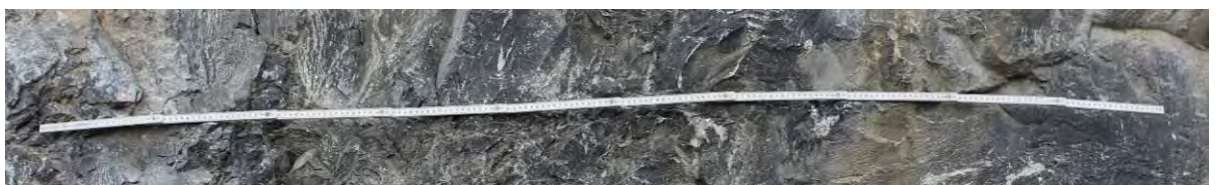
**Figure 24 RQD of eastern upper face norther section**

The measured RQD at two locations is 90 making it a competent rock however the development of large loose blocks is clear in the upper sections of the face. All discontinuities were dry on the day of the site visit and have a medium to high persistence, high roughness coefficient and low aperture.

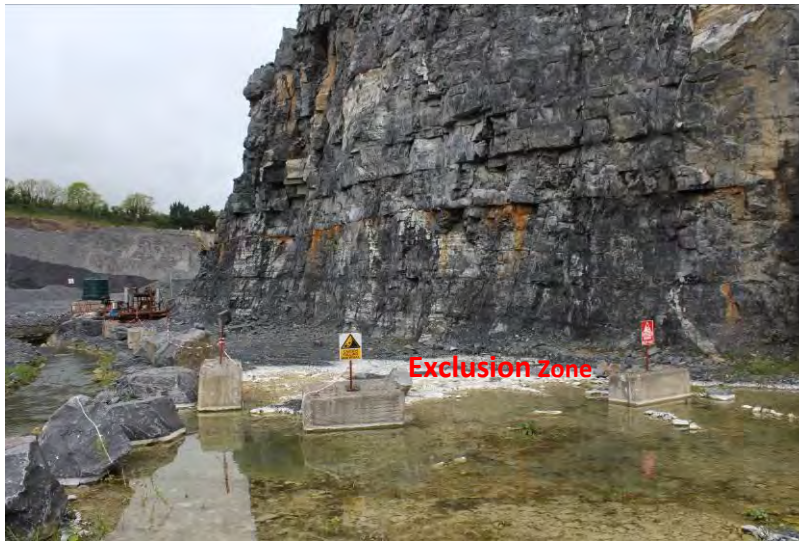
**Figure 25 Exclusion zone beneath overheight face.**

the top of the face and there is also a short section where the middle bench reduces to a width that is too small to be considered as two separate faces making it a singular face that is 32m in height. By the 2008 regulation this is considered to be a significant hazard. The 2016 assessment identified this hazard and recommended the quarry place an exclusion zone beneath this face. This exclusion zone is in place and access beneath this face remains heavily restricted. This face has been observed by AMS for many years now and has not shown any further signs of instability in this time. The control measures in place are effective for this hazard.

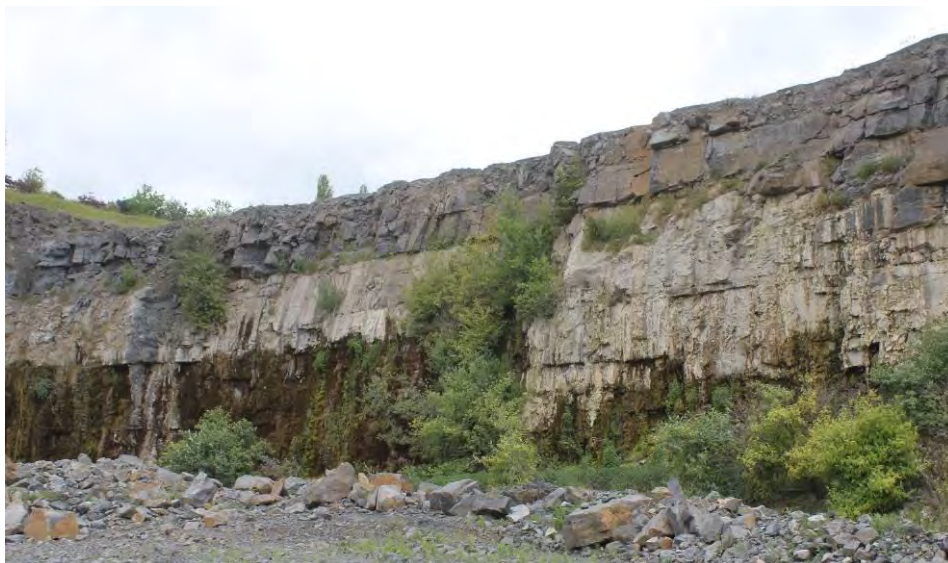
**Figure 26 Eastern Lower Face**

The lower eastern face has not been worked since the 2016 assessment. This face is noticeably the wettest face in the quarry and also is visibly more weathered than most faces. The rock in this section also appears to be more dolomitic in composition than the rest of the quarry. Despite the weathered nature of the rock and the presence of water which always adds to stability concerns this face appears to have less loose material than others. This could be down to the fact that the face has a noticeably shallower angle than most of the other faces which are vertical.

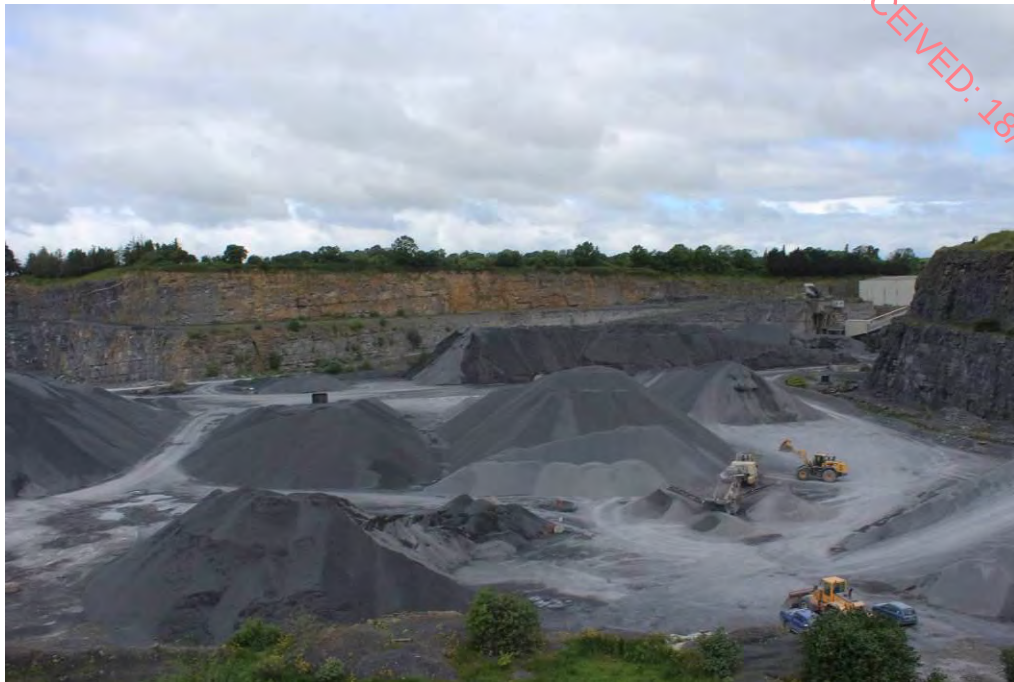
**Figure 27 The western face (northern portion)**

The northern portion of the western faces in Bennettsbridge Limestone shown above have not been active for many years. Some hazards have been identified in this area in previous geotechnical assessments specifically relating to a large overhang in the upper benches and the main fault system, but these hazards have been recognised and control measures in the form of catch trenches and bunds have been put in place and maintained.

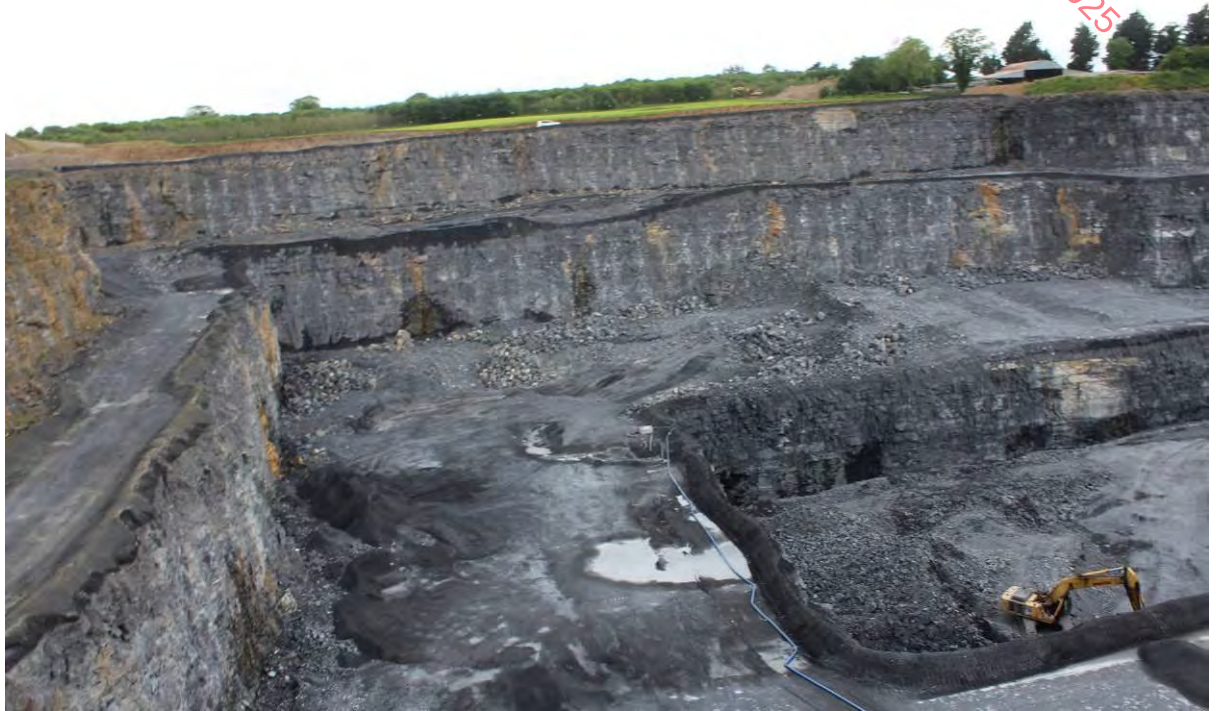
**Figure 29 Western Face Southern portion**

The southern western corner has been developed extensively in recent years. The quality of the rock is excellent. The upper southern face was being prepared for a blast on the day of AMS visit and this face will continue to be developed westwards in the coming years.

The measured RQD at two locations in the western faces is 80 making it a competent rock. All discontinuities were dry on the day of the site visit and have a medium to high persistence, high roughness coefficient and low aperture. AMS has no recommendations regarding the Western faces other than continued observation.
