# APPENDICES INDEX

## Appendix 7-1      GSI & TII Scoping responses with Hydro-G technical responses

**Re: Proposed extension of limestone quarry, Kilree, Sheastown, Bennettsbridge, Co Kilkenny**

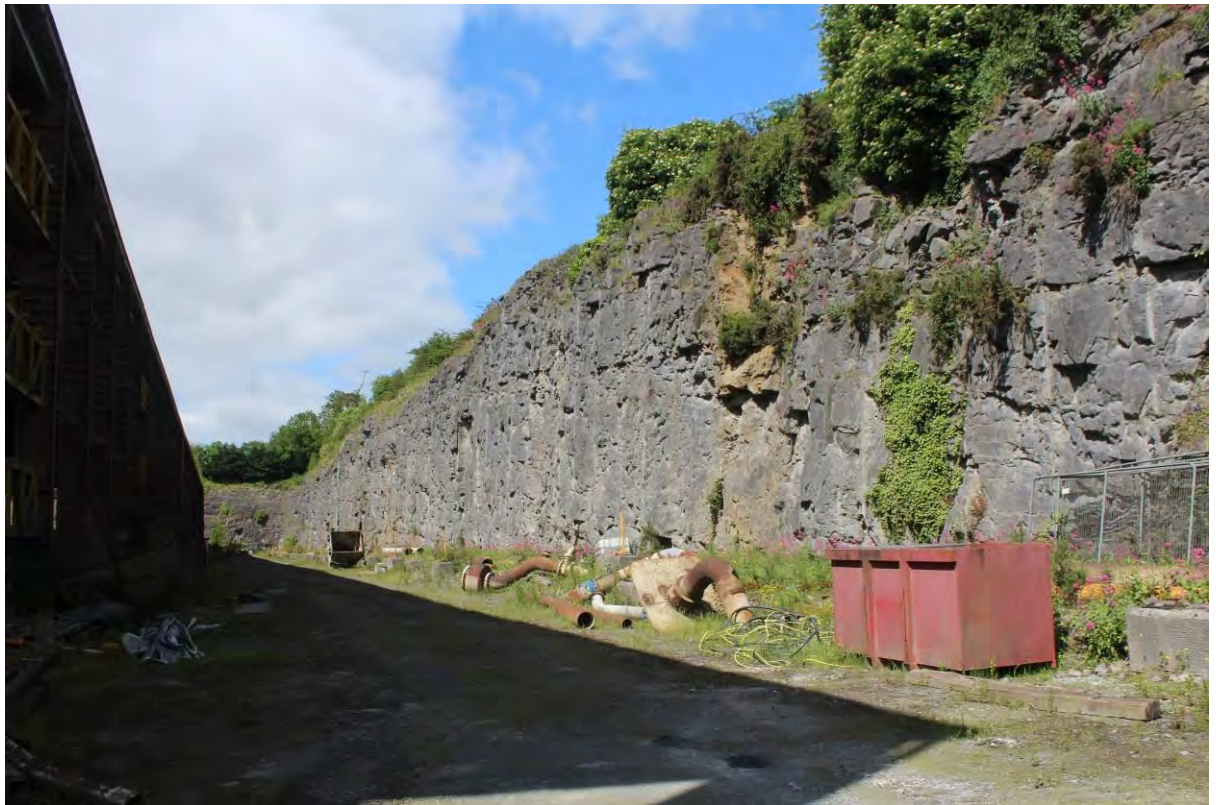
**Figure 31 Northern Upper face**

The upper section of the Northern face is located parallel to the pre-cast building in the north of the quarry. For the most part this face has been there for a long time and been stable for most of that period. There is a chained, signed and banded exclusion zone at the base of this face

The measured RQD at two locations in the Northern faces is 88 making it a competent rock. All discontinuities were dry on the day of the site visit and have a medium to high persistence, high roughness coefficient and low aperture.

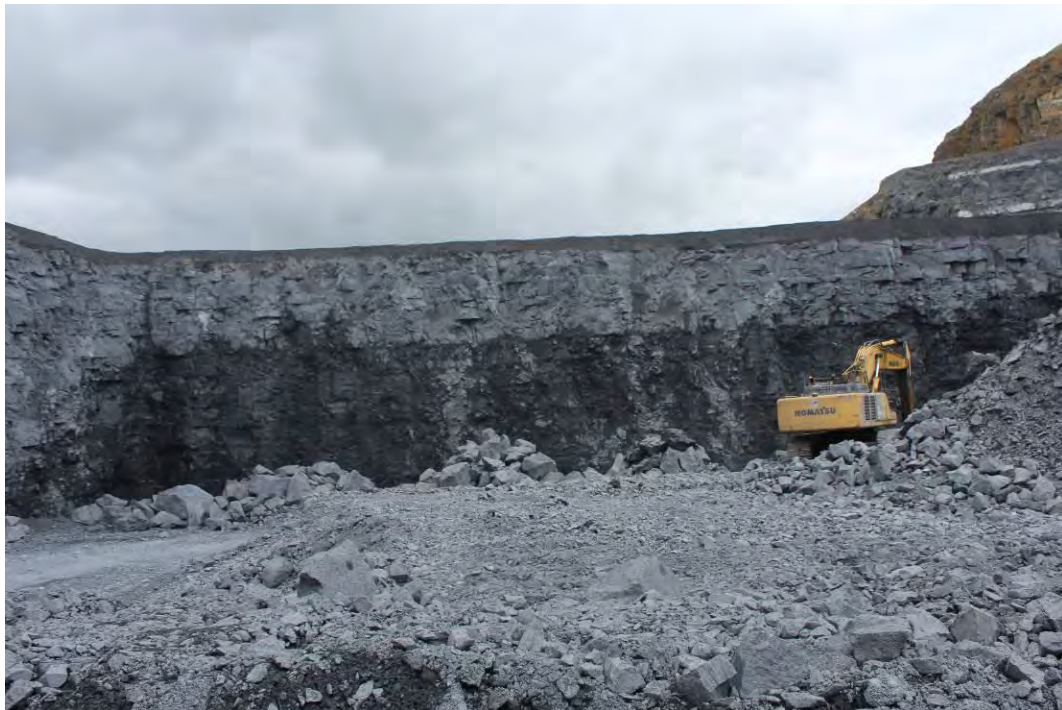
**Figure 33 Lower Face Extension**

Since the last AMS assessment in 2022 the quarry has started a lower bench in the central portion of the southwest floor. The face will be expanded in the coming years. It is currently 15m high and consists of extremely competent rock.

The measured RQD of the lower face extension is 92 making it a competent rock. All discontinuities were dry on the day of the site visit and have a medium to high persistence, high roughness coefficient and low aperture.

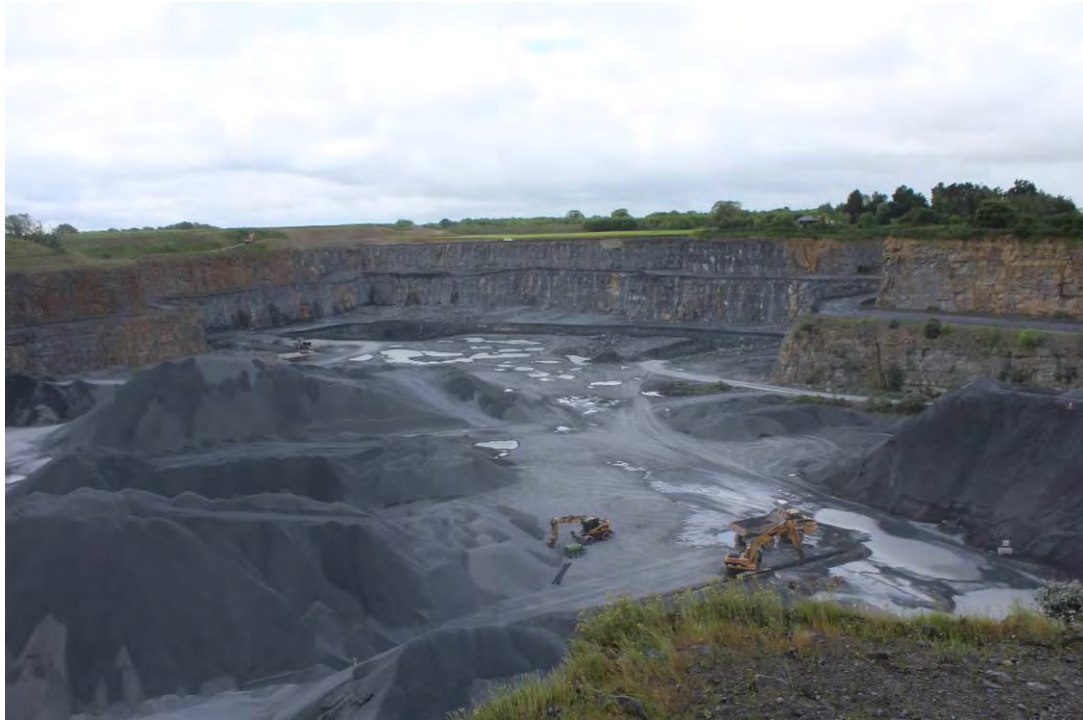
**Figure 34 Showing stockpiles at BBL**

From the site investigation/ geotechnical appraisal it was noted that all stockpiles appear to conform to the guidelines set out in the 2008 regulations. All stockpiles are below 20m in height, do not cover an area greater than 10,000m<sup>2</sup> and are sufficiently drained so as not to cause liquefaction.

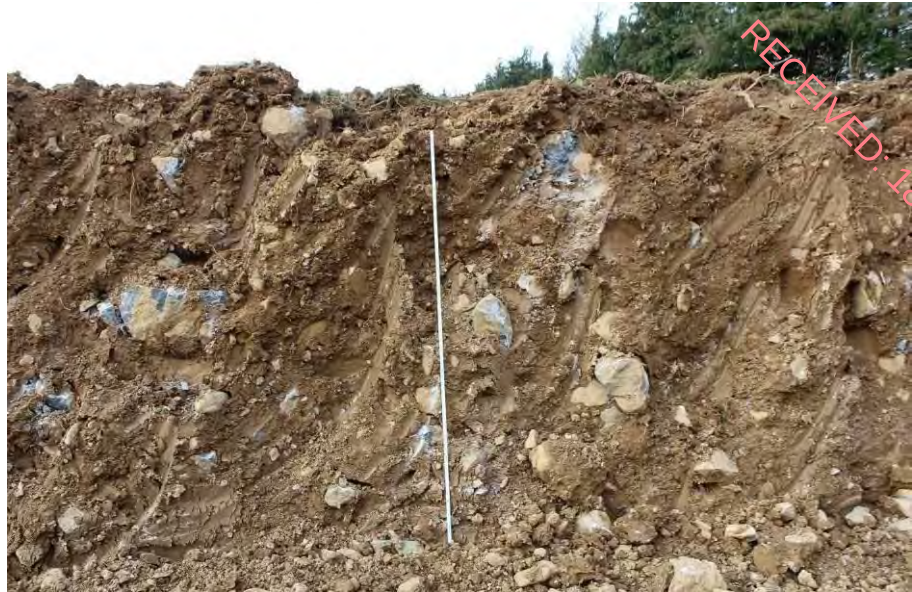
**Figure 35 Excavated material used in bund construction**

In 2020 a significant bund was placed to the south of the quarry site along the boundary with the M9 motorway. During construction material was excavated from the southwestern extension of the quarry. The material was found to be a medium brown, sandy, gravelly CLAY with intermittent grey to blue limestone cobbles.

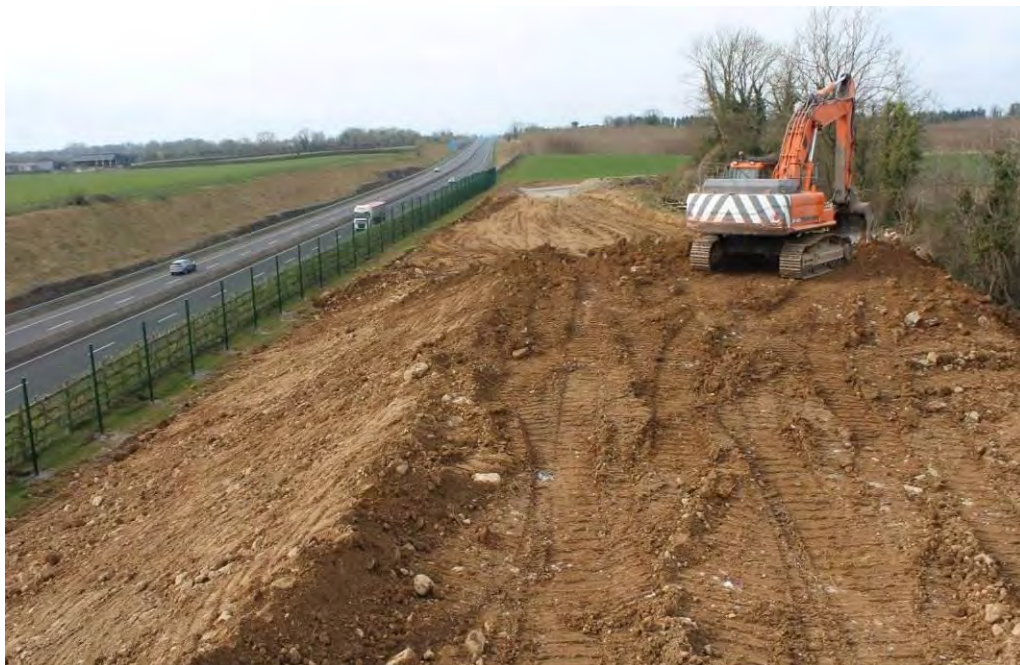
**Figure 36 Bund Construction**

During construction the material was transported across the site and dumped before being placed using a 360 excavator and compacted.

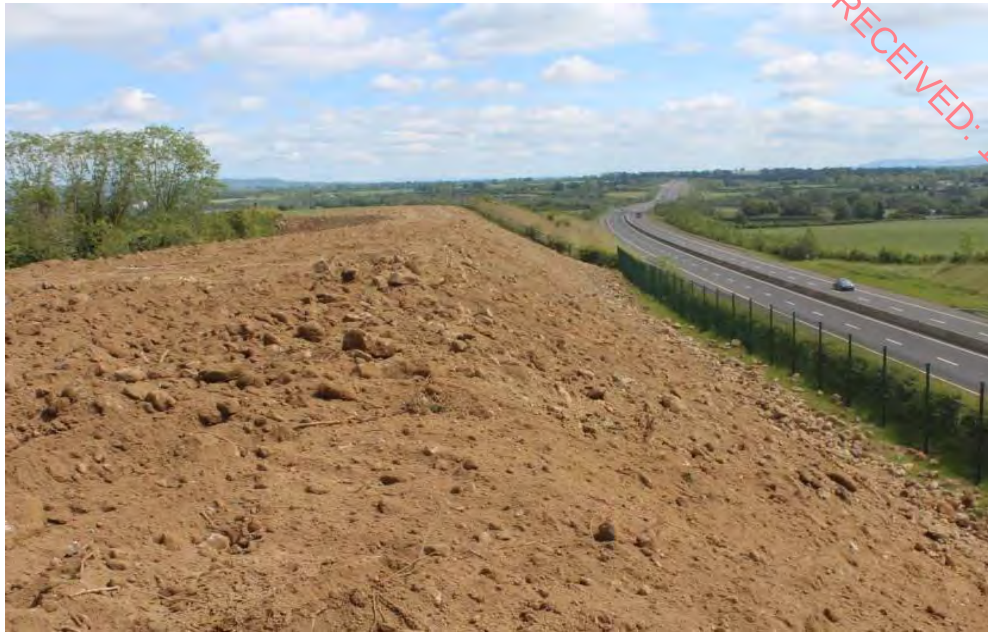
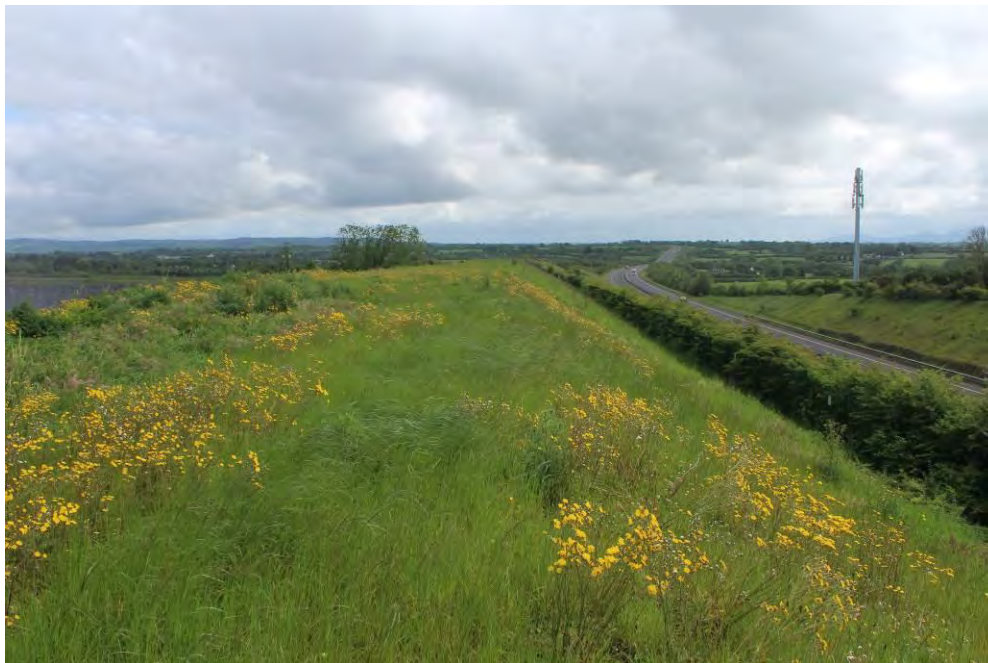
**Figure 38 Bund on completion and bund in 2024**

After construction the berm height was measure as being between 4.5m and 6.6m high with a slope angle of between 20.4° and 27° which complies with the design submitted in the planning application and is shallow enough to be stable for this material type.

Since AMS last visit the bund there has been no further change to the bund and it remains stable. AMS has no further recommendation relating to the bund and it will be re- assessed during the next geotechnical assessment.

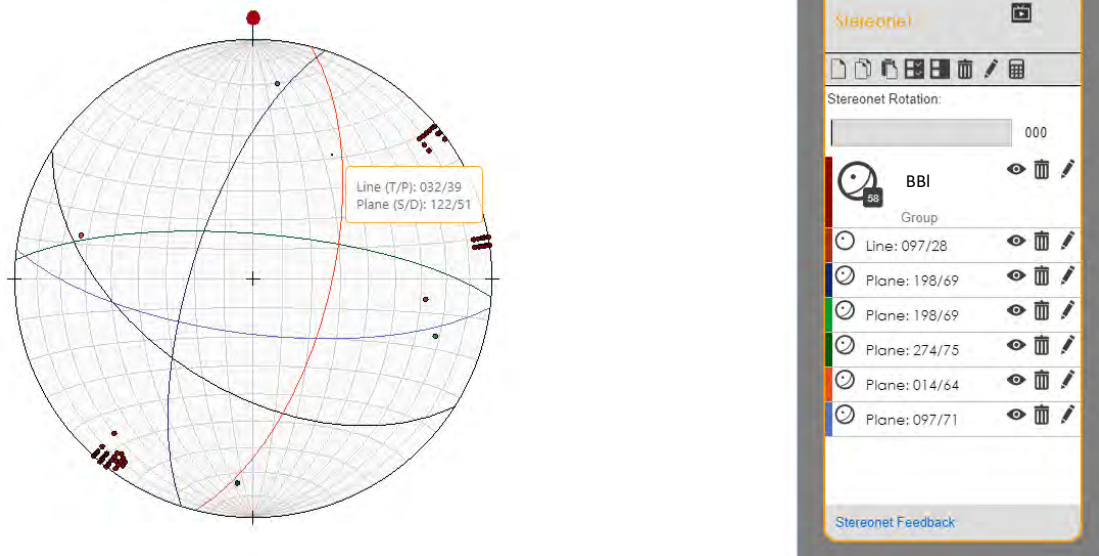
**Figure 39 Discontinuity pole analysis**

Analysis of the poles shows a propensity for toppling failure in the Eastern face. The northern and southern face is more likely to form larger wedge or planar failures however there is a clear potential larger failure directly observed in the Eastern face also.

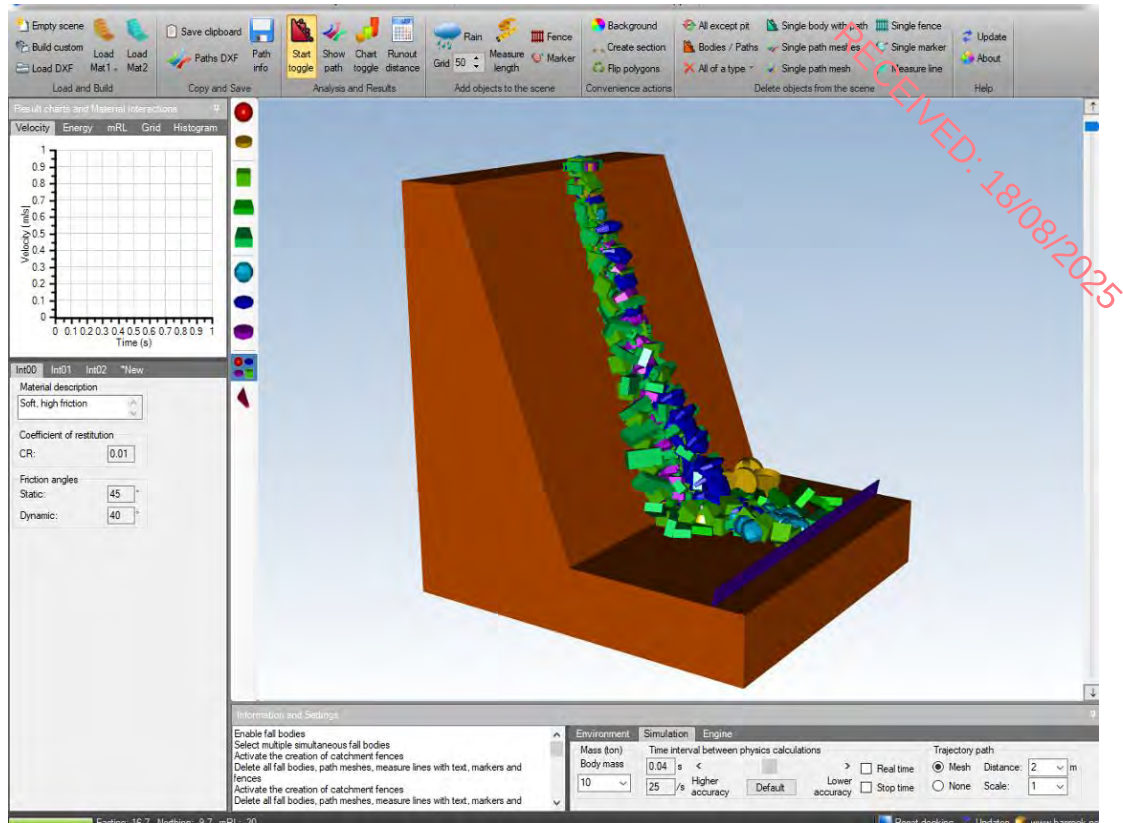
**Figure 42 East face rockfall simulation with 1.5m bund**

If the placement of the bund is an appropriate measure for the highest face in the quarry, then it can be applied to the other faces with the same effectiveness. Given that all new faces since 2016 have been quarried below 20m in height then it is an effective means of protection in the new areas of the quarry also.

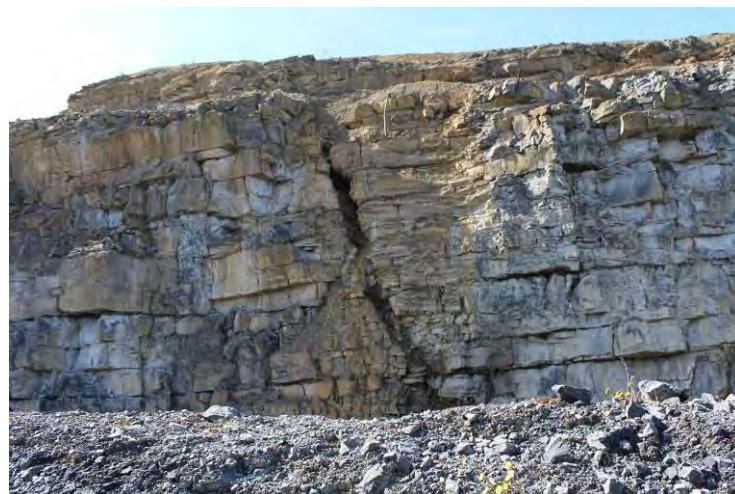
**Figure 5 The main West East trending fault in the northern portion of the west face**

From visual observations the intact rock strength of the rock in the quarry is good. There are local areas of weathering to the East and South East of the quarry primarily in the upper benches. Structurally there is a large fault running close to West East through the middle of the quarry. This fault has a large persistence, an aperture of c.0.5m with a weathered clay/rock infill. The fault has a measured strike of 080° and a Dip of 80° South. It is likely that this fault will continue westwards into the new proposed extension. The likely condition of this fault in the extension can be inferred from the geophysical data later in this report.

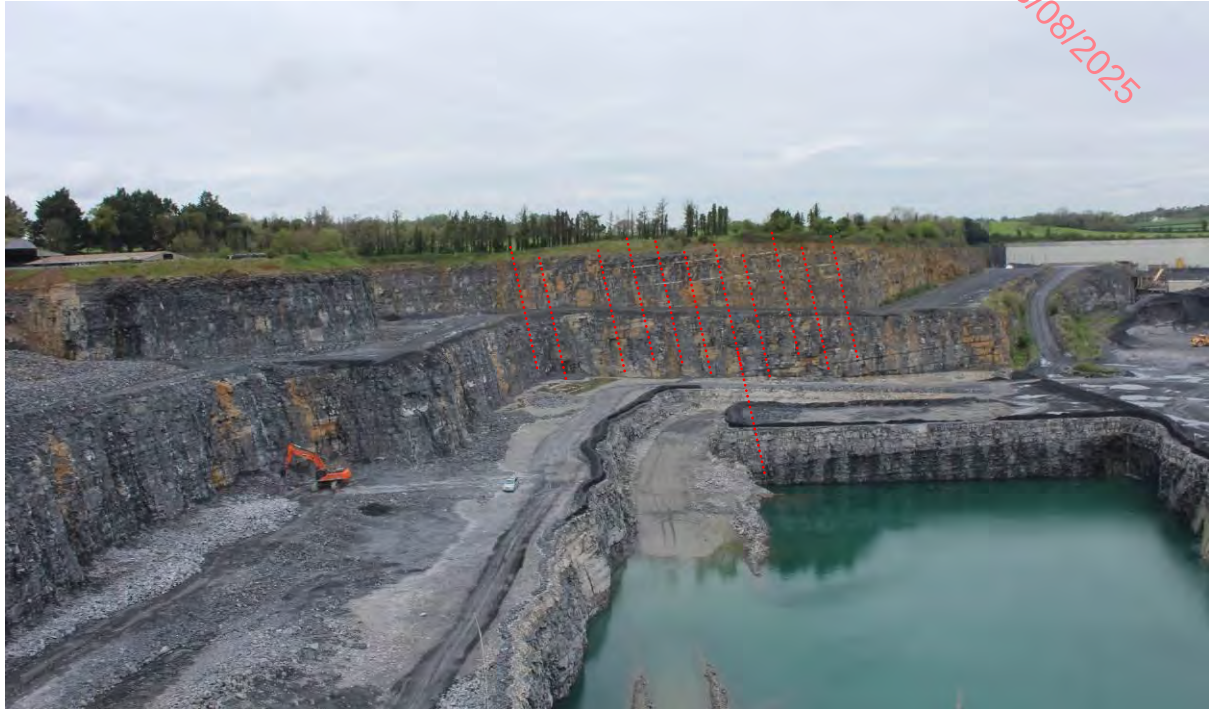
**Figure 6 The Primary joint set (highlighted in red)**

The primary joint set has an average orientation of 350° Strike and 85° Dip with a secondary joint set with an average orientation of 064° Strike and 82° Dip. The bedding within the rock is close to horizontal with a slight tendency in dipping to the East.

These orientations give a slight proclivity towards potential toppling failure or minor planar failure in the western faces with more likely planar or wedge failure in the northern, southern and eastern faces. Overall the quarry is very stable and the quarry operators and manager have excellent knowledge of the rock conditions and quarry safety.

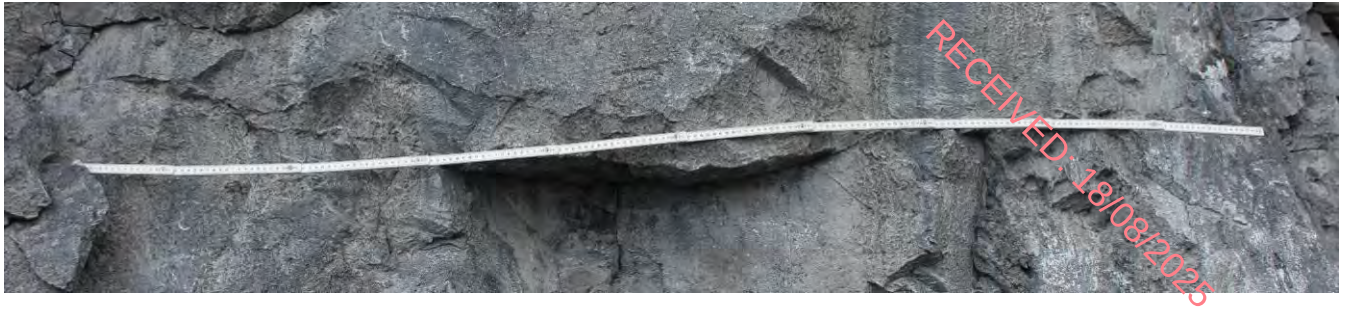
Upper South Western face: Unweathered, medium thick bedded limestone. Large joint spacing. Low joint aperture with clean joint surface. RQD-92.

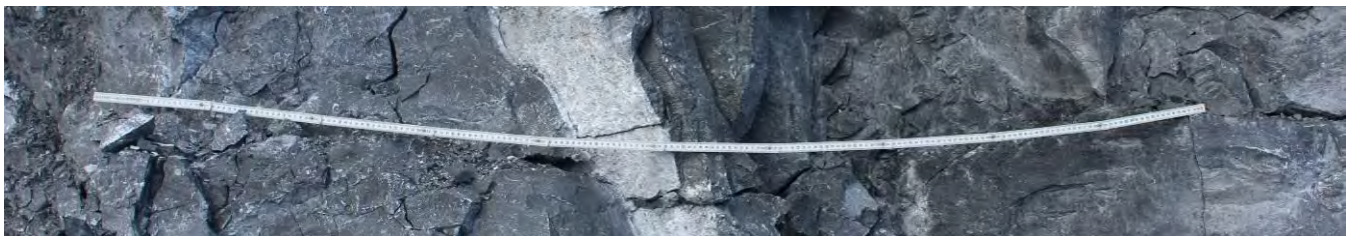
Lower South Western face: Unweathered, medium thick bedded limestone. Medium joint spacing. Low joint aperture with some light calcite infill. RQD-80.

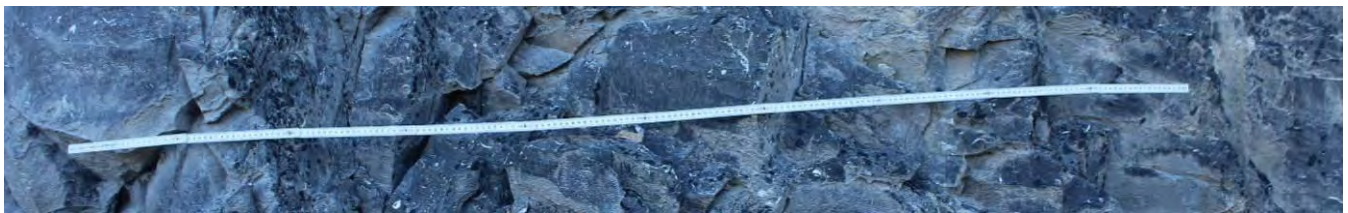
Upper North Western Face: Unweathered, medium thick bedded limestone. Medium joint spacing. Low joint aperture with some light brown staining. RQD-78.

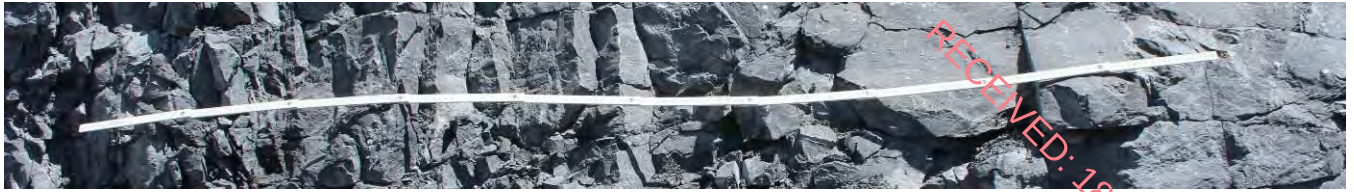
Upper North Western Face: Unweathered, medium thick bedded limestone. Small to Medium joint spacing. Low joint aperture with clean joint surface. RQD-64.

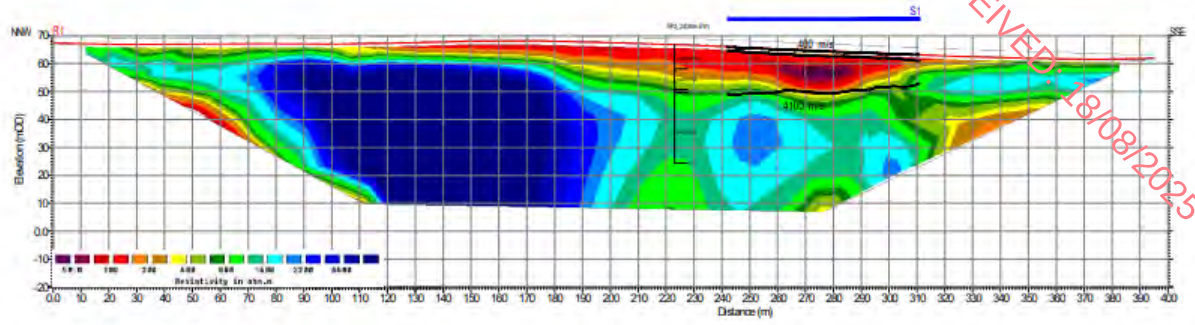
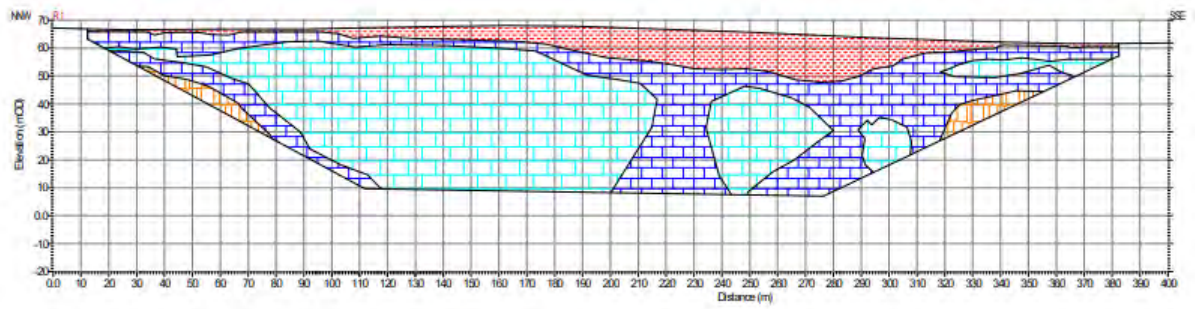
R1

The interpreted inverse resistivity profiles show large areas of clean limestone throughout. In the north west area of the extension there is an area of highly weathered limestone towards the south which correlates with the orientation of the existing known structure highlighted in Figure 5. Although this structure has some aperture and clay infill the weathering surrounding this structure is highly localised and it will pose little stability issues to blasting operations if handled in a similar manner to how it has been managed to date.

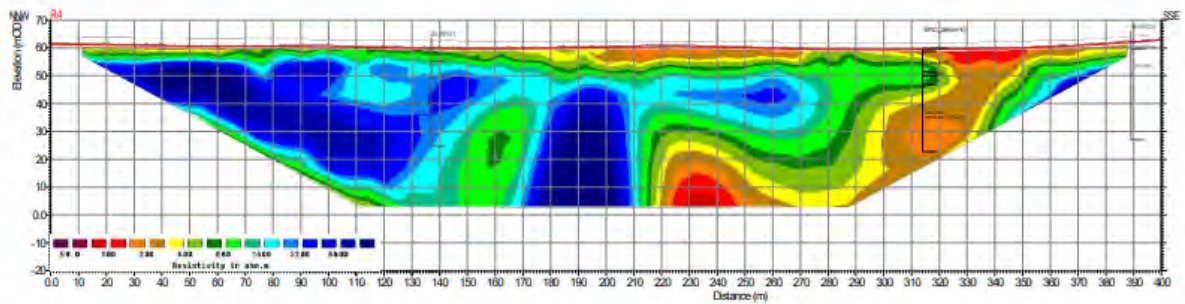
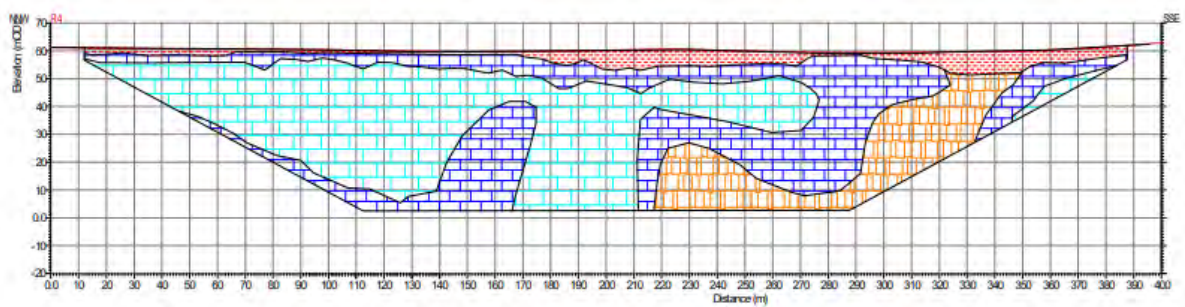
The following is the 2d resistivity sections with the interpreted rock conditions. Sections R1 to R4 run roughly north-south across the north west portion of the extension shown in Figure 9. R7 to R10 run roughly north south across the south west portion of the extension. The associated online seismic survey interpretation is included with the resistivity lines. The legend below is the interpreted rock conditions from the survey data:

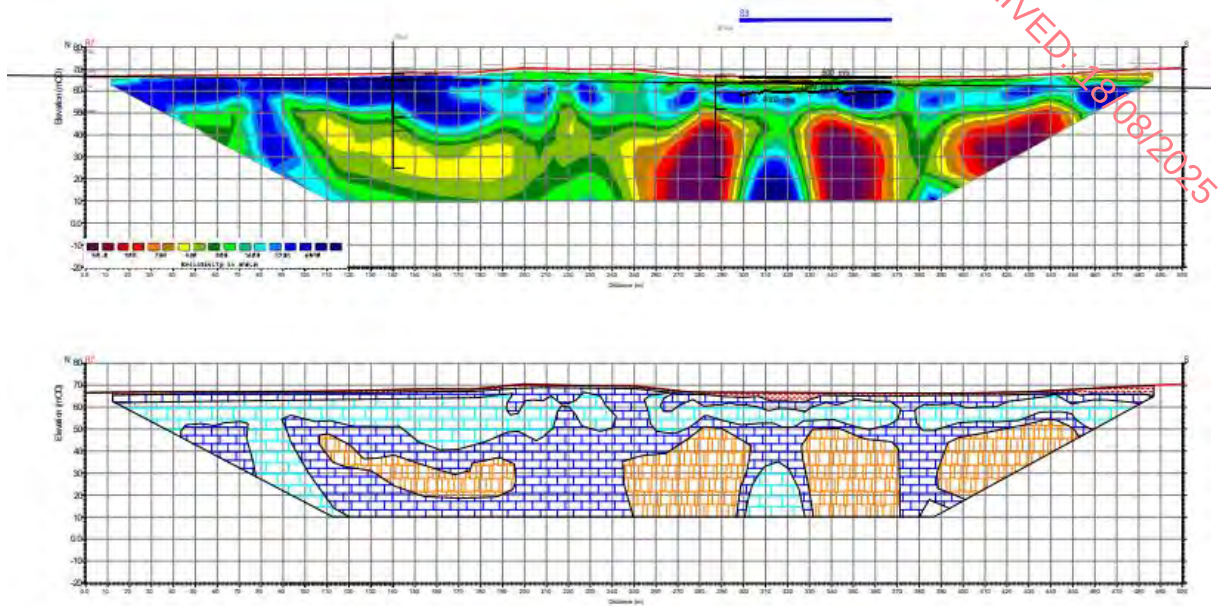
R7

There are some similar high conductivity zones highlighted in the south west area of the extension. There are 3 to 4 separate areas interpreted as highly weathered limestone areas at depth. These could be interpreted as similar structures to the one found in the north west face. There is little evidence currently in the south west face to support this hypothesis

but structures could come across this face starting in the south making their way into the face as it progresses westwards. Great care should be taken when quarrying this face as it could lead to large scale wedge or planar failures.

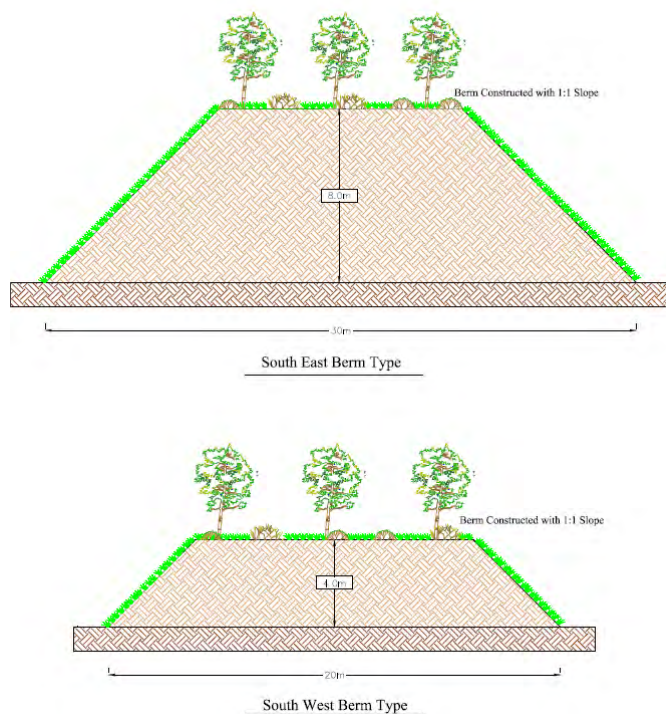
The proposed berm to the south of the quarry will follow the same design as the berm currently in place and will be approximately 10m in height over a width of approximately 30m founded on level ground with proposed side slopes of 1:1.5 and will consist of stripped overburden material which is comprised of Grey to brown sandy cobbly clay. External faces will be vegetated. Given the proposed location of this berm and the observed stability of the existing berm it is deemed as being stable in AMS's opinion.

**Figure 9 Berm design**
