Chapter 15

Architectural Heritage

This report has been produced as an assessment of the potential effects of the N5 Ballaghaderreen to Scramoge Proposed Road Development on built heritage.

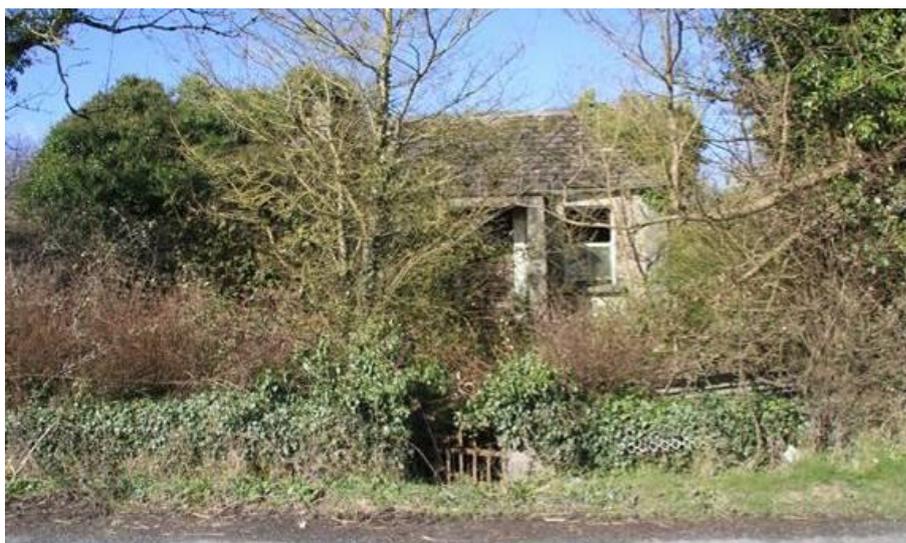
Plate 15.33 House at Kildalloge

Single-storey vacant house on northern side of existing local road, set back from road margin behind a garden and with a wall along road frontage. Wrought iron pedestrian gate at road side. Windows are two-over-two sashes with quadrant horns. Front door is a late 20th century replacement and is set behind a flat-roofed porch. Former estate cottage associated with Strokestown Park House and demesne.

Reference number:	BH-C16 on Figure 15.21 and 15.22
Photo reference number:	Plate 15.33
Address:	Kildalloge
Co-ordinates:	M 9363 8196
Chainage:	On local road near 50+000. Ch. 0+650 on Strokestown Link Road.
Site type & location:	House at Kildalloge on northern side of existing LP-1405 road. Vacant.
Description:	Single-storey house
Approximate date:	Mid-19 th century
Sources:	OS 1 st edition 6" Roscommon sheet 23, 1837-38, 1:2500 Roscommon sheet 23-14
Special interest:	Social, historical
Special interest rating:	Local
Conservation status:	None
NIAH	Not listed
Distance from centre line:	Within footprint of local road at Junction 17 LP-1405 (South).
Type of impact:	Direct

Extent of impact:	House will be demolished
Nature of impact:	Demolition.
Quality of impact:	Negative
Magnitude of impact:	Very high
Impact significance:	Significant
Mitigation measures:	Record house by measured drawings, photographs and written description.
Magnitude with mitigation	Very high
Impact significance after mitigation:	Significant

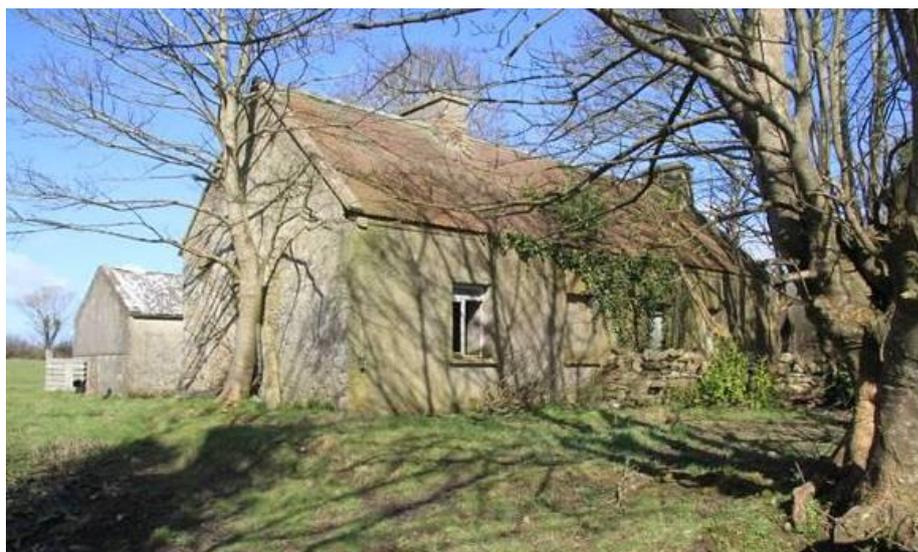
Plate 15.34 House at Kildalloge

Reference number:	BH-C17 on Figure 15.21 and 15.22
Photo reference number:	Plate 15.34
Address:	Kildalloge
Co-ordinates:	M 9359 8192
Chainage:	On local road near 50+000. Ch. 0+550 on Strokestown Link Road.
Site type & location:	House on northern side of existing LP-1405 road at Kildalloge
Description:	Single-storey house with shed at rear.
Approximate date:	Late 19 th century
Sources:	OS 1 st edition 6" Roscommon sheet 23, 1837-38, 1:2500 Roscommon sheet 23-14
Special interest:	Social, historical
Special interest rating:	Local
Conservation status:	None
NIAH	Not listed
Distance from centre line:	12m from centre of realigned local road at Junction 17 LP-1405 (South).
Type of impact:	Indirect

Extent of impact:	Slight
Nature of impact:	Visual
Quality of impact:	Negative
Magnitude of impact:	Low
Impact significance:	Imperceptible
Mitigation measures:	None
Magnitude with mitigation	n/a
Impact significance after mitigation:	n/a

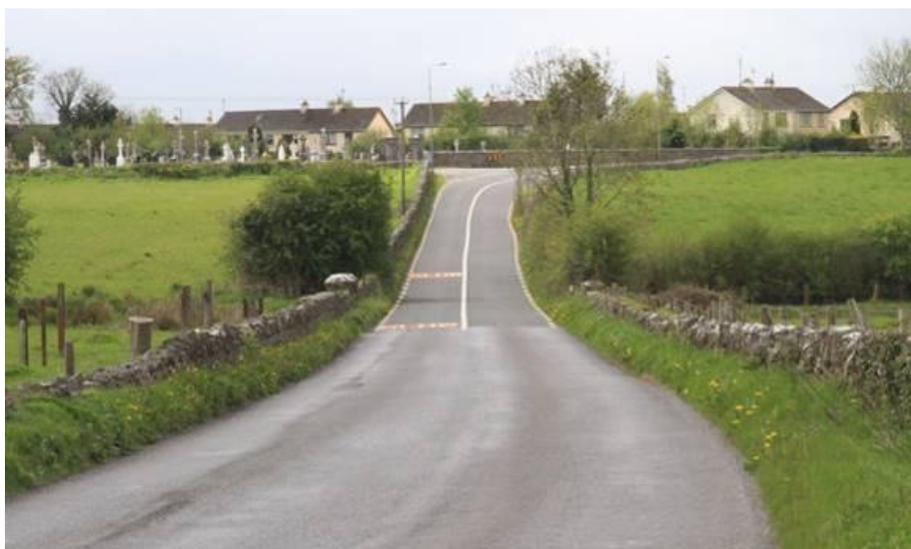
Plate 15.35 Stone Walls at Kildalloge

Reference number:	BH-C18 on Figure 15.21 and 15.22
Photo reference number:	Plate 15.35
Address:	Kildalloge and Lavally
Co-ordinates:	Between M 9339 8170 and M 9267 8198 approximately
Chainage:	On local road LP-1405 (south) near junction 17B.
Site type & location:	Walls alongside local road (LP-1405) at Kildalloge and Lavally.
Description:	Dry-stone walls.
Approximate date:	Eighteenth or early 19 th century
Sources:	Ordnance Survey maps and site survey.
Special interest:	Cultural, social, historical
Special interest rating:	Local
Conservation status:	None
NIAH	Not listed
Distance from centre line:	Within footprint of improved local road at Kildalloge and Lavally
Type of impact:	Direct
Extent of impact:	Profound

Nature of impact:	Roadside walls will be removed along parts of the local road.
Quality of impact:	Negative
Magnitude of impact:	Very high
Impact significance:	Significant
Mitigation measures:	Record walls with photographs and written description. Rebuild sections of stone wall to be removed alongside new LP-1405 (Strokestown Link Road) roadside.
Magnitude with mitigation	Medium
Impact significance after mitigation:	Slight

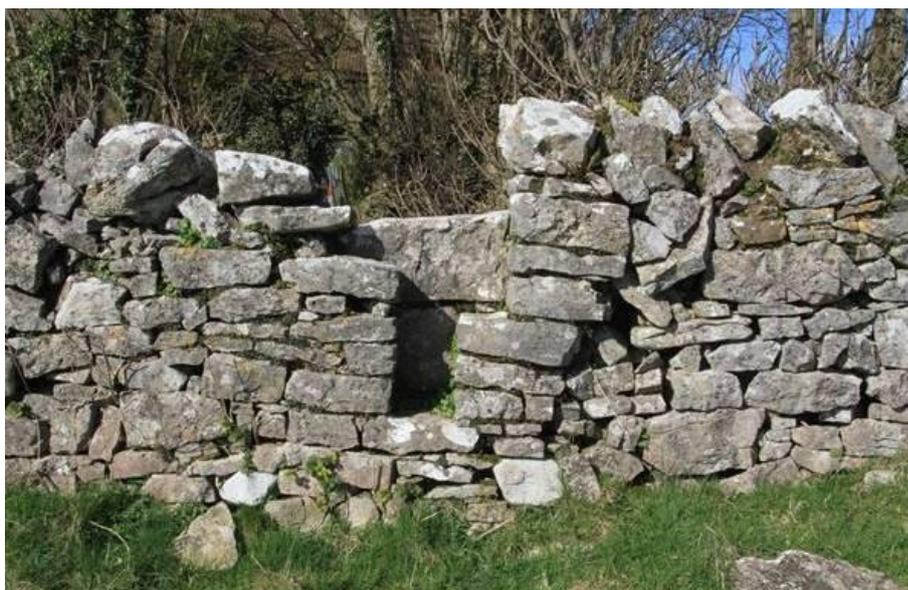
Plate 15.36 Stone Stile at Kildallogge

Reference number:	BH-C19 on Figure 15.21 and 15.22
Photo reference number:	Plate 15.36
Address:	Kildallogge
Co-ordinates:	M 9360 8191
Chainage:	On local road near 50+000. Ch. 0+550 on Strokestown Link Road.
Site type & location:	Stile in wall at roadside margin existing LP-1405.
Description:	Dry-stone stile.
Approximate date:	Early 19 th century
Sources:	Assumed to have served previous house that was shown on first edition Ordnance Survey map of 1837, as well as present house.
Special interest:	Cultural, social, historical
Special interest rating:	Local
Conservation status:	None
NIAH	Not listed
Distance from centre line:	Within footprint of improved local road at Junction 17B LP-1405 (South)
Type of impact:	Direct

Extent of impact:	Profound
Nature of impact:	Roadside wall will be removed, with stile.
Quality of impact:	Negative
Magnitude of impact:	Very high
Impact significance:	Significant
Mitigation measures:	Record stile with photographs and written description. Rebuild into new roadside wall.
Magnitude with mitigation	Medium
Impact significance after mitigation:	Slight

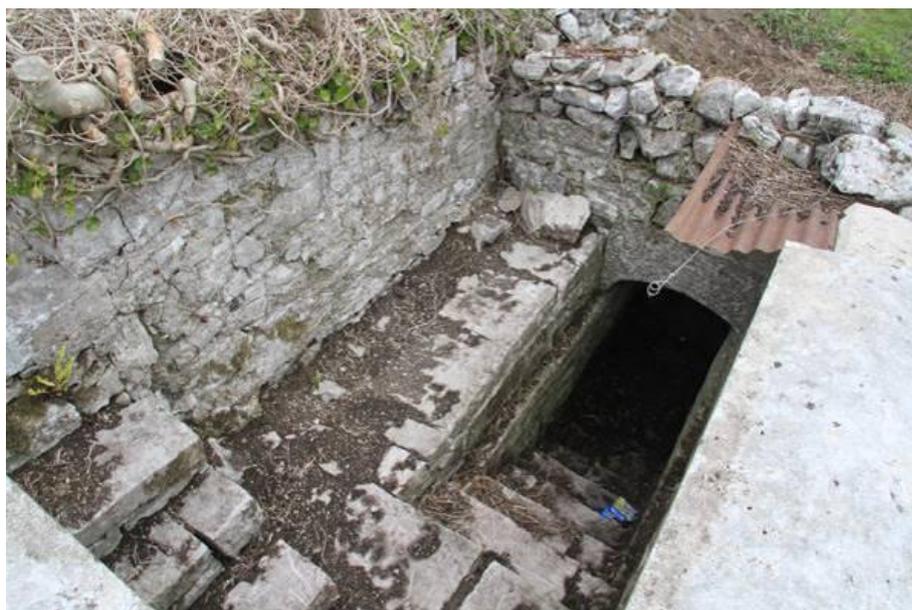
Plate 15.37 Well at Kildalloge

Reference number:	BH-C20 on Figure 15.21 and 15.22
Photo reference number:	Plate 15.37
Address:	Kildalloge
Co-ordinates:	M 9354 8185
Chainage:	On local road near 50+000. Ch. 0+500 on Strokestown Link Road.
Site type & location:	Well on south side of existing LP-1405 road at Kildalloge
Description:	Well, enclosed by stone-built structure.
Approximate date:	ca. late 19 th century

Sources:	OS 1 st edition 6" Roscommon sheet 23, 1837-38, 1:2500 Roscommon sheet 23-14
Special interest:	Cultural, social, historical
Special interest rating:	Local
Conservation status:	None
NIAH	Not listed
Distance from centre line:	Within footprint of local Strokestown Link Road (LP-1405)
Type of impact:	Direct
Extent of impact:	Upper structure would be removed. The well itself would be covered over with a slab to retain it in situ.
Nature of impact:	Well will be encroached upon.
Quality of impact:	Negative
Magnitude of impact:	Very high
Impact significance:	Significant
Mitigation measures:	Record by measured drawings, photographs and written description.
Magnitude with mitigation	Very high
Impact significance after mitigation:	Significant

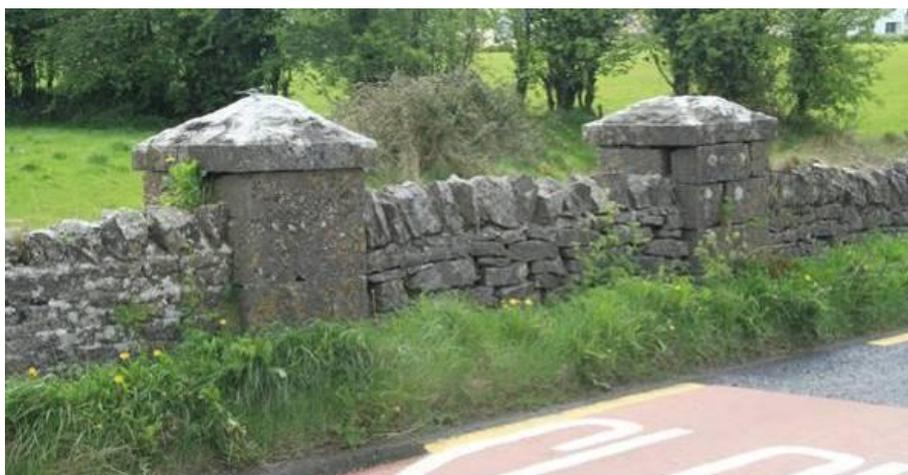
Plate 15.38 Gateway on Eastern Side of Road

Reference number:	BH-C21 on Figure 15.21 and 15.22
Photo reference number:	Plates 15.38 and 15.38
Address:	Kildalloge
Co-ordinates:	M 9342 8172 and M 9341 8172

Chainage:	On local road near 50+000. Ch. 0+325 on Strokestown Link Road.
Site type & location:	Gateways on local existing LP-1405 road at Kildalloge
Description:	Two gateways with stone piers, one with wrought iron gates.
Approximate date:	Late 19 th century
Sources:	Site survey, based on style
Special interest:	n/a
Special interest rating:	Record only
Conservation status:	None
NIAH	Not listed
Distance from centre line:	Within take line for local road improvement It is the intention to retain the eastern gateway in situ however it will be recorded in case of damage during construction due to the proximity to the works.
Type of impact:	Direct on western gateway. Indirect on eastern gateway.
Extent of impact:	Profound impact on western gateway
Nature of impact:	Western gateway will be removed
Quality of impact:	Negative
Magnitude of impact:	n/a
Impact significance:	n/a
Mitigation measures:	Record western gateway with photographs and written description prior to removal.

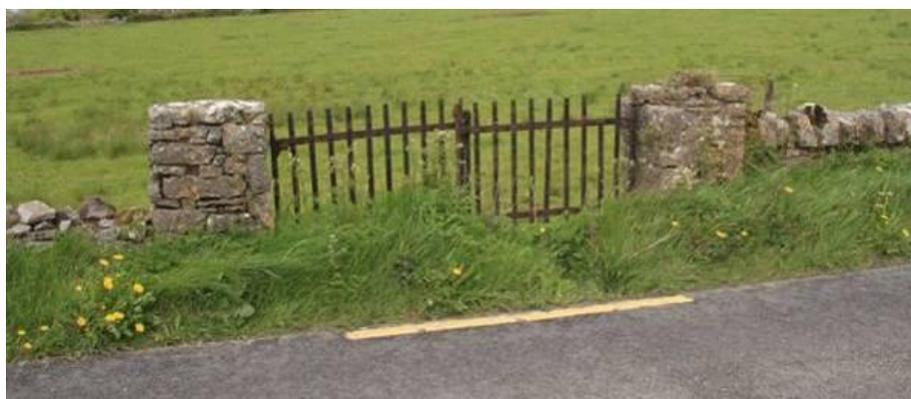
Plate 15.39 Gateway on Western Side of Road

The western gate piers are not quite so large and are constructed of limestone rubble; the cappings are missing. The gates are in place and are of wrought iron.

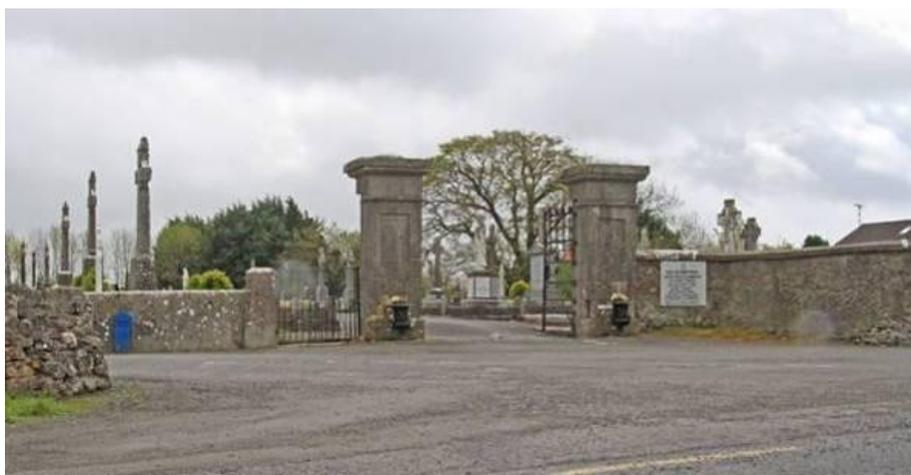
Plate 15.40 **Entrance to Cemetery**

Reference number:	BH-C22 on Figure 15.22
Photo reference number:	Plate 15.40
Address:	Kildalloge
Co-ordinates:	M 9329 8153
Chainage:	On local road near 50+000. Ch. 0+100 on Strokestown Link Road.
Site type & location:	Gateway on existing LT-14054 at Kildalloge (Junction 17E)
Description:	Limestone ashlar gate piers with wrought iron gates, set in walls of mass concrete.
Approximate date:	Gateway early-19 th century; cemetery opened in 1925.
Sources:	OS 1 st edition 6" Roscommon sheet 23, 1837-38, 1:2500 Roscommon sheet 23-14, local information.
Special interest:	Architectural, historical

Special interest rating:	Local
Conservation status:	None
NIAH	Not listed
Distance from centre line:	Adjacent to Junction 17E local access.
Type of impact:	Indirect
Extent of impact:	Slight
Nature of impact:	Visual
Quality of impact:	Low
Magnitude of impact:	Imperceptible
Impact significance:	Slight
Mitigation measures:	None
Magnitude with mitigation	n/a
Impact significance after mitigation:	n/a

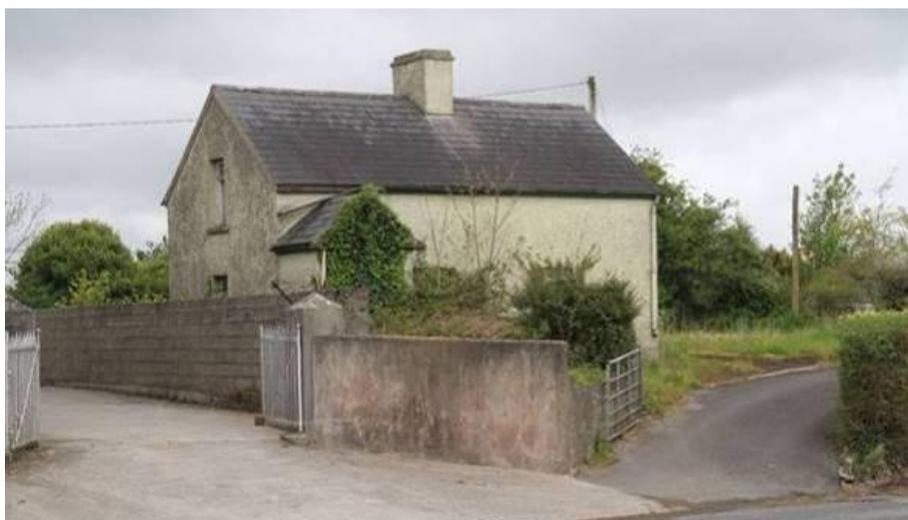
Plate 15.43 **Former Labourer's Cottage at Elphin Street**

Two-storey, three-bay house, built as labourer's cottage in about 1900. Upper floor is partially in roof space, with side-facing windows only, the walls above ground floor to front and rear having no windows. Roughcast rendered and with slate roof. Windows have been replaced. Gable-fronted porch projects to front of main door.

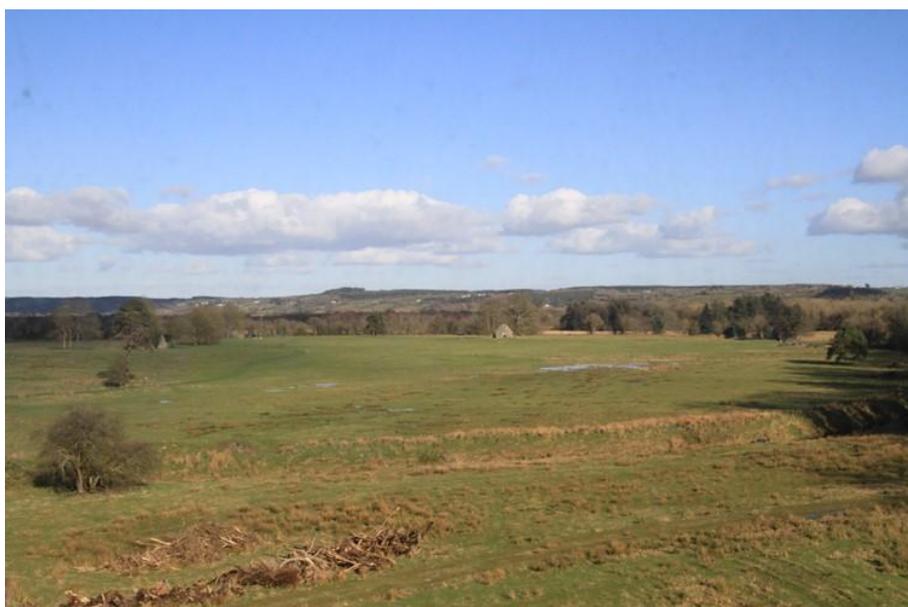
Plate 15.48 Parkland at Rear of Main House

Plate 15.47 shows the parkland to the rear of Strokestown Park House from ground level, while the photograph above (Plate 15.48) shows a similar view, but from the top floor of Strokestown Park House. The old Urney Church is visible in the distance near the centre of the view. It should be noted that the church is approximately 500m from the main house, while the road would be approx. 1100m. The majority of the parkland trees have gone and the two dense belts of trees in the distance have been reduced to single lines.

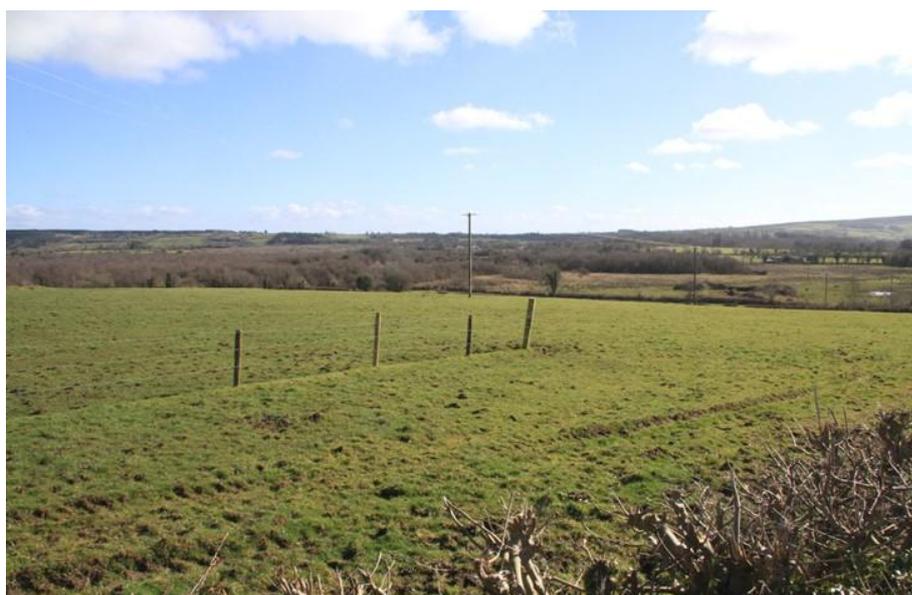
Plate 15.49 Hill Slope at Visnoy

The photograph above shows a view over this hillside from near the top; there are no trees remaining on the slopes and the land has been laid out in fields for grazing.

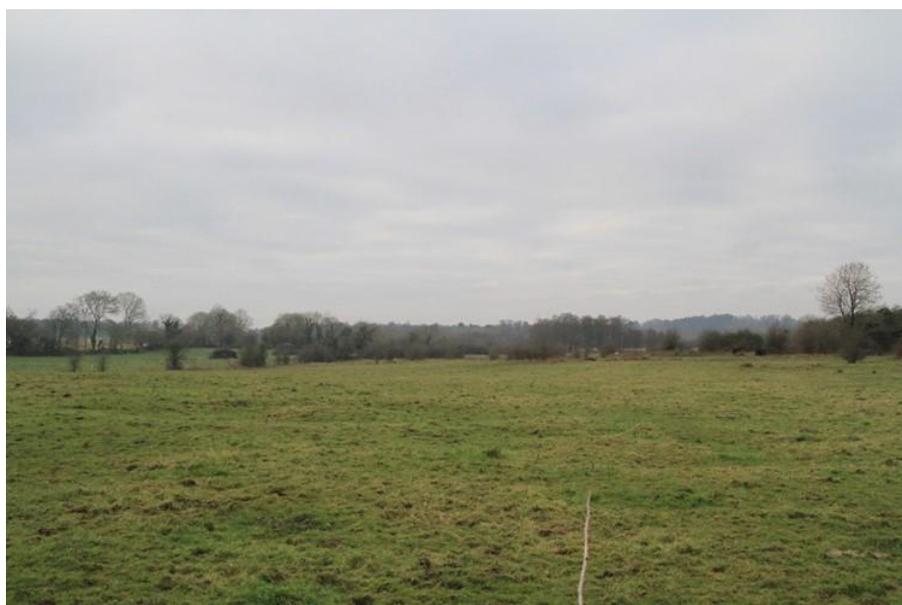
Plate 15.50 Former Woodland at Clonradoon

The photograph above shows a view looking west across the former woodland. The northern part of this woodland is still extant, north of the green broken line on the map extract above. South of this line the area has been cleared and laid out in fields for grazing, with hedgerow trees planted along the field boundaries.

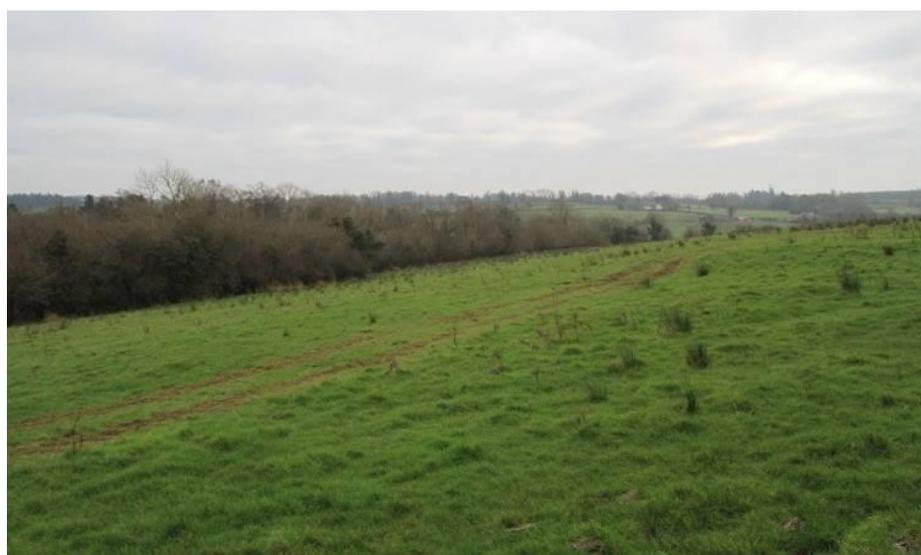
Plate 15.51 Woodland at Bumlin

This strip of woodland is largely intact today, though the westernmost part of it has receded somewhat. The woodland is seen in the photograph above, with the adjacent land used for grazing.

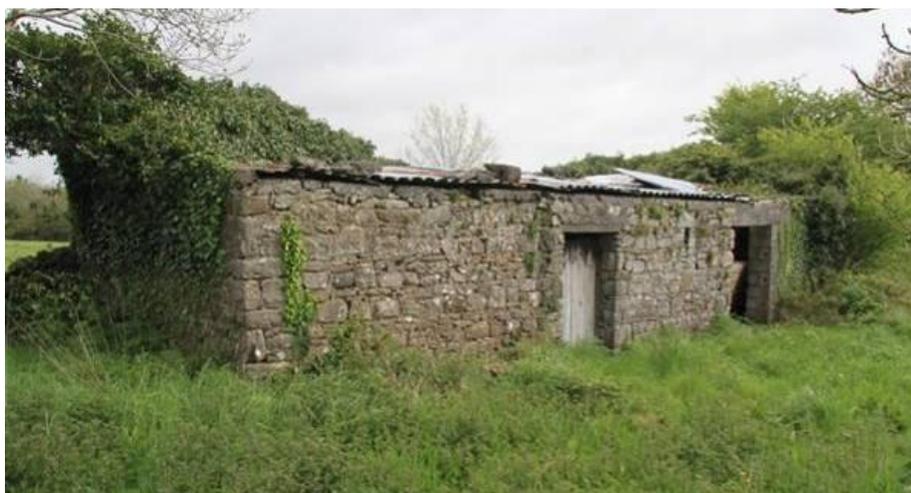
Plate 15.52 Shed at Bumlin

The building was noted in Griffith's valuation as a herd's house.

Reference number:	BH-D04 on Figure 15.24
Photo reference number:	Plate 15.52
Address:	Bumlin
Co-ordinates:	M 9549 8008
Chainage:	52+700
Site type & location:	Stone-built shed at Bumlin
Description:	Single-storey stone-built shed with corrugated iron roof, which is partially collapsed.
Approximate date:	Early 19 th century
Sources:	OS 1 st edition 6" Roscommon sheet 29, 1837-38, 1:2500 Roscommon sheet 29-3 and Griffith's Valuation, at http://www.askaboutireland.ie/griffith-valuation
Special interest:	n/a
Special interest rating:	Record only
Conservation status:	None
NIAH	Not listed
Distance from centre line:	30m from centre line.
Type of impact:	Indirect
Extent of impact	No direct impact

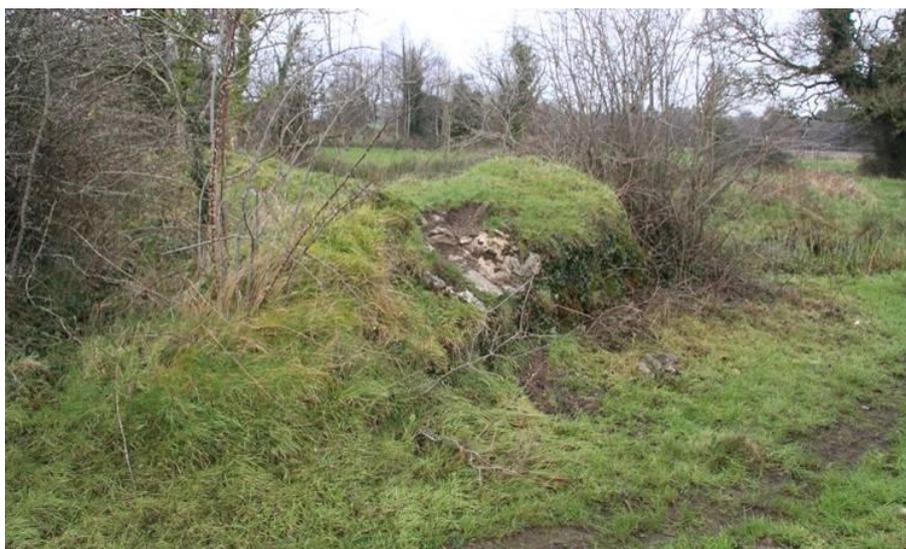
Plate 15.54 Bridge at Bumlin/Scramoge

Reference number:	BH-D06 on Figure 15.24
Photo reference number:	Plate 15.54
Address:	Bumlin and Scramoge
Co-ordinates:	M 9554 7997
Chainage:	52+800
Site type & location:	Bridge, Scramoge River
Description:	Remnants of bridge on two banks.
Approximate date:	Probably pre-18 th century
Sources:	Site inspection, local information
Special interest:	Historical, technical
Special interest rating:	Local
Conservation status:	None
NIAH	Not listed
Distance from centre line:	35m from centre line, c.7m from embankment.
Type of impact:	Indirect – new river crossing will be adjacent to old bridge ruin. The remnants of the bridge will need to be safeguarded during construction.

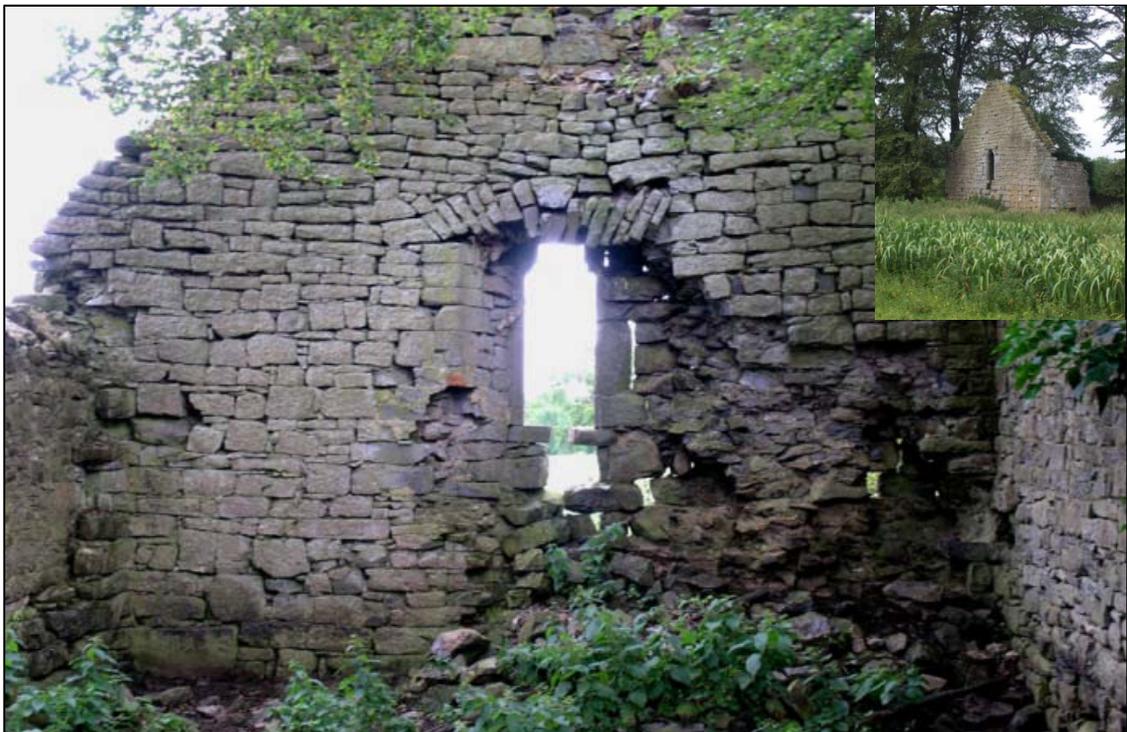
Figure 2 Urney Church circa 2006 (Source: *The Mulvihill Voice – Summer 2006*)

The vibration limits outlined above are intended for the purposes of preventing cosmetic damage to vibration sensitive buildings primarily. It is important to note that a Structural Survey and Assessment Report prepared by Architectural Conservation Professionals (April 2016) (Appendix C) identified the structure as being in a very poor condition (Figure 2 for reference) and the Local Authority has recently notified the property owner of its instability. Bearing this in mind, it is important to note that collapse due to the inherent instability may be imminent. In such a case, no limit on vibration would be sufficient to prevent this.

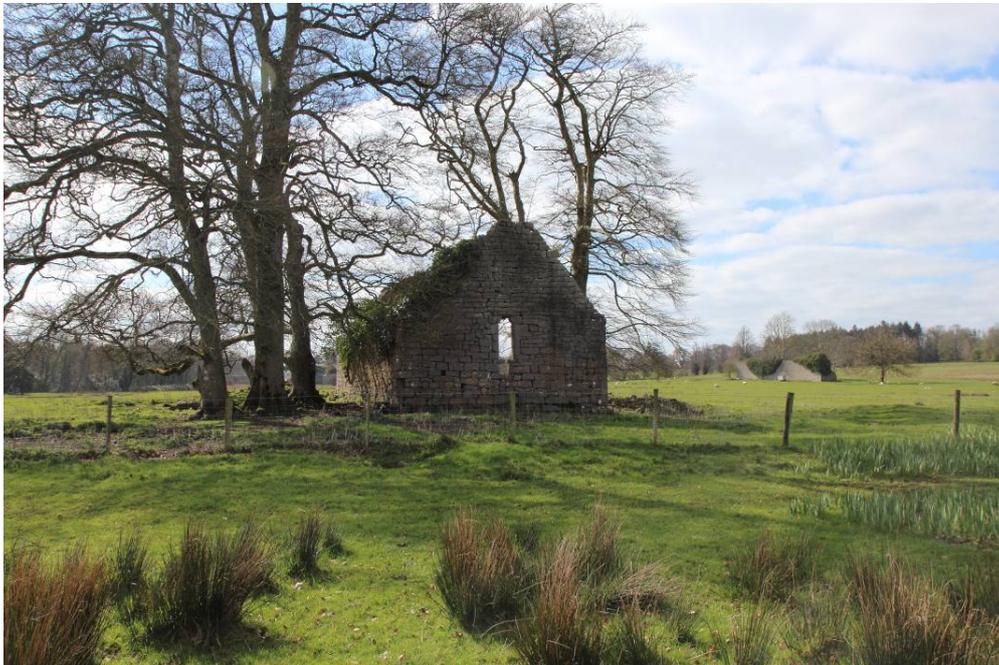
Photograph 3 General view of ruin in landscape looking west

The structure consists of an east/west orientated stone ruin approximately 14.5m x 7.5 m with the western and eastern gables standing. Walls are approximately 800mm in thickness. The southern wall is partly standing and the northern wall is almost completely collapsed except for a section near the east end that looks to have been rebuilt. The west elevation is recorded as being repaired at some stage in the past. There are a number of mature deciduous trees growing adjacent to the ruin and are causing some damage to the masonry due to branch fall etc. These trees were probably planted as part of a landscape development of the estate to emphasise the role of the ruin as a folly. There is a significant amount of fallen masonry around and within the ruin.

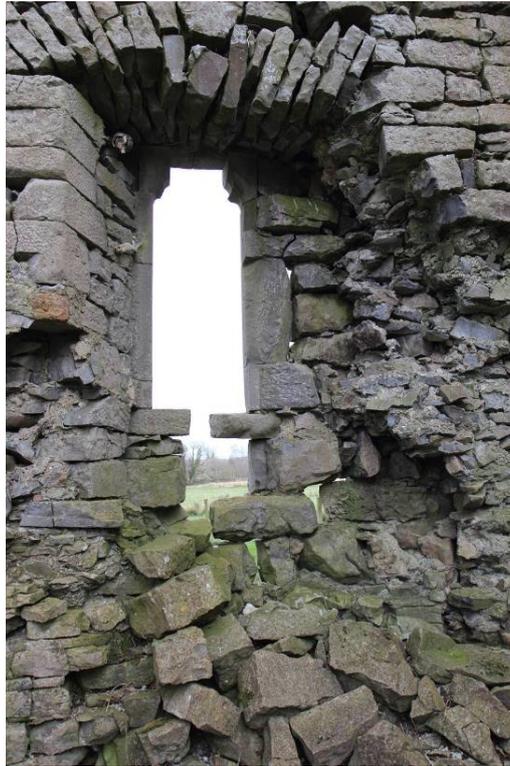
Photograph 6 Detail of Inner Face of East Gable

The outer face is showing signs of structural failure partially due to the increased loading on the stone outer face where the inner face is gone. It is also possible to see through the stone works where mortar has been washed out.

There are a number of stones particularly around the window opening showing severe structural stresses where the stones have cracked and failed (green line photograph 5). A

number of stones have also fell out of position or been robbed in the outer face (red line photograph 5).

The wall top has ivy growth and water is ingressing into the fabric resulting in washing out of fines and mortar and also frost heave.

Immediate	The ruin needs to be fenced off and dangerous building signs erected to ensure the safety of the public and prevent access.
Urgent	<p>The gable needs to be propped and repairs undertaken to secure the fabric from falling. Works will include reinstating the inner face of the gable, removal of ivy, repairing the stone arch and rebuilding the inner window reveals. Repointing and re-grouting the wall and repairing the wall top.</p> <p>The fallen stone to be archaeologically assessed and sorted for reuse in the repairing of the gable.</p>

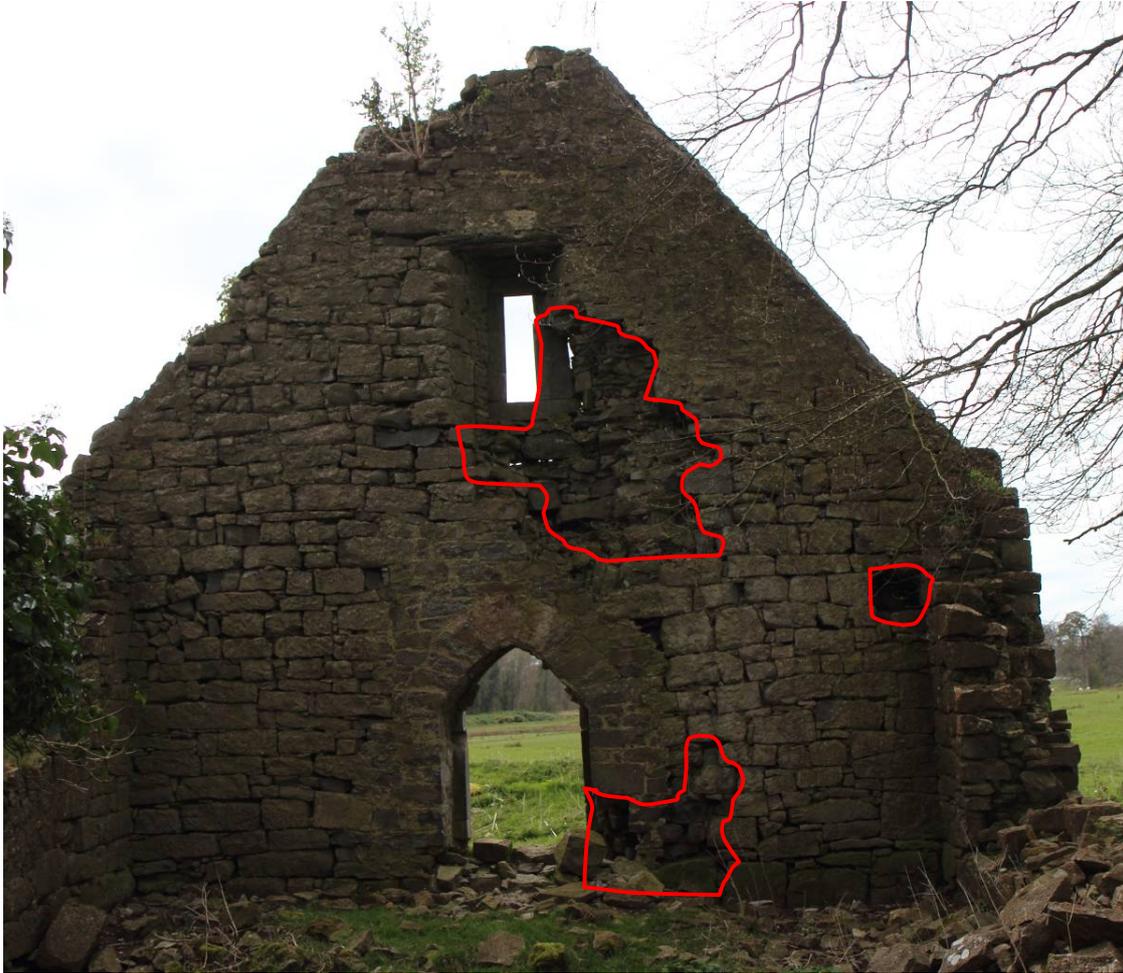
Photograph 9 West Gable Inner Face

The west gable has a central doorway and stands almost to its original full height. There is some vegetation growth on the wall top. The inner face has collapsed with the loss of part of the window reveal (red line photograph 9). The stone head to the window is supported by wrought iron bars which are rusting. There are other fallen stones on the inner face particularly near the door opening. This gable has undergone repairs at some point. The stone is on the ground at the base of the wall.

Dangerous	The gable is in imminent danger of collapsing particularly around the section that has bulged and failed on the inner face.
-----------	---

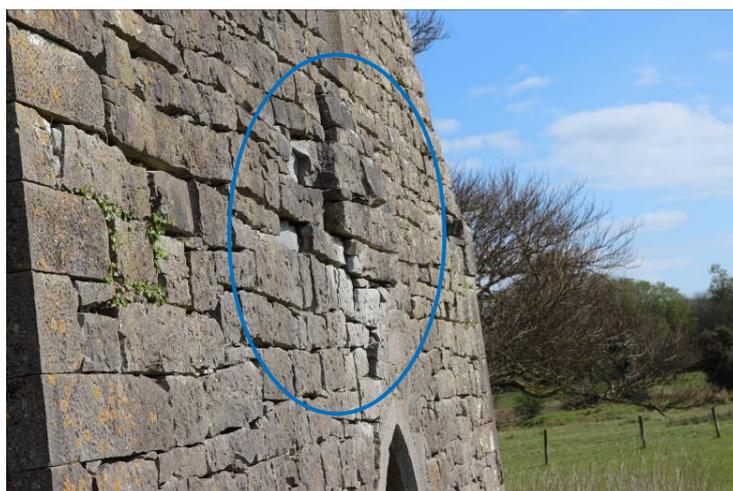
Photograph 11 Detail of Bulge on West Gable

There is a significant bulge (photographs 10 & 11) on the outer face to the left of the door opening below the window – in line with the inner collapse. It was not possible to assess the wall top but it is likely that this is in need of significant repairs to prevent water ingress into the gable.
