# APPENDIX A

# Building Inventories

Protected Structures Impact Statement

PARNELL SQUARE CULTURAL QUARTER  
 Architectural Heritage—Decorative Fabric Inventory  
 Nos. 20, 21, 23-28 Parnell Square, Dublin 1  
 November 2015—Shaffrey Associates Architects

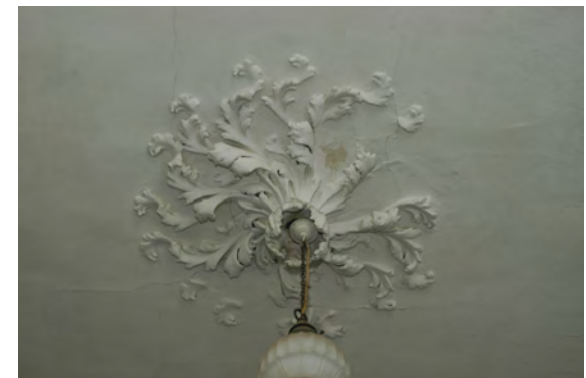
TYPE AND DESCRIPTION OF FABRIC Ceiling rose: medium-high relief; foliate decoration forming circular pattern; heavily overpainted.
BUILDING PHASE C18th
CONDITION Poor

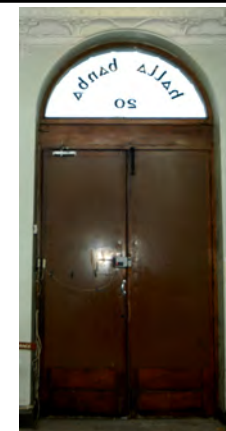
TYPE AND DESCRIPTION OF FABRIC Entrance door: arched opening breaking into cornice above; timber casing; 2-leaf timber doors, flush finish to interior; glazed fanlight to arch.
BUILDING PHASE C20th
CONDITION Poor

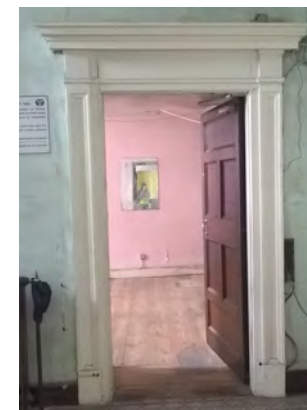
<b>TYPE AND DESCRIPTION OF FABRIC</b> Door to No.21: timber casing and surround with carved flanking pilasters and plain frieze and cornice; 6-panel timber door.
<b>BUILDING PHASE</b> C20th
<b>CONDITION</b> Fair

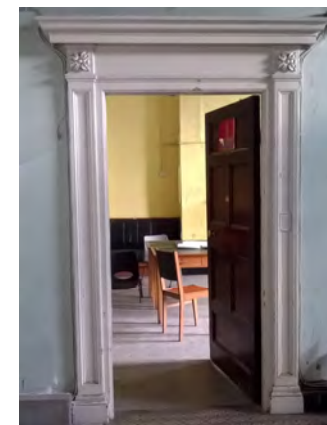
<b>TYPE AND DESCRIPTION OF FABRIC</b> Door to front reception room: timber casing and surround with carved flanking pilasters, rosettes and cornice; 6-panel timber door.
<b>BUILDING PHASE</b> C18th
<b>CONDITION</b> Poor—fair

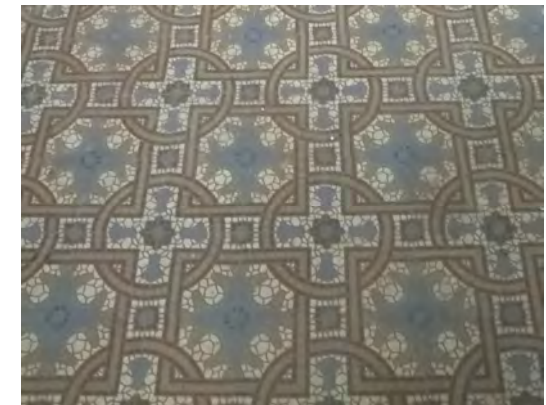
TYPE AND DESCRIPTION OF FABRIC Floor: patterned encaustic tiles in blue/brown/white
BUILDING PHASE C18th
CONDITION Fair

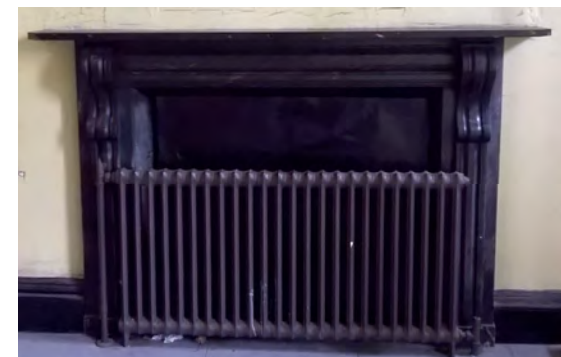
TYPE AND DESCRIPTION OF FABRIC Fireplace: polished stone surround; mild steel radiator fixed to opening.
BUILDING PHASE C18th—C20th
CONDITION Poor—Fair

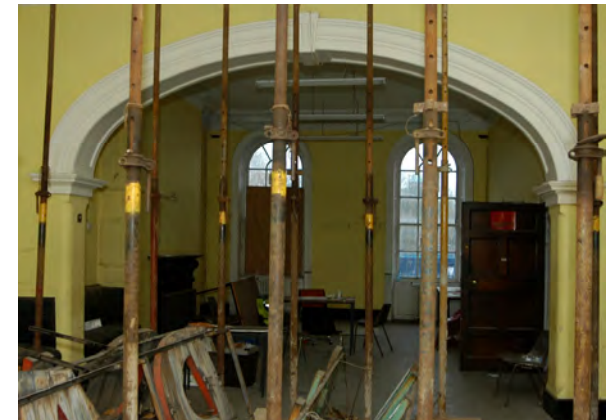
<b>TYPE AND DESCRIPTION OF FABRIC</b> Opening between front and rear rooms: elliptical archway; plasterwork detail to arch with keystone motif and impost mouldings to flanking walls.
<b>BUILDING PHASE</b> C20th
<b>CONDITION</b> Fair

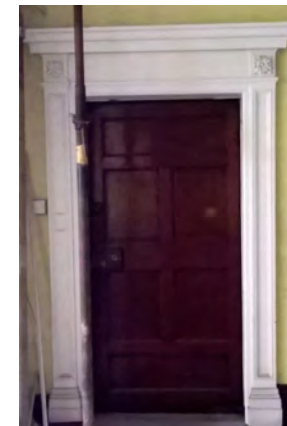
<b>TYPE AND DESCRIPTION OF FABRIC</b> Door to stair hall: timber casing and surround with carved flanking pilasters, rosettes and cornice; 6-panel timber door.
<b>BUILDING PHASE</b> C18th
<b>CONDITION</b> Fair

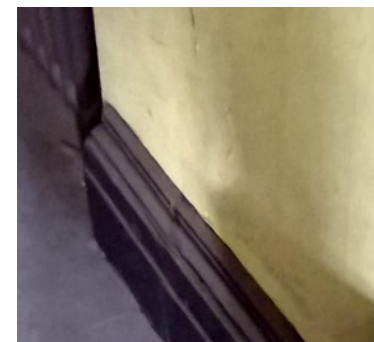
<b>TYPE AND DESCRIPTION OF FABRIC</b> Skirting: timber profile
<b>BUILDING PHASE</b> C18th
<b>CONDITION</b> Poor—Fair

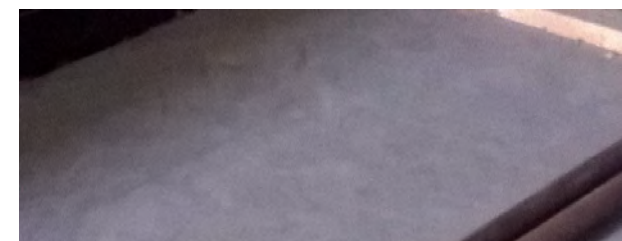
<b>TYPE AND DESCRIPTION OF FABRIC</b> Floor: linoleum
<b>BUILDING PHASE</b> C20th
<b>CONDITION</b> Poor

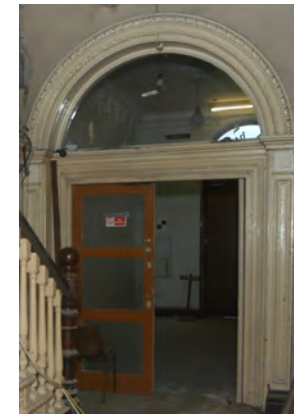
TYPE AND DESCRIPTION OF FABRIC Door to entrance hall: arched opening; timber casing and surround with carved flanking pilasters having impost moulding to arch; carved surround to archway; 2-leaf timber doors with glazed panels.
BUILDING PHASE C18th surround, C20th doors
CONDITION Fair

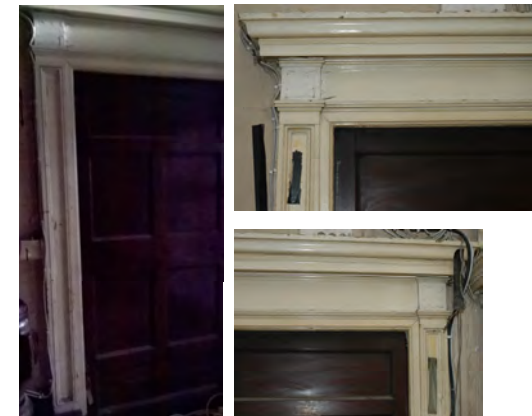
TYPE AND DESCRIPTION OF FABRIC Door to rear reception room: timber casing and surround with carved flanking pilasters and plain frieze and cornice; 6-panel timber door.
BUILDING PHASE C18th
CONDITION Fair

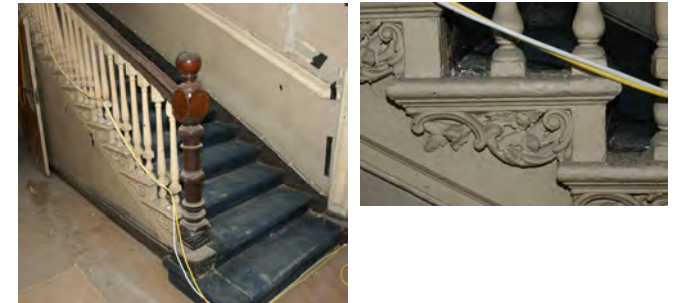
<b>TYPE AND DESCRIPTION OF FABRIC</b> Staircase: timber stairs with open string, having carved detail; turned paired balusters; mahogany handrail and newel post.
<b>BUILDING PHASE</b> C18th
<b>CONDITION</b> Fair

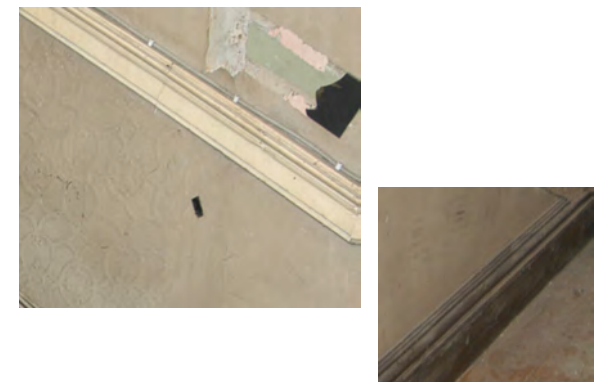
<b>TYPE AND DESCRIPTION OF FABRIC</b> Dado and skirting: timber profiles
<b>BUILDING PHASE</b> C18th
<b>CONDITION</b> Poor—Fair

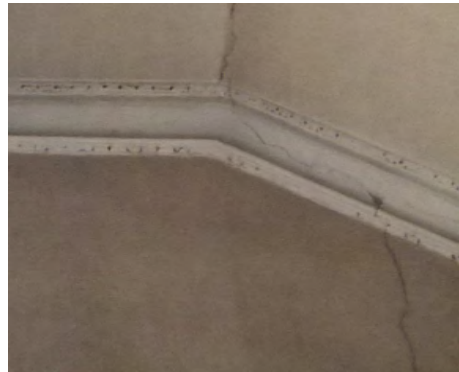
<b>TYPE AND DESCRIPTION OF FABRIC</b> Cornice: plain coving between moulded borders; heavily over-painted.

<b>BUILDING PHASE</b> C18th	
<b>CONDITION</b> Poor

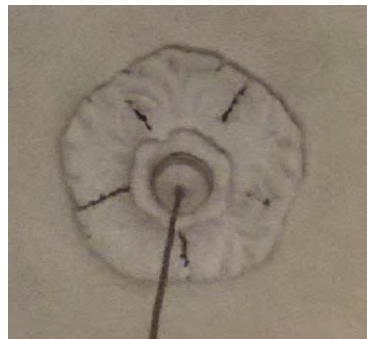
<b>TYPE AND DESCRIPTION OF FABRIC</b> Ceiling rose: small centrepiece of foliate moulding arranged in a circular pattern; heavily overpainted.

<b>BUILDING PHASE</b> C18th	
<b>CONDITION</b> Poor

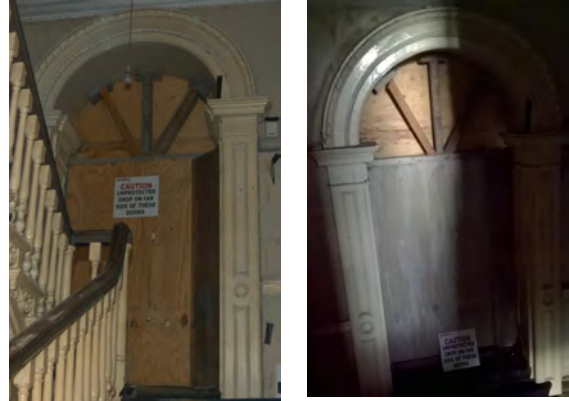
<b>TYPE AND DESCRIPTION OF FABRIC</b> Opening at half-landing level: round-headed arch; timber casing and surround with carved flanking pilasters having impost moulding to arch; carved surround to archway; plywood insert.

<b>BUILDING PHASE</b> C18th—C20th	
<b>CONDITION</b> Poor

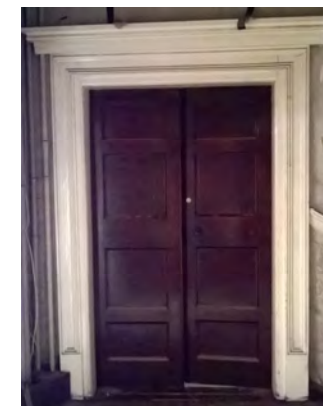
TYPE AND DESCRIPTION OF FABRIC Door to No.21: timber casing; carved timber surround with cornice and architrave; 2-leaf timber doors, each having 4no. panels.
BUILDING PHASE C20th
CONDITION Fair

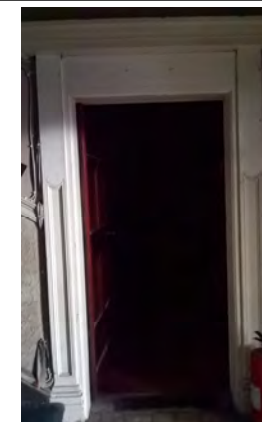
TYPE AND DESCRIPTION OF FABRIC Door to rear reception room: timber casing; carved timber surround with cornice and architrave; 6-panel timber door with brass door furniture.
BUILDING PHASE C19th
CONDITION Fair

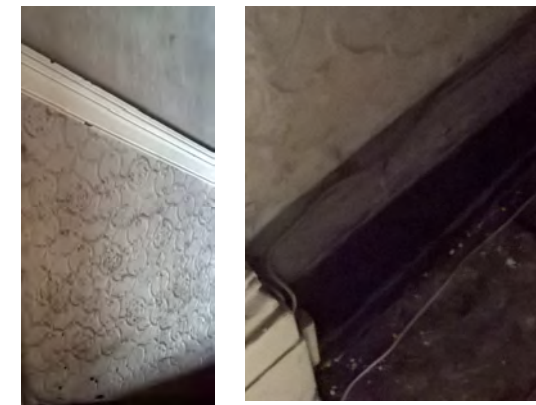
<b>TYPE AND DESCRIPTION OF FABRIC</b> Dado and skirting: timber profiles; dado rail to stair well only.
<b>BUILDING PHASE</b> C18th—C20th
<b>CONDITION</b> Poor—Fair

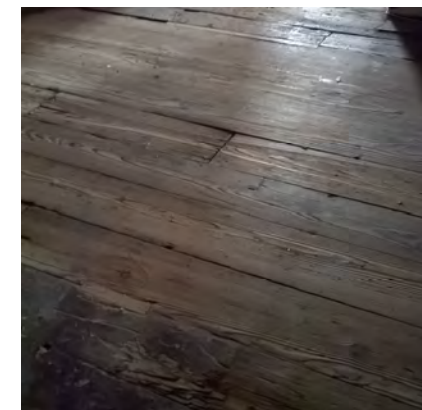
<b>TYPE AND DESCRIPTION OF FABRIC</b> Floor: timber boards
<b>BUILDING PHASE</b> C18th—C20th
<b>CONDITION</b> Poor—Fair

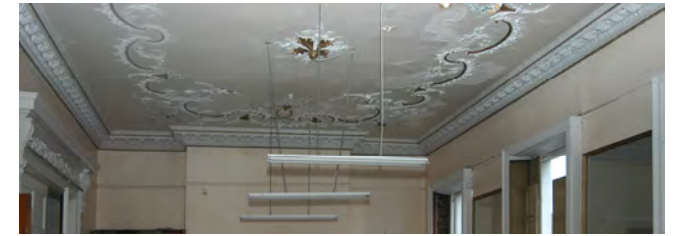
TYPE AND DESCRIPTION OF FABRIC Ceiling: Rococo plasterwork (further details below).
BUILDING PHASE C18th
CONDITION Fair

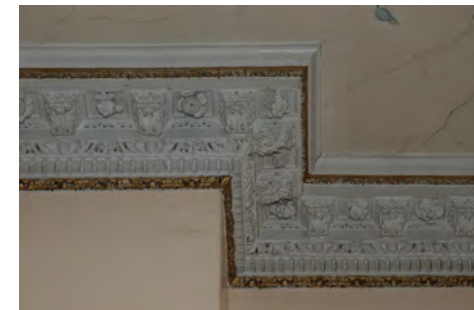
TYPE AND DESCRIPTION OF FABRIC Cornice: in medium-high relief; modillion and rosette detail, between borders.
BUILDING PHASE C18th
CONDITION Fair

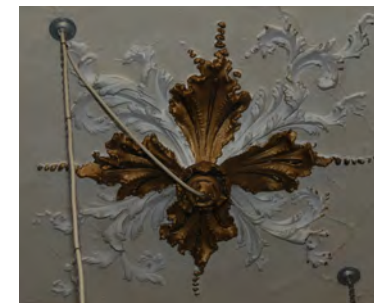
TYPE AND DESCRIPTION OF FABRIC Ceiling rose/centrepiece: medium-high relief; rocaille and floral mouldings arranged in a circular pattern.
BUILDING PHASE C18th
CONDITION Fair

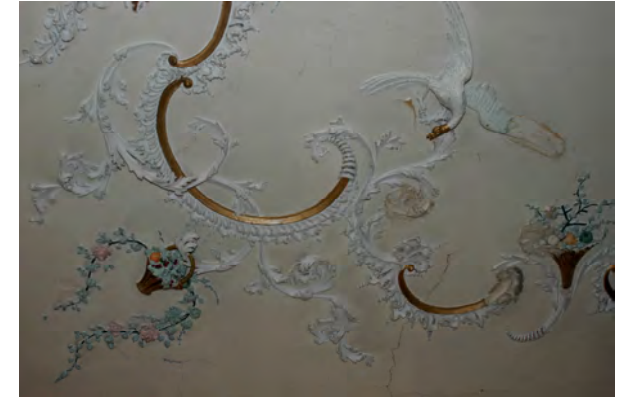
TYPE AND DESCRIPTION OF FABRIC Ceiling border decoration: low-medium relief; C-scrolls with rocaille; birds; cornucopias; baskets of flowers.
BUILDING PHASE C18th
CONDITION Fair

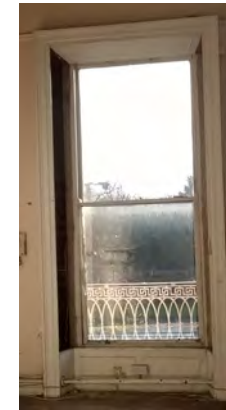
TYPE AND DESCRIPTION OF FABRIC Window, E (LHS internally): timber casing with panelled shutters; timber architrave extending to floor; single-pane sliding timber sashes.
BUILDING PHASE C19th
CONDITION Poor—Fair

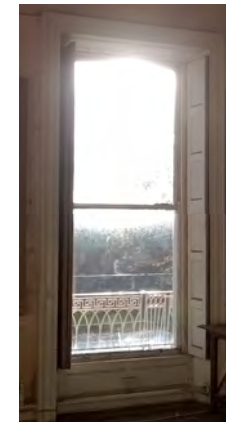
TYPE AND DESCRIPTION OF FABRIC Window, centre: timber casing with panelled shutters; timber architrave extending to floor; single-pane sliding timber sashes.
BUILDING PHASE C19th
CONDITION Poor—Fair

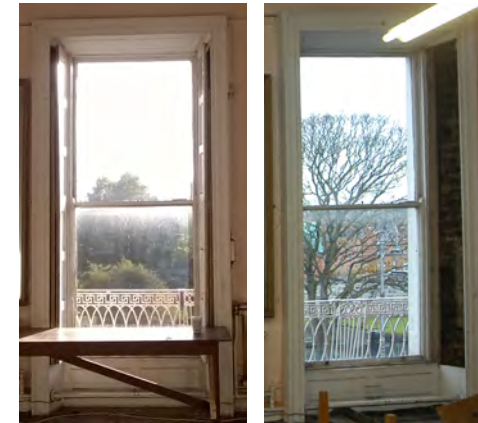
TYPE AND DESCRIPTION OF FABRIC Window, W (RHS internally): timber casing with panelled shutters; timber architrave extending to floor; single-pane sliding timber sashes.
BUILDING PHASE C19th
CONDITION Poor—fair

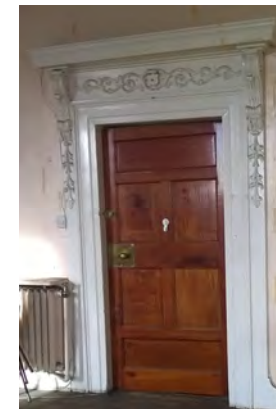
TYPE AND DESCRIPTION OF FABRIC Door to stair hall: timber casing; carved timber surround with modillion brackets, cornice and carved frieze; 6-panel timber door with brass door furniture.
BUILDING PHASE C19th
CONDITION Fair

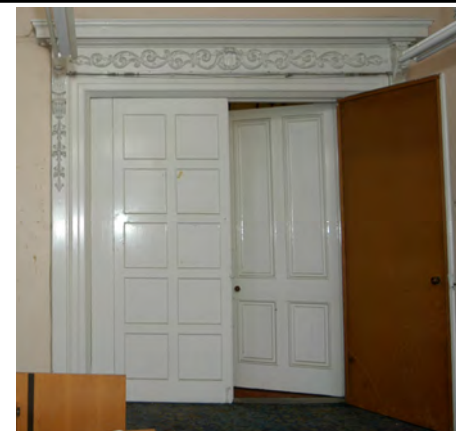
TYPE AND DESCRIPTION OF FABRIC Door to rear reception room: timber casing; carved timber surround with modillion brackets, cornice and carved frieze; 2-leaf timber doors, each having 4no. raised and fielded panels; additional pair of 10-panel timber doors opening to front room.
BUILDING PHASE C19th
CONDITION Fair

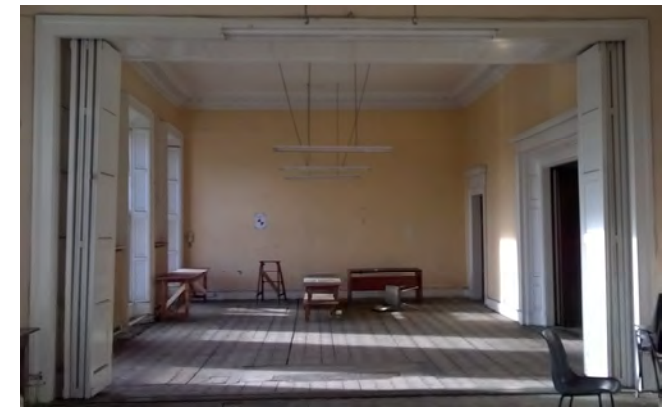
TYPE AND DESCRIPTION OF FABRIC Partition doors to No.21: opening extending across majority of party wall; timber casing; timber architrave; multi-leaf folding/sliding timber doors.
BUILDING PHASE C20th
CONDITION Poor—fair

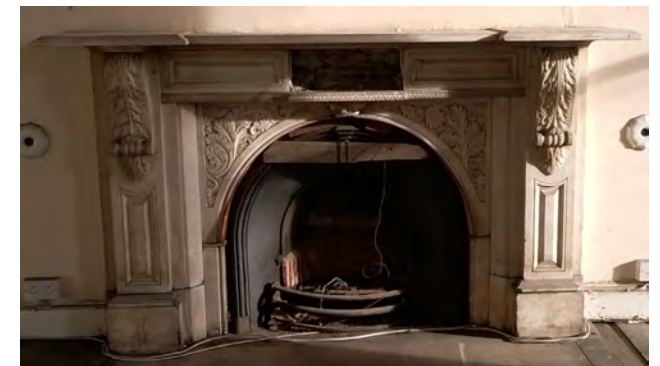
TYPE AND DESCRIPTION OF FABRIC Fireplace: carved stone surround; modillion brackets; central plaque missing; cast iron insert.
BUILDING PHASE C18th
CONDITION Poor

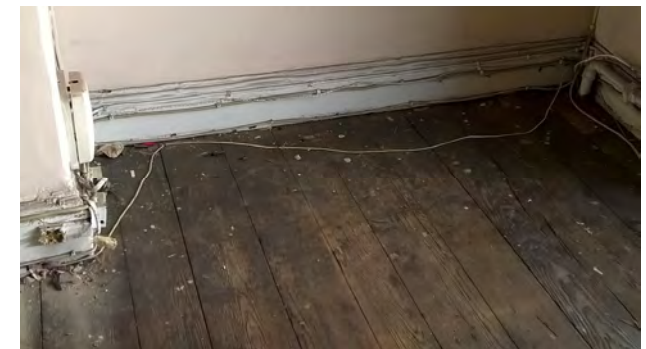
TYPE AND DESCRIPTION OF FABRIC Skirting: timber profile
BUILDING PHASE C18th—C20th
CONDITION Poor

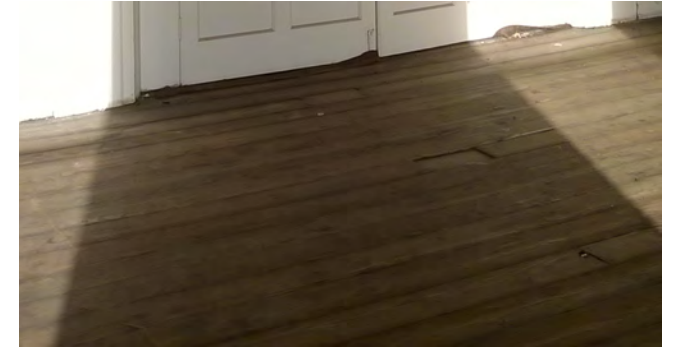
TYPE AND DESCRIPTION OF FABRIC Floor: timber boards
BUILDING PHASE C18th—C20th
CONDITION Poor—fair

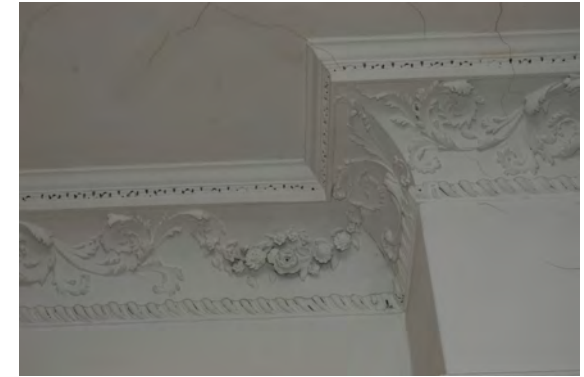
<b>TYPE AND DESCRIPTION OF FABRIC</b> Cornice: medium-high relief; rinceau mouldings and floral details between borders.
<b>BUILDING PHASE</b> C18th
<b>CONDITION</b> Poor—fair

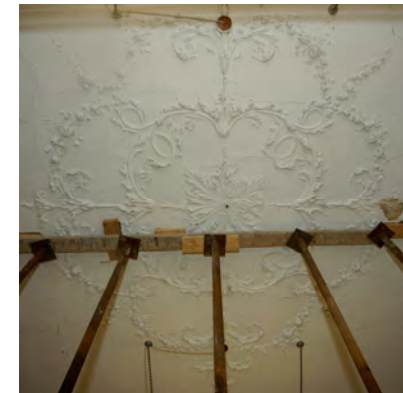
<b>TYPE AND DESCRIPTION OF FABRIC</b> Centrepiece: large plasterwork centrepiece; low-medium relief; rocaille centre surrounded by foliated scrolls with outer floral details; ceiling/floor above supported with accro props.
<b>BUILDING PHASE</b> C18th
<b>CONDITION</b> Poor

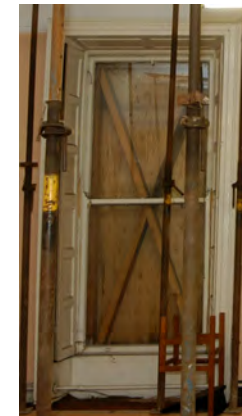
<b>TYPE AND DESCRIPTION OF FABRIC</b> Window, W (LHS internally): timber casing with panellled shutters; timber architrave extending to floor; single-pane sliding timber sashes; boarded and braced externally.
<b>BUILDING PHASE</b> C19th
<b>CONDITION</b> Poor

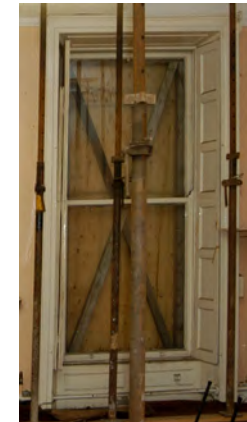
TYPE AND DESCRIPTION OF FABRIC Window, E (RHS internally): timber casing with pan-elled shutters; timber architrave extending to floor; single-pane sliding timber sashes; boarded and braced externally.
BUILDING PHASE C19th
CONDITION Poor

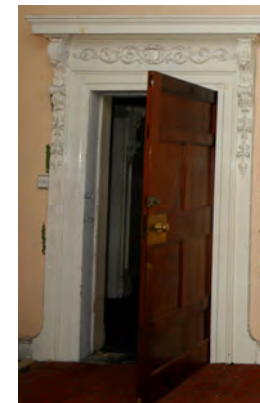
TYPE AND DESCRIPTION OF FABRIC Door to stair hall: timber casing; carved timber surround with modillion brackets, cornice and carved frieze; 6-panel timber door with brass door furniture.
BUILDING PHASE C19th
CONDITION Fair

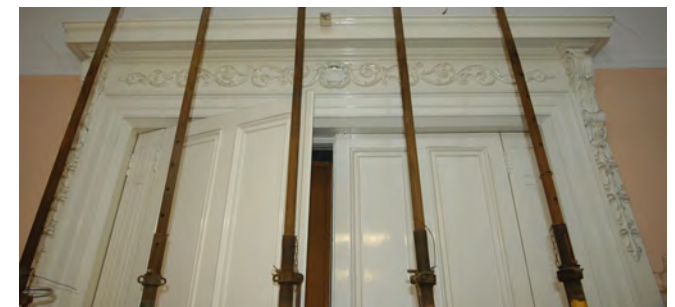
TYPE AND DESCRIPTION OF FABRIC Door to front reception room: timber casing; carved timber surround with modillion brackets, cornice and carved frieze; 2-leaf timber doors, each having 4no. raised and fielded panels; additional pair of 10-panel timber doors opening to front room.
BUILDING PHASE C19th
CONDITION Fair

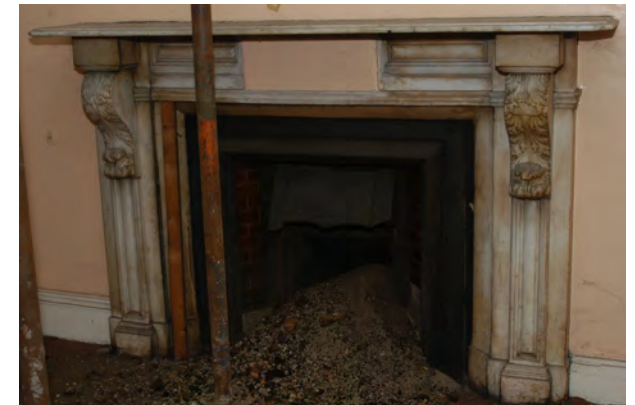
TYPE AND DESCRIPTION OF FABRIC Fireplace: carved stone surround; modillion brackets; central plaque missing; cast iron and tiled insert.
BUILDING PHASE C18th
CONDITION Poor

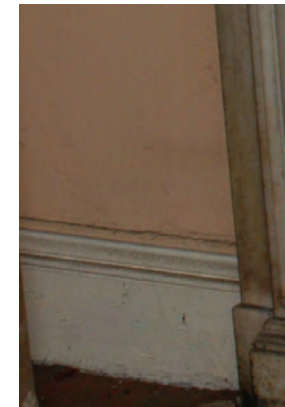
TYPE AND DESCRIPTION OF FABRIC Skirting: timber profile
BUILDING PHASE C18th—C20th
CONDITION Poor

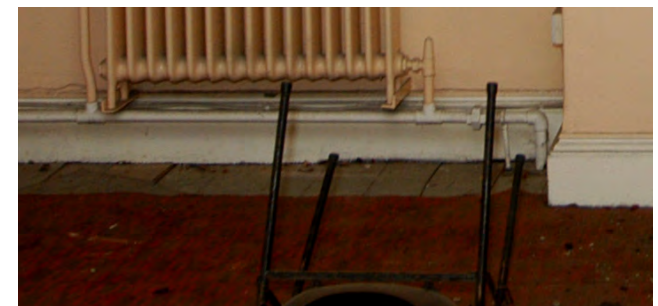
TYPE AND DESCRIPTION OF FABRIC Floor: carpet over timber boards
BUILDING PHASE C18th
CONDITION Poor—Fair

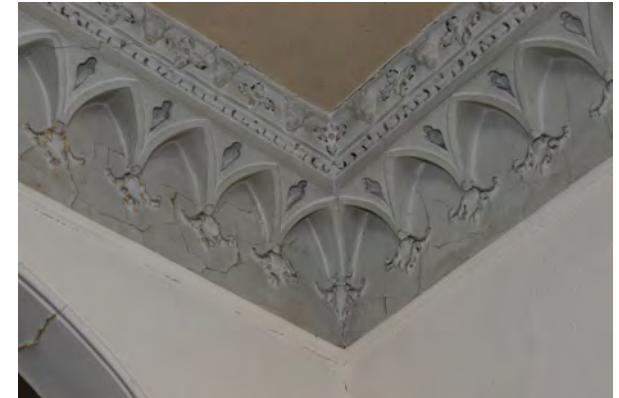
TYPE AND DESCRIPTION OF FABRIC Cornice: in medium-high relief; decorative frieze of foliate bunches forming trefoil arches.
BUILDING PHASE C18th
CONDITION Fair

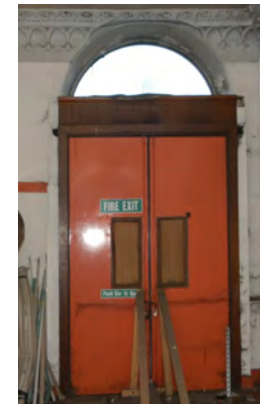
TYPE AND DESCRIPTION OF FABRIC Entrance door: arched opening breaking into cornice above; timber casing; 2-leaf timber doors, flush finish to interior; glazed fanlight to arch.
BUILDING PHASE C20th
CONDITION Poor

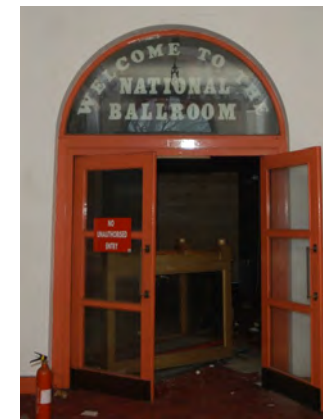
TYPE AND DESCRIPTION OF FABRIC Door to stair hall: arched opening; timber casing, 2-leaf timber doors with glazed panels, glazed fanlight
BUILDING PHASE C20th
CONDITION Poor

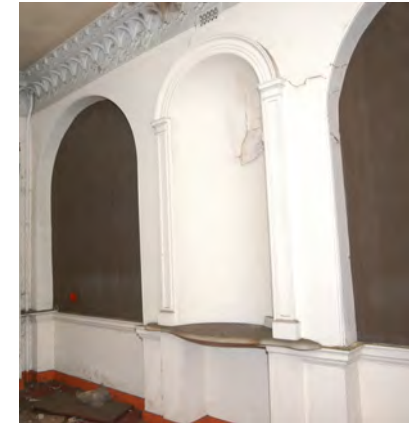
<b>TYPE AND DESCRIPTION OF FABRIC</b>
Wall niches: Central arched niche with flanking pilasters and moulded plasterwork arch; stone slab at plinth level; plain flanking arches either side of central niche.
<b>BUILDING PHASE</b>
C18th
<b>CONDITION</b>
Fair

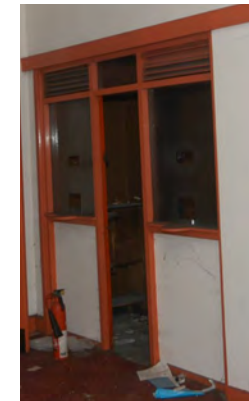
<b>TYPE AND DESCRIPTION OF FABRIC</b>
Ticket booth: timber framed partition with upper glazed panels and central door opening
<b>BUILDING PHASE</b>
C20th
<b>CONDITION</b>
Poor

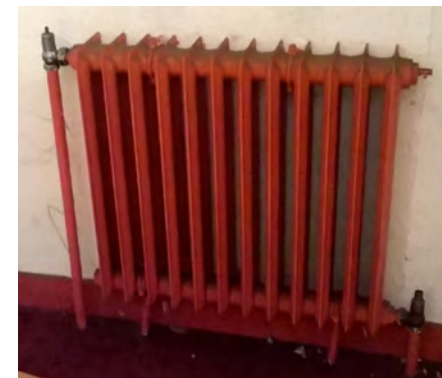
<b>TYPE AND DESCRIPTION OF FABRIC</b>
Cast iron radiator: located on E wall adjacent ticket booth.
<b>BUILDING PHASE</b>
C20th
<b>CONDITION</b>
Poor—fair

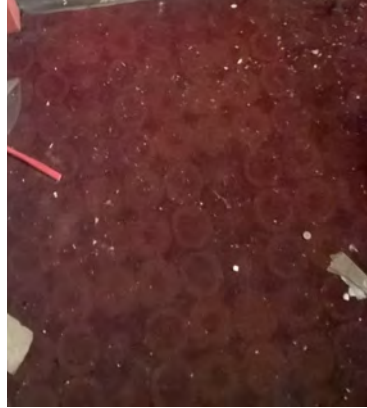
TYPE AND DESCRIPTION OF FABRIC Floor: carpet covering

BUILDING PHASE C20th	
CONDITION Poor

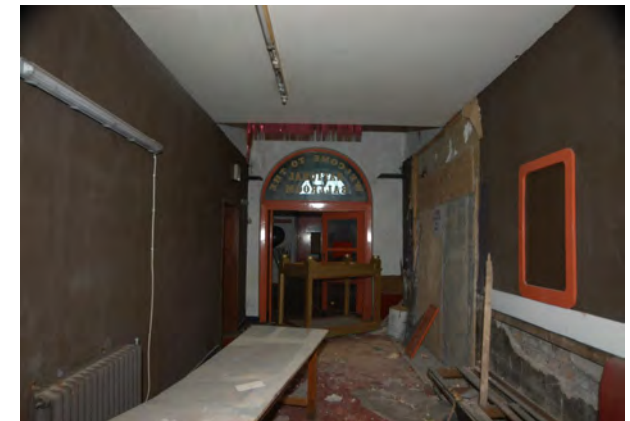
TYPE AND DESCRIPTION OF FABRIC Stairs have been removed; no surviving decorative fabric of note.
BUILDING PHASE
CONDITION

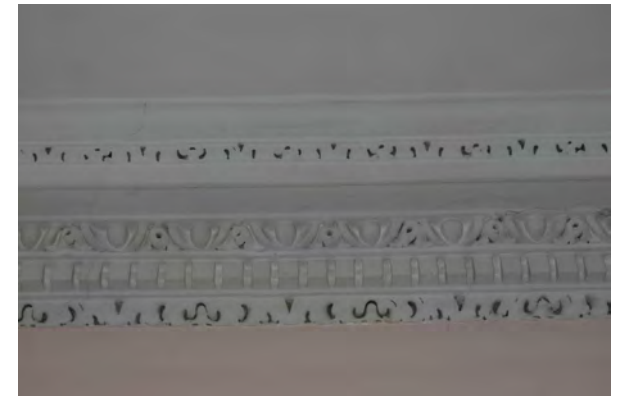
TYPE AND DESCRIPTION OF FABRIC Cornice: medium relief; heavily overpainted
BUILDING PHASE C18th
CONDITION Poor—fair

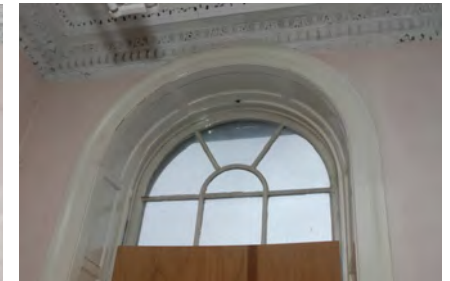
TYPE AND DESCRIPTION OF FABRIC Window, E (LHS internally): round-headed ope; timber casing; timber architrave extending to floor level; 10-pane hubbed timber sash over 6-pane timber sash; timber panel below; plywood sheeting.
BUILDING PHASE C20th
CONDITION Poor—fair

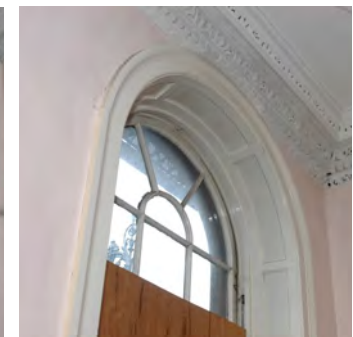
TYPE AND DESCRIPTION OF FABRIC Window, W (RHS internally): round-headed ope; timber casing; timber architrave extending to floor level; 10-pane hubbed timber sash over 6-pane timber sash; timber panel below; plywood sheeting.
BUILDING PHASE C20th
CONDITION Poor—fair

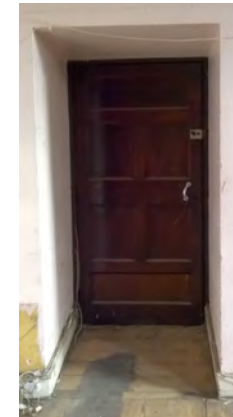
TYPE AND DESCRIPTION OF FABRIC Door to No.20: timber casing; 6-panel timber door leaf
BUILDING PHASE C20th
CONDITION Fair

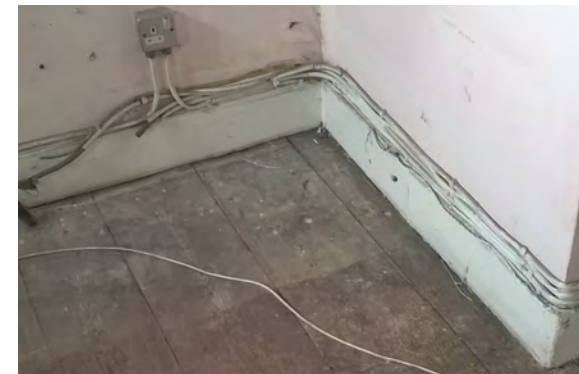
TYPE AND DESCRIPTION OF FABRIC Skirting boards: timber profile
BUILDING PHASE C18th
CONDITION Poor

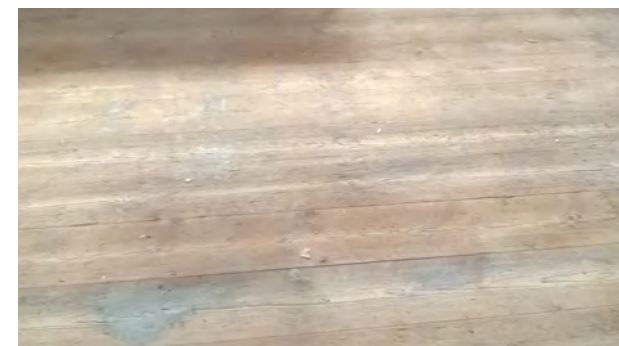
TYPE AND DESCRIPTION OF FABRIC Floor: timber boards
BUILDING PHASE C18th
CONDITION Poor—fair

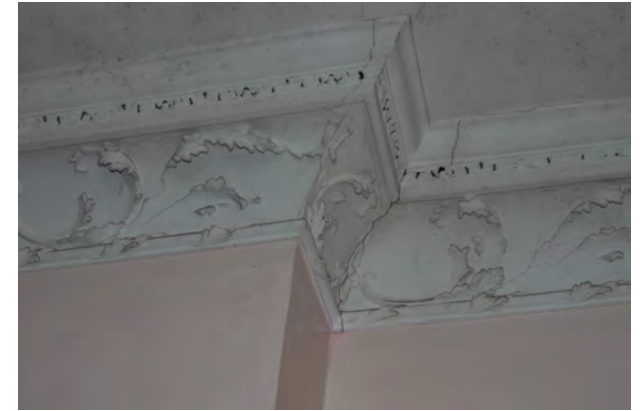
TYPE AND DESCRIPTION OF FABRIC Cornice: rinceau frieze in medium-high relief; heavily overpainted obscuring detail.
BUILDING PHASE C18th
CONDITION Poor

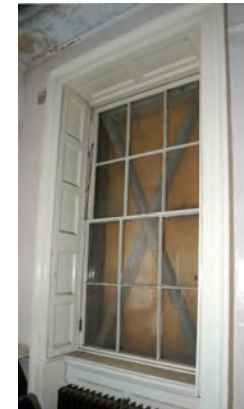
TYPE AND DESCRIPTION OF FABRIC Window, W (LHS internally): timber casing; panelled timber shutters; timber architrave extending to floor level; 6-over-6 pane timber sashes; timber panel below; braced externally
BUILDING PHASE C18th
CONDITION Fair

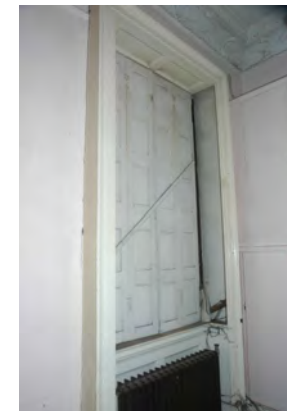
TYPE AND DESCRIPTION OF FABRIC Window, E (RHS internally): timber casing; panelled timber shutters; timber architrave extending to floor level; 6-over-6 pane timber sashes; timber panel below.
BUILDING PHASE C20th
CONDITION Fair

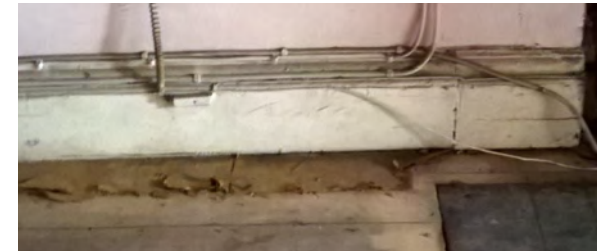
TYPE AND DESCRIPTION OF FABRIC Skirting boards: timber profile
BUILDING PHASE C18th
CONDITION Poor

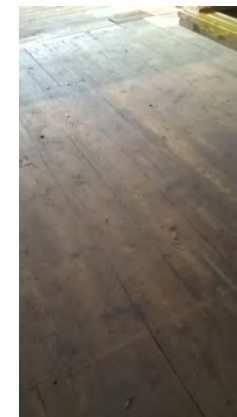
TYPE AND DESCRIPTION OF FABRIC Floor: timber boards
BUILDING PHASE C18th
CONDITION Fair

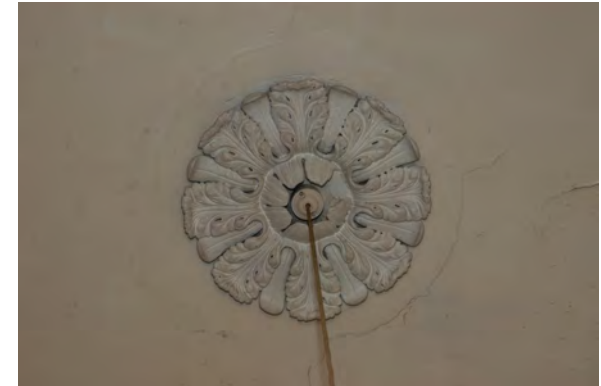
TYPE AND DESCRIPTION OF FABRIC Ceiling rose: palm leaves arranged in circular pattern.
BUILDING PHASE C18th
CONDITION Poor

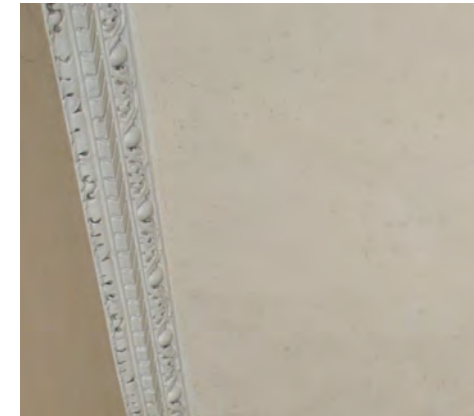
TYPE AND DESCRIPTION OF FABRIC Cornice: 3 moulded profiles; heavily overpainted.
BUILDING PHASE C18th
CONDITION Poor

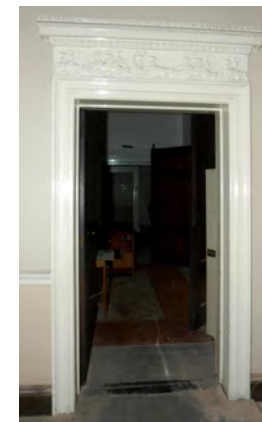
TYPE AND DESCRIPTION OF FABRIC Door to rear reception room: timber casing; carved timber surround with cornice and carved frieze; 6-panel timber door with brass door furniture.
BUILDING PHASE C19th
CONDITION Fair

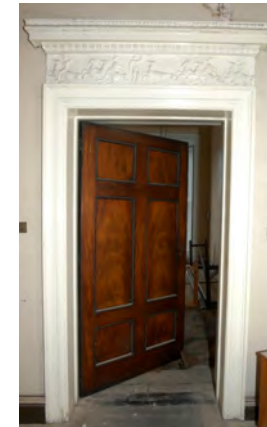
TYPE AND DESCRIPTION OF FABRIC Door to front reception room: timber casing; carved timber surround with cornice and carved frieze; 6-panel timber door with brass door furniture.
BUILDING PHASE C19th
CONDITION Fair

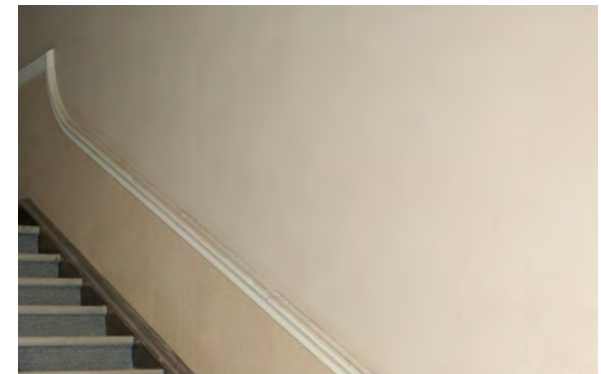
TYPE AND DESCRIPTION OF FABRIC Dado: timber profile
BUILDING PHASE C18th
CONDITION Fair

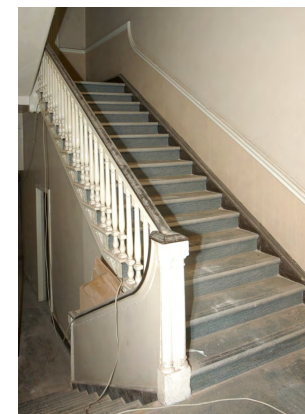
TYPE AND DESCRIPTION OF FABRIC Staircase: timber stairs with open string, having carved detail; turned paired balusters; mahogany handrail; elbow detail with swans neck and paired newel posts; linoleum covering.
BUILDING PHASE C18th with C20th coverings
CONDITION Fair

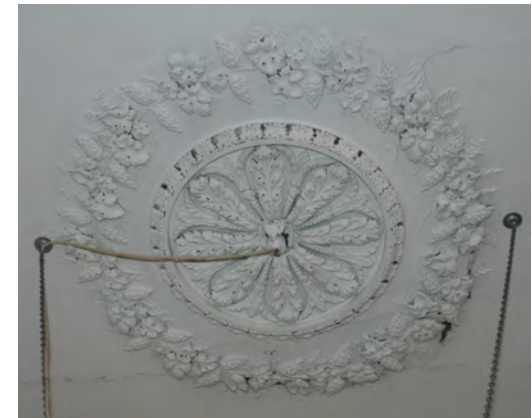
TYPE AND DESCRIPTION OF FABRIC Ceiling rose: in medium-high relief; palm leaves arranged in circular pattern within raised border; outer circular foliated/floral border.
BUILDING PHASE C18th
CONDITION Fair

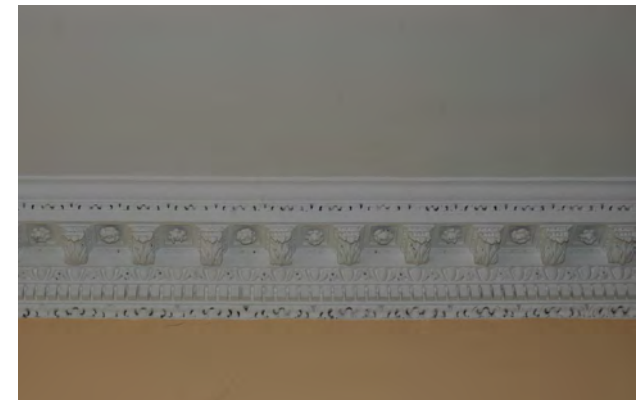
TYPE AND DESCRIPTION OF FABRIC Cornice: in medium relief; alternating rosette and modillion mouldings.
BUILDING PHASE C18th
CONDITION Fair

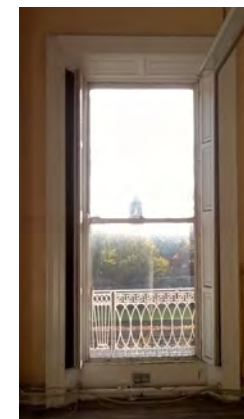
TYPE AND DESCRIPTION OF FABRIC Window, E (LHS internally): timber casing with panelled shutters; timber architrave extending to floor; single-pane sliding timber sashes.
BUILDING PHASE C19th
CONDITION Poor—Fair

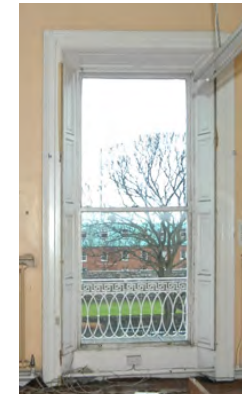
TYPE AND DESCRIPTION OF FABRIC Window, centre: timber casing with panelled shutters; timber architrave extending to floor; single-pane sliding timber sashes.
BUILDING PHASE C19th
CONDITION Poor—Fair

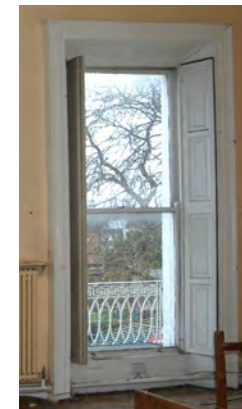
TYPE AND DESCRIPTION OF FABRIC Window, W (RHS internally): timber casing with panelled shutters; timber architrave extending to floor; single-pane sliding timber sashes.
BUILDING PHASE C19th
CONDITION Poor—fair

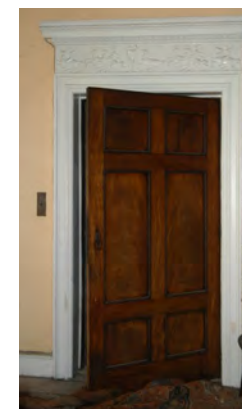
TYPE AND DESCRIPTION OF FABRIC Door to stair hall: timber casing; carved timber surround with decorative frieze; 6-panel timber door.
BUILDING PHASE C19th
CONDITION Fair

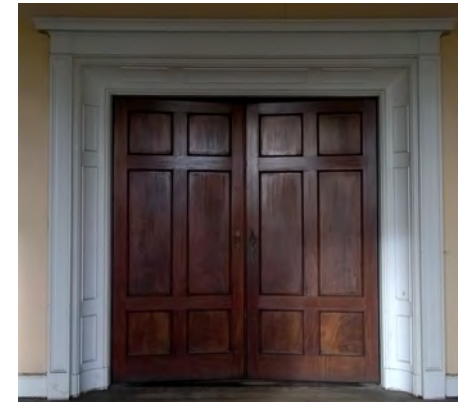
TYPE AND DESCRIPTION OF FABRIC Door to rear reception room: timber casing; carved timber surround with concave profile, plain cornice and frieze; 2-leaf timber doors, each having 6no. fielded panels.
BUILDING PHASE C19th
CONDITION Fair

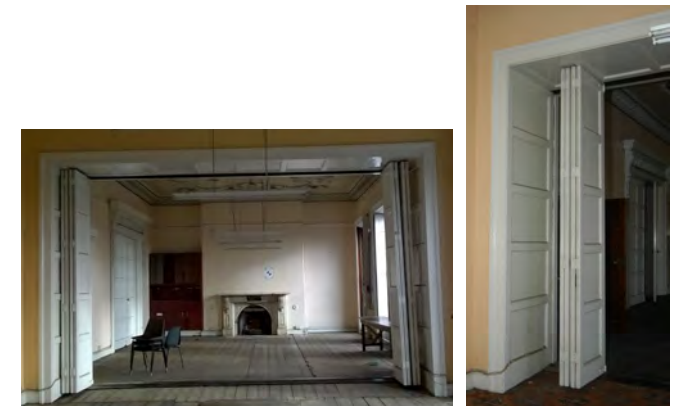
TYPE AND DESCRIPTION OF FABRIC Partition doors to No.20: opening extending across majority of party wall; timber casing; timber architrave; multi-leaf folding/sliding timber doors.
BUILDING PHASE C20th
CONDITION Poor—fair

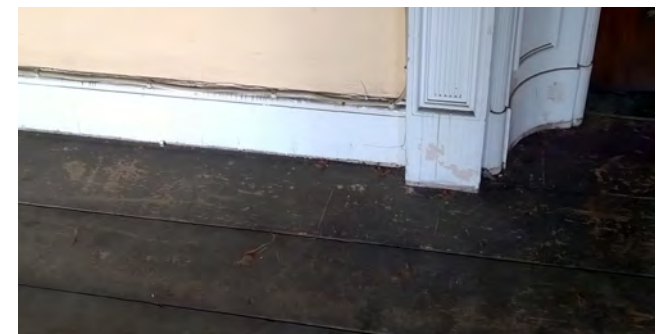
TYPE AND DESCRIPTION OF FABRIC Skirting boards: timber profile
BUILDING PHASE C18th—C20th
CONDITION Poor

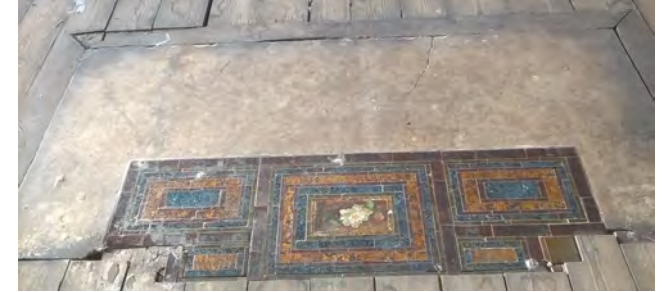
TYPE AND DESCRIPTION OF FABRIC Floor at partition doors to No.20: surviving hearth where fireplace/chimney were removed; tiled inset with stone hearth
BUILDING PHASE C18th
CONDITION Poor

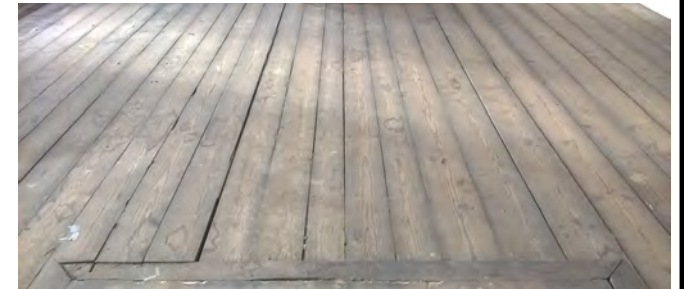
TYPE AND DESCRIPTION OF FABRIC Floor: timber boards
BUILDING PHASE C18th
CONDITION Fair

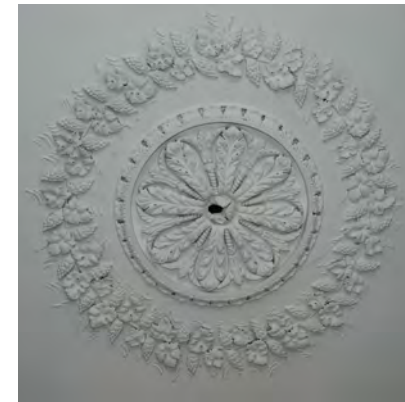
TYPE AND DESCRIPTION OF FABRIC Ceiling rose: in medium-high relief; palm leaves arranged in circular pattern within raised border; outer circular foliated/floral border.
BUILDING PHASE C18th
CONDITION Poor—fair

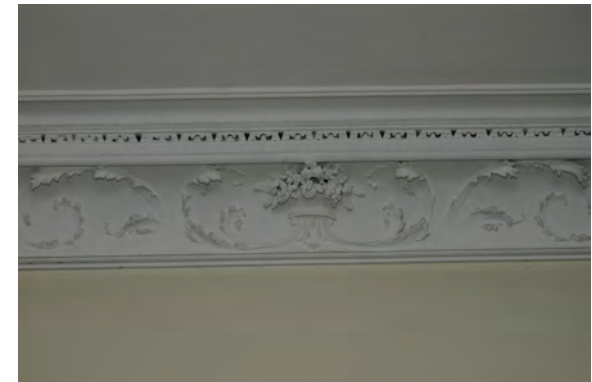
TYPE AND DESCRIPTION OF FABRIC Cornice: rinceau frieze with flower bunches in medium-high relief.
BUILDING PHASE C18th
CONDITION Fair

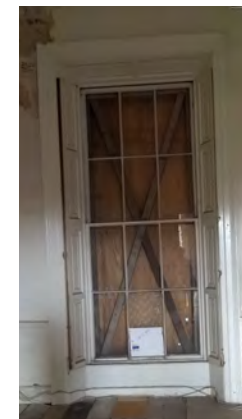
TYPE AND DESCRIPTION OF FABRIC Window, W (LHS internally): timber casing with panelled shutters; timber architrave extending to floor; 6-over-6 sliding timber sashes; boarded and braced externally.
BUILDING PHASE C19th
CONDITION Poor—Fair

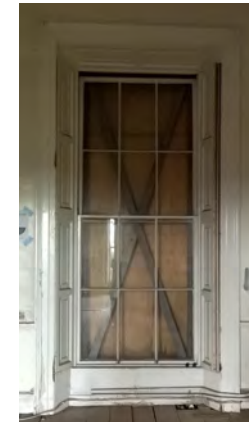
TYPE AND DESCRIPTION OF FABRIC Window, E (RHS internally): timber casing with panellled shutters; timber architrave extending to floor; 6-over-6 sliding timber sashes; boarded and braced externally.
BUILDING PHASE C19th
CONDITION Poor—fair

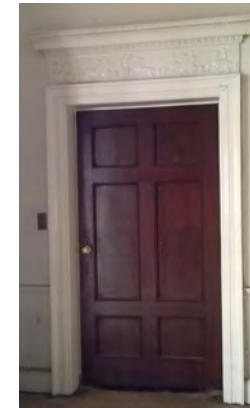
TYPE AND DESCRIPTION OF FABRIC Door to stair hall: timber casing; carved timber surround with cornice and carved frieze; 6-panel timber door with brass door furniture.
BUILDING PHASE C19th
CONDITION Fair

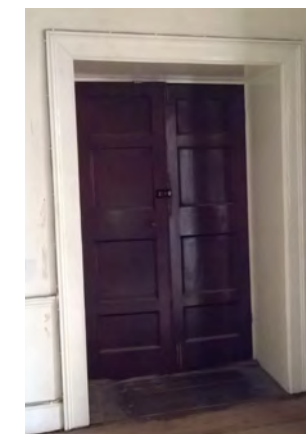
TYPE AND DESCRIPTION OF FABRIC Door to No.20: timber casing; timber architrave; a pair of 4-panel timber doors.
BUILDING PHASE C20th
CONDITION Fair

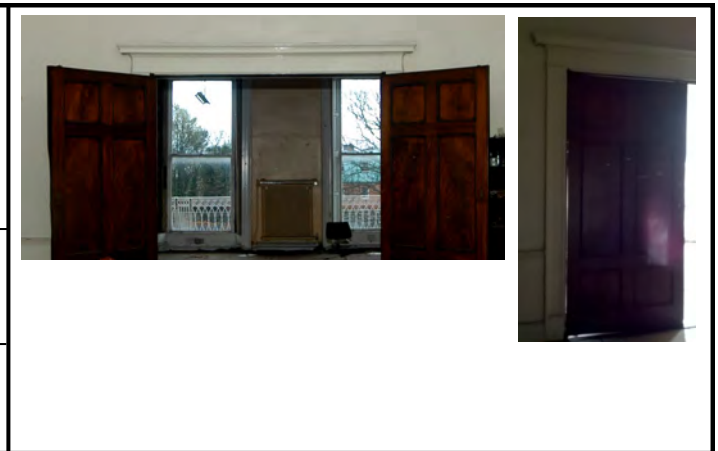
TYPE AND DESCRIPTION OF FABRIC Door to front reception room: timber casing; timber surround with plain cornice; 2-leaf timber doors, each having 6no. fielded panels.
BUILDING PHASE C19th
CONDITION Fair

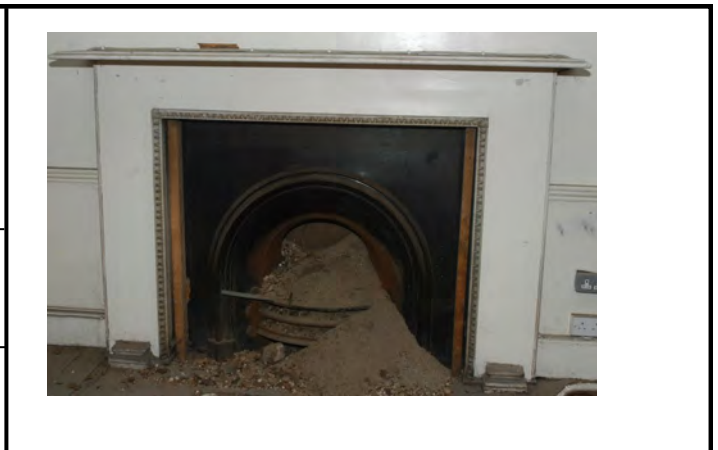
TYPE AND DESCRIPTION OF FABRIC Fireplace: plain surround; cast iron mantel and insert.
BUILDING PHASE C20th
CONDITION Poor

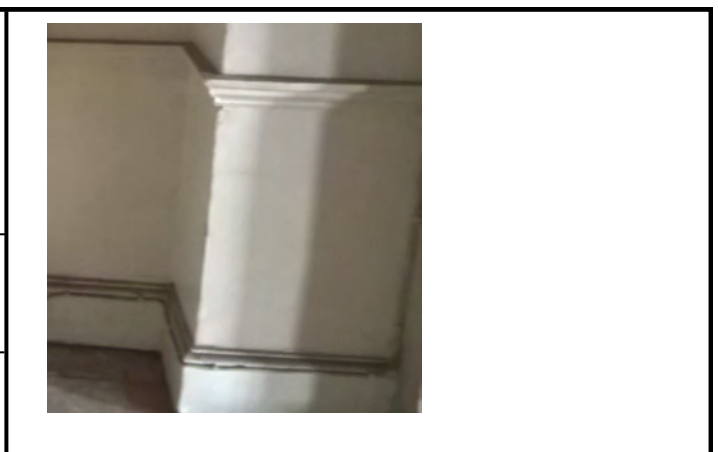
TYPE AND DESCRIPTION OF FABRIC Dado and skirting: timber profiles
BUILDING PHASE C18th
CONDITION Poor—Fair

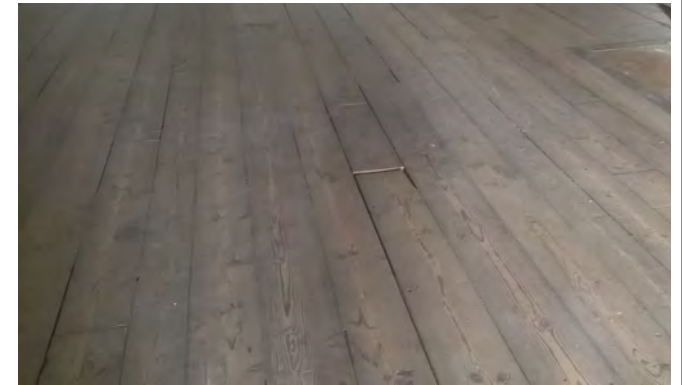
TYPE AND DESCRIPTION OF FABRIC Floor: timber boards
BUILDING PHASE C18th
CONDITION Fair

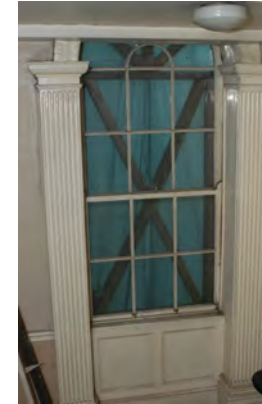
TYPE AND DESCRIPTION OF FABRIC Window at half-landing level: round-headed arch; timber casing and surround with carved flanking pilasters having impost moulding to arch; 10-pane hubbed sash over 6-pane lower sash; fielded panels
BUILDING PHASE C18th with C20th alterations
CONDITION Poor

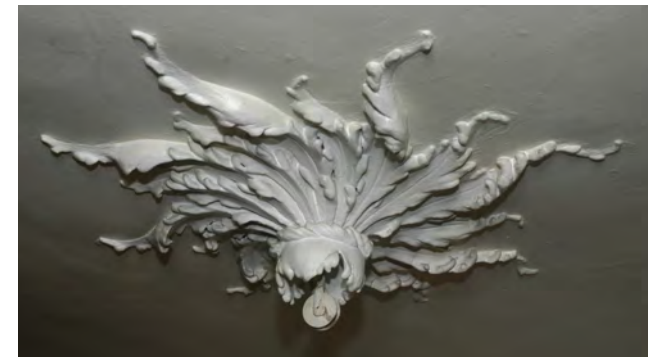
TYPE AND DESCRIPTION OF FABRIC Ceiling rose: foliate mouldings forming bunch in centre; in medium-high relief
BUILDING PHASE C18th
CONDITION Fair

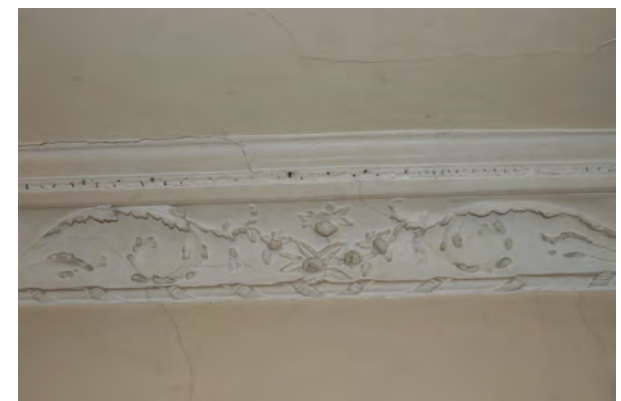
TYPE AND DESCRIPTION OF FABRIC Cornice: rinceau frieze with additional floral motifs.
BUILDING PHASE C18th
CONDITION Poor

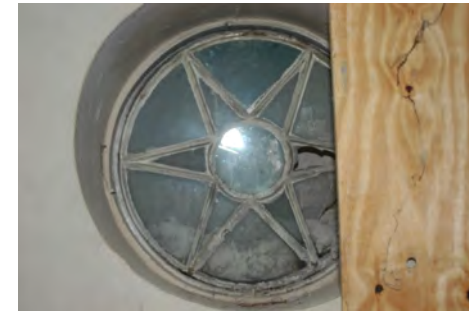
TYPE AND DESCRIPTION OF FABRIC Window at landing: circular opening with metal frame having leaded star pattern.
BUILDING PHASE C19th
CONDITION Poor

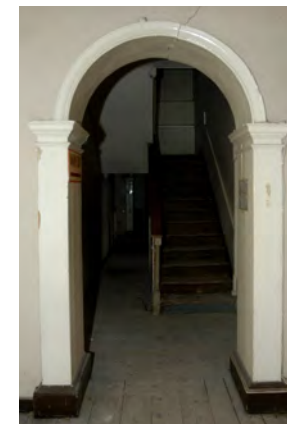
TYPE AND DESCRIPTION OF FABRIC Arch to inner hall: flanking timber panelling forming impost moulding; moulded plaster to arch.
BUILDING PHASE C18th
CONDITION Poor—Fair

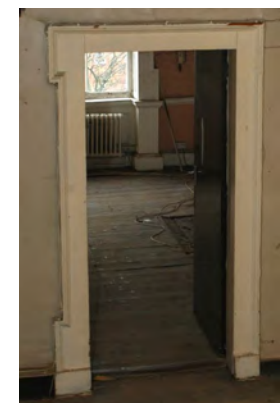
TYPE AND DESCRIPTION OF FABRIC Door to front room: timber casing; timber architrave having lugged and shouldered profile to LHS only; timber flush door.
BUILDING PHASE C18th—C20th
CONDITION Poor

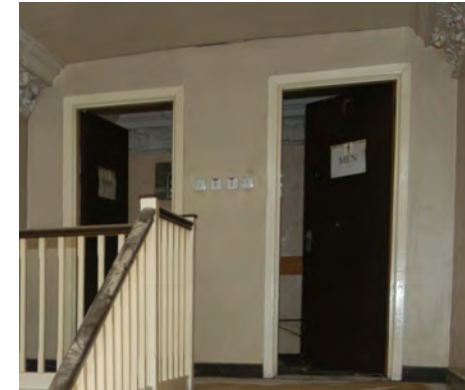
TYPE AND DESCRIPTION OF FABRIC Doors to WCs: located on additional half-landing; timber flush doors with timber architraves.
BUILDING PHASE C20th
CONDITION Poor

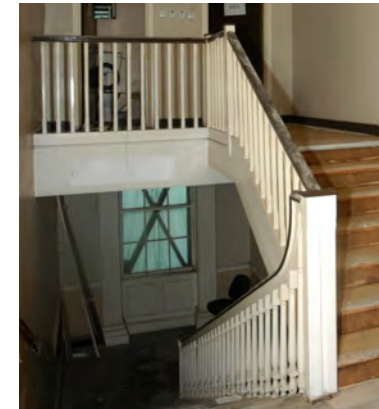
TYPE AND DESCRIPTION OF FABRIC Staircase: timber stairs with open string, having carved detail; turned paired balusters; mahogany handrail; additional section with plain balusters and closed string.
BUILDING PHASE C18th—C20th
CONDITION Poor—Fair

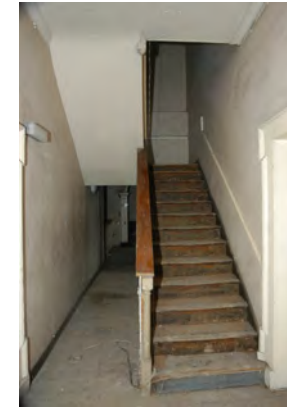
<b>TYPE AND DESCRIPTION OF FABRIC</b> Staircase: timber stairs; timber handrail.
<b>BUILDING PHASE</b> C18th
<b>CONDITION</b> Poor

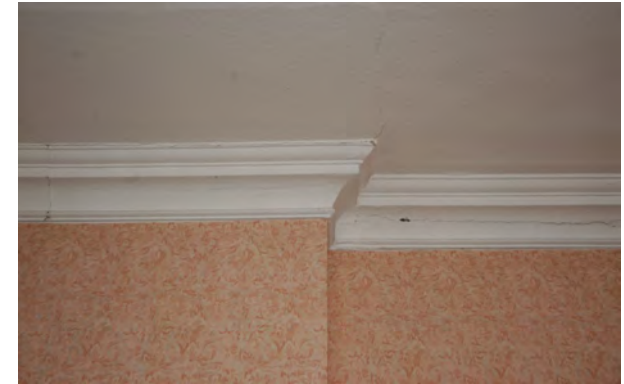
TYPE AND DESCRIPTION OF FABRIC Cornice: running mould type
BUILDING PHASE C18th
CONDITION Poor—fair

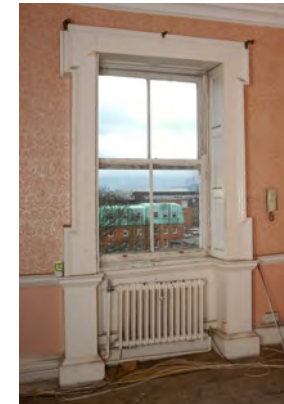
TYPE AND DESCRIPTION OF FABRIC Window: timber casing with panelled shutters; lugged and shouldered timber architrave; split-pane sliding timber sashes.
BUILDING PHASE C18th
CONDITION Poor—Fair

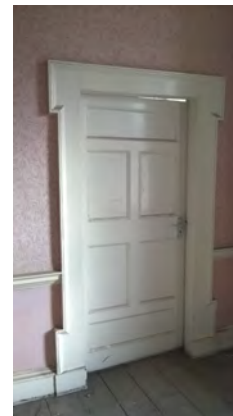
TYPE AND DESCRIPTION OF FABRIC Door to adjoining room: timber casing; lugged and shouldered timber architrave; 6-panel timber door.
BUILDING PHASE C18th
CONDITION Fair

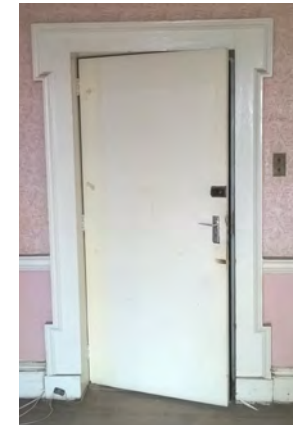
TYPE AND DESCRIPTION OF FABRIC Door to stair hall: timber casing; lugged and shouldered timber architrave; timber flush door.
BUILDING PHASE C18th—C20th
CONDITION Poor
