# APPENDIX A

# Building Inventories

Protected Structures Impact Statement

PARNELL SQUARE CULTURAL QUARTER  
 Architectural Heritage—Decorative Fabric Inventory  
 Nos. 20, 21, 23-28 Parnell Square, Dublin 1  
 November 2015—Shaffrey Associates Architects

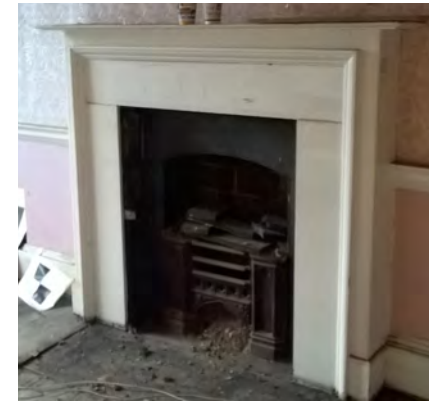
TYPE AND DESCRIPTION OF FABRIC Fireplace: carved painted timber surround; cast iron mantel.
BUILDING PHASE C18th—C20th
CONDITION Poor

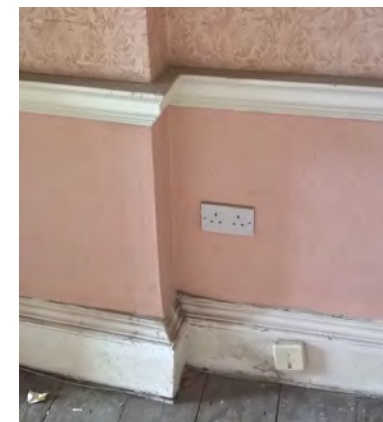
TYPE AND DESCRIPTION OF FABRIC Dado and skirting: timber profiles
BUILDING PHASE C18th
CONDITION Fair

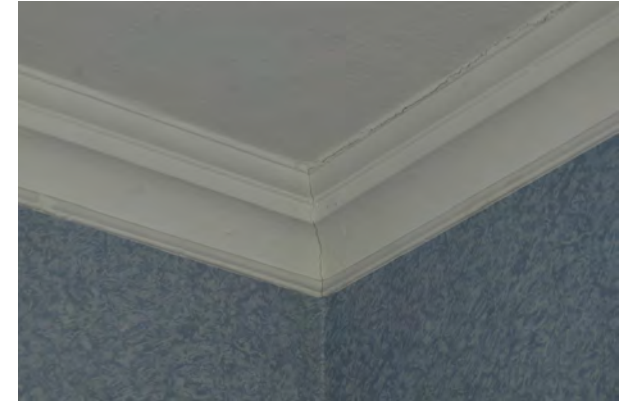
TYPE AND DESCRIPTION OF FABRIC Cornice: running mould type with coving
BUILDING PHASE C18th
CONDITION Fair

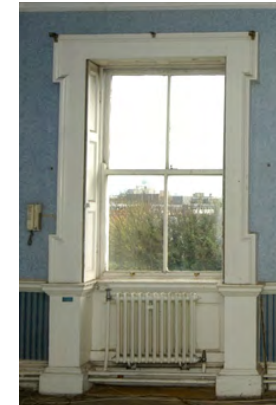
TYPE AND DESCRIPTION OF FABRIC Window, E (LHS internally): timber casing with panelled shutters; lugged and shouldered timber architrave; split-pane sliding timber sashes.
BUILDING PHASE C18th
CONDITION Poor—Fair

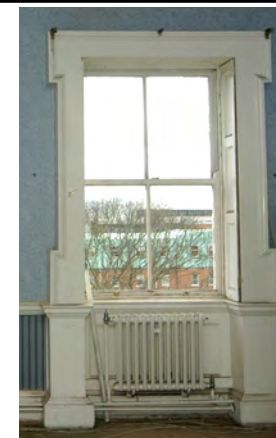
TYPE AND DESCRIPTION OF FABRIC Window, W (RHS internally): timber casing with panelled shutters; lugged and shouldered timber architrave; split-pane sliding timber sashes.
BUILDING PHASE C18th
CONDITION Fair

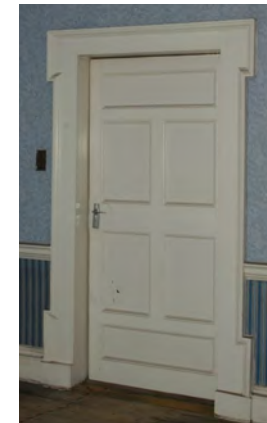
TYPE AND DESCRIPTION OF FABRIC Door to inner hall: timber casing; lugged and shouldered timber architrave; 6-panel timber door.
BUILDING PHASE C18th
CONDITION Poor—fair

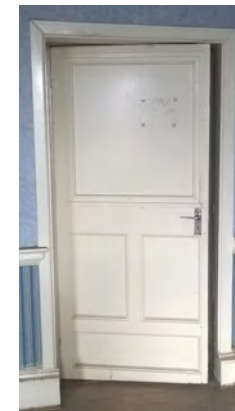
TYPE AND DESCRIPTION OF FABRIC Door to understairs area: timber casing; plain timber architrave; 4-panel timber door.
BUILDING PHASE C18th—C20th
CONDITION Poor

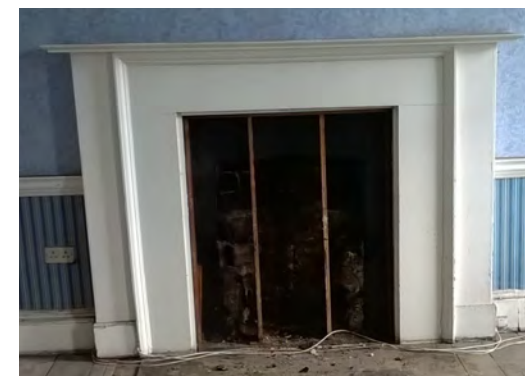
TYPE AND DESCRIPTION OF FABRIC Fireplace: timber surround with cast iron mantel.
BUILDING PHASE C18th—C20th
CONDITION Poor—Fair

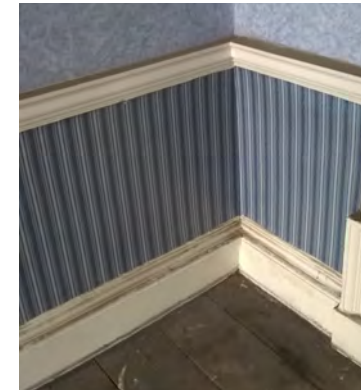
TYPE AND DESCRIPTION OF FABRIC Dado and skirting: timber profiles.
BUILDING PHASE C18th
CONDITION Fair

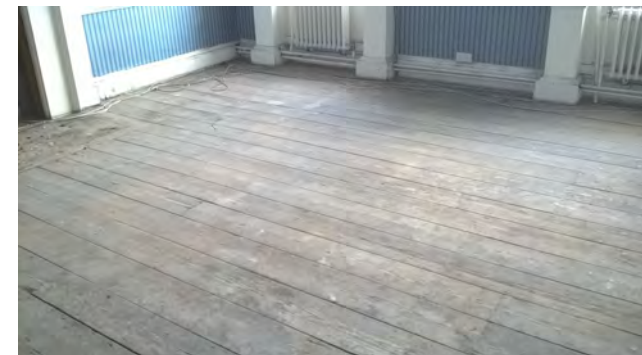
TYPE AND DESCRIPTION OF FABRIC Floor: timber boards
BUILDING PHASE C18th
CONDITION Poor—Fair

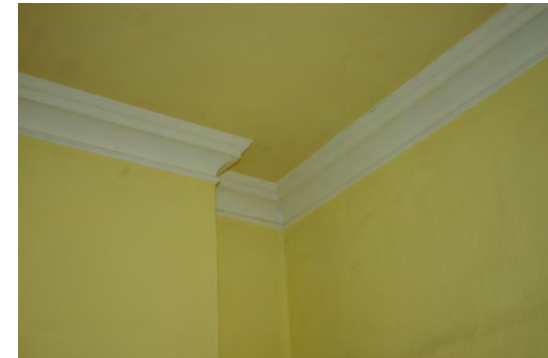
TYPE AND DESCRIPTION OF FABRIC Cornice: running mould type with coving
BUILDING PHASE C18th
CONDITION Fair

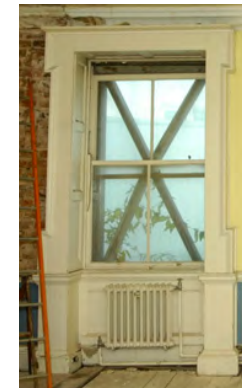
TYPE AND DESCRIPTION OF FABRIC Window, W (LHS internally): timber casing with panelled shutters; lugged and shouldered timber architrave; split-pane sliding timber sashes; braced externally.
BUILDING PHASE C18th
CONDITION Poor

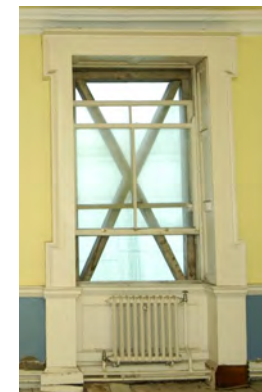
TYPE AND DESCRIPTION OF FABRIC Window, E (RHS internally): timber casing with panelled shutters; lugged and shouldered timber architrave; split-pane sliding timber sashes; braced externally.
BUILDING PHASE C18th
CONDITION Poor

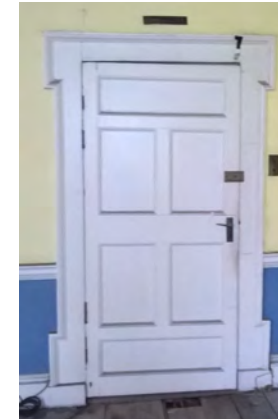
TYPE AND DESCRIPTION OF FABRIC Door to inner hall: timber casing; lugged and shouldered timber architrave; 6-panel timber door.
BUILDING PHASE C18th
CONDITION Poor—Fair

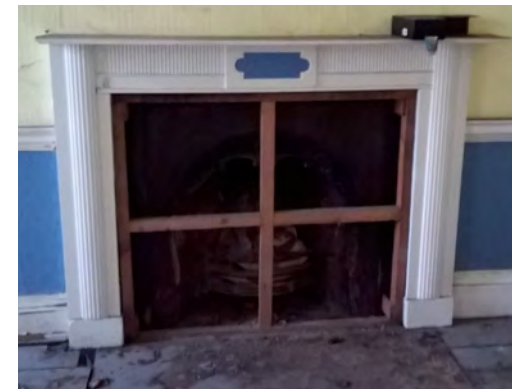
TYPE AND DESCRIPTION OF FABRIC Fireplace: timber surround; cast iron mantel.
BUILDING PHASE C18th
CONDITION Poor

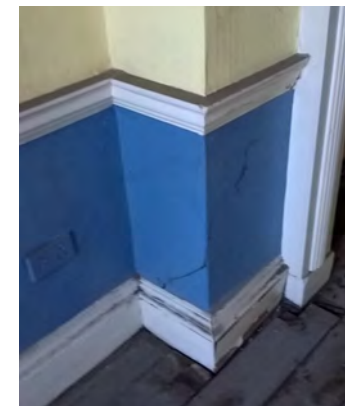
TYPE AND DESCRIPTION OF FABRIC Dado and skirting: timber profiles.
BUILDING PHASE C18th
CONDITION Poor—Fair

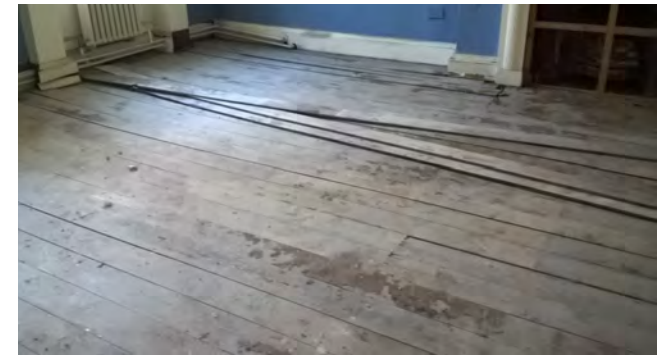
TYPE AND DESCRIPTION OF FABRIC Floor: timber boards
BUILDING PHASE C18th
CONDITION Poor—Fair

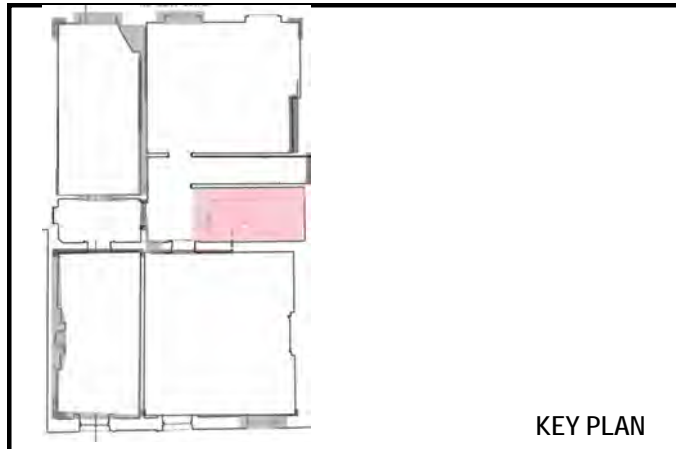
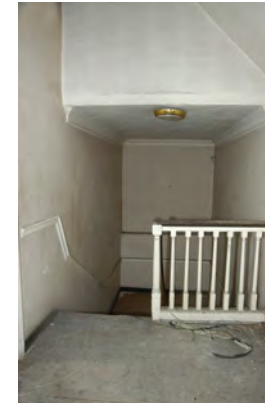
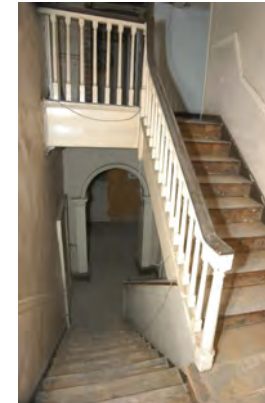
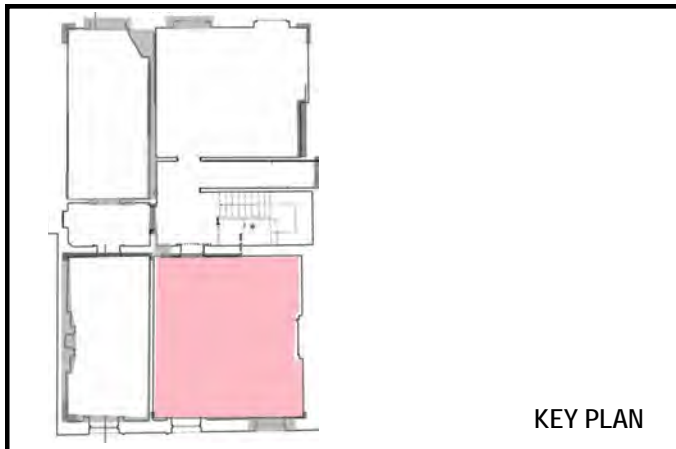
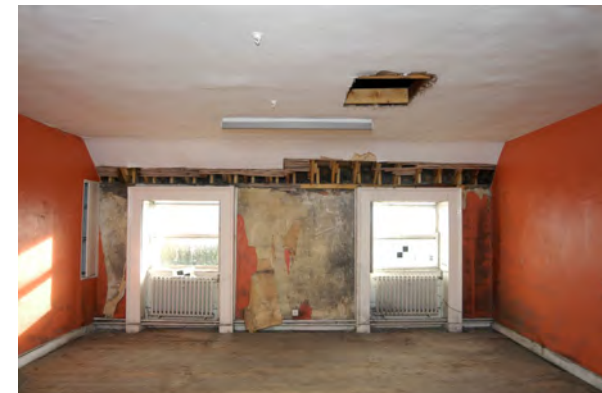
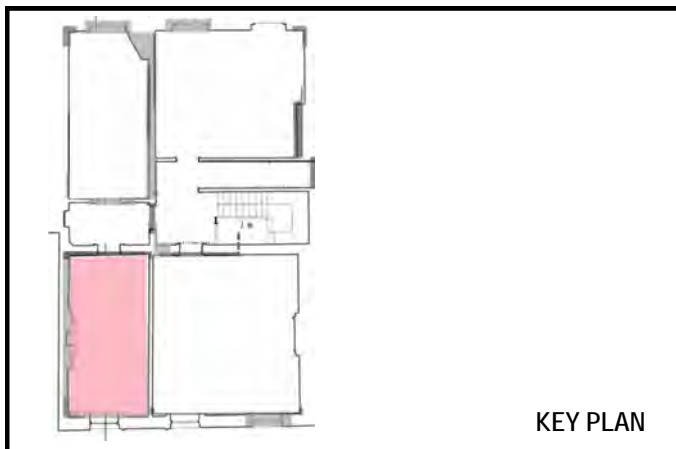
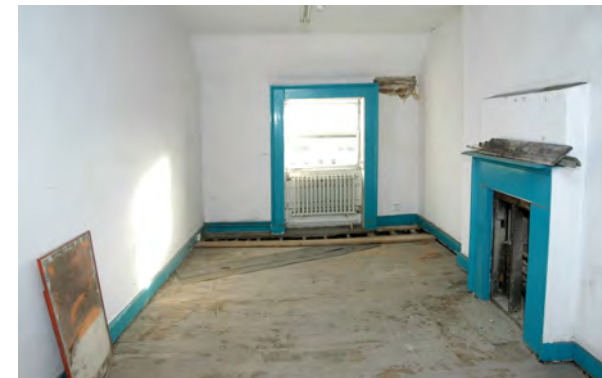
BUILDING NO.	21
FLOOR	Third Floor
ROOM	Stair and front rooms

TYPE AND DESCRIPTION OF FABRIC	<p>Minimal decorative fabric on 3rd floor:

</p> <p>Window joinery: generally timber casings single-pane timber sashes;</p> <p>Some timber panelled doors survive—architraves missing in several cases;</p> <p>Timber staircase with turned balusters and timber handrail;</p> <p>Plain skirtings;</p> <p>Floors—timber with large areas of boards missing;</p> <p>Plain, coved ceilings;</p> <p>Opening to No.20.</p>
--------------------------------	--

BUILDING PHASE	C18th—C20th
CONDITION	Poor

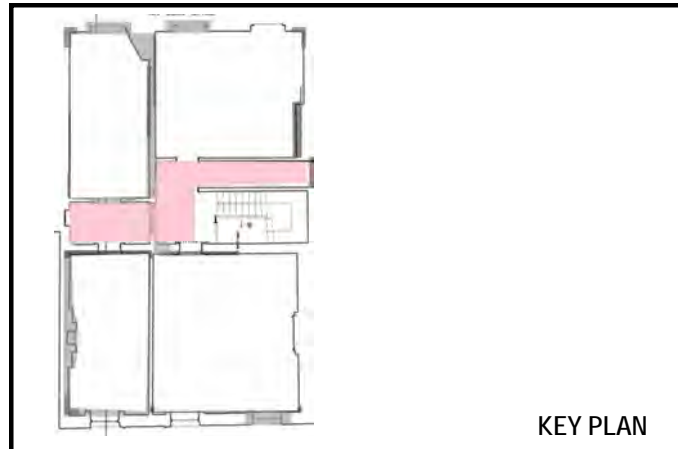
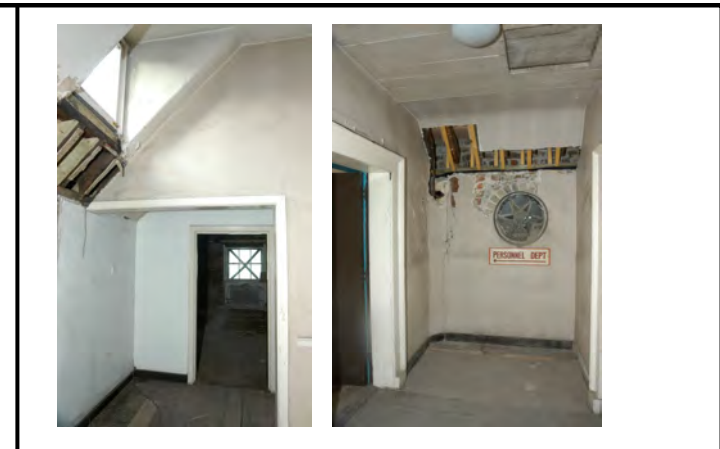
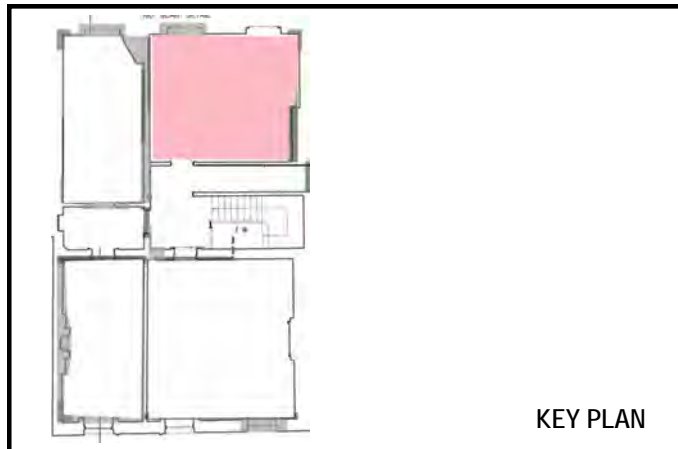
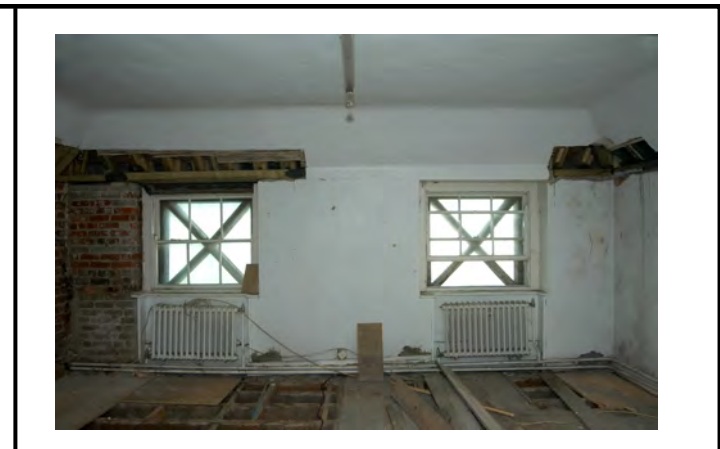
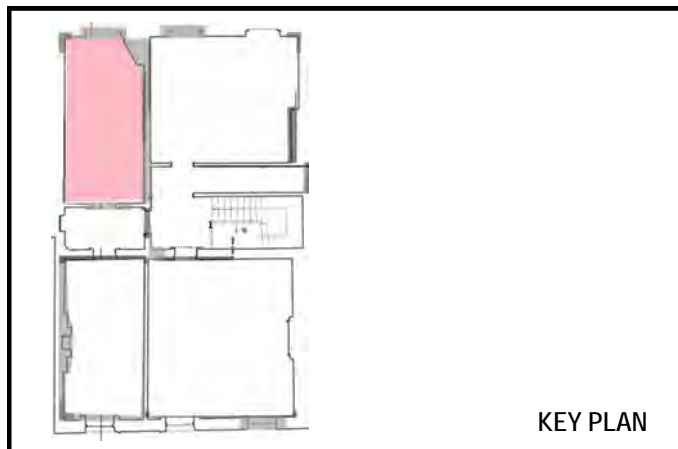
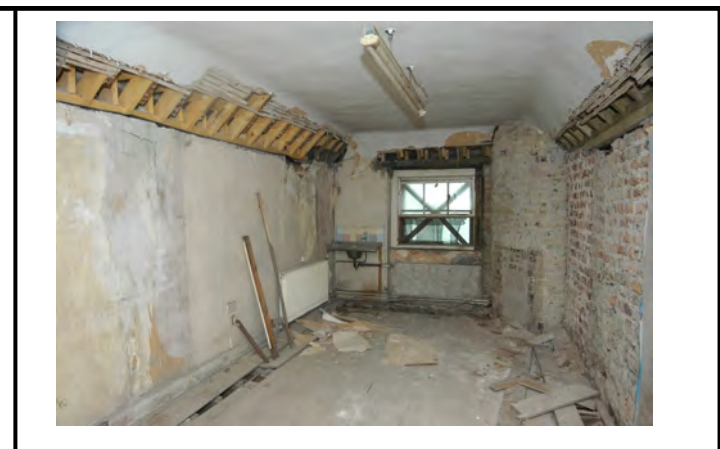
BUILDING NO.
21
FLOOR
Third Floor
ROOM
Hall and rear rooms

TYPE AND DESCRIPTION OF FABRIC
Minimal decorative fabric on 3rd floor: Window joinery: generally timber casings with lugged architraves extending to floor, having single-pane timber sashes; Some timber panelled doors survive—architraves missing in several cases; Plain skirtings; Floors—timber with large areas of boards missing; Plain, coved ceilings; Opening to No.20.

BUILDING PHASE
C18th—C20th
CONDITION
Poor

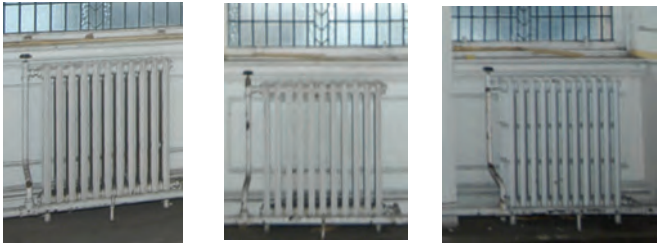
TYPE AND DESCRIPTION OF FABRIC Cast iron radiators (3 no.) located within window surround

BUILDING PHASE C20th	
CONDITION Fair

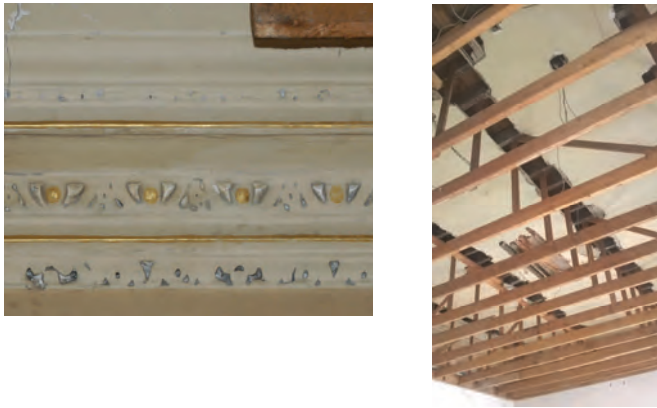
TYPE AND DESCRIPTION OF FABRIC Cornice: in low relief—mouldings indistinct due to overpainting; missing sections—notably at W wall Ceiling: strips have been removed to facilitate hangers for a suspended ceiling (now removed)

BUILDING PHASE C18th	
CONDITION Poor

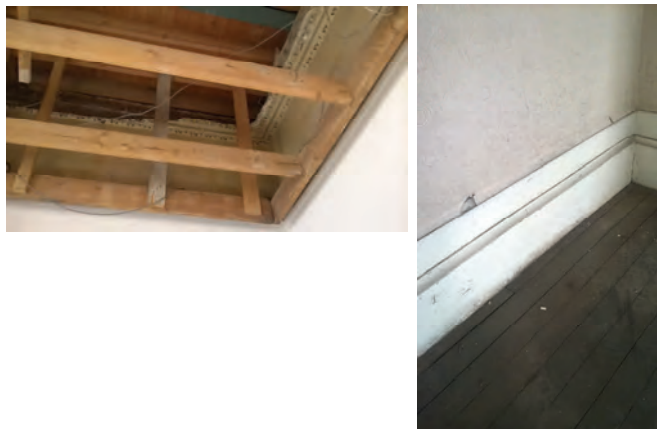
TYPE AND DESCRIPTION OF FABRIC Walls: plasterwork stripped below suspended ceiling level and drylined with gypsum boards to level of skirting. Skirting boards remain but moulding profile obscured by dry-lining.

BUILDING PHASE C20th (with limited C18th)	
CONDITION Poor

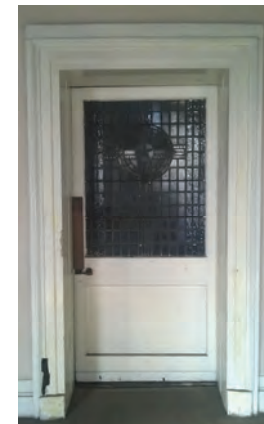
<b>TYPE AND DESCRIPTION OF FABRIC</b> Door; architrave and leaf: Simple mouldings to architrave surrounded by C20th boxing-out; C20th replacement door leaf with glazed panel, having leaded Celtic cross pattern, and bronze door furniture.
<b>BUILDING PHASE</b> C20th (with limited surviving C18th joinery)
<b>CONDITION</b> Poor—Fair

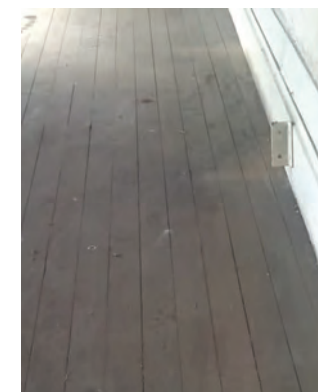
<b>TYPE AND DESCRIPTION OF FABRIC</b> Floor: Solid timber floor; narrow boards
<b>BUILDING PHASE</b> C20th
<b>CONDITION</b> Poor—fair

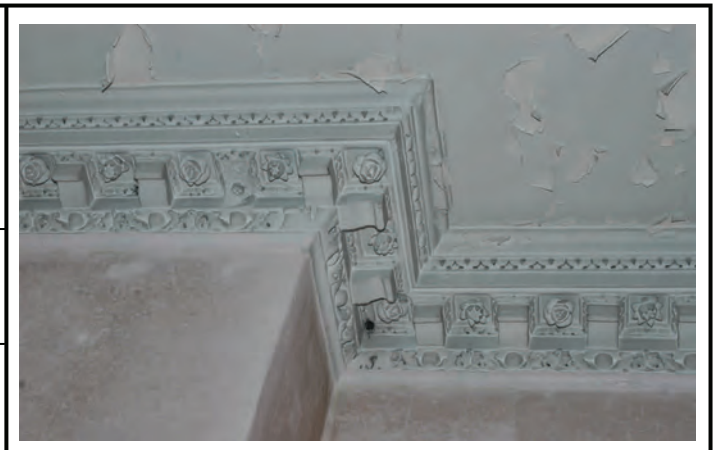
<b>TYPE AND DESCRIPTION OF FABRIC</b> Cornice: medium relief with modillion and rosette detail Ceiling: flat, lacking decoration with abundance of peeling paint
<b>BUILDING PHASE</b> C18th
<b>CONDITION</b> Fair

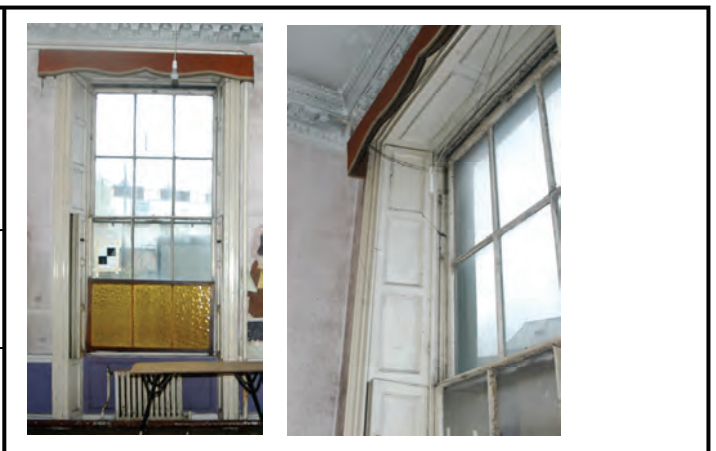
<b>TYPE AND DESCRIPTION OF FABRIC</b> Window (West) (LHS internally): Timber 6-over-6 sashes; timber cases; divided shutters; replacement glazing.
<b>BUILDING PHASE</b> C18th
<b>CONDITION</b> Poor

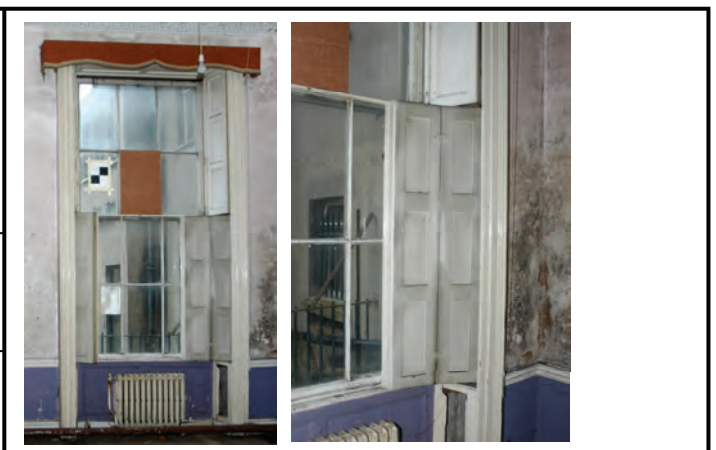
<b>TYPE AND DESCRIPTION OF FABRIC</b> Window (East) (RHS internally): Timber 6-over-6 sashes; timber cases; divided shutters; replacement glazing.
<b>BUILDING PHASE</b> C18th
<b>CONDITION</b> Poor

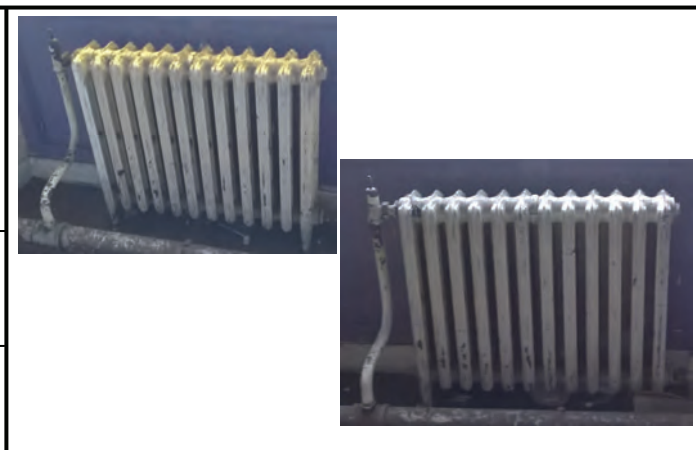
TYPE AND DESCRIPTION OF FABRIC Cast iron radiators: 2 no., located below windows
BUILDING PHASE C20th
CONDITION Poor—Fair

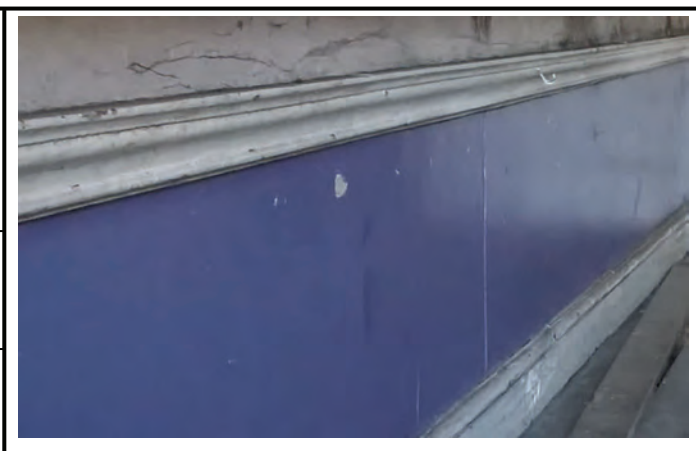
TYPE AND DESCRIPTION OF FABRIC Timber dado rail and skirting boards
BUILDING PHASE C18th
CONDITION Poor—fair

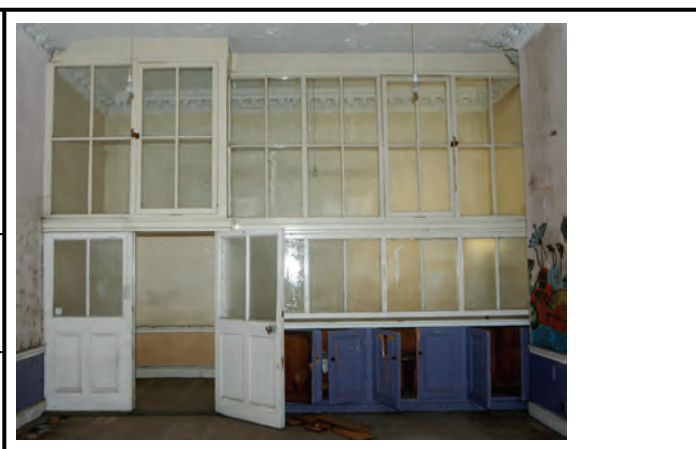
TYPE AND DESCRIPTION OF FABRIC Timber and glazed partition: divides room, creating inner hallway; timber storage units at floor level, with obscured glass panels above and clear glass panes at high level; bronze stays to openable casements
BUILDING PHASE C20th
CONDITION Fair

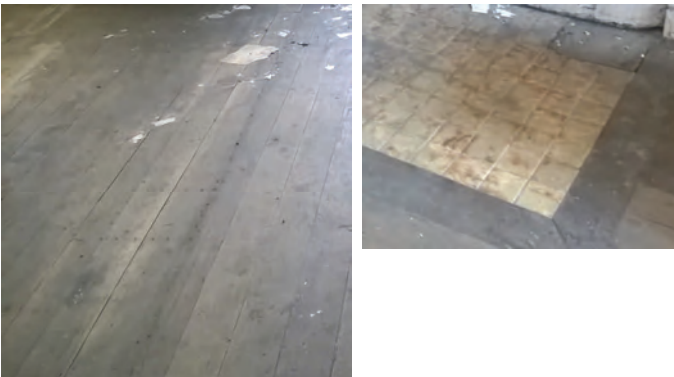
TYPE AND DESCRIPTION OF FABRIC Floor: solid timber; narrow boards; tiled area at former hearth area

BUILDING PHASE C20th	
CONDITION Poor—fair

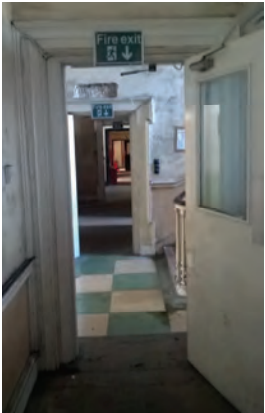
TYPE AND DESCRIPTION OF FABRIC Door to No.24: timber casing; timber fire door having wired glass panel

BUILDING PHASE C20th	
CONDITION Poor—Fair

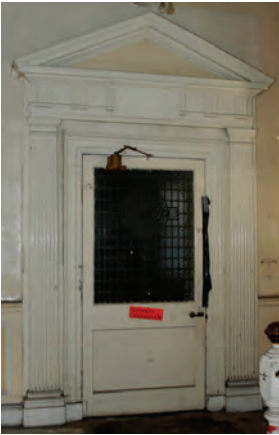
<b>TYPE AND DESCRIPTION OF FABRIC</b> Door; casing and leaf: Timber casing, having pediment and Doric frieze and pilasters C20th replacement door leaf with glazed panel, having leaded Celtic cross pattern, and bronze door furniture.

<b>BUILDING PHASE</b> C18th (door casing) C20th (door leaf)	
<b>CONDITION</b> Fair

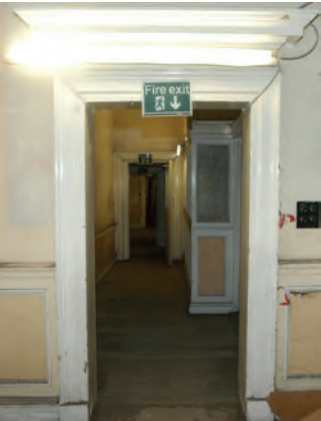
<b>TYPE AND DESCRIPTION OF FABRIC</b> Door casing: shallow mouldings to architrave; elaborate carved cornice over door. No door leaf.

<b>BUILDING PHASE</b> C18th	
<b>CONDITION</b> Poor

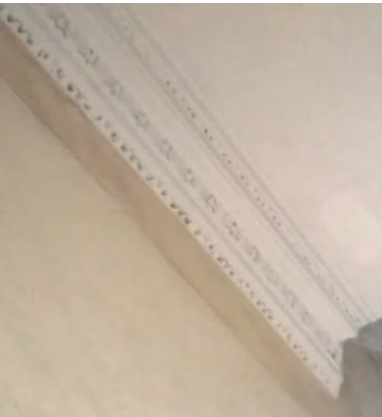
<b>TYPE AND DESCRIPTION OF FABRIC</b> Cornice: In low relief; mouldings indistinct due to overpainting

<b>BUILDING PHASE</b> C18th	
<b>CONDITION</b> Poor

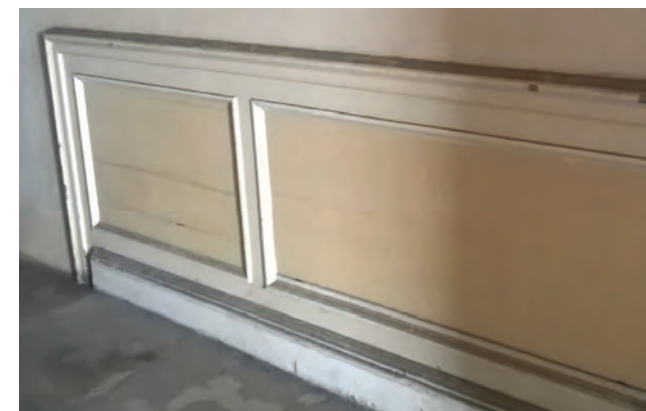
TYPE AND DESCRIPTION OF FABRIC Wall panelling: Timber dado rail with fielded panels below above deep skirting boards; to front area of stair hall (base of stairs)
BUILDING PHASE C18th
CONDITION Fair

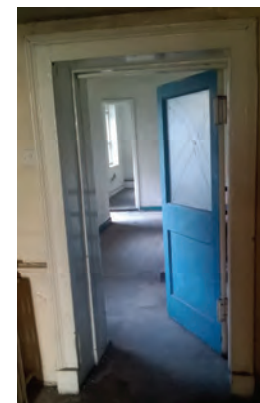
TYPE AND DESCRIPTION OF FABRIC Door casing: simply moulded architrave Door leaf: 2-panel door with wired glass above flat panel
BUILDING PHASE C18th (casing) C20th (leaf)
CONDITION Poor—fair

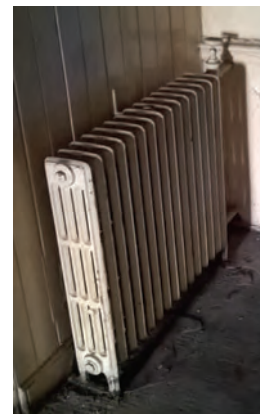
TYPE AND DESCRIPTION OF FABRIC Cast iron radiator located LHS of door to rear
BUILDING PHASE C20th
CONDITION Fair

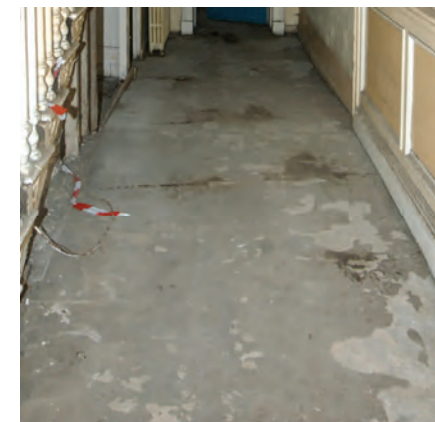
TYPE AND DESCRIPTION OF FABRIC Floor: concrete floor Area of stone flagging survives below the staircase
BUILDING PHASE C20th
CONDITION Poor—Fair

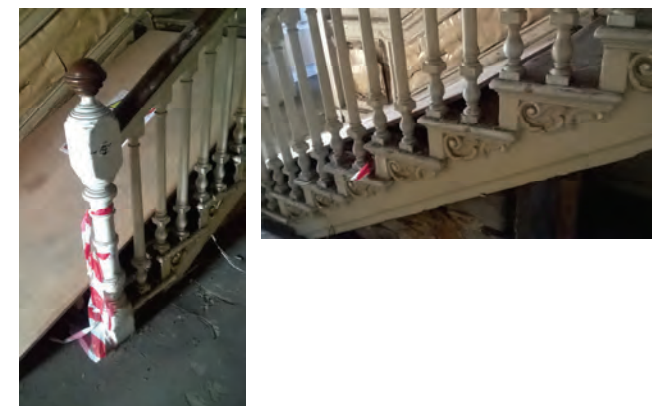
TYPE AND DESCRIPTION OF FABRIC Stairs: Timber stairs; open string with carved detail; turned, paired balusters and turned newel post; mahogany handrail.
BUILDING PHASE C18th
CONDITION Poor—structurally unsound

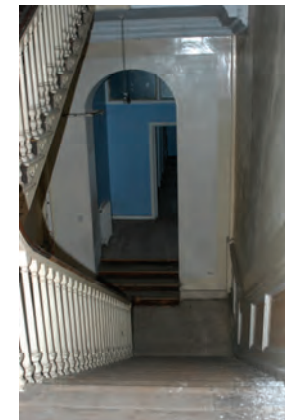
TYPE AND DESCRIPTION OF FABRIC Arch to toilet block at half-landing; C20th intervention to C18th window ope. No embellishment. Window fabric removed.
BUILDING PHASE C20th
CONDITION Fair

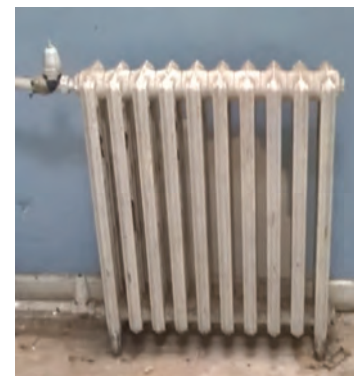
TYPE AND DESCRIPTION OF FABRIC Cast iron radiator located at half-landing lobby to WCs.
BUILDING PHASE C20th
CONDITION Fair

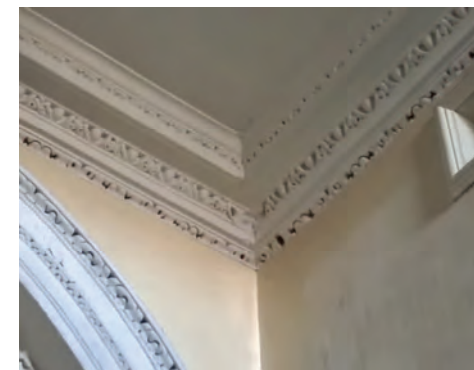
TYPE AND DESCRIPTION OF FABRIC Cornice: Low relief, plasterwork heavily overpainted
BUILDING PHASE C18th
CONDITION Fair

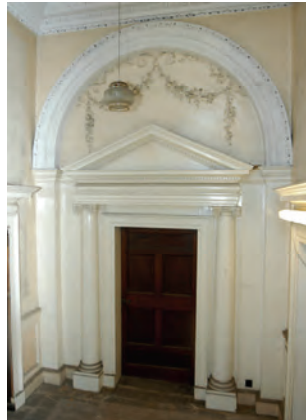
TYPE AND DESCRIPTION OF FABRIC Door, casing and leaf: entrance to front reception room having timber door casing with half-engaged ionic columns and pediment; archway above with cornice and festoon detail; timber 6-panel door with C20th bronze furniture

BUILDING PHASE C18th with some C20th fabric	
CONDITION Fair—good

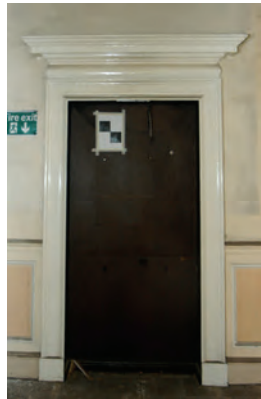
TYPE AND DESCRIPTION OF FABRIC Door case: timber casing to blind ope reflecting doorway opposite; carved overdoor detail and architrave

BUILDING PHASE C18th	
CONDITION Fair

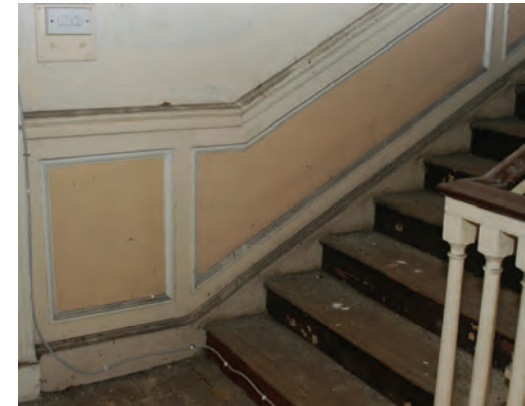
TYPE AND DESCRIPTION OF FABRIC Panelling to walls: lath-and-plaster fielded panels with timber dado and skirtings
BUILDING PHASE C18th
CONDITION Fair

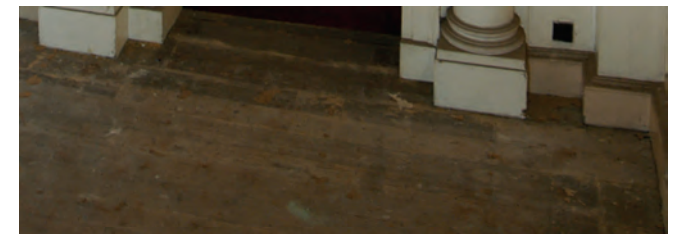
TYPE AND DESCRIPTION OF FABRIC Floor: timber boards
BUILDING PHASE C18th
CONDITION Fair

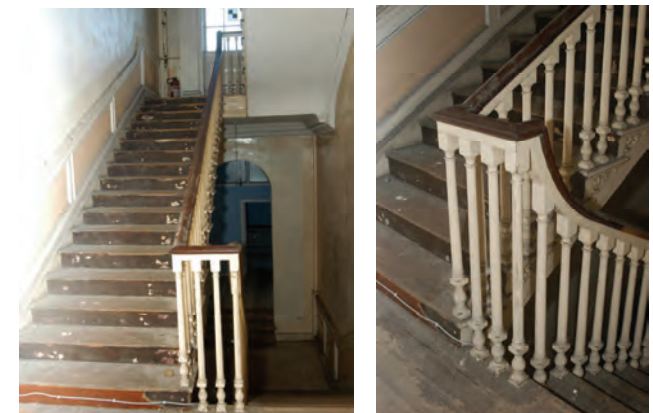
TYPE AND DESCRIPTION OF FABRIC Staircase: timber stairs; paired and turned balusters; mahogany handrail; open string with carved detail.
BUILDING PHASE C18th
CONDITION Fair

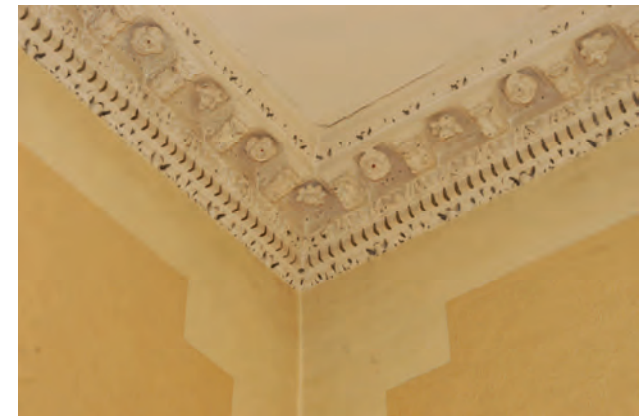
TYPE AND DESCRIPTION OF FABRIC Cornice: modillion and rosette detail in medium-high relief; heavily overpainted
BUILDING PHASE C18th
CONDITION Fair

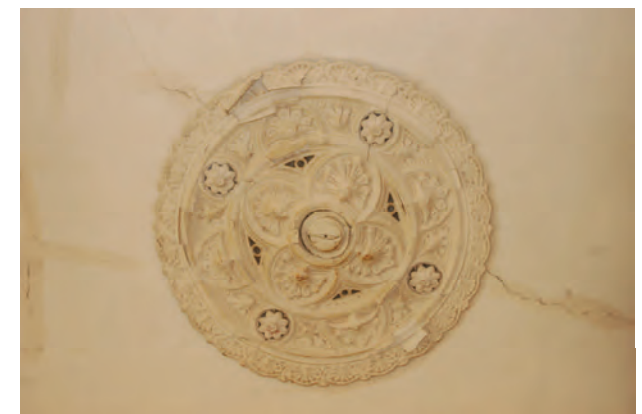
TYPE AND DESCRIPTION OF FABRIC Ceiling rose: quatrefoil palmette pattern with surrounding foliate and rosette detail; evidence of cracking.
BUILDING PHASE C18th
CONDITION Poor—fair

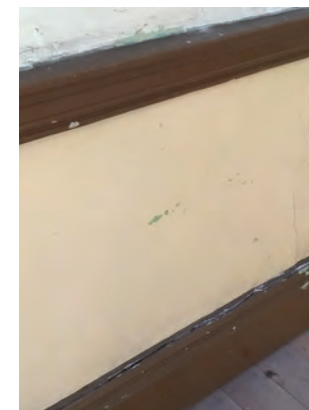
TYPE AND DESCRIPTION OF FABRIC Timber dado and skirtings
BUILDING PHASE C20th
CONDITION Poor—fair

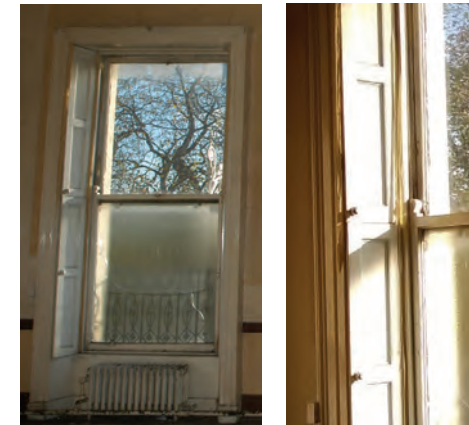
TYPE AND DESCRIPTION OF FABRIC Window: single-pane sashes; divided shutters, timber window case
BUILDING PHASE C18th surrounds/C19th sashes
CONDITION Poor

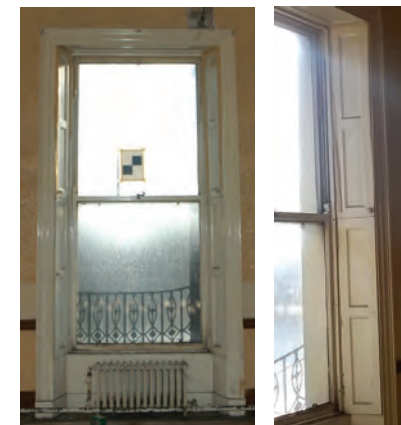
TYPE AND DESCRIPTION OF FABRIC Window: single-pane sashes; divided shutters, timber window case
BUILDING PHASE C18th surrounds/C19th sashes
CONDITION Poor

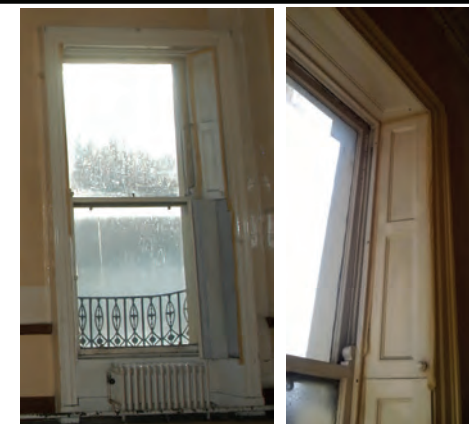
TYPE AND DESCRIPTION OF FABRIC Window: single-pane sashes; divided shutters, timber window case
BUILDING PHASE C18th surrounds/C19th sashes
CONDITION Poor

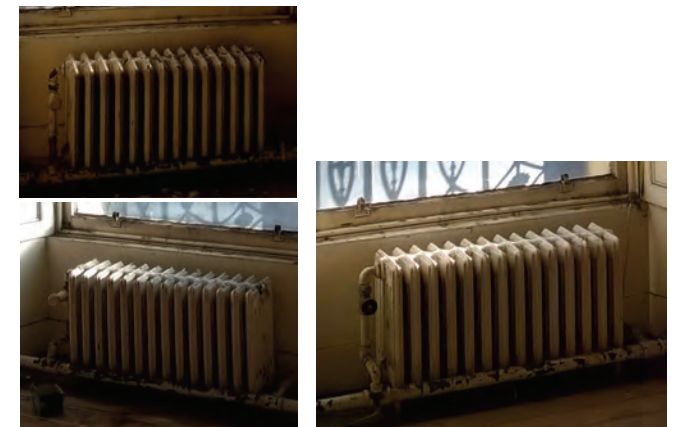
TYPE AND DESCRIPTION OF FABRIC Cast iron radiators: 3no., located below windows
BUILDING PHASE C20th
CONDITION Fair

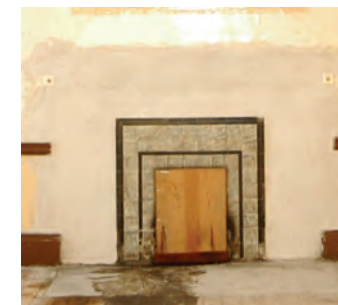
TYPE AND DESCRIPTION OF FABRIC Fireplace: tiled surround with concrete hearth
BUILDING PHASE C20th
CONDITION Poor

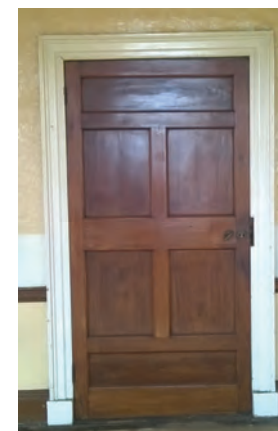
TYPE AND DESCRIPTION OF FABRIC Door: timber architrave with simple moulding; timber 6-panel door
BUILDING PHASE C18th
CONDITION Fair

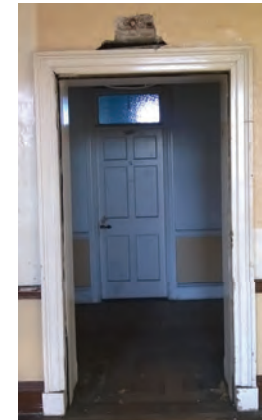
TYPE AND DESCRIPTION OF FABRIC Door case: timber architrave with simple mouldings; no door leaf; damage to door head
BUILDING PHASE C18th
CONDITION Fair

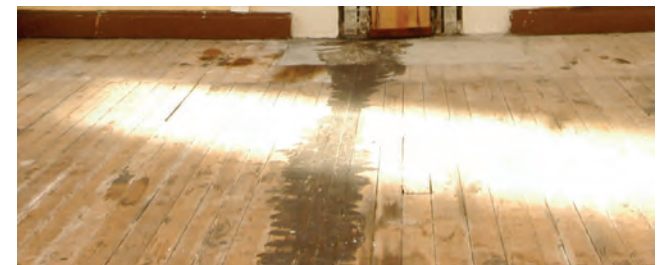
TYPE AND DESCRIPTION OF FABRIC Floor: timber boards; area of replacement boards to W of room
BUILDING PHASE C18th—C20th
CONDITION Poor

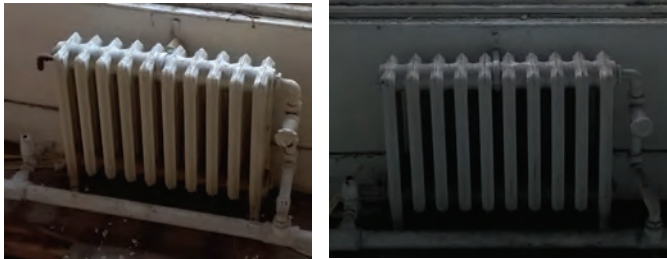
TYPE AND DESCRIPTION OF FABRIC Cast iron radiators: 2no., located below the windows;

BUILDING PHASE C20th	
CONDITION Fair

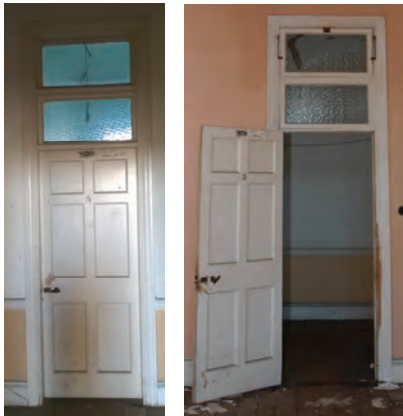
TYPE AND DESCRIPTION OF FABRIC Doors: 2no., located within partition wall, giving access to rooms from inner hallway; timber 6-panel doors with double overlights, the upper being a bottom-hung casement; bronze door furniture.

BUILDING PHASE C20th	
CONDITION Fair

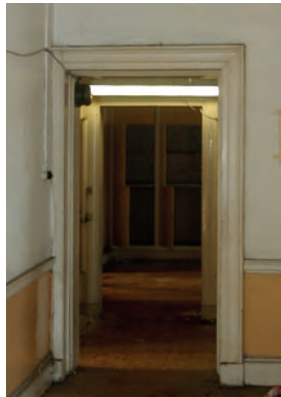
TYPE AND DESCRIPTION OF FABRIC Door casing: timber architrave to ope; no door leaf; located at access to No.24

BUILDING PHASE C20th	
CONDITION Fair

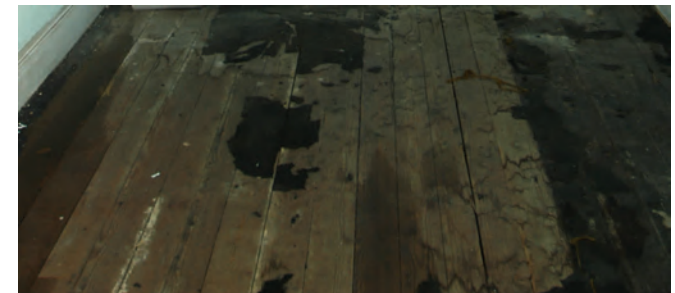
TYPE AND DESCRIPTION OF FABRIC Floor: timber boards
BUILDING PHASE C18th—C20th
CONDITION Fair

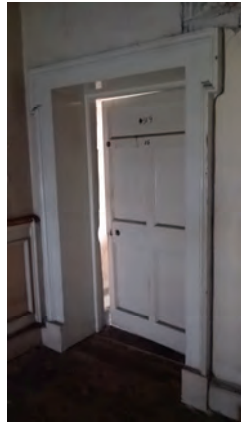
TYPE AND DESCRIPTION OF FABRIC Door to front room: timber, lugged architrave having simple moulding profile; 5-panel timber door.

BUILDING PHASE C18th	
CONDITION Fair

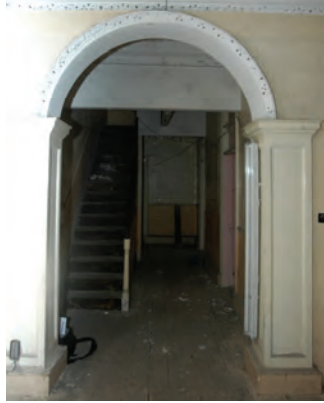
TYPE AND DESCRIPTION OF FABRIC Archway to inner hall: moulded plaster detail to arch; timber panelling to flanking walls

BUILDING PHASE C18th	
CONDITION Poor—Fair

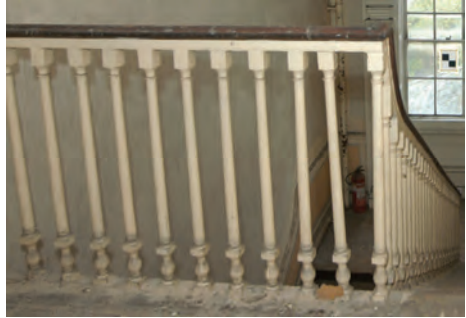
TYPE AND DESCRIPTION OF FABRIC Staircase: timber stairs with timber turned balusters and mahogany handrail

BUILDING PHASE C18th	
CONDITION Fair

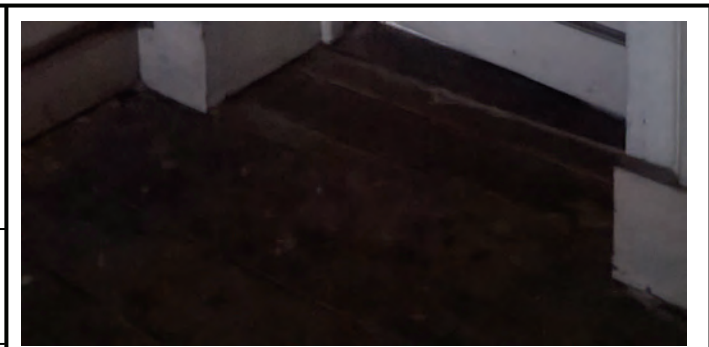
TYPE AND DESCRIPTION OF FABRIC Floor: timber boards
BUILDING PHASE C18th
CONDITION Fair

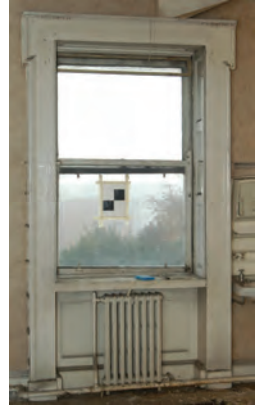
TYPE AND DESCRIPTION OF FABRIC Window: Lugged, timber window casing with simple mouldings and timber shutters; single-pane timber sashes; raised timber panel below.

BUILDING PHASE C18th casing, C19th sashes	
CONDITION Poor

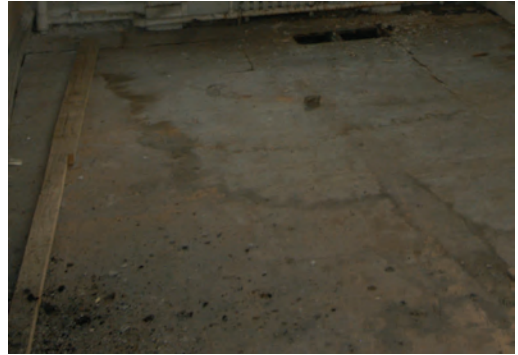
TYPE AND DESCRIPTION OF FABRIC Floor: timber wide plank with some missing sections

BUILDING PHASE C18th	
CONDITION Fair

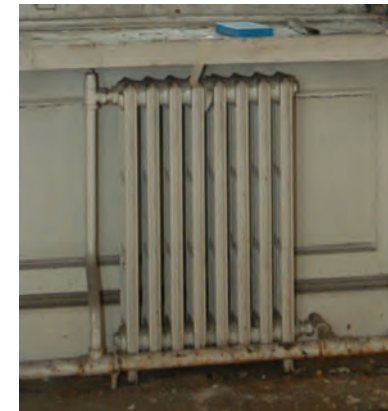
TYPE AND DESCRIPTION OF FABRIC Cast iron radiator: located below window
BUILDING PHASE C20th
CONDITION Fair

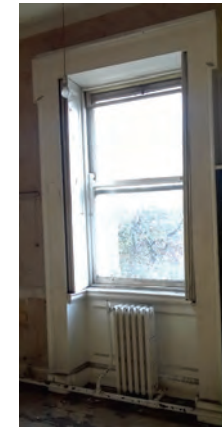
TYPE AND DESCRIPTION OF FABRIC Window, E (LHS internally): Lugged, timber window casing with simple mouldings and timber shutters; single-pane timber sashes; raised timber panel below.
BUILDING PHASE C18th casing, C19th sashes
CONDITION Poor

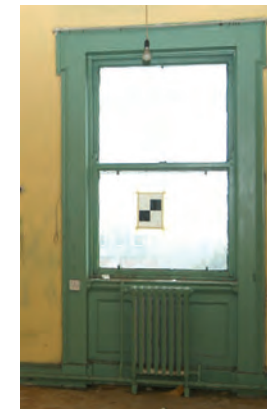
TYPE AND DESCRIPTION OF FABRIC Window, W (RHS internally): Lugged, timber window casing with simple mouldings and timber shutters; single-pane timber sashes; raised timber panel below.
BUILDING PHASE C18th casing, C19th sashes
CONDITION Poor

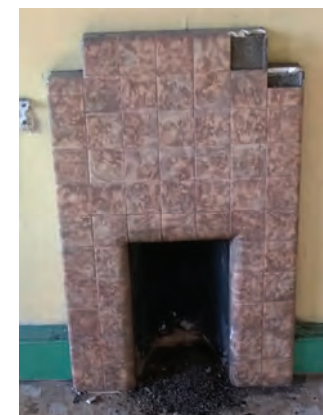
TYPE AND DESCRIPTION OF FABRIC Fireplace: Tiled surround
BUILDING PHASE C20th
CONDITION Poor

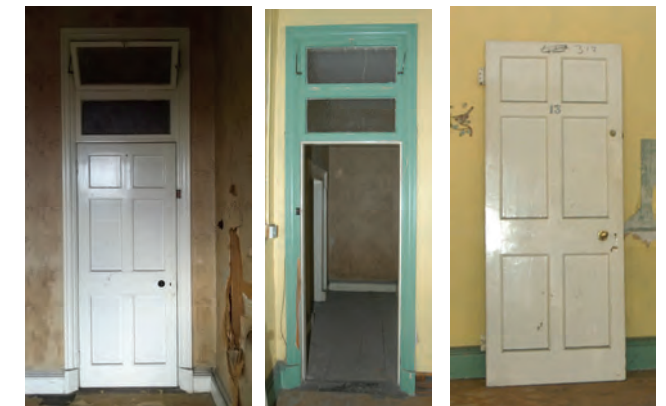
<b>TYPE AND DESCRIPTION OF FABRIC</b> Doors: 2no., to lobby into room from inner hallway; timber 6-panel doors with double overlights, the upper being a bottom-hung casement; bronze door furniture; one door off its hinges.
<b>BUILDING PHASE</b> C20th
<b>CONDITION</b> Poor

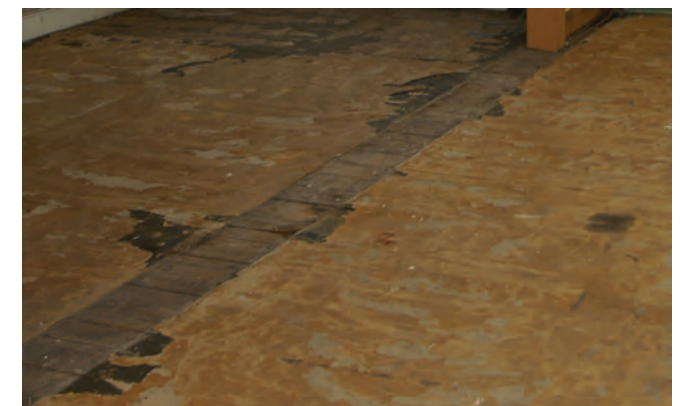
<b>TYPE AND DESCRIPTION OF FABRIC</b> Floor: wide-plank timber boards
<b>BUILDING PHASE</b> C18th
<b>CONDITION</b> Fair

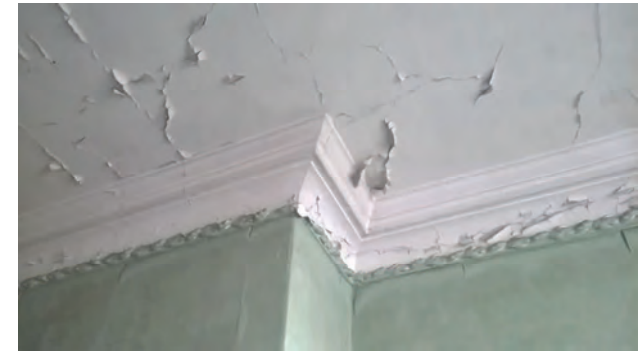
TYPE AND DESCRIPTION OF FABRIC Cornice: simple running-mould cornice to ceiling with cable-moulding below
BUILDING PHASE C18th
CONDITION Poor

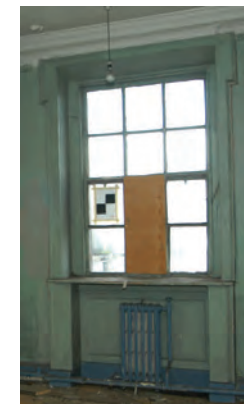
TYPE AND DESCRIPTION OF FABRIC Window, W (LHS internally): Lugged casing that breaks into cornice above; 6-over-6 timber sashes; some historic glass surviving; C20th window board.
BUILDING PHASE C18th
CONDITION Poor

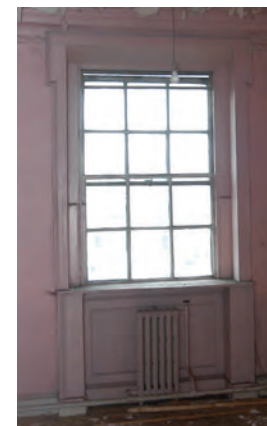
TYPE AND DESCRIPTION OF FABRIC Window, E (RHS internally): Lugged casing that breaks into cornice above; 6-over-6 timber sashes; some historic glass surviving; C20th window board.
BUILDING PHASE C18th
CONDITION Poor

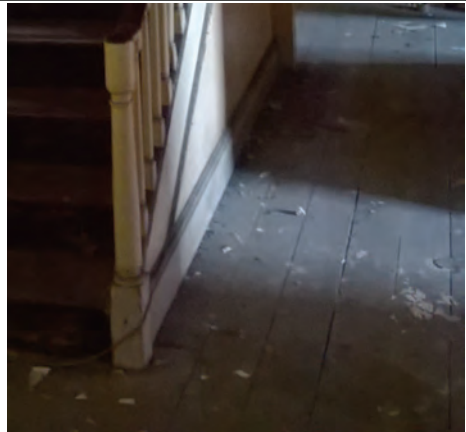
TYPE AND DESCRIPTION OF FABRIC Floor: timber boards

BUILDING PHASE C18th	
CONDITION Poor–Fair

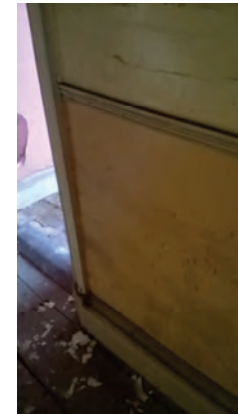
TYPE AND DESCRIPTION OF FABRIC Dado and skirting: simple timber mouldings
BUILDING PHASE C20th
CONDITION Fair

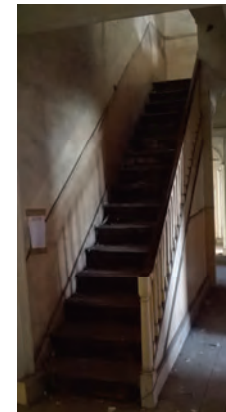
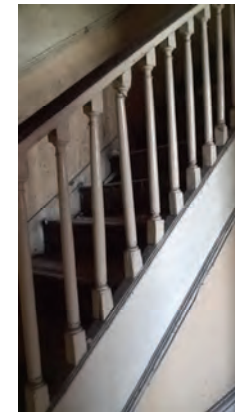
TYPE AND DESCRIPTION OF FABRIC Staircase: timber stairs; timber balusters; mahogany handrail; closed string; plain newel post.
BUILDING PHASE C18th
CONDITION Poor—structurally unsound
