# APPENDIX A

# Building Inventories

Protected Structures Impact Statement

PARNELL SQUARE CULTURAL QUARTER  
 Architectural Heritage—Decorative Fabric Inventory  
 Nos. 20, 21, 23-28 Parnell Square, Dublin 1  
 November 2015—Shaffrey Associates Architects

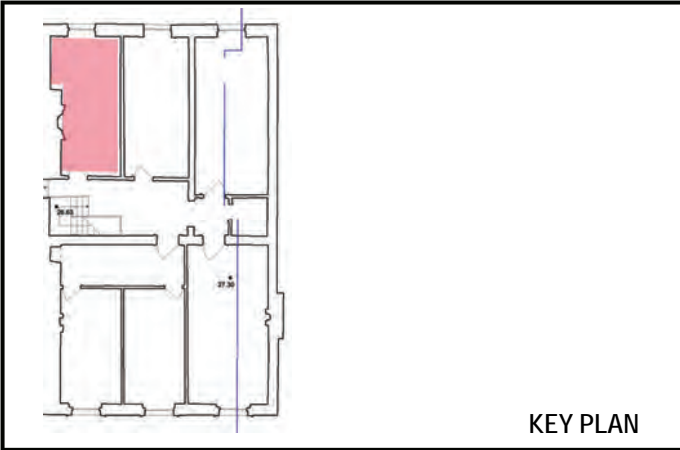
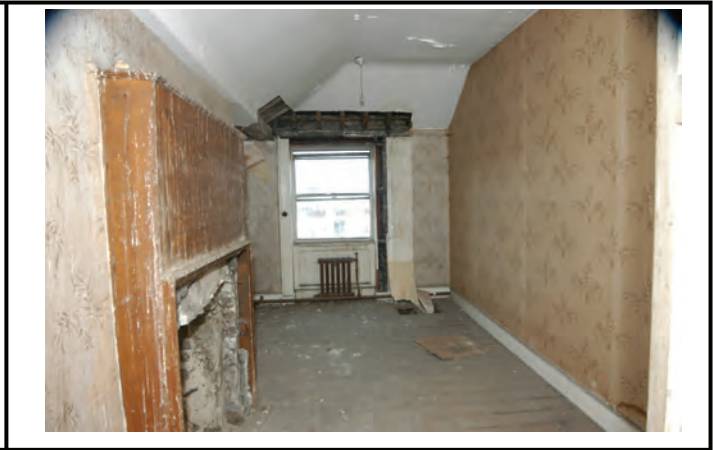
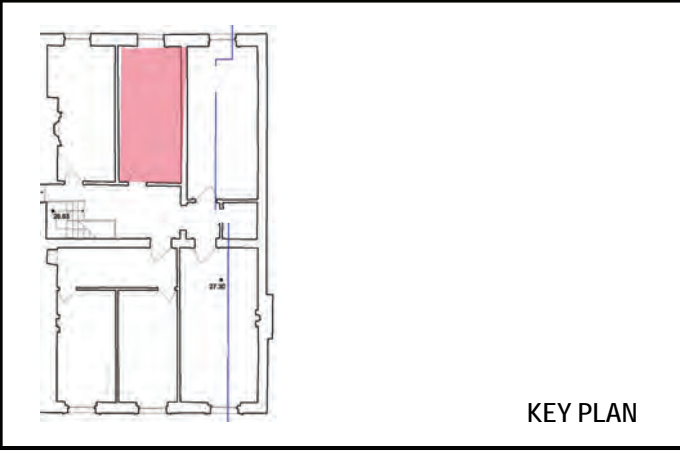
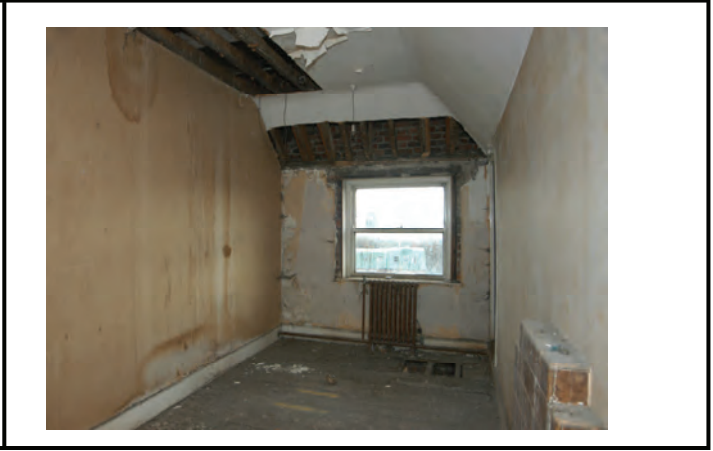
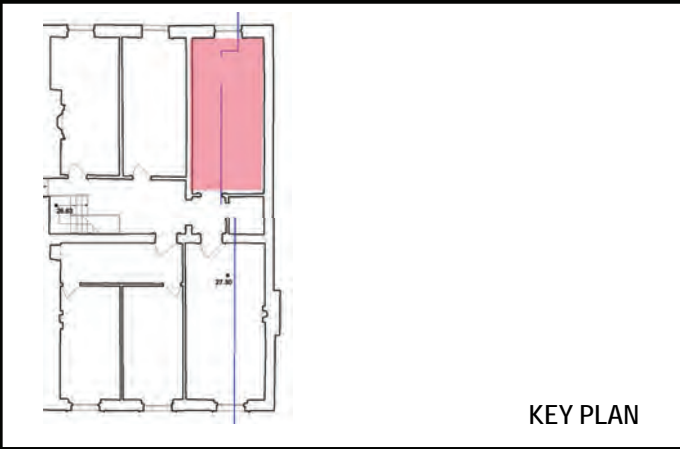
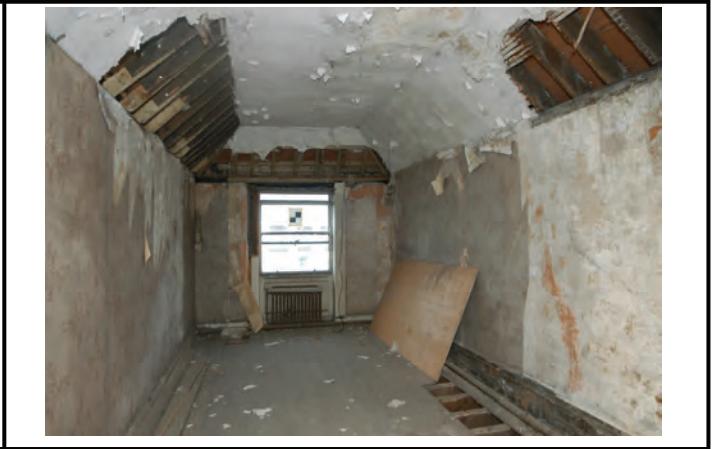
BUILDING NO. 23
FLOOR Third Floor
ROOM Rear rooms (access limited due to safety issues)

TYPE AND DESCRIPTION OF FABRIC  Minimal decorative fabric on 3rd floor: Window joinery—as pictured; Doors; Plain skirtings; Floors—timber throughout; Plain, coved ceilings; Cast iron radiators below windows; Opening to No.24.
--

BUILDING PHASE C18th –C20th
CONDITION Generally poor

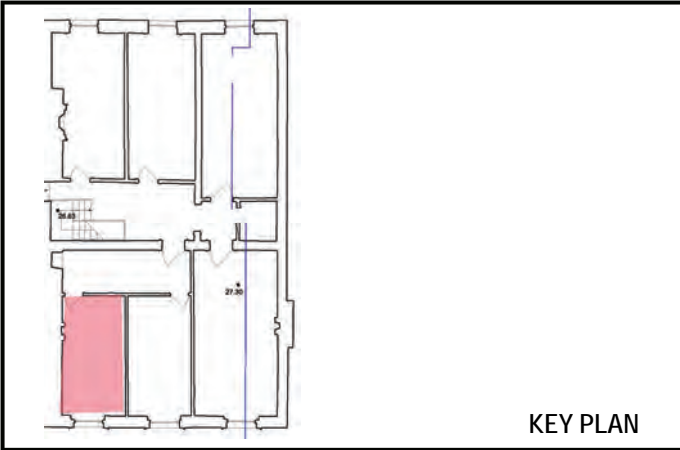
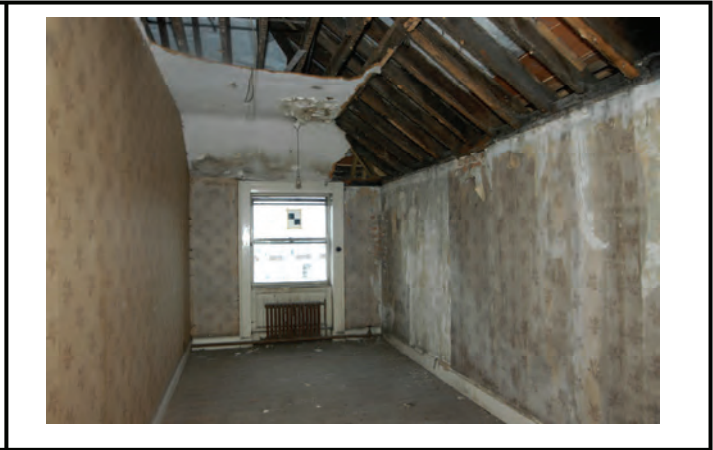
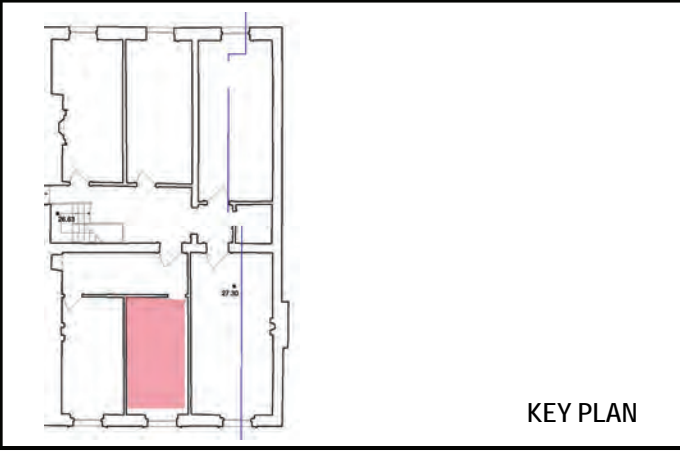
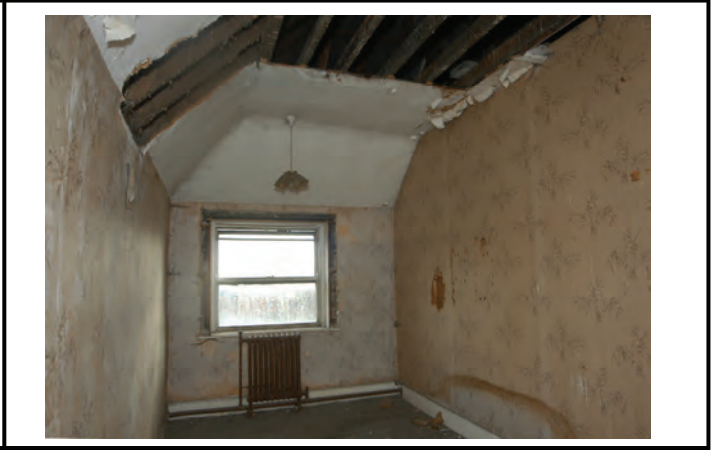
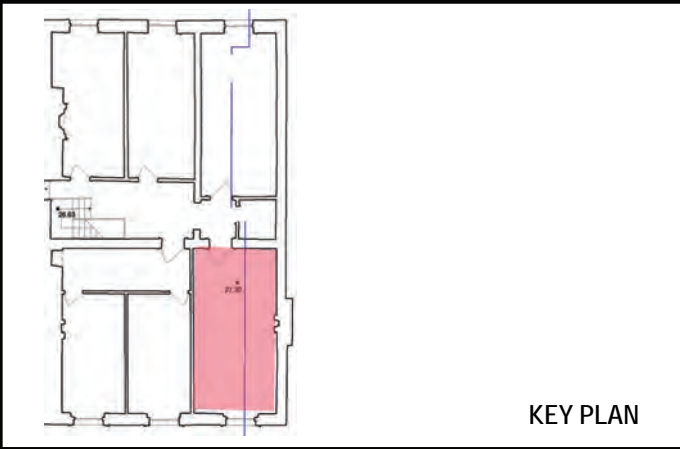
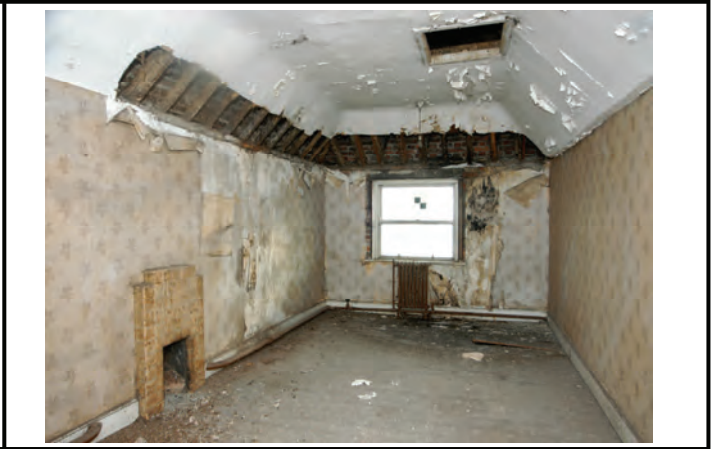
BUILDING NO.
23
FLOOR
Third Floor
ROOM
Front rooms (access limited due to safety issues)

TYPE AND DESCRIPTION OF FABRIC
Minimal decorative fabric on 3rd floor: Window joinery—as pictured; Doors; Plain skirtings; Floors—timber throughout; Plain, coved ceilings; Cast iron radiators below windows; Opening to No.24.

BUILDING PHASE
C18th –C20th
CONDITION
Generally poor

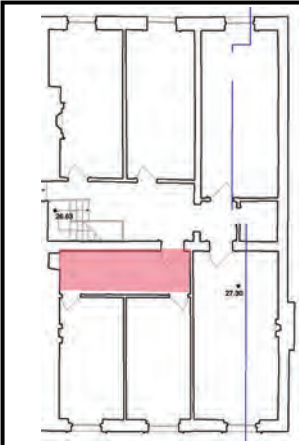
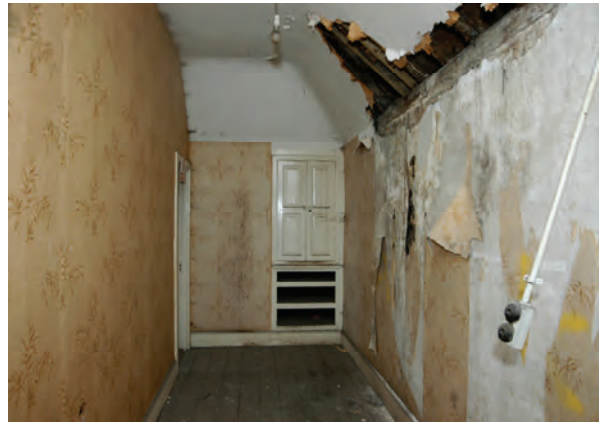
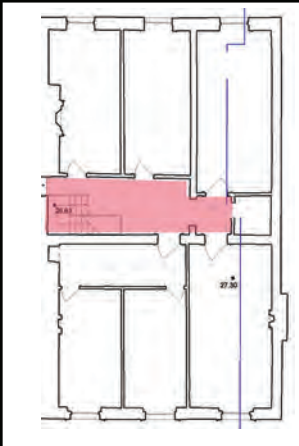
BUILDING NO.
23
FLOOR
Third Floor
ROOM
Stairhall/landing & inner hallway

TYPE AND DESCRIPTION OF FABRIC
Minimal decorative fabric on 3rd floor: Window joinery—as pictured; Doors; Plain skirtings; Floors—timber throughout; Plain, coved ceilings; Cast iron radiators below windows; Opening to No.24.

BUILDING PHASE
C18th –C20th
CONDITION
Generally poor

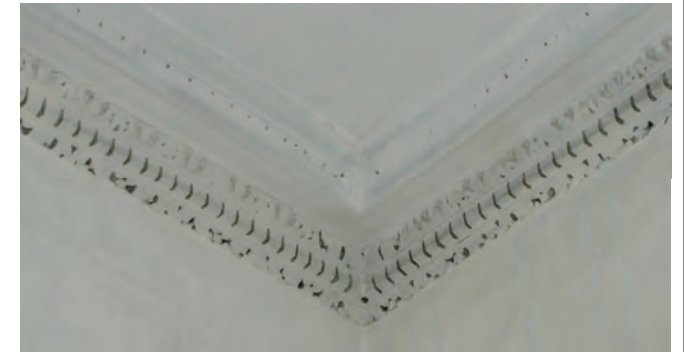
TYPE AND DESCRIPTION OF FABRIC Cornice: in medium-low relief, mouldings indistinct due to overpainting—include dentil and egg-and-dart motifs.
BUILDING PHASE C18th
CONDITION Poor-fair

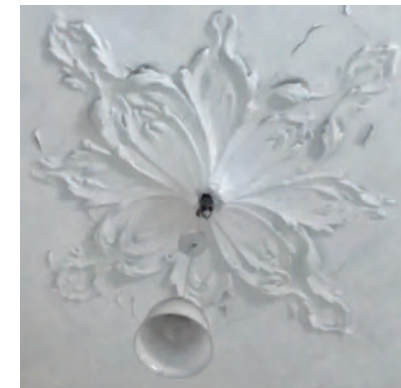
TYPE AND DESCRIPTION OF FABRIC Ceiling rose: Foliated ornament in medium-high relief.
BUILDING PHASE C18th
CONDITION Fair

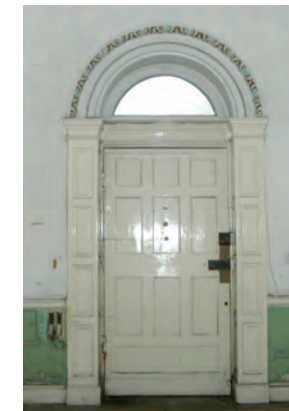
TYPE AND DESCRIPTION OF FABRIC Entrance door: 10-panel timber door with flanking timber panelled box-casing and carved lintel forming impost moulding to arch; plasterwork arch with egg-and-dart detail.
BUILDING PHASE C18th with some later repairs/fabric
CONDITION Poor

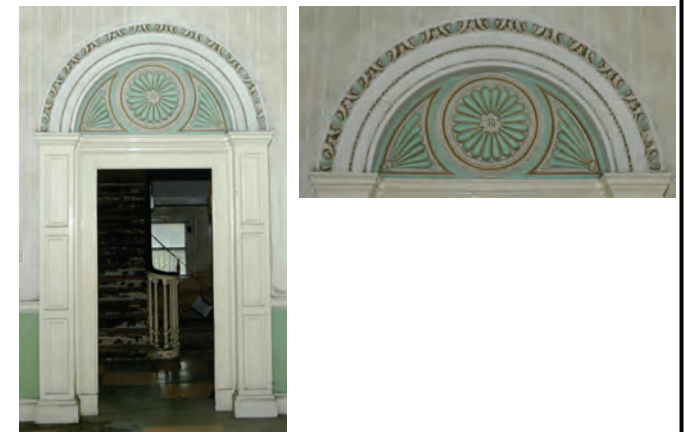
TYPE AND DESCRIPTION OF FABRIC Doorway to stairhall: timber panelled box-casing and carved lintel forming impost moulding to arch; plasterwork arch with egg-and-dart detail; plasterwork panel in place of fanlight with floral motif; no door leaf; timber architrave survives.
BUILDING PHASE C18th
CONDITION Poor

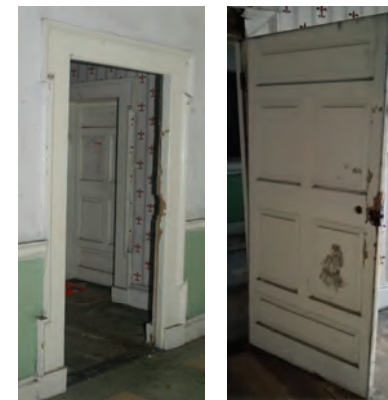
TYPE AND DESCRIPTION OF FABRIC Door to front reception room: timber casing, lugged and shouldered; 6-panel timber door, having raised panels.
BUILDING PHASE C18th
CONDITION V. poor

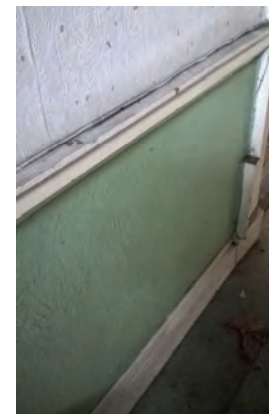
TYPE AND DESCRIPTION OF FABRIC Dado and skirting: timber dado with curved profile, having flat upper surface; plain skirting with simple moulding to top.
BUILDING PHASE C18th with some later fabric
CONDITION Fair

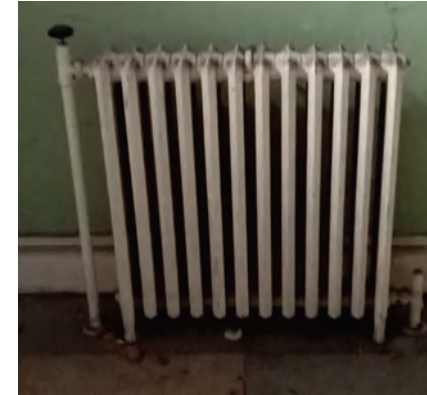
TYPE AND DESCRIPTION OF FABRIC Cast iron radiator located on W wall
BUILDING PHASE C20th
CONDITION Fair

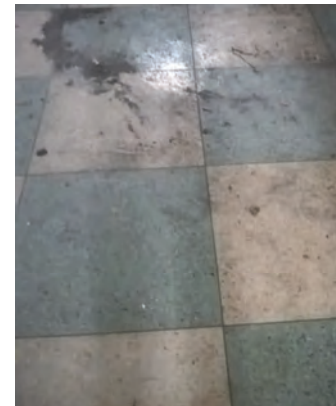
TYPE AND DESCRIPTION OF FABRIC Floor: terrazzo floor in chequered green/gold pattern
BUILDING PHASE C20th
CONDITION Fair

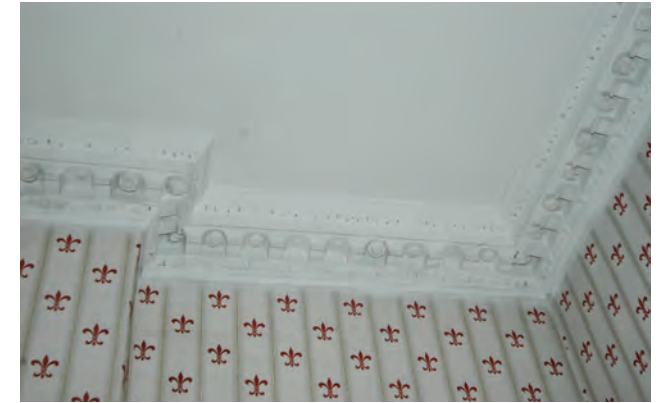
TYPE AND DESCRIPTION OF FABRIC Cornice: modillion and rosette detail in medium-high relief; heavily overpainted; a section to the SW corner is water-stained and there is pipework breaking-through in this location.
BUILDING PHASE C18th
CONDITION Poor-Fair

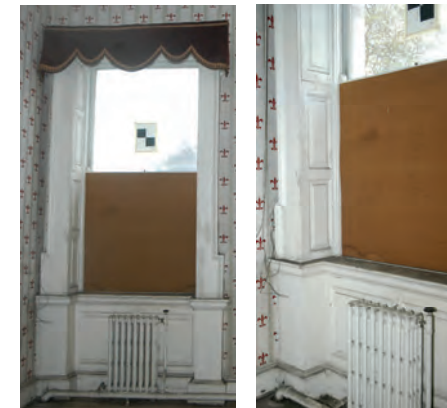
TYPE AND DESCRIPTION OF FABRIC Window E (LHS internally): Lugged and shouldered timber casing with timber shutters; raised timber panels below window; single-pane timber sashes
BUILDING PHASE C18th casing, C19th sashes
CONDITION Poor

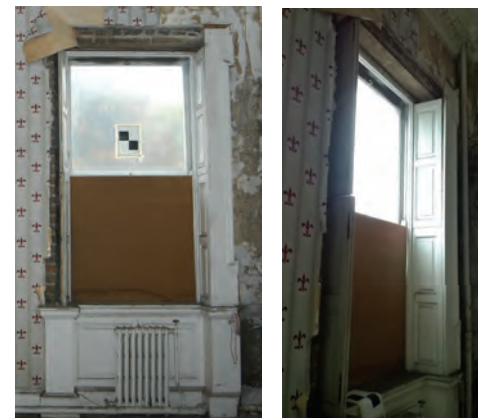
TYPE AND DESCRIPTION OF FABRIC Window W (RHS internally): Lugged and shouldered timber casing, section missing on LHS; timber shutters; raised timber panels below window; single-pane timber sashes; lintel exposed above.
BUILDING PHASE C18th casing, C19th sashes
CONDITION V. Poor

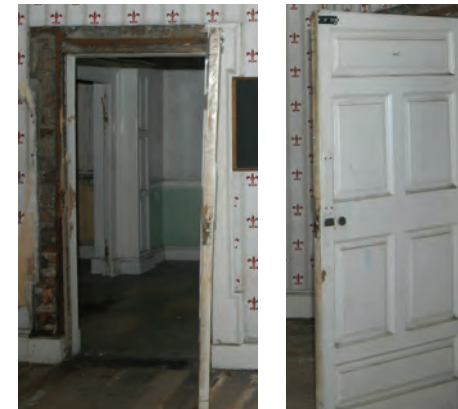
TYPE AND DESCRIPTION OF FABRIC Door to entrance hall: lugged and shouldered timber casing only surviving on RHS; 6-panel timber door, having raised panels.
BUILDING PHASE C18th
CONDITION Poor-Fair

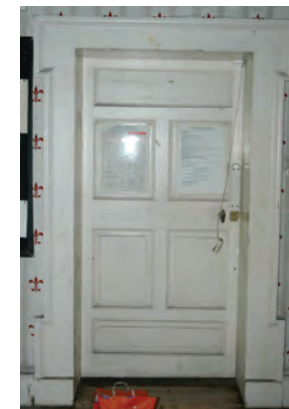
TYPE AND DESCRIPTION OF FABRIC Door to rear room: lugged and shouldered timber casing; 6-panel timber door, having raised panels; bronze handle.
BUILDING PHASE C18th (with C20th handle)
CONDITION Fair

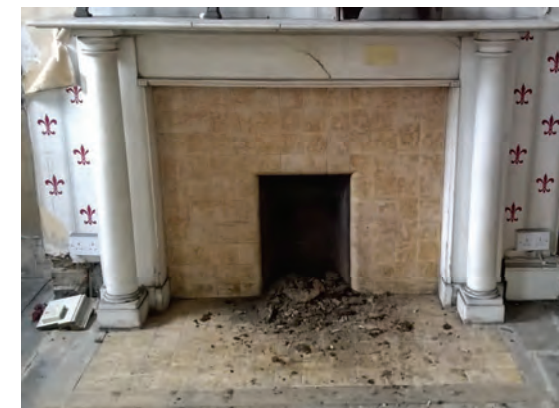
TYPE AND DESCRIPTION OF FABRIC Fireplace: marble chimneypiece with Doric columns and plan mantel; tiled inset; matching floor tiles to hearth.
BUILDING PHASE C18th chimneypiece, C20th inset and hearth
CONDITION Fair

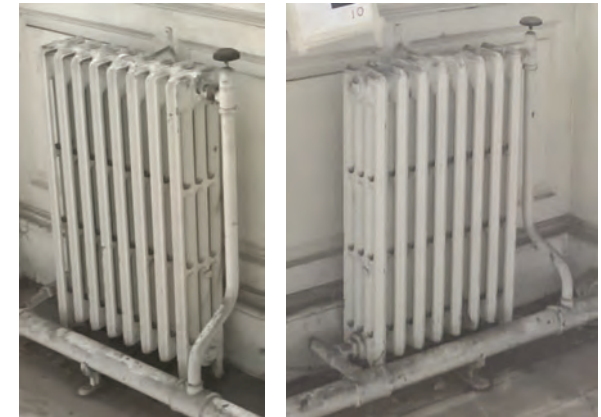
TYPE AND DESCRIPTION OF FABRIC Cast iron radiators located below windows
BUILDING PHASE C20th
CONDITION Poor-Fair

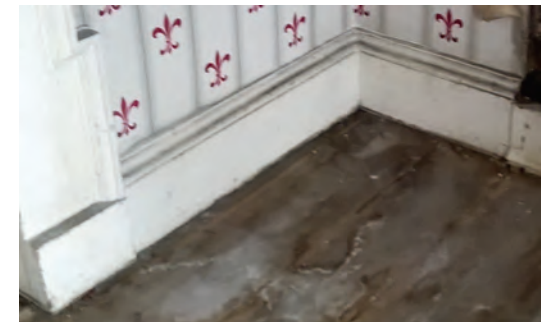
TYPE AND DESCRIPTION OF FABRIC Timber skirtings; sections missing in SW corner and NW corner
BUILDING PHASE C18th
CONDITION Poor

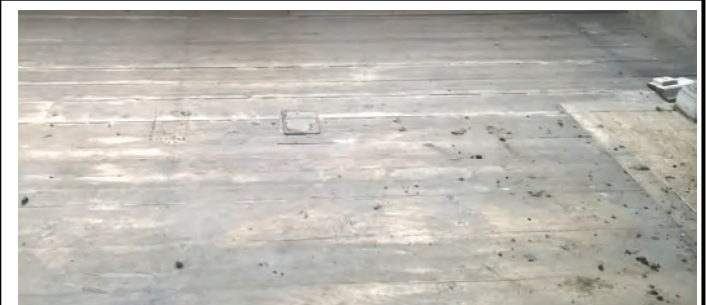
TYPE AND DESCRIPTION OF FABRIC Floor: wide timber boards; some cut for services installations
BUILDING PHASE C18th
CONDITION Poor—Fair

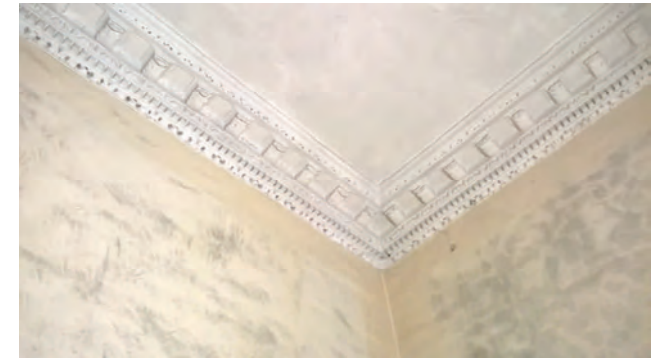
<b>TYPE AND DESCRIPTION OF FABRIC</b>
Cornice: modillion detail in medium-high relief; heavily overpainted; water-staining and damage to NE corner and along E wall. Ceiling/floor above propped.
<b>BUILDING PHASE</b>
C18th
<b>CONDITION</b>
Poor

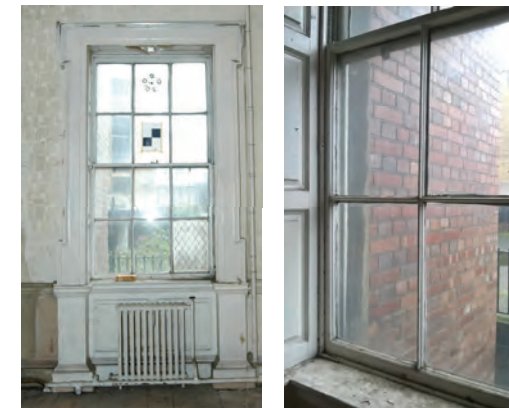
<b>TYPE AND DESCRIPTION OF FABRIC</b>
Window, W (LHS internally): Lugged and shouldered timber casing; 6-over-6 timber sashes; raised timber panel below; some historic glass survives.
<b>BUILDING PHASE</b>
C18th
<b>CONDITION</b>
Poor

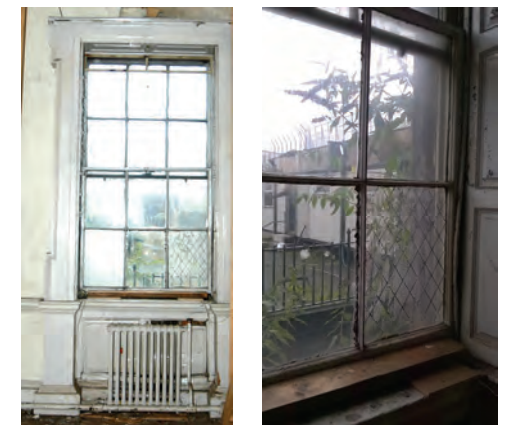
<b>TYPE AND DESCRIPTION OF FABRIC</b>
Window, E (RHS internally): Lugged and shouldered timber casing; 6-over-6 timber sashes; raised timber panel below; some historic glass survives.
<b>BUILDING PHASE</b>
C18th
<b>CONDITION</b>
Poor

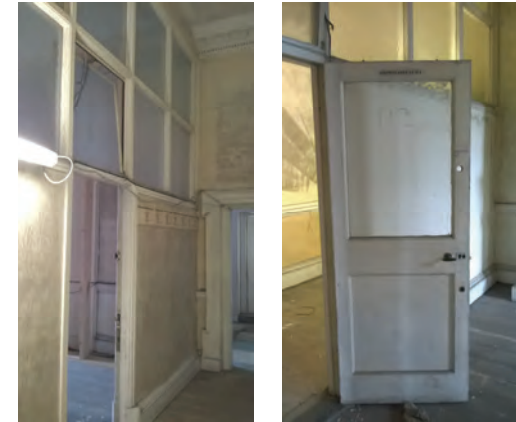
TYPE AND DESCRIPTION OF FABRIC Partition: timber-framed partition with glazed panels at high level; one bottom-hung casement above door; 2-panel timber door with upper glazed panel; bronze door furniture and window stays.
BUILDING PHASE C20th
CONDITION Fair

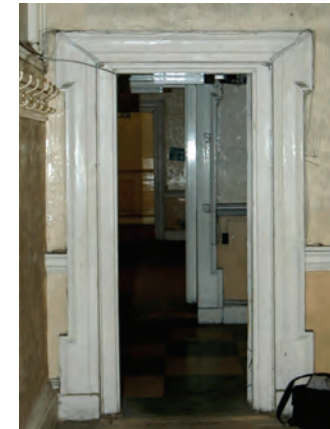
TYPE AND DESCRIPTION OF FABRIC Door to stair hall: Lugged and shouldered timber casing; fire door with wired glass panel.
BUILDING PHASE C18th casing, C20th door leaf
CONDITION Poor

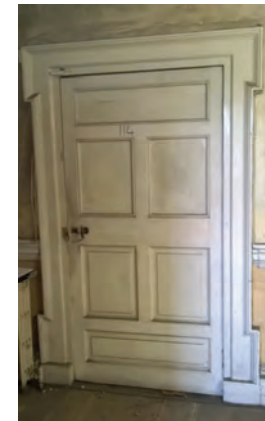
TYPE AND DESCRIPTION OF FABRIC Door to front reception room: Lugged and shouldered timber casing; 6-panel timber door; bronze handle.
BUILDING PHASE C18th
CONDITION Fair

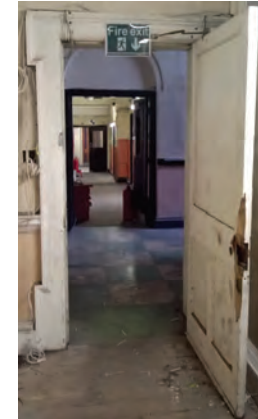
<b>TYPE AND DESCRIPTION OF FABRIC</b>
Door to No.25: Lugged and shouldered timber casing; 3-panel timber door
<b>BUILDING PHASE</b>
C20th
<b>CONDITION</b>
Poor

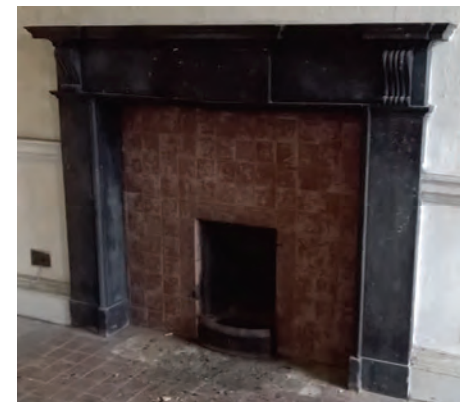
<b>TYPE AND DESCRIPTION OF FABRIC</b>
Fireplace: polished black limestone chimneypiece; tiled inset; matching tiles to hearth
<b>BUILDING PHASE</b>
C18th chimneypiece, C20th inset
<b>CONDITION</b>
Fair

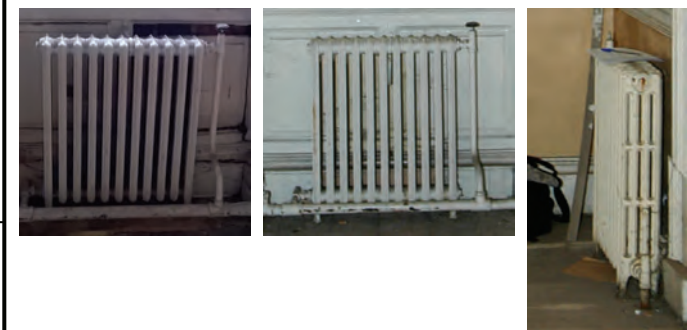
<b>TYPE AND DESCRIPTION OF FABRIC</b>
Cast iron radiators: 3no., located below windows and between doors to stairhall and front reception room.
<b>BUILDING PHASE</b>
C20th
<b>CONDITION</b>
Fair

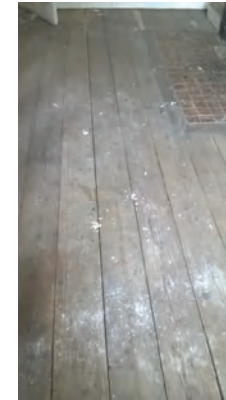
TYPE AND DESCRIPTION OF FABRIC Floor: timber boards
BUILDING PHASE C18th
CONDITION Fair

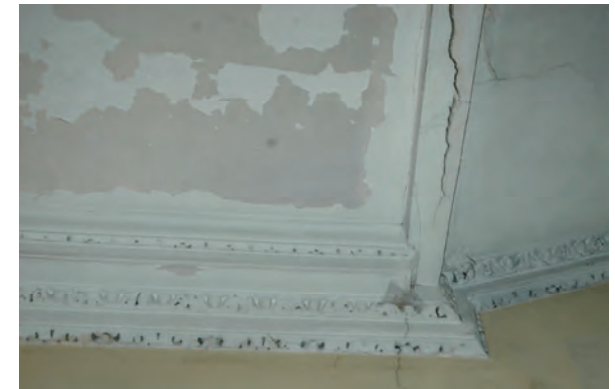
TYPE AND DESCRIPTION OF FABRIC Cornice: mouldings in low-relief; heavily overpainted.
BUILDING PHASE C18th
CONDITION Poor—Fair

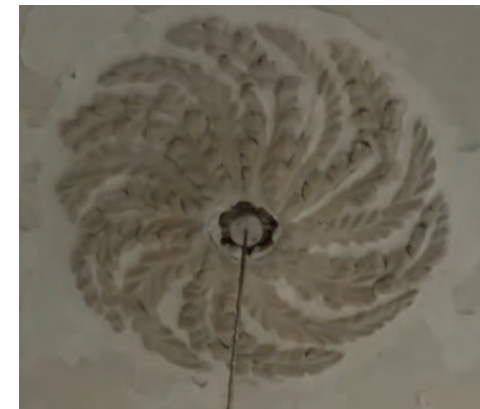
TYPE AND DESCRIPTION OF FABRIC Ceiling rose: plasterwork in low relief featuring swirling foliage.
BUILDING PHASE C18th
CONDITION Poor—Fair

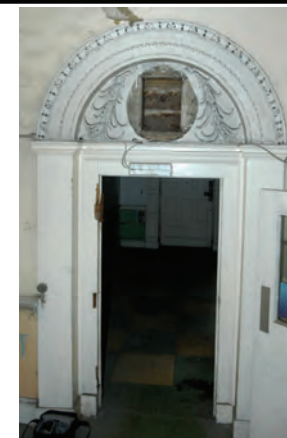
TYPE AND DESCRIPTION OF FABRIC Doorway to entrance hall: timber panelled box-casing and carved lintel forming impost moulding to arch; plasterwork arch with egg-and-dart detail; plasterwork panel in place of fanlight with missing plaque; no door leaf; timber architrave survives.
BUILDING PHASE C18th
CONDITION Poor

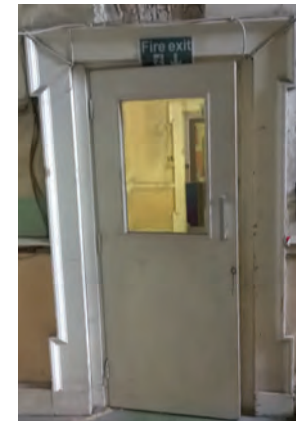
TYPE AND DESCRIPTION OF FABRIC Door to rear room/inner hall: Lugged and shouldered timber casing; timber fire door with wired glass panel.
BUILDING PHASE C18th casing, C20th door leaf
CONDITION Poor

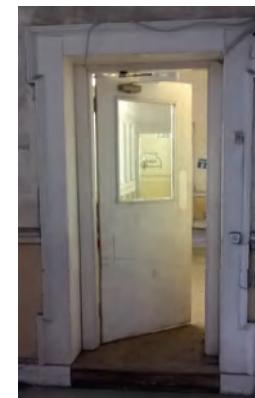
TYPE AND DESCRIPTION OF FABRIC Door to No.23: Lugged and shouldered timber casing; timber fire door with wired glass panel; stepped threshold.
BUILDING PHASE C20th
CONDITION Poor

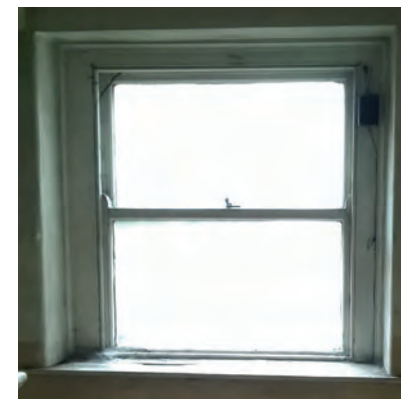
TYPE AND DESCRIPTION OF FABRIC Window to rear, E (RHS): timber single-pane sashes; plain timber casing.
BUILDING PHASE C20th
CONDITION Poor

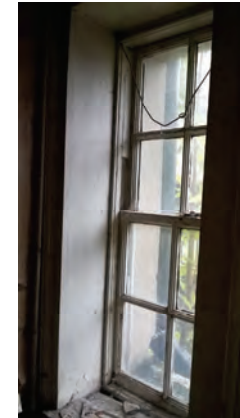
TYPE AND DESCRIPTION OF FABRIC Window to rear, W (LHS): located to top of basement stairs; 4-over-4 timber sashes; timber casing and window board.
BUILDING PHASE C18th
CONDITION Poor—fair

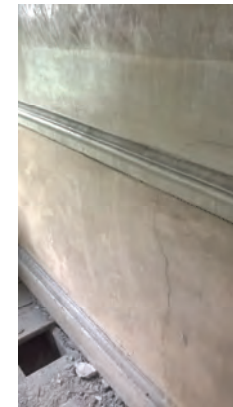
TYPE AND DESCRIPTION OF FABRIC Dado and skirting: timber profiles
BUILDING PHASE C18th
CONDITION Poor

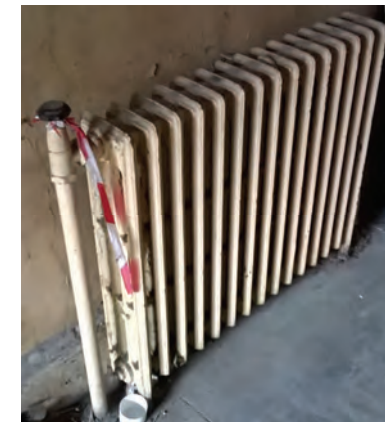
TYPE AND DESCRIPTION OF FABRIC Cast iron radiator: located alongside stairs
BUILDING PHASE C20th
CONDITION Poor

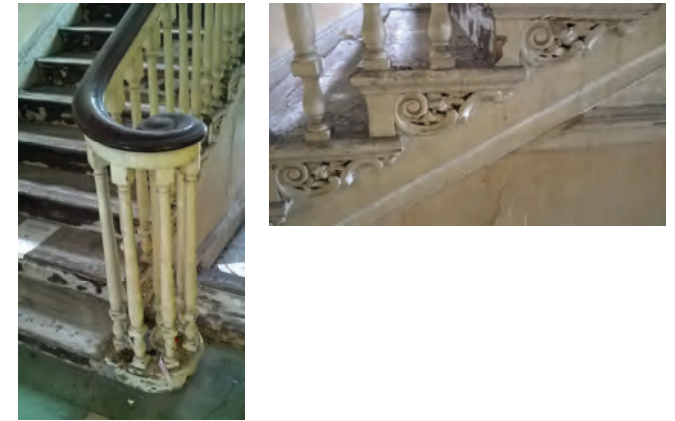
TYPE AND DESCRIPTION OF FABRIC Staircase: timber stairs; turned, paired balusters; mahogany handrail with terminating scroll; open string with carved detail
BUILDING PHASE C18th
CONDITION Poor

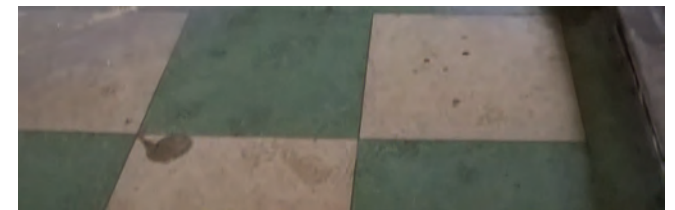
TYPE AND DESCRIPTION OF FABRIC Floor to bottom of stairs: terrazzo in chequered green/gold pattern
BUILDING PHASE C20th
CONDITION Fair

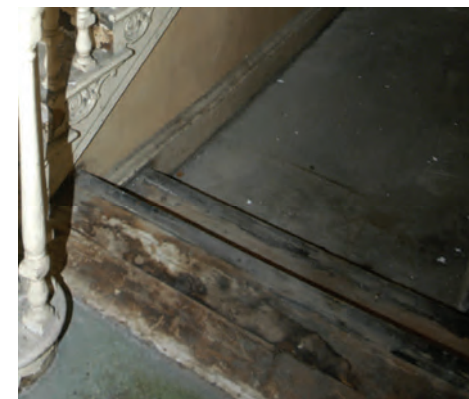
TYPE AND DESCRIPTION OF FABRIC Floor leading to rear: timber boards
BUILDING PHASE C18th
CONDITION Poor

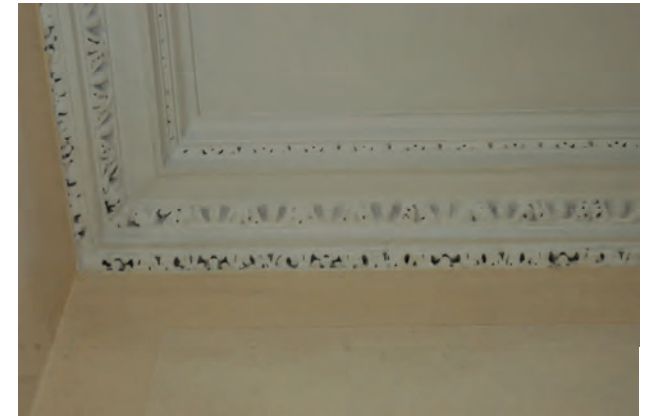
TYPE AND DESCRIPTION OF FABRIC Cornice: mouldings in low-relief; heavily overpainted.
BUILDING PHASE C18th
CONDITION Poor—fair

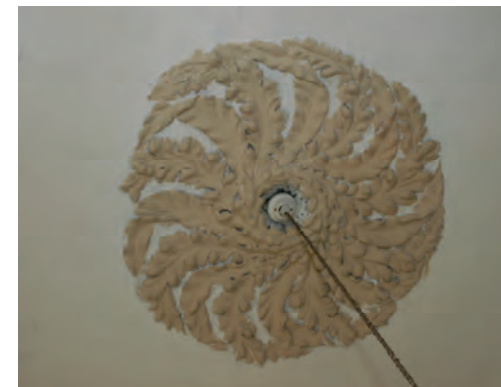
TYPE AND DESCRIPTION OF FABRIC Ceiling rose: plasterwork in low relief featuring swirling foliage.
BUILDING PHASE C18th
CONDITION Fair

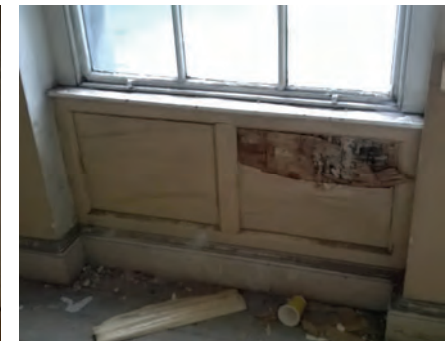
TYPE AND DESCRIPTION OF FABRIC Window to half-landing: arched window with plain surround; timber sashes having 10-pane hubbed sash over 6-pane lower sash; timber panels below.
BUILDING PHASE C18th (upper sash), C19th (lower sash)
CONDITION Poor

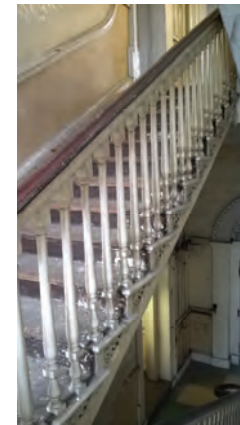
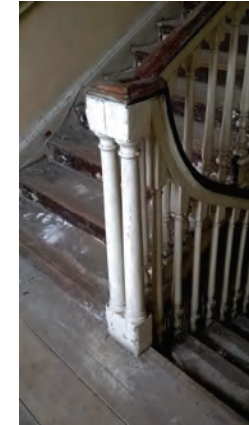
TYPE AND DESCRIPTION OF FABRIC Staircase: timber stairs; turned, paired balusters; mahogany handrail; open string with carved detail.
BUILDING PHASE C18th
CONDITION Poor

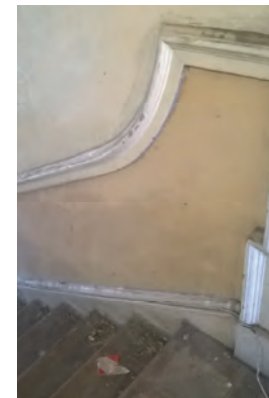
TYPE AND DESCRIPTION OF FABRIC Dado and skirting: timber profiles as ground floor stair hall.
BUILDING PHASE C18th
CONDITION Fair

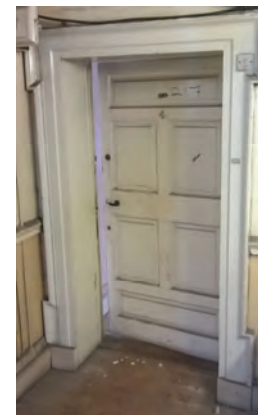
TYPE AND DESCRIPTION OF FABRIC Door to front room: lugged and shouldered timber casing; 6-panel door; bronze handle
BUILDING PHASE C18th (with C20th handle)
CONDITION Poor

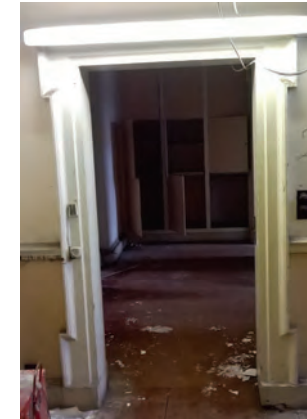
TYPE AND DESCRIPTION OF FABRIC Doorway to inner hall: lugged and shouldered timber casing; no door leaf.
BUILDING PHASE C18th
CONDITION Poor

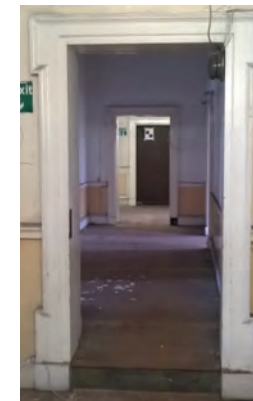
TYPE AND DESCRIPTION OF FABRIC Doorway to No.23: lugged and shouldered timber casing; no door leaf; stepped threshold
BUILDING PHASE C20th
CONDITION Fair

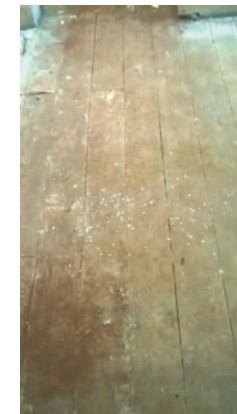
TYPE AND DESCRIPTION OF FABRIC Floor: timber boards; some crude repairs/replacement fabric due to services installations
BUILDING PHASE C18th
CONDITION Poor

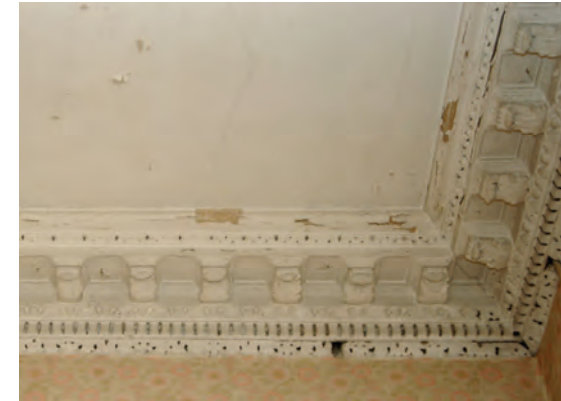
TYPE AND DESCRIPTION OF FABRIC Cornice: modillion detail ; heavily overpainted; damage to area above central window; water damage and staining at SW corner and pipework breaking through; cracking in evidence.
BUILDING PHASE C18th
CONDITION Poor

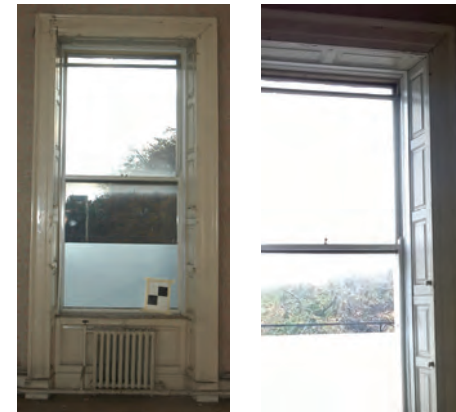
TYPE AND DESCRIPTION OF FABRIC Window, E (LHS internally): located in room accessed directly from stair hall; timber casing; timber panelled, divided shutters; single-pane sashes; timber panelling below window.
BUILDING PHASE C18h surround, C19th sashes
CONDITION Poor

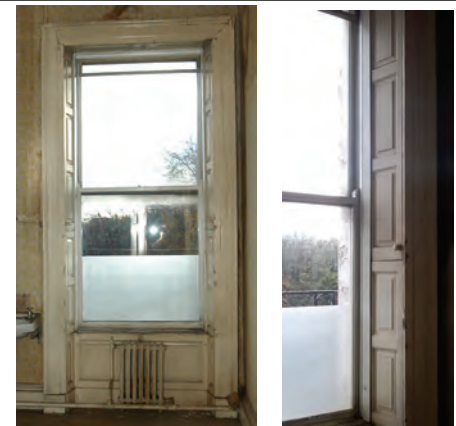
TYPE AND DESCRIPTION OF FABRIC Window, centre: located in central room accessed from inner hall; timber casing; timber panelled, divided shutters; single-pane sashes; timber panelling below window.
BUILDING PHASE C18th surround, C19th sashes
CONDITION Poor

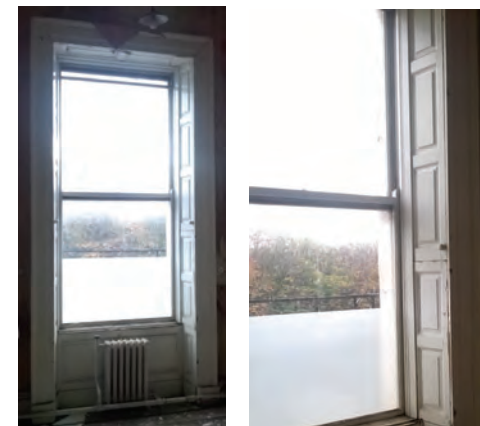
TYPE AND DESCRIPTION OF FABRIC Window, W (RHS internally): located in room accessed from inner hall; timber casing; timber panelled, divided shutters; single-pane sashes; timber panelling below window.
BUILDING PHASE C18th surround, C19th sashes
CONDITION Poor

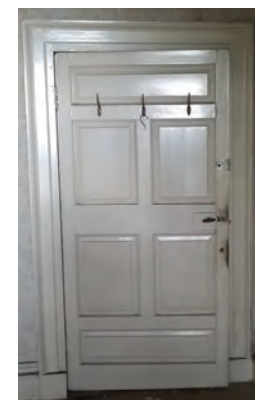
TYPE AND DESCRIPTION OF FABRIC Door to stair hall: timber casing; 6-panel door; bronze handle
BUILDING PHASE C18h, C20th handle
CONDITION Poor—fair

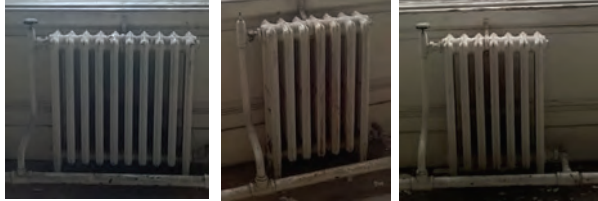
TYPE AND DESCRIPTION OF FABRIC Cast iron radiators: located below windows

BUILDING PHASE C20th	
CONDITION Fair

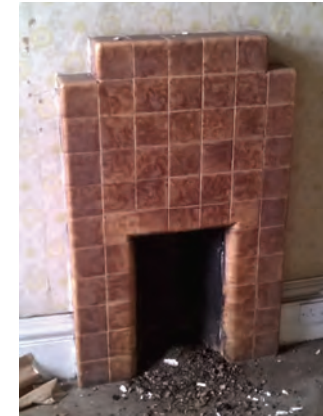
TYPE AND DESCRIPTION OF FABRIC Fireplace: located on party wall with No.25 (W wall); tiled surround; concrete hearth
BUILDING PHASE C20th
CONDITION Fair

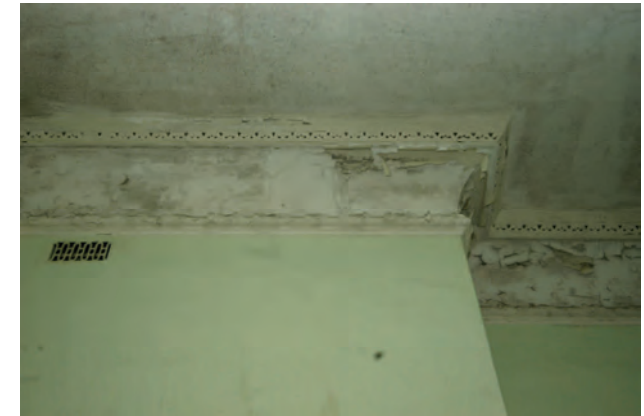
TYPE AND DESCRIPTION OF FABRIC Cornice: plain, coved cornice with moulded borders; missing from NE area (in location of former bathroom)
BUILDING PHASE C18th
CONDITION Poor

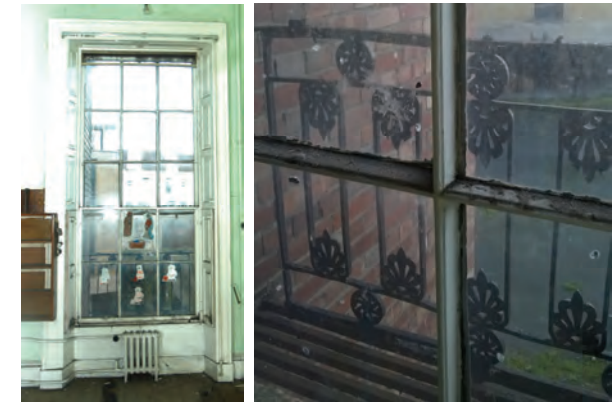
TYPE AND DESCRIPTION OF FABRIC Window, W (LHS internally): timber casing with divid- ed shutters; 9-over-6 sashes; some historic glass sur- viving
BUILDING PHASE C18th
CONDITION Poor

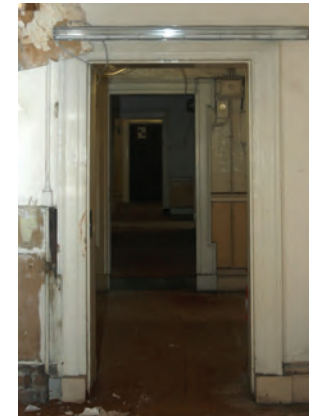
TYPE AND DESCRIPTION OF FABRIC Doorway to stair hall: timber casing; no door leaf.
BUILDING PHASE C18th
CONDITION Poor

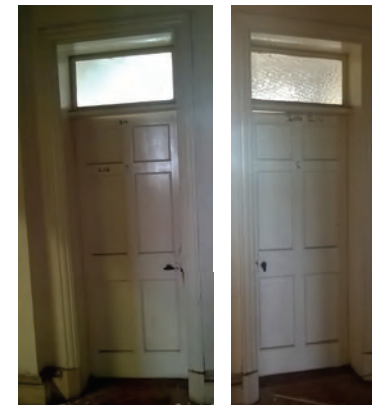
TYPE AND DESCRIPTION OF FABRIC Doors to front reception room: timber casings with glazed overlights having bottom-hung casements; 6-panel timber doors; bronze handles and window stays.
BUILDING PHASE C20th
CONDITION Poor—fair

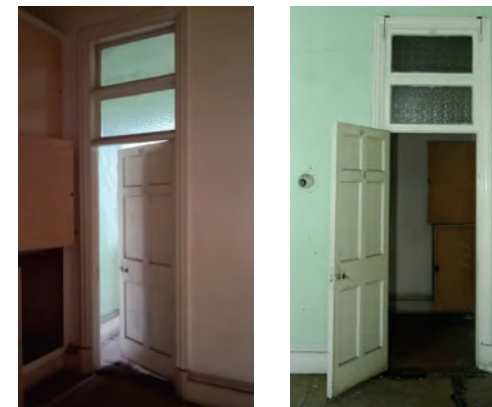
TYPE AND DESCRIPTION OF FABRIC Door to rear room (W): timber casing with glazed overlights having a bottom-hung openable casement over fixed-glass casement ; 6-panel timber door; bronze handles and window stays.
BUILDING PHASE C20th
CONDITION Fair

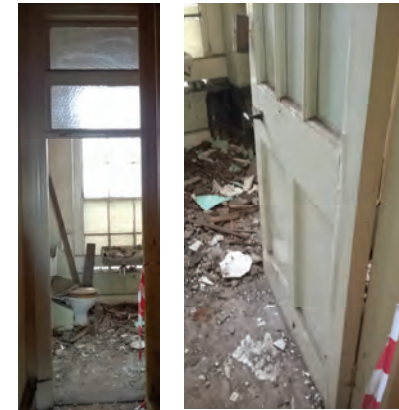
TYPE AND DESCRIPTION OF FABRIC Door to former bathroom: timber casing with glazed overlights, having openable casement over fixed glazed panel; timber door having 6-glazed panels over 2 solid panels; bronze handles.
BUILDING PHASE C20th
CONDITION Poor

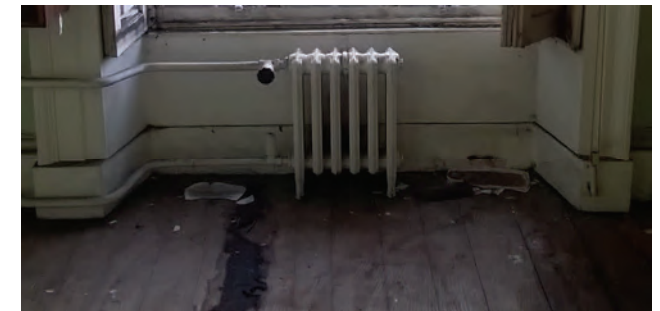
TYPE AND DESCRIPTION OF FABRIC Cast iron radiator: located below window (W)
BUILDING PHASE C20th
CONDITION Poor—fair

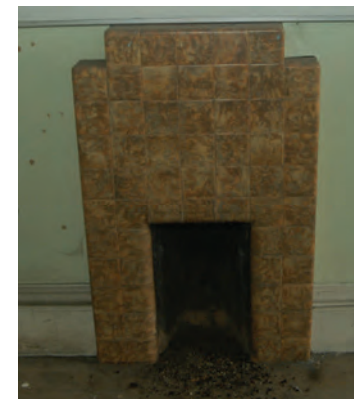
TYPE AND DESCRIPTION OF FABRIC Fireplace: located on party wall with No.25 (W wall); tiled surround; concrete hearth
BUILDING PHASE C20th
CONDITION Fair

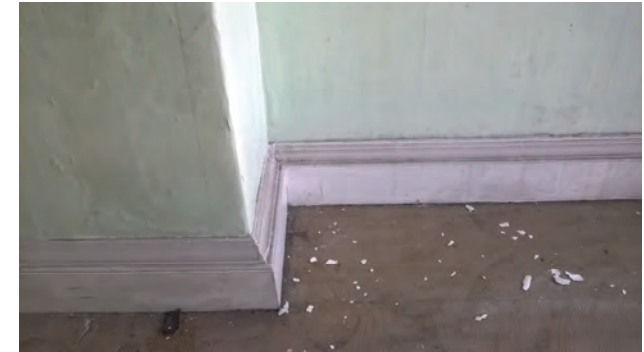
<b>TYPE AND DESCRIPTION OF FABRIC</b> Skirting: timber profile
<b>BUILDING PHASE</b> C20th
<b>CONDITION</b> Fair

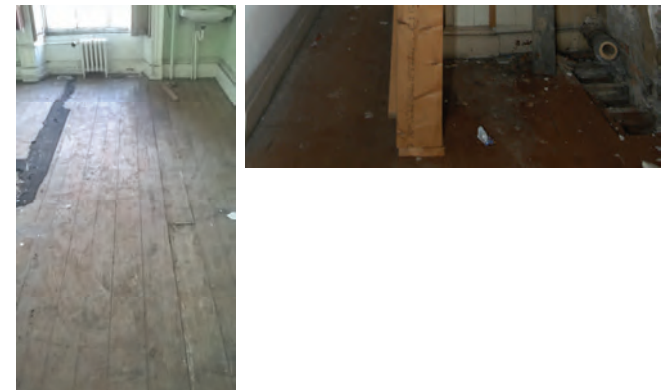
<b>TYPE AND DESCRIPTION OF FABRIC</b> Floor: timber boards; sections missing; plywood covering in NE corner
<b>BUILDING PHASE</b> C18th—C20th
<b>CONDITION</b> Poor—fair

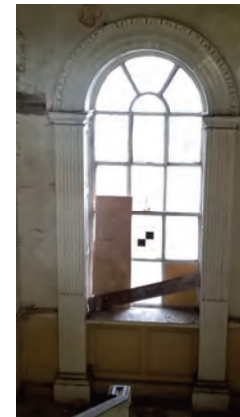
TYPE AND DESCRIPTION OF FABRIC Window to half-landing: timber casing in form of flanking Doric pilasters; plasterwork arch above; 10-pane hubbed sash over 6-pane sash; some historic glass surviving; raised timber panelling below window.
BUILDING PHASE C18th
CONDITION Poor

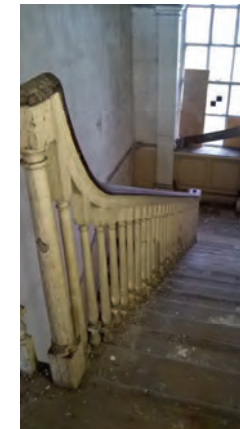
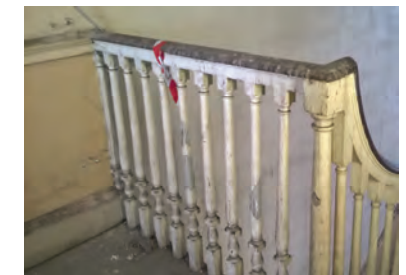
TYPE AND DESCRIPTION OF FABRIC Staircase: timber stairs; turned, paired balusters; mahogany handrail; open string with carved detail.
BUILDING PHASE C18th
CONDITION Poor—structurally unsound

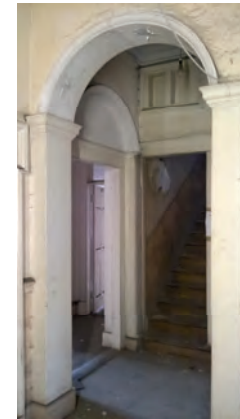
TYPE AND DESCRIPTION OF FABRIC Doorway to inner hall: timber panelling flanking ope; plasterwork arch with simple moulding.
BUILDING PHASE C18th
CONDITION Poor

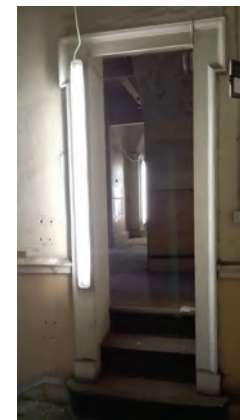
TYPE AND DESCRIPTION OF FABRIC Doorway to No.23: lugged timber casing; no door leaf; stepped threshold.
BUILDING PHASE C20th
CONDITION Fair

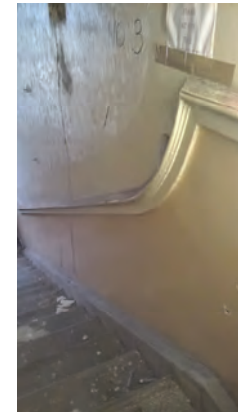
<b>TYPE AND DESCRIPTION OF FABRIC</b> Dado and skirting: timber profiles; section missing at half-landing
<b>BUILDING PHASE</b> C18th
<b>CONDITION</b> Poor

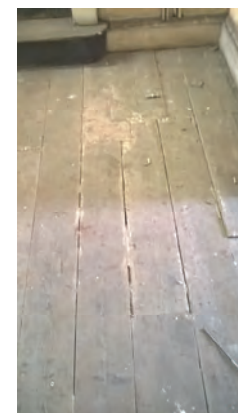
<b>TYPE AND DESCRIPTION OF FABRIC</b> Floor: timber boards; cut in several places to accommodate services installation
<b>BUILDING PHASE</b> C18th
<b>CONDITION</b> Poor—fair

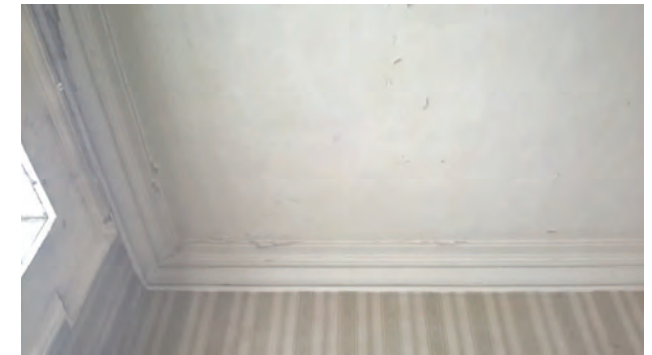
TYPE AND DESCRIPTION OF FABRIC Cornice: simple running-mould plasterwork
BUILDING PHASE C18th
CONDITION Fair

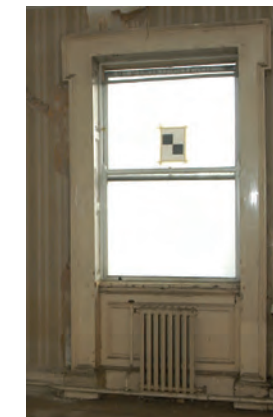
TYPE AND DESCRIPTION OF FABRIC Window: lugged timber casing with panelled shutters; single-pane sashes; raised timber panelling below window.
BUILDING PHASE C18th surround, C19th sashes
CONDITION Poor

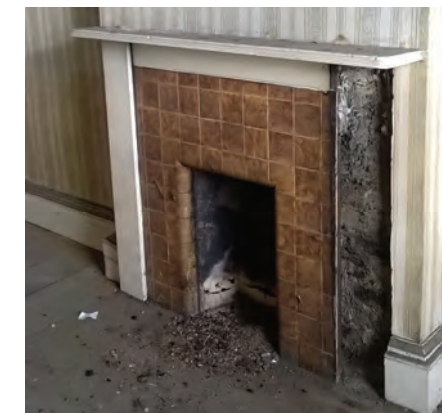
TYPE AND DESCRIPTION OF FABRIC Fireplace: tiled surround; cast iron mantel; RHS section of chimneypiece missing; concrete hearth.
BUILDING PHASE C20th
CONDITION Poor

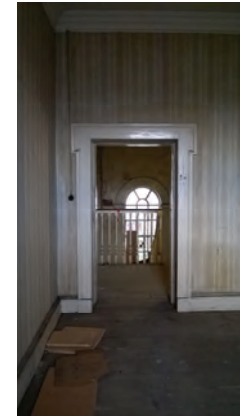
TYPE AND DESCRIPTION OF FABRIC Door to stair hall: lugged timber casing; door leaf missing
BUILDING PHASE C18th
CONDITION Poor

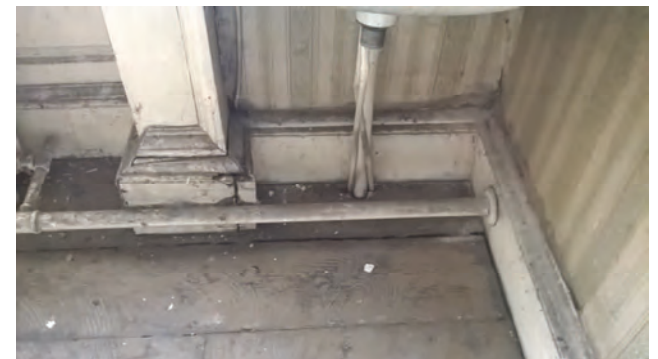
TYPE AND DESCRIPTION OF FABRIC Skirting: deep sections with timber profile
BUILDING PHASE C18th
CONDITION Poor

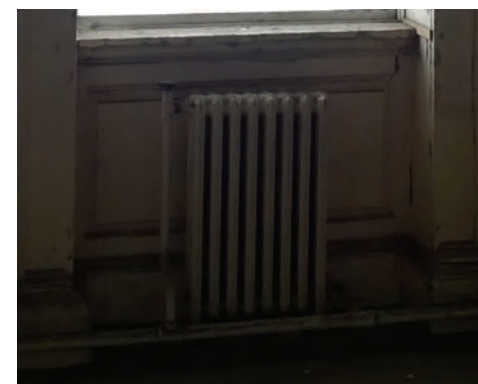
TYPE AND DESCRIPTION OF FABRIC Cast iron radiator: located below window
BUILDING PHASE C20th
CONDITION Poor

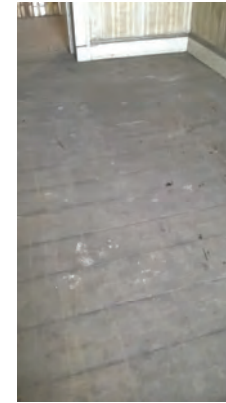
TYPE AND DESCRIPTION OF FABRIC Floor: timber boards
BUILDING PHASE C18th
CONDITION Fair

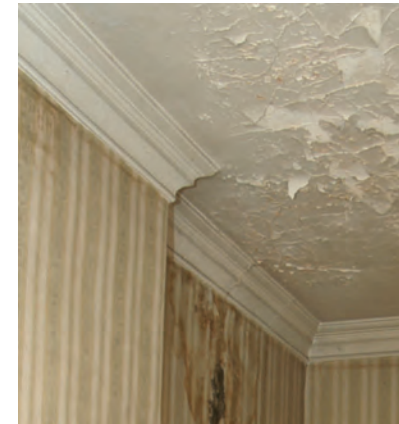
TYPE AND DESCRIPTION OF FABRIC Cornice: simple running-mould plasterwork
BUILDING PHASE C18th
CONDITION Fair

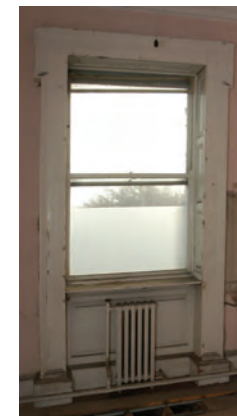
TYPE AND DESCRIPTION OF FABRIC Window, E (centre room): lugged, timber casing with panelled shutters; single-pane sashes; raised timber panelling below window.
BUILDING PHASE C18th surround, C19th sashes
CONDITION Poor

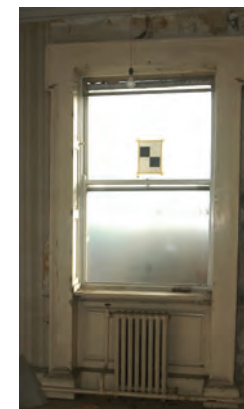
TYPE AND DESCRIPTION OF FABRIC Window, W (RHS room): lugged, timber casing with panelled shutters; single-pane sashes; raised timber panelling below window.
BUILDING PHASE C18th
CONDITION Poor

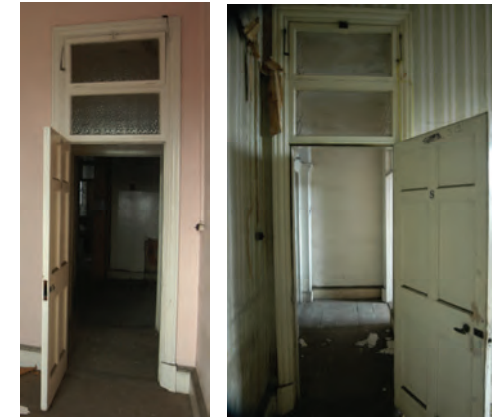
TYPE AND DESCRIPTION OF FABRIC Doors set within partitions: timber casings with double overlights having bottom-hung opening casements over fixed glass panels; 6-panel timber doors; bronze handles and window stays.
BUILDING PHASE C20th
CONDITION Fair

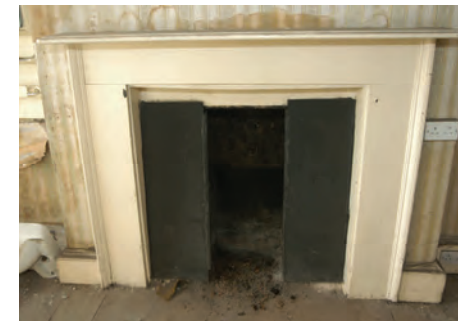
TYPE AND DESCRIPTION OF FABRIC Fireplace: timber surround with cast iron mantel; concrete hearth.
BUILDING PHASE C20th
CONDITION Poor
