# APPENDIX A

# Building Inventories

Protected Structures Impact Statement

PARNELL SQUARE CULTURAL QUARTER  
 Architectural Heritage—Decorative Fabric Inventory  
 Nos. 20, 21, 23-28 Parnell Square, Dublin 1  
 November 2015—Shaffrey Associates Architects

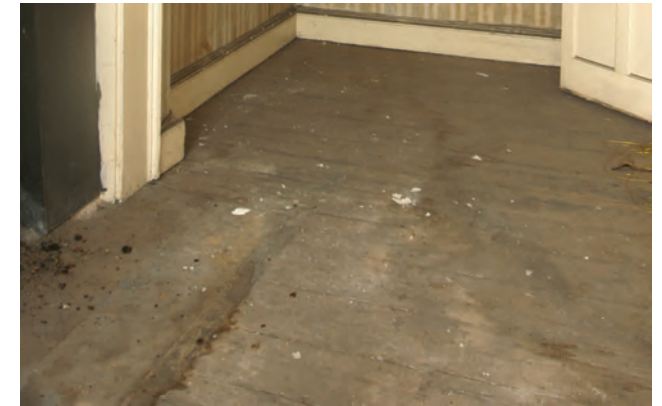
TYPE AND DESCRIPTION OF FABRIC Floor: timber boards
BUILDING PHASE C18th
CONDITION Fair

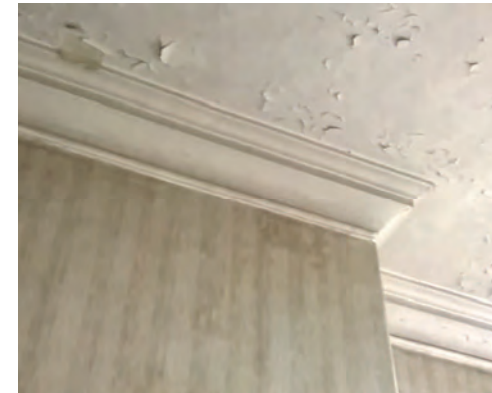
TYPE AND DESCRIPTION OF FABRIC Cornice: simple running-mould plasterwork
BUILDING PHASE C18th
CONDITION Fair

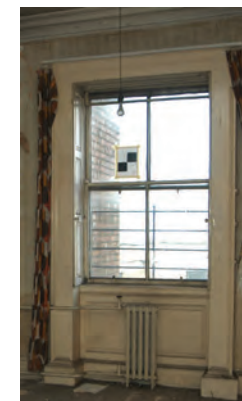
TYPE AND DESCRIPTION OF FABRIC Window, W: timber casing with panelled shutters; 2-over-2 sashes; raised timber panelling below.
BUILDING PHASE C18th surround, C19th sashes
CONDITION Poor—fair

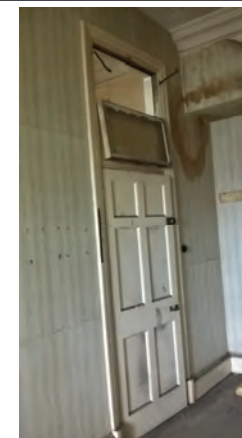
TYPE AND DESCRIPTION OF FABRIC Doors set within partitioning: timber casings with double overlights having bottom-hung opening casements over fixed glass panels; 6-panel timber doors; bronze handles and window stays.
BUILDING PHASE C20th
CONDITION Poor

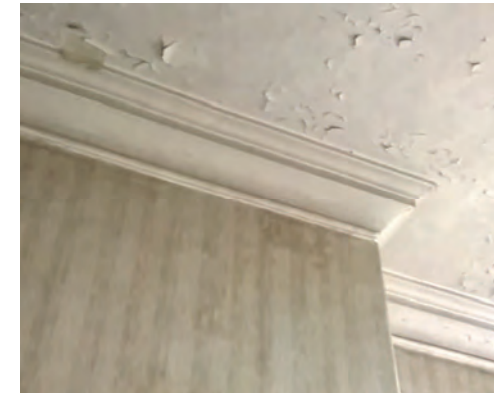
TYPE AND DESCRIPTION OF FABRIC Cornice: simple running-mould plasterwork
BUILDING PHASE C18th
CONDITION Fair

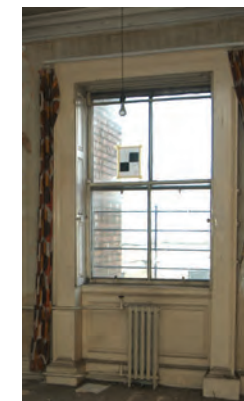
TYPE AND DESCRIPTION OF FABRIC Window, W: timber casing with panelled shutters; 2-over-2 sashes; raised timber panelling below.
BUILDING PHASE C18th surround, C19th sashes
CONDITION Poor—fair

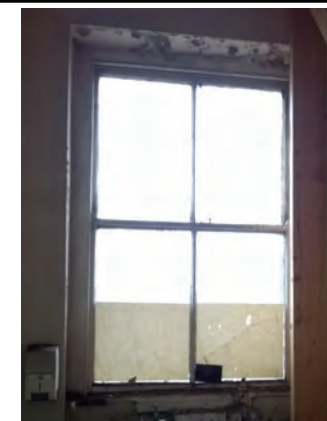
TYPE AND DESCRIPTION OF FABRIC Window, E: located in former bathroom; no casings; 2-over-2 timber sashes
BUILDING PHASE C19th
CONDITION Poor

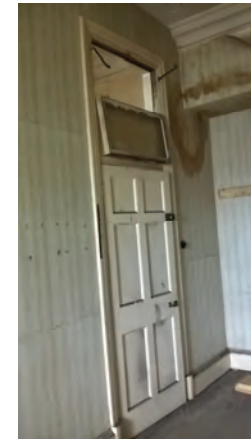
TYPE AND DESCRIPTION OF FABRIC Doors set within partitioning: timber casings with double overlights having bottom-hung opening casements over fixed glass panels; 6-panel timber doors; bronze handles and window stays.
BUILDING PHASE C20th
CONDITION Poor

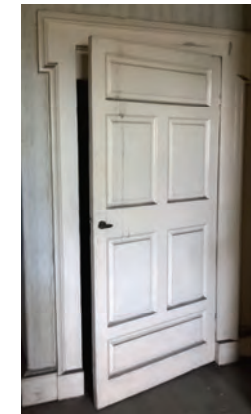
TYPE AND DESCRIPTION OF FABRIC Door to under-stairs cupboard: timber casing and door leaf; lugged architrave; 6-panel door; bronze handle.
BUILDING PHASE C18th with C20th handle
CONDITION Fair

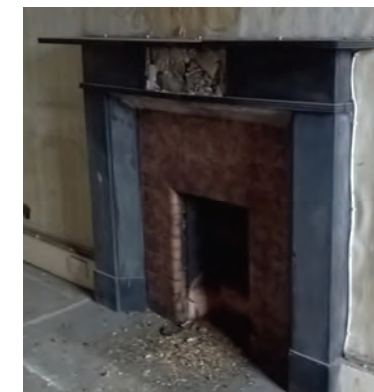
TYPE AND DESCRIPTION OF FABRIC Fireplace: Polished stone chimneypiece—central panel missing; tiled inset; concrete hearth.
BUILDING PHASE C18th surround, C20th inset
CONDITION Poor

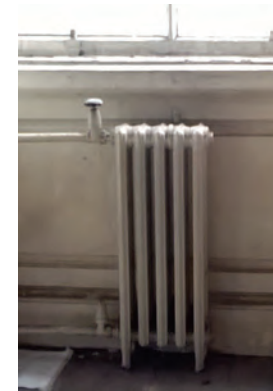
<b>TYPE AND DESCRIPTION OF FABRIC</b> Cast iron radiator: located below window
<b>BUILDING PHASE</b> C20th
<b>CONDITION</b> Poor—fair

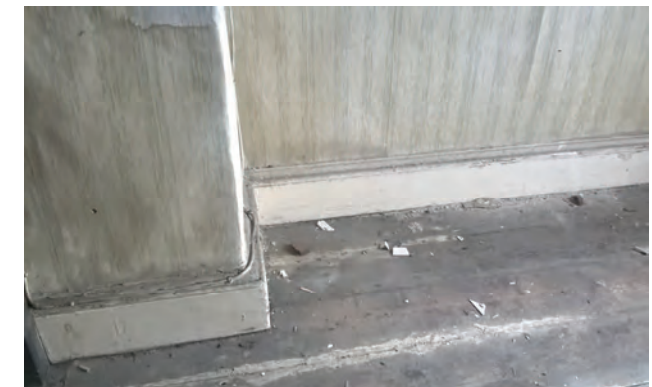
<b>TYPE AND DESCRIPTION OF FABRIC</b> Skirting: timber profile
<b>BUILDING PHASE</b> C20th
<b>CONDITION</b> Poor—Fair

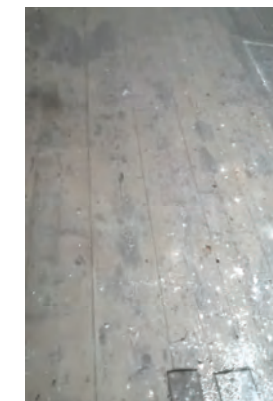
<b>TYPE AND DESCRIPTION OF FABRIC</b> Floor timber boards; badly damaged in bathroom area
<b>BUILDING PHASE</b> C18th
<b>CONDITION</b> Poor—fair

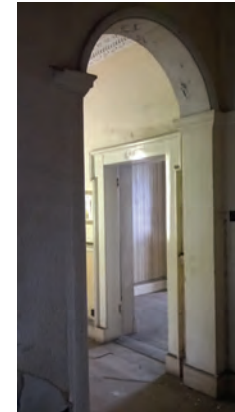
TYPE AND DESCRIPTION OF FABRIC Doorway to stair hall: timber panelling flanking ope; plasterwork arch with simple moulding.
BUILDING PHASE C18th
CONDITION Poor—Fair

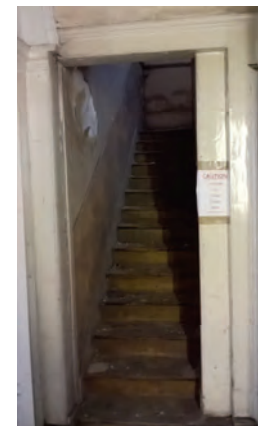
TYPE AND DESCRIPTION OF FABRIC Doorway to 3rd floor staircase: timber door case; lugged on RHS only (running into wall on LHS); no door leaf.
BUILDING PHASE C18th
CONDITION Poor

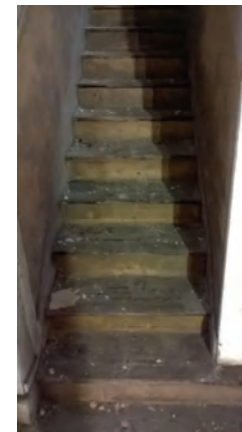
TYPE AND DESCRIPTION OF FABRIC Staircase to 3rd floor: timber stairs; no handrail/ guardrail as fully enclosed.
BUILDING PHASE C18th
CONDITION Poor

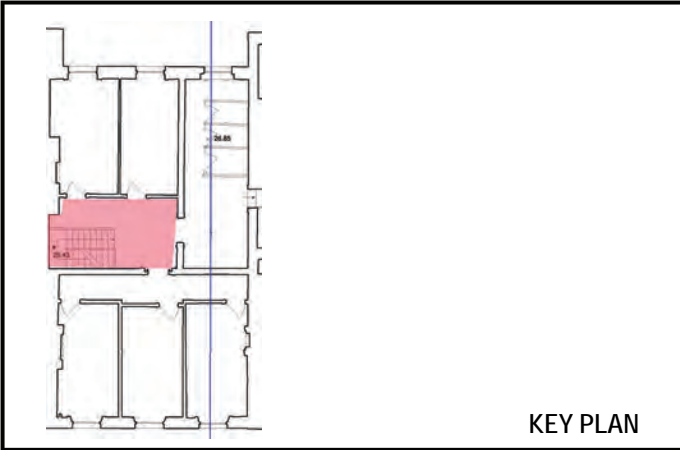
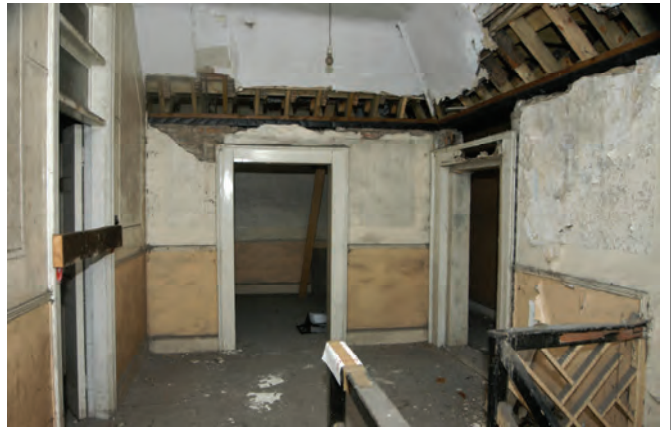
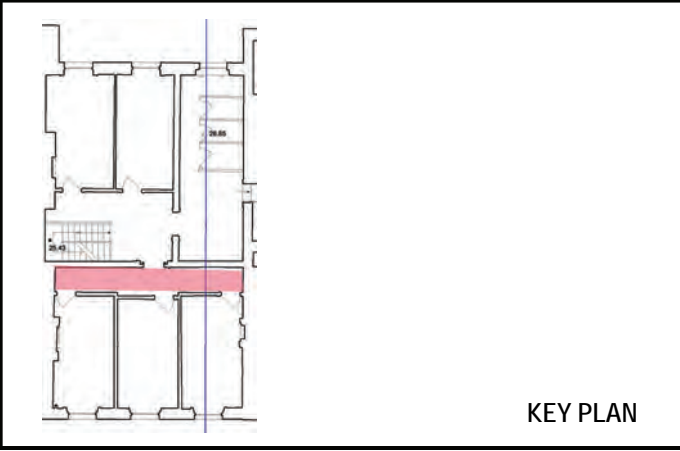
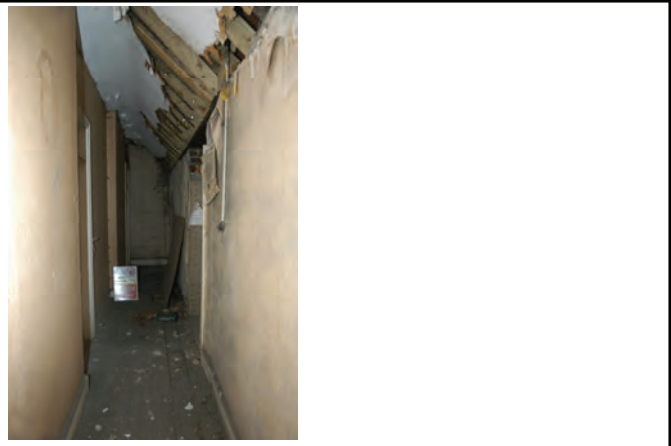
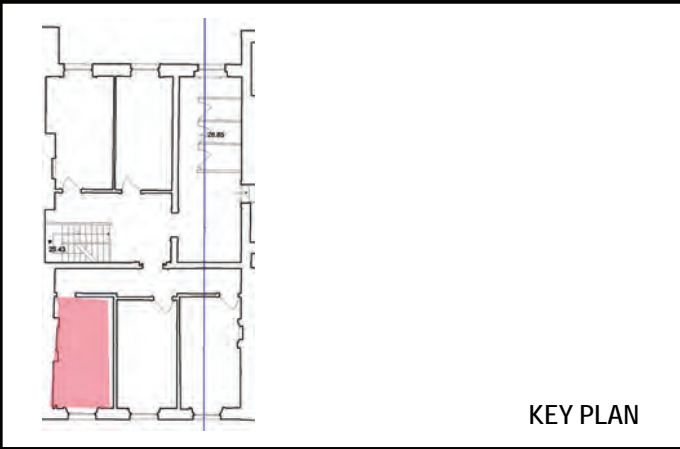
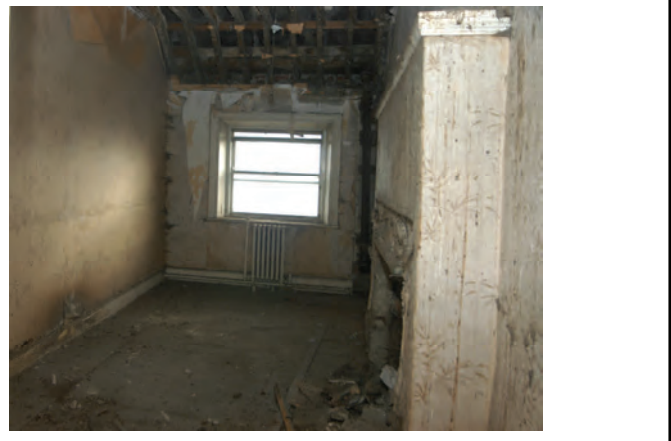
BUILDING NO.
24
FLOOR
Third Floor
ROOM
Stairhall/landing; Inner hallway; Front room, W

TYPE AND DESCRIPTION OF FABRIC
Minimal decorative fabric on 3rd floor: Window joinery—as pictured; Doors; Plain skirtings; Floors—timber throughout; Plain, coved ceilings; Cast iron radiators below windows; Opening to No.25.

BUILDING PHASE
C18th –C20th
CONDITION
Generally poor

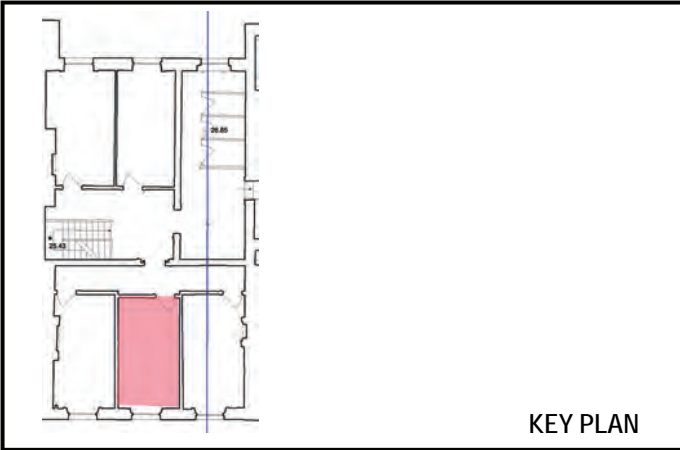
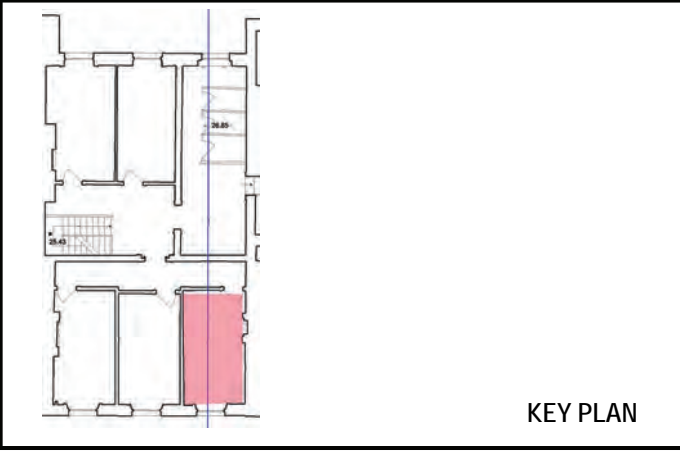
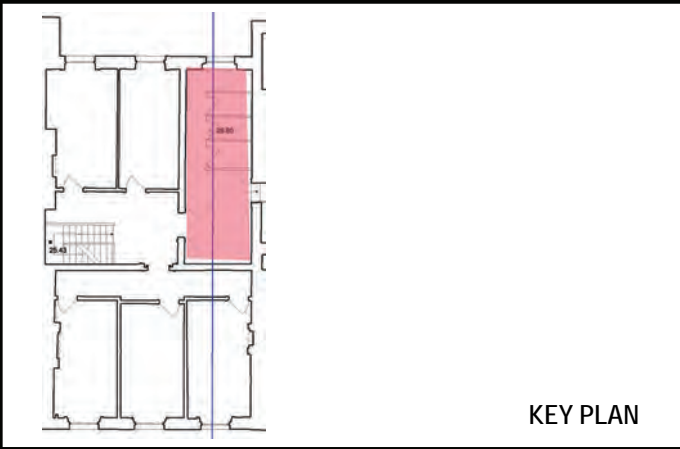
BUILDING NO.
24
FLOOR
Third Floor
ROOM
Front room, centre; Front room, E; Rear room, E

TYPE AND DESCRIPTION OF FABRIC
Minimal decorative fabric on 3rd floor: Window joinery—as pictured; Doors; Plain skirtings; Floors—timber throughout; Plain, coved ceilings; Cast iron radiators below windows; Opening to No.25.

BUILDING PHASE
C18th –C20th
CONDITION
Generally poor

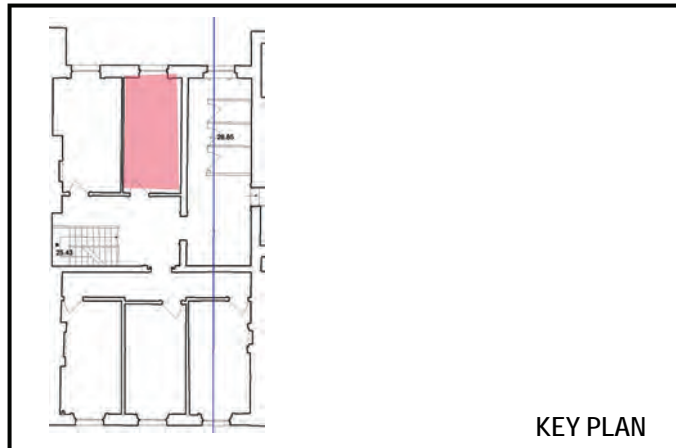
BUILDING NO. 24
FLOOR Third Floor
ROOM Rear room, centre; Rear room, W

<p>TYPE AND DESCRIPTION OF FABRIC</p> <p>Minimal decorative fabric on 3rd floor: Window joinery—as pictured; Doors; Plain skirtings; Floors—timber throughout; Plain, coved ceilings; Cast iron radiators below windows; Opening to No.25.</p>
--

BUILDING PHASE C18th –C20th
CONDITION Generally poor

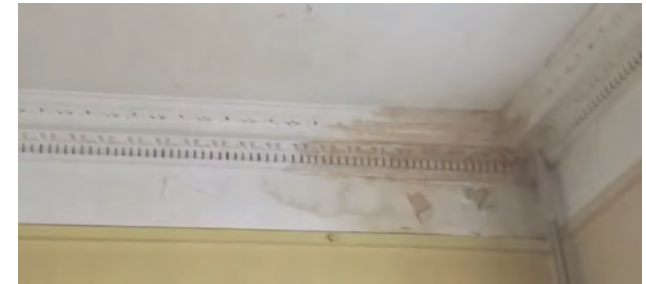
TYPE AND DESCRIPTION OF FABRIC Cornice: in low relief, mouldings indistinct due to overpainting—include dentil and egg-and-dart motifs; SE corner has water staining.
BUILDING PHASE C18th
CONDITION Poor-fair

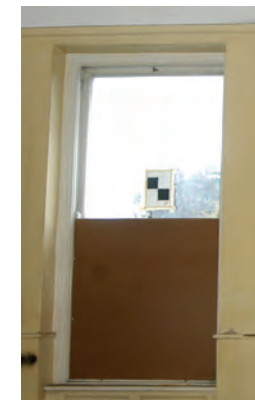
TYPE AND DESCRIPTION OF FABRIC Window, E (LHS): timber casing; single-pane sashes; no shutters, boxes, architrave.
BUILDING PHASE C20th
CONDITION Poor—Fair

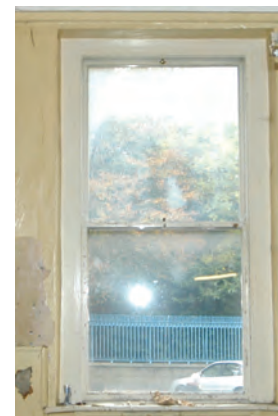
TYPE AND DESCRIPTION OF FABRIC Window, centre: timber casing; single-pane sashes.
BUILDING PHASE C19th
CONDITION Fair

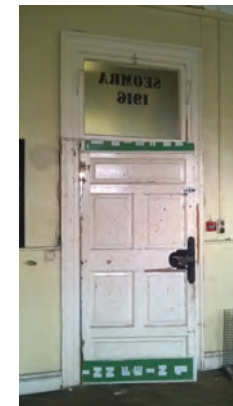
TYPE AND DESCRIPTION OF FABRIC Door to rear reception room: timber casing, with over-light having bottom-hung sash; 8-panel door
BUILDING PHASE C18th—C20th
CONDITION Poor—Fair

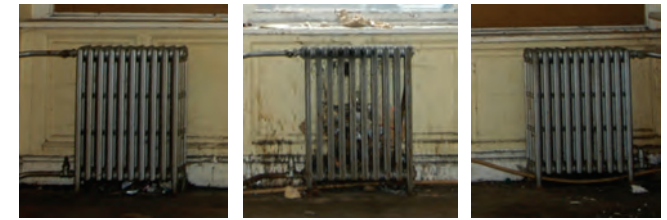
TYPE AND DESCRIPTION OF FABRIC Cast iron radiators: 3no. Located below windows
BUILDING PHASE C20th
CONDITION Poor

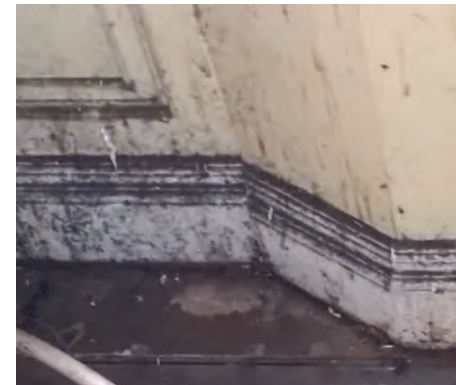
TYPE AND DESCRIPTION OF FABRIC Skirting: timber profile
BUILDING PHASE C20th
CONDITION Poor—Fair

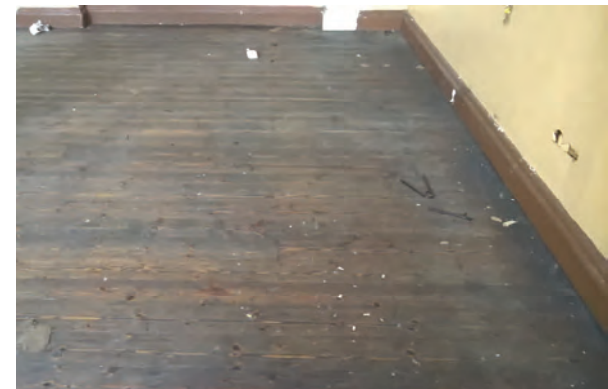
TYPE AND DESCRIPTION OF FABRIC Floor: narrow timber boards
BUILDING PHASE C20th
CONDITION Fair

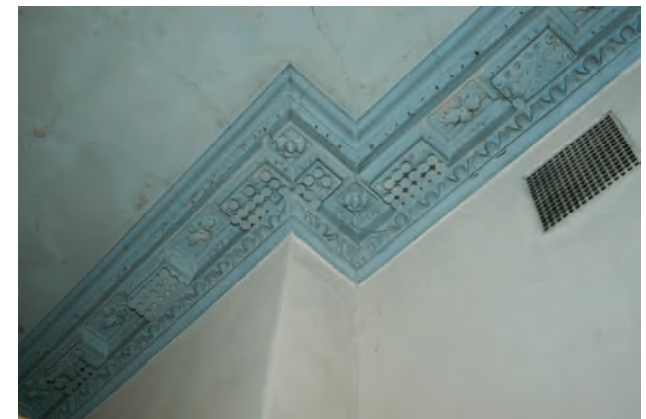
TYPE AND DESCRIPTION OF FABRIC Cornice: medium-high relief; guttae and rosette detail.
BUILDING PHASE C18th
CONDITION Poor—fair

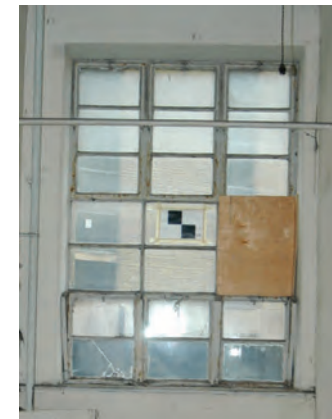
TYPE AND DESCRIPTION OF FABRIC Window, W (LHS internally): steel-framed window; 3no. upper opening casement; 3no. lower opening casements; steel mullions.
BUILDING PHASE C20th
CONDITION Poor—Fair

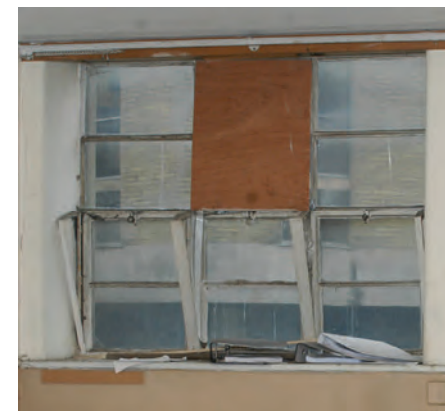
TYPE AND DESCRIPTION OF FABRIC Window, centre: steel-framed window; 3no. lower opening casements; steel mullions.
BUILDING PHASE C20th
CONDITION Fair—poor

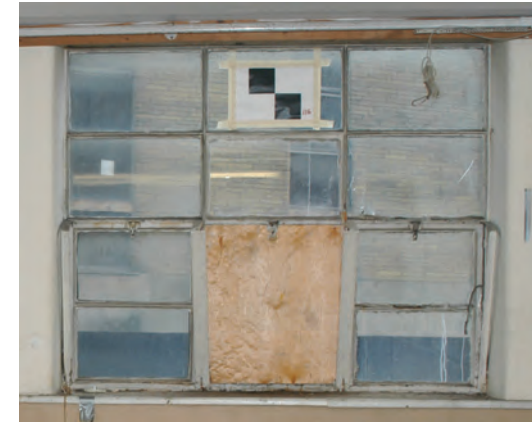
<b>TYPE AND DESCRIPTION OF FABRIC</b>
Window, E (RHS internally): steel-framed window; 3no. lower opening casements; steel mullions.
<b>BUILDING PHASE</b>
C20th
<b>CONDITION</b>
Poor—fair

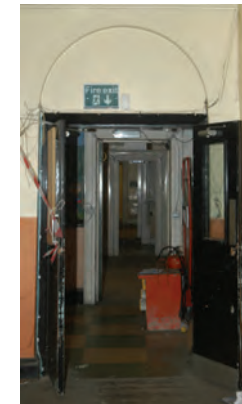
<b>TYPE AND DESCRIPTION OF FABRIC</b>
Door to stair hall: 2-leaf timber doors, having glazed upper panels; set into archway.
<b>BUILDING PHASE</b>
C18th—C20th
<b>CONDITION</b>
Poor

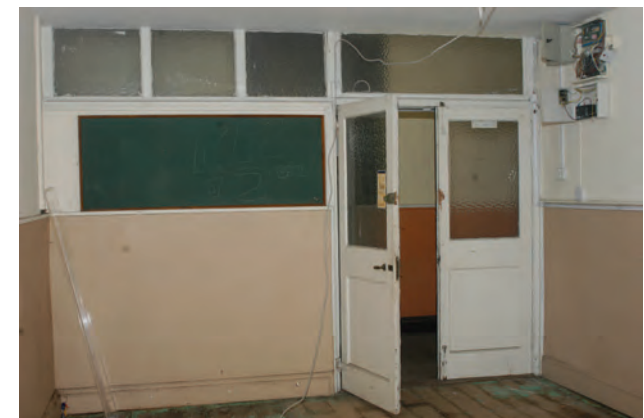
<b>TYPE AND DESCRIPTION OF FABRIC</b>
Partition: timber-framed with upper glazed panels; 2-leaf timber door having glazed panels.
<b>BUILDING PHASE</b>
C20th
<b>CONDITION</b>
Fair

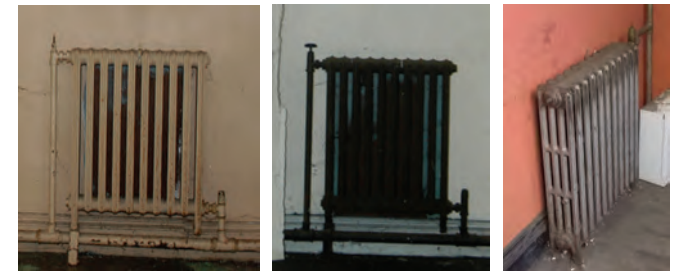
TYPE AND DESCRIPTION OF FABRIC Cast iron radiators: 2no. located below windows; 1no. located on wall to front reception room.
BUILDING PHASE C20th
CONDITION Poor—fair

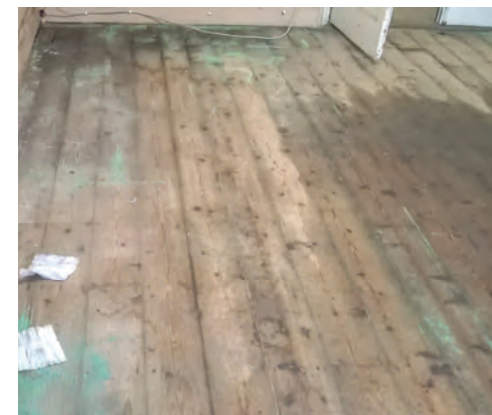
TYPE AND DESCRIPTION OF FABRIC Floor: timber boards.
BUILDING PHASE C18th
CONDITION Fair

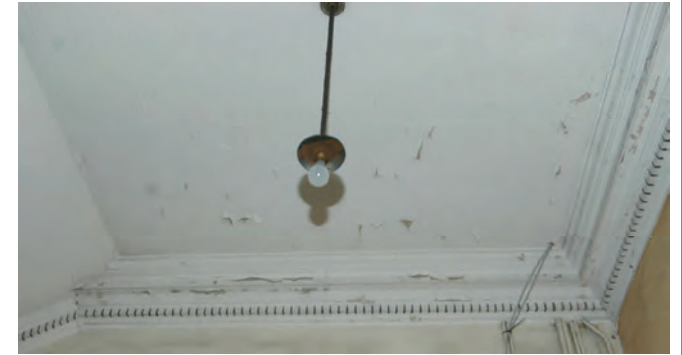
TYPE AND DESCRIPTION OF FABRIC Cornice: low-relief; heavily overpainted
BUILDING PHASE C18th
CONDITION Poor

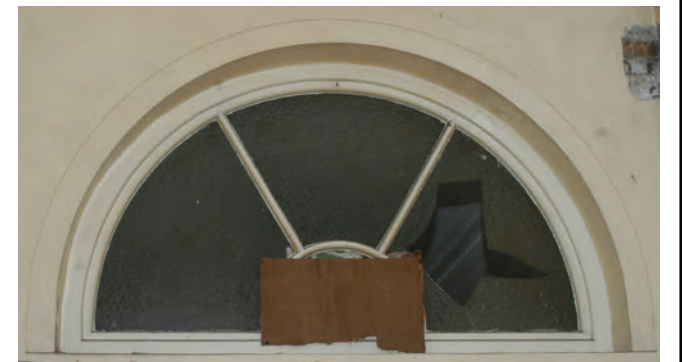
TYPE AND DESCRIPTION OF FABRIC Fanlight to front room/former entrance hall: located within blocked-up archway; plasterwork arch with simple moulding; hubbed, 4-pane fanlight.
BUILDING PHASE C20th
CONDITION Poor

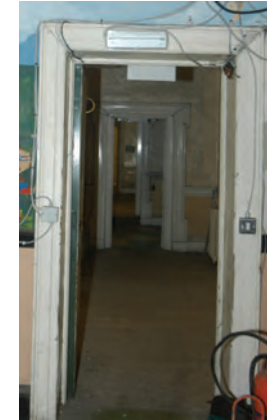
TYPE AND DESCRIPTION OF FABRIC Doorway to No.24: timber architrave; timber fire door.
BUILDING PHASE C20th
CONDITION Poor

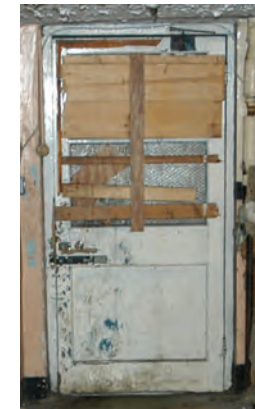
TYPE AND DESCRIPTION OF FABRIC Door to rear: timber door.
BUILDING PHASE C20th
CONDITION V. Poor

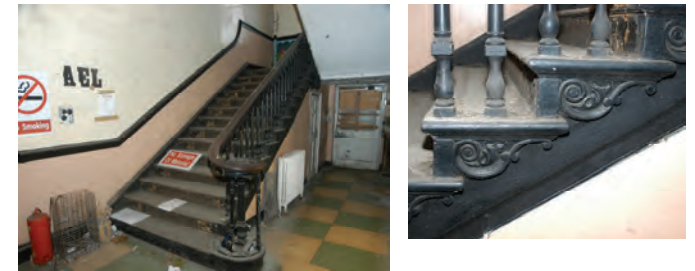
TYPE AND DESCRIPTION OF FABRIC Staircase: timber stairs; turned, paired balusters; mahogany handrail; open string with carved detail; terminating scroll.
BUILDING PHASE C18th
CONDITION Poor—structurally unsound

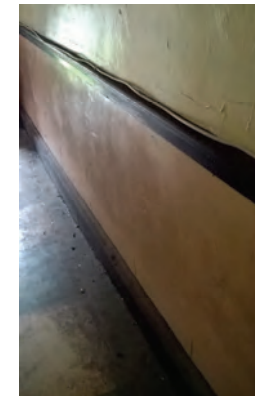
TYPE AND DESCRIPTION OF FABRIC Dado and skirting: timber profiles
BUILDING PHASE C18th
CONDITION Poor—fair

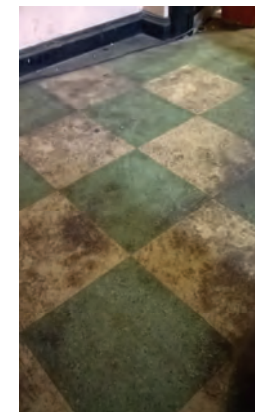
TYPE AND DESCRIPTION OF FABRIC Floor: terrazzo in green/gold chequered pattern
BUILDING PHASE C20th
CONDITION Poor—fair

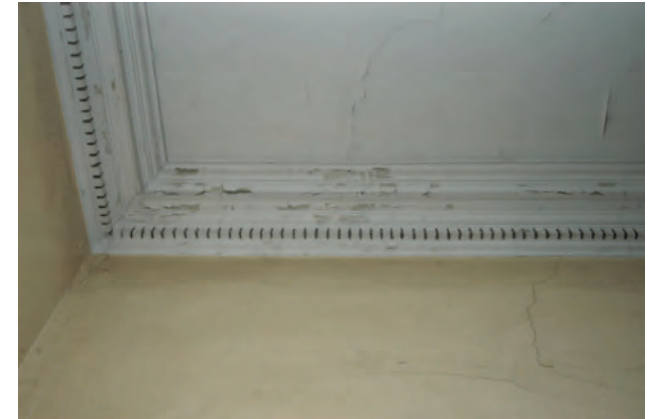
TYPE AND DESCRIPTION OF FABRIC Cornice: in low relief, mouldings indistinct due to overpainting—include dentil moulding; pipework breaking-through in NE corner.
BUILDING PHASE C18th
CONDITION Poor—fair

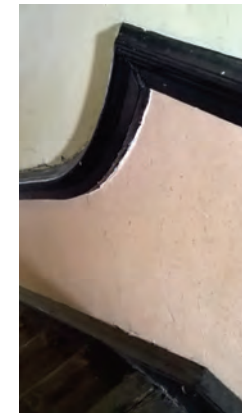
TYPE AND DESCRIPTION OF FABRIC Dado and skirting: timber profiles
BUILDING PHASE C18th
CONDITION Poor—fair

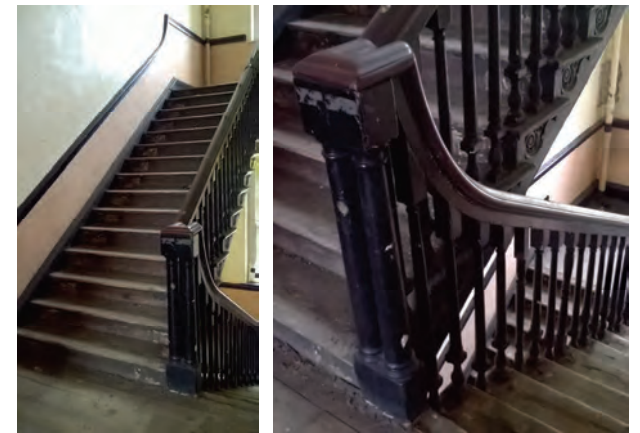
TYPE AND DESCRIPTION OF FABRIC Staircase: timber stairs; turned, paired balusters; mahogany handrail; open string with carved detail.
BUILDING PHASE C18th
CONDITION Poor—fair

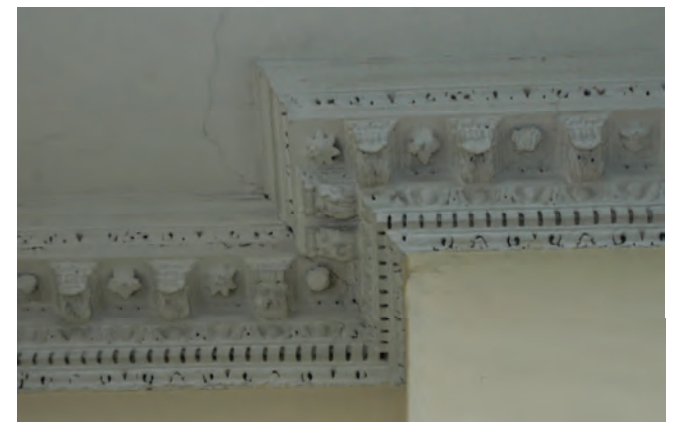
TYPE AND DESCRIPTION OF FABRIC Cornice: medium-high relief; modillion and rosette detail; heavily overpainted.
BUILDING PHASE C18th
CONDITION Fair

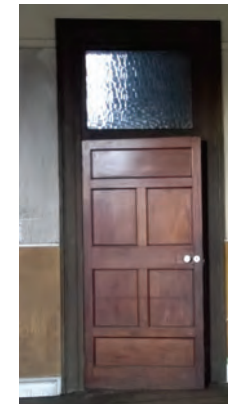
TYPE AND DESCRIPTION OF FABRIC Door to stair hall: timber casing; 6-panel timber door with overlight; timber architrave with moulded profile.
BUILDING PHASE C20h
CONDITION Fair

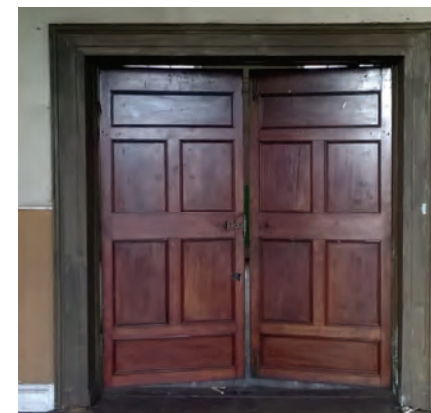
TYPE AND DESCRIPTION OF FABRIC Door to rear reception room: timber casing; 2-leaf doorset having 6-panel timber doors; timber architrave with moulded profile.
BUILDING PHASE C20th
CONDITION Fair

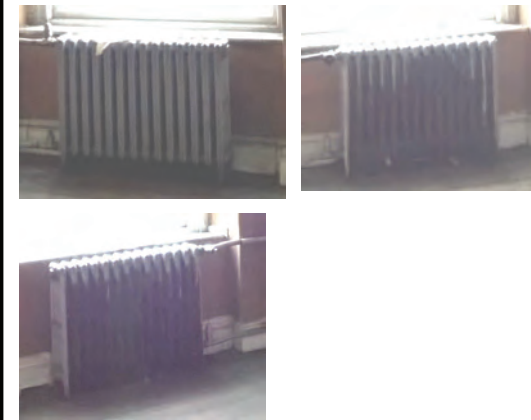
TYPE AND DESCRIPTION OF FABRIC Cast iron radiators: located below windows
BUILDING PHASE C20th
CONDITION Poor

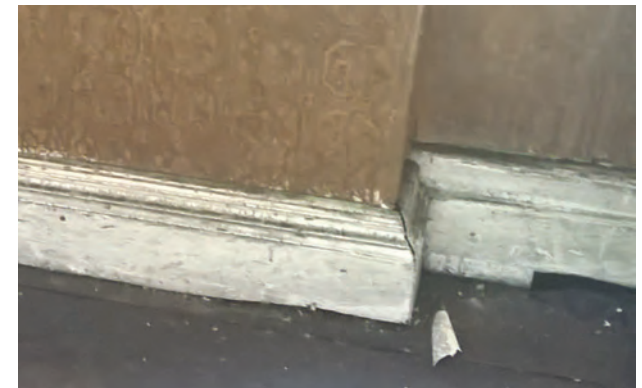
TYPE AND DESCRIPTION OF FABRIC Skirting: timber profile
BUILDING PHASE C18th
CONDITION Poor—Fair

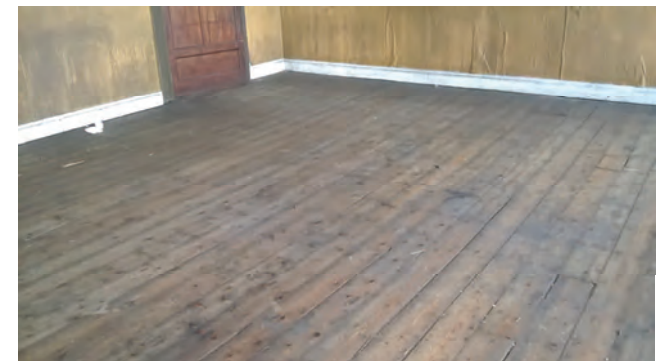
TYPE AND DESCRIPTION OF FABRIC Floor: timber boards
BUILDING PHASE C18th
CONDITION Fair

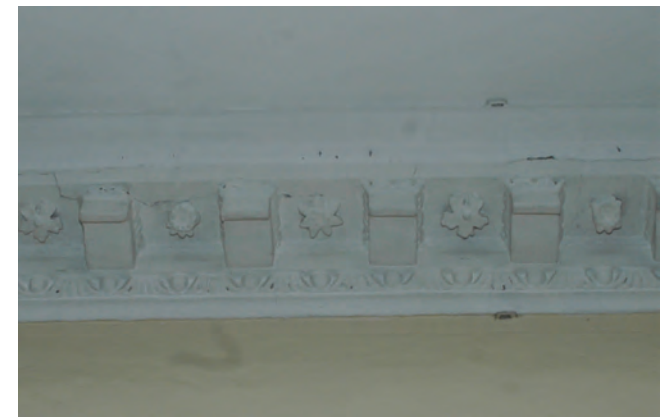
TYPE AND DESCRIPTION OF FABRIC Cornice: medium-high relief; modillion and rosette detail; heavily overpainted.
BUILDING PHASE C18th
CONDITION Poor—fair

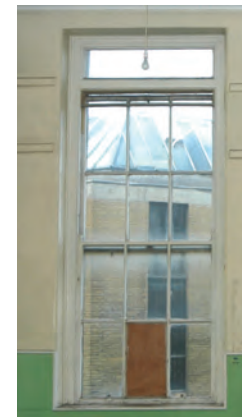
TYPE AND DESCRIPTION OF FABRIC Window, W (LHS internally): timber casing; 6-over-6 timber sashes with glazed overhead; no shutters, boxes, architrave surviving.
BUILDING PHASE C18th sashes, C20th casing
CONDITION Poor—Fair

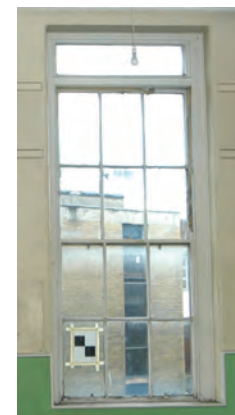
TYPE AND DESCRIPTION OF FABRIC Window, E (RHS internally): timber casing; 6-over-6 timber sashes with glazed overhead; no shutters, boxes, architrave surviving.
BUILDING PHASE C18th sashes, C20th casing
CONDITION Poor—Fair

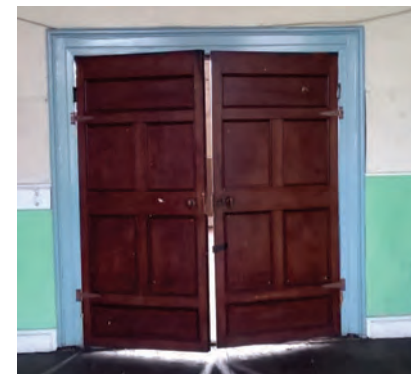
TYPE AND DESCRIPTION OF FABRIC Door to front reception room: timber casing; 2-leaf doorset having 6-panel timber doors; timber architrave with moulded profile.
BUILDING PHASE C20th
CONDITION Fair

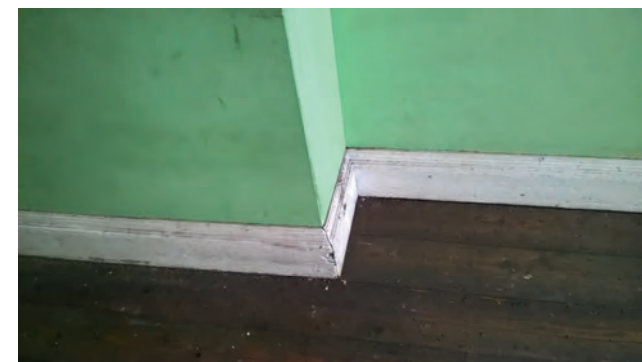
TYPE AND DESCRIPTION OF FABRIC Skirting: timber profile
BUILDING PHASE C18th
CONDITION Poor—Fair

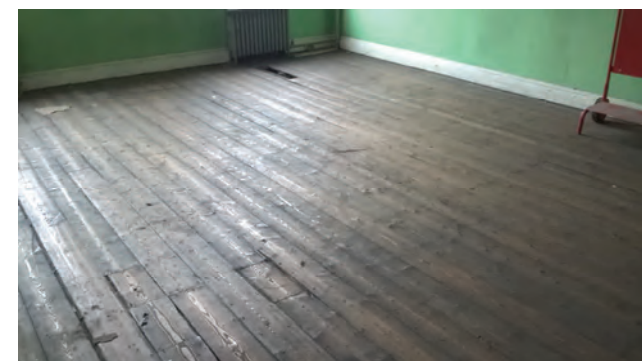
TYPE AND DESCRIPTION OF FABRIC Floor: timber boards
BUILDING PHASE C18th
CONDITION Fair

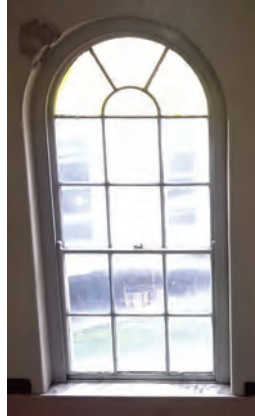
TYPE AND DESCRIPTION OF FABRIC Window to half-landing: arched window with timber casing and sashes; 10-pane hubbed sash over 6-pane lower sash.

BUILDING PHASE C19th	
CONDITION Fair

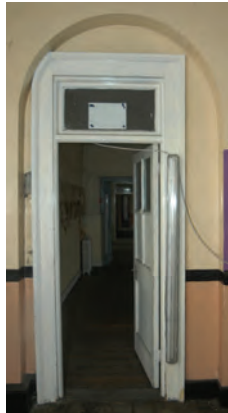
TYPE AND DESCRIPTION OF FABRIC Door to rear reception room: timber casing set into archway; 5-panel door having 2 glazed panels, with glazed overlight; timber architrave.

BUILDING PHASE C20th	
CONDITION Poor—Fair

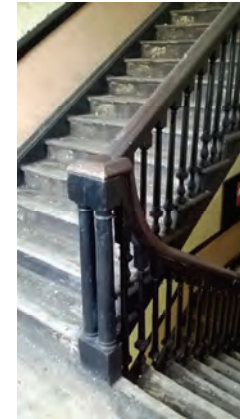
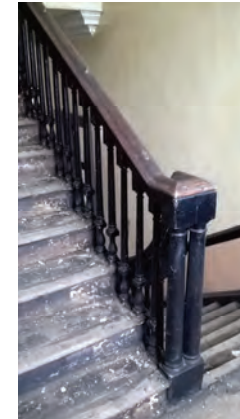
TYPE AND DESCRIPTION OF FABRIC Staircase: timber stairs; turned, paired balusters; mahogany handrail; open string with carved detail.
BUILDING PHASE C20th
CONDITION Fair

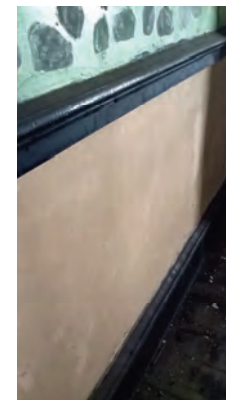
TYPE AND DESCRIPTION OF FABRIC Dado and skirting: timber profiles
BUILDING PHASE C18th
CONDITION Fair

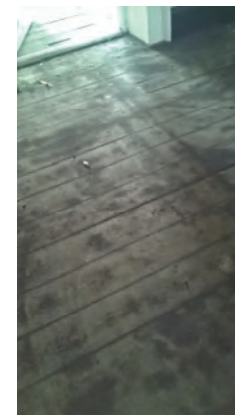
TYPE AND DESCRIPTION OF FABRIC Floor: timber boards
BUILDING PHASE C18th
CONDITION Poor—Fair

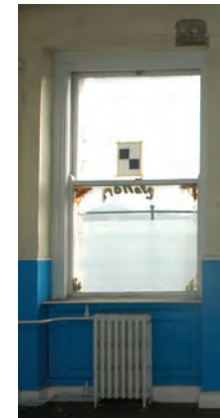
TYPE AND DESCRIPTION OF FABRIC Window, E (LHS internally): timber casing; single-pane timber sashes; timber panelling below window.
BUILDING PHASE C18th panelling below, C19th window casing and sashes
CONDITION Poor—Fair

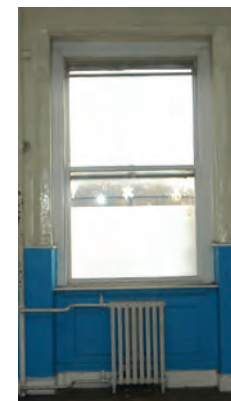
TYPE AND DESCRIPTION OF FABRIC Window, centre: timber casing; single-pane timber sashes; timber panelling below window.
BUILDING PHASE C18th panelling below, C19th window casing and sashes
CONDITION Poor—Fair

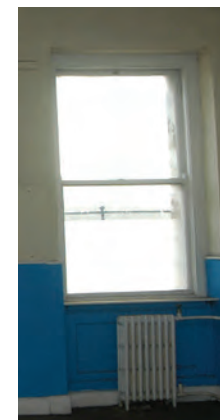
TYPE AND DESCRIPTION OF FABRIC Window, W (RHS internally): timber casing; single-pane timber sashes; timber panelling below window.
BUILDING PHASE C18th panelling below, C19th window casing and sashes
CONDITION Poor—Fair

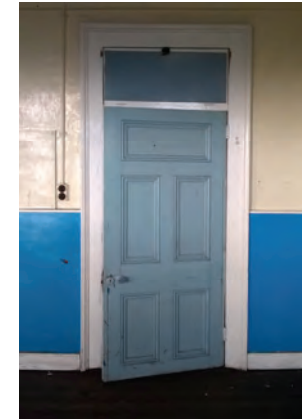
TYPE AND DESCRIPTION OF FABRIC Door to stair hall: timber casing; 5-panel door with overlight; timber architrave.
BUILDING PHASE C18th surround, C20th door leaf and overlight
CONDITION Poor—Fair

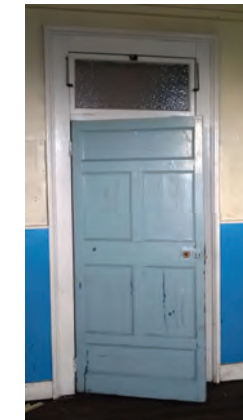
TYPE AND DESCRIPTION OF FABRIC Door to rear reception room: timber casing; 6-panel timber door; timber architrave
BUILDING PHASE C18th—C20th
CONDITION Poor—Fair

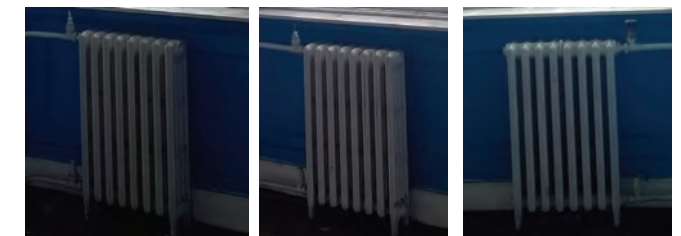
TYPE AND DESCRIPTION OF FABRIC Cast iron radiators: 3no., located below windows
BUILDING PHASE C20th
CONDITION Poor—Fair

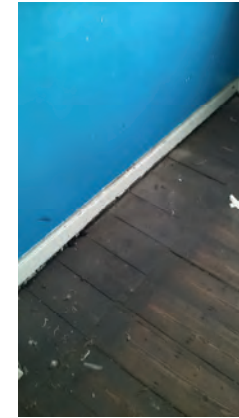
TYPE AND DESCRIPTION OF FABRIC Skirting: plain timber skirting with rounded edge
BUILDING PHASE C18th—C20th
CONDITION Poor—Fair

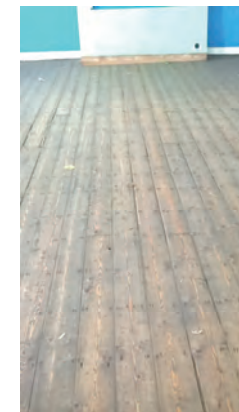
TYPE AND DESCRIPTION OF FABRIC Floor: timber boards
BUILDING PHASE C20th
CONDITION Poor—Fair

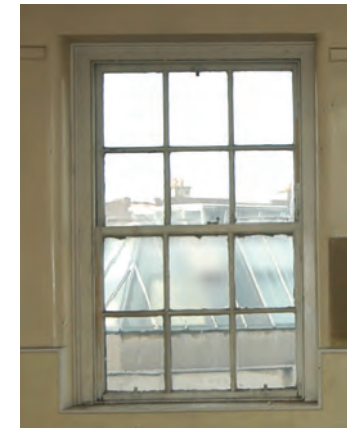
TYPE AND DESCRIPTION OF FABRIC Window, W (LHS internally): timber casing; 6-over-6 sliding sashes
BUILDING PHASE C18th sashes, C19th casing
CONDITION Poor—Fair

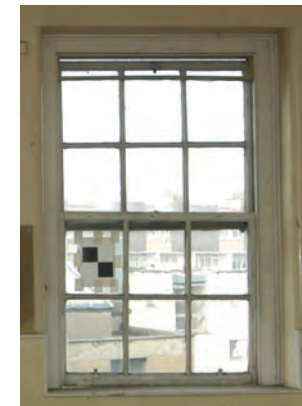
TYPE AND DESCRIPTION OF FABRIC Window, E (RHS internally): timber casing; 6-over-6 sliding sashes
BUILDING PHASE C18th sashes, C19th casing
CONDITION Poor—Fair

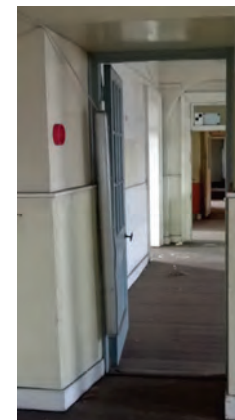
TYPE AND DESCRIPTION OF FABRIC Doorway to No.26: timber casing; timber door leaf having 9 glazed panels over a single lower timber panel; sloped threshold.
BUILDING PHASE C20th
CONDITION Poor—Fair

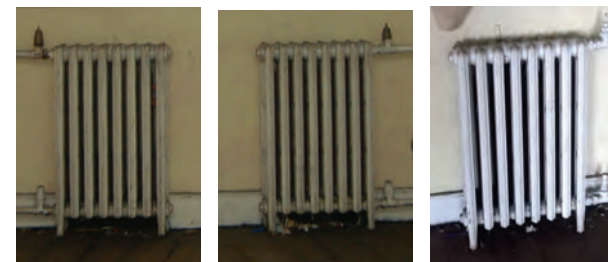
TYPE AND DESCRIPTION OF FABRIC Cast iron radiators: 2no. located below windows, 1no. located in SW corner.
BUILDING PHASE C20th
CONDITION Poor—Fair

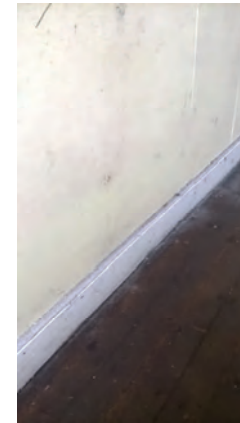
TYPE AND DESCRIPTION OF FABRIC Skirting: timber, having rounded profile
BUILDING PHASE C20th
CONDITION Fair

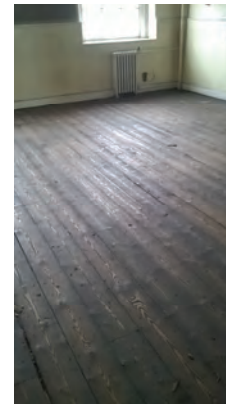
TYPE AND DESCRIPTION OF FABRIC Floor: timber boards
BUILDING PHASE C18th
CONDITION Fair

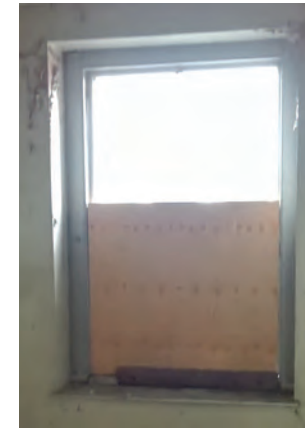
TYPE AND DESCRIPTION OF FABRIC Window to half-landing: timber casing; single-pane sashes
BUILDING PHASE C19th—C20th
CONDITION Poor

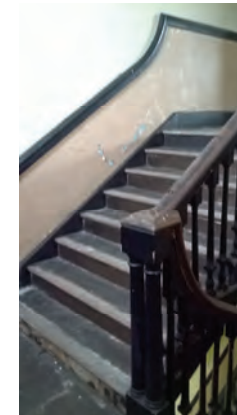
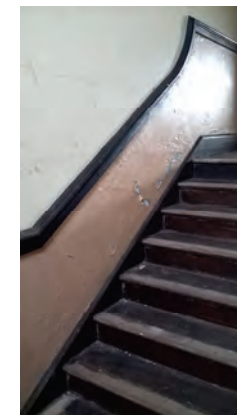
TYPE AND DESCRIPTION OF FABRIC Staircase: timber stairs; turned, paired balusters; mahogany handrail; open string with carved detail.
BUILDING PHASE C18th
CONDITION Fair

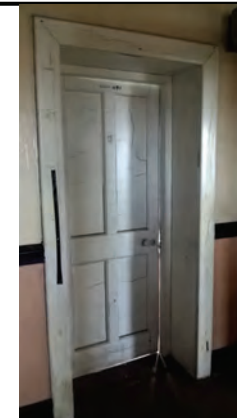
TYPE AND DESCRIPTION OF FABRIC Door to front room: timber casing; 4-panel door; rounded-edge architrave.
BUILDING PHASE C18th—C20th
CONDITION Poor

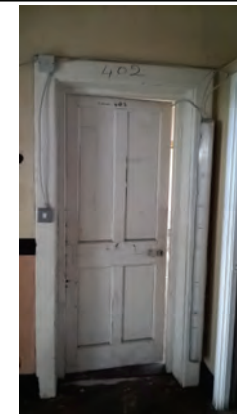
TYPE AND DESCRIPTION OF FABRIC Door to rear room: timber casing; 4-panel timber door; rounded-edge architrave.
BUILDING PHASE C19th—C20th
CONDITION Poor

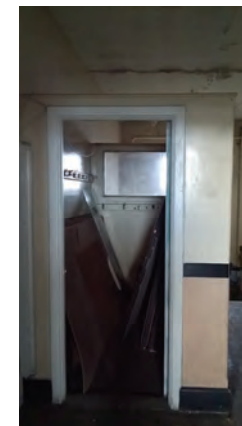
TYPE AND DESCRIPTION OF FABRIC Cloakroom enclosure: light partition with framed doorway; fixed light over staircase
BUILDING PHASE C20th
CONDITION Poor—Fair

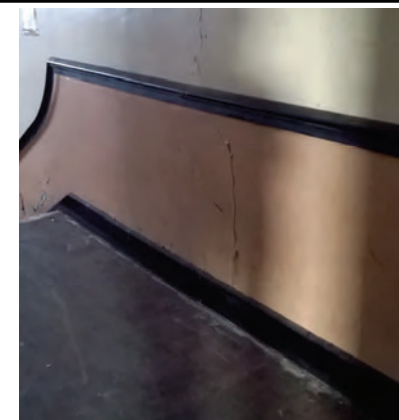
TYPE AND DESCRIPTION OF FABRIC Dado and skirting: timber profiles.
BUILDING PHASE C18th
CONDITION Poor—fair

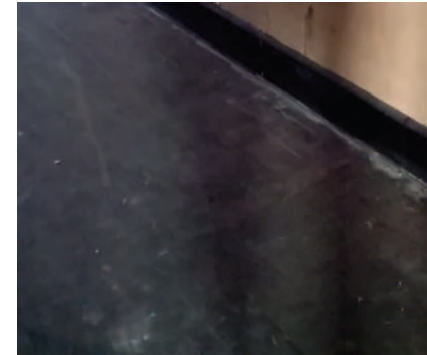
TYPE AND DESCRIPTION OF FABRIC Floor: timber boards.
BUILDING PHASE C18th
CONDITION Poor—fair

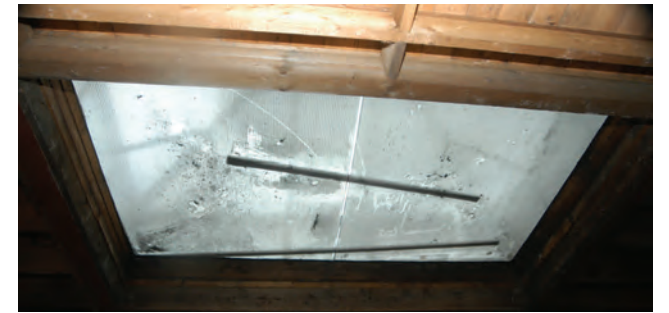
TYPE AND DESCRIPTION OF FABRIC Rooflight: steel-framed, hipped rooflight
BUILDING PHASE C20th
CONDITION Poor

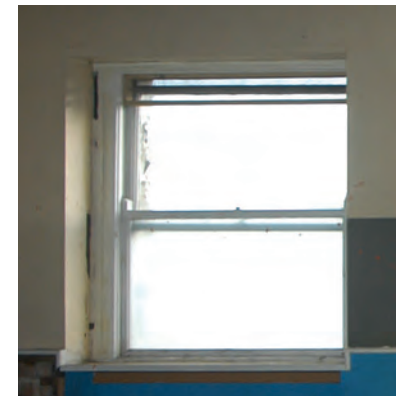
TYPE AND DESCRIPTION OF FABRIC Window, E (LHS internally): timber casing; single-pane timber sashes.
BUILDING PHASE C19th
CONDITION Poor—Fair

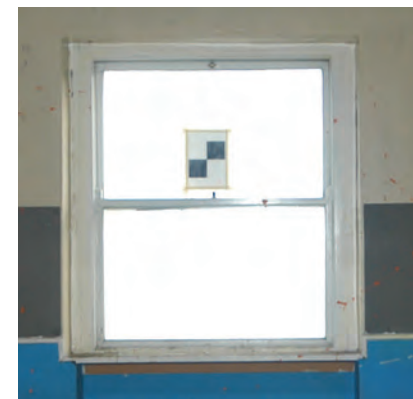
TYPE AND DESCRIPTION OF FABRIC Window, centre: timber casing; single-pane timber sashes
BUILDING PHASE C19th
CONDITION Poor—fair

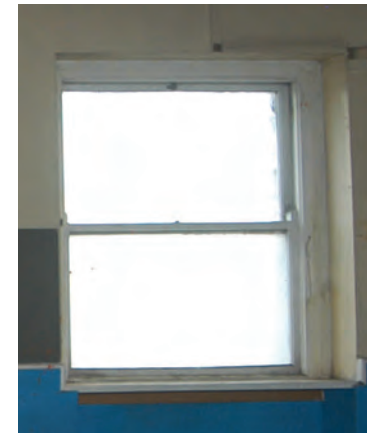
TYPE AND DESCRIPTION OF FABRIC Window, W (RHS internally): timber casing, single-pane timber sashes.
BUILDING PHASE C19th
CONDITION Poor—fair

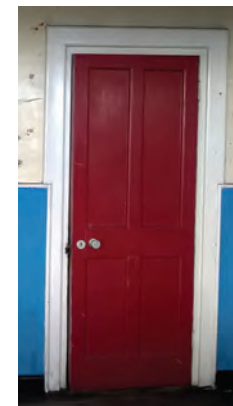
TYPE AND DESCRIPTION OF FABRIC Door to stair hall: timber casing; 4-panel door; round-ed-edge architrave.
BUILDING PHASE C18th—C20th
CONDITION Poor

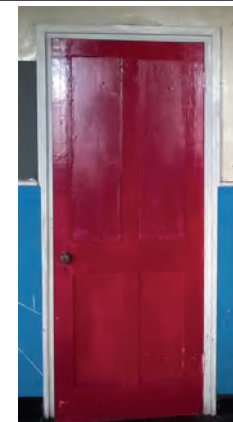
TYPE AND DESCRIPTION OF FABRIC Door to rear room: timber casing; 4-panel timber door; narrow architrave.
BUILDING PHASE C19th—C20th
CONDITION Poor

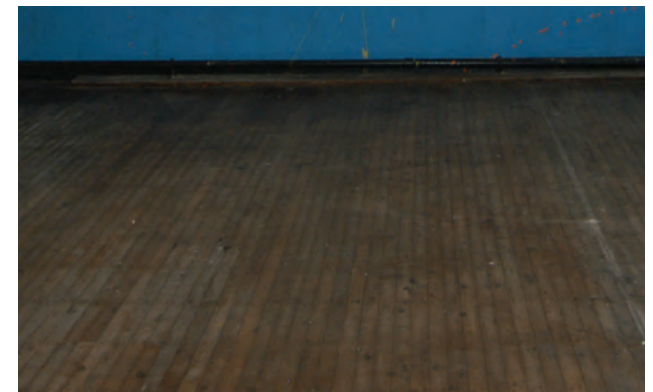
TYPE AND DESCRIPTION OF FABRIC Floor and skirting: Narrow timber boards with round-ed-edge skirting
BUILDING PHASE C20th
CONDITION Fair

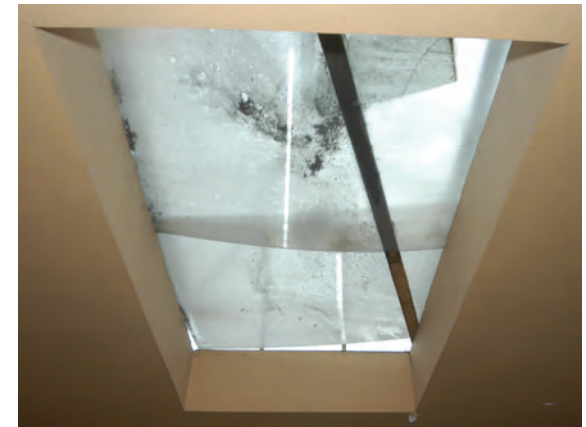
TYPE AND DESCRIPTION OF FABRIC Rooflight: steel-framed hipped rooflight
BUILDING PHASE C20th
CONDITION Poor

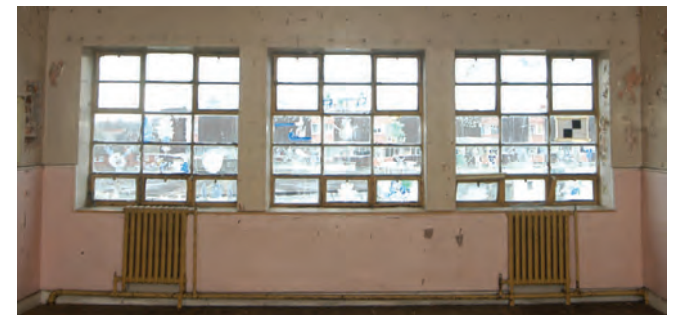
TYPE AND DESCRIPTION OF FABRIC Windows: 3no. square-ope, steel-frame windows in place of original 2-window arrangement; each having 15-pane frame with 5no. bottom-hung opening casements.
BUILDING PHASE C20th
CONDITION Fair

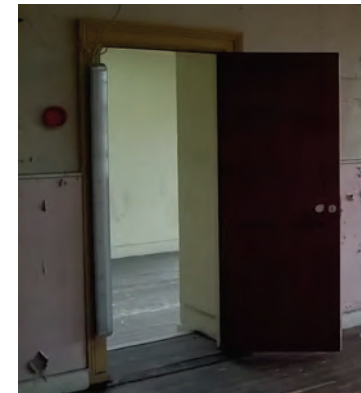
TYPE AND DESCRIPTION OF FABRIC Door No.26: timber casing; 5-panel timber door; timber architrave having moulded profile
BUILDING PHASE C20th
CONDITION Fair

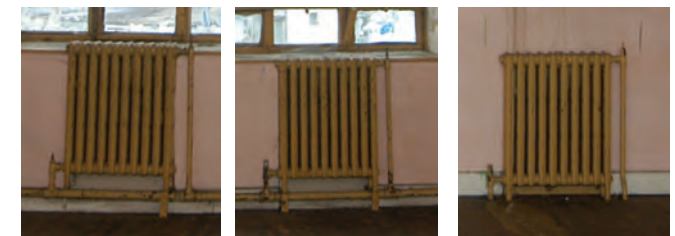
TYPE AND DESCRIPTION OF FABRIC Cast iron radiators: 2no. located below windows, 1no. located in SW corner.
BUILDING PHASE C20th
CONDITION Poor—fair

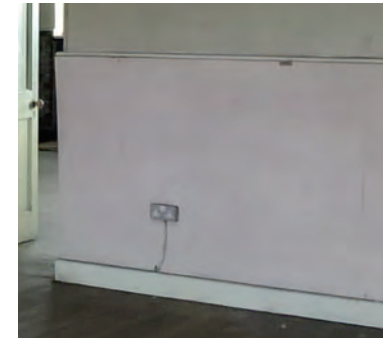
TYPE AND DESCRIPTION OF FABRIC Dado and skirting: flat dado panelling with rounded-edge skirting
BUILDING PHASE C20th
CONDITION Poor—fair

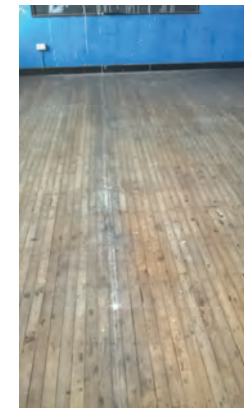
TYPE AND DESCRIPTION OF FABRIC Floor: narrow timber boards
BUILDING PHASE C20th
CONDITION Fair

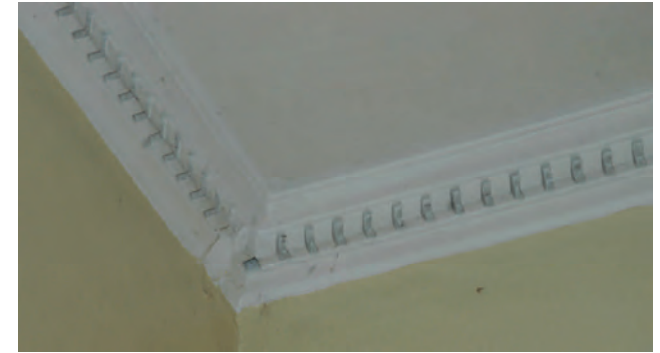
TYPE AND DESCRIPTION OF FABRIC Cornice: in low relief, mouldings indistinct due to overpainting—include dentil motif.
BUILDING PHASE C18th
CONDITION Poor-fair

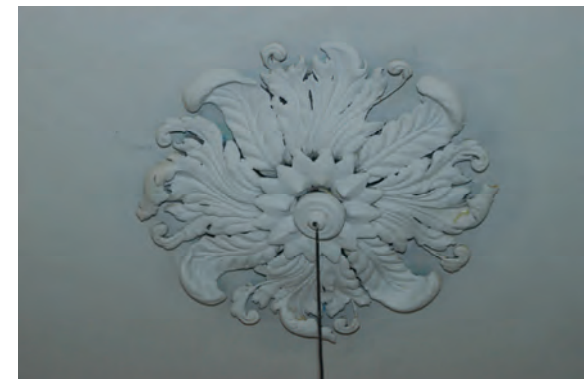
TYPE AND DESCRIPTION OF FABRIC Ceiling rose: foliated design, in medium-high relief.
BUILDING PHASE C18th
CONDITION Poor—Fair

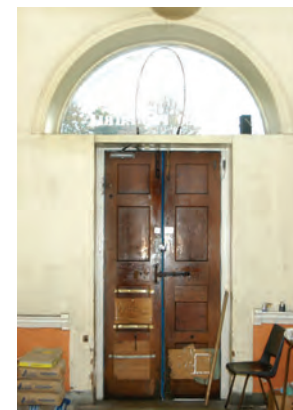
TYPE AND DESCRIPTION OF FABRIC Entrance door: timber casing; 8-panel timber door with two-leaves having been divided vertically; glazed single-pane fanlight.
BUILDING PHASE C18th door, C20th fanlight
CONDITION Poor

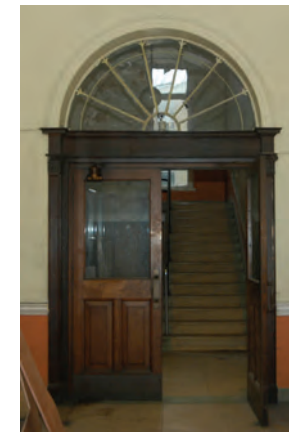
TYPE AND DESCRIPTION OF FABRIC Door to stair hall: arched opening with glazed fanlight having 6no. glazing bars; timber door casing with 2-leaf doors, each having upper glazed panels over 2no. raised panels below.
BUILDING PHASE C18th fanlight and door casing, C20th leaves
CONDITION Fair

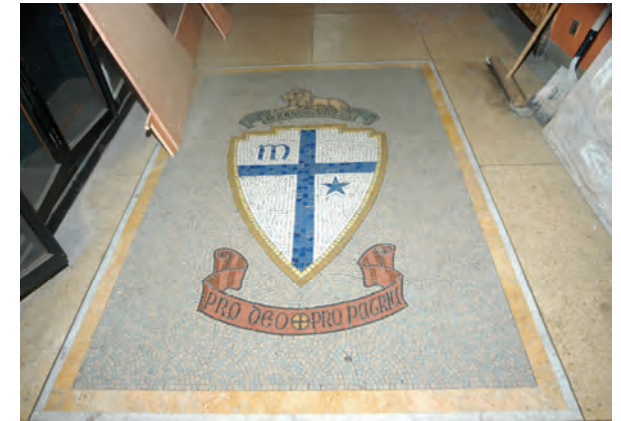
TYPE AND DESCRIPTION OF FABRIC Floor: terrazzo floor covering with patterned central panel of school crest; edges filleted against walls, replacing skirtings.
BUILDING PHASE C20th
CONDITION Fair
