# APPENDIX A

# Building Inventories

Protected Structures Impact Statement

PARNELL SQUARE CULTURAL QUARTER  
 Architectural Heritage—Decorative Fabric Inventory  
 Nos. 20, 21, 23-28 Parnell Square, Dublin 1  
 November 2015—Shaffrey Associates Architects

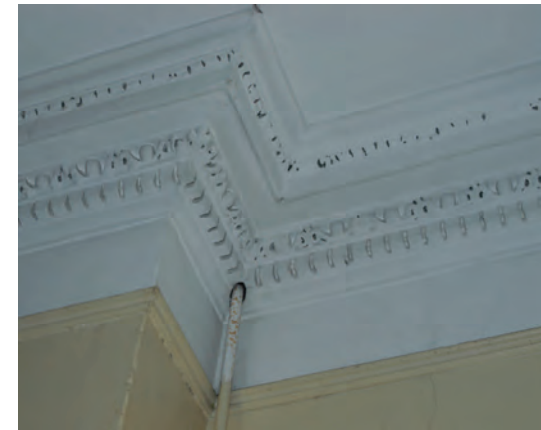
TYPE AND DESCRIPTION OF FABRIC Cornice: in low relief, mouldings indistinct due to overpainting—include dentil and egg-and-dart motifs; picture rail moulding below; pipework breaking-through on E wall.
BUILDING PHASE C18th
CONDITION Poor—Fair

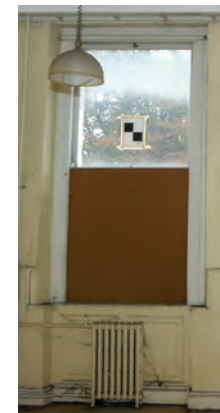
TYPE AND DESCRIPTION OF FABRIC Window, E (LHS internally): timber casing; single-pane sliding sashes; 2no. raised timber panels below.
BUILDING PHASE C18th—C19th
CONDITION Poor

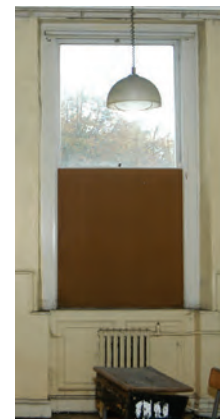
TYPE AND DESCRIPTION OF FABRIC Window, W (RHS internally): timber casing; single-pane sliding sashes; 2no. raised timber panels below.
BUILDING PHASE C18th—C19th
CONDITION Poor

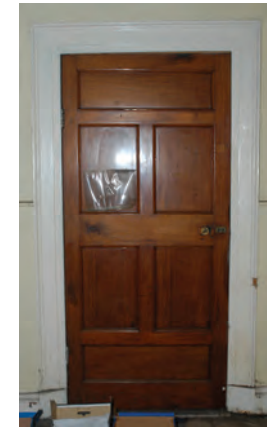
TYPE AND DESCRIPTION OF FABRIC Door to entrance hall: timber casing; 6-panel timber door; timber architrave.
BUILDING PHASE C18th
CONDITION Poor—Fair

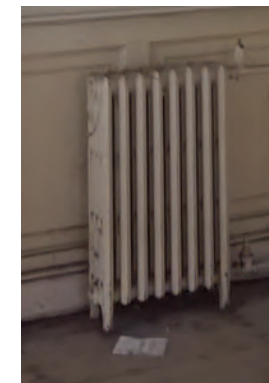
TYPE AND DESCRIPTION OF FABRIC Cast iron radiators: located below windows.
BUILDING PHASE C20th
CONDITION Poor

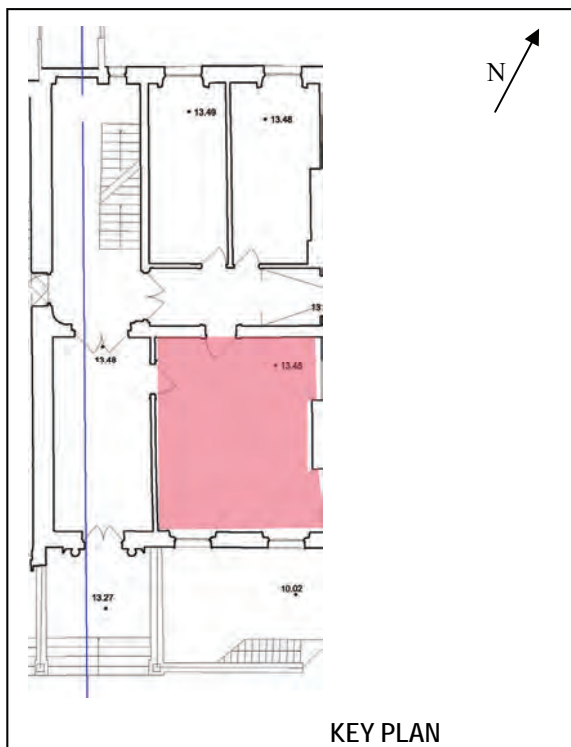
TYPE AND DESCRIPTION OF FABRIC Dado panelling: narrow timber dado rail and flat timber panelling below.
BUILDING PHASE C20th
CONDITION Poor

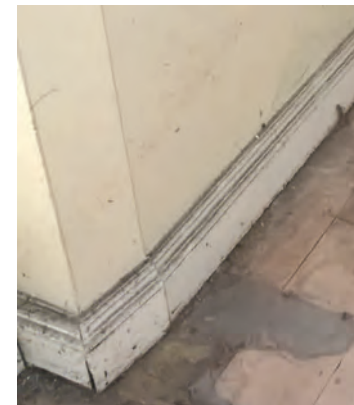
TYPE AND DESCRIPTION OF FABRIC Skirting: timber profile
BUILDING PHASE C18th
CONDITION Poor

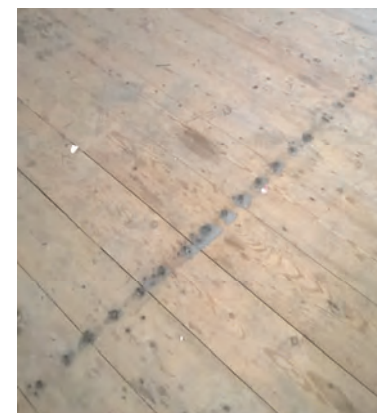
TYPE AND DESCRIPTION OF FABRIC Floor: timber boards
BUILDING PHASE C18th
CONDITION Poor—fair

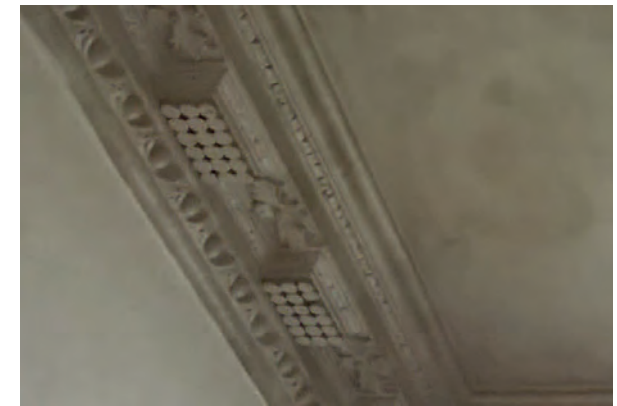
<b>TYPE AND DESCRIPTION OF FABRIC</b>
Cornice: medium-high relief; guttae with floral/ foliate details between moulded borders; heavily overpainted in most areas; an area in NW has had paint removed.
<b>BUILDING PHASE</b>
C18th
<b>CONDITION</b>
Fair

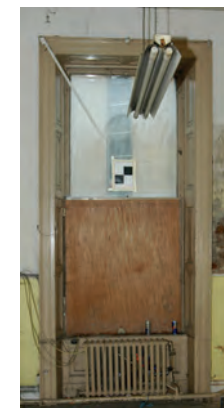
<b>TYPE AND DESCRIPTION OF FABRIC</b>
Window, W (LHS): timber casing; single-pane sliding sashes; panelled shutters; raised panelling below; timber architrave.
<b>BUILDING PHASE</b>
C18th surround, C19th sashes
<b>CONDITION</b>
Poor

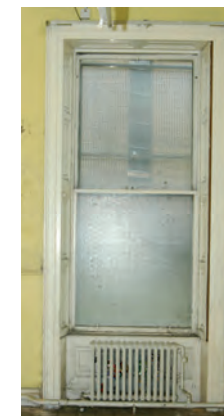
<b>TYPE AND DESCRIPTION OF FABRIC</b>
Window, E (RHS): timber casing; single-pane sliding sashes; panelled shutters; raised panelling below; timber architrave.
<b>BUILDING PHASE</b>
C18th surround, C19th sashes
<b>CONDITION</b>
Poor

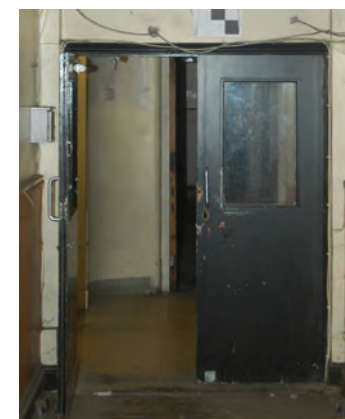
TYPE AND DESCRIPTION OF FABRIC Door to stair hall: timber casing; two-leaf doorset having flush doors with upper glazed panels.
BUILDING PHASE C20th
CONDITION Poor

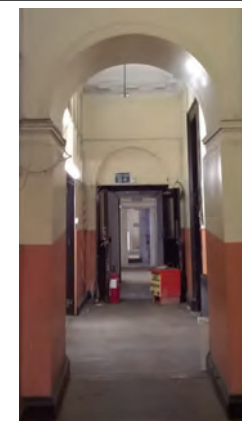
TYPE AND DESCRIPTION OF FABRIC Archway to No.25: simple moulded plasterwork to arch; plasterwork impost mouldings to flanking walls.
BUILDING PHASE C20th
CONDITION Fair

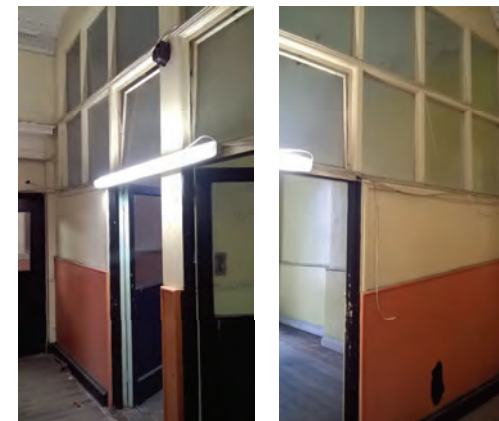
TYPE AND DESCRIPTION OF FABRIC Partitioning: timber-framed; fixed-glazing upper panels; opening, bottom-hung casements above doors; 2-panel timber doors having glazed upper panels; flat dado panelling and timber profile skirting.
BUILDING PHASE C20th
CONDITION Poor—fair

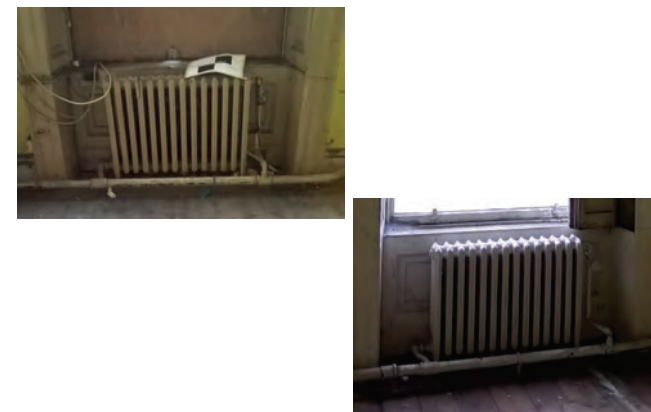
TYPE AND DESCRIPTION OF FABRIC Cast iron radiators: 2no. located below windows.
BUILDING PHASE C20th
CONDITION Poor—fair

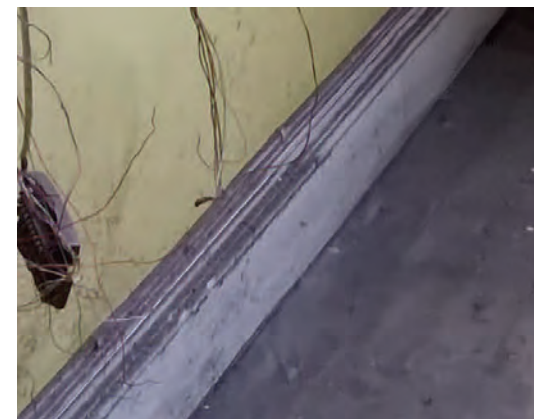
TYPE AND DESCRIPTION OF FABRIC Skirting: timber profile.
BUILDING PHASE C18th
CONDITION Poor—Fair

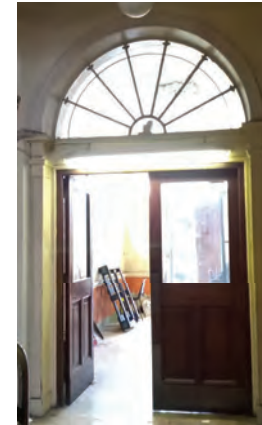
TYPE AND DESCRIPTION OF FABRIC Door to entrance hall: arched opening with moulded impost and flanking pilasters; glazed fanlight having 6no. glazing bars; timber door casing with 2-leaf doors, each having upper glazed panels over 2no. raised panels below.
BUILDING PHASE C18th surround, C20th door leaves
CONDITION Fair

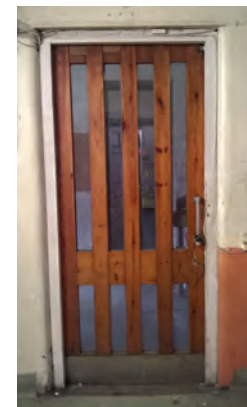
TYPE AND DESCRIPTION OF FABRIC Door to No.27: rounded-edge to reveals; timber casing; timber door leaf with 8no. vertical glazed panels.
BUILDING PHASE C20th
CONDITION Poor—Fair

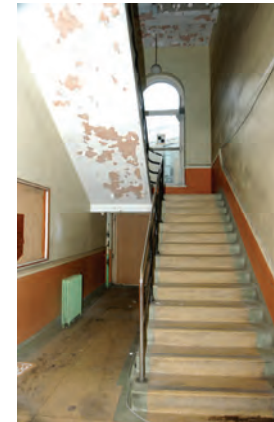
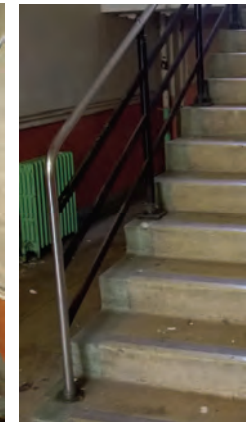
TYPE AND DESCRIPTION OF FABRIC Staircase: concrete stairs with terrazzo finish, having pale gold/yellow colour with green borders; steel handrail with circular section; steel guardrails in flat rectangular bars
BUILDING PHASE C20th
CONDITION Fair

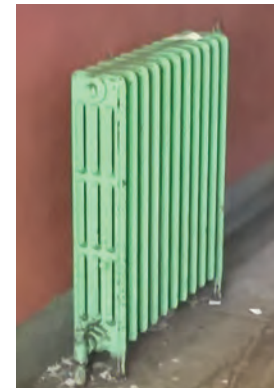
TYPE AND DESCRIPTION OF FABRIC Cast iron radiator: located in passage to rear
BUILDING PHASE C20th
CONDITION Poor—fair

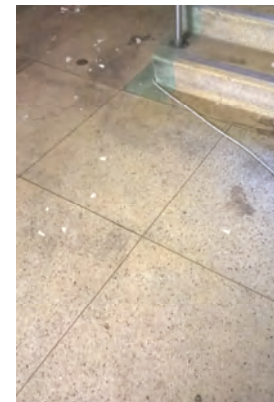
TYPE AND DESCRIPTION OF FABRIC Floor: terrazzo in squared pattern—pale gold/yellow with green borders
BUILDING PHASE C20th
CONDITION Fair

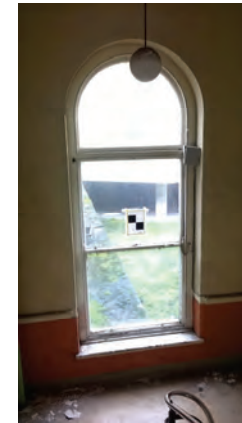
TYPE AND DESCRIPTION OF FABRIC Window to half-landing: arched opening; timber casing; single-pane timber sashes with fixed-pane glazing to archway above.
BUILDING PHASE C20th
CONDITION Fair

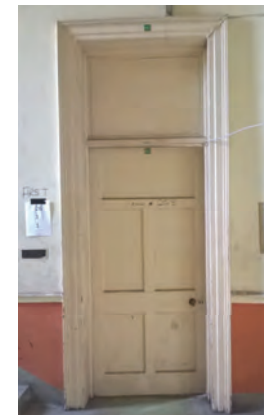
TYPE AND DESCRIPTION OF FABRIC Door to rear room: timber casing; 5-panel timber door with timber panel to overlight; timber architrave.
BUILDING PHASE C18th—C20th
CONDITION Poor

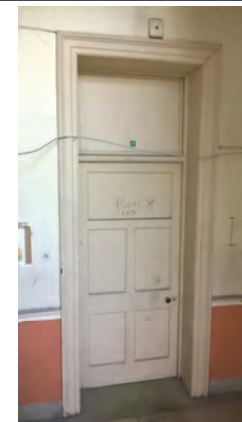
TYPE AND DESCRIPTION OF FABRIC Door to front room: timber casing; 5-panel timber door with timber panel to overlight; timber architrave.
BUILDING PHASE C18th—C20th
CONDITION Poor

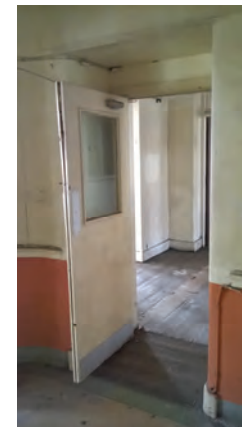
TYPE AND DESCRIPTION OF FABRIC Door to No.27: timber casing; timber fire door with upper glazed panel; rounded edges to reveals; sloped threshold.
BUILDING PHASE C20th
CONDITION Poor—Fair

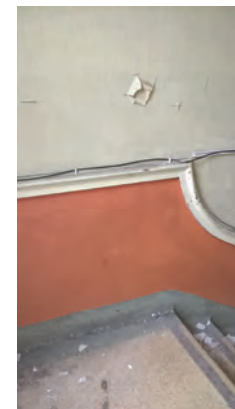
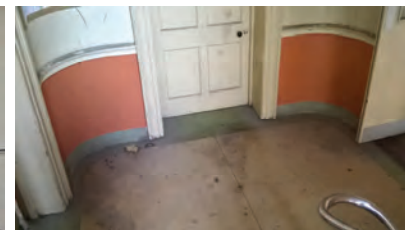
TYPE AND DESCRIPTION OF FABRIC Dado: timber profile.
BUILDING PHASE C18th—C20th
CONDITION Poor—fair

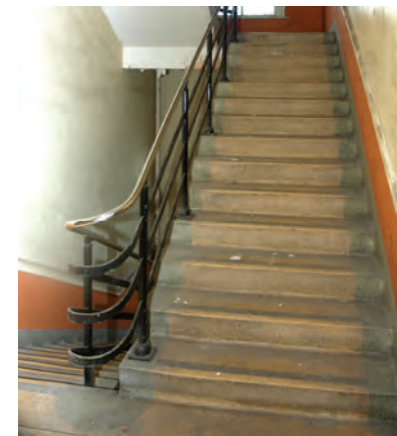
TYPE AND DESCRIPTION OF FABRIC Staircase: concrete stairs with terrazzo finish, having pale gold/yellow colour with green borders; steel handrail with circular section; steel guardrails in flat rectangular bars
BUILDING PHASE C20th
CONDITION Fair

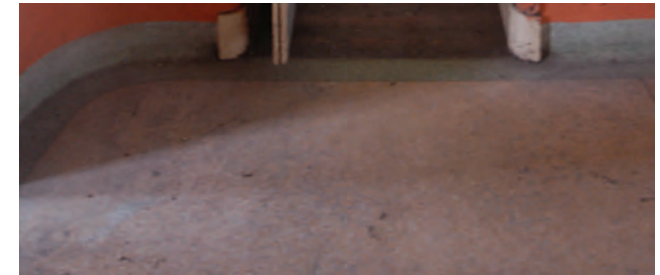
TYPE AND DESCRIPTION OF FABRIC Floor: terrazzo in squared pattern—pale gold/yellow with green borders
BUILDING PHASE C20th
CONDITION Fair

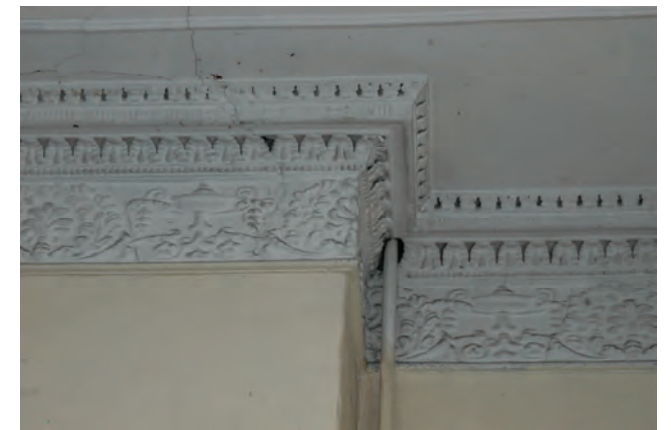
<b>TYPE AND DESCRIPTION OF FABRIC</b> Cornice: in low-medium relief; floriated frieze; heavily overpainted; pipework breaks-through in several locations.
<b>BUILDING PHASE</b> C18th
<b>CONDITION</b> Poor—Fair

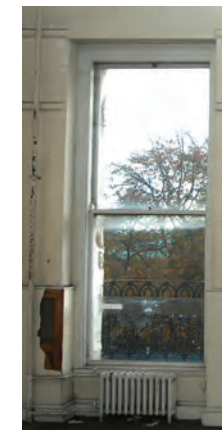
<b>TYPE AND DESCRIPTION OF FABRIC</b> Window, E (LHS internally): timber casing; single-pane timber sashes.
<b>BUILDING PHASE</b> C19th
<b>CONDITION</b> Poor—fair

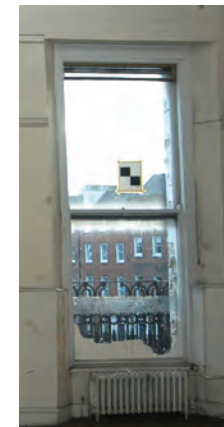
TYPE AND DESCRIPTION OF FABRIC Window, W (RHS internally): timber casing; single-pane timber sashes.
BUILDING PHASE C19th
CONDITION Poor—Fair

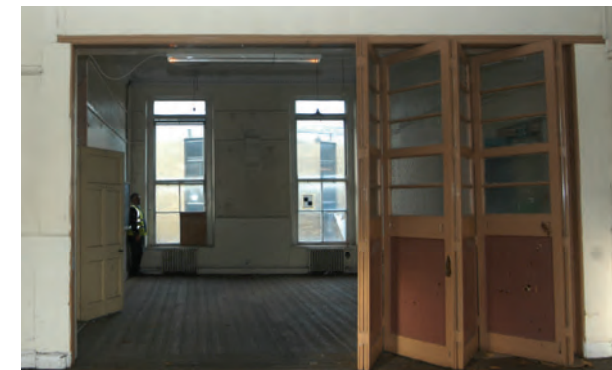
TYPE AND DESCRIPTION OF FABRIC Door between front and rear rooms: timber folding/sliding door; 5no. leaves, each having 5no. horizontal glazed panels over timber panel
BUILDING PHASE C20th
CONDITION Fair

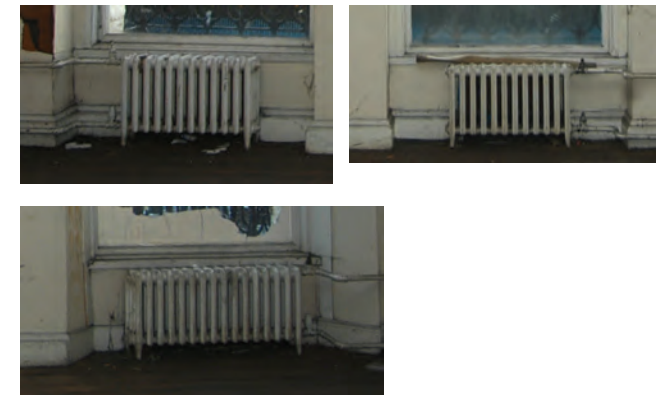
TYPE AND DESCRIPTION OF FABRIC Cast iron radiators: 3no., located below windows.
BUILDING PHASE C20th
CONDITION Poor

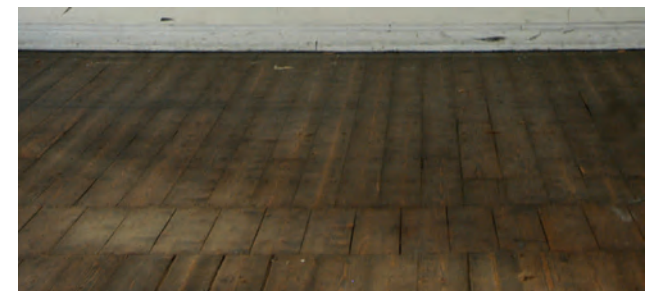
TYPE AND DESCRIPTION OF FABRIC Floor: timber boards
BUILDING PHASE C18th—C20th
CONDITION Poor

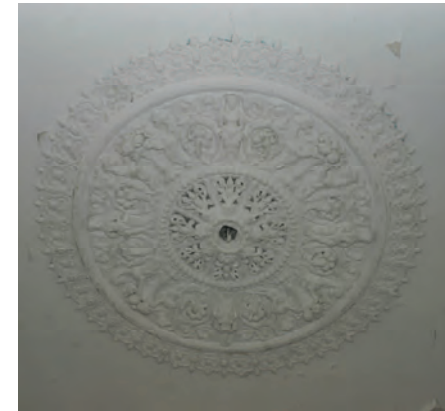
TYPE AND DESCRIPTION OF FABRIC Ceiling rose: low relief; floriated pattern.
BUILDING PHASE C19th
CONDITION Fair

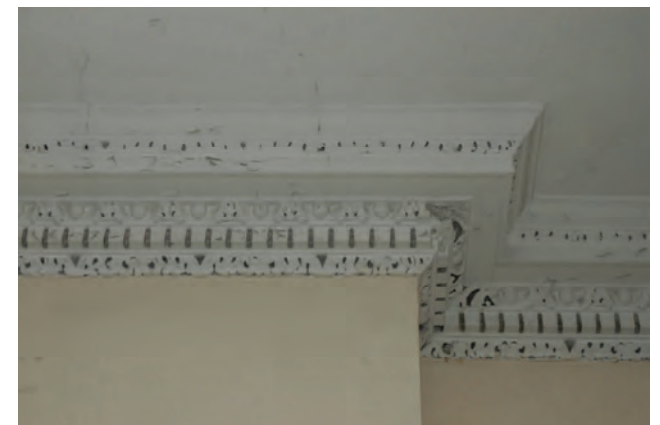
TYPE AND DESCRIPTION OF FABRIC Cornice: In low-medium relief; dentil and egg-and-dart motifs; heavily over-painted.
BUILDING PHASE C18th
CONDITION Poor—Fair

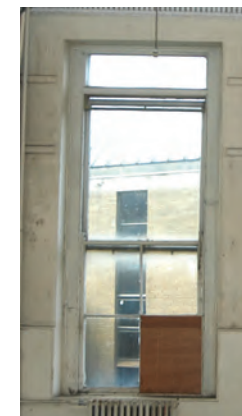
TYPE AND DESCRIPTION OF FABRIC Window, W (LHS internally): timber casing; single-pane timber sashes with fixed-glass overlight;
BUILDING PHASE C20th
CONDITION Poor

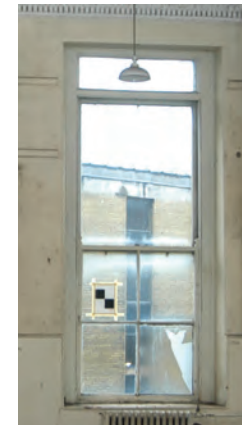
TYPE AND DESCRIPTION OF FABRIC Window, E (RHS internally): timber casing; single-pane timber sash over 4-pane sash with fixed-glass overlight.
BUILDING PHASE C20th
CONDITION Poor

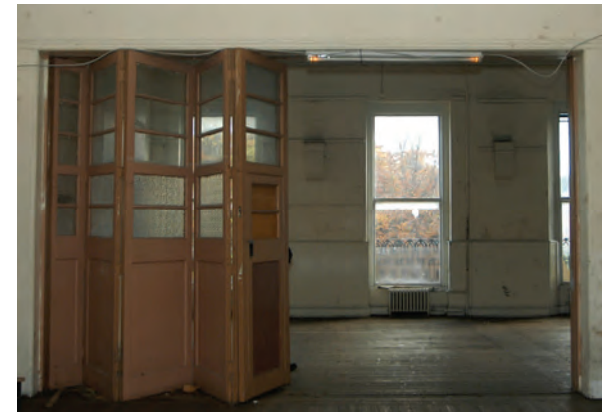
TYPE AND DESCRIPTION OF FABRIC Door between front and rear rooms: timber folding/sliding door; 5no. leaves, each having 5no. horizontal glazed panels over timber panel
BUILDING PHASE C20th
CONDITION Fair

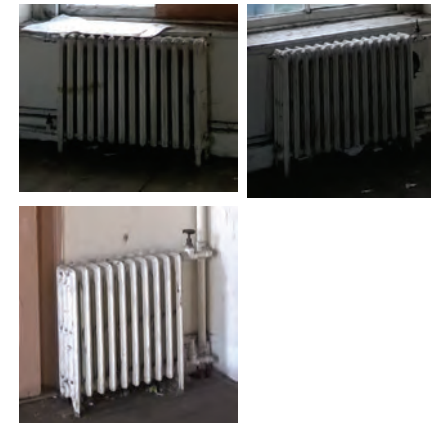
TYPE AND DESCRIPTION OF FABRIC Cast iron radiators: 3no., located below windows and adjacent to door to No.25.
BUILDING PHASE C20th
CONDITION Poor—Fair

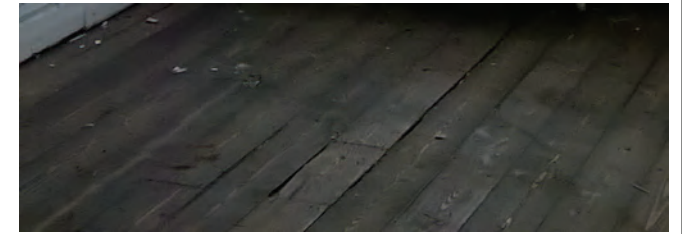
TYPE AND DESCRIPTION OF FABRIC Floor: timber boards
BUILDING PHASE C18th—C20th
CONDITION Poor—fair

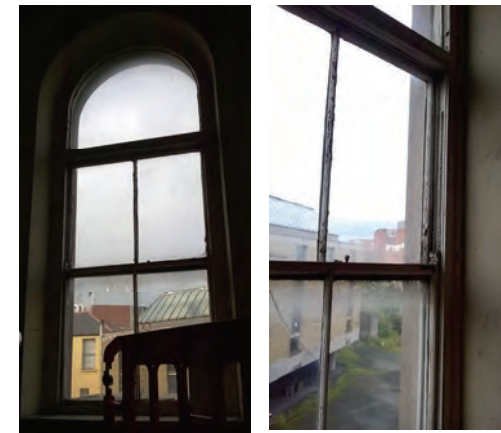
TYPE AND DESCRIPTION OF FABRIC Window to half-landing: timber casing; split-pane timber sashes with fixed-glass overlight to arch.
BUILDING PHASE C19th—C20th
CONDITION Poor—Fair

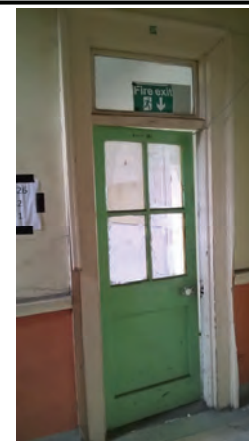
TYPE AND DESCRIPTION OF FABRIC Door to rear room: timber casing; 4-pane glazed panel over flat, solid timber panel; bottom-hung opening casement above.
BUILDING PHASE C18th—C20th
CONDITION Poor

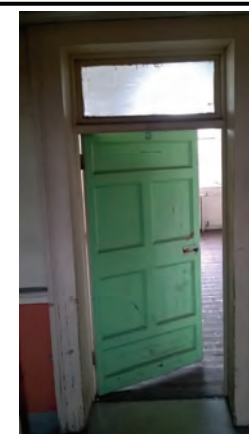
TYPE AND DESCRIPTION OF FABRIC Door to front room: timber casing; 6-panel timber door with bottom-hung overlight.
BUILDING PHASE C18th—C20th
CONDITION Poor

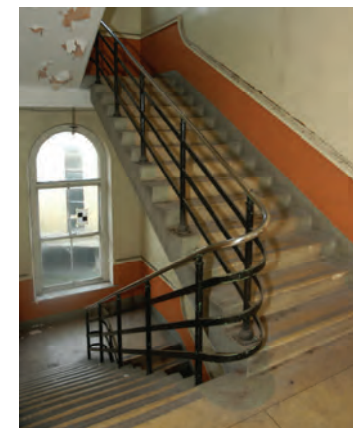
<b>TYPE AND DESCRIPTION OF FABRIC</b>
Staircase: concrete stairs with terrazzo finish, having pale gold/yellow colour with green borders; steel handrail with circular section; steel guardrails in flat rectangular bars
<b>BUILDING PHASE</b>
C20th
<b>CONDITION</b>
Fair

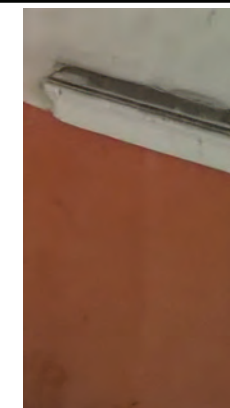
<b>TYPE AND DESCRIPTION OF FABRIC</b>
Dado: timber profile.
<b>BUILDING PHASE</b>
C18th
<b>CONDITION</b>
Poor—Fair

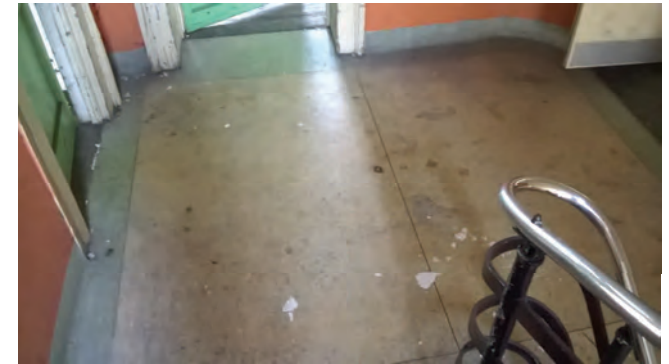
TYPE AND DESCRIPTION OF FABRIC Floor: terrazzo finish, having pale gold/yellow colour with green borders; brought up walls to form skirtings.
BUILDING PHASE C20th
CONDITION Fair

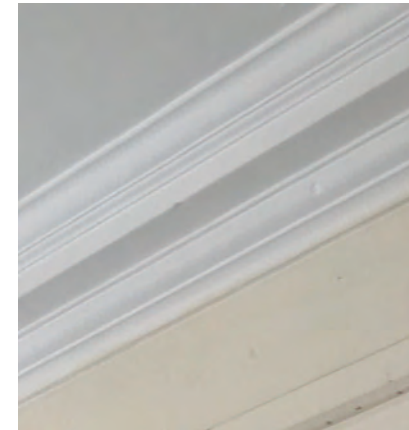
TYPE AND DESCRIPTION OF FABRIC Cornice: running mould type
BUILDING PHASE C18th
CONDITION Fair

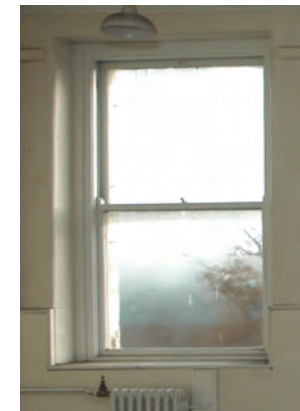
TYPE AND DESCRIPTION OF FABRIC Window, E (LHS internally): timber casing; single-pane timber sashes.
BUILDING PHASE C19th
CONDITION Poor—Fair

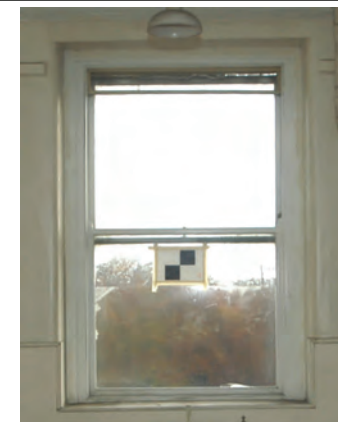
TYPE AND DESCRIPTION OF FABRIC Window, centre: timber casing; single-pane timber sashes.
BUILDING PHASE C19th
CONDITION Poor—Fair

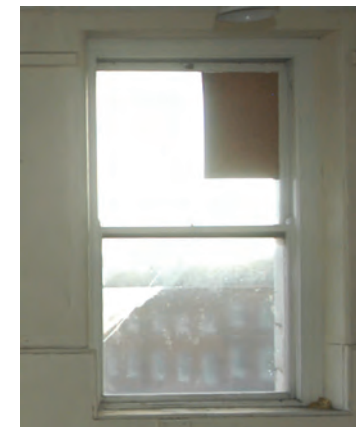
TYPE AND DESCRIPTION OF FABRIC Window, W (RHS internally): timber casing; single-pane timber sashes.
BUILDING PHASE C19th
CONDITION Poor—Fair

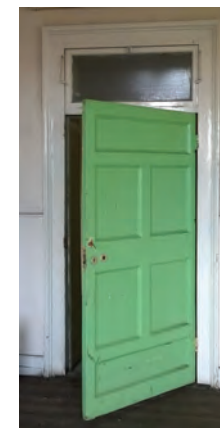
TYPE AND DESCRIPTION OF FABRIC Door to stair hall: timber casing; 6-panel timber door with bottom-hung overhead.
BUILDING PHASE C18th—C20th
CONDITION Poor

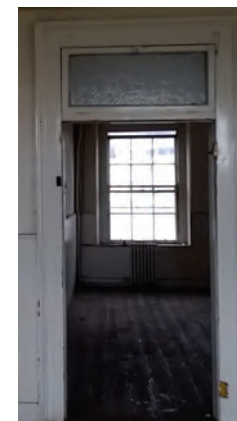
TYPE AND DESCRIPTION OF FABRIC Door to rear room: timber casing; door leaf missing; bottom-hung overhead.
BUILDING PHASE C18th—C20th
CONDITION Poor

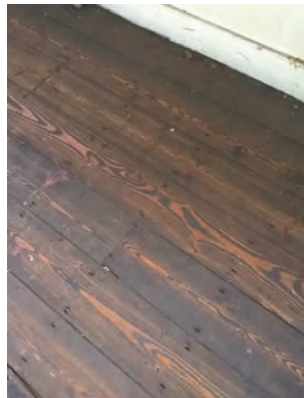
TYPE AND DESCRIPTION OF FABRIC Floor: timber boards

BUILDING PHASE C18th—C20th	
CONDITION Fair

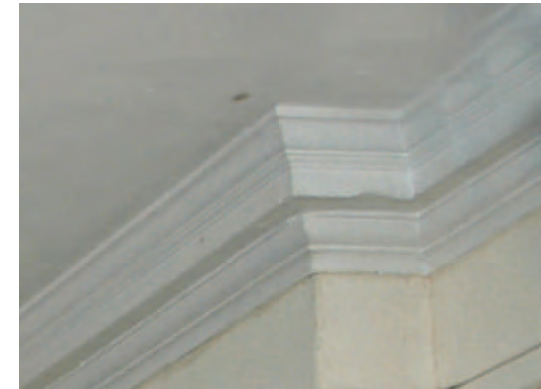
TYPE AND DESCRIPTION OF FABRIC Cornice: running-mould type
BUILDING PHASE C18th
CONDITION Poor—Fair

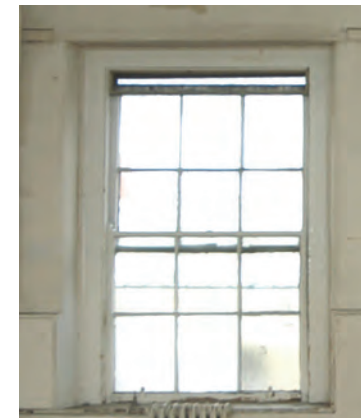
TYPE AND DESCRIPTION OF FABRIC Window, W (LHS internally): timber casing; 6-over-6 timber sashes; filleted edge to reveals
BUILDING PHASE C19th
CONDITION Poor—Fair

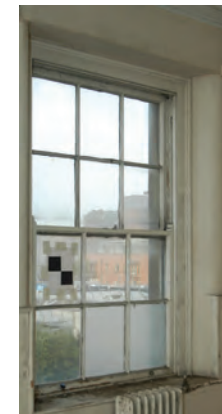
TYPE AND DESCRIPTION OF FABRIC Window, E (RHS internally): timber casing; 6-over-6 timber sashes; filleted edge to reveals
BUILDING PHASE C19th
CONDITION Poor—Fair

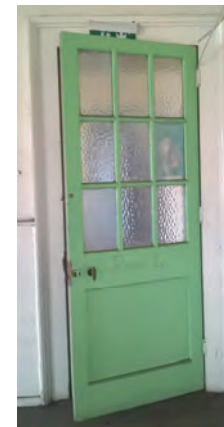
TYPE AND DESCRIPTION OF FABRIC Door to No.25: timber casing; timber door having 9-pane upper panel over flat lower panel.
BUILDING PHASE C20th
CONDITION Poor

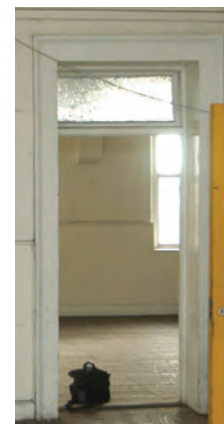
TYPE AND DESCRIPTION OF FABRIC Door to front room: timber casing; door leaf missing; bottom-hung oversight.
BUILDING PHASE C18th-C20th
CONDITION Poor

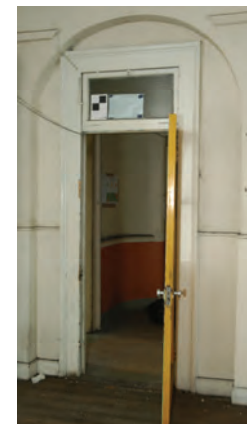
TYPE AND DESCRIPTION OF FABRIC Door to stair hall: timber casing; 4-pane glazed panel over flat, solid timber panel; bottom-hung opening casement above.
BUILDING PHASE C18th-C20th
CONDITION Poor

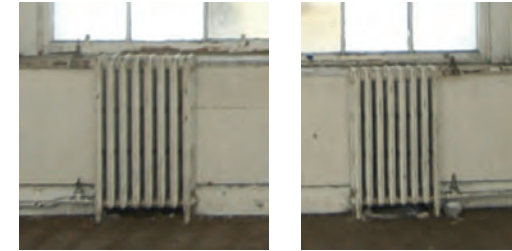
TYPE AND DESCRIPTION OF FABRIC Cast iron radiators: 2no., below windows
BUILDING PHASE C20th
CONDITION Poor

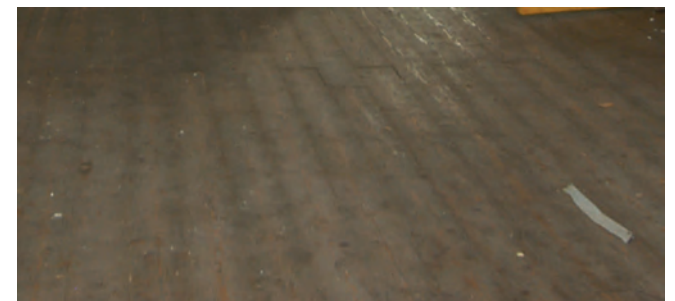
TYPE AND DESCRIPTION OF FABRIC Floor: timber boards
BUILDING PHASE C18th-C20th
CONDITION Poor—fair

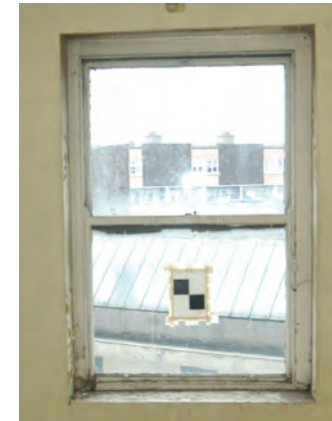
TYPE AND DESCRIPTION OF FABRIC Window to half-landing: timber casing; single-pane timber sashes.
BUILDING PHASE C19th
CONDITION Poor

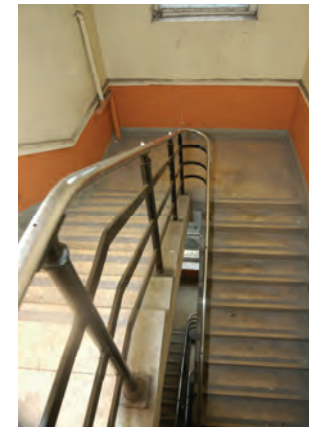
TYPE AND DESCRIPTION OF FABRIC Staircase: concrete stairs with terrazzo finish, having pale gold/yellow colour with green borders; steel handrail with circular section; steel guardrails in flat rectangular bars
BUILDING PHASE C20th
CONDITION Fair

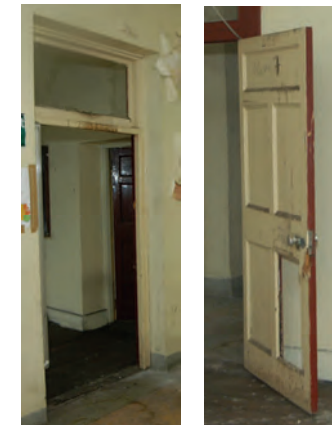
TYPE AND DESCRIPTION OF FABRIC Door to rear room: timber casing; timber 5-panel door; bottom-hung casement to overlight.
BUILDING PHASE C18th—C20th
CONDITION Poor

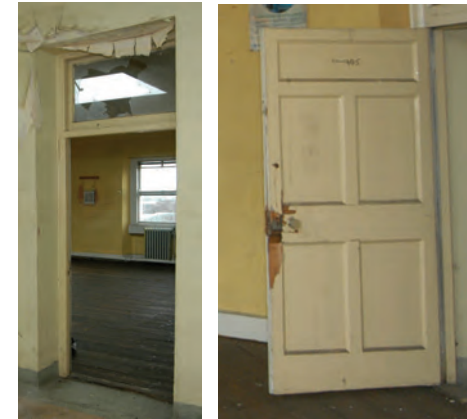
TYPE AND DESCRIPTION OF FABRIC Door to front room: timber casing; timber 5-panel timber door; bottom-hung casement to overlight
BUILDING PHASE C18th—C20th
CONDITION Poor

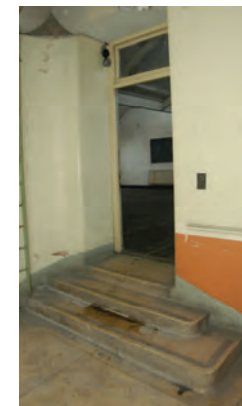
TYPE AND DESCRIPTION OF FABRIC Door to No.27: timber casing; door leaf missing; bottom-hung casement to overlight; terrazzo steps to threshold.
BUILDING PHASE C20th
CONDITION Poor—Fair

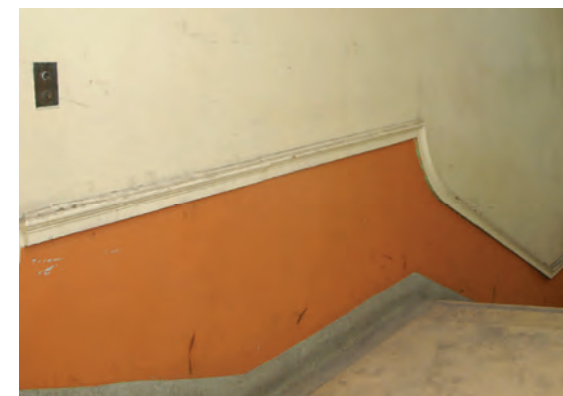
TYPE AND DESCRIPTION OF FABRIC Dado: timber profile
BUILDING PHASE C18th
CONDITION Poor—fair

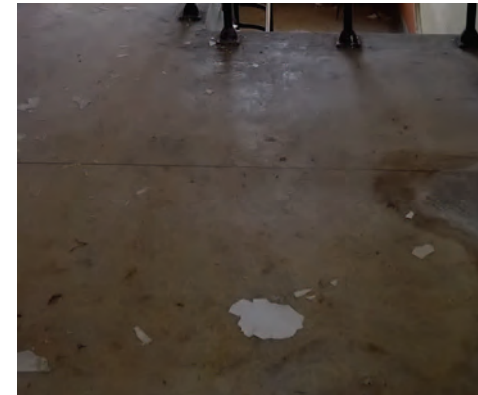
TYPE AND DESCRIPTION OF FABRIC Floor: terrazzo finish, having pale gold/yellow colour with green borders; brought up walls to form skirtings.
BUILDING PHASE C20th
CONDITION Poor—fair

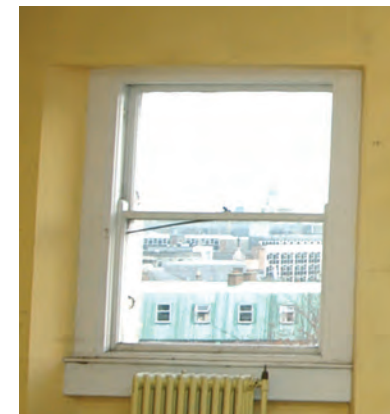
TYPE AND DESCRIPTION OF FABRIC Window, E (LHS internally): timber casing; single-pane timber sashes.
BUILDING PHASE C19th
CONDITION Poor—Fair

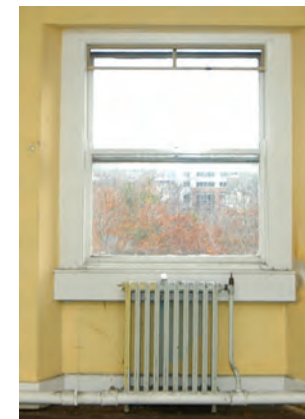
TYPE AND DESCRIPTION OF FABRIC Window, centre: timber casing; single-pane timber sashes.
BUILDING PHASE C19th
CONDITION Poor—fair

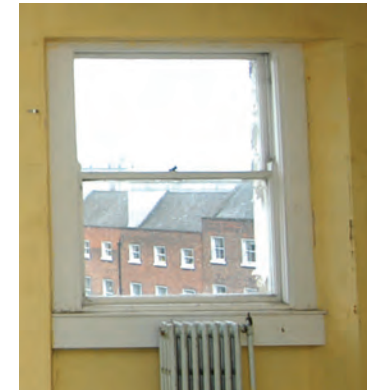
TYPE AND DESCRIPTION OF FABRIC Window, W (RHS internally): timber casing; single-pane timber sashes.
BUILDING PHASE C19th
CONDITION Poor—fair

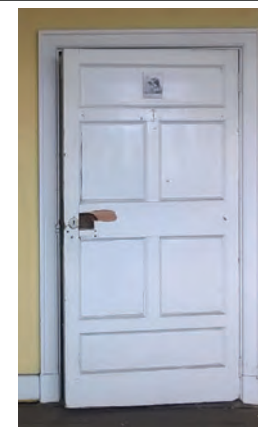
TYPE AND DESCRIPTION OF FABRIC Door to rear room: timber casing; 6-panel timber door.
BUILDING PHASE C18th
CONDITION Poor

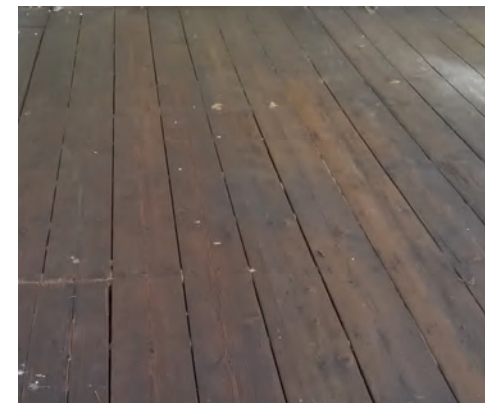
TYPE AND DESCRIPTION OF FABRIC Floor: timber boards
BUILDING PHASE C18th—C20th
CONDITION fair

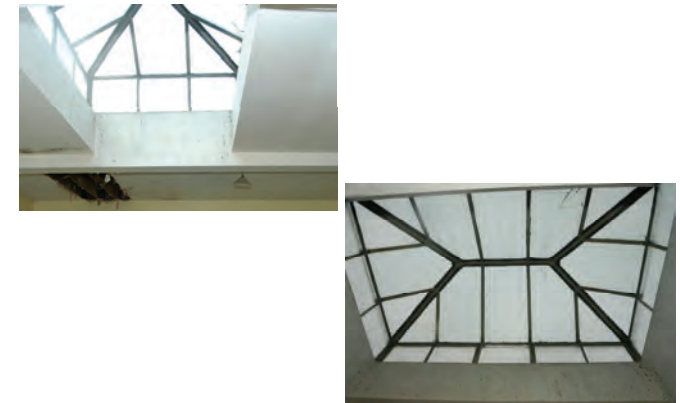
TYPE AND DESCRIPTION OF FABRIC Ceiling/rooflight: flat plaster ceiling with rectangular opening for hipped-profile, steel-framed rooflight.
BUILDING PHASE C20th
CONDITION Poor—fair

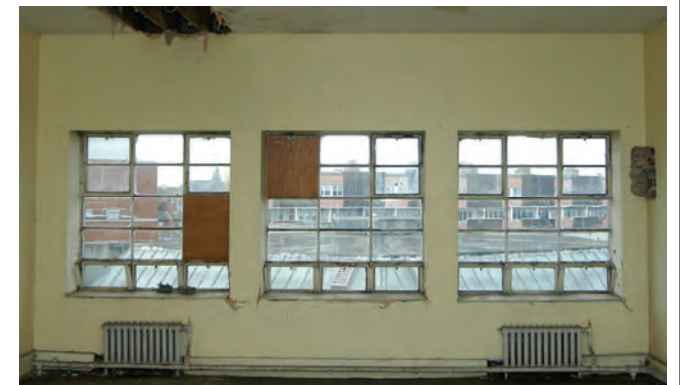
TYPE AND DESCRIPTION OF FABRIC Windows: 3no. square-ope, steel-frame windows in place of original 2-window arrangement; each having 15-pane frame with 5no. bottom-hung opening casements.
BUILDING PHASE C20th
CONDITION Poor—fair

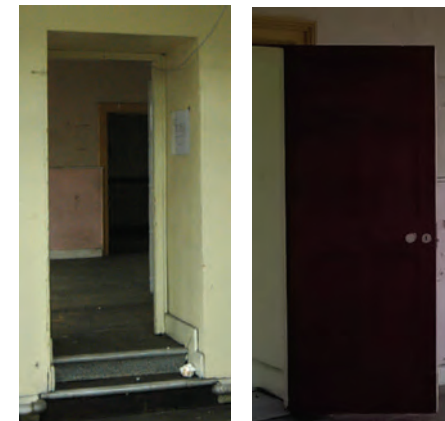
TYPE AND DESCRIPTION OF FABRIC Door to No.25: timber casing; timber door leaf; stepped threshold
BUILDING PHASE C20th
CONDITION Poor

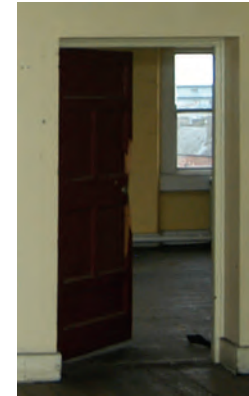
TYPE AND DESCRIPTION OF FABRIC Door to front room: timber casing; 6-panel timber door.
BUILDING PHASE C18th
CONDITION Poor

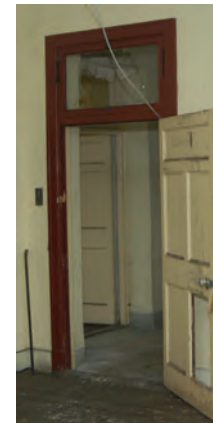
TYPE AND DESCRIPTION OF FABRIC Door to stair hall: timber casing; timber 5-panel door; bottom-hung casement to overlight.
BUILDING PHASE C18th—C20th
CONDITION Poor

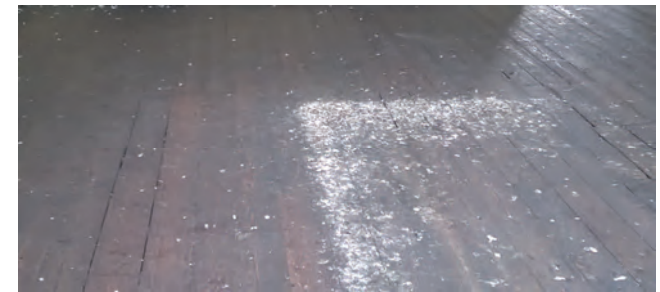
TYPE AND DESCRIPTION OF FABRIC Floor: timber boards
BUILDING PHASE C18th—C20th
CONDITION Poor—fair

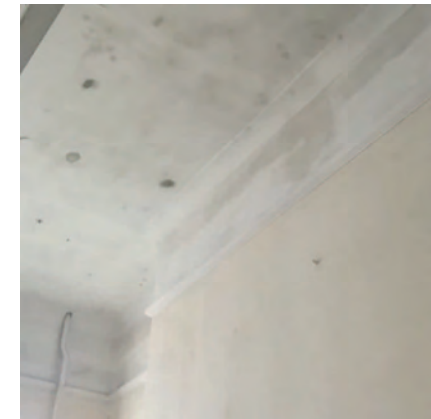
TYPE AND DESCRIPTION OF FABRIC Cornice: plain coving
BUILDING PHASE C20th
CONDITION Poor

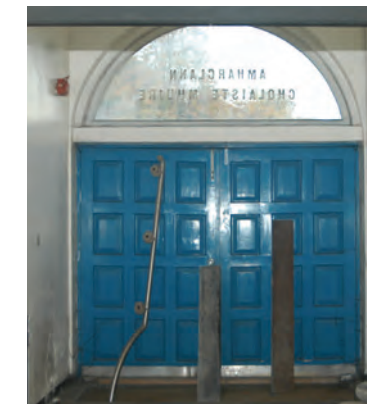
TYPE AND DESCRIPTION OF FABRIC Entrance door: timber casing in arched opening, enlarged to extend full-width of hallway; 2-leaf doorset, each having 12no. raised panels; clear glass fanlight to arch.
BUILDING PHASE C20th
CONDITION Poor—Fair

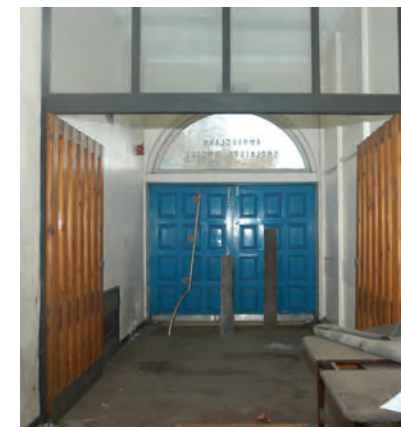
TYPE AND DESCRIPTION OF FABRIC Doors to inner hall: timber casing; 4-pane overhead; 2-leaf doorset, each having narrow vertical glass panels.
BUILDING PHASE C20th
CONDITION Fair

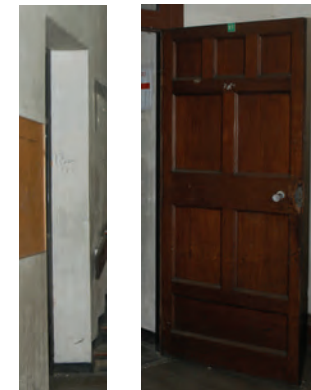
TYPE AND DESCRIPTION OF FABRIC Door to rear entrance room:
BUILDING PHASE C20th
CONDITION Poor

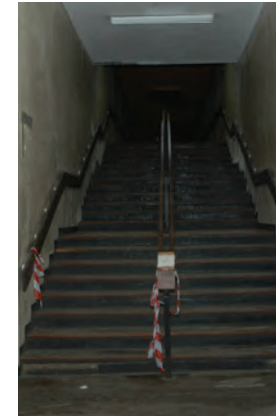
TYPE AND DESCRIPTION OF FABRIC Stairs to theatre entrance: straight flight with landing mid-way; concrete stair with timber treads; central timber handrail; 2no. wall-mounted timber handrails.
BUILDING PHASE C20th
CONDITION Poor—fair

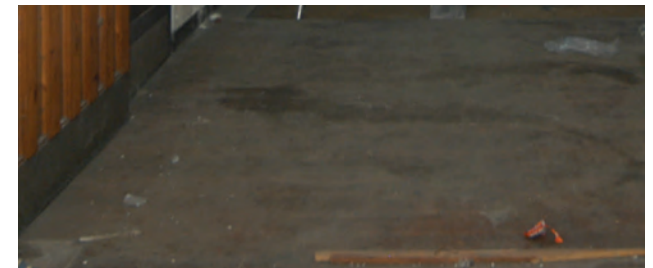
TYPE AND DESCRIPTION OF FABRIC Floor:
BUILDING PHASE C20th
CONDITION Poor

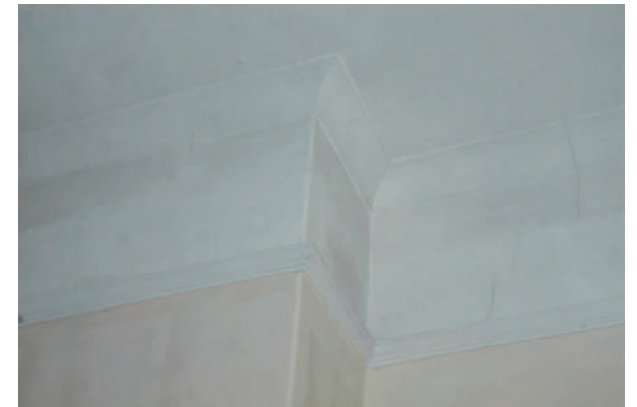
TYPE AND DESCRIPTION OF FABRIC Cornice: plain coving
BUILDING PHASE C20th
CONDITION Poor—fair

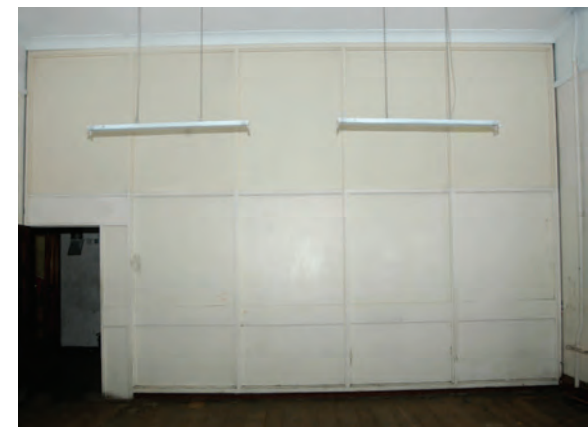
TYPE AND DESCRIPTION OF FABRIC Partition: timber framed with flat timber panelling
BUILDING PHASE C20th
CONDITION Poor—fair

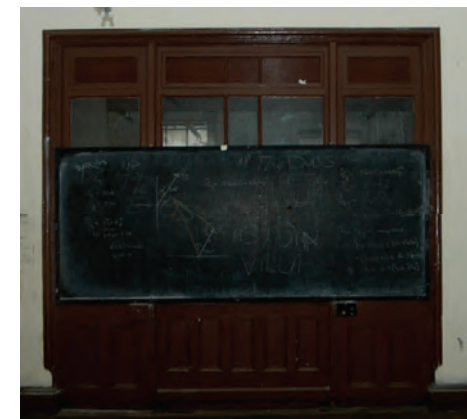
TYPE AND DESCRIPTION OF FABRIC Door to rear room: timber casing; timber framed partition/doors with glazed panels above timber panels; timber doors to RHS and LHS
BUILDING PHASE C20th
CONDITION Poor— fair

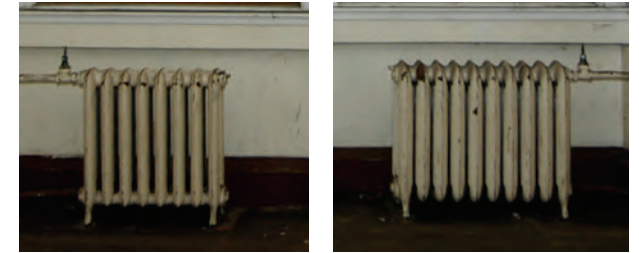
TYPE AND DESCRIPTION OF FABRIC Cast iron radiators: 2no., located below windows
BUILDING PHASE C20th
CONDITION Poor

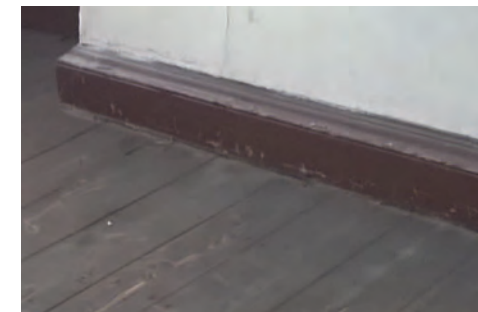
TYPE AND DESCRIPTION OF FABRIC Skirting: timber profile
BUILDING PHASE C20th
CONDITION Poor

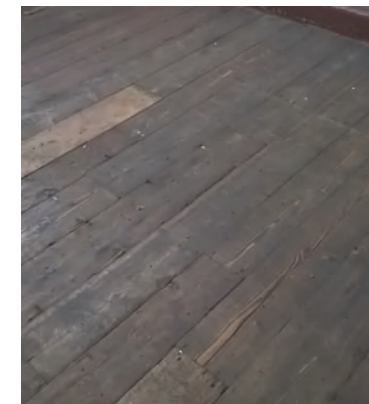
TYPE AND DESCRIPTION OF FABRIC Floor: timber boards
BUILDING PHASE C18th—C20th
CONDITION Poor—Fair

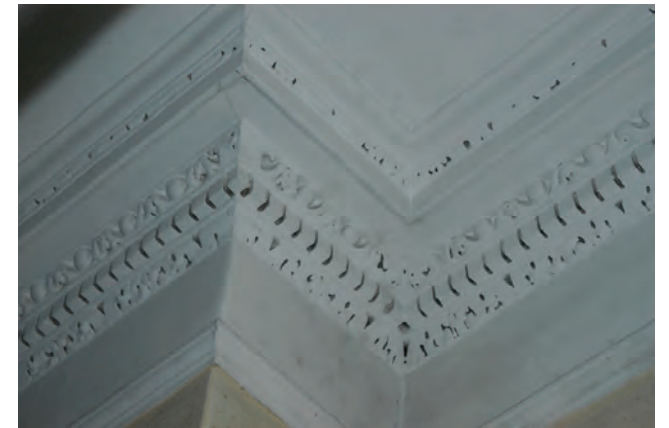
TYPE AND DESCRIPTION OF FABRIC Cornice: dentil and egg-and-dart mouldings; heavily overpainted.
BUILDING PHASE C18th
CONDITION Poor—fair

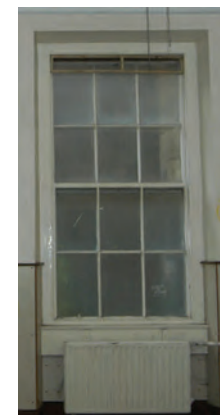
TYPE AND DESCRIPTION OF FABRIC Window, E (RHS internally): timber casing; 6-over-6 timber sashes.
BUILDING PHASE C19th
CONDITION Poor

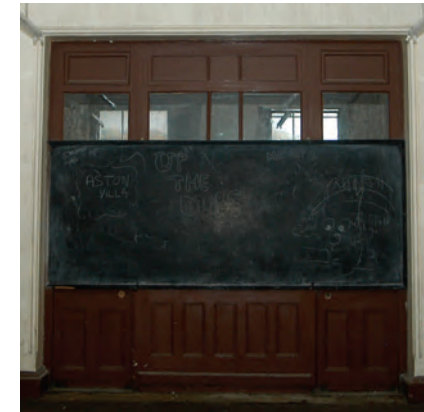
TYPE AND DESCRIPTION OF FABRIC Door to front room: timber casing; timber framed partition/doors with glazed panels above timber panels; timber doors to RHS and LHS
BUILDING PHASE C20th
CONDITION Fair

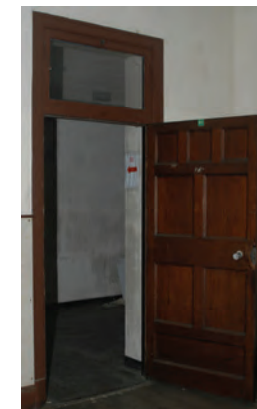
TYPE AND DESCRIPTION OF FABRIC Door to hallway: timber casing; 8-panel timber door leaf; overlight with bottom-hung casement
BUILDING PHASE C18th—C20th
CONDITION Poor—fair

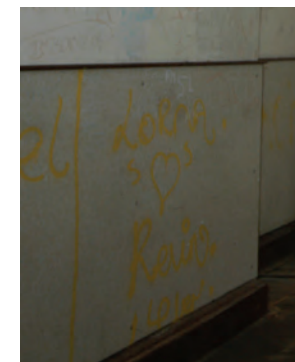
TYPE AND DESCRIPTION OF FABRIC Dado and skirting: flat timber panelling with narrow timber profile dado rail; timber profile skirting
BUILDING PHASE C20th
CONDITION Poor—Fair

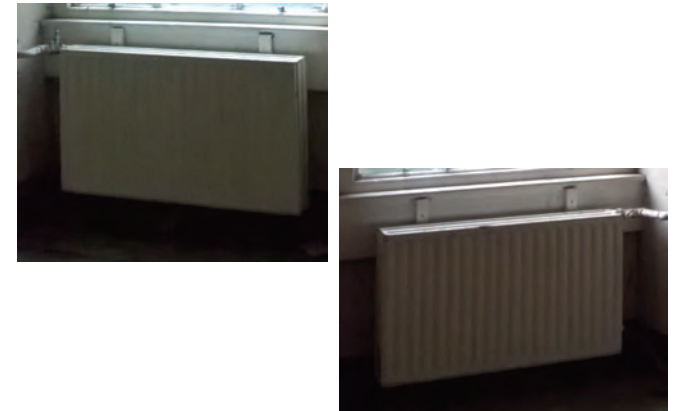
TYPE AND DESCRIPTION OF FABRIC Mild steel radiators: 2no., located below windows
BUILDING PHASE C20th
CONDITION Poor

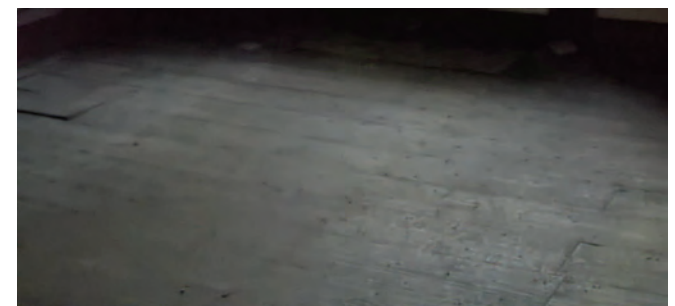
TYPE AND DESCRIPTION OF FABRIC Floor: timber boards
BUILDING PHASE C18th—C20th
CONDITION Poor

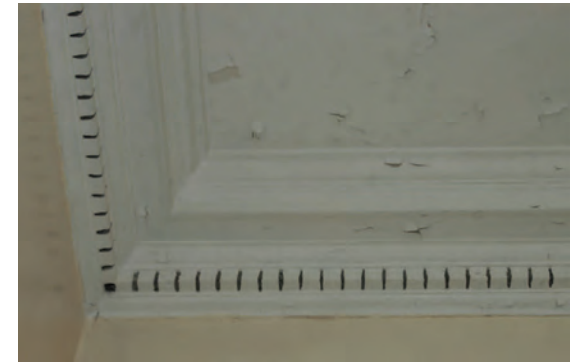
TYPE AND DESCRIPTION OF FABRIC Cornice: simple moulding with dentil motif; survives only in sections.
BUILDING PHASE C18th
CONDITION Poor

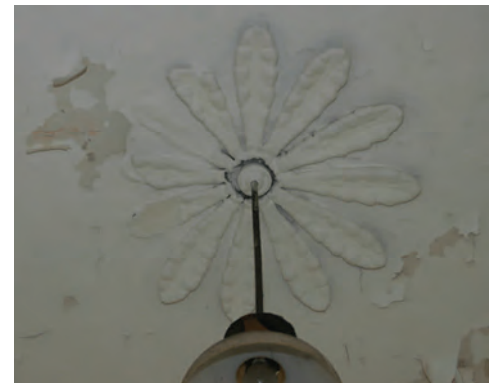
TYPE AND DESCRIPTION OF FABRIC Ceiling rose: Palm leaves forming circular pattern; sections missing
BUILDING PHASE C18th
CONDITION Poor

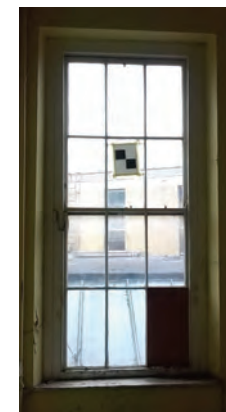
TYPE AND DESCRIPTION OF FABRIC Window: timber casing; 6-over-6 timber sashes.
BUILDING PHASE C20th
CONDITION Poor

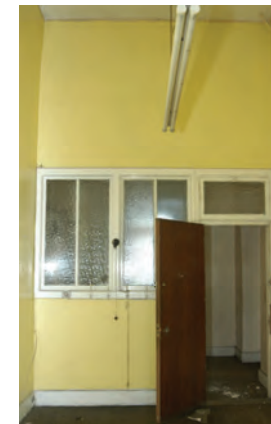
TYPE AND DESCRIPTION OF FABRIC Partition: timber framed with plasterboard finish; 2no. fixed-glass panels, each divided vertically into 2no. panes; flush timber door with overlight.
BUILDING PHASE C20th
CONDITION Poor

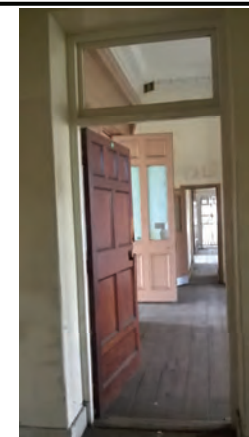
TYPE AND DESCRIPTION OF FABRIC Door to rear reception room: timber casing; 8-panel timber door with overlight.
BUILDING PHASE C18th—C20th
CONDITION Fair

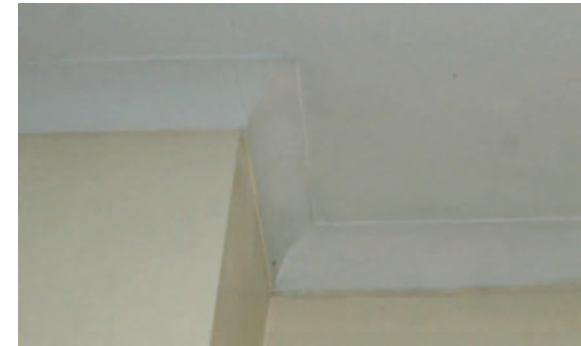
TYPE AND DESCRIPTION OF FABRIC Cornice: coved ceiling
BUILDING PHASE C20th
CONDITION Fair

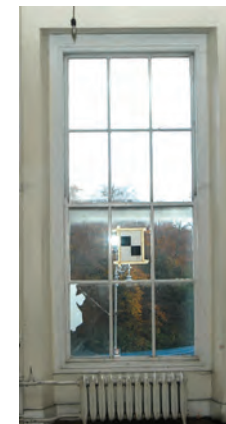
TYPE AND DESCRIPTION OF FABRIC Window, centre: timber casing; 6-over-6 timber sashes.
BUILDING PHASE C19th
CONDITION Poor

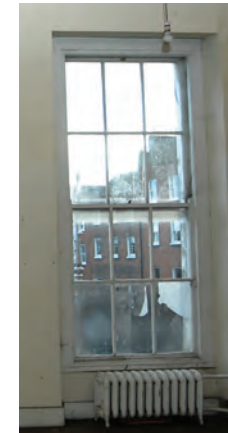
TYPE AND DESCRIPTION OF FABRIC Window, W (RHS internally): timber casing; 6-over-6 timber sashes.
BUILDING PHASE C19th
CONDITION Poor

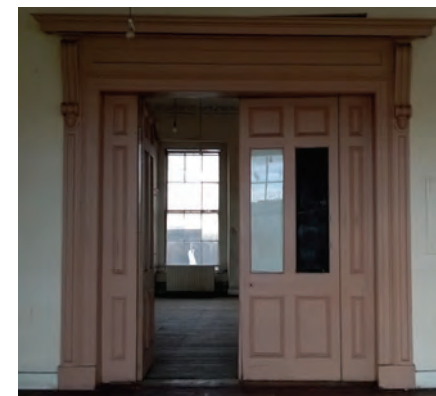
TYPE AND DESCRIPTION OF FABRIC Doors to rear room: timber casing with carved cornice and modillion brackets; 2no., 6-panel timber doors with fixed side panels.
BUILDING PHASE C18th
CONDITION Poor—fair

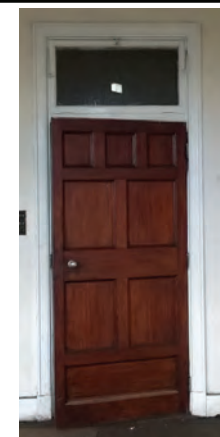
TYPE AND DESCRIPTION OF FABRIC Door to former stair hall/lobby: timber casing; 8-panel timber door with overlight.
BUILDING PHASE C18th—C20th
CONDITION Poor—fair

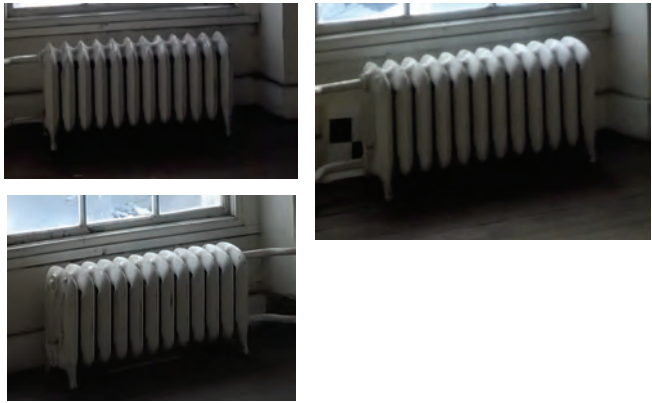
TYPE AND DESCRIPTION OF FABRIC Cast iron radiators: 3no., located below windows.

BUILDING PHASE C20th	
CONDITION Poor

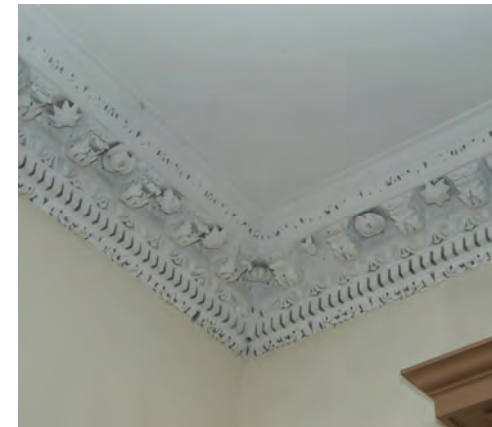
TYPE AND DESCRIPTION OF FABRIC Cornice: in medium-high relief; modillion and rosette mouldings; heavily overpainted.
BUILDING PHASE C18th
CONDITION Poor—fair

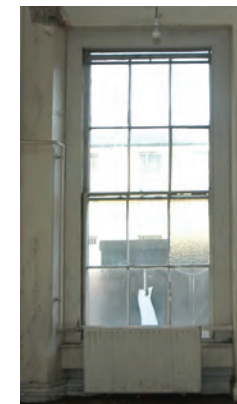
TYPE AND DESCRIPTION OF FABRIC Window, W (LHS internally): timber casing; 6-over-6 timber sashes.
BUILDING PHASE C18th sashes, C20th casing
CONDITION Poor
