# APPENDIX A

# Building Inventories

Protected Structures Impact Statement

PARNELL SQUARE CULTURAL QUARTER  
 Architectural Heritage—Decorative Fabric Inventory  
 Nos. 20, 21, 23-28 Parnell Square, Dublin 1  
 November 2015—Shaffrey Associates Architects

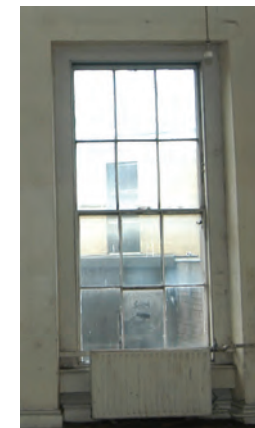
TYPE AND DESCRIPTION OF FABRIC Window, E (RHS internally): timber casing; 6-over-6 timber sashes.
BUILDING PHASE C18th sashes, C20th casing
CONDITION Poor

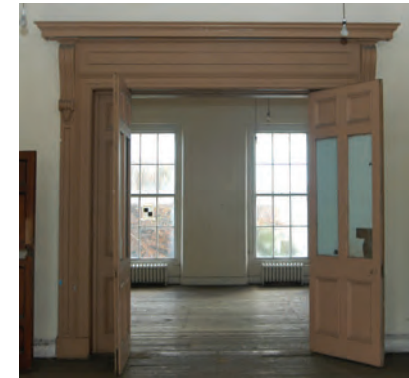
TYPE AND DESCRIPTION OF FABRIC Doors to front room: timber casing with carved cornice and modillion brackets; 2no., 6-panel timber doors with fixed side panels.
BUILDING PHASE C18th
CONDITION Poor—fair

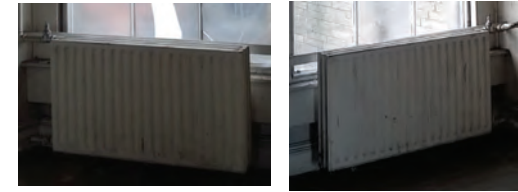
TYPE AND DESCRIPTION OF FABRIC Mild steel radiators: 2no., located below windows.
BUILDING PHASE C20th
CONDITION Poor

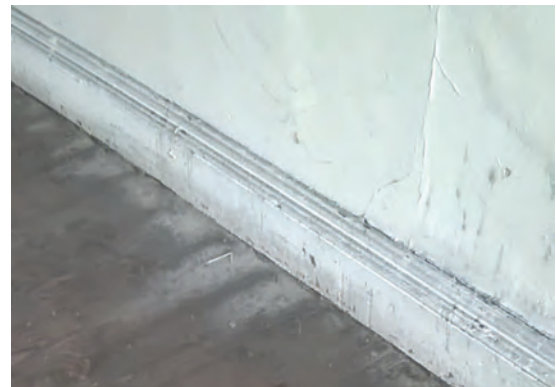
TYPE AND DESCRIPTION OF FABRIC Skirting: timber profile.
BUILDING PHASE C18th
CONDITION Poor

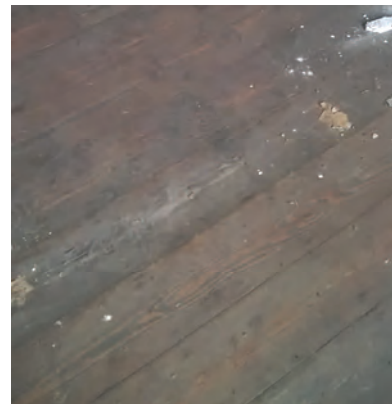
TYPE AND DESCRIPTION OF FABRIC Floor: timber boards
BUILDING PHASE C18th—C20th
CONDITION Poor—fair

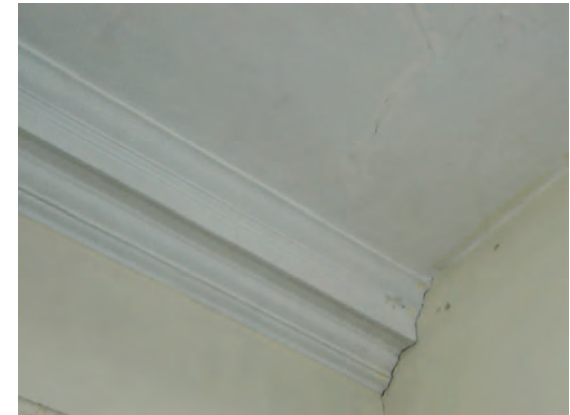
TYPE AND DESCRIPTION OF FABRIC Cornice: running-mould type
BUILDING PHASE C18th
CONDITION Poor

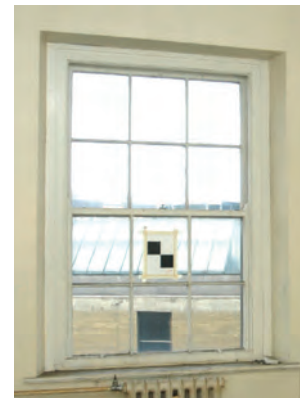
TYPE AND DESCRIPTION OF FABRIC Window: timber casing; 6-over-6 timber sashes
BUILDING PHASE C20th
CONDITION Poor

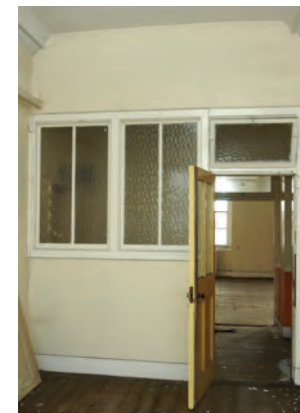
TYPE AND DESCRIPTION OF FABRIC Partition: timber framed with plasterboard finish; 2no. fixed-glass panels, each divided vertically into 2no. panes; 4-panel timber door with overlight.
BUILDING PHASE C20th
CONDITION Poor—fair

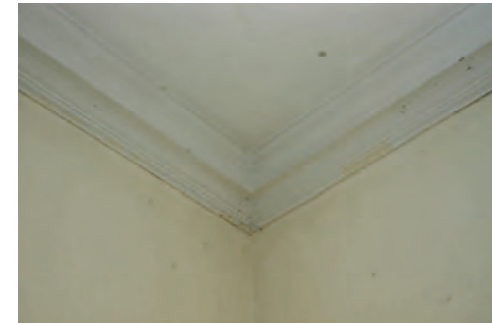
TYPE AND DESCRIPTION OF FABRIC Cornice: running-mould type
BUILDING PHASE C18th
CONDITION Poor—fair

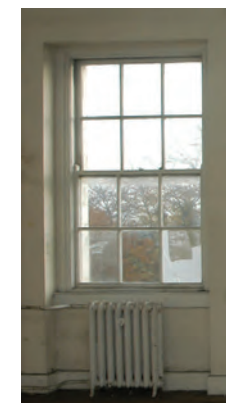
TYPE AND DESCRIPTION OF FABRIC Window, E (LHS internally): timber casing; 6-over-6 timber sashes.
BUILDING PHASE C19th
CONDITION Poor—fair

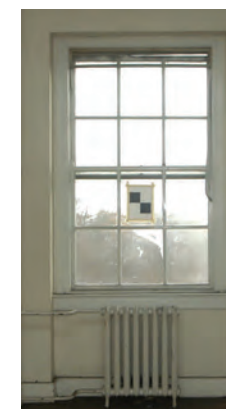
TYPE AND DESCRIPTION OF FABRIC Window, centre: timber casing; 6-over-6 timber sashes.
BUILDING PHASE C19th
CONDITION Poor—fair

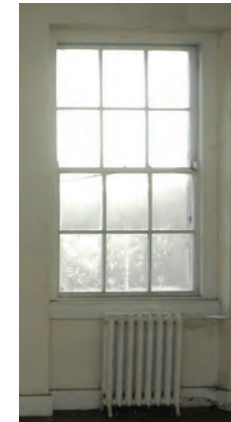
TYPE AND DESCRIPTION OF FABRIC Window, W (RHS internally): timber casing; 6-over-6 timber sashes.
BUILDING PHASE C19th
CONDITION Poor—fair

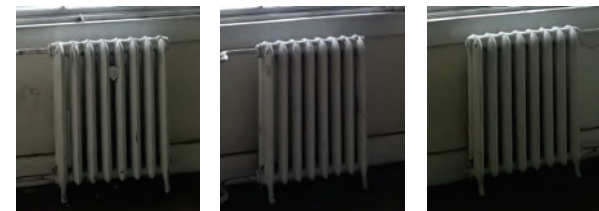
TYPE AND DESCRIPTION OF FABRIC Cast iron radiators: 3no., located below windows
BUILDING PHASE C20th
CONDITION Poor—fair

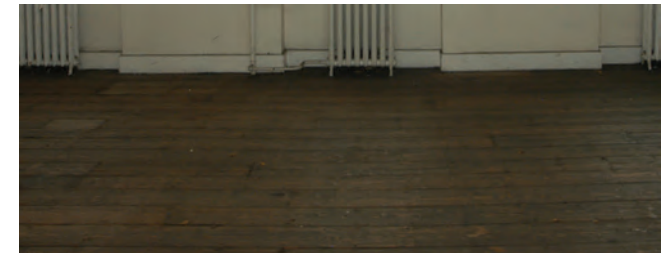
TYPE AND DESCRIPTION OF FABRIC Floor: timber boards
BUILDING PHASE C18th—C20th
CONDITION Poor—fair

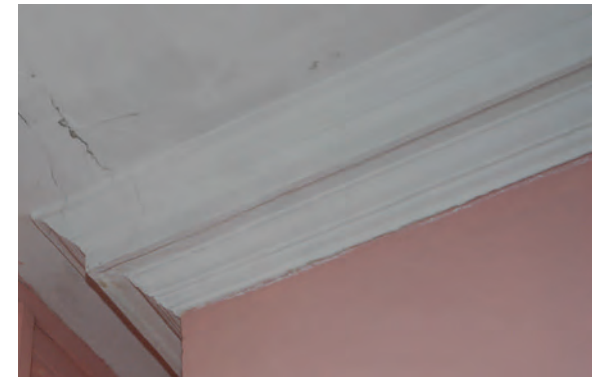
TYPE AND DESCRIPTION OF FABRIC Cornice: running-mould type
BUILDING PHASE C18th
CONDITION Poor

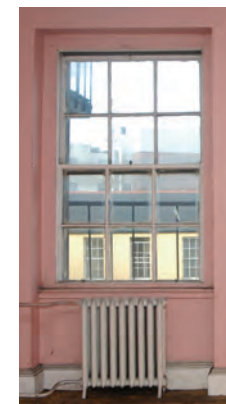
TYPE AND DESCRIPTION OF FABRIC Window, W (LHS internally): timber casing; 6-over-6 timber sashes.
BUILDING PHASE C18th sashes, C20th casing
CONDITION Poor

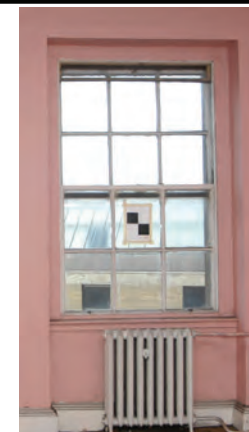
TYPE AND DESCRIPTION OF FABRIC Window, E (RHS internally): timber casing; 6-over-6 timber sashes.
BUILDING PHASE C18th sashes, C20th casing
CONDITION Poor

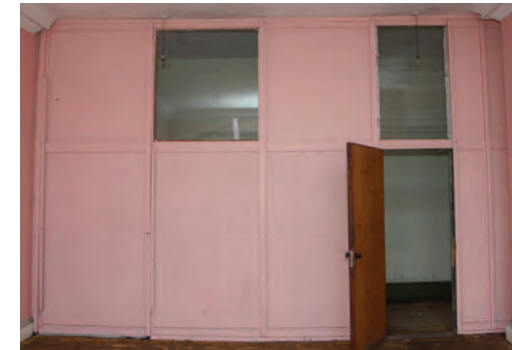
TYPE AND DESCRIPTION OF FABRIC Partition: timber-framed with timber and glass panels; timber flush door.
BUILDING PHASE C20th
CONDITION Poor

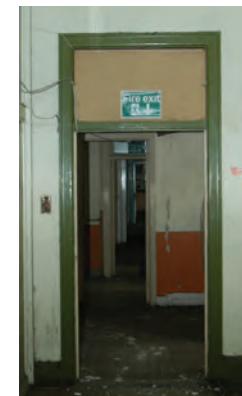
TYPE AND DESCRIPTION OF FABRIC Door to former stair hall/lobby: timber casing; door missing; casement for overlight missing.
BUILDING PHASE C20th
CONDITION Poor

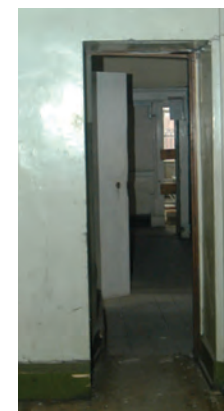
TYPE AND DESCRIPTION OF FABRIC Door to No.28: timber casing.
BUILDING PHASE C20th
CONDITION Poor

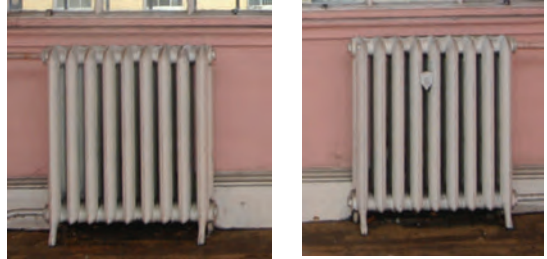
TYPE AND DESCRIPTION OF FABRIC Cast iron radiators: 2no., located below windows

BUILDING PHASE C20th	
CONDITION Poor

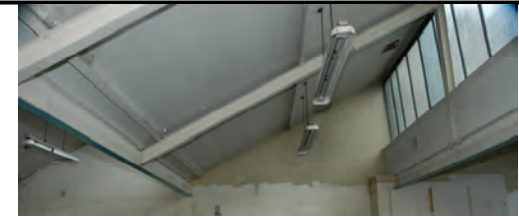
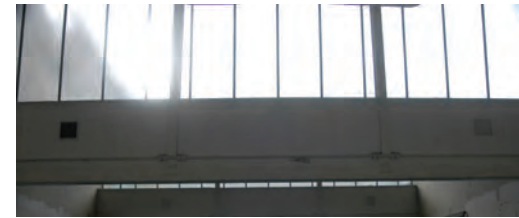
TYPE AND DESCRIPTION OF FABRIC Rooflights: steel-framed saw-tooth profile northlight roof
BUILDING PHASE C20th
CONDITION Fair

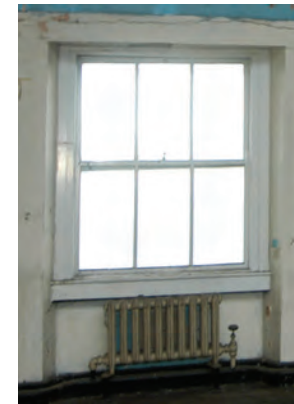
TYPE AND DESCRIPTION OF FABRIC Window, E (LHS internally): timber casing; 3-over-3 timber sashes
BUILDING PHASE C19th
CONDITION Poor

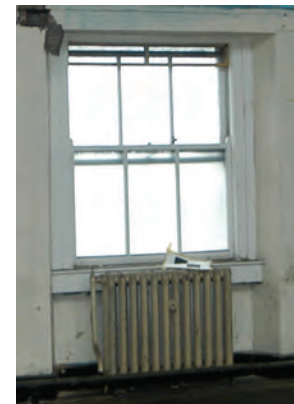
TYPE AND DESCRIPTION OF FABRIC Window, centre: timber casing; 3-over-3 timber sashes
BUILDING PHASE C19th
CONDITION Poor

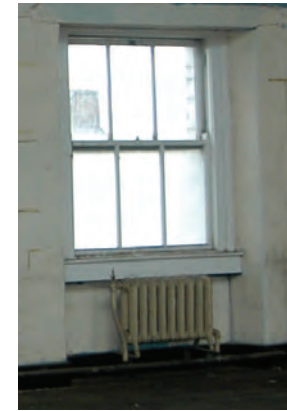
TYPE AND DESCRIPTION OF FABRIC Window, W (RHS internally): timber casing; 3-over-3 timber sashes
BUILDING PHASE C19th
CONDITION Poor

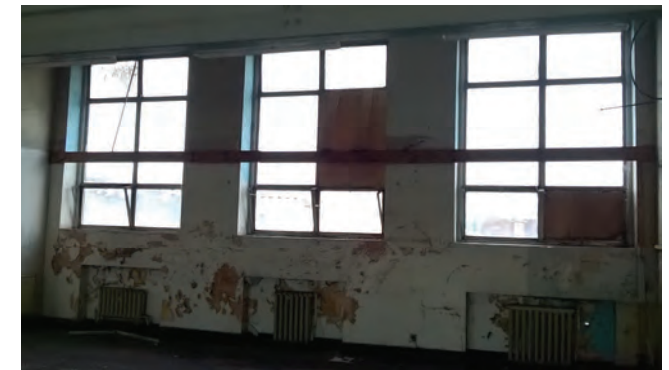
TYPE AND DESCRIPTION OF FABRIC Rear windows: 3no. large openings with steel-framed casements, having bottom-hung opening casements
BUILDING PHASE C20th
CONDITION Poor

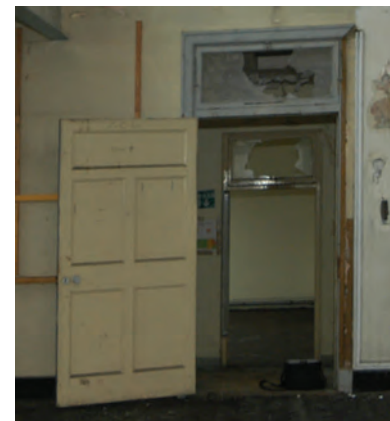
TYPE AND DESCRIPTION OF FABRIC Door to No.26: timber casing; 5-panel timber door; overlight with bottom-hung timber casement.
BUILDING PHASE C18th—C20th
CONDITION Poor

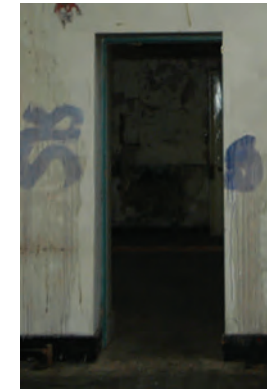
TYPE AND DESCRIPTION OF FABRIC Door to No.28: opening only, no door leaf or linings
BUILDING PHASE C20th
CONDITION Poor

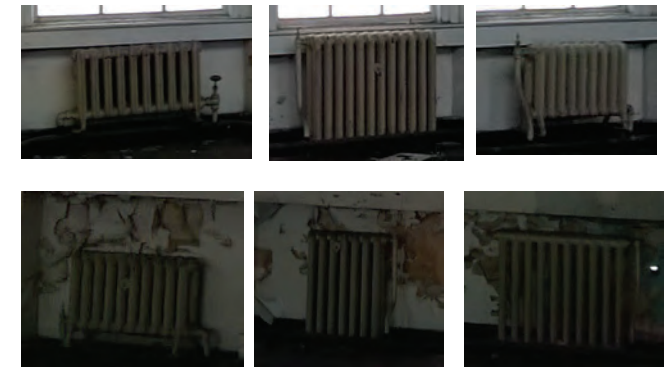
TYPE AND DESCRIPTION OF FABRIC Cast iron radiators: 6no., located below radiators
BUILDING PHASE C20th
CONDITION Poor

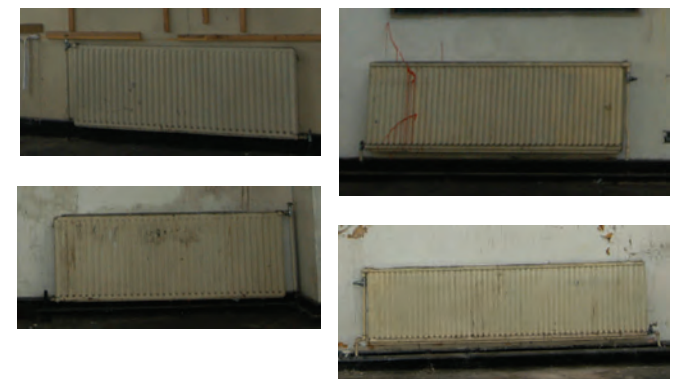
TYPE AND DESCRIPTION OF FABRIC Mild steel radiators: 4no., located on party walls
BUILDING PHASE C20th
CONDITION Poor

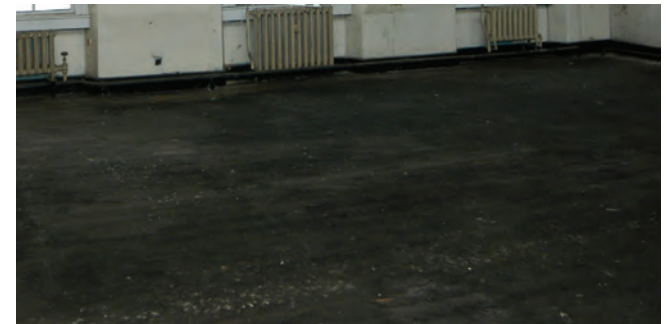
TYPE AND DESCRIPTION OF FABRIC Floor: timber boards
BUILDING PHASE C18th—C20th
CONDITION Poor

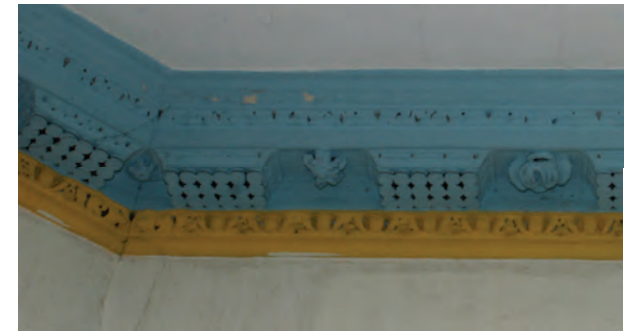
TYPE AND DESCRIPTION OF FABRIC Cornice: in medium-high relief, featuring guttae and floral mouldings; heavily overpainted.
BUILDING PHASE C18th
CONDITION Poor

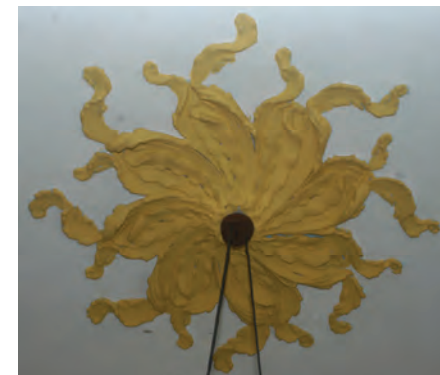
TYPE AND DESCRIPTION OF FABRIC Ceiling rose: foliate decoration forming circular pattern; heavily overpainted.
BUILDING PHASE C18th
CONDITION Poor

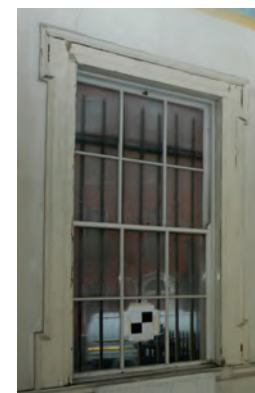
TYPE AND DESCRIPTION OF FABRIC Window: timber casing; lugged and shouldered architrave; 6-over-6 replacement sashes.
BUILDING PHASE C18th surround, C20th sashes
CONDITION Poor

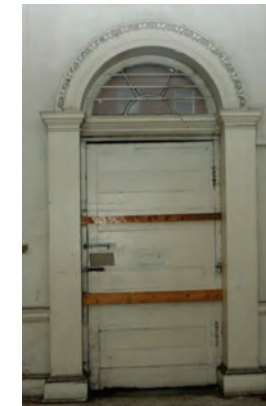
TYPE AND DESCRIPTION OF FABRIC Entrance door: round-headed opening with plaster moulding to arch; timber casing featuring carved timber pilasters flanking doorway; 10-panel timber door leaf.
BUILDING PHASE C18th
CONDITION Poor

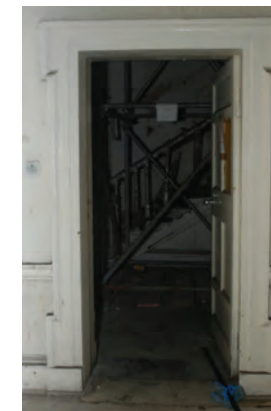
TYPE AND DESCRIPTION OF FABRIC Door to main stair hall: timber casing; lugged and shouldered timber architrave; 6-panel timber door leaf
BUILDING PHASE C18th
CONDITION Poor

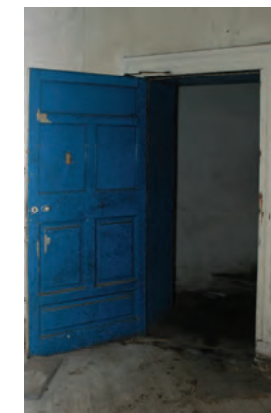
TYPE AND DESCRIPTION OF FABRIC Door to rear/basement: timber casing; lugged and shouldered timber architrave; 6-panel timber door leaf.
BUILDING PHASE C18th
CONDITION Poor

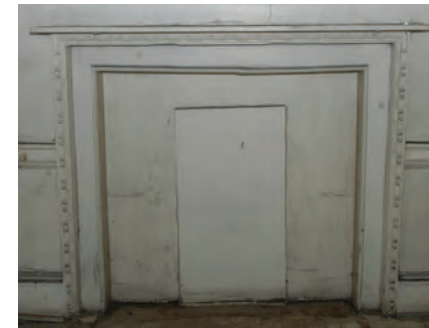
TYPE AND DESCRIPTION OF FABRIC Fireplace: carved timber surround.
BUILDING PHASE C18th
CONDITION Poor

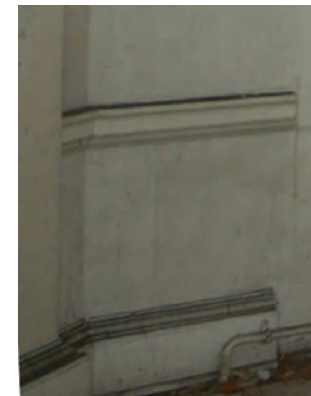
TYPE AND DESCRIPTION OF FABRIC Dado and skirting: timber profiles
BUILDING PHASE C18th
CONDITION Poor

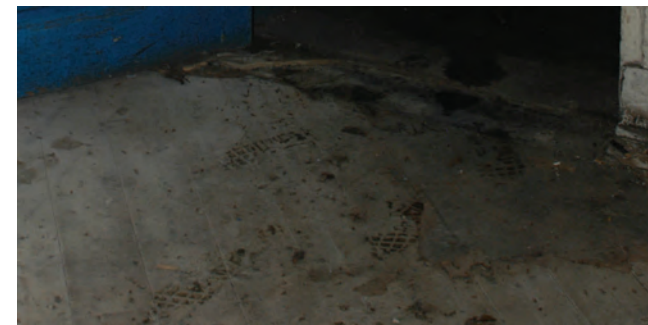
TYPE AND DESCRIPTION OF FABRIC Floor: timber boards.
BUILDING PHASE C18th
CONDITION Poor

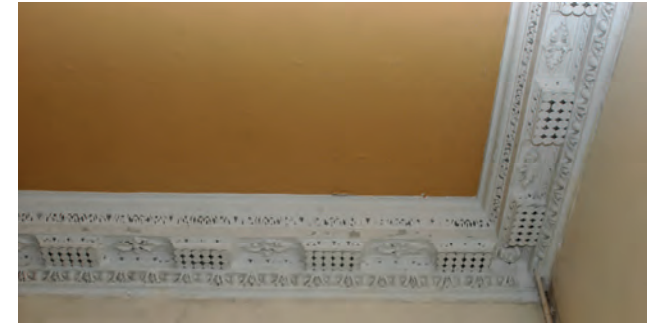
<b>TYPE AND DESCRIPTION OF FABRIC</b>
Cornice: in medium-high relief, featuring guttae and foliate mouldings; heavily overpainted.
<b>BUILDING PHASE</b>
C18th
<b>CONDITION</b>
Poor

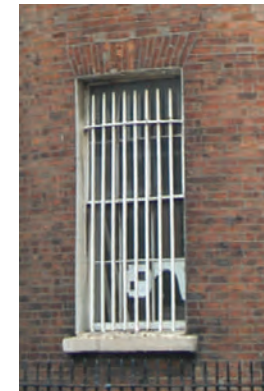
<b>TYPE AND DESCRIPTION OF FABRIC</b>
Window, N (no internal photography possible due to limited access): timber casing; 6-over-6 sashes.
<b>BUILDING PHASE</b>
C18th
<b>CONDITION</b>
Poor

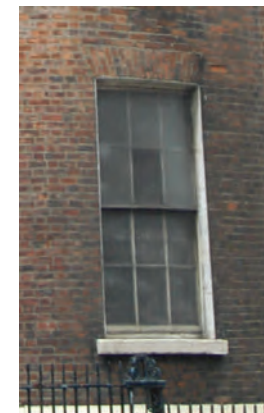
<b>TYPE AND DESCRIPTION OF FABRIC</b>
Window, S (no internal photography possible due to limited access): timber casing; 6-over-6 sashes.
<b>BUILDING PHASE</b>
C18th
<b>CONDITION</b>
Poor

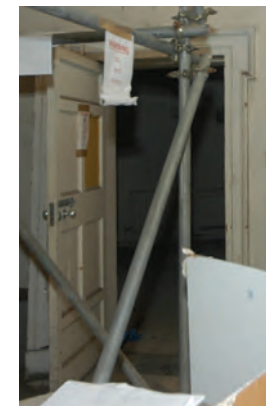
TYPE AND DESCRIPTION OF FABRIC Door to entrance hall: timber casing; lugged and shouldered timber architrave; 6-panel timber door
BUILDING PHASE C18th
CONDITION Poor

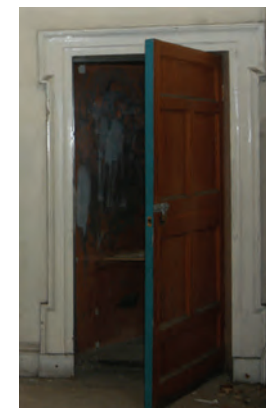
TYPE AND DESCRIPTION OF FABRIC Door to cupboard: timber casing; lugged and shouldered timber architrave; 6-panel timber door
BUILDING PHASE C18th
CONDITION Poor

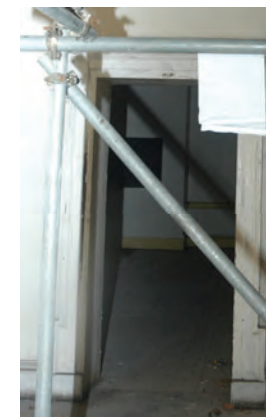
TYPE AND DESCRIPTION OF FABRIC Door to rear room: timber casing; lugged and shouldered timber architrave; 6-panel timber door
BUILDING PHASE C18th
CONDITION Poor

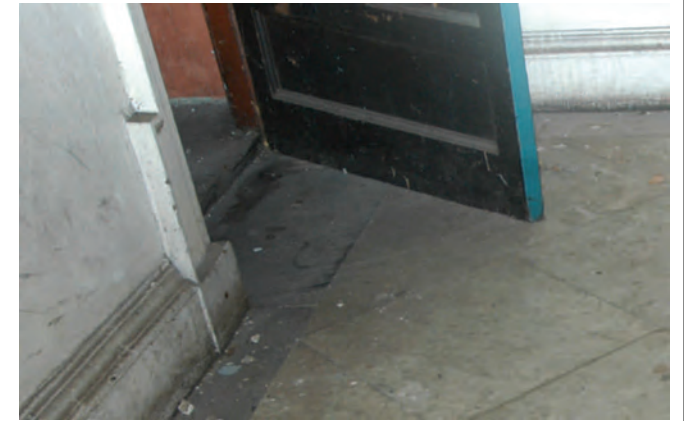
TYPE AND DESCRIPTION OF FABRIC Skirting: timber profile
BUILDING PHASE C18th
CONDITION Poor

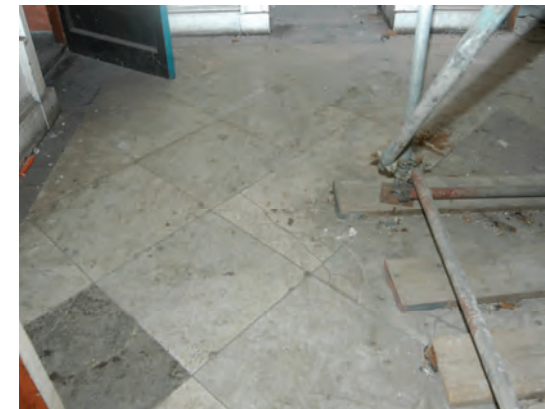
TYPE AND DESCRIPTION OF FABRIC Floor: stone flags
BUILDING PHASE C18th
CONDITION Poor

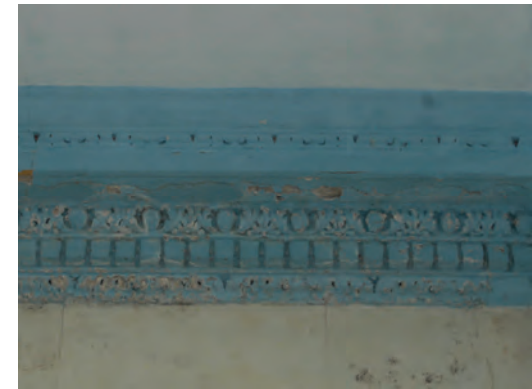
TYPE AND DESCRIPTION OF FABRIC Cornice: low-medium relief; heavily overpainted, obscuring detail of mouldings; sections missing due to later installation of downstand beams.
BUILDING PHASE C18th
CONDITION Poor

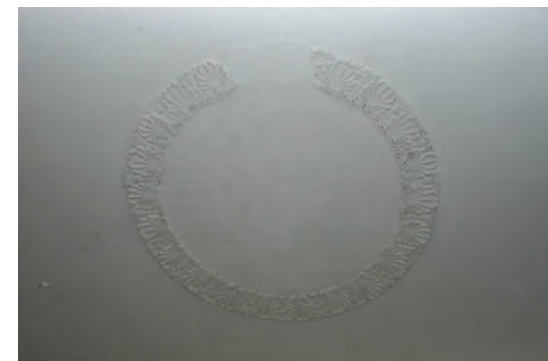
TYPE AND DESCRIPTION OF FABRIC Ceiling rose: palmette detail in circular pattern; no further mouldings survive.
BUILDING PHASE C18th
CONDITION Poor

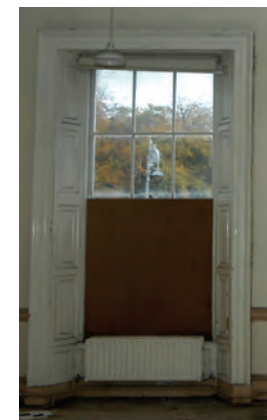
TYPE AND DESCRIPTION OF FABRIC Window, E (LHS internally): timber casing; timber shutters with raised and fielded panels; 6-over-6 timber sashes.
BUILDING PHASE C18th—C19th
CONDITION Poor

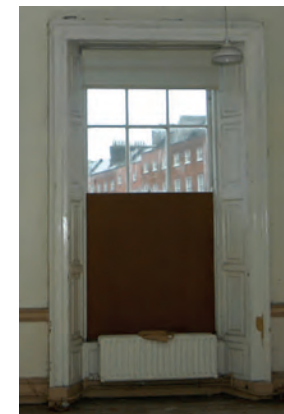
TYPE AND DESCRIPTION OF FABRIC Window, W (RHS internally): timber casing; timber shutters with raised and fielded panels; 6-over-6 timber sashes.
BUILDING PHASE C18th—C19th
CONDITION Poor

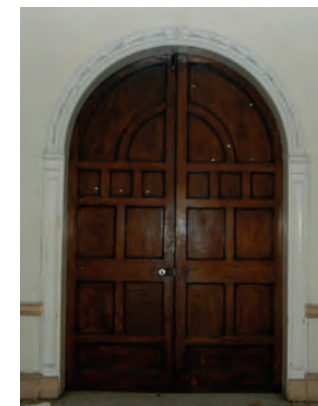
TYPE AND DESCRIPTION OF FABRIC Door to rear reception room: arched opening with timber casing; carved timber architrave; 2-leaf timber doorset, having multi-panelled doors with upper quadrant-shaped sections to arch.
BUILDING PHASE C18th
CONDITION Fair

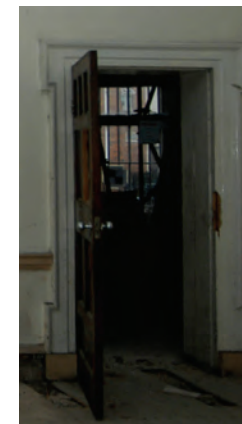
TYPE AND DESCRIPTION OF FABRIC Door to main stair hall: timber casing; lugged and shouldered timber architrave; 8-panel timber door.
BUILDING PHASE C18th
CONDITION Poor—Fair

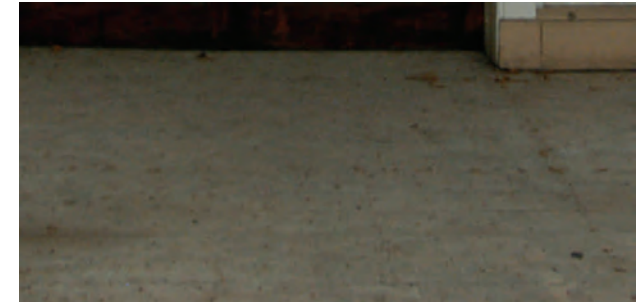
TYPE AND DESCRIPTION OF FABRIC Floor: timber boards
BUILDING PHASE C18th
CONDITION Poor

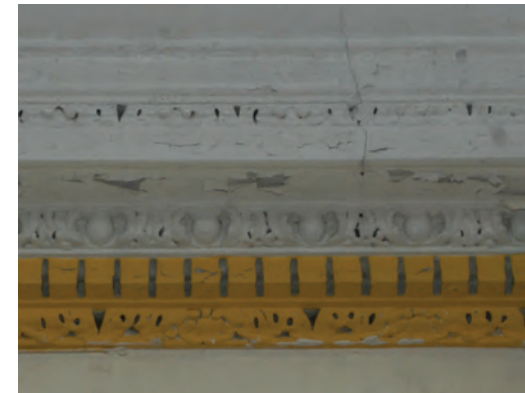
TYPE AND DESCRIPTION OF FABRIC Cornice: low-medium relief; heavily overpainted, obscuring detail of mouldings; sections missing due to later installation of downstand beams.
BUILDING PHASE C18th
CONDITION Poor

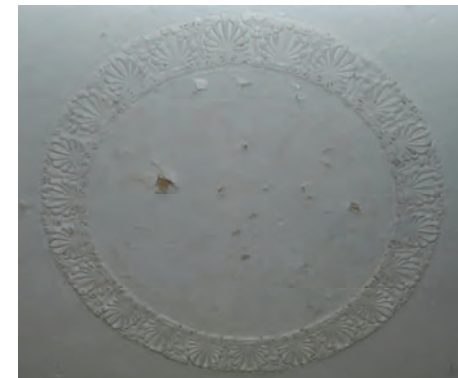
TYPE AND DESCRIPTION OF FABRIC Ceiling rose: palmette detail in circular pattern; no further mouldings survive.
BUILDING PHASE C18th
CONDITION Poor

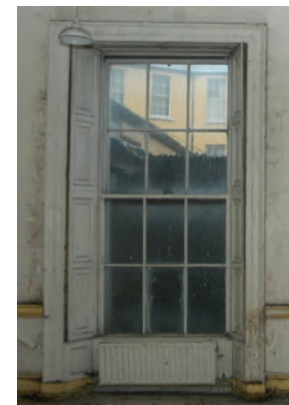
TYPE AND DESCRIPTION OF FABRIC Window, W (LHS internally): timber casing; timber shutters with raised and fielded panels; 6-over-6 timber sashes.
BUILDING PHASE C18th—C19th
CONDITION Poor

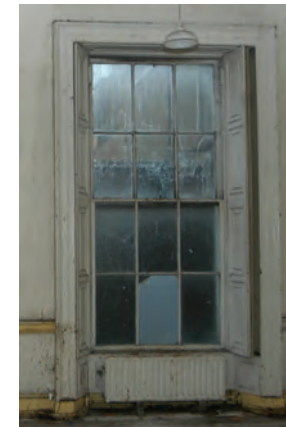
<b>TYPE AND DESCRIPTION OF FABRIC</b>
Window, E (RHS internally): timber casing; timber shutters with raised and fielded panels; 6-over-6 timber sashes.
<b>BUILDING PHASE</b>
C18th—C19th
<b>CONDITION</b>
Poor

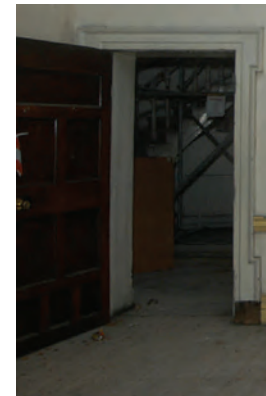
<b>TYPE AND DESCRIPTION OF FABRIC</b>
Door to main stair hall: timber casing; lugged and shouldered timber architrave; 8-panel timber door
<b>BUILDING PHASE</b>
C18th
<b>CONDITION</b>
Poor

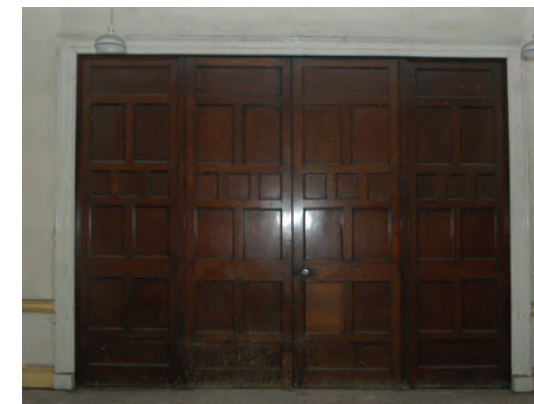
<b>TYPE AND DESCRIPTION OF FABRIC</b>
Door to front reception room: large, square-headed surround to smaller arched opening within (see front reception room also); timber casing and architrave; 4no. timber leaves, each having 11-panels; two central opening leaves with two flanking fixed leaves.
<b>BUILDING PHASE</b>
C18th
<b>CONDITION</b>
Fair

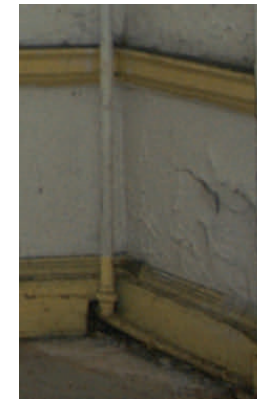
TYPE AND DESCRIPTION OF FABRIC Dado and skirting: timber profiles
BUILDING PHASE C18th
CONDITION Poor

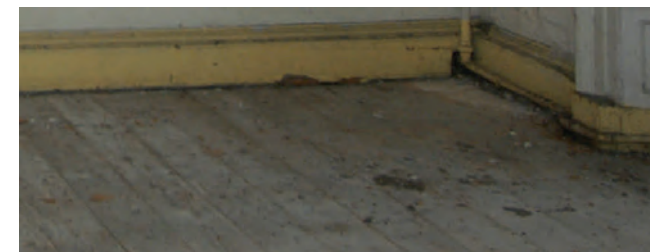
TYPE AND DESCRIPTION OF FABRIC Floor: timber boards
BUILDING PHASE C18th
CONDITION Poor

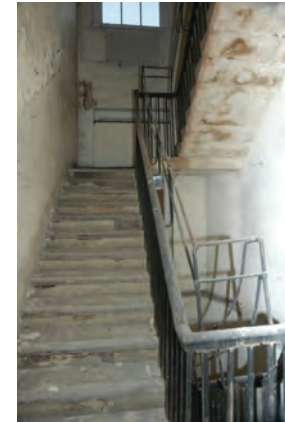
TYPE AND DESCRIPTION OF FABRIC Staircase: granite stairs; wrought iron balusters and handrail
BUILDING PHASE C18th
CONDITION Poor

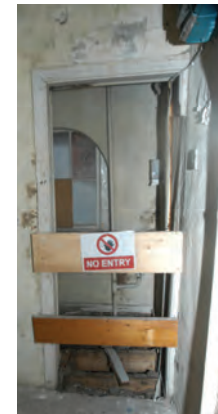
TYPE AND DESCRIPTION OF FABRIC Door to alcove: timber casing; timber architrave; door leaf missing.
BUILDING PHASE C20th
CONDITION Poor

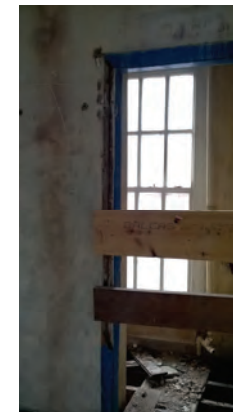
TYPE AND DESCRIPTION OF FABRIC Window in alcove (facing W): timber casing; 6-over-6 timber sashes.
BUILDING PHASE C18th—C19th
CONDITION Poor

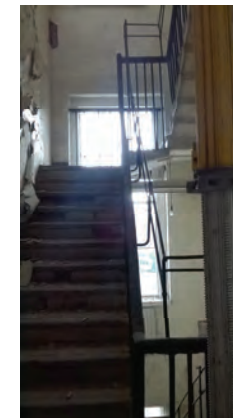
TYPE AND DESCRIPTION OF FABRIC Staircase: granite stairs; wrought iron balusters and handrail
BUILDING PHASE C18th
CONDITION Poor

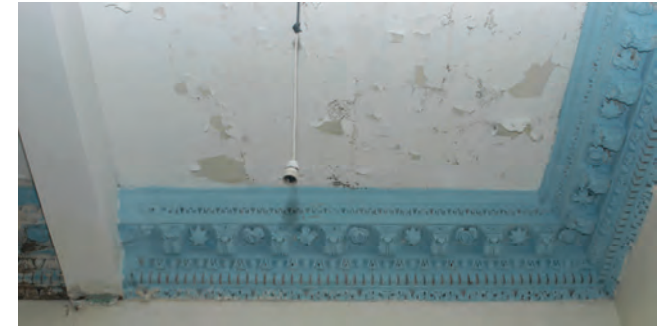
<b>TYPE AND DESCRIPTION OF FABRIC</b>
Cornice: in medium-high relief; modillion and rosette mouldings; heavily over-painted; sections missing due to later installation of downstand beams.
<b>BUILDING PHASE</b>
C18th
<b>CONDITION</b>
Poor

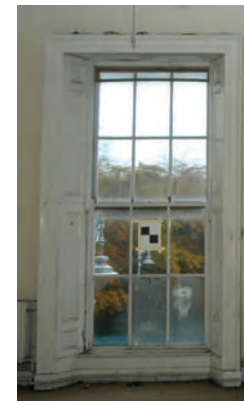
<b>TYPE AND DESCRIPTION OF FABRIC</b>
Window, E (LHS internally): timber casing; fielded panels to shutters; timber architrave; 6-over-6 timber sashes; window and surround extends to floor level.
<b>BUILDING PHASE</b>
C18th—C19th
<b>CONDITION</b>
Poor—fair

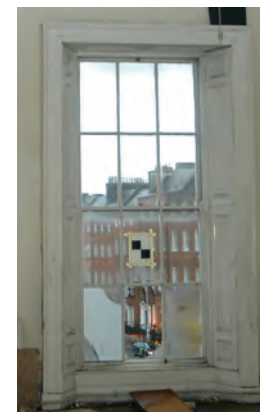
<b>TYPE AND DESCRIPTION OF FABRIC</b>
Window, W (RHS internally): timber casing; fielded panels to shutters; timber architrave; 6-over-6 timber sashes; window and surround extends to floor level.
<b>BUILDING PHASE</b>
C18th—C19th
<b>CONDITION</b>
Poor—fair

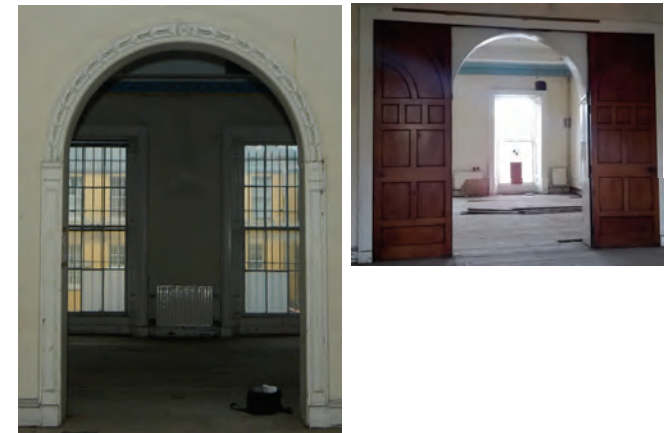
<b>TYPE AND DESCRIPTION OF FABRIC</b>
Door to rear reception room: arched opening with timber casing; carved timber architrave; 2-leaf timber door having parliament hinges to fold back into rear room; 11-panel doors with upper quadrant-shaped panels to reflect arched opening.
<b>BUILDING PHASE</b>
C18th
<b>CONDITION</b>
Fair

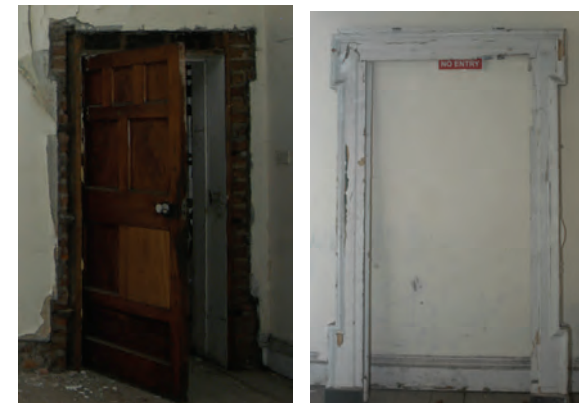
<b>TYPE AND DESCRIPTION OF FABRIC</b>
Door to main stair hall: timber casing; 8-panel timber door leaf; lugged and shouldered architrave survives but is detached.
<b>BUILDING PHASE</b>
C18th
<b>CONDITION</b>
Poor

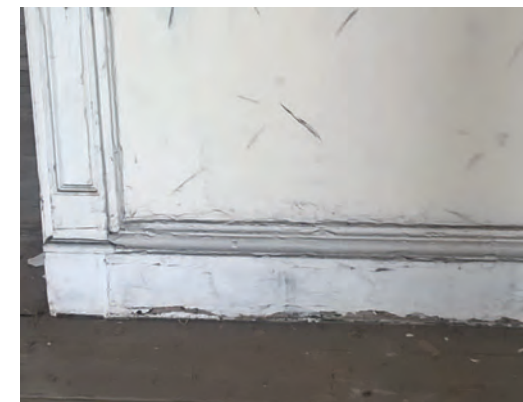
<b>TYPE AND DESCRIPTION OF FABRIC</b>
Skirting: timber profile
<b>BUILDING PHASE</b>
C18th
<b>CONDITION</b>
Poor

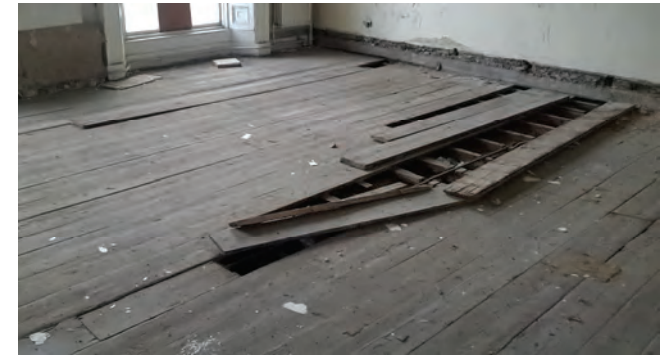
<b>TYPE AND DESCRIPTION OF FABRIC</b> Floor: timber boards
<b>BUILDING PHASE</b> C18th
<b>CONDITION</b> Poor

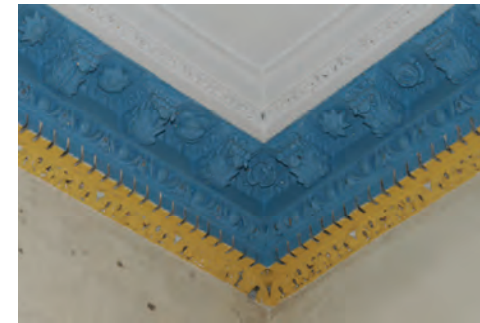
<b>TYPE AND DESCRIPTION OF FABRIC</b> Cornice: in medium-high relief; modillion and rosette mouldings; heavily over-painted; sections missing due to later installation of downstand beams.
<b>BUILDING PHASE</b> C18th
<b>CONDITION</b> Poor

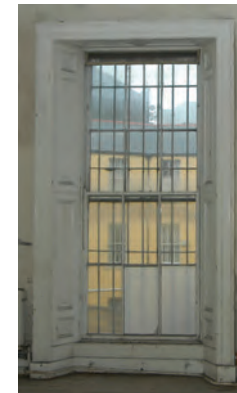
<b>TYPE AND DESCRIPTION OF FABRIC</b> Window, W (LHS internally): timber casing; fielded panels to shutters; timber architrave; 6-over-6 timber sashes; window and surround extends to floor level.
<b>BUILDING PHASE</b> C18th—C19th
<b>CONDITION</b> Poor

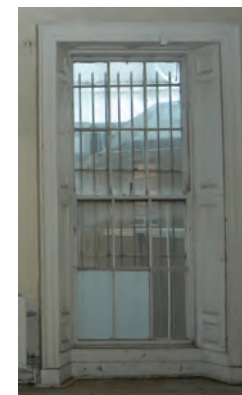
<b>TYPE AND DESCRIPTION OF FABRIC</b> Window, E (RHS internally): timber casing; fielded panels to shutters; timber architrave; 6-over-6 timber sashes; window and surround extends to floor level.
<b>BUILDING PHASE</b> C18th—C19th
<b>CONDITION</b> Poor

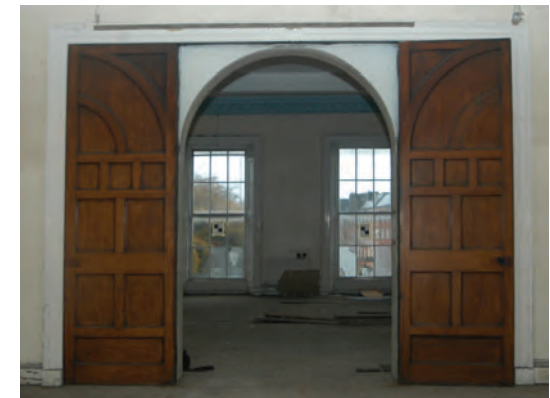
TYPE AND DESCRIPTION OF FABRIC Door to rear front room: arched opening within square-headed surround having carved timber architrave; 2-leaf timber door having parliament hinges to fold back into room; 11-panel doors with upper quadrant-shaped panels to reflect arched opening.
BUILDING PHASE C18th
CONDITION Fair

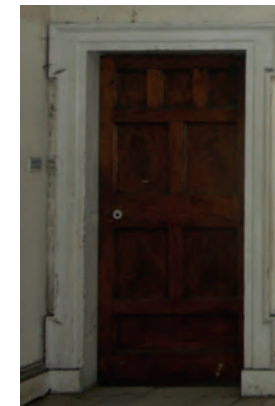
TYPE AND DESCRIPTION OF FABRIC Door to main stair hall: timber casing; 8-panel timber door leaf; lugged and shouldered timber architrave.
BUILDING PHASE C18th
CONDITION Poor—fair

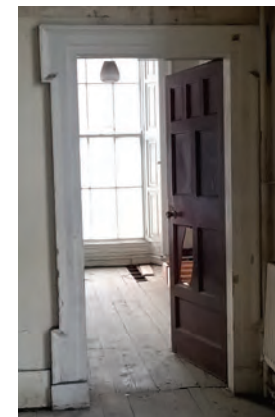
TYPE AND DESCRIPTION OF FABRIC Door to octagonal room: timber casing; 8-panel timber door leaf; lugged and shouldered timber architrave.
BUILDING PHASE C18th
CONDITION Poor

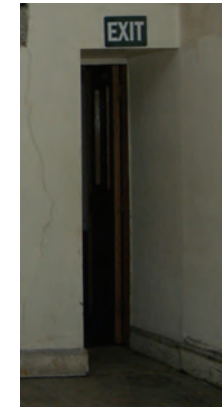
TYPE AND DESCRIPTION OF FABRIC Door to No.27: timber casing; timber door leaf.
BUILDING PHASE C20th
CONDITION Poor

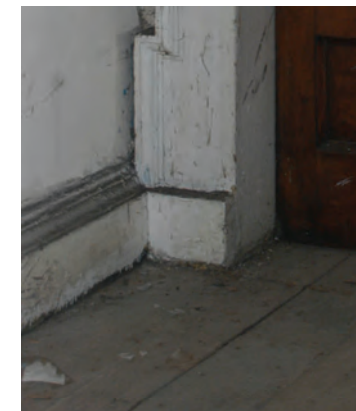
TYPE AND DESCRIPTION OF FABRIC Skirting: timber profile
BUILDING PHASE C18th
CONDITION Poor

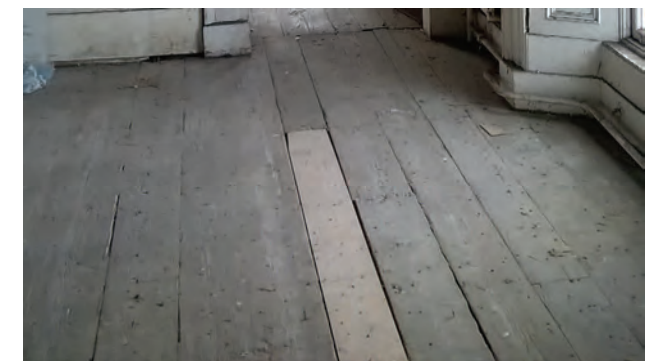
TYPE AND DESCRIPTION OF FABRIC Floor: timber boards
BUILDING PHASE C18th—C20th
CONDITION Poor

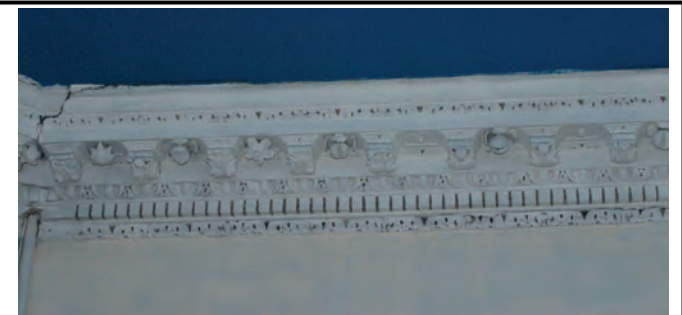
TYPE AND DESCRIPTION OF FABRIC Cornice: in medium-high relief; modillion and rosette mouldings; heavily over-painted.
BUILDING PHASE C18th
CONDITION Poor

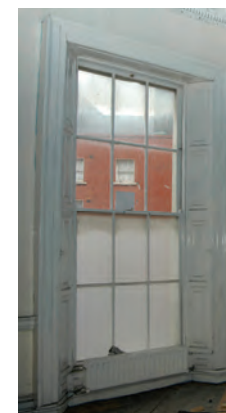
TYPE AND DESCRIPTION OF FABRIC Window, SW (LHS internally): timber casing; fielded panels to shutters; timber architrave; 6-over-6 timber sashes; window and surround extends to floor level.
BUILDING PHASE C18th—C19th
CONDITION Poor—fair

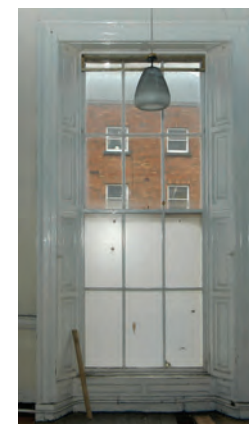
TYPE AND DESCRIPTION OF FABRIC Window, centre: timber casing; fielded panels to shutters; timber architrave; 6-over-6 timber sashes; window and surround extends to floor level.
BUILDING PHASE C18th—C19th
CONDITION Poor—fair

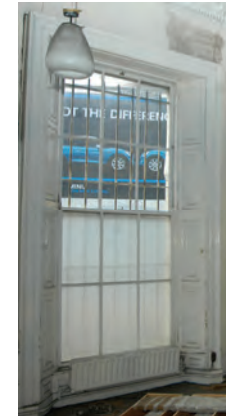
TYPE AND DESCRIPTION OF FABRIC Window, NW (RHS internally): timber casing; field-ed panels to shutters; timber architrave; 6-over-6 timber sashes; window and surround extends to floor level.
BUILDING PHASE C18th—C19th
CONDITION Poor—fair

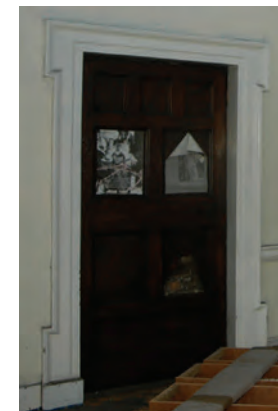
TYPE AND DESCRIPTION OF FABRIC Blind door: fixed 8-panel timber door; lugged and shouldered timber architrave.
BUILDING PHASE C18th
CONDITION Poor—fair

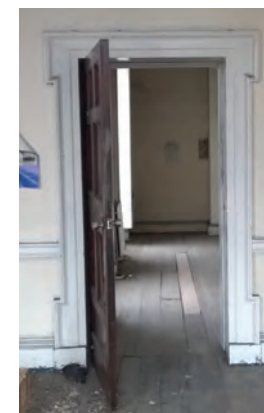
TYPE AND DESCRIPTION OF FABRIC Door to rear room: timber casing; 8-panel timber door; lugged and shouldered timber architrave.
BUILDING PHASE C18th
CONDITION Poor—fair

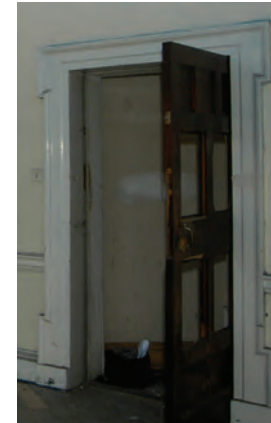
TYPE AND DESCRIPTION OF FABRIC Door to main stair hall (via alcove): timber casing; 8-panel timber door; lugged and shouldered timber architrave.
BUILDING PHASE C18th
CONDITION Poor

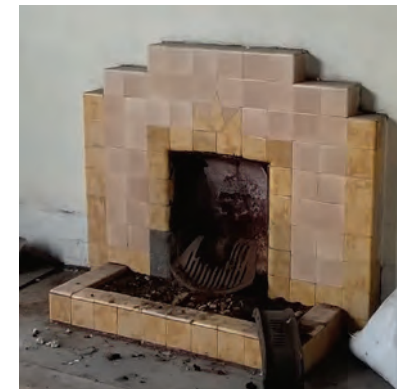
TYPE AND DESCRIPTION OF FABRIC Fireplace: tiled surround and hearth
BUILDING PHASE C20th
CONDITION Poor—fair

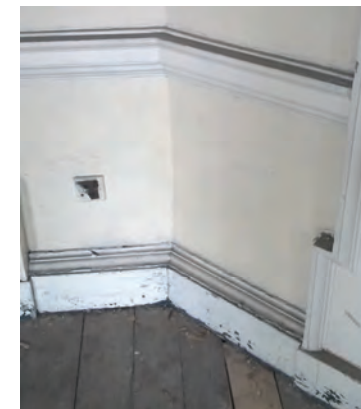
TYPE AND DESCRIPTION OF FABRIC Dado and skirting: timber profiles
BUILDING PHASE C18th
CONDITION Poor

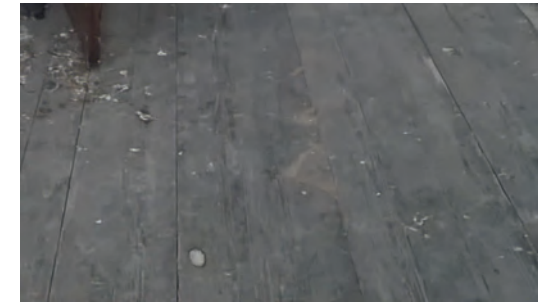
TYPE AND DESCRIPTION OF FABRIC Floor: timber boards
BUILDING PHASE C18th
CONDITION Poor

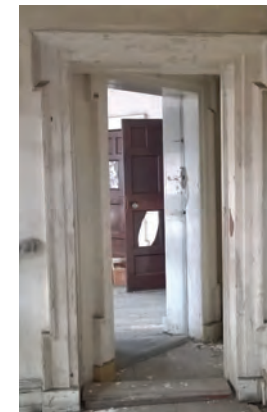
TYPE AND DESCRIPTION OF FABRIC Floor: timber boards
BUILDING PHASE C18th
CONDITION Poor

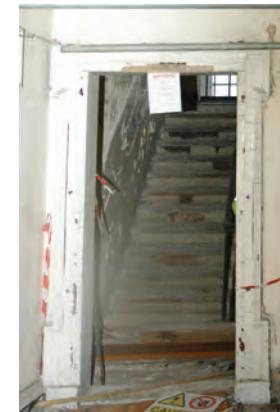
TYPE AND DESCRIPTION OF FABRIC Floor: timber boards
BUILDING PHASE C18th
CONDITION Poor

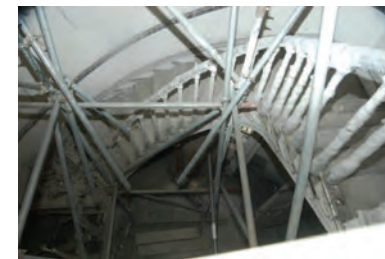
TYPE AND DESCRIPTION OF FABRIC Staircase: granite stairs; wrought iron balusters and handrail
BUILDING PHASE C18th
CONDITION Poor

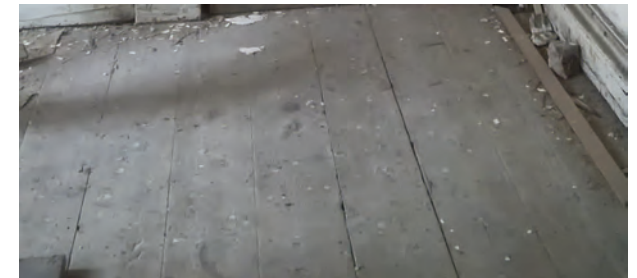
<b>TYPE AND DESCRIPTION OF FABRIC</b> Floor: timber boards
<b>BUILDING PHASE</b> C18th
<b>CONDITION</b> Poor

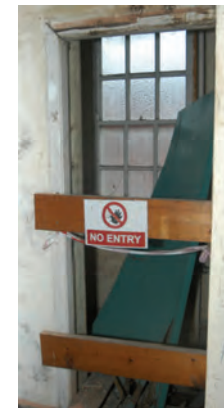
TYPE AND DESCRIPTION OF FABRIC Window to alcove off stairs: timber casing; 6-over-6 timber sashes.
BUILDING PHASE C18th-C19th
CONDITION Poor

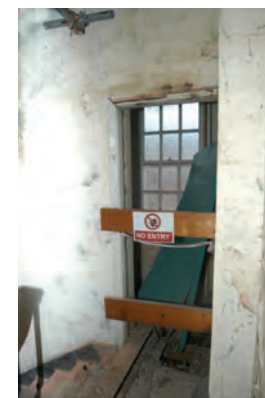
TYPE AND DESCRIPTION OF FABRIC Door to alcove: timber casing; timber architrave; door leaf missing.
BUILDING PHASE C18th—C20th
CONDITION V. Poor

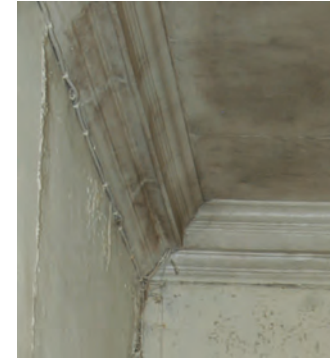
TYPE AND DESCRIPTION OF FABRIC Cornice: running mould type
BUILDING PHASE C18th
CONDITION Poor

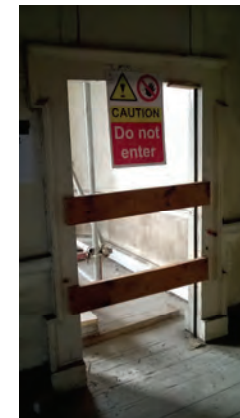
TYPE AND DESCRIPTION OF FABRIC Door to bowed room: timber casing; lugged and shouldered timber architrave; door leaf missing.
BUILDING PHASE C18th
CONDITION Poor

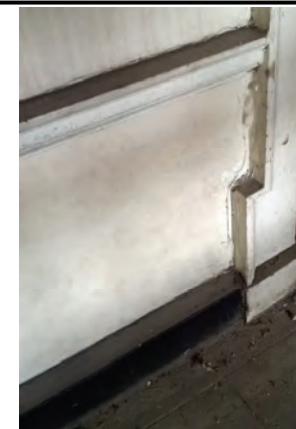
TYPE AND DESCRIPTION OF FABRIC Dado and skirting: timber profiles
BUILDING PHASE C18th
CONDITION Poor—fair

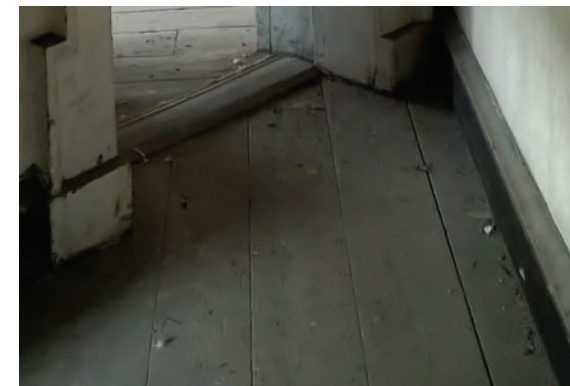
TYPE AND DESCRIPTION OF FABRIC Floor: timber boards
BUILDING PHASE C18th
CONDITION Poor—fair

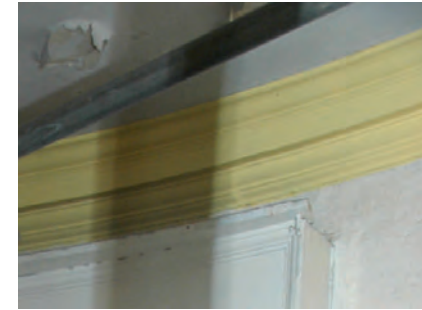
<b>TYPE AND DESCRIPTION OF FABRIC</b> Cornice: running mould type
<b>BUILDING PHASE</b> C18th
<b>CONDITION</b> Poor

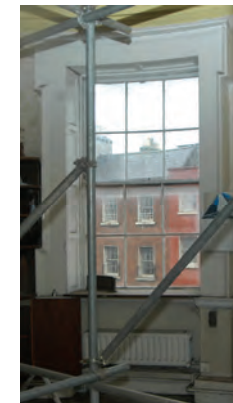
<b>TYPE AND DESCRIPTION OF FABRIC</b> Window, S (LHS internally): timber casing with pan-elled shutters; 6-over-6 timber sliding sashes; lugged and shouldered timber architrave.
<b>BUILDING PHASE</b> C18th
<b>CONDITION</b> Poor—fair

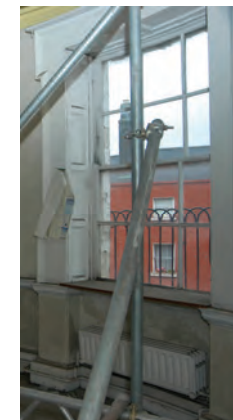
<b>TYPE AND DESCRIPTION OF FABRIC</b> Window, N (RHS internally): timber casing with pan-elled shutters; 6-over-6 timber sliding sashes; lugged and shouldered timber architrave.
<b>BUILDING PHASE</b> C18th
<b>CONDITION</b> Poor—fair

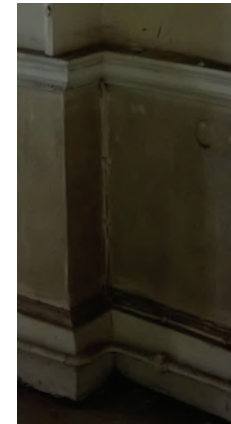
TYPE AND DESCRIPTION OF FABRIC Dado and skirting: timber profiles
BUILDING PHASE C18th
CONDITION Poor—fair

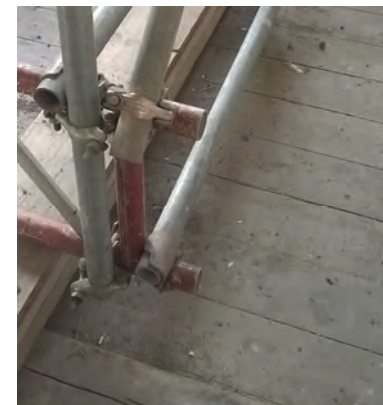
TYPE AND DESCRIPTION OF FABRIC Floor: timber boards
BUILDING PHASE C18th
CONDITION Poor—fair

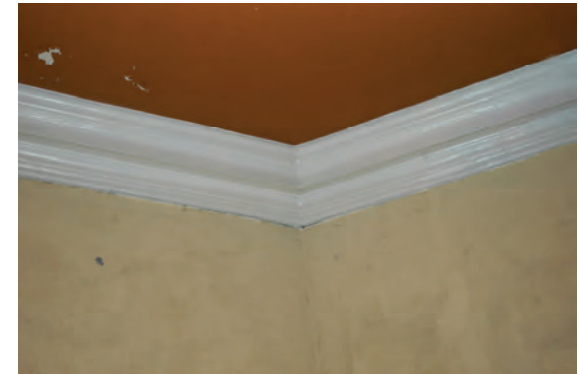
TYPE AND DESCRIPTION OF FABRIC Cornice: running mould type
BUILDING PHASE C18th
CONDITION Poor—fair

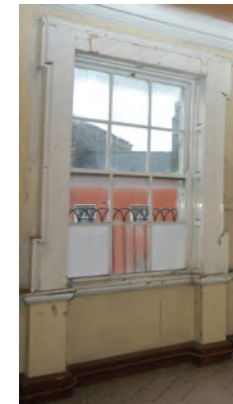
TYPE AND DESCRIPTION OF FABRIC Window, S (LHS internally): timber casing; 6-over-6 timber sliding sashes; lugged and shouldered timber architrave.
BUILDING PHASE C18th
CONDITION Poor—fair

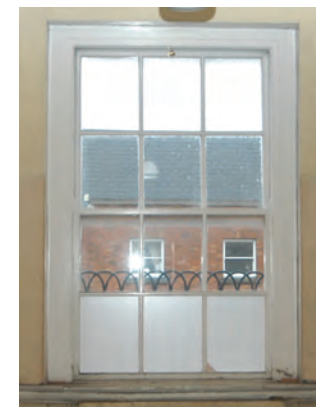
TYPE AND DESCRIPTION OF FABRIC Window, centre: timber casing; 6-over-6 timber sliding sashes; timber architrave.
BUILDING PHASE C18th
CONDITION Poor—fair

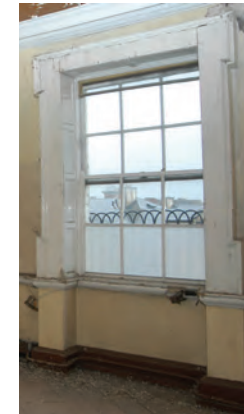
TYPE AND DESCRIPTION OF FABRIC Window, N (RHS internally): timber casing; 6-over-6 timber sliding sashes; lugged and shouldered timber architrave.
BUILDING PHASE C18th
CONDITION Poor—fair

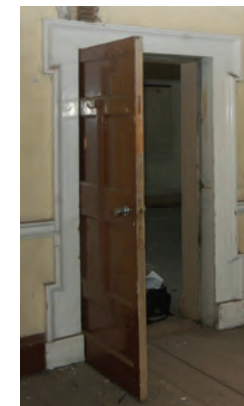
TYPE AND DESCRIPTION OF FABRIC Door to rear room: timber casing; lugged and shouldered timber architrave; 6-panel timber door leaf.
BUILDING PHASE C18th
CONDITION Poor—fair

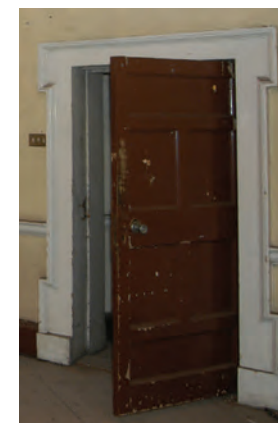
TYPE AND DESCRIPTION OF FABRIC Door to inner hall: timber casing; lugged and shouldered timber architrave; 6-panel timber door leaf.
BUILDING PHASE C18th
CONDITION Poor

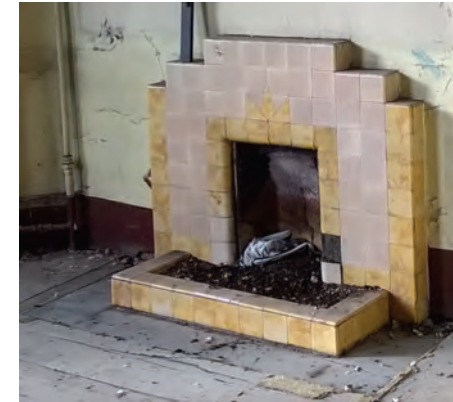
TYPE AND DESCRIPTION OF FABRIC Fireplace: tiled surround and hearth.
BUILDING PHASE C20th
CONDITION Poor

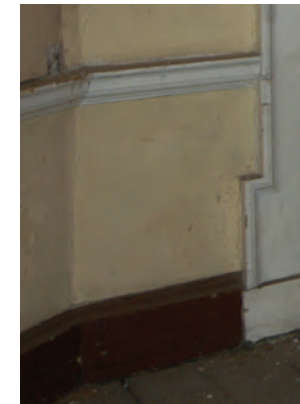
TYPE AND DESCRIPTION OF FABRIC Dado and skirting: timber profiles
BUILDING PHASE C18th
CONDITION Poor—fair

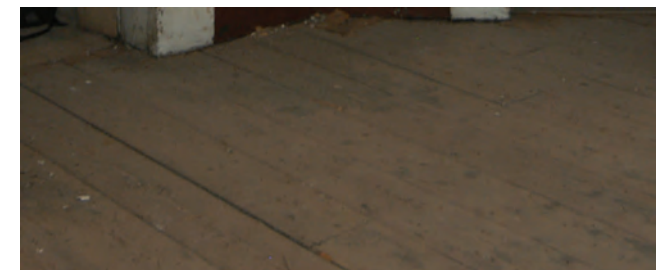
TYPE AND DESCRIPTION OF FABRIC Floor: timber boards
BUILDING PHASE C18th
CONDITION Poor

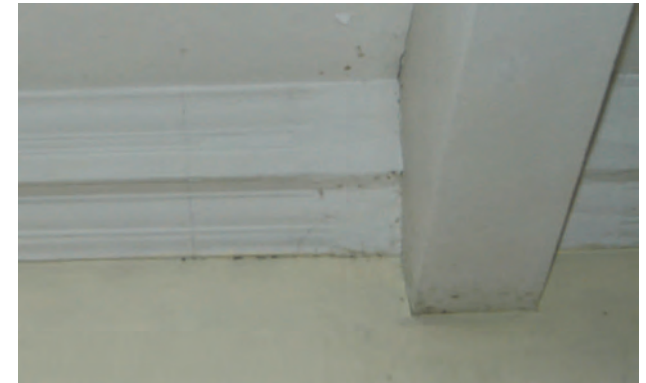
<b>TYPE AND DESCRIPTION OF FABRIC</b> Cornice: running mould type; broken-into by down-stand beams.
<b>BUILDING PHASE</b> C18th—C20th
<b>CONDITION</b> Poor

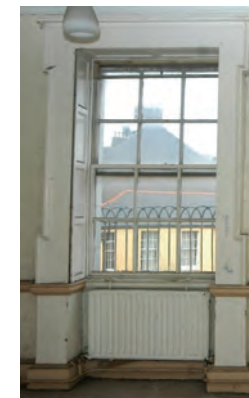
<b>TYPE AND DESCRIPTION OF FABRIC</b> Window, W (LHS internally): timber casing with pan- elled shutters; 6-over-6 timber sliding sashes; lugged and shouldered timber architrave.
<b>BUILDING PHASE</b> C18th
<b>CONDITION</b> Poor—fair

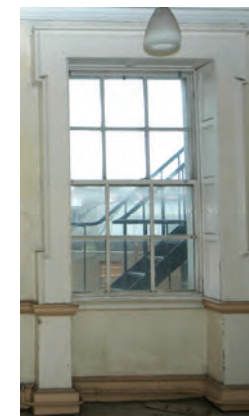
<b>TYPE AND DESCRIPTION OF FABRIC</b> Window, E (RHS internally): timber casing with pan- elled shutters; 6-over-6 timber sliding sashes; lugged and shouldered timber architrave.
<b>BUILDING PHASE</b> C18th
<b>CONDITION</b> Poor—fair

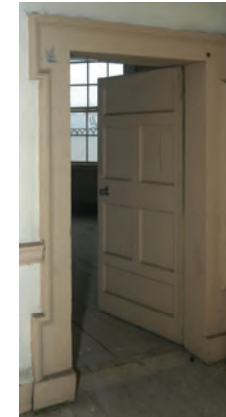
TYPE AND DESCRIPTION OF FABRIC Door to octagonal room: timber casing; lugged and shouldered timber architrave; 6-panel timber door leaf.
BUILDING PHASE C18th
CONDITION Poor—fair
