# APPENDIX A

# Building Inventories

Protected Structures Impact Statement

PARNELL SQUARE CULTURAL QUARTER  
 Architectural Heritage—Decorative Fabric Inventory  
 Nos. 20, 21, 23-28 Parnell Square, Dublin 1  
 November 2015—Shaffrey Associates Architects

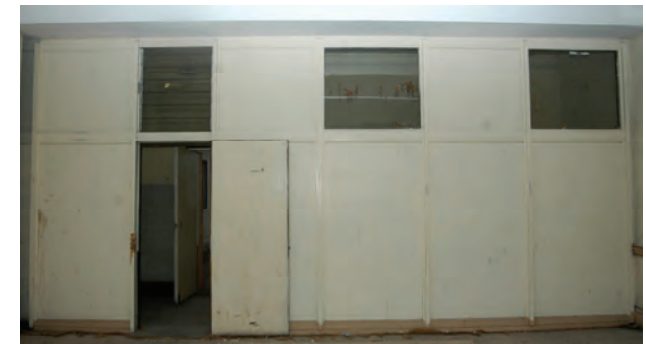
TYPE AND DESCRIPTION OF FABRIC Partition: timber frame with timber panels; 3no. upper glazed panels; flush door.
BUILDING PHASE C20th
CONDITION Poor

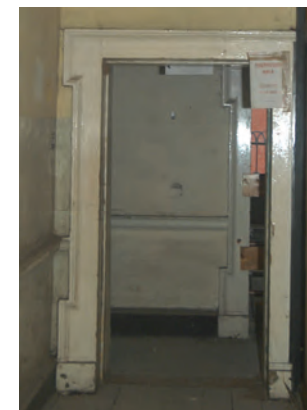
TYPE AND DESCRIPTION OF FABRIC Door to inner hall: timber casing; lugged and shouldered timber architrave; door leaf missing.
BUILDING PHASE C18th
CONDITION Poor

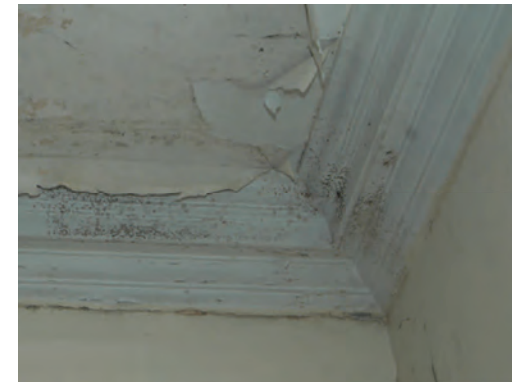
TYPE AND DESCRIPTION OF FABRIC Cornice: running mould type
BUILDING PHASE C18th
CONDITION Poor

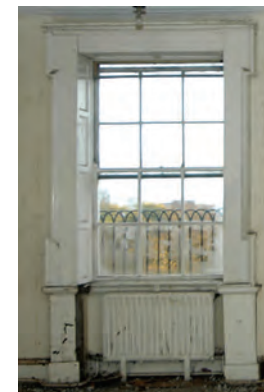
TYPE AND DESCRIPTION OF FABRIC Window, E (LHS internally): timber casing with pan- elled shutters; 6-over-6 timber sliding sashes; lugged and shouldered timber architrave.
BUILDING PHASE C18th
CONDITION Poor

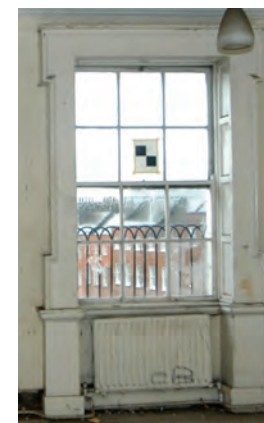
TYPE AND DESCRIPTION OF FABRIC Window, W (RHS internally): timber casing with pan- elled shutters; 6-over-6 timber sliding sashes; lugged and shouldered timber architrave.
BUILDING PHASE C18th
CONDITION Poor

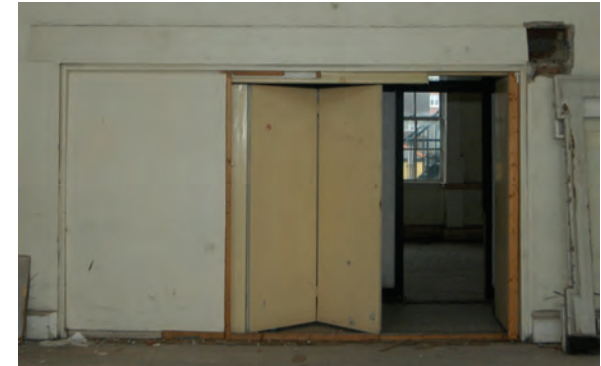
TYPE AND DESCRIPTION OF FABRIC Door to rear reception room/access hall: timber casing; folding and sliding timber.
BUILDING PHASE C20th
CONDITION Poor

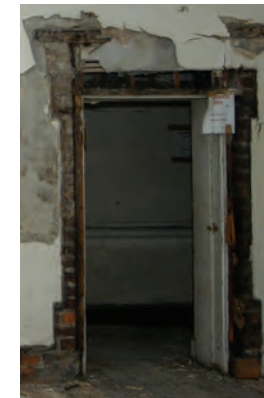
TYPE AND DESCRIPTION OF FABRIC Door to inner hall: timber casing; architrave missing; door leaf missing
BUILDING PHASE C18th
CONDITION V. Poor

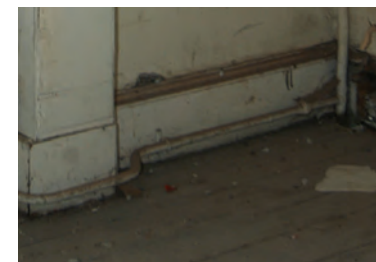
TYPE AND DESCRIPTION OF FABRIC Skirting: timber profile
BUILDING PHASE C18th—C20th
CONDITION Poor

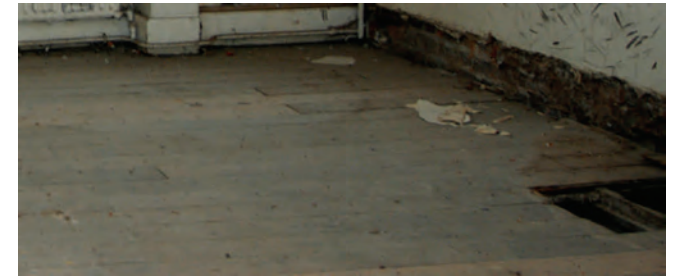
TYPE AND DESCRIPTION OF FABRIC Floor: timber boards
BUILDING PHASE C18th—C20th
CONDITION Poor

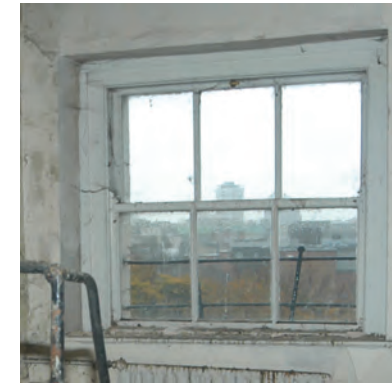
<b>TYPE AND DESCRIPTION OF FABRIC</b> Window (facing S onto Parnell Sq.): timber casing; 3-over-3 sliding timber sashes.
<b>BUILDING PHASE</b> C18th—C19th
<b>CONDITION</b> Poor

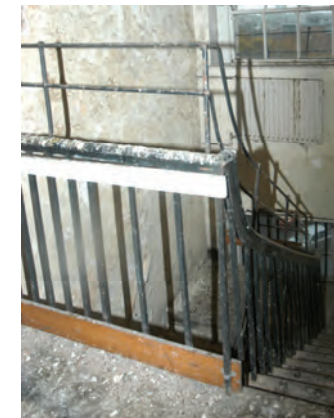
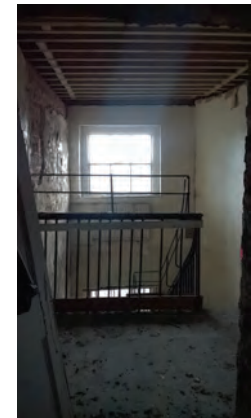
<b>TYPE AND DESCRIPTION OF FABRIC</b> Staircase: granite stairs; wrought iron balusters and handrail.
<b>BUILDING PHASE</b> C18th
<b>CONDITION</b> Poor—fair

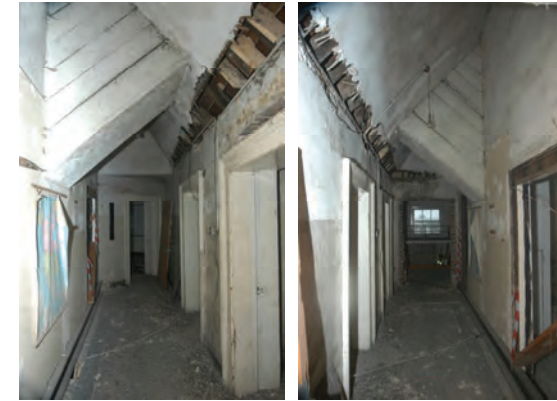
<b>TYPE AND DESCRIPTION OF FABRIC</b> Ceiling: coved ceiling with plaster finish
<b>BUILDING PHASE</b> C18th
<b>CONDITION</b> Poor

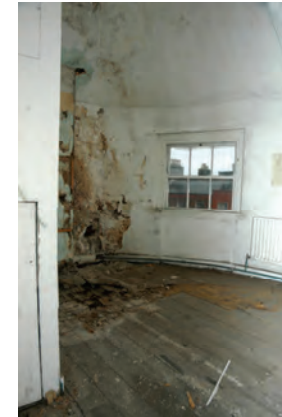
TYPE AND DESCRIPTION OF FABRIC Ceiling: coved ceiling with plaster finish
BUILDING PHASE C18th
CONDITION Poor

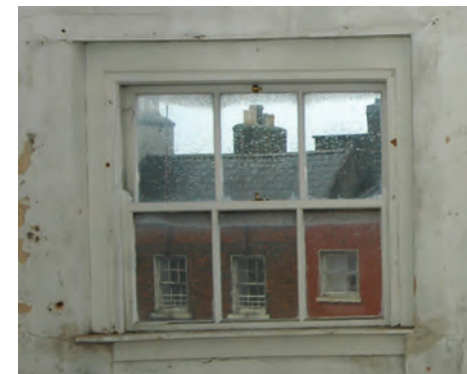
TYPE AND DESCRIPTION OF FABRIC Window, S (LHS internally): timber casing; 3-over-3 sliding timber sashes.
BUILDING PHASE C18th—C19th
CONDITION Poor

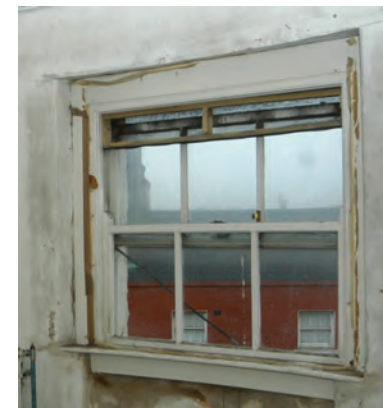
TYPE AND DESCRIPTION OF FABRIC Window, N (RHS internally): timber casing; 3-over-3 sliding timber sashes.
BUILDING PHASE C18th—C20th
CONDITION Poor

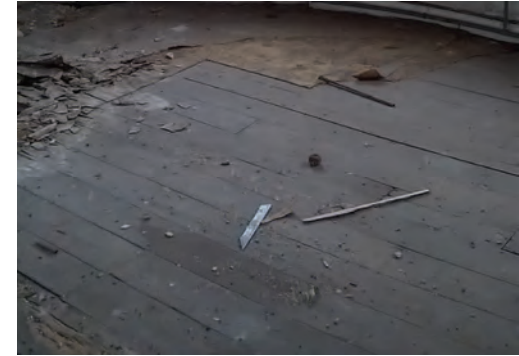
TYPE AND DESCRIPTION OF FABRIC Floor: timber boards
BUILDING PHASE C18th
CONDITION V. Poor

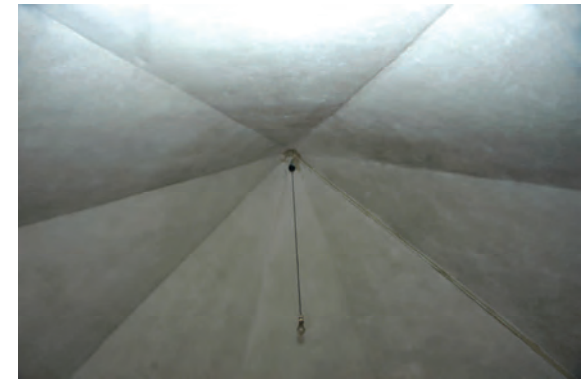
<b>TYPE AND DESCRIPTION OF FABRIC</b> Ceiling: segmental covered ceiling with plaster finish.
<b>BUILDING PHASE</b> C18th
<b>CONDITION</b> Fair

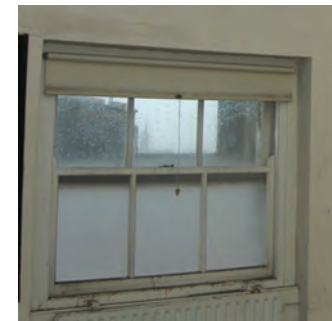
<b>TYPE AND DESCRIPTION OF FABRIC</b> Window, S (LHS internally): timber casing; 3-over-3 sliding timber sashes.
<b>BUILDING PHASE</b> C18th—C19th
<b>CONDITION</b> Poor—fair

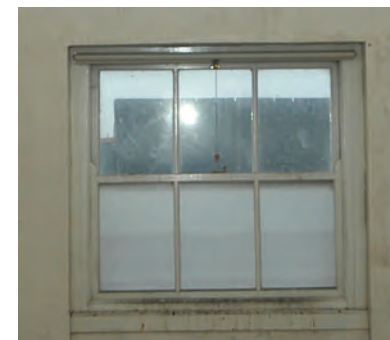
<b>TYPE AND DESCRIPTION OF FABRIC</b> Window, centre: timber casing; 3-over-3 sliding timber sashes.
<b>BUILDING PHASE</b> C18th—C19th
<b>CONDITION</b> Poor—fair

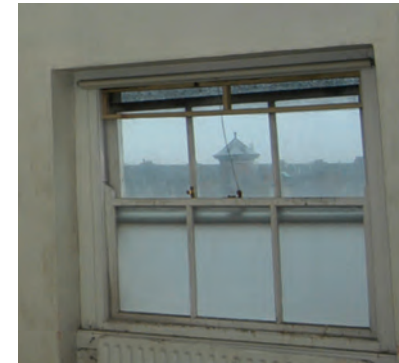
<b>TYPE AND DESCRIPTION OF FABRIC</b> Window, N (RHS internally): timber casing; 3-over-3 sliding timber sashes.
<b>BUILDING PHASE</b> C18th—C19th
<b>CONDITION</b> Poor

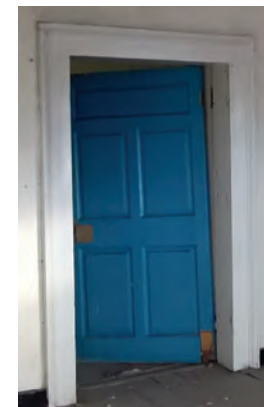
<b>TYPE AND DESCRIPTION OF FABRIC</b> Door to rear reception room: timber casing; timber architrave; 5-panel timber door leaf.
<b>BUILDING PHASE</b> C18th
<b>CONDITION</b> Poor

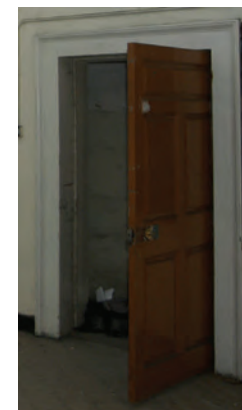
<b>TYPE AND DESCRIPTION OF FABRIC</b> Door to inner hall: timber casing; timber architrave; 5-panel timber door leaf.
<b>BUILDING PHASE</b> C18th
<b>CONDITION</b> Poor—fair

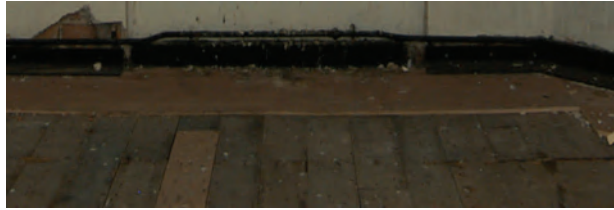
TYPE AND DESCRIPTION OF FABRIC Floor: timber boards and plywood sheeting

BUILDING PHASE C18th—C20th	
CONDITION Poor

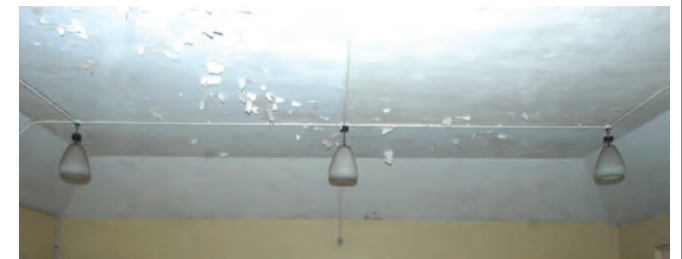
<b>TYPE AND DESCRIPTION OF FABRIC</b> Ceiling: coved ceiling with plaster finish
<b>BUILDING PHASE</b> C18th
<b>CONDITION</b> Poor

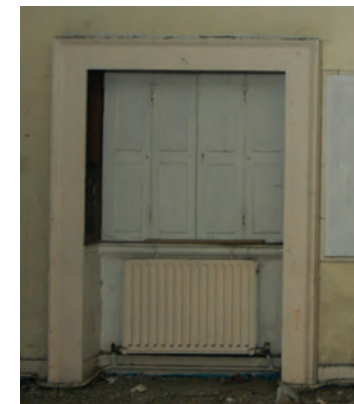
<b>TYPE AND DESCRIPTION OF FABRIC</b> Window, W (LHS internally): timber casing with panelled shutters; timber architrave extending to floor.
<b>BUILDING PHASE</b> C18th
<b>CONDITION</b> Poor—fair

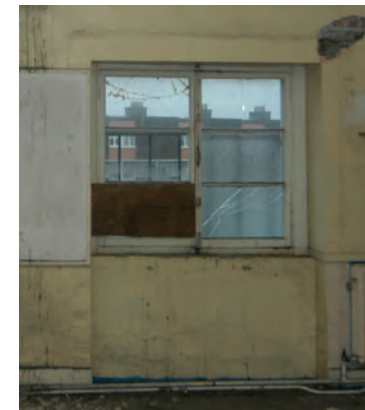
<b>TYPE AND DESCRIPTION OF FABRIC</b> Window, E (RHS internally): timber casing; 2no. side-hung timber opening casements, each having 2no. horizontal mullions.
<b>BUILDING PHASE</b> C20th
<b>CONDITION</b> Poor

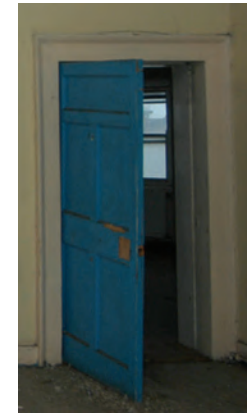
TYPE AND DESCRIPTION OF FABRIC Door to octagonal room: timber casing; timber architrave; 5-panel timber door leaf.
BUILDING PHASE C18th
CONDITION Poor

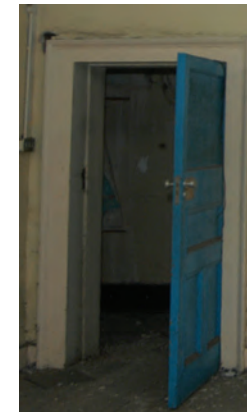
TYPE AND DESCRIPTION OF FABRIC Door to inner hall: timber casing; timber architrave; 5-panel timber door leaf.
BUILDING PHASE C18th
CONDITION Poor

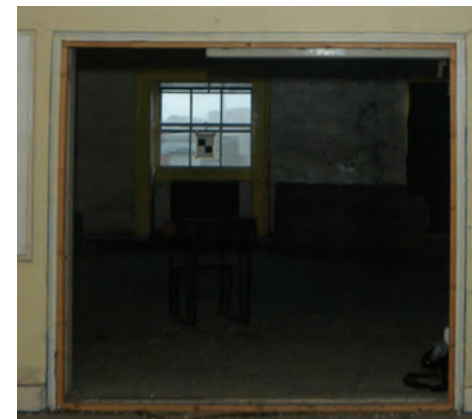
TYPE AND DESCRIPTION OF FABRIC Door to front reception room: large square-headed opening; timber casing.
BUILDING PHASE C18th—C20th
CONDITION Poor

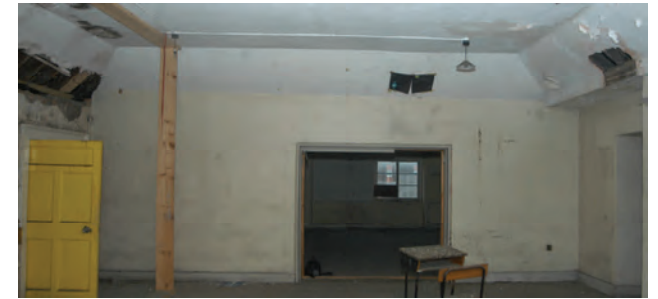
TYPE AND DESCRIPTION OF FABRIC Ceiling: coved ceiling with plaster finish
BUILDING PHASE C18th
CONDITION V. Poor

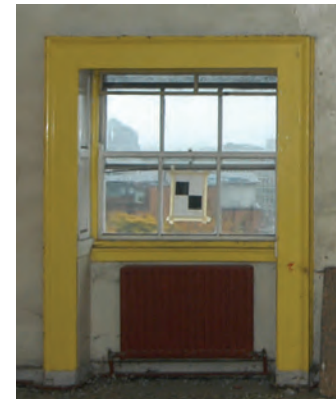
TYPE AND DESCRIPTION OF FABRIC Window, E (LHS internally): timber casing; 3-over-3 timber sliding sashes; timber architrave extending to floor.
BUILDING PHASE C18th—C19th
CONDITION Poor

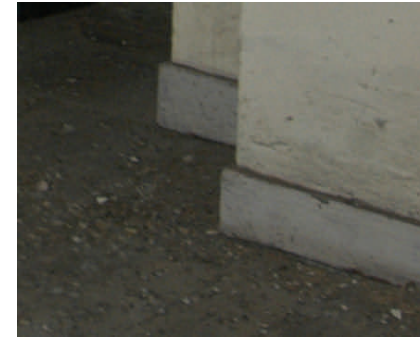
TYPE AND DESCRIPTION OF FABRIC Skirting: timber profile
BUILDING PHASE C18th—C20th
CONDITION Poor

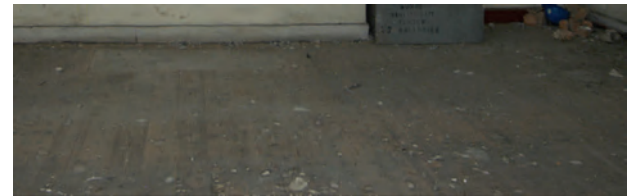
TYPE AND DESCRIPTION OF FABRIC Floor: timber boards
BUILDING PHASE C18th—C20th
CONDITION Poor
