Project Opera Limerick

Infrastructure Report

Project number: 60568520

8 March 2019

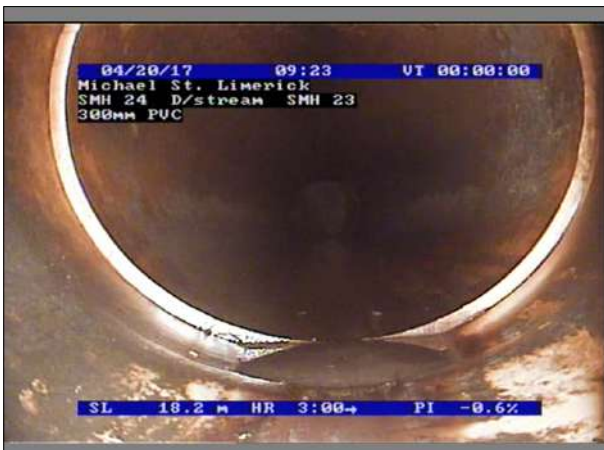
Photo: 3_3_22_A.jpg, 00:02:32
 18.2m, Open joint, medium

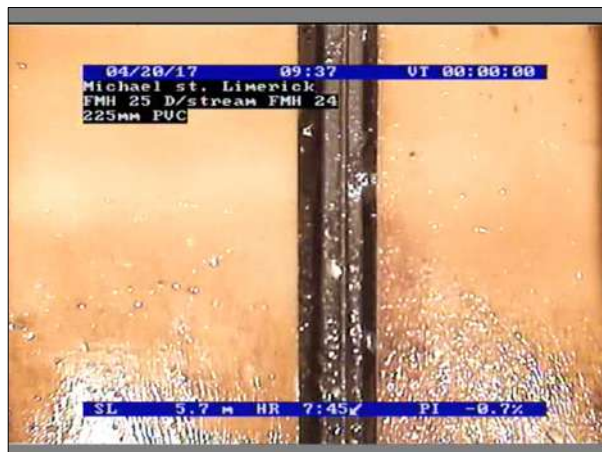
Photo: 4_4_26_A.jpg, 00:00:50
5.7m, Open joint, medium

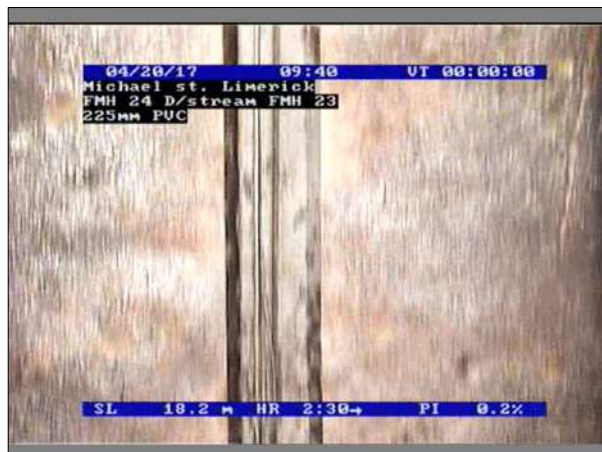
Photo: 5_5_30_A.jpg, 00:02:12
 18.2m, Open joint, medium

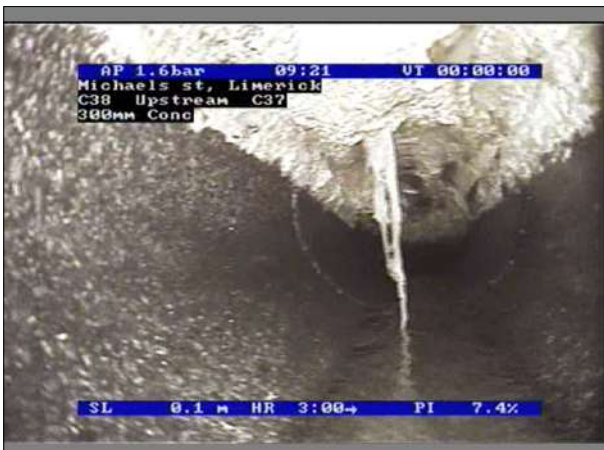
Photo: 8_8_35_A.jpg, 00:00:17
 0.1m, Attached deposits, grease, from 10 to 2 o'clock, 10% cross-sectional area loss
 Remarks: Jet unable to remove,

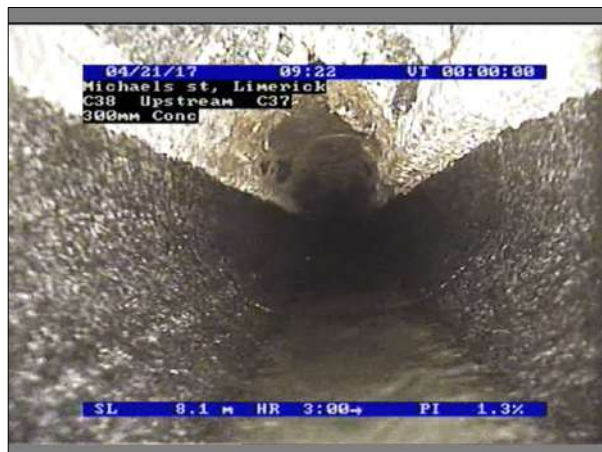
Photo: 8.8_38_A.jpg, 00:01:44
 8.1m, Attached deposits, grease, from 10 to 2 o'clock, 10% cross-sectional area loss
 Remarks: continuous

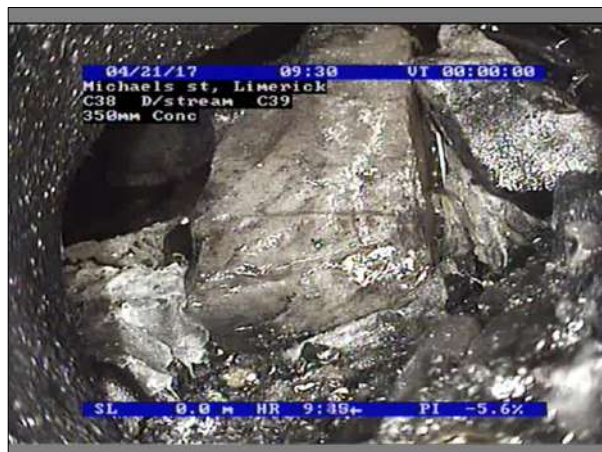
Photo: 9_9_41_A.jpg, 00:00:02
 0m, Other obstacles, brick or masonry in invert, from 12 to 12 o'clock, 95% cross-sectional area loss Remarks: pipe fully blocked. possibly collapsed, unable to determine

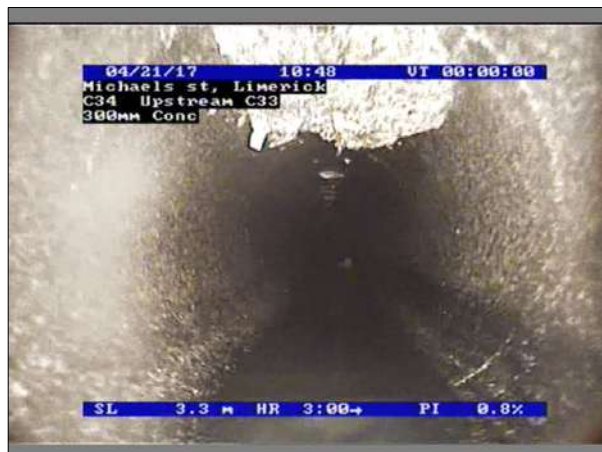
Photo: 11_11_45_A.jpg, 00:00:21
 3.3m, Attached deposits, fouling, from 12 to 2 o'clock, 5% cross-sectional area loss

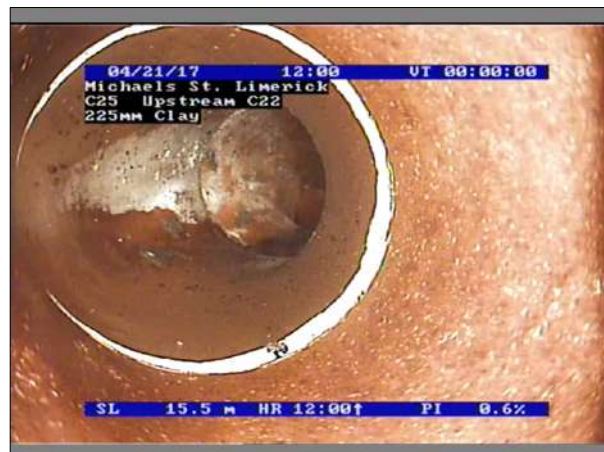
Photo: 12_12_50_A.jpg, 00:03:03
 15.5m, Connection other than junction, at 12 o'clock, diameter 100mm

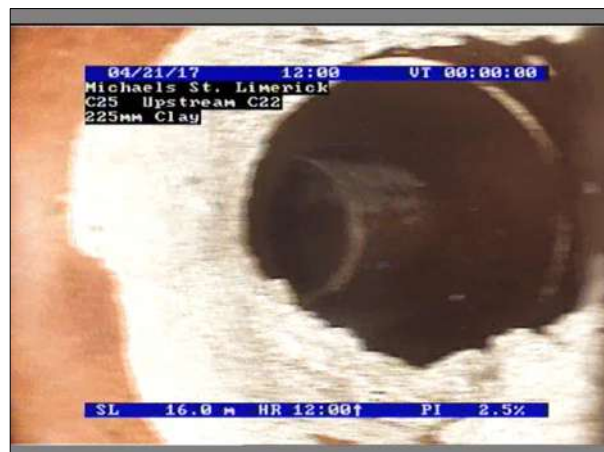
Photo: 12_12_52_A.jpg, 00:03:38
 16m, Connection other than junction, at 12 o'clock, diameter 100mm

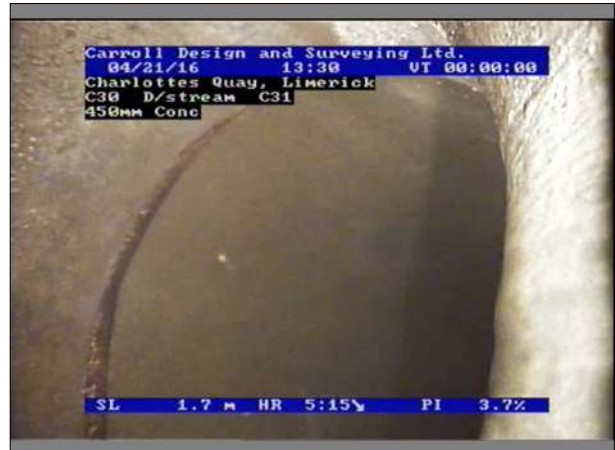
Photo: 13_13_314_A.jpg, 00:00:44
 1.7m, Connection other than junction, at 6 o'clock, diameter 450mm Remarks: backdrop

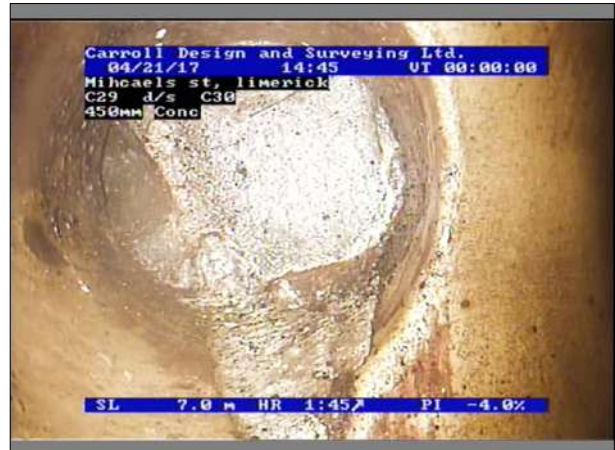
Photo: 15_15_321_A.jpg, 00:01:21
 7m, Connection other than junction, closed, at 2 o'clock,
 diameter 150mm

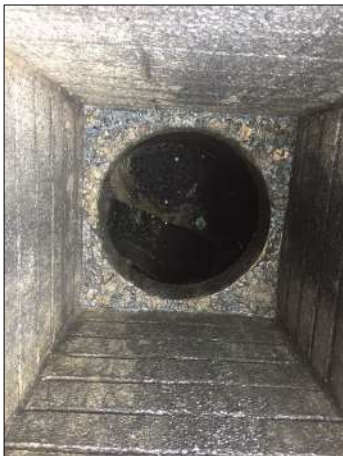
Photo: 2017-04-28-PHOTO-00000052.jpg
 9.01m, General photograph taken at this point Remarks:
 manhole C30 picture

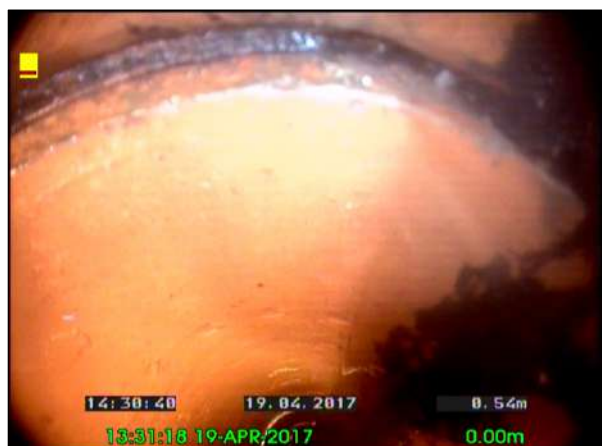
Photo: 16_16_59_A.jpg, 00:00:38
 0.33m, Joint displaced, medium

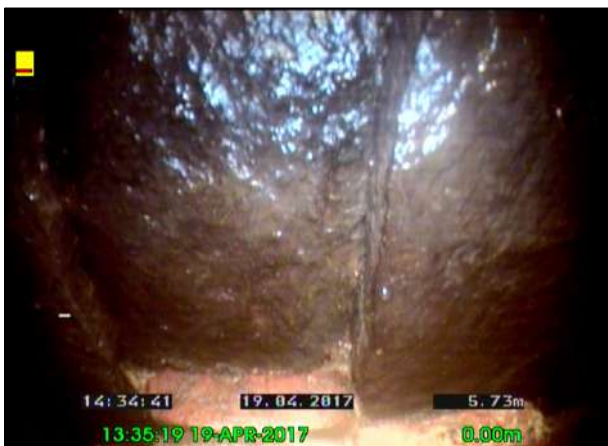
Photo: 16_16_62_A.jpg, 00:04:39
 5.73m, General remark Remarks: CHAMBER

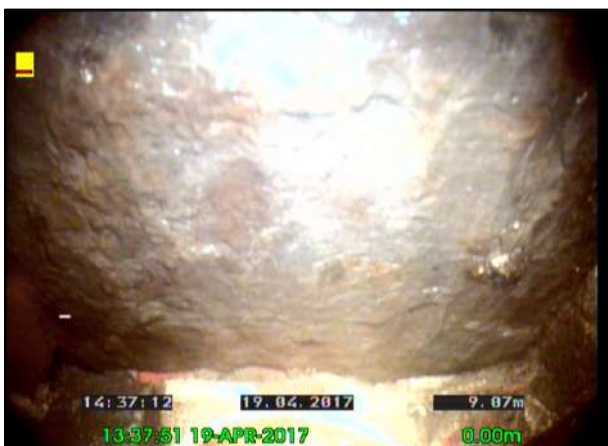
Photo: 16_16_65_A.jpg, 00:07:10
 9.87m, General remark Remarks: CHAMBER

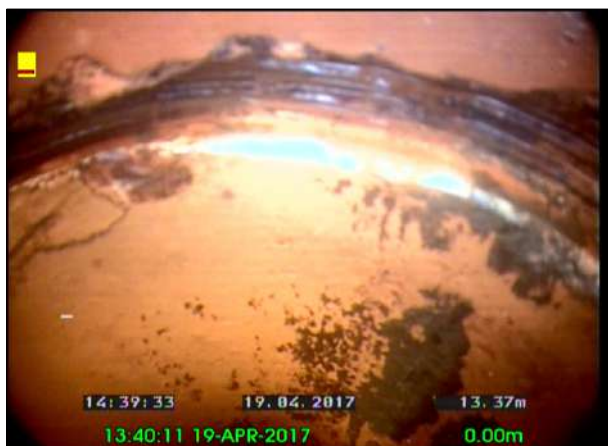
Photo: 16_16_69_A.jpg, 00:09:31
 13.37m, Open joint, medium

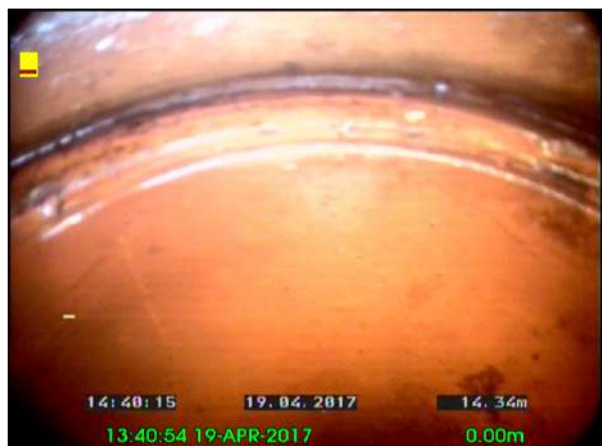
Photo: 16_16_70_A.jpg, 00:10:13
 14.34m, Open joint, medium

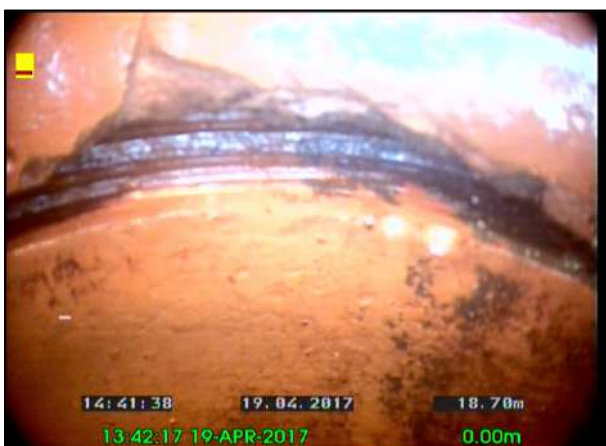
Photo: 16_16_71_A.jpg, 00:11:36
 18.78m, Open joint, medium

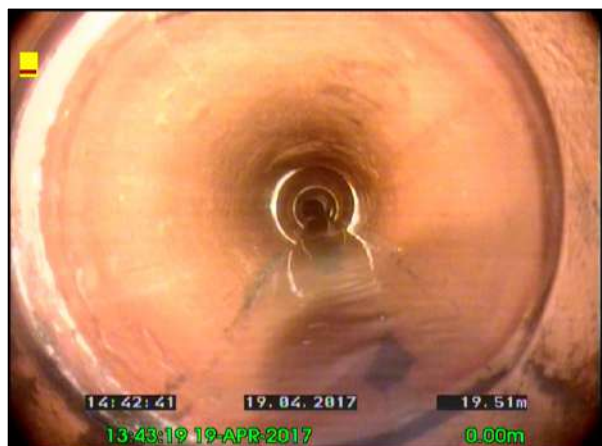
Photo: 16_16_74_A.jpg, 00:12:39
 19.51m, Joint displaced, medium

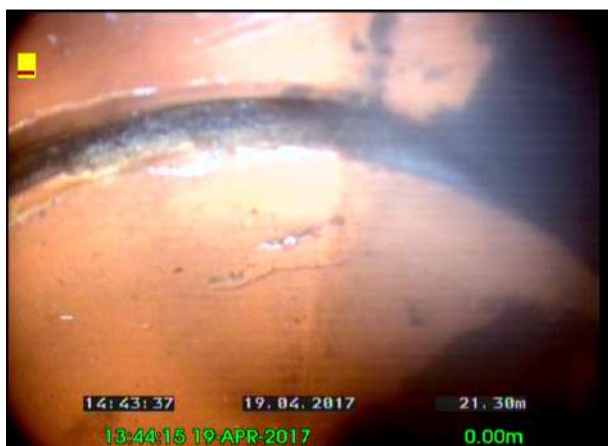
Photo: 16_16_75_A.jpg, 00:13:35
 21.38m, Open joint, medium

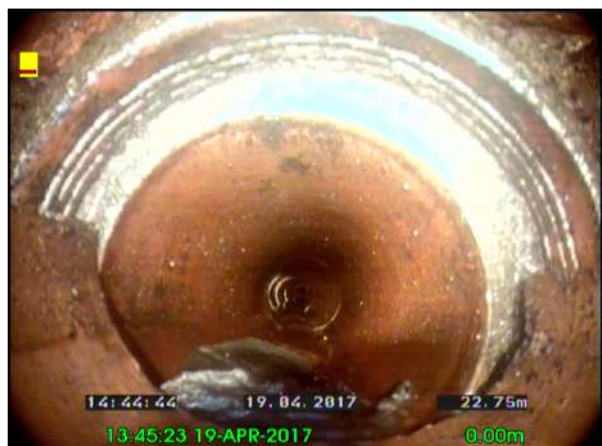
Photo: 16_16_79_A.jpg, 00:14:42
 22.75m, Joint displaced, large Remarks: LEAVING CHAMBER TO LINE

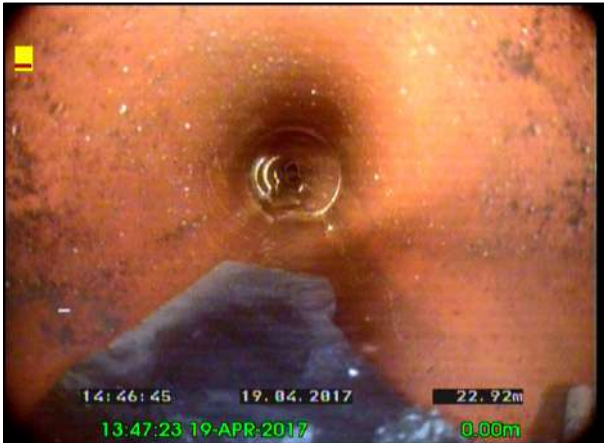
Photo: 16_16_80_A.jpg, 00:16:43
 22.92m, Other obstacles, other objects in invert at joint, from 5 to 7 o'clock, 10% cross-sectional area loss Remarks: CAUGHT IN DISPLACED JOINT UNABLE TO REMOVE

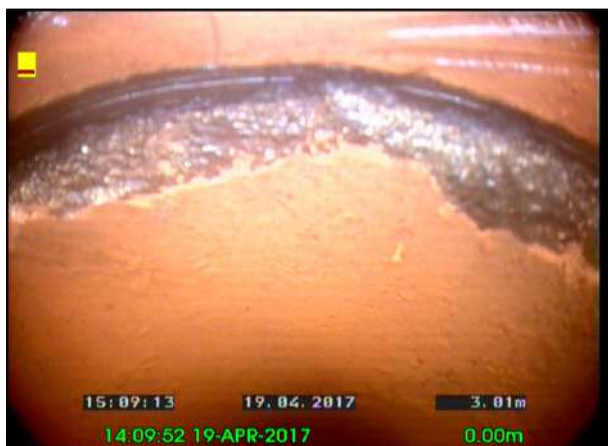
Photo: 17_17_85_A.jpg, 00:02:12
 3.01m, Open joint, medium

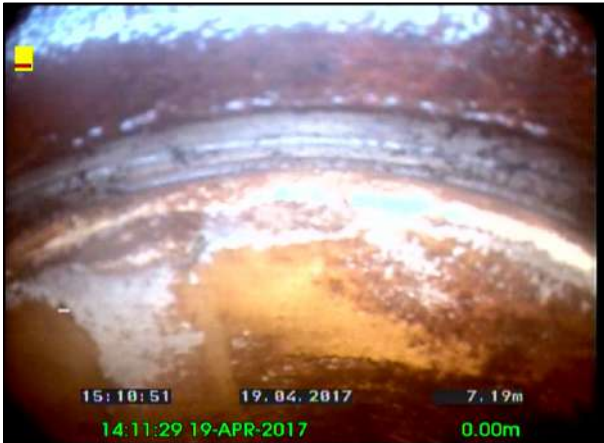
Photo: 17_17_87_A.jpg, 00:03:50
 7.19m, Open joint, medium

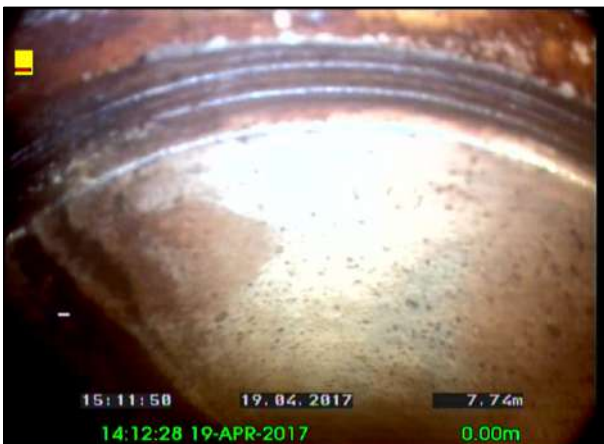
Photo: 17_17_89_A.jpg, 00:04:49
 7.74m, Open joint, medium

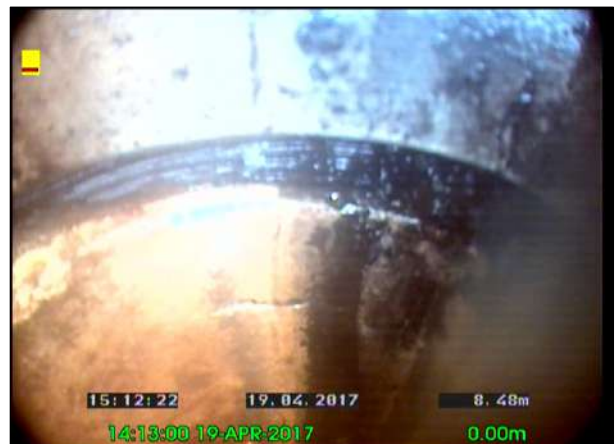
Photo: 17_17_90_A.jpg, 00:05:21
 8.48m, Open joint, medium

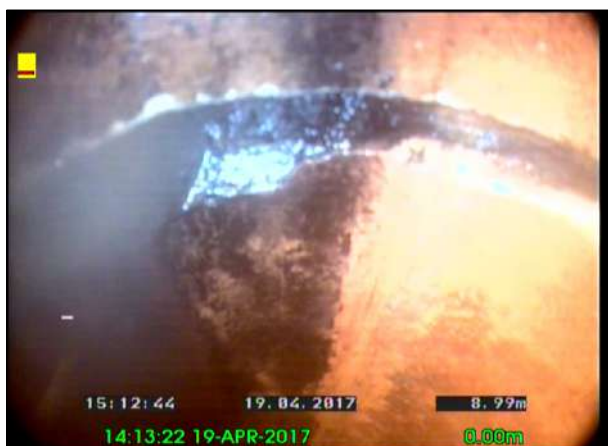
Photo: 17_17_91_A.jpg, 00:05:50
 8.99m, Open joint, medium

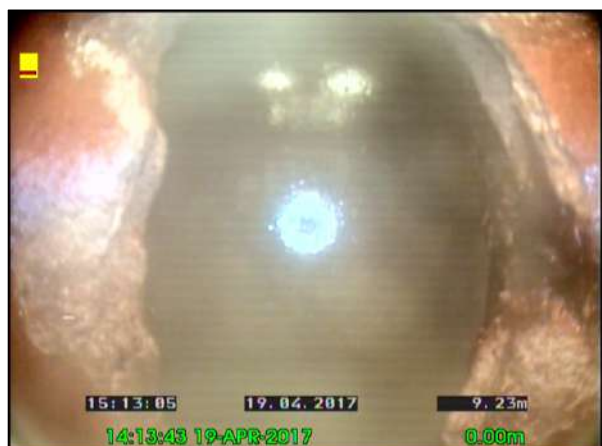
Photo: 17_17_92_A.jpg, 00:06:04
 9.22m, Hole in drain/sewer, at 12 o'clock Remarks: COVERED

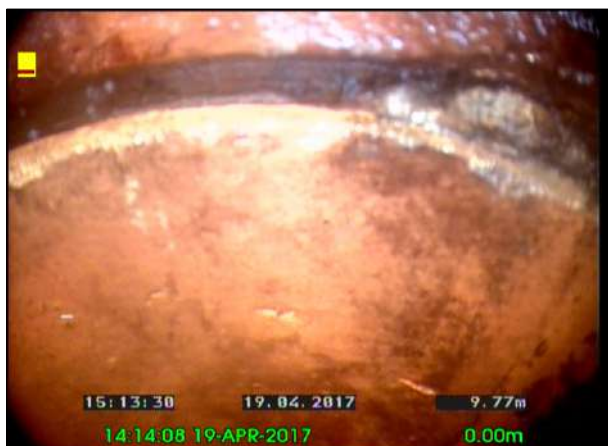
Photo: 17_17_93_A.jpg, 00:06:29
 9.76m, Open joint, medium

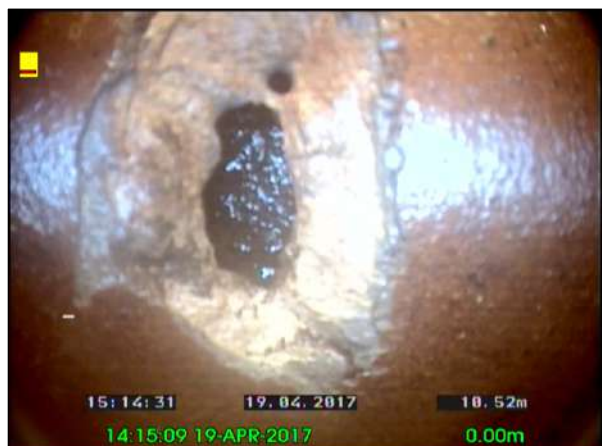
Photo: 17_17_94_A.jpg, 00:07:30
 10.52m, Hole in drain/sewer, at 12 o'clock Remarks: HOLE

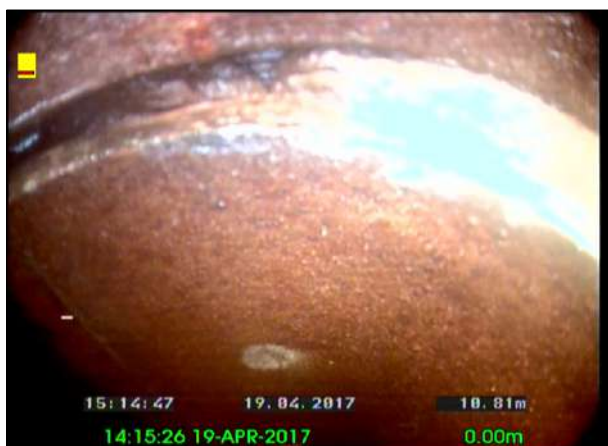
Photo: 17_17_95_A.jpg, 00:07:46
 10.8m, Open joint, medium

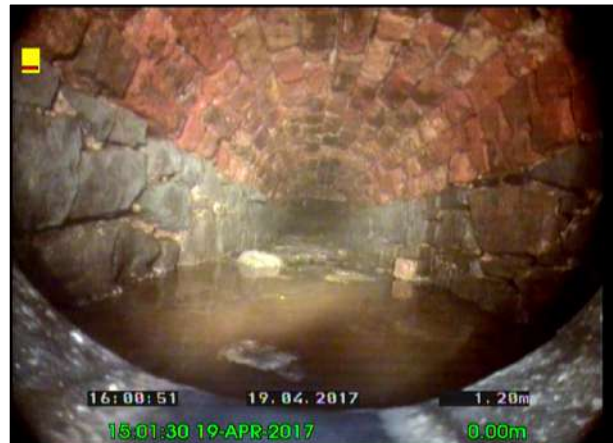
Photo: 19_19_109_A.jpg, 00:00:37
 1.2m, Start node type, major connection without manhole,
 reference number : C 7 Remarks: connecting to mainline culvert

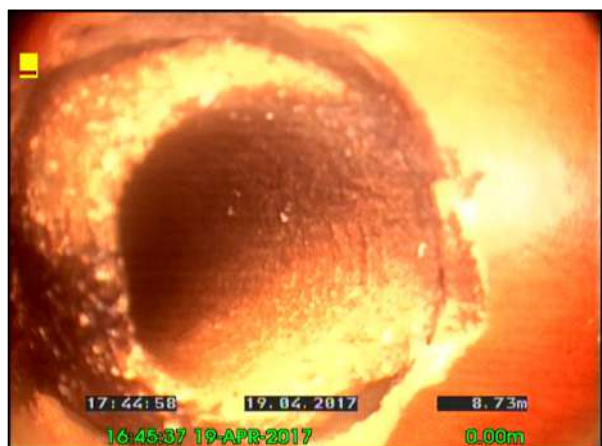
Photo: 20_20_115_A.jpg, 00:02:50
 8.73m, Connection other than junction, at 10 o'clock, diameter 100mm

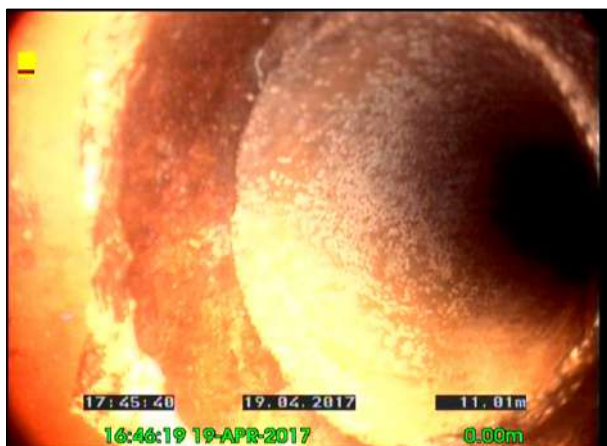
Photo: 20_20_116_A.jpg, 00:03:32
 11.01m, Connection other than junction, at 2 o'clock, diameter 100mm

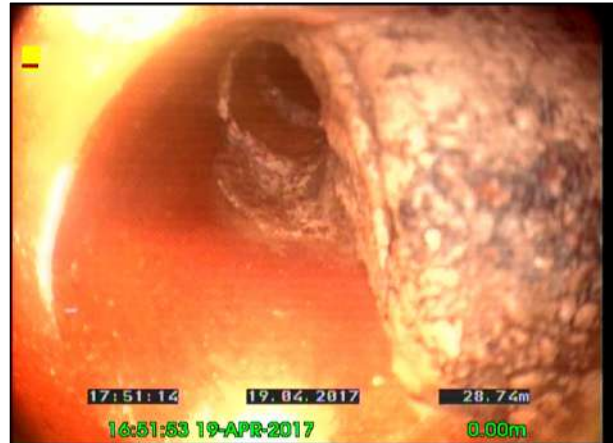
Photo: 20_20_123_A.jpg, 00:09:06
 28.74m, Connection other than junction, at 2 o'clock, diameter 100mm

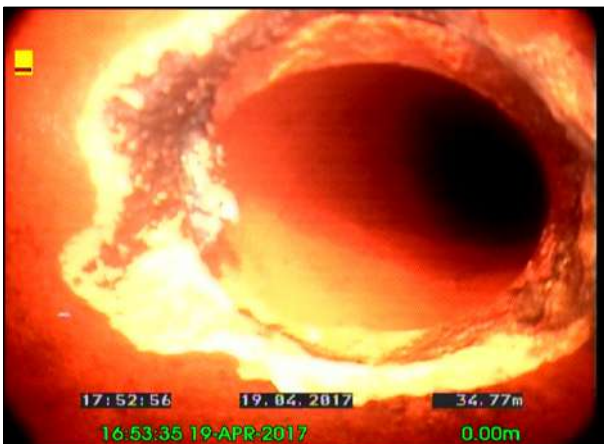
Photo: 20_20_125_A.jpg, 00:10:49
 34.77m, Connection other than junction, at 2 o'clock, diameter 100mm

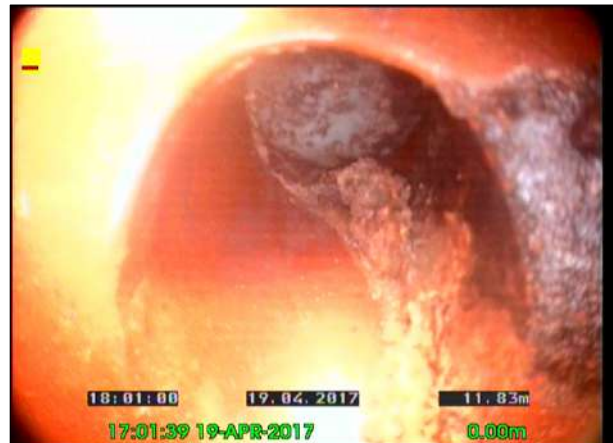
Photo: 21_21_130_A.jpg, 00:02:15
 11.83m, Connection other than junction, at 2 o'clock, diameter 100mm

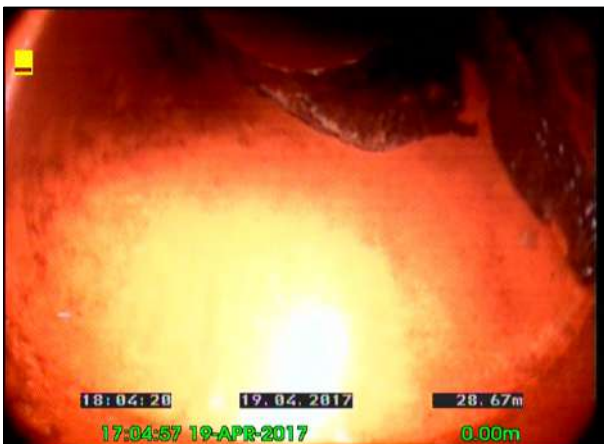
Photo: 21_21_131_A.jpg, 00:05:34
 28.67m, Connection other than junction, at 2 o'clock, diameter 100mm

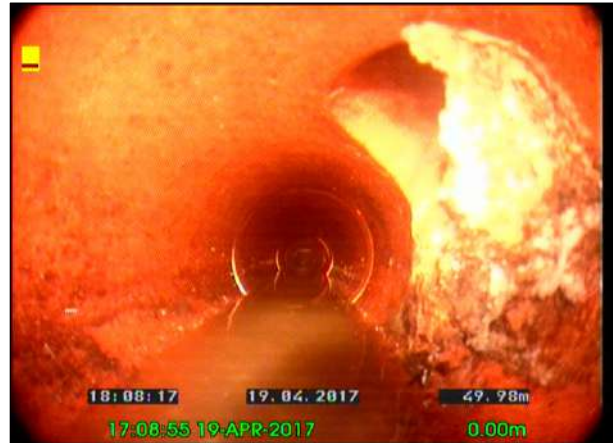
Photo: 21_21_134_A.jpg, 00:09:31
 49.98m, General photograph taken at this point Remarks: OF CONNECTION

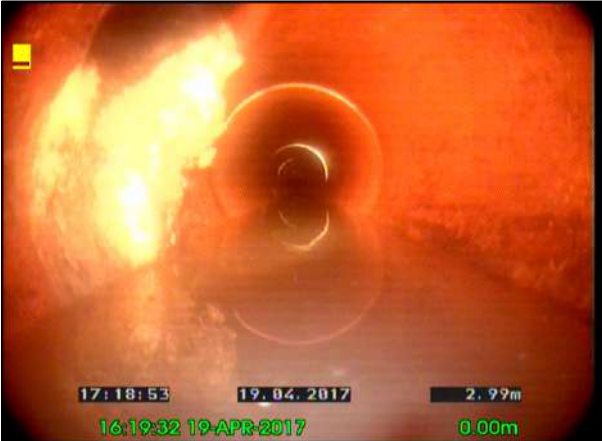
Photo: 22_22_140_A.jpg, 00:02:11
3.32m, General photograph taken at this point Remarks: OF
OBSTRUCTING CONNECTION

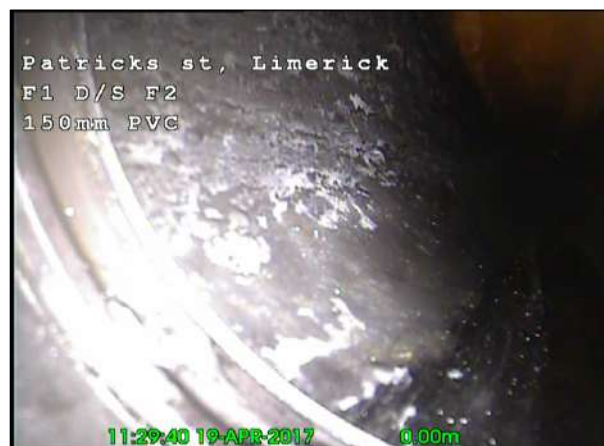
Photo: 28_28_164_A.jpg, 00:00:07
 0.1m, Open joint, medium

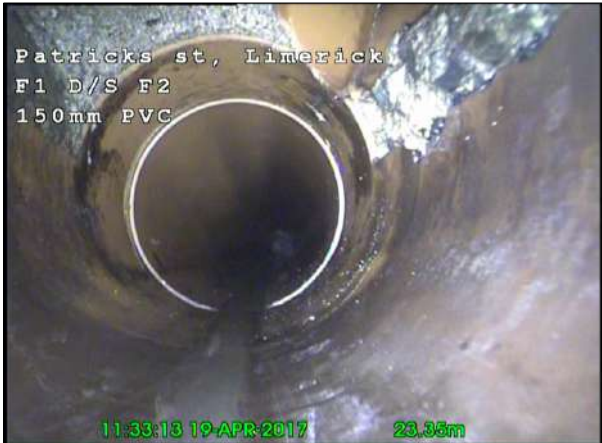
Photo: 28_28_167_A.jpg, 00:03:40
23.35m, Water level, 5% of the vertical dimension

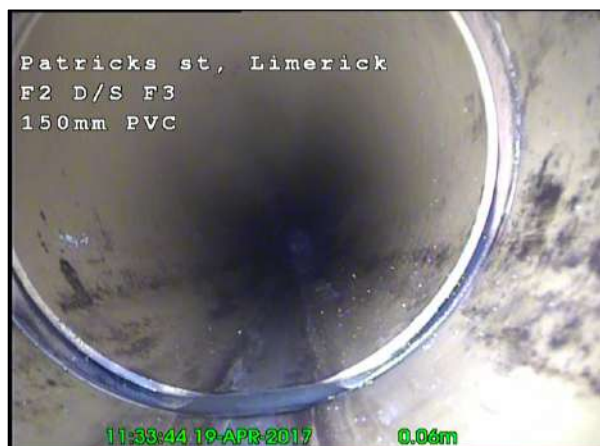
Photo: 29_29_171_A.jpg, 00:00:04
 0.1m, Open joint, medium Remarks: SEALING RING INTRUDING AT BOTTOM OF PIPE

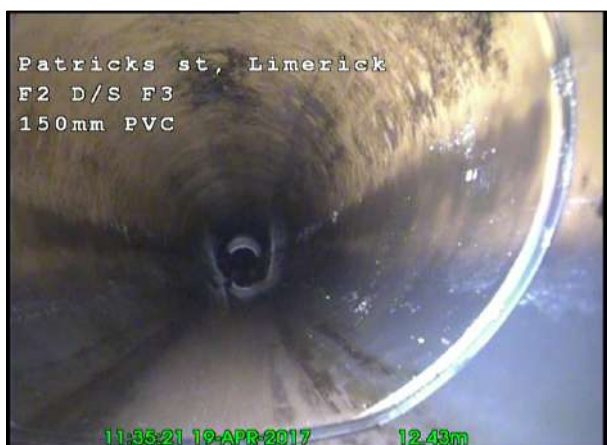
Photo: 29_29_172_A.jpg, 00:01:41
 12.43m, Open joint, medium

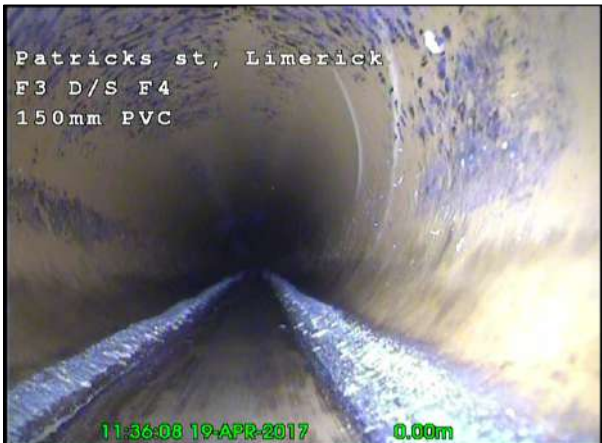
Photo: 30_30_175_A.jpg, 00:00:00
 0m, Start node type, manhole, reference number : FMH 3

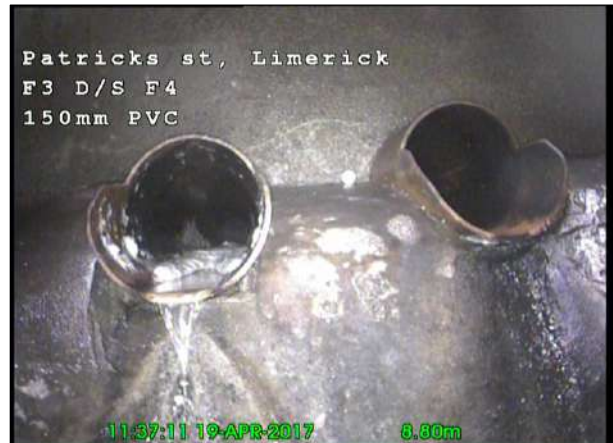
Photo: 30_30_178_A.jpg, 00:01:03
 8.8m, Finish node type, manhole reference number: FMH 4

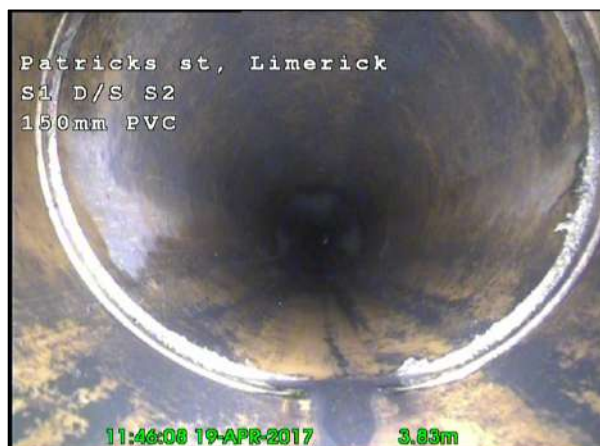
Photo: 31_31_181_A.jpg, 00:00:39
 3.83m, Open joint, medium

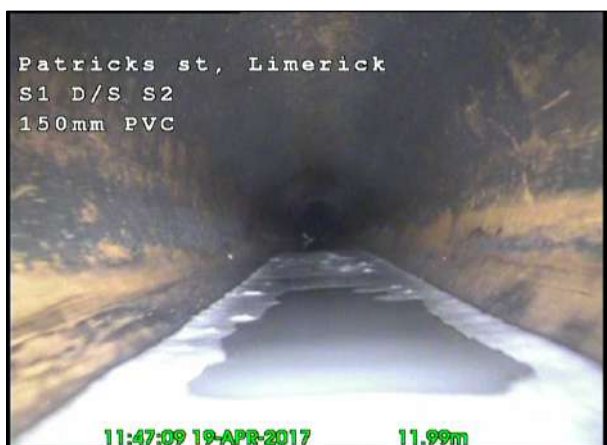
Photo: 31_31_182_A.jpg, 00:01:40
 11.99m, Water level, 10% of the vertical dimension Remarks:
 DIP IN LINE

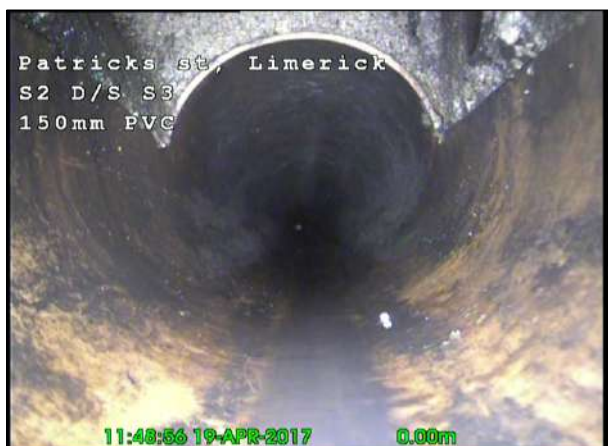
Photo: 32_32_186_A.jpg, 00:00:01
 0m, Start node type, manhole, reference number : SMH 2

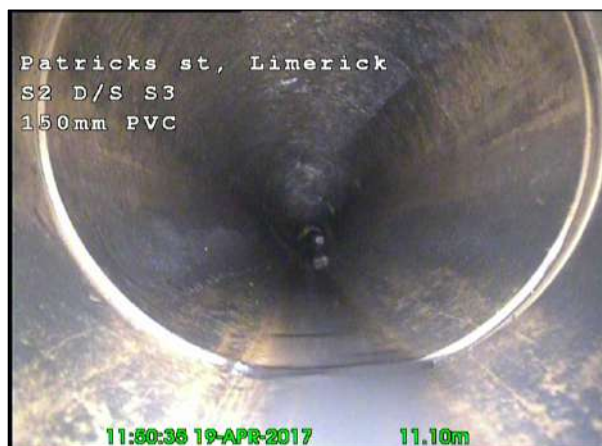
Photo: 32_32_188_A.jpg, 00:01:39
 11.1m, Open joint, medium

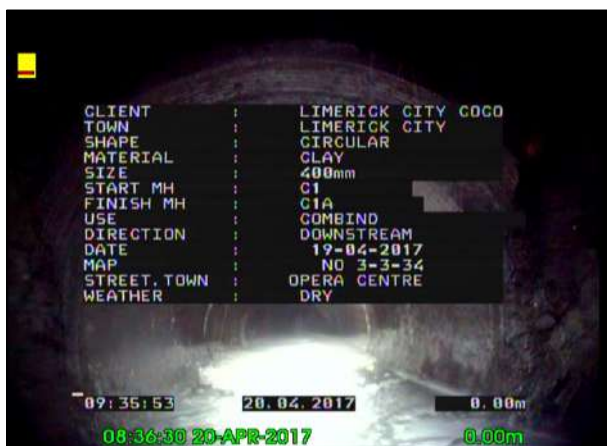
Photo: 33_33_191_A.jpg, 00:00:01
 0m, Start node type, manhole, reference number : C 1

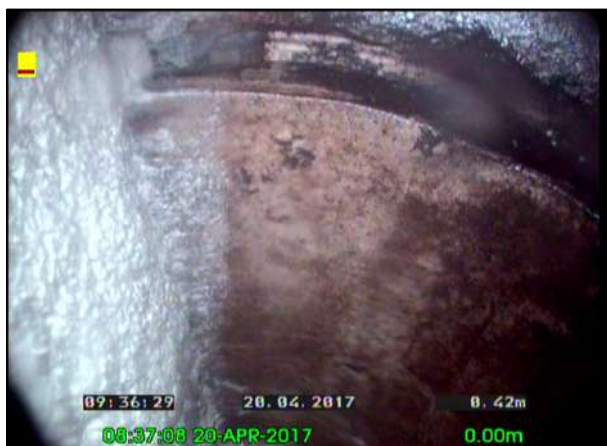
Photo: 33_33_193_A.jpg, 00:00:38
 0.42m, Open joint, medium

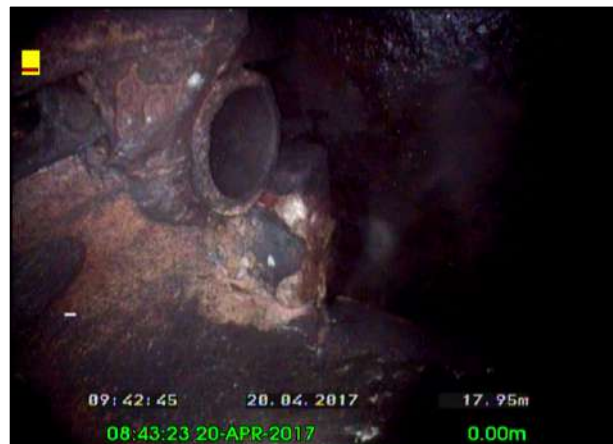
Photo: 33_33_200_A.jpg, 00:06:54
 17.95m, Connection other than junction, at 10 o'clock, diameter
 150mm

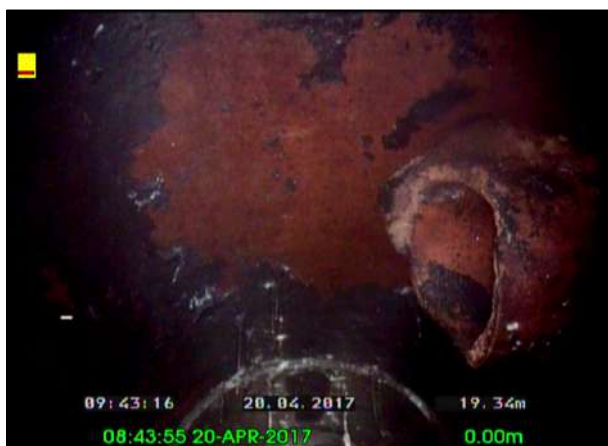
Photo: 33_33_201_A.jpg, 00:07:25
 19.34m, Connection other than junction, at 2 o'clock, diameter 150mm

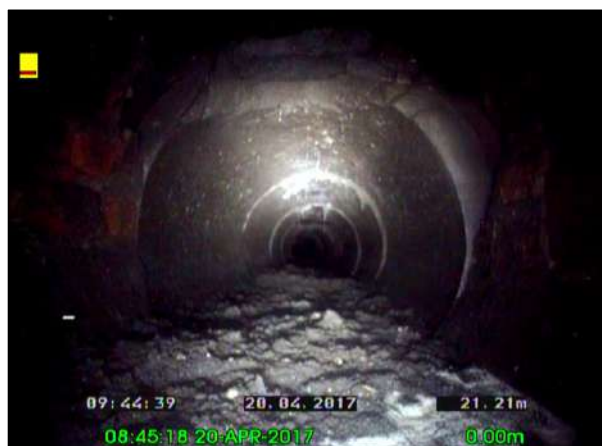
Photo: 33_33_202_A.jpg, 00:08:48
 21.21m, Settled deposits, fine, 20% cross-sectional area loss

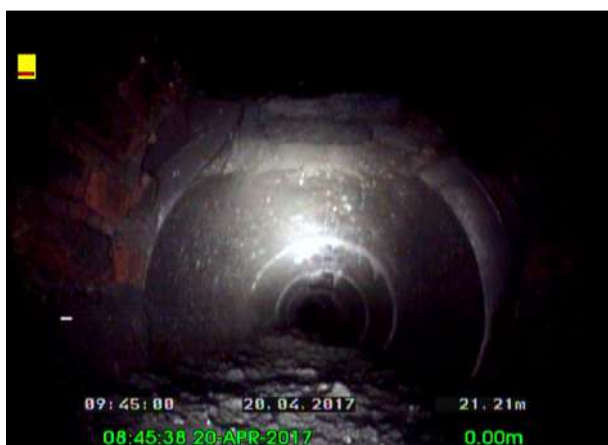
Photo: 33_33_203_A.jpg, 00:09:09
 21.21m, General remark Remarks: CHAMBER

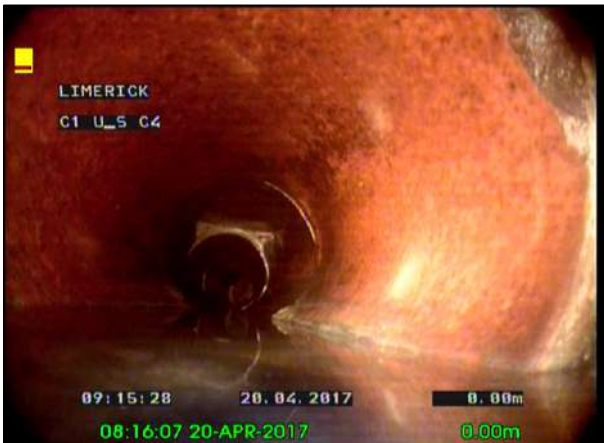
Photo: 34_34_205_A.jpg, 00:00:00
 0m, Start node type, manhole, reference number : C 1

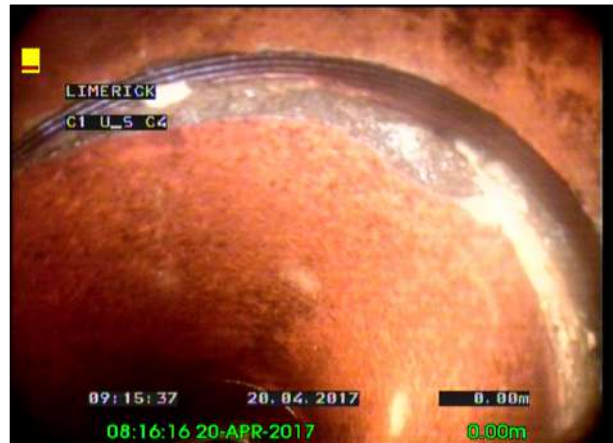
Photo: 34_34_207_A.jpg, 00:00:09
 0m, Open joint, medium

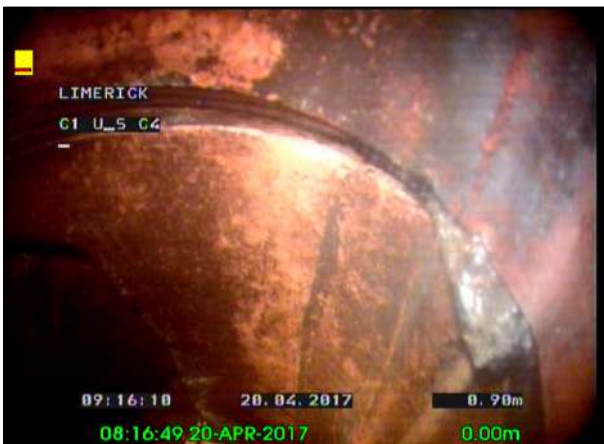
Photo: 34_34_208_A.jpg, 00:00:42
 0.9m, Open joint, medium

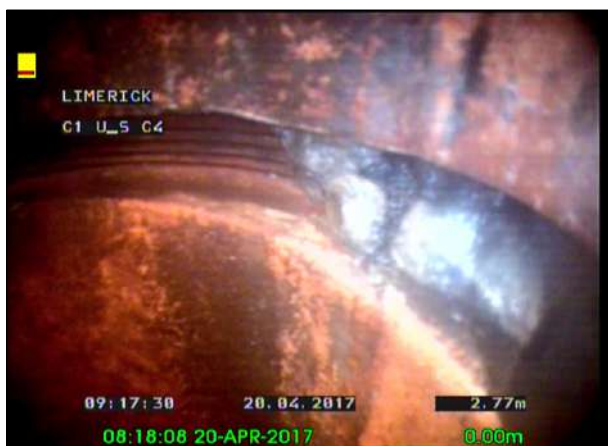
Photo: 34_34_210_A.jpg, 00:02:02
 2.77m, Open joint, medium

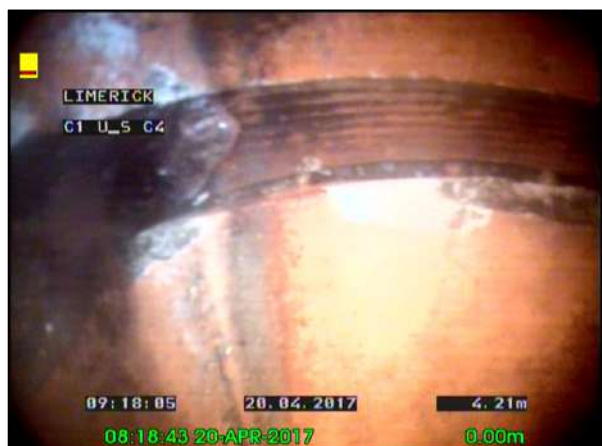
Photo: 34_34_211_A.jpg, 00:02:37
 4.21m, Open joint, medium

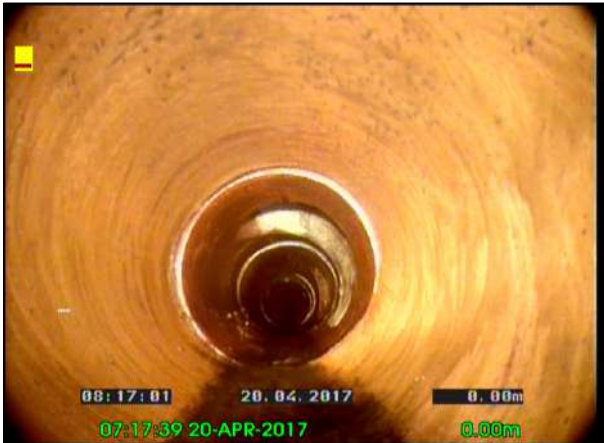
Photo: 35_35_214_A.jpg, 00:00:04
 0m, Start node type, manhole, reference number : C 2

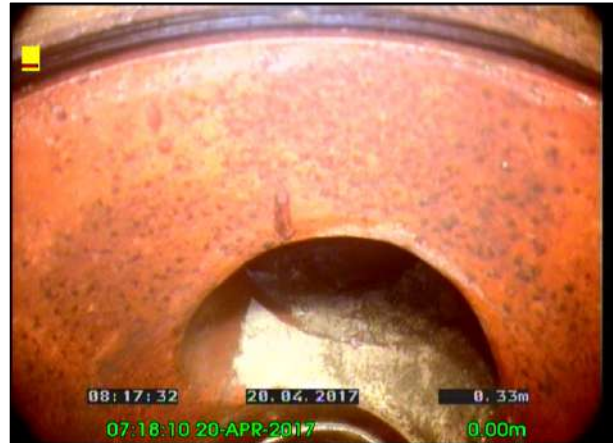
Photo: 35_35_216_A.jpg, 00:00:36
 0.33m, Open joint, medium

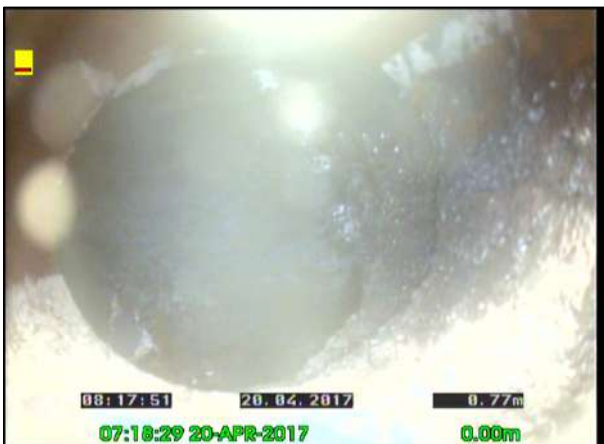
Photo: 35_35_217_A.jpg, 00:00:55
 0.77m, Connection other than junction, at 12 o'clock, diameter 150mm

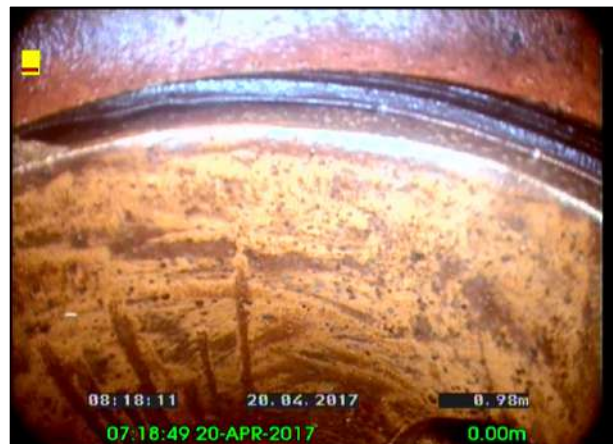
Photo: 35_35_218_A.jpg, 00:01:15
 0.98m, Open joint, medium

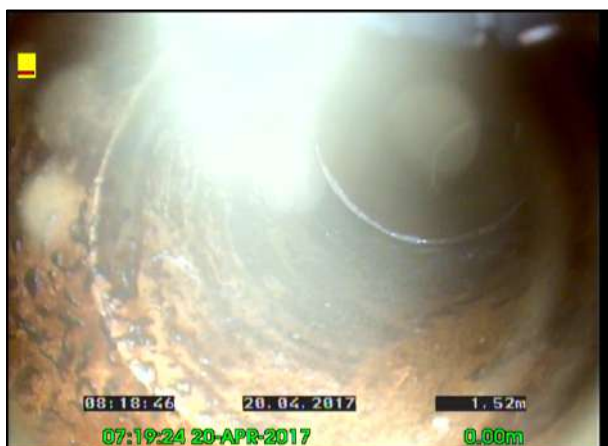
Photo: 35_35_219_A.jpg, 00:01:49
 1.52m, Connection other than junction, at 2 o'clock, diameter 150mm

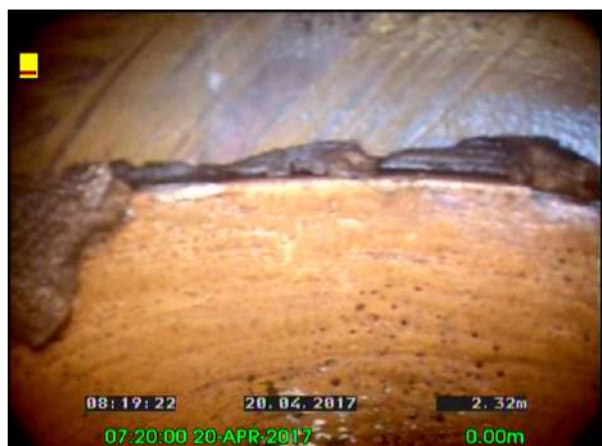
Photo: 35_35_220_A.jpg, 00:02:25
 2.32m, Open joint, medium

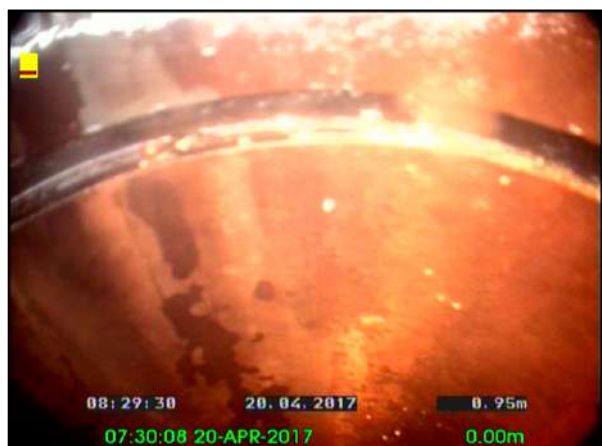
Photo: 36_36_227_A.jpg, 00:00:29
 0.95m, Open joint, medium

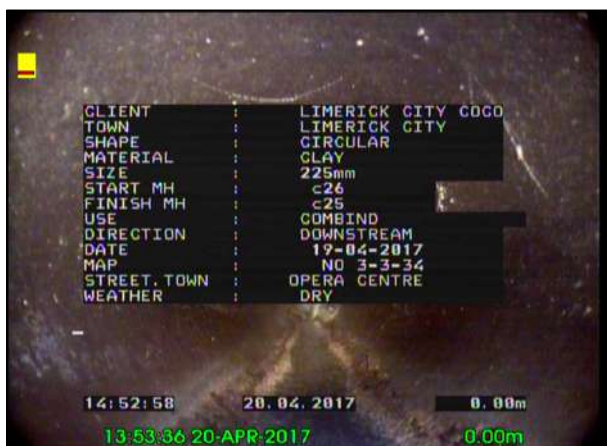
Photo: 37_37_230_A.jpg, 00:00:00
 0m, Start node type, manhole, reference number : C 26

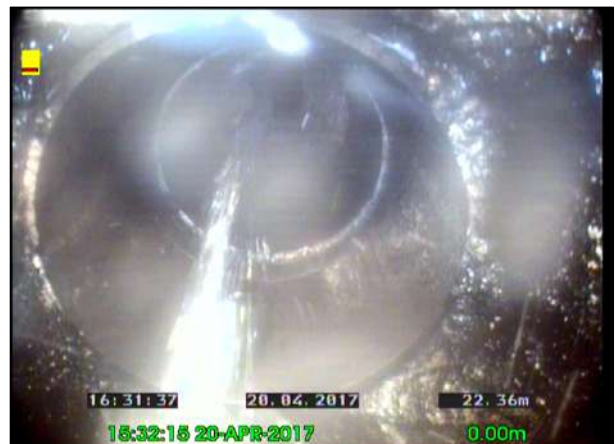
Photo: 38_38_240_A.jpg, 00:03:09
 22.36m, Connection other than junction, at 12 o'clock, diameter 150mm

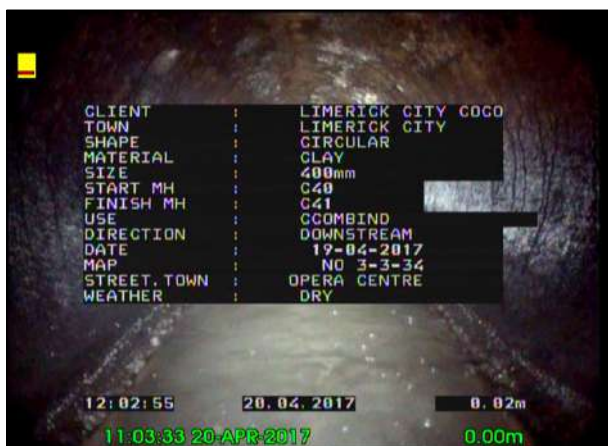
Photo: 39_39_243_A.jpg, 00:00:01
 0m, Start node type, manhole, reference number : C 40

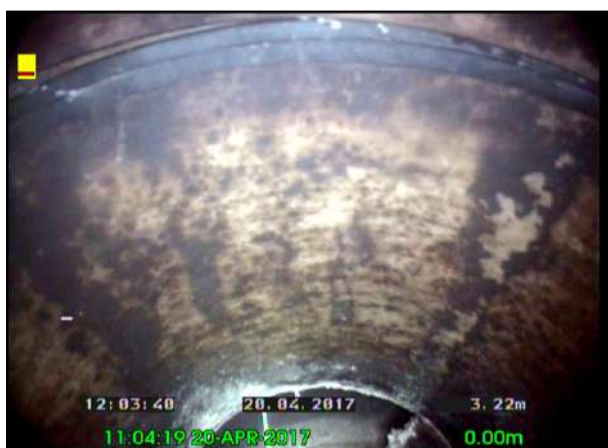
Photo: 39_39_245_A.jpg, 00:00:47
 3.22m, Open joint, medium

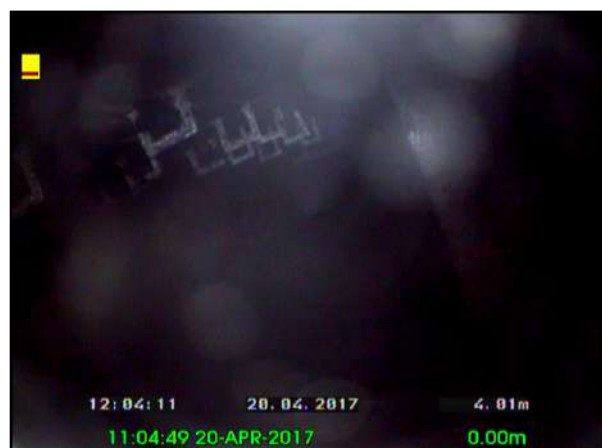
Photo: 39_39_246_A.jpg, 00:01:18
 4.01m, General remark Remarks: INTERMEDIATE BURIED
 MANHOLE ON LINE

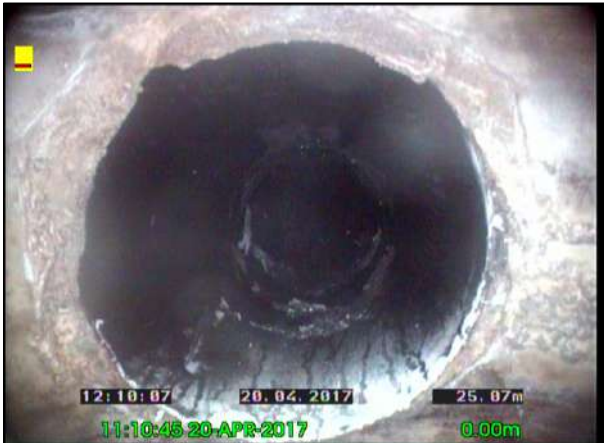
Photo: 39_39_249_A.jpg, 00:05:24
 25.87m, Connection other than junction, at 12 o'clock, diameter 225mm

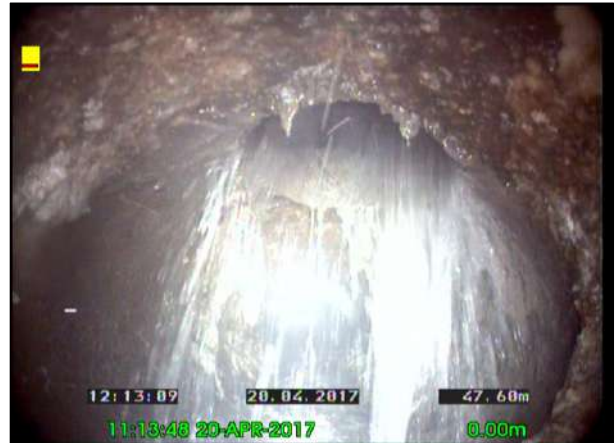
Photo: 39_39_250_A.jpg, 00:08:27
 47.6m, Connection other than junction, at 12 o'clock, diameter 150mm

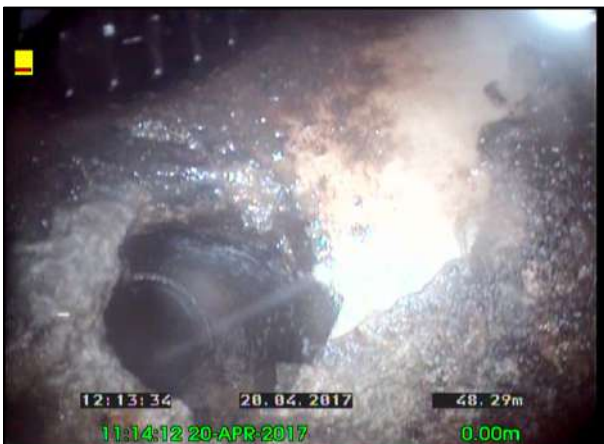
Photo: 39_39_251_A.jpg, 00:08:52
 48.3m, Connection other than junction, at 9 o'clock, diameter 150mm

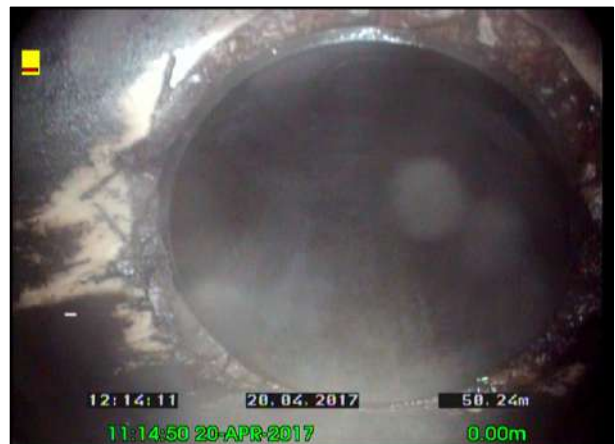
Photo: 39_39_252_A.jpg, 00:09:29
 50.24m, Connection other than junction, at 12 o'clock, diameter 150mm

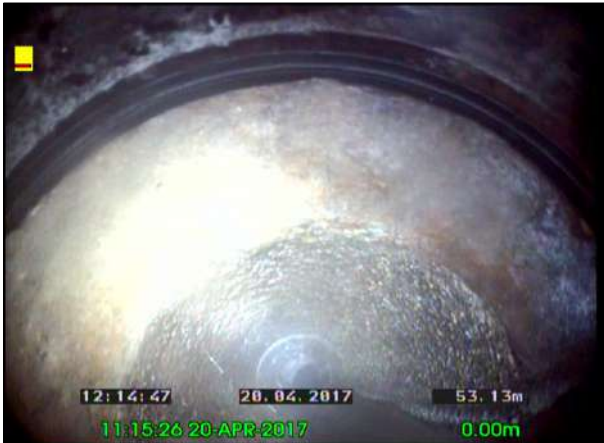
Photo: 39_39_253_A.jpg, 00:10:04
 53.13m, Open joint, medium

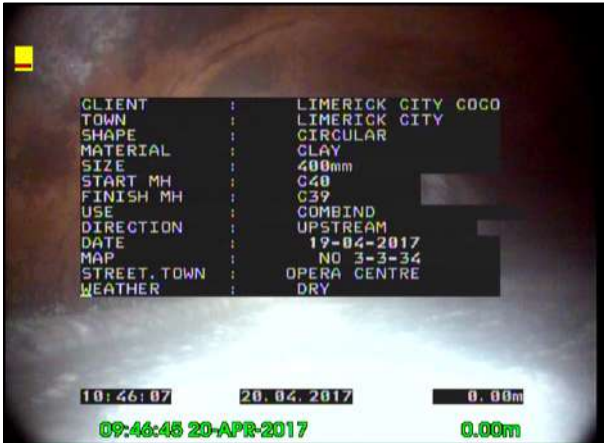
Photo: 40_40_257_A.jpg, 00:00:01
 0m, Start node type, manhole, reference number : C 40
