Project Opera Limerick

Infrastructure Report

Project number: 60568520

8 March 2019

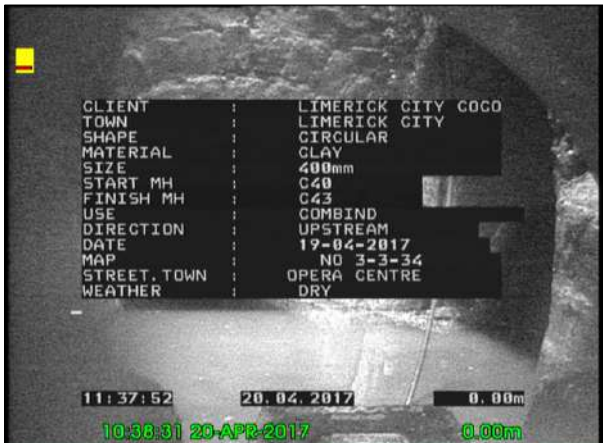
Photo: 41_41_259_A.jpg, 00:00:00
 0m, Start node type, manhole, reference number : C 40

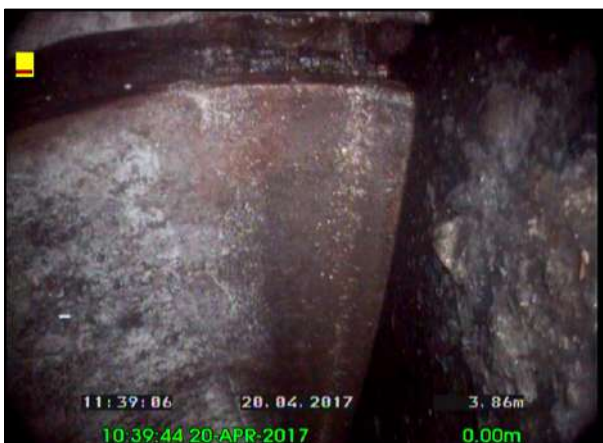
Photo: 41_41_261_A.jpg, 00:01:13
 3.86m, Open joint, medium

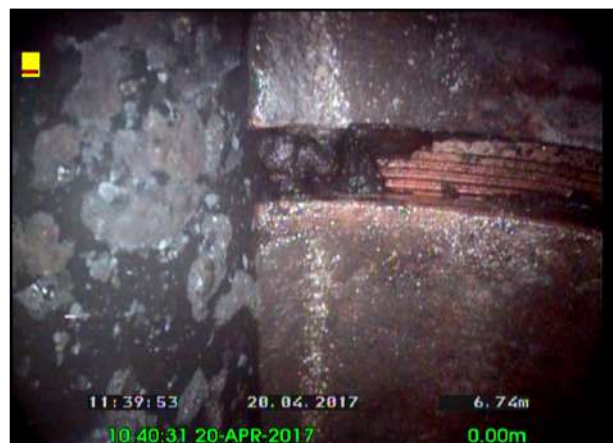
Photo: 41_41_262_A.jpg, 00:02:00
 6.74m, Open joint, medium

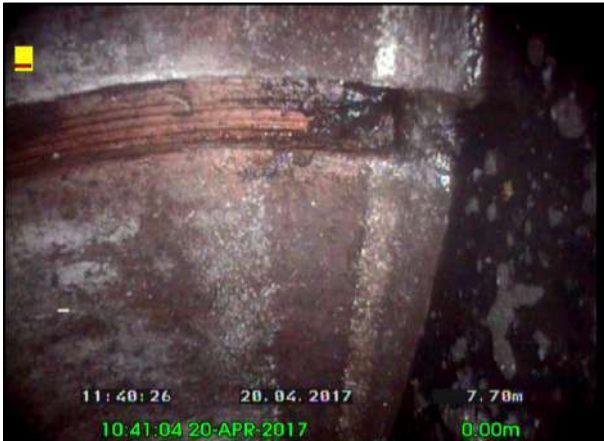
Photo: 41_41_263_A.jpg, 00:02:33
 7.78m, Open joint, medium

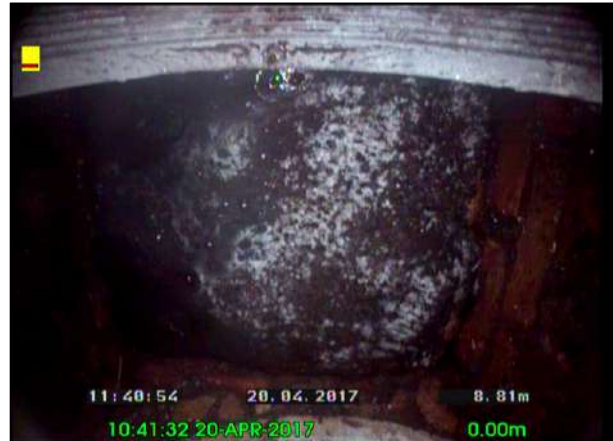
Photo: 41_41_264_A.jpg, 00:03:01
 8.81m, General remark Remarks: BURIED MANHOLE
 CHAMBER ON LINE

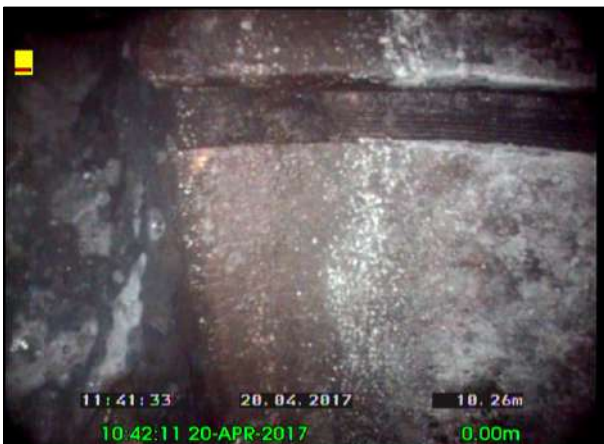
Photo: 41_41_265_A.jpg, 00:03:40
 10.26m, Open joint, medium

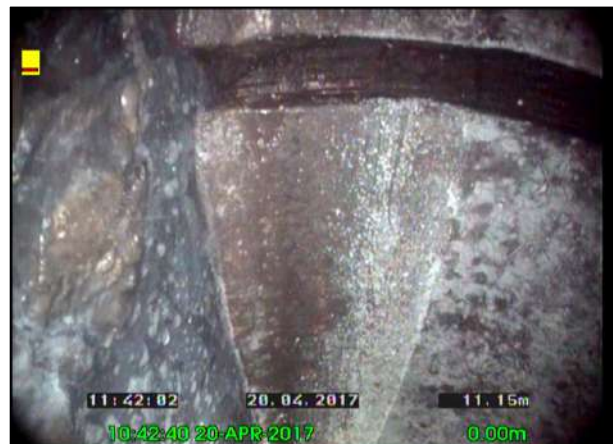
Photo: 41_41_266_A.jpg, 00:04:09
 11.15m, Open joint, medium

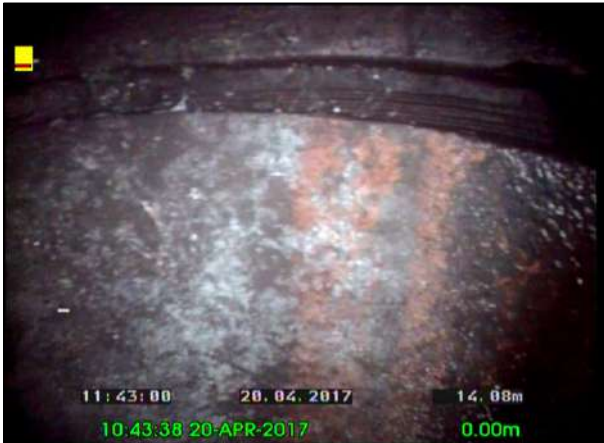
Photo: 41_41_267_A.jpg, 00:05:07
 14.08m, Open joint, medium

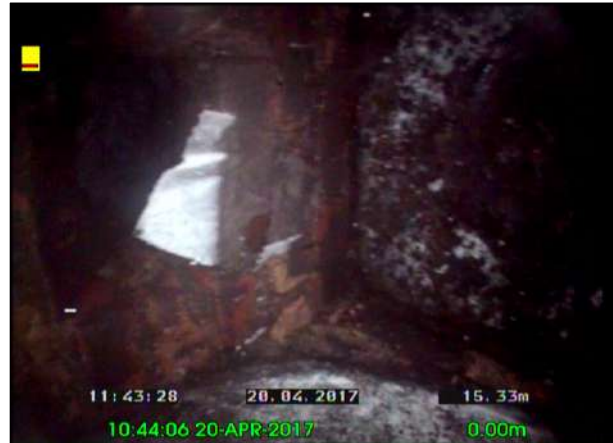
Photo: 41_41_268_A.jpg, 00:05:36
 15.33m, General remark Remarks: BURIED MANHOLE CHAMBER ON LINE

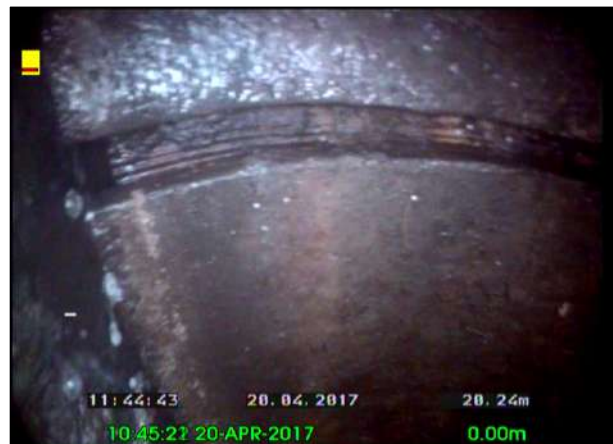
Photo: 41_41_270_A.jpg, 00:06:50
 20.24m, Open joint, medium

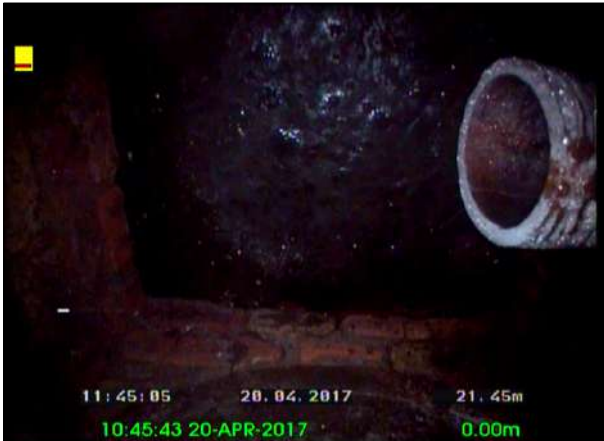
Photo: 41_41_271_A.jpg, 00:07:12
 21.45m, General remark Remarks: BURIED MANHOLE CHAMBER

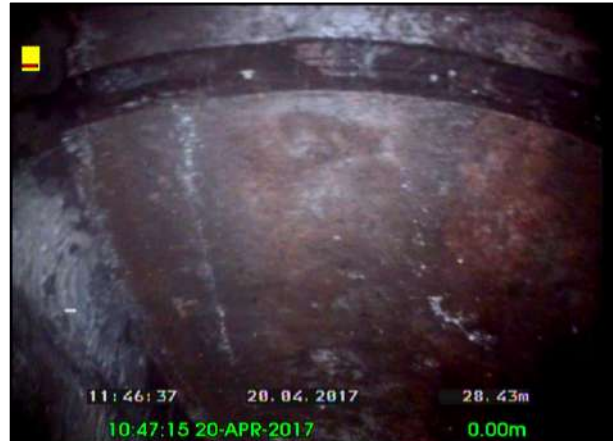
Photo: 41_41_272_A.jpg, 00:08:44
 28.43m, Open joint, medium

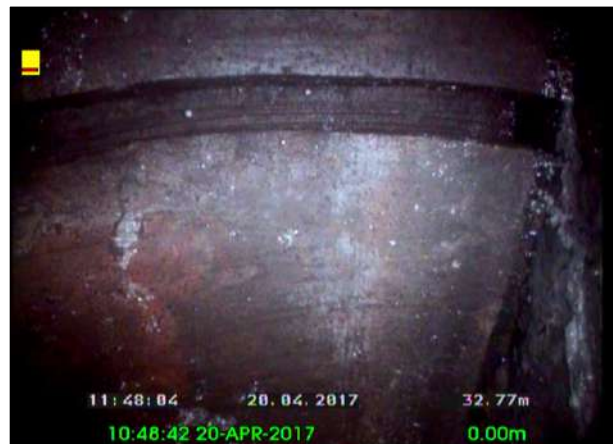
Photo: 41_41_274_A.jpg, 00:10:11
 32.77m, Open joint, medium

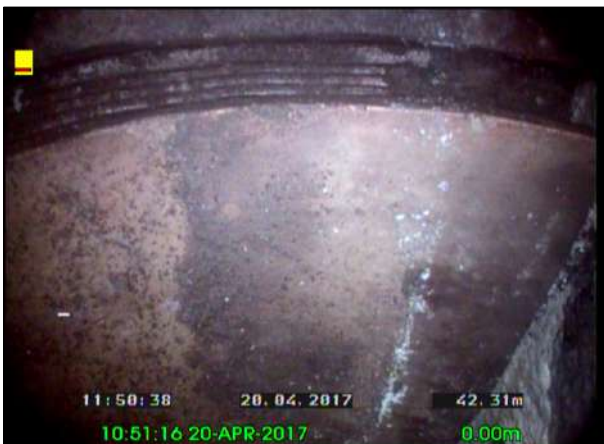
Photo: 41_41_278_A.jpg, 00:12:46
 42.31m, Open joint, medium

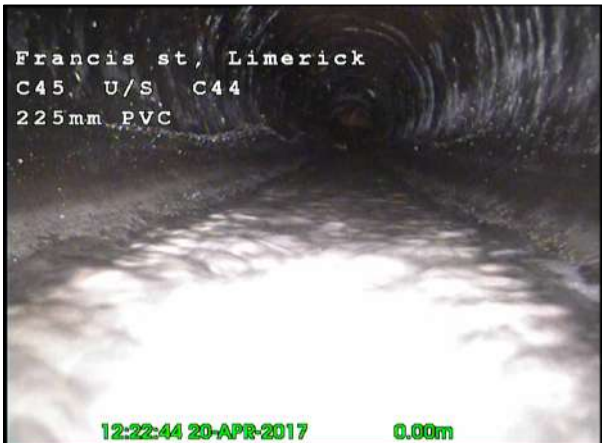
Photo: 42_42_281_A.jpg, 00:00:01
 0m, Start node type, manhole, reference number : C 45

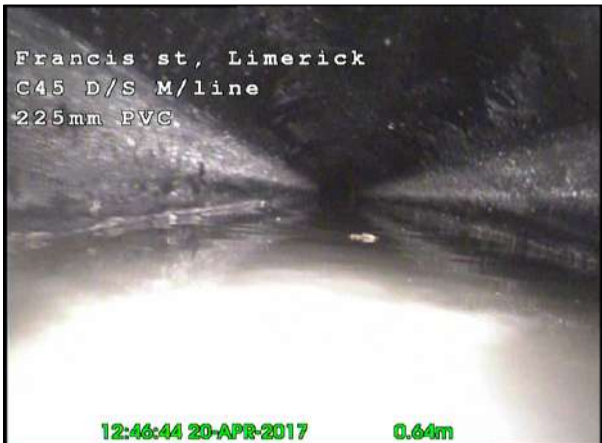
Photo: 43_43_285_A.jpg, 00:00:06
 0.64m, Start node type, manhole, reference number : C 45

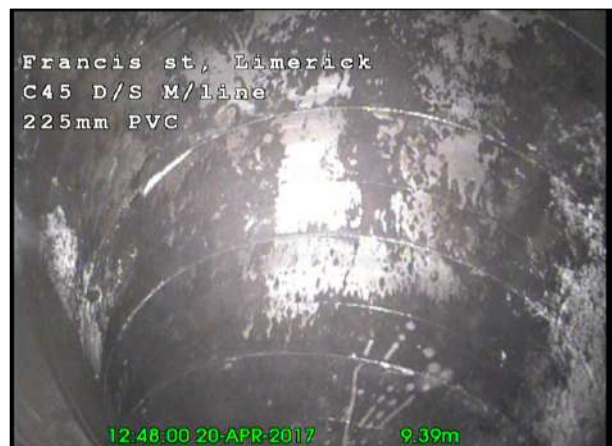
Photo: 43_43_288_A.jpg, 00:01:22
 9.39m, Line deviates down Remarks: DOWNWARDS INTO MAINLINE

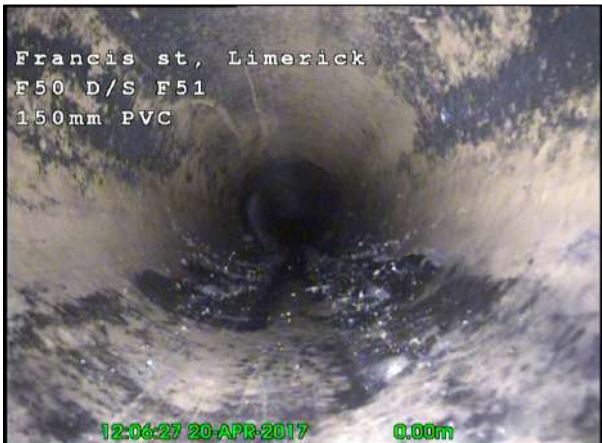
Photo: 44_44_290_A.jpg, 00:00:01
 0m, Start node type, manhole, reference number : F 50

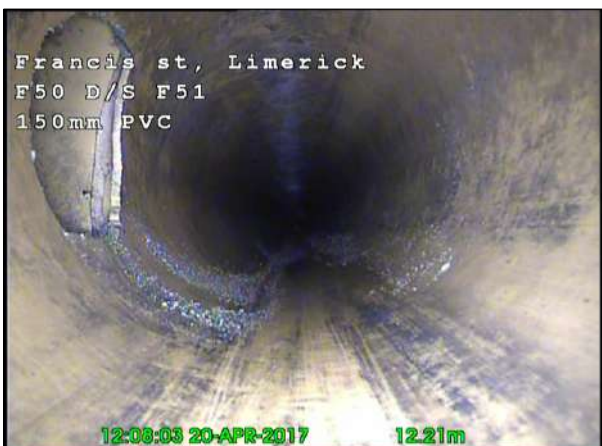
Photo: 44_44_293_A.jpg, 00:01:36
 12.21m, Connection other than junction, at 9 o'clock, diameter 100mm

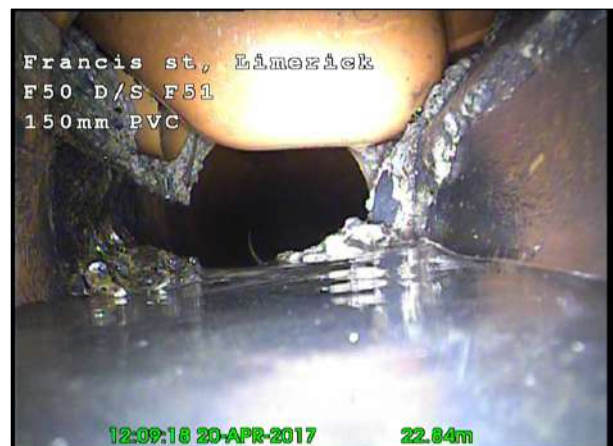
Photo: 44_44_295_A.jpg, 00:02:51
 22.84m, Finish node type, manhole reference number: F 51

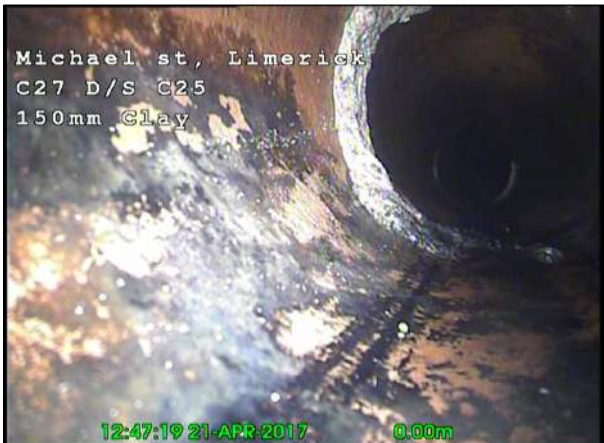
Photo: 45_45_296_A.jpg, 00:00:00
0m, Start node type, manhole, reference number : C 27

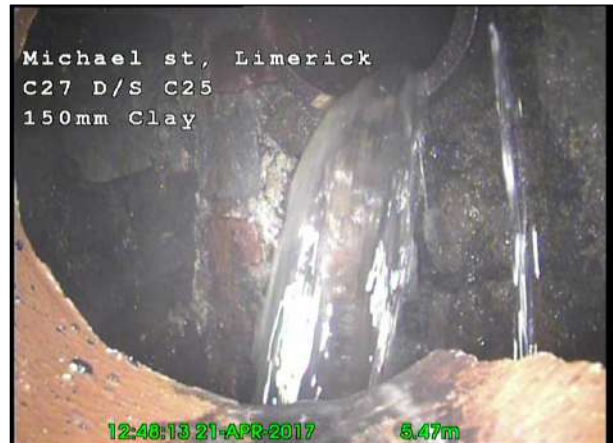
Photo: 45_45_299_A.jpg, 00:00:53
5.47m, Start node type, manhole, reference number : C 27

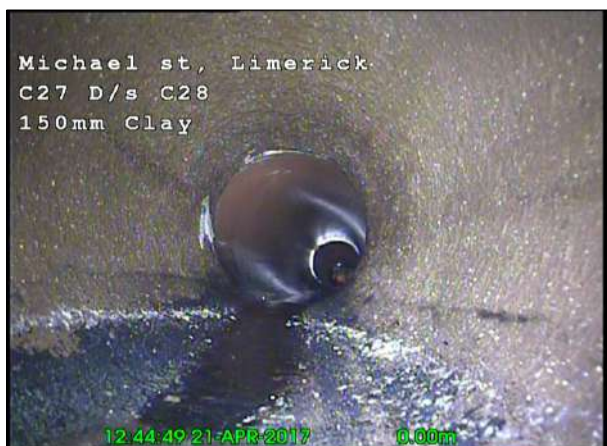
Photo: 46_46_300_A.jpg, 00:00:01
 0m, Start node type, manhole, reference number : C 27

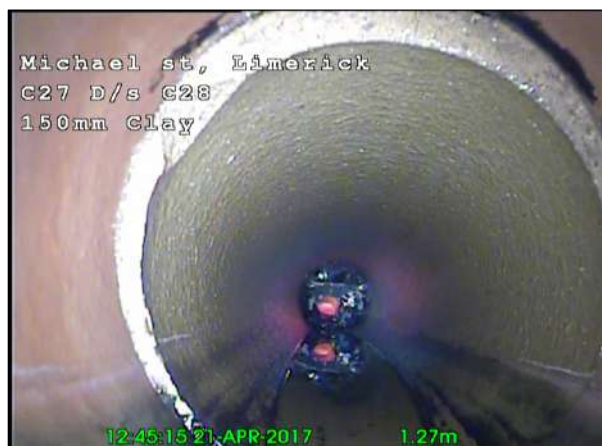
Photo: 46_46_302_A.jpg, 00:00:27
 1.27m, Joint displaced, medium

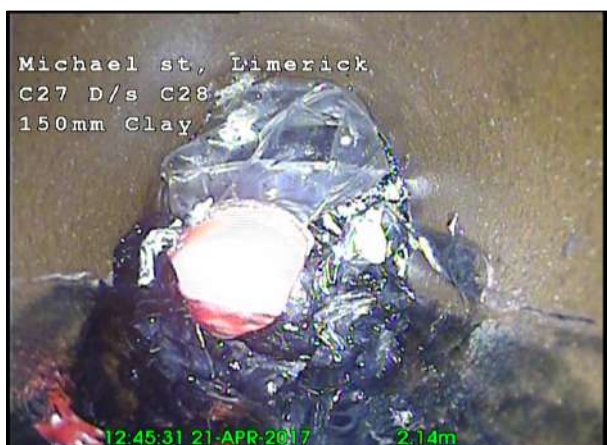
Photo: 46_46_303_A.jpg, 00:00:43
 2.14m, Other obstacles, other object in invert, from 12 to 12 o'clock, 95% cross-sectional area loss Remarks: UNABLE TO PASS

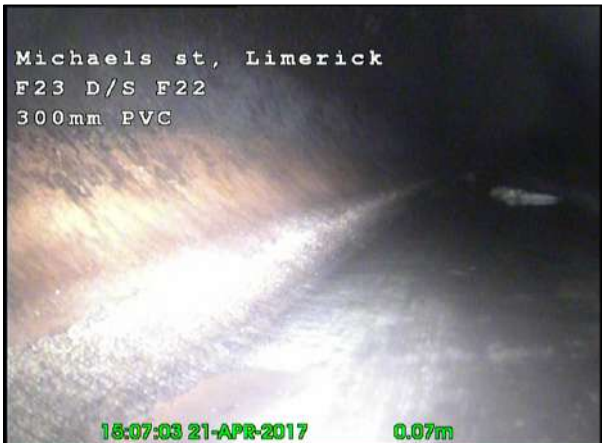
Photo: 47_47_304_A.jpg, 00:00:04
 0m, Start node type, manhole, reference number : F 23

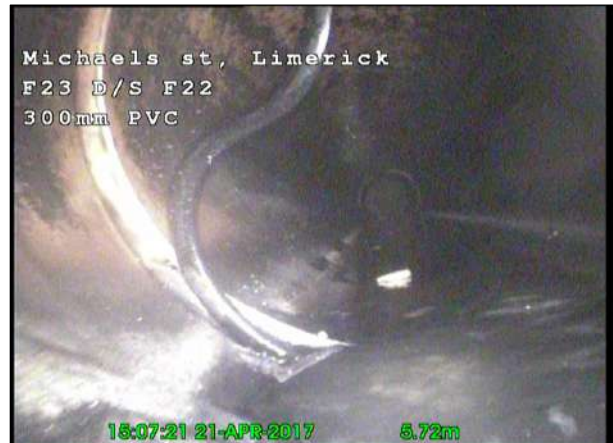
Photo: 47_47_306_A.jpg, 00:00:22
 5.72m, Sealing ring intruding, from 6 to 12 o'clock

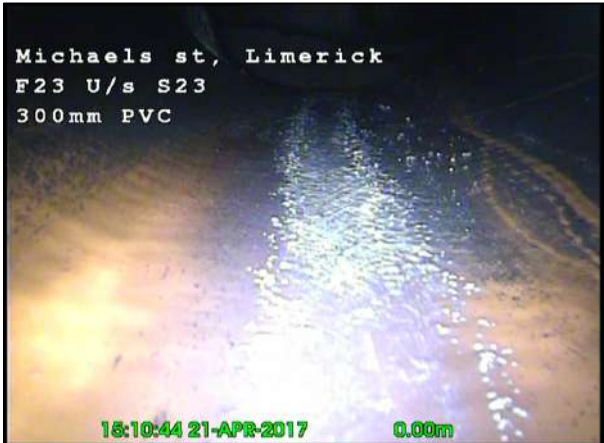
Photo: 48_48_308_A.jpg, 00:00:00
0m, Start node type, manhole, reference number : F 23

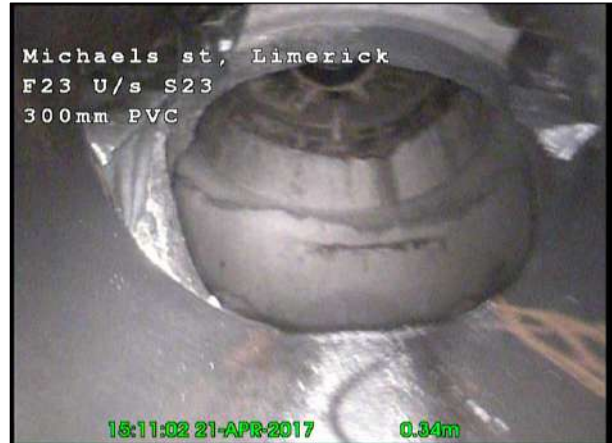
Photo: 48_48_310_A.jpg, 00:00:18
1m, Finish node type, manhole reference number: S 23
