## Cairn Homes Development - Castletreasure

### Road Safety Audit: Stage 1

April 2019

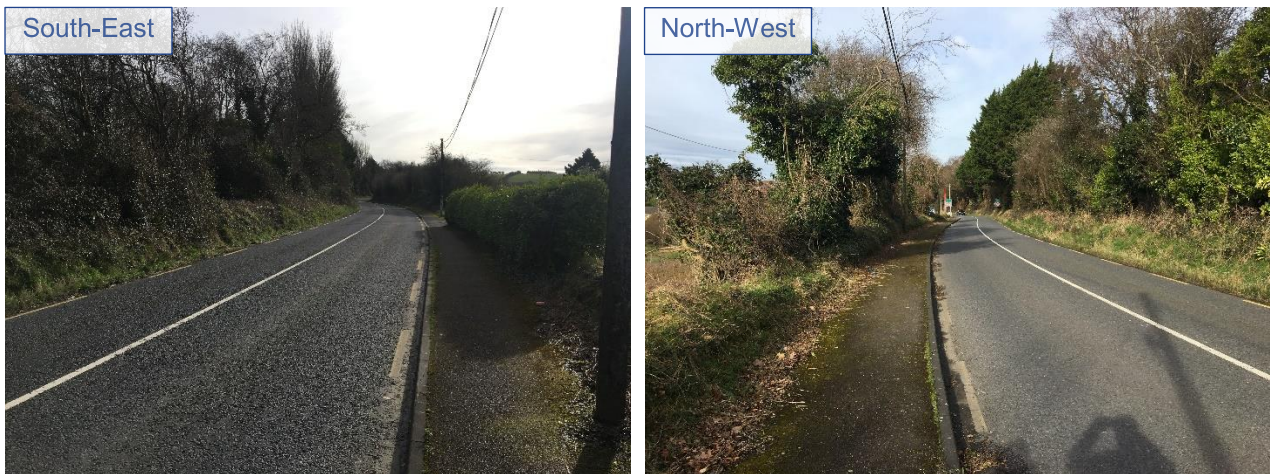
**Figure 3: Carrigaline Road at Main Access looking South-East & North-West**

On the day of the site visit it was observed that the Carrigaline Road carried a low volume of traffic. However, it appeared vehicles were travelling at excessive speed.

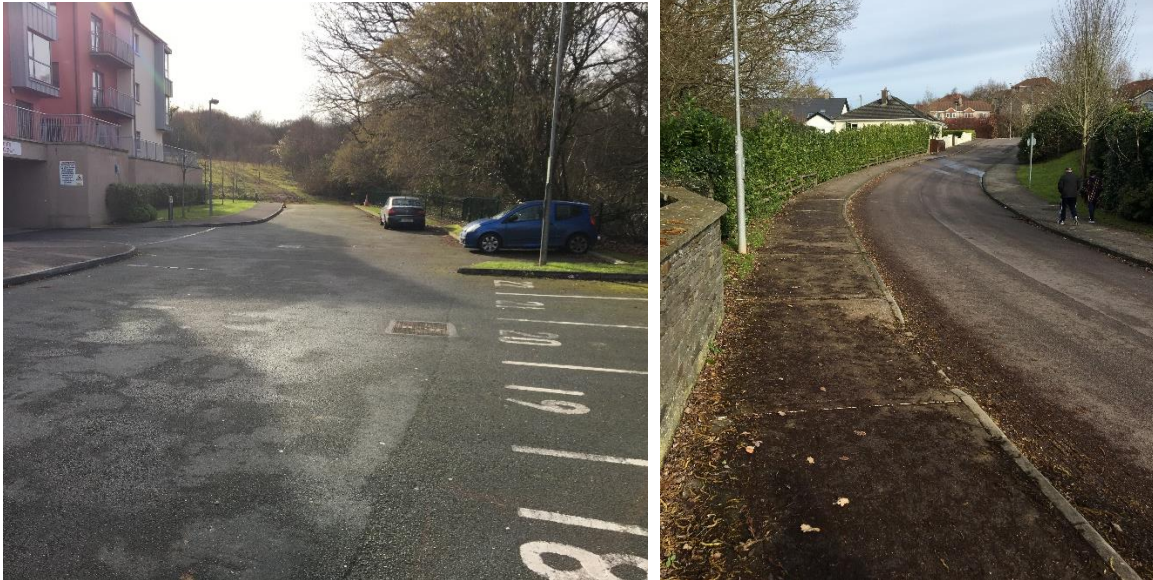
**Figure 4: Templegrove looking towards the secondary development access & Berkeley looking towards junction onto Carrigaline Road**

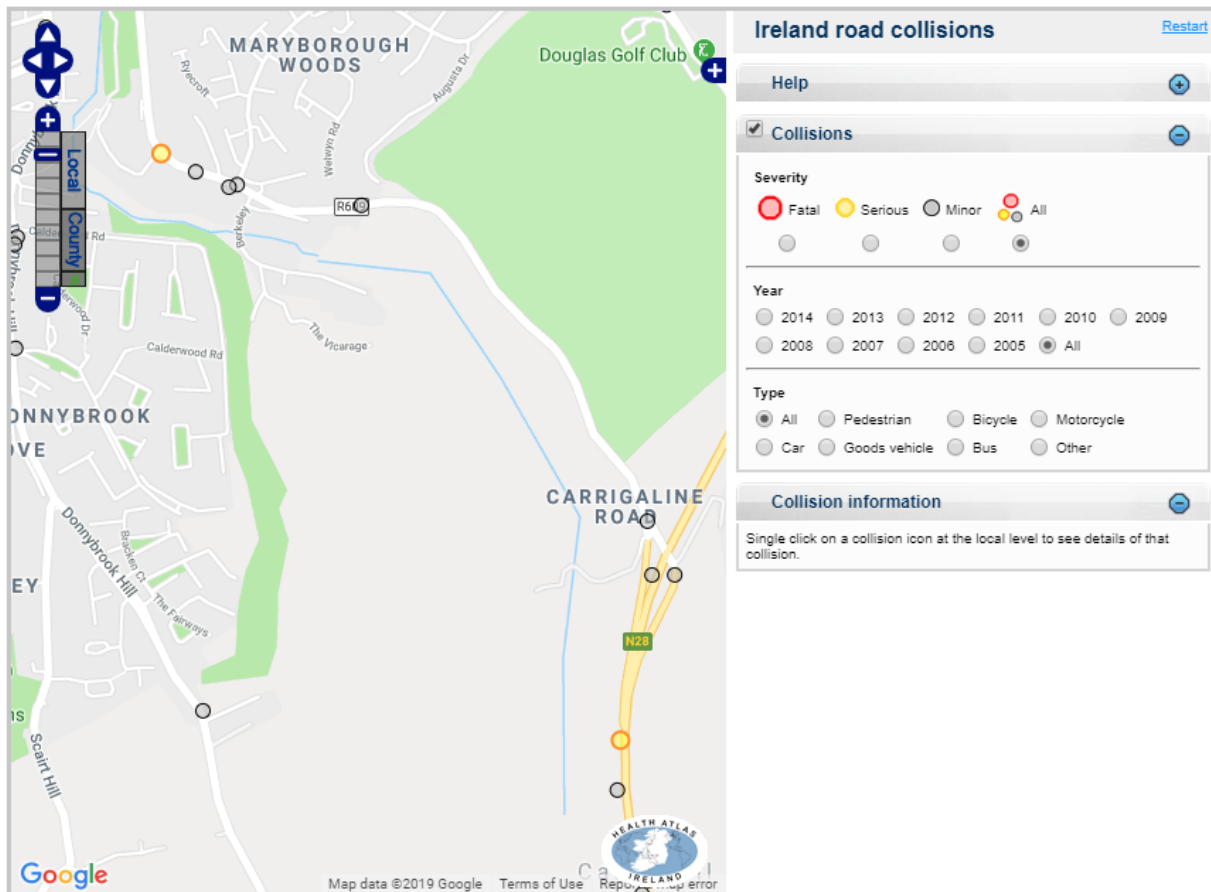
Historical road collision data 2005-2014 from the Road Safety Authority website indicates that there was one serious and five minor collision along the Carrigaline Road, none of which occurred directly adjacent to the development site. The serious collision was a single car, head-on accident on a Friday afternoon. The minor accidents were all car collisions (one single vehicle, one two vehicle and three other vehicle collisions) all at various times and days of the week. There are no apparent common causation factors.

Figure 5: Traffic collisions 2005-2014 at the Carrigaline Road, Co. Cork
