Road Safety Audit
Stage 1
for
PROPOSED MIXED USE DEVELOPMENT
AT
NEWTOWN, DROGHEDA, CO LOUTH

Date: July 2019

Report produced by: Road Safety Matters

Reference: RSM/MOB/080719/NEWTOWN RSA1

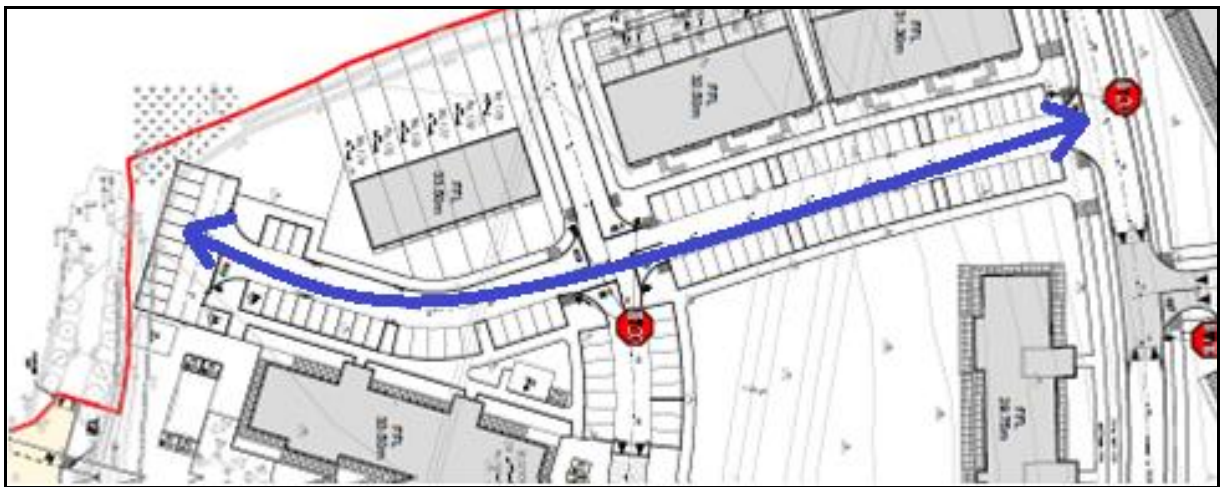
There is no provision for reduced speed limit signage (e.g. 30 km/hr) or ‘Slow Zone’ signage within the site. The posted speed limits of 60 km/hr and 50 km/hr on the network adjacent would be inappropriately high for the internal roads in a residential environment, where high proportions of VRUs should be anticipated, and where a number of relatively long links have been provided, with limited provision for traffic calming, e.g. figures 7 and 8, including on relatively steep access roads and links, although the design includes for raised tables/ramps at some locations on the proposed access road network throughout the site.

2.1.5 Problem - Internal Site Speeds and Speed Limit	Yes	Yes - agree that internal housing estate speed limits are to be 30kph. Advisory signs will be provided as necessary. The traffic calming measures as shown on the drawings are thought to be necessary. The stretch of road shown in Figure 7 includes on-street parking, a cul-de-sac and stop signs at the junction to encourage low speeds. The stretch of road in Figure 8 has a bend to reduce speeds. An additional raised		Yes ²

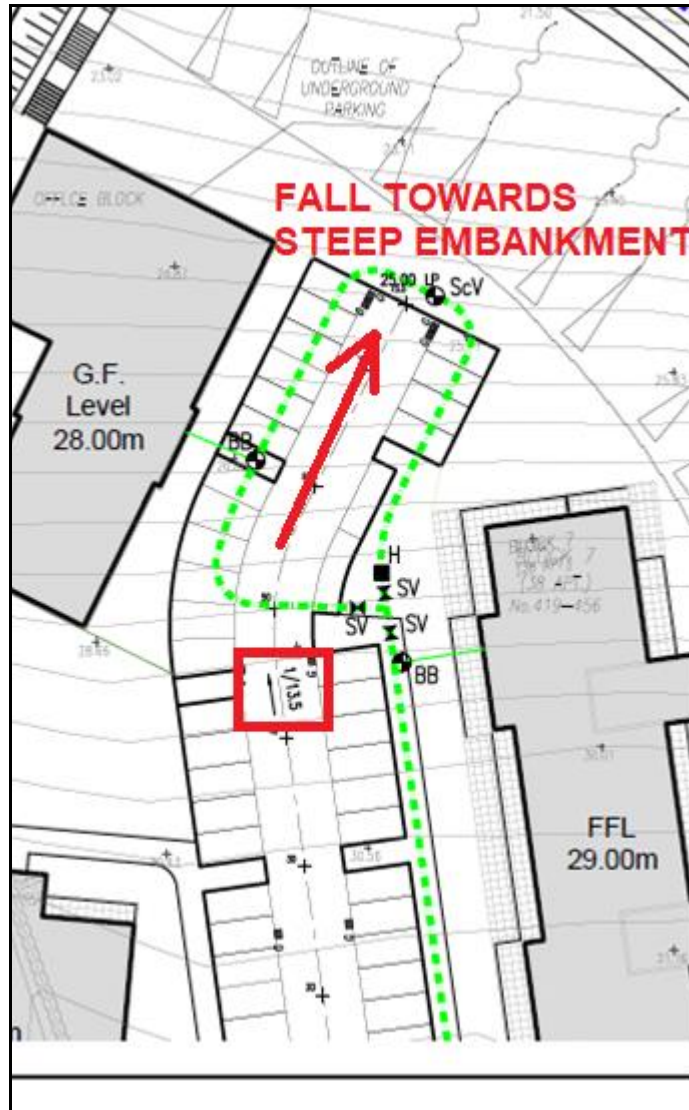
Figure 30

The proposed vertical alignment on the LIHAF will result in gradients of almost 7%, which will present difficulties for some vehicles and for some VRUs in wet and icy conditions. Steeper gradients were noted on a number of other links throughout the site, including gradients exceeding 10%, which is a departure from standard. Examples of such locations are shown in figures 27-30. Figure 31 shows a location where the shallow gradient may cause drainage issues, as there is no provision for gullies along the link. Steep gradients were also noted on approaches to junctions/intersection points, which increases the risk of vehicular conflict and vehicular/VRU conflict at these locations. There was no horizontal or vertical alignment design provided with the preliminary design layout to determine any issues in respect of Stopping Sight Distance (SSD).

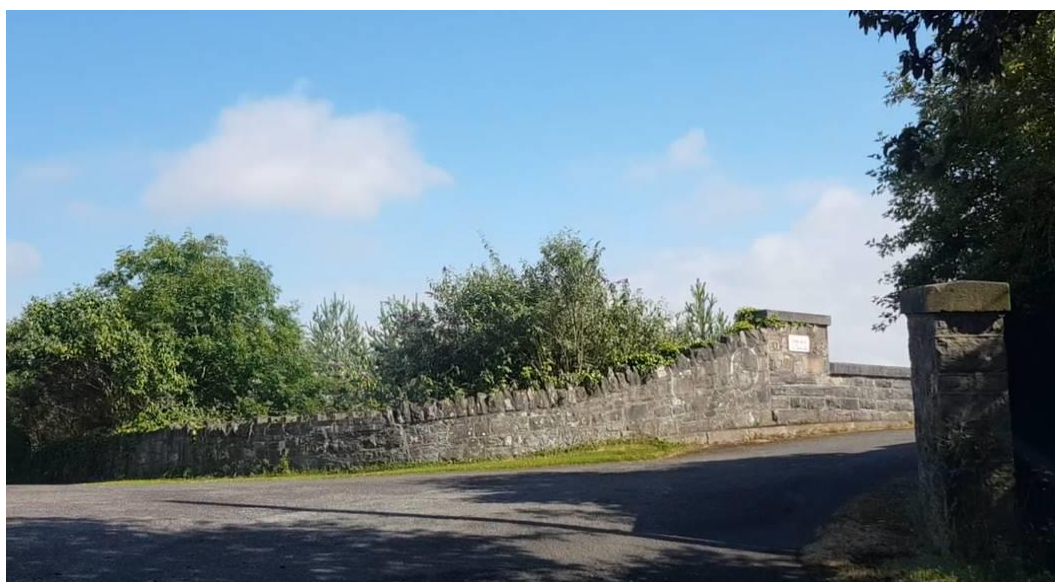
Figure 43

It was noted that there is no provision for guidance on the priority movement and rights of way at McGrath's Lane/Railway Terrace to the north of the railway overbridge, where sightlines are poor due to the height of the bridge walls, as shown in figure 43, and where provision has been made for pedestrians to cross the centre of the junction, as shown in figure 45. There is no provision for form of control at a number of internal junctions/intersection points, and one of the internal crossroads has been marked with a stop line on each arm, as shown in figure 46, which will lead to ambiguity and uncertainty regarding rights of way.

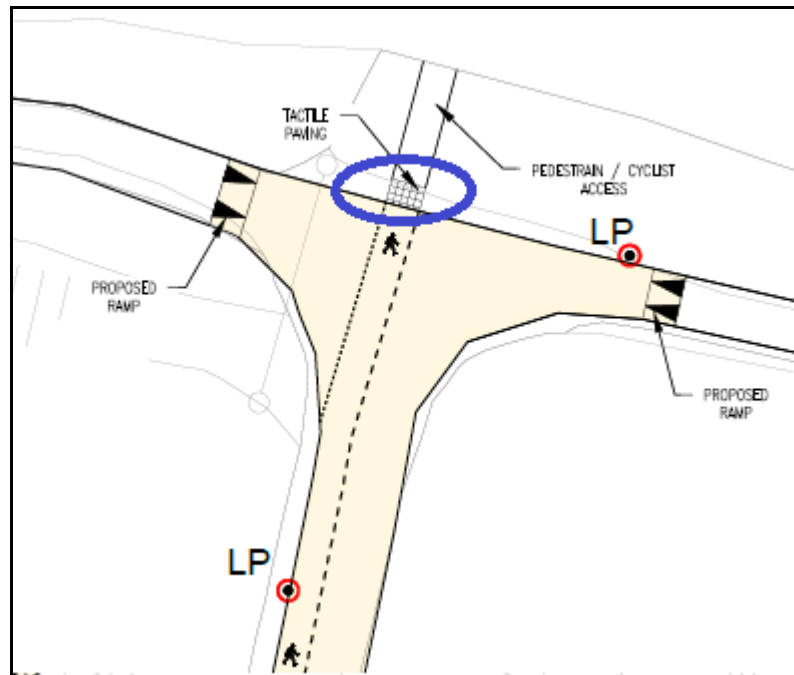
Figure 51

- Tactile paving has been provided at the southern link to the site at the intersection with McGrath's Lane, as shown in figure 51, which leads visually and mobility impaired pedestrians directly into the centre of the carriageway, on a shared surface where rights of way and priority are unclear, and where the risk of conflict with moving vehicles is higher. This will occur at a location where intervisibility is compromised by the bridge crest, and abutment walls, as shown in figure 52.
- There is no provision for tactile paving at the top and bottom of steps within the site to alert visually impaired pedestrians to the presence of the hazards.

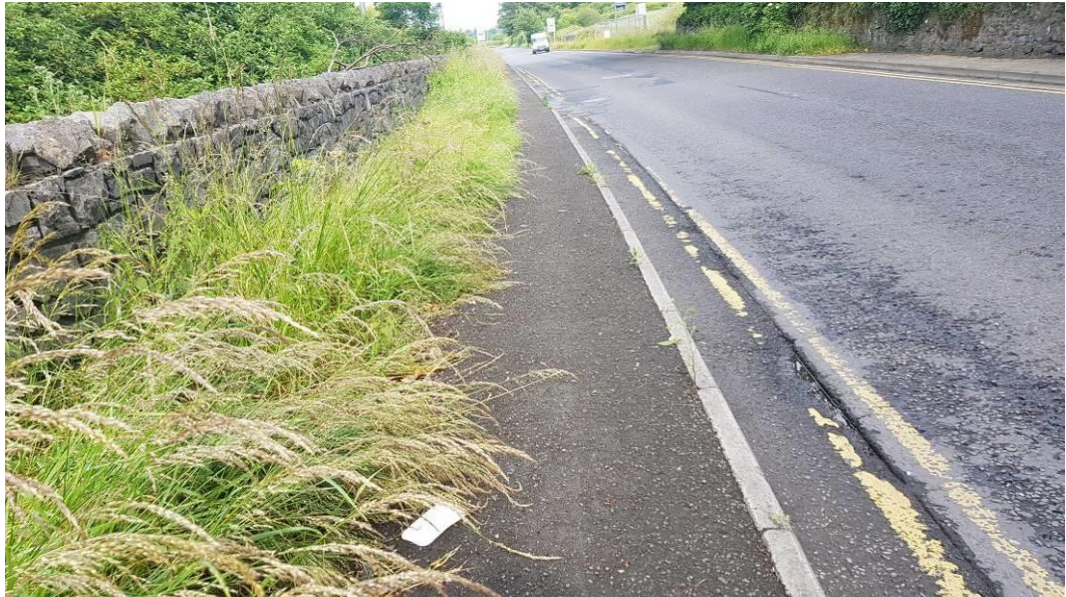
Figure 54

- It was noted that existing footways on the R150 are dark due to overhanging trees, with debris and potentially slippery conditions noted, as shown in figure 53. These existing pedestrian facilities are also narrow, on both sides of the carriageway, including directly opposite the proposed site access, as shown in figure 54. Pedestrian flows and desire lines to use these footways and to cross the R150 carriageway are likely to increase significantly as a direct result of the development proposals. There is no provision for a safe controlled crossing facility on this link on approaches to the site, and high traffic volumes at peak times, or high traffic speeds at off peak times, may present difficulties for some pedestrians to cross safely.

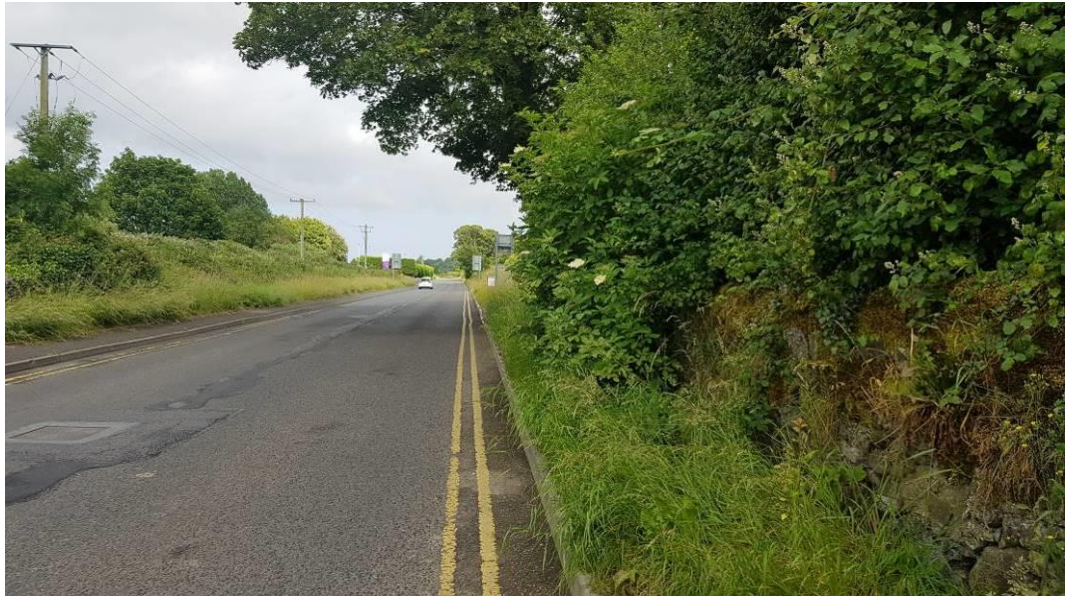
Figure 55

- The proposed footway and cycleway along the northern boundary of the site terminates abruptly, tying in to an existing overgrown verge, as shown in figures 55 and 56, with a mature tree located in close proximity to the carriageway edge at the tie-in point, as shown in figure 56, which would obstruct the movement of pedestrians and cyclists and force them out onto the carriageway, where there is no provision for a safe crossing facility onto the narrow footway on the opposing side of the carriageway, as outlined previously.

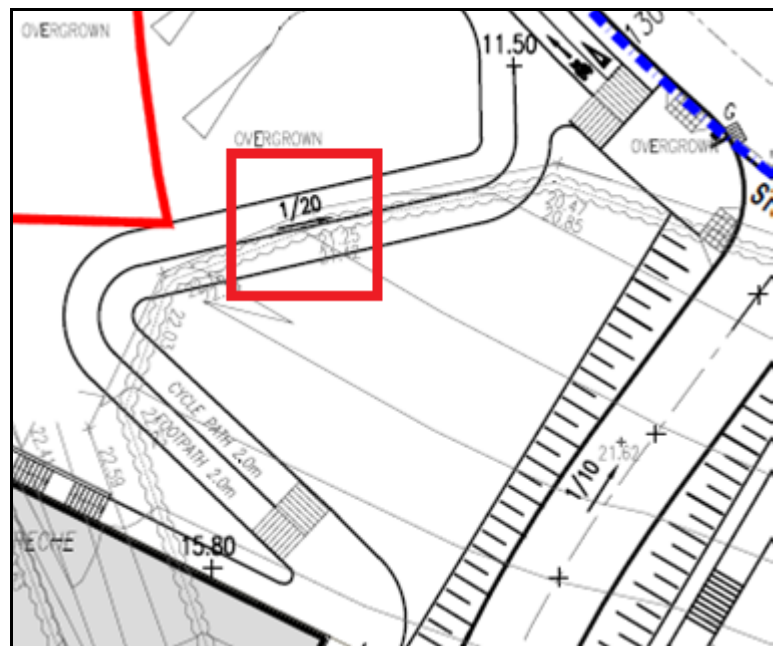
Figure 60

- Gradients are exceeding 3% on new dedicated cycling facilities, as shown in figure 60, which is a departure from standard, with a gradient of 8% on the new LIHAF and gradients exceeding 10% on links into basement carparking.

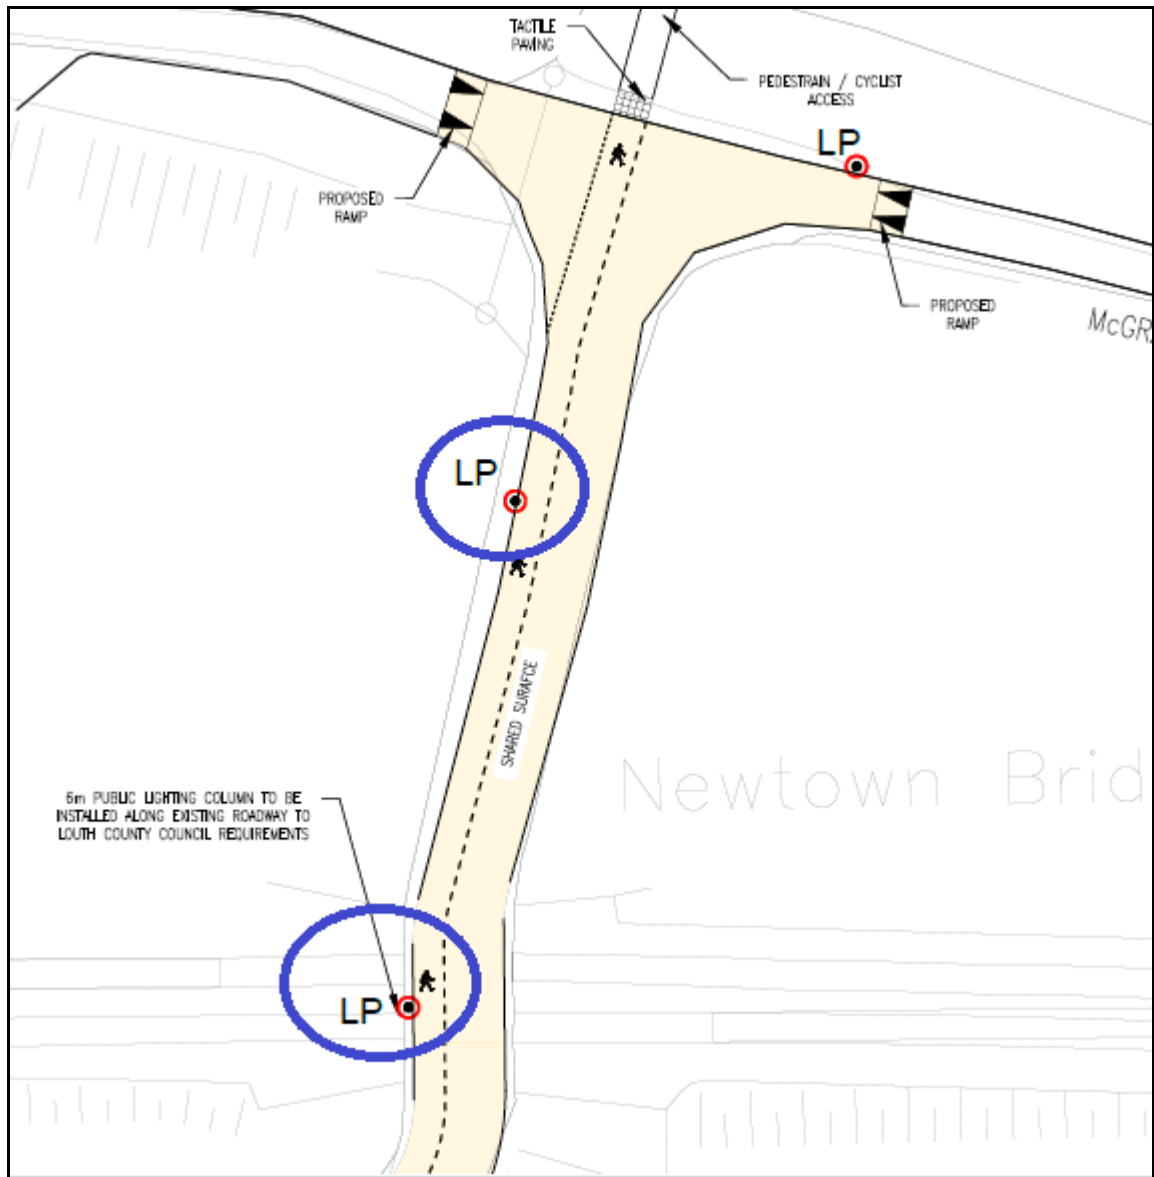
Figure 65

64, where they may obstruct the movement of VRUs and present a strike hazard to passing vehicles on a limited cross section. The columns on the railway bridge, highlighted in figure 65, may also, if struck, present a hazard on the railway line underneath.
