Quality Audit
Inclusive of Stage 1 Road Safety Audit
for
PROPOSED RESIDENTIAL DEVELOPMENT
AT
THE GRANGE
BREWERY RD, STILLORGAN, DUBLIN 18

Date: August 2019

Report produced by: Road Safety Matters

Reference: RSM/MOB/080719/GRANGE-QA1

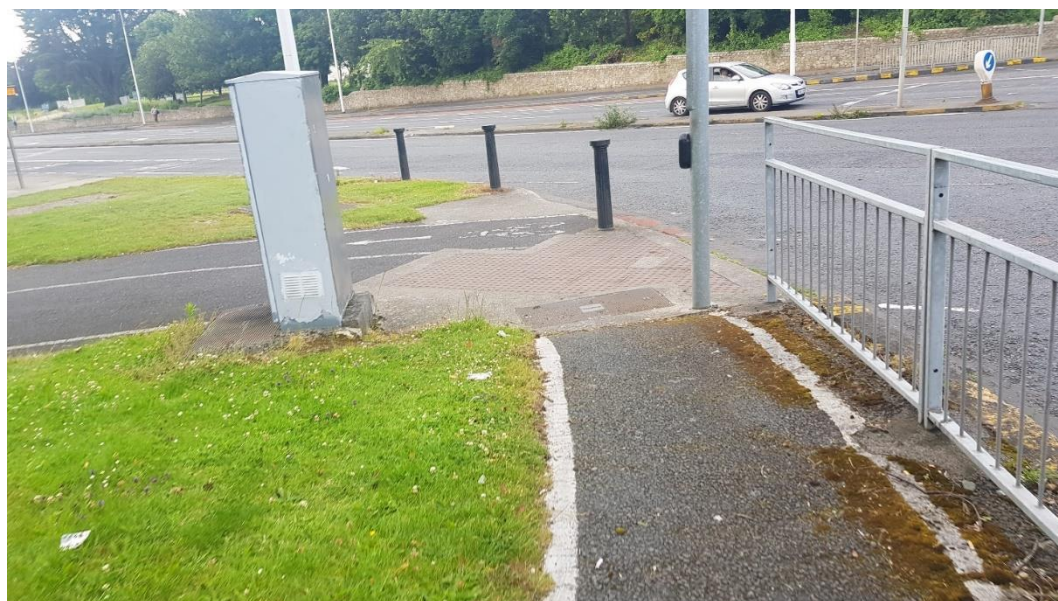
Figure 5

- Poor surface condition was noted at some locations on the current pedestrian access routes to and from the site, as shown in photos in figures 4 - 6. The extent of new surfacing is not clear from the plans supplied. Poor uneven surfaces can lead to trip hazards and ponding, which can lead to an increased risk of pedestrians slipping during wet and icy conditions.

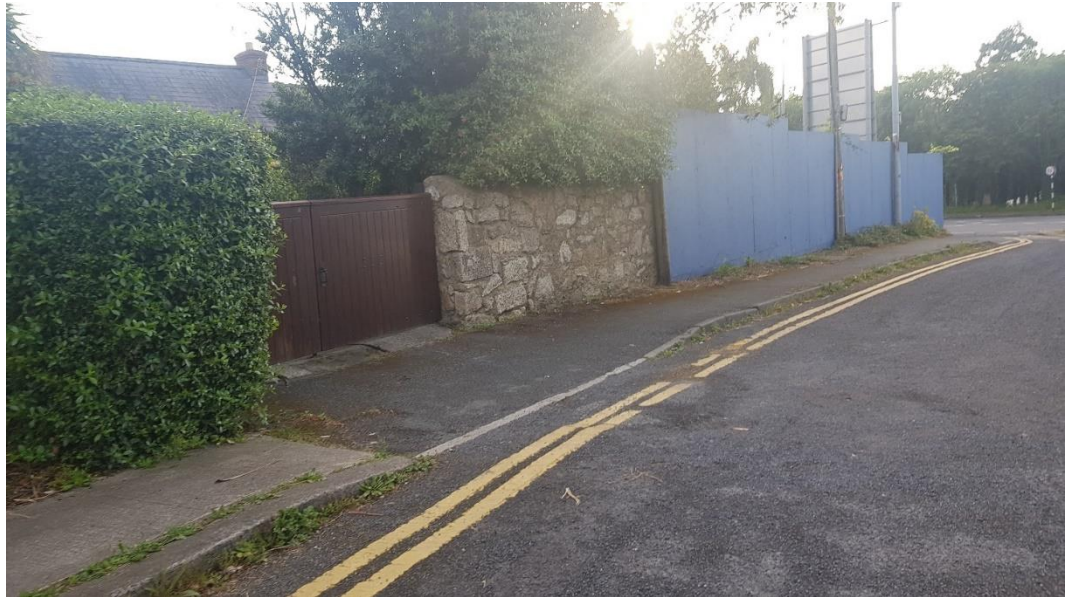
Figure 8

- Intervisibility between pedestrians and motorists is poor at some locations surrounding the site, and there are no proposals for improvements on the preliminary design layout. Potential intervisibility issues were also noted on the proposed layout, including at an existing access on the eastern side of the site, which is shown in figure 8, and at crossing points adjacent to hoarding surrounding the site, as shown in figure 9.

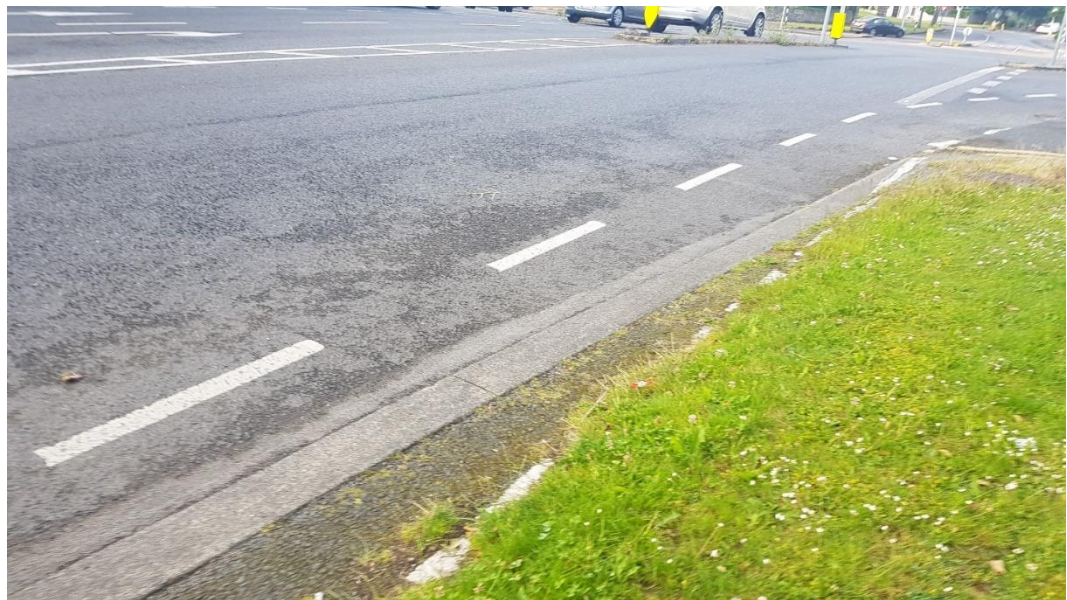
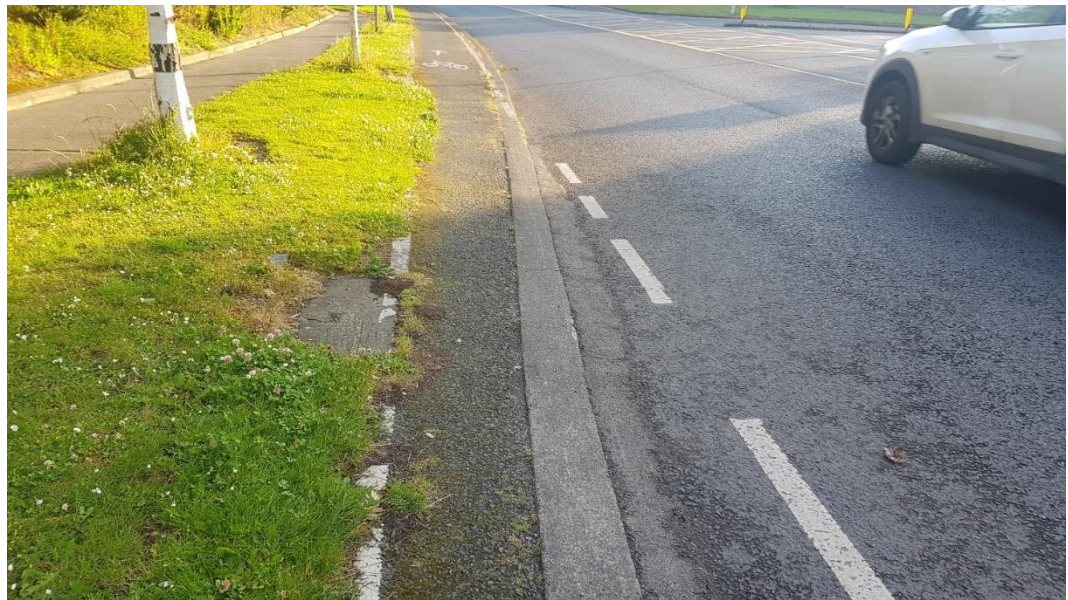
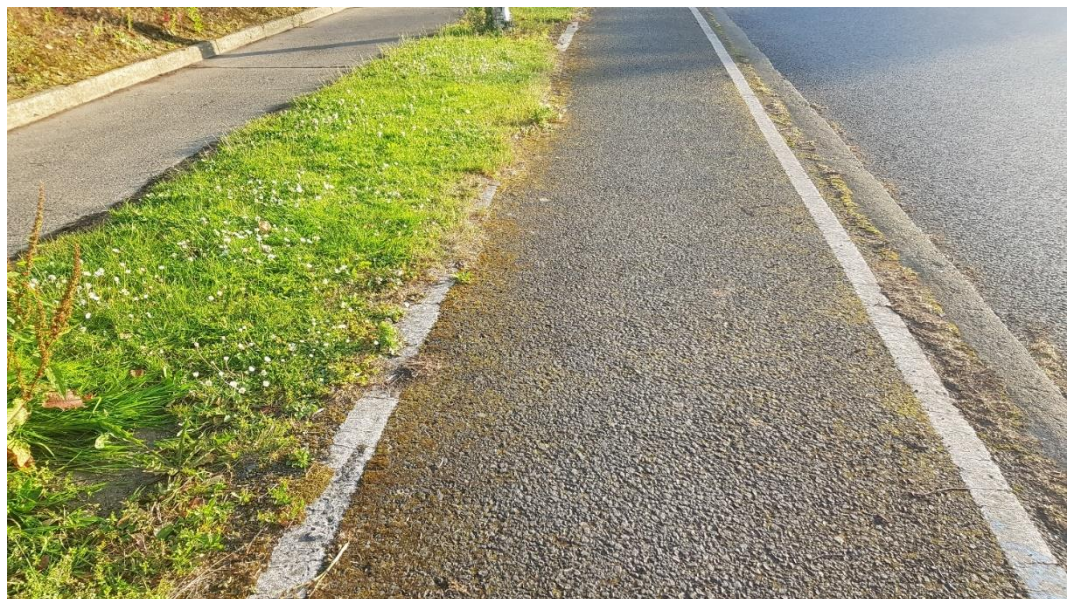
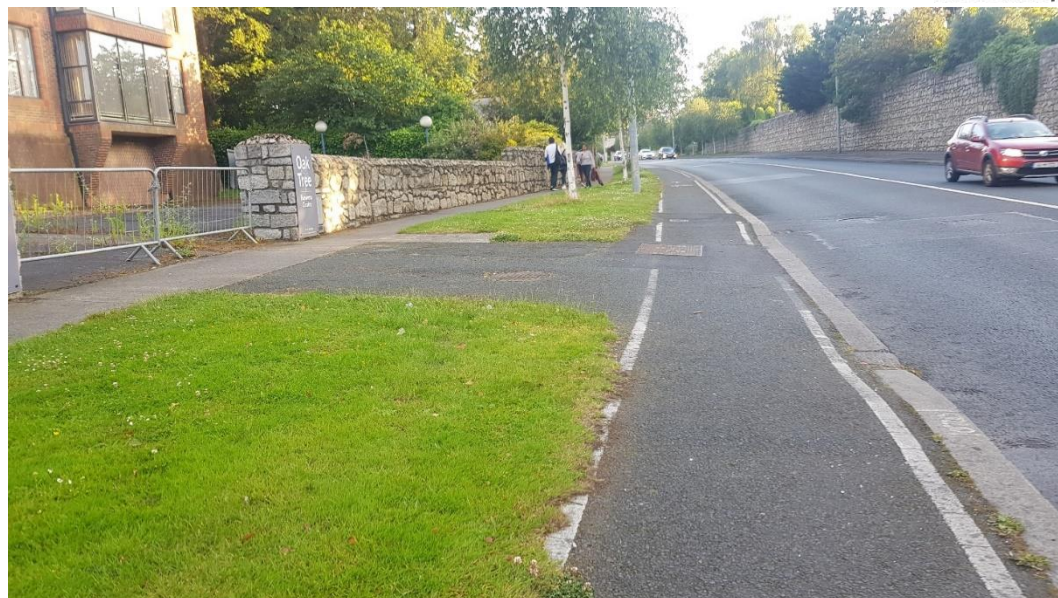
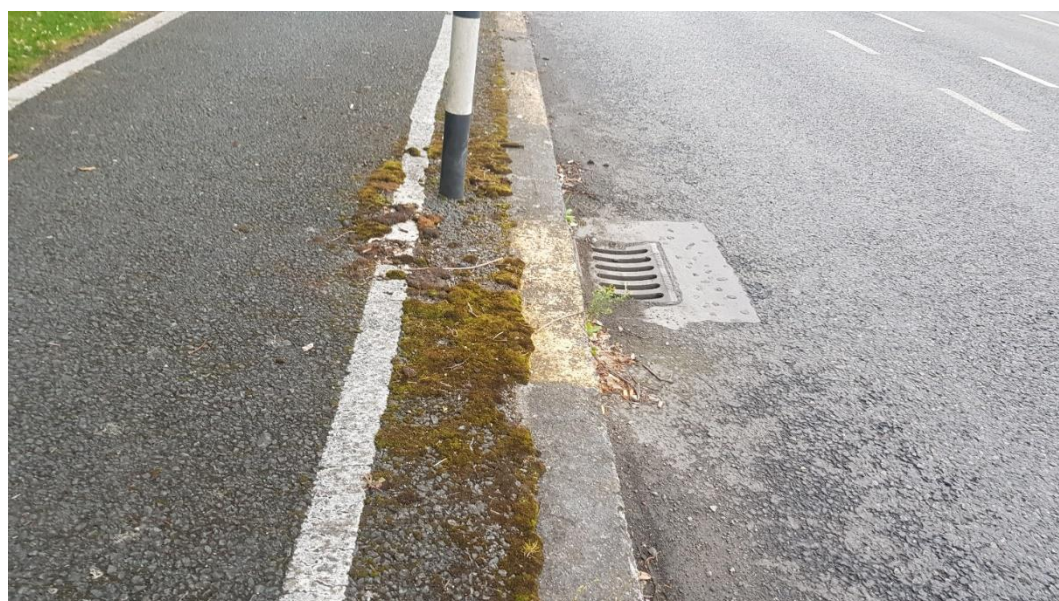
- Uneven surfacing and hazards were noted within cycle lanes and adjacent footways on the surrounding network, and markings are very well worn and illegible. Surface condition within the lanes is also poor and slippery at some locations. Examples of some of the hazards have been shown in photos presented in figures 14-21.

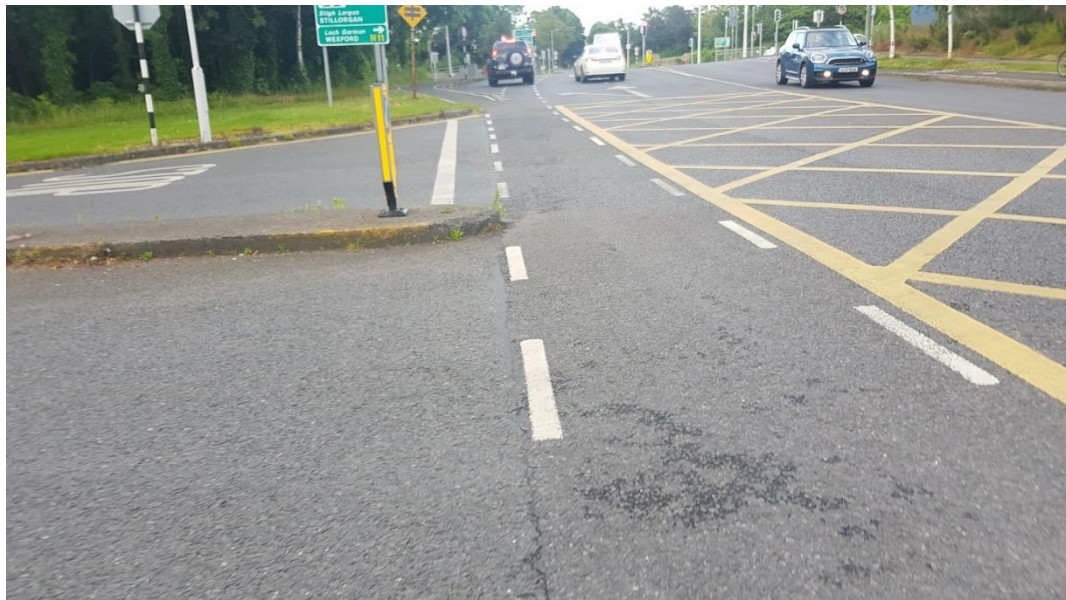
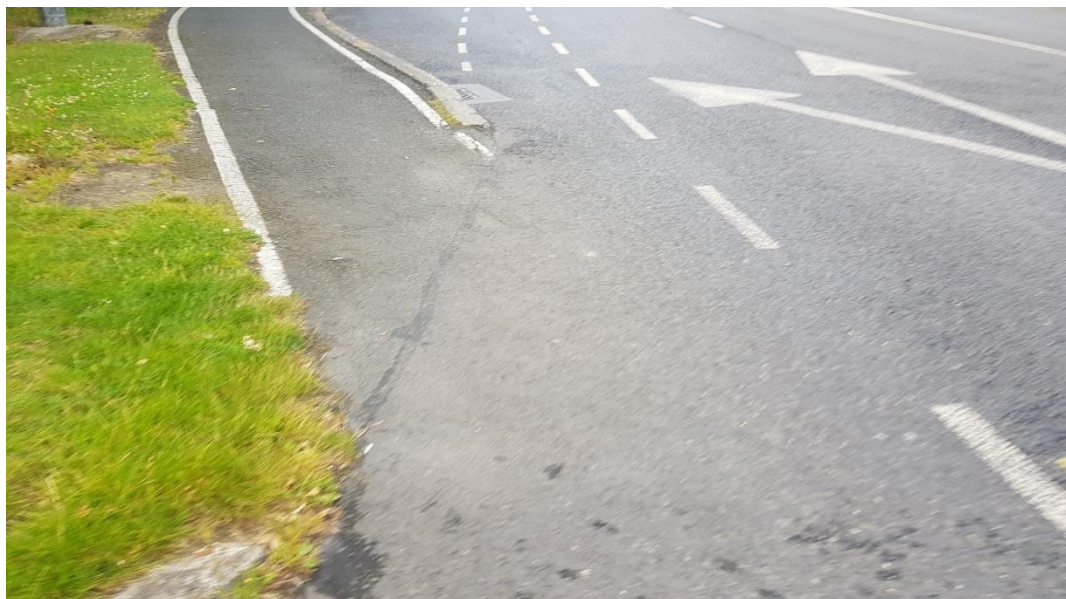
- Figures 22 -24 show the current arrangements for cyclists at the intersection with the N31 and St Brigid's church Rd and the connectivity towards the signalised crossroads at the N31. There are no proposed changes to the design at this location arising as a direct result of the development proposals, however it is recommended that the layout be reviewed at detailed design stage to determine the need for any remediation, bearing in mind the proportion of collisions at this location involving cyclists, as detailed further in the RSA section of this report.

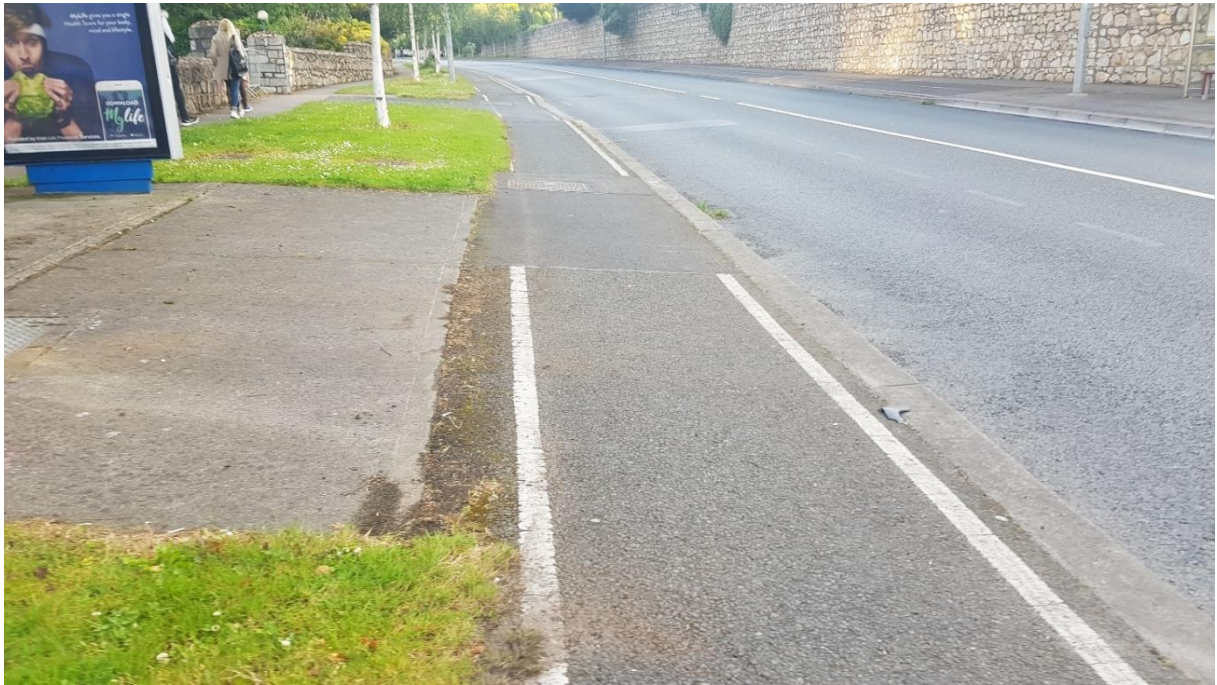
Figure 29: Layout at Bus Stop on Brewery Rd, N31 (Note No kassel kerbs)

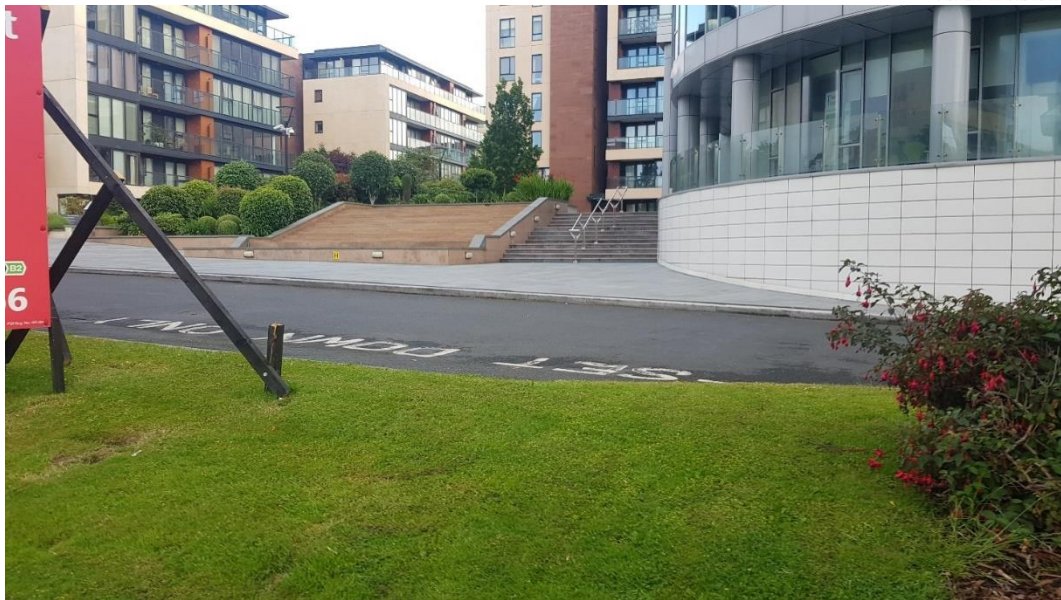
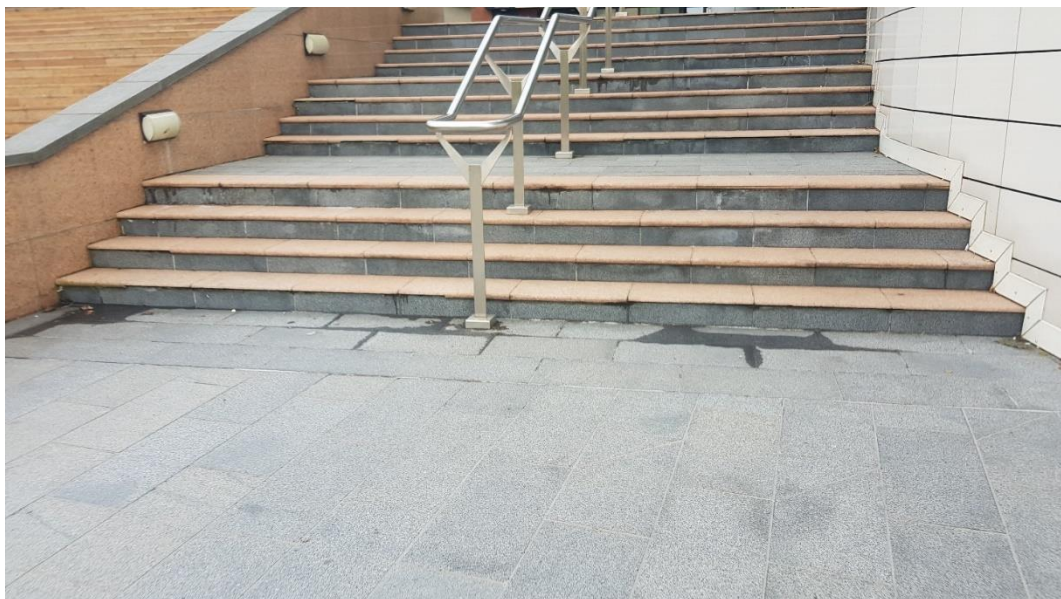
- Access to the site from the N11 through the existing completed Grange development is highly likely. There is no provision for tactile paving at the top and bottom of a number of existing steps, as shown in figures 35 and 36.

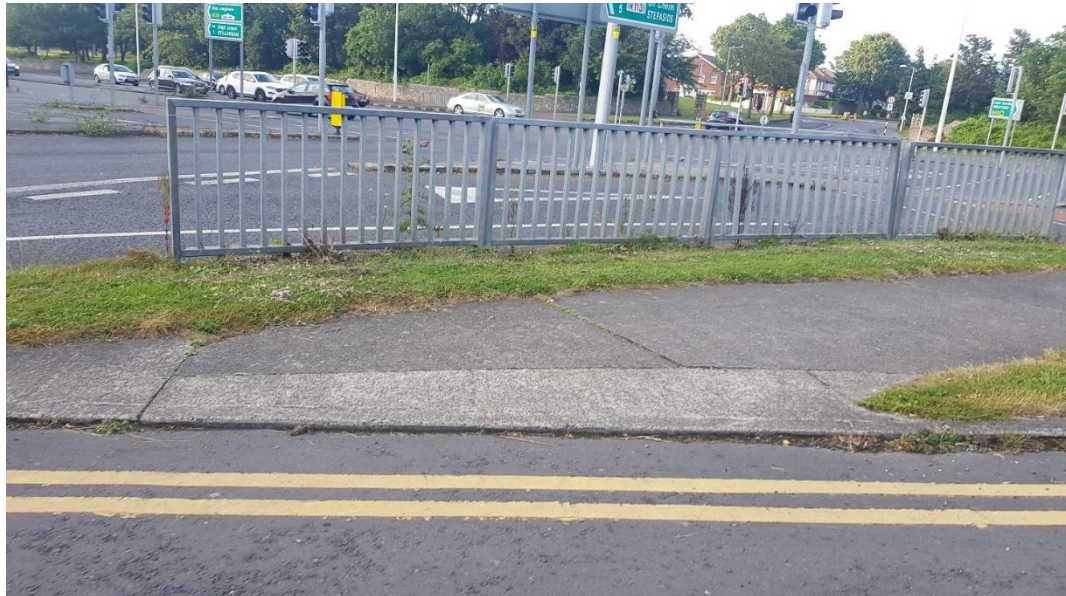
- Dropped kerbs and tactile paving are absent from junction mouths and many other potential points of conflict with vehicles both on the existing layout, and on the proposed layout for the redeveloped site. The lack of suitable dropped kerb facilities, and lack of informal / formal tactile guidance would create additional barriers to accessibility for disabled road users on the approaches to and adjacent to the site.

Figure 37: Tactile Paving Absent

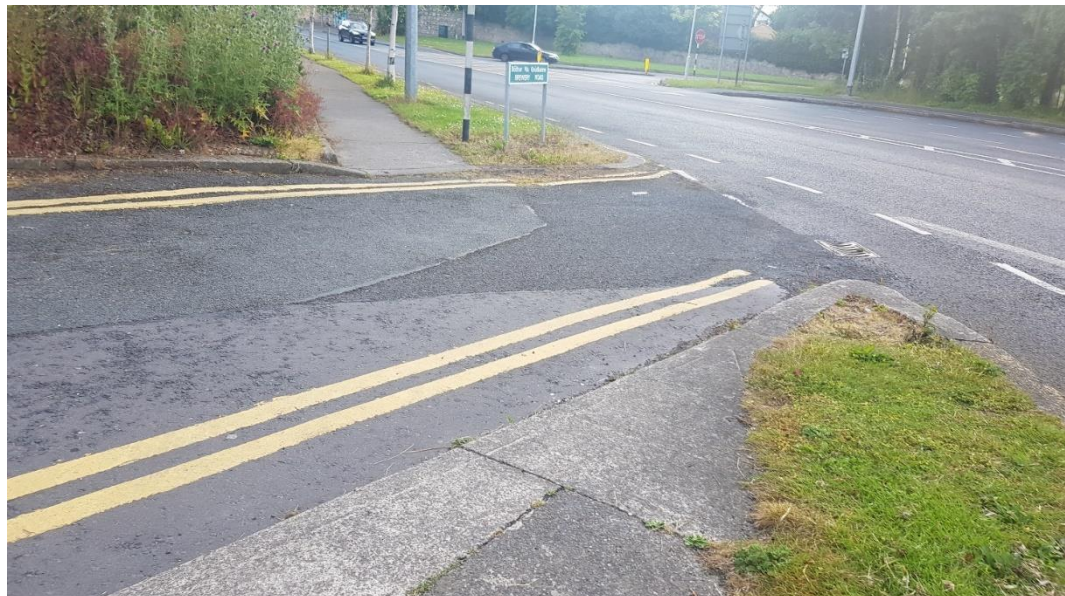
Figure 38: Tactile Paving Absent

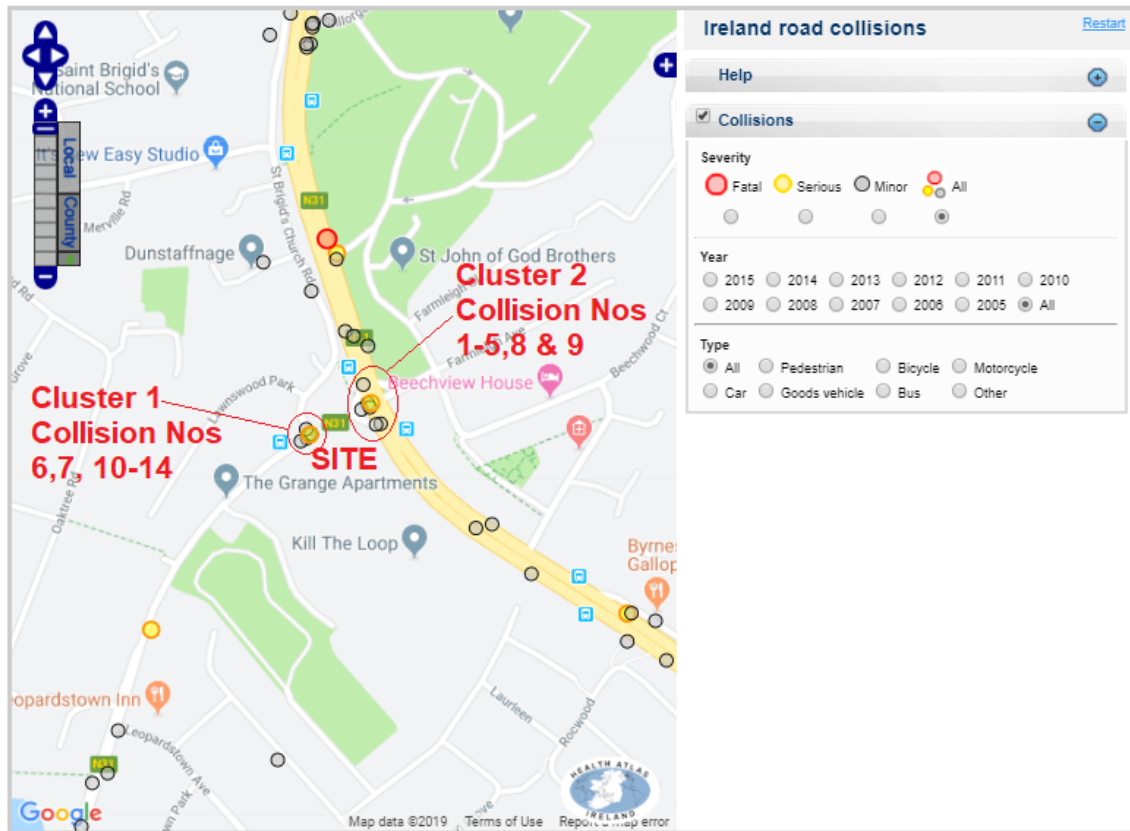
- 3.1.3 No information was provided on any existing collision statistics in the vicinity of the site. A review of the Road Safety Authority online collision database indicates that there are records of a significant number of collisions occurring on the road network immediately adjacent to the site between 2005 and 2015 inclusive, with two collision clusters noted at nearby junctions. The location of these collisions has been shown in Figure 39, with the collision characteristics summarised in Table 1. As mentioned previously in the NMU Audit Section of this QA report, a significant number of collisions occurring at the junction of Brewery Rd/St Brigid's Church Rd involved cyclists (4 collisions occurring at one location over a two year period, one resulting in a serious casualty), which conflicts with the aspirations of an urban area where VRUs should be at the top of the road user hierarchy. The Audit Team considered it likely that a statistically significant increase in collision risk has occurred at this junction in recent times, and further detailed collision investigation into the contributory factors and patterns within these collisions is therefore highly recommended before site development progresses to detailed design stage, particularly since such a high proportion of trips to and from the development are expected to be made by cyclists. The site design should therefore include for remediation and layout improvements where necessary to address the existing collision risks on the approaches to the site.

Figure 39: Collision Plot for Road Network Surrounding Site

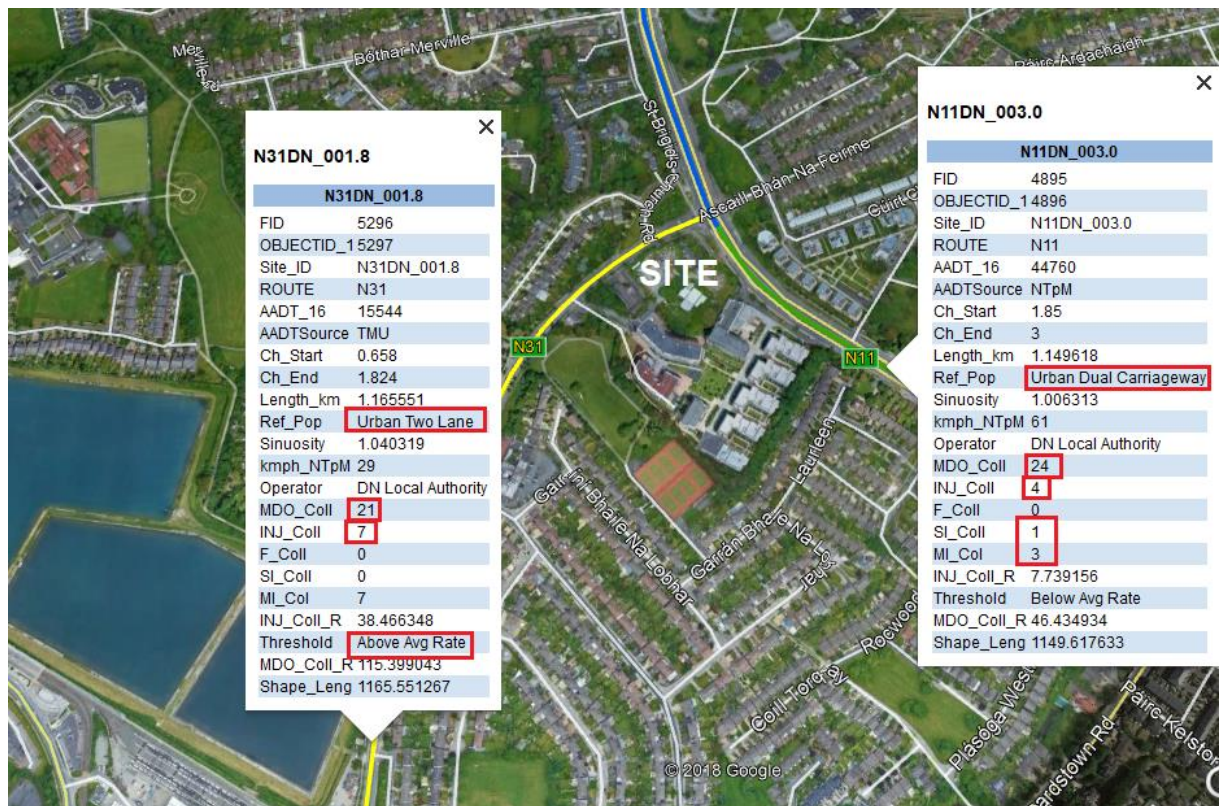
Additional summary data was obtained for the period 2015 to 2017 inclusive, which shows that 21 material damage only collisions and 7 collisions resulting in a minor casualty were recorded over a 1km (approximately) stretch of the N31 to the northwest of the site, which gives this section of the N31 a collision rate which is above the National Average rate for similar links (urban two lane), in accordance with TII GE-STY-01022, as shown in figure 40. To the northeast of the site, there were 24 material damage only collisions, 3 minor collisions and one serious collision recorded over a 1km (approximately) stretch of the N11, which gives this section of the N11 a collision rate which is below the National Average rate for similar links (urban dual carriageway), in accordance with TII GE-STY-01022.

Figure 40: TII GE-STY-01022 Collision Rates 2015 to 2017 adjacent to Site

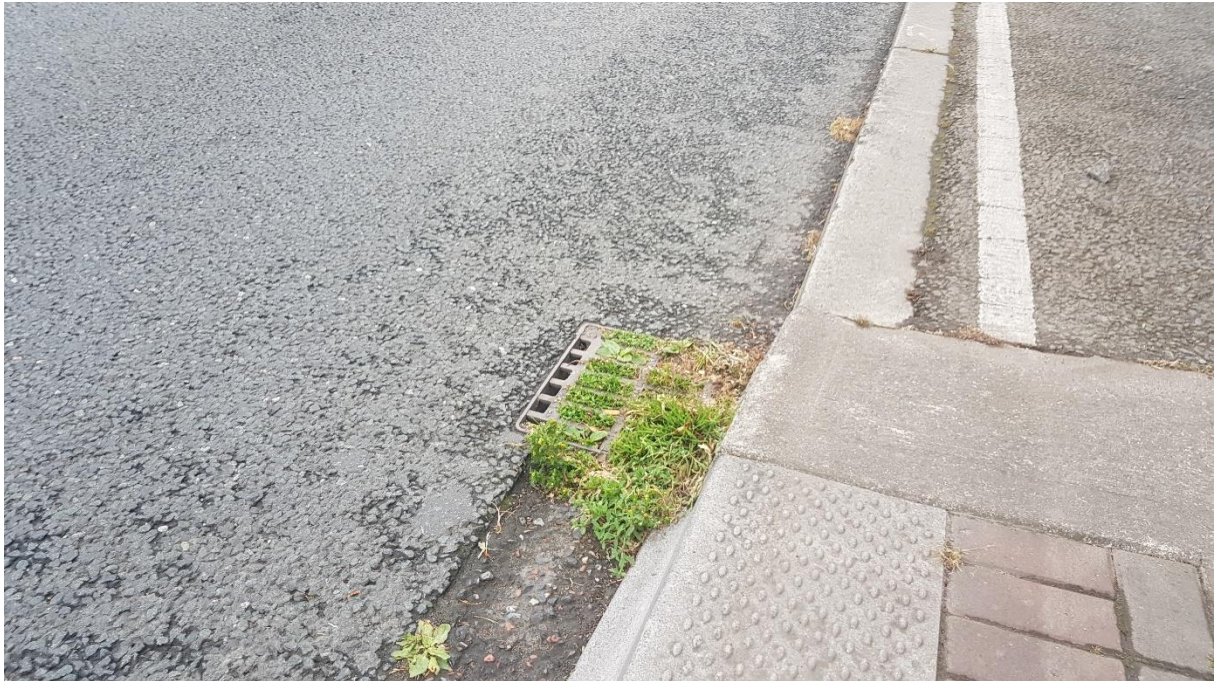
Figure 42: Blocked gully adjacent to Bus Stop on Brewery Rd N31

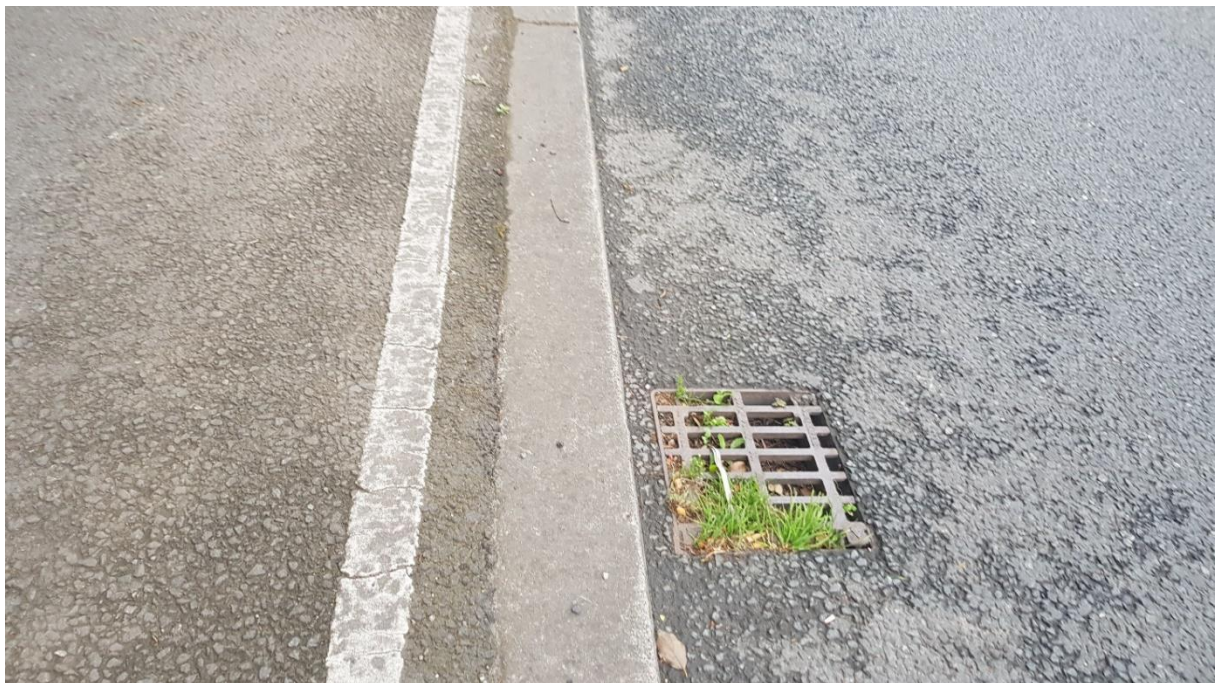
Figure 43: Blocked Gully on N31 adjacent to site

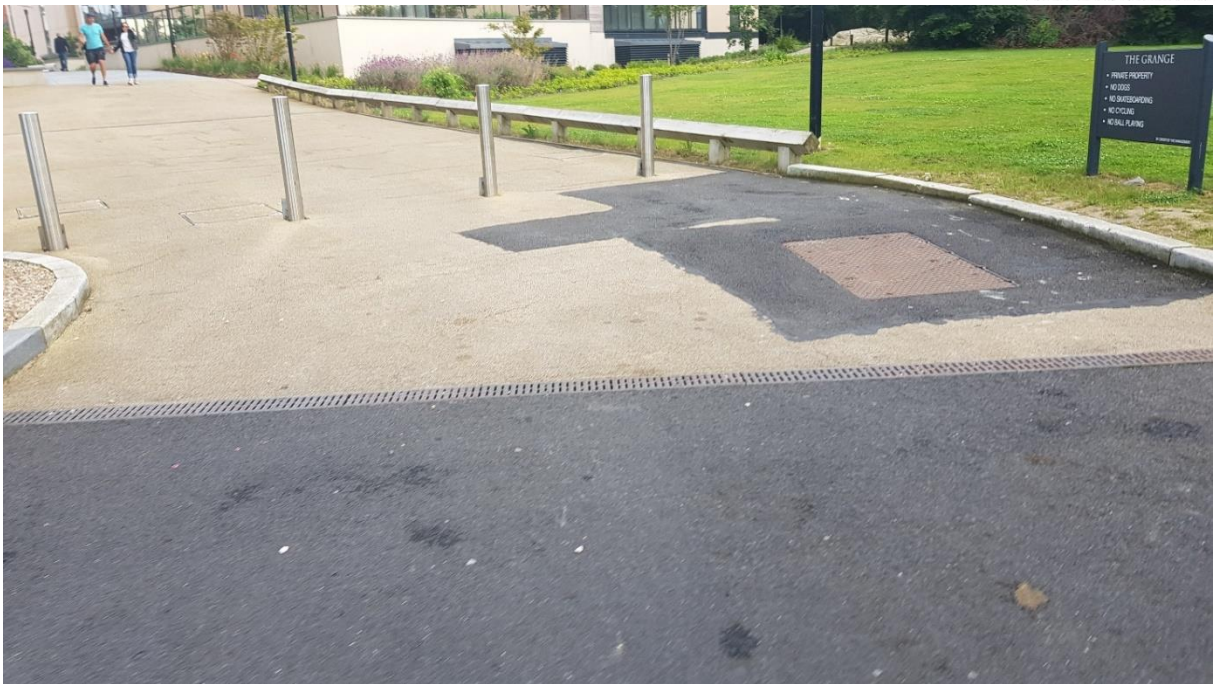
Vehicular access to the basement car park will be provided via an existing pedestrianised area where vehicular access is currently restricted by bollards, as shown in figure 45. A similar arrangement is currently provided at the proposed access to the car parking area for the proposed creche, with the existing layout in this area shown in figure 46. It is unclear if this existing paving surface on the site will be sufficient to withstand loading from ongoing vehicular access, as pavements typically exhibit greater settlement over a shorter space of time than full depth standard carriageway construction and flexible pavement.

Figure 46: Existing Layout at location of proposed creche car park

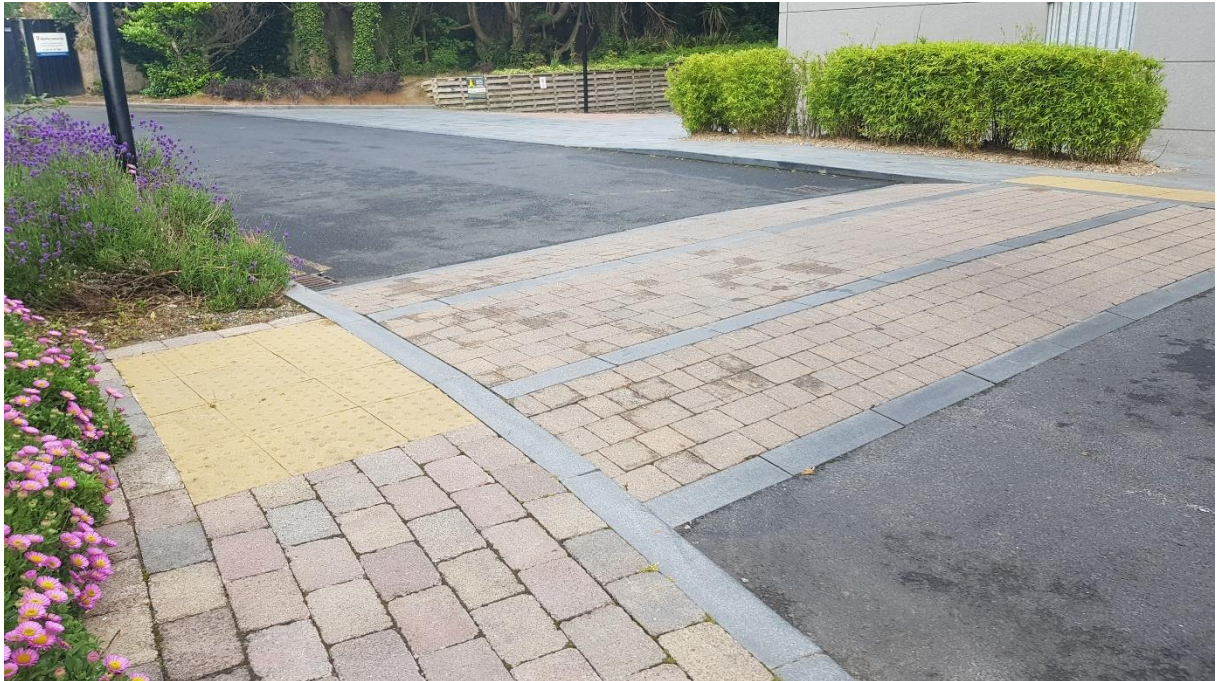
There were no details provided on proposed internal site speed limits, however advisory reduced speed limit signage is advisable throughout the carpark area and access roads, particularly as large proportions of VRUs should be expected to circulate within these areas. It was noted that existing raised crossing points, and proposed raised crossing points on the access roads to and from the site, which are shown in figures 50 and 51, are likely to have a positive impact on vehicle speeds within the site. Provision has been made for speed bumps at the existing basement car park access, as shown in figures 51 and 52. There is no provision for speed control measures on the proposed ramped access to the new basement car park for the development.

Figure 50: Existing raised crossing on access to the Grange

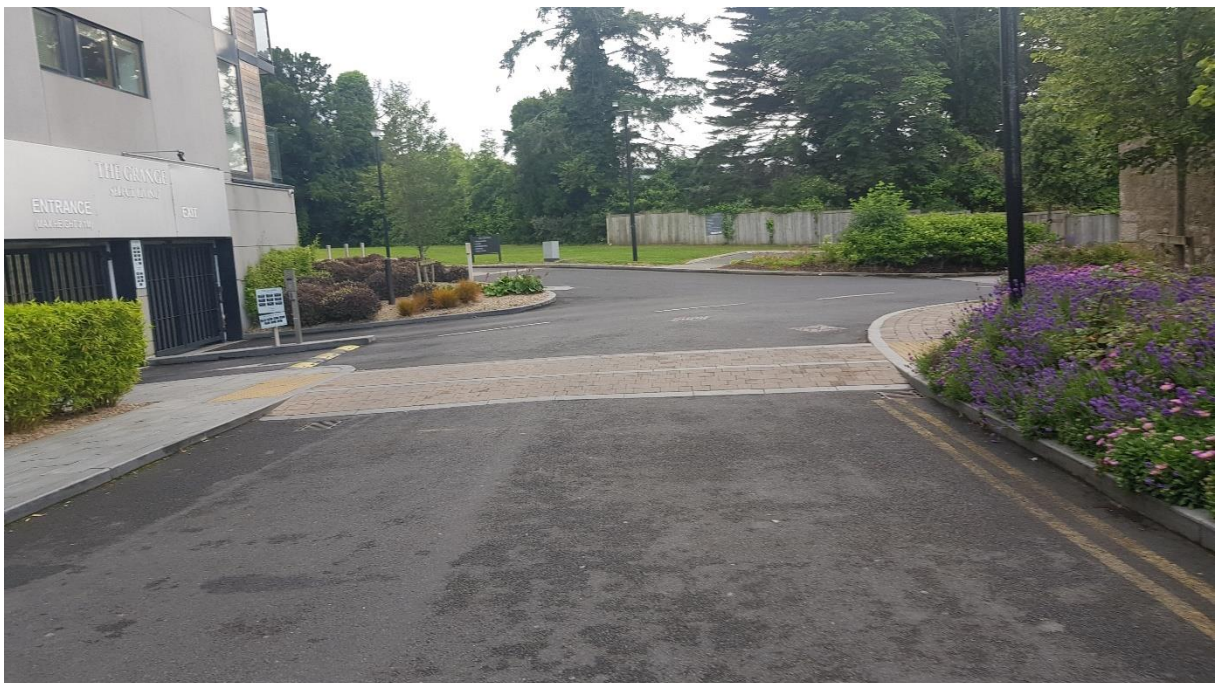
Figure 51: Existing raised crossing & Speed Bump at Car Park Access

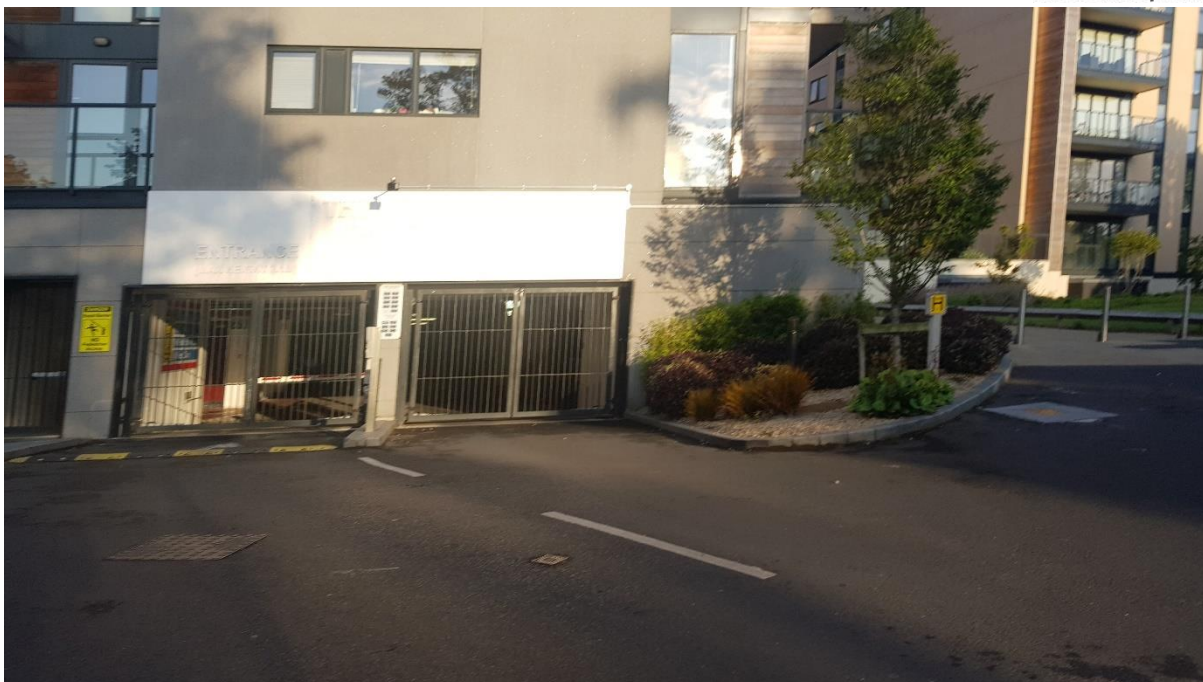
Figure 52: Existing Speed Bump at Car Park Access

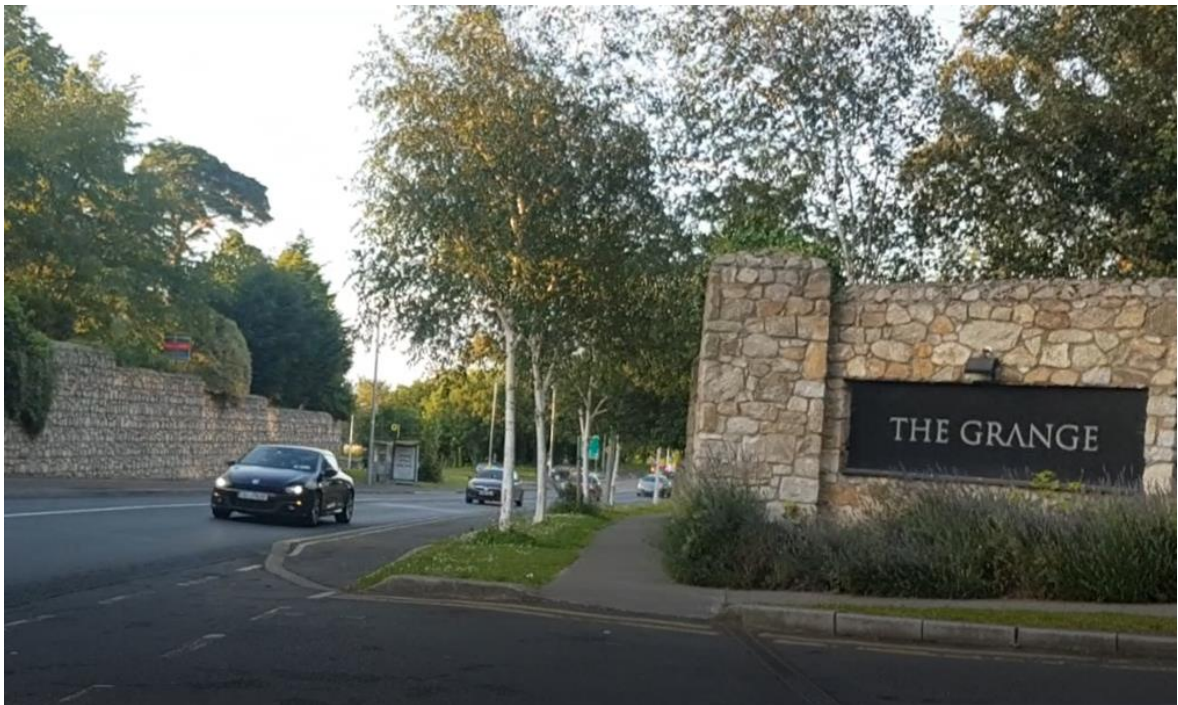
The Traffic and Transportation Assessment (TTA) provided for the site concluded that the reconfigured access junction will operate with sufficient capacity in the future design year. It was noted that there is no provision for a right turn reservoir into the Grange development, and there is insufficient room in the carriageway at present to accommodate waiting vehicles without obstructing through traffic on the N31, as shown in figure 53. Significant difficulties were also observed in terms of gap acceptance when exiting the site, despite the site visit occurring at off peak times. This may increase the risk that motorists will become impatient

Figure 54: Limited Gaps in Traffic for right turning vehicles out of site

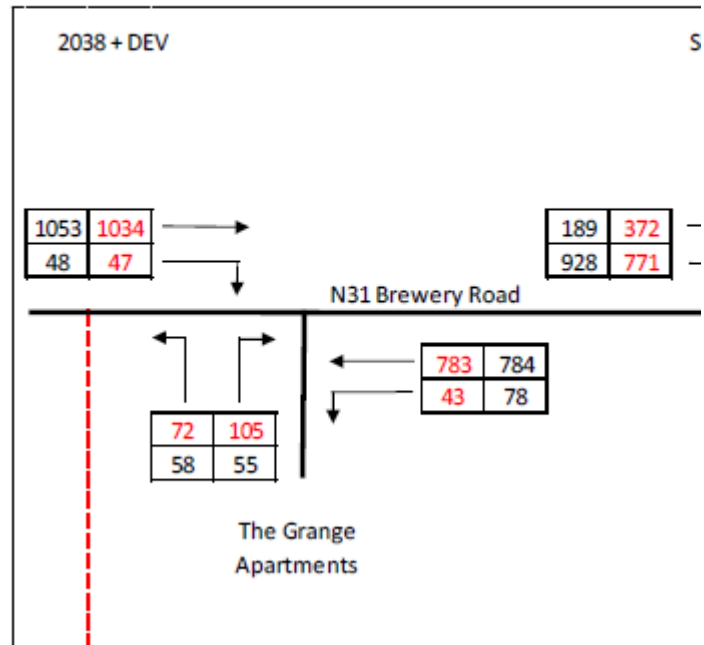
For high volumes of traffic on the major road, which would be the case with the N31, priority controlled junctions are generally deemed inappropriate for Annual Average Daily Traffic (AADT) flows in excess of 2,000 vehicles, which would equate to an approximate peak hour flow in the region of 200 vehicles. Figure 55 shows an extract from the TTA provided for the site which shows that anticipated AM peak hour flows will exceed 200 vehicles in the design year.

Figure 55: Anticipated peak hour traffic volumes at site access

The Designer should demonstrate that the proposed junction form will safely accommodate all anticipated traffic volumes and speeds. Caution should be exercised when considering capacities at the upper end of each junction type (with reference to the diagram presented in Figure 56) due to the high likelihood of an increase in collision risk and safety concerns. A conservative approach, on safety grounds, is therefore recommended in the determination of the appropriate junction form in the medium to long term.

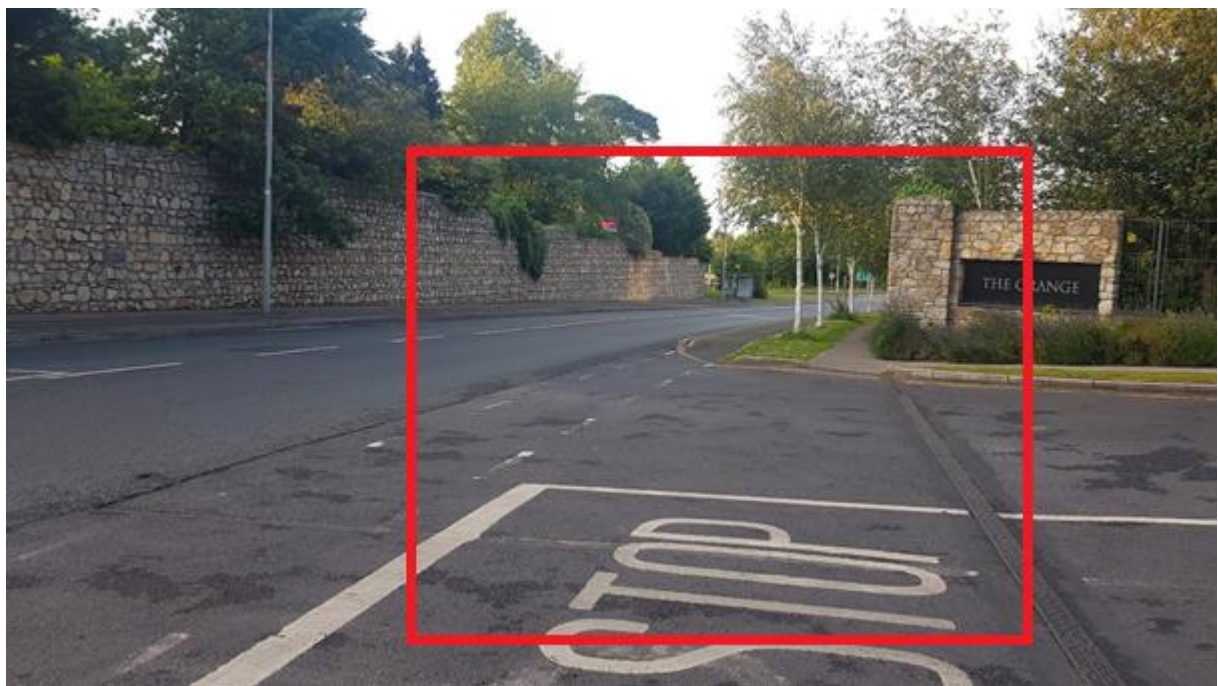
The design appears to include for retention of a two lane egress from the site, with carriageway widening and kerb setback on the nearside, as shown in figure 58. Provision of two lanes of egressing traffic at the stop line on the minor arm of the access junction will increase the number of simultaneously turning traffic streams at the junction, with vehicles queuing in the adjacent lane also potentially reducing visibility to and from traffic approaching from each direction on the N31, as indicated in figures 59 and 60, leading into an increased risk of pulling out type collisions, right angled collisions and rear shunt collisions. Two wheeled vehicles are also more vulnerable on this arrangement, particularly those wishing to turn right, with insufficient space to queue and move alongside larger vehicles in particular.

Figure 59: Waiting Vehicle potentially obscuring visibility to right

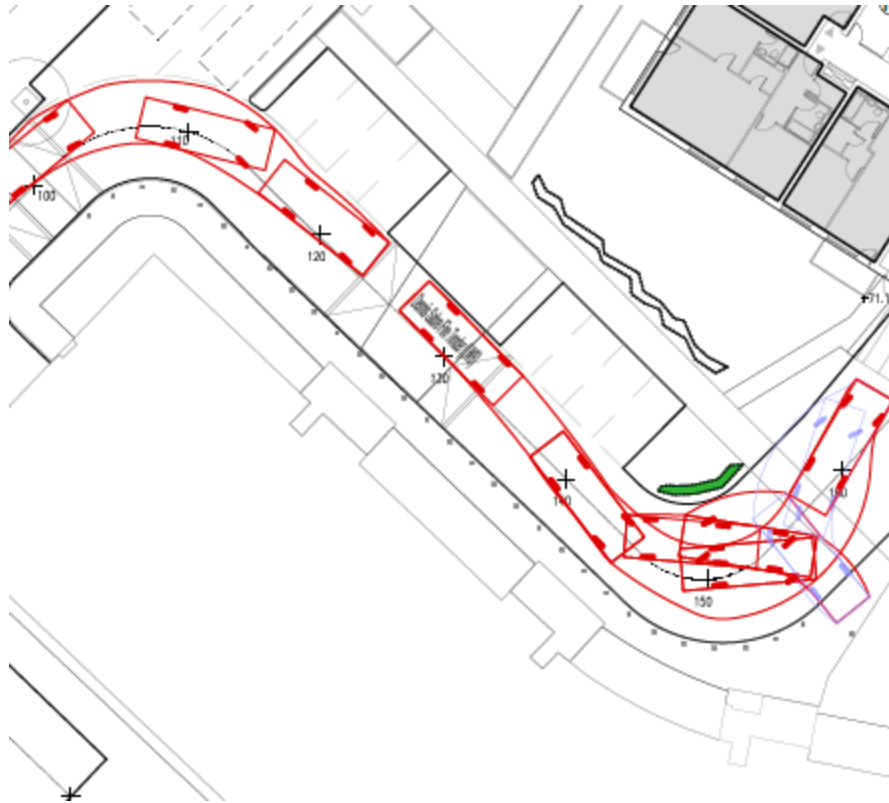
- A number of bollards have been provided at locations which are likely to obstruct pedestrian movement, including at raised ramps. The bollards are also located too close to the carriageway edges where they will present an increased risk of being struck by passing vehicles, particularly on the tight radii on the access road.

Figure 67: Bollards Adjacent to Carriageway at Crossing Points

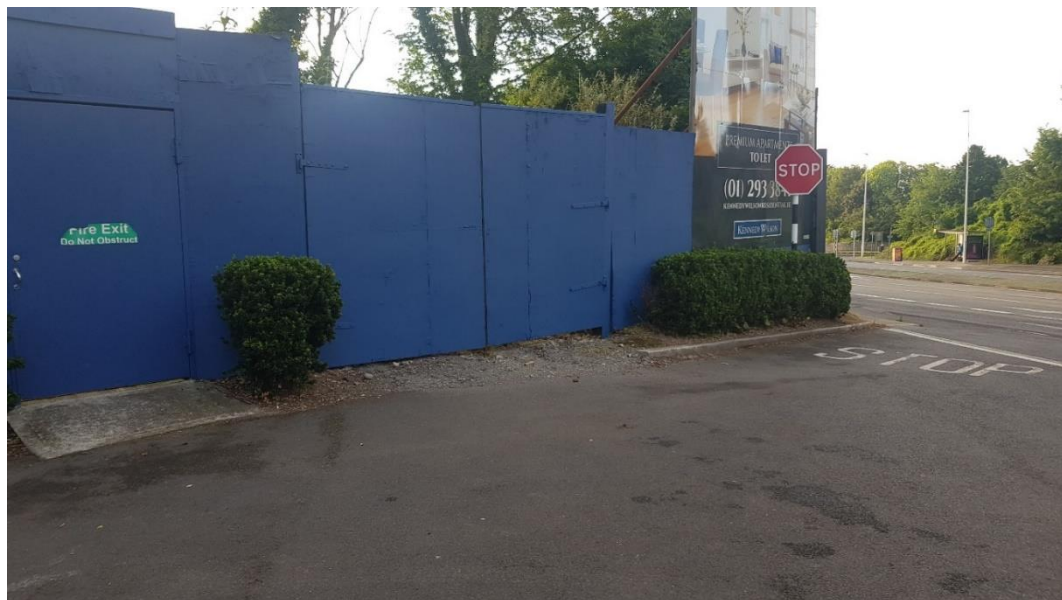
- The potential for poor Intervisibility was also noted at some locations within the site, including at the tie-ins on the N11, where pedestrians egressing the site will be brought directly out into a junction where there is no current footway provision, and where the risk of conflict with turning and waiting vehicles will be higher, as shown in figure 71. There are a number of locations throughout the site where landscaping is proposed in close proximity to crossing points and potential desire lines, with examples shown in figures 74-76. Insufficient intervisibility can increase the risk of pedestrian/vehicular conflict.

Figure 72: Connectivity to Footways Unclear
