Quality Audit
Inclusive of Stage 1 Road Safety Audit
for
PROPOSED RESIDENTIAL DEVELOPMENT
AT
THE GRANGE
BREWERY RD, STILLORGAN, DUBLIN 18

Date: August 2019

Report produced by: Road Safety Matters

Reference: RSM/MOB/080719/GRANGE-QA1

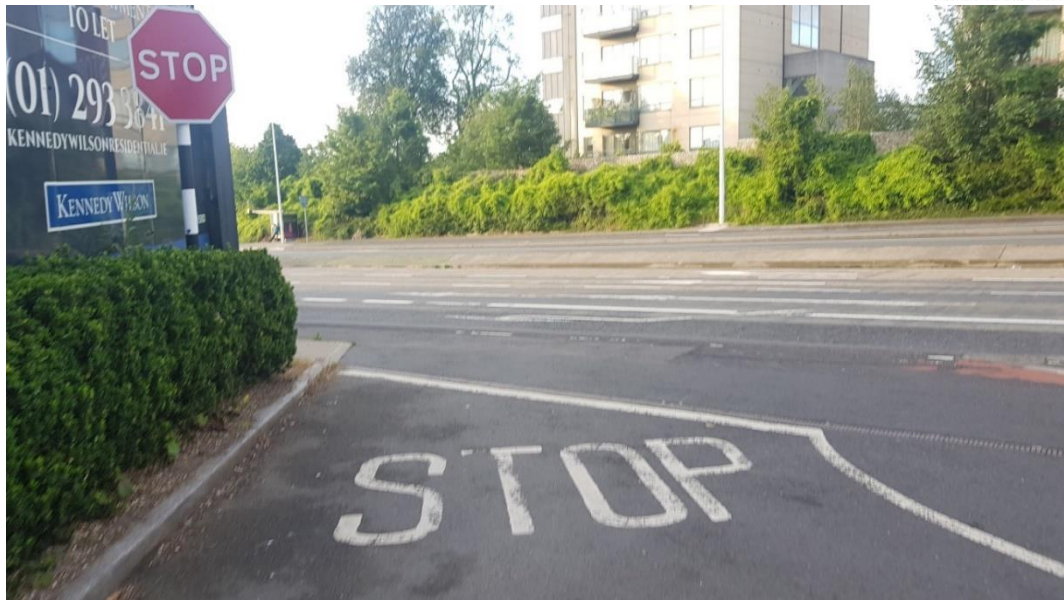
- The potential for poor Intervisibility was also noted at some locations within the site, including at the tie-ins on the N11, where pedestrians egressing the site will be brought directly out into a junction where there is no current footway provision, and where the risk of conflict with turning and waiting vehicles will be higher, as shown in figure 71. There are a number of locations throughout the site where landscaping is proposed in close proximity to crossing points and potential desire lines, with examples shown in figures 74-76. Insufficient intervisibility can increase the risk of pedestrian/vehicular conflict.

Figure 73: Lack of Safe connectivity to footways on N11

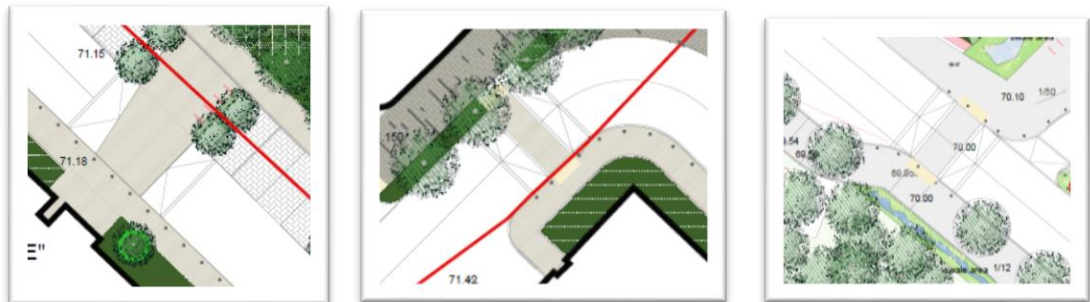
Figures 74, 75 and 76: Landscaping compromising Intervisibility
