Proposed Housing Development
in Farrankelly, Co. Wicklow

Stage 1 Road Safety Audit

Document Ref: P18-067-RP-001

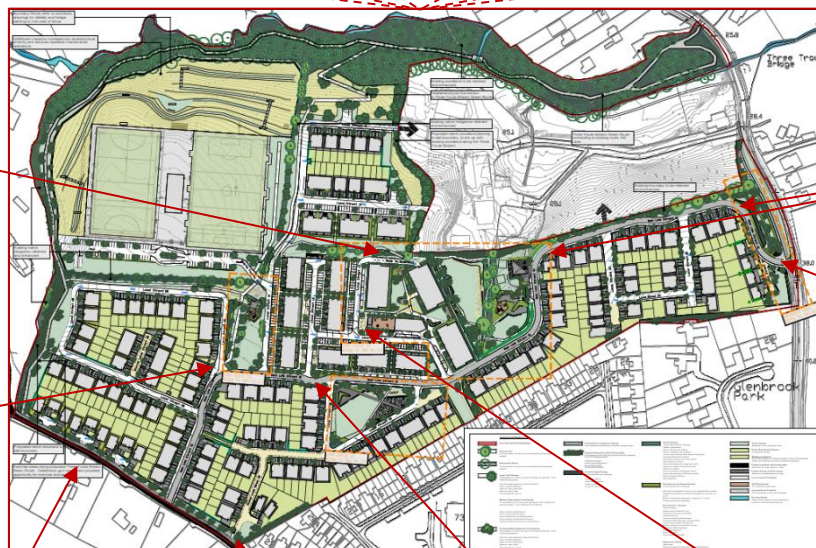
The junction mouth at Local Street 08 and Local Street 14 is wide and may promote high entry and exit speeds. This may lead to loss of control collisions where drivers fail to reduce their speed on approach to the junction. Additionally, the wide junction mouth may lead to longer crossing times for pedestrians, particularly for visually impaired pedestrians, increasing the risk of pedestrians being struck by a vehicle.

- General Problem 3.2:** Unclear if there is sufficient drainage provision within the proposed development.
- General Problem 3.3:** Designated crossing points within the residential road network have not been indicated at junctions.
- General Problem 3.4:** No junction control or priority type has been indicated at junctions within the development.
- General Problem 3.5:** Unclear where public lighting columns will be located relative to the footpath.
- General Problem 3.6:** Information regarding signage/ roadmarkings not provided to the Audit Team.
- General Problem 3.7:** Visibility exiting side roads could be restricted by trees within the footpath.

Problem 3.11: Ramp to basement at the end of Local Street 12 is near a footway, which may increase the risk of falling from height if no edge protection is provided.

Problem 3.9: Junction mouth width may encourage high entry/exit speeds.
