**PROPOSED STRATEGIC HOUSING DEVELOPMENT  
'THE CONNOLLY QUARTER': DESIGNERS' RESPONSE  
TO QUALITY & ROAD SAFETY AUDITS**

**OXLEY HOLDINGS LIMITED**

**PROJECT NO. 0635**

**30<sup>th</sup> SEPTEMBER 2019**

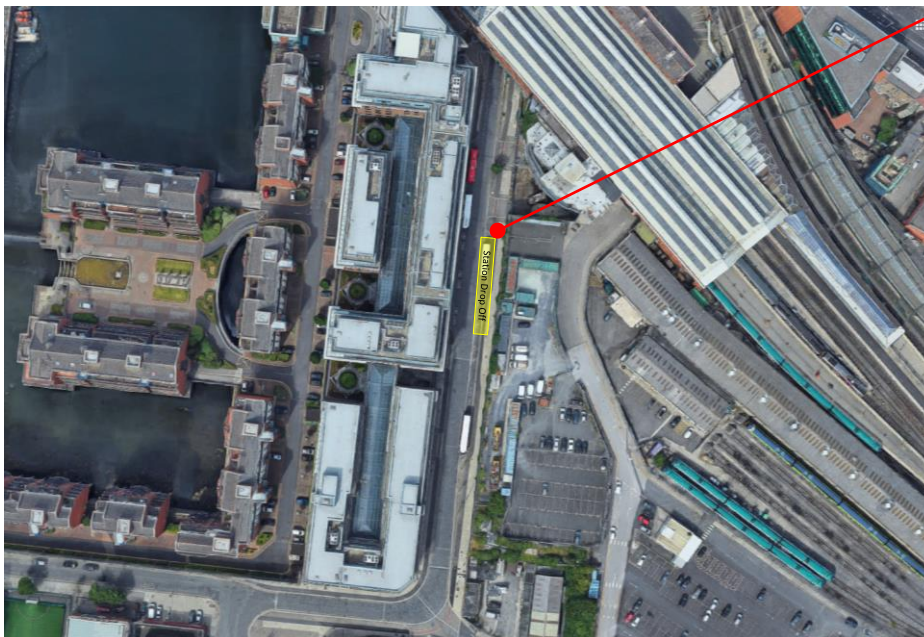
*Figure 5: Proposed Connolly Station Drop Off Area*

**Problem:** The existing Connolly Station Car park will be replaced by a basement carpark. There is currently no provision for a drop off area. This will lead to drivers stopping in traffic lanes, mounting footpaths or cycle tracks.

**Recommendation:** It is recommended that a drop off area be provided along Sheriff Street Lower.

**Response:** There is ample room on either side of Sheriff Street to accommodate a Drop Off Area. It is proposed that an area on the north side, close to the bridge be provided as shown in Figure 5 below.

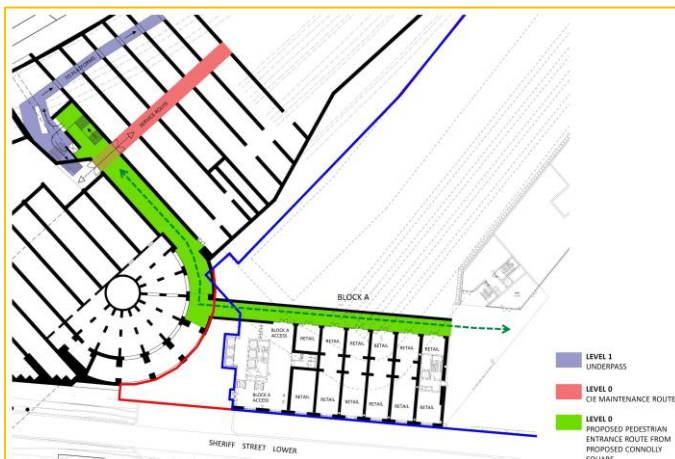
*Figure 8: Potential Pedestrian Link to Station*

**Problem:** There appears to be access to the platforms of Connolly Station at two levels. It is unclear if the accesses are wide enough to cater for the volumes of people that may use the station at the same time as trains arrive/depart. Inadequate space for pedestrians may lead to squashing of vulnerable road users such as the mobility impaired, the elderly and the young.

**Recommendation:** An analysis should be carried out of likely user volumes of Connolly station from and through the new development and adequate route widths should be provided with suitable ventilation and lighting.

**Response:** The applicants are in detailed discussions with Iarnród Éireann in relation to providing a pedestrian link between the proposed development (at Connolly Square) and the DART commuter platforms in Connolly Station. An initial route for the proposed connection is shown in Figure 8.

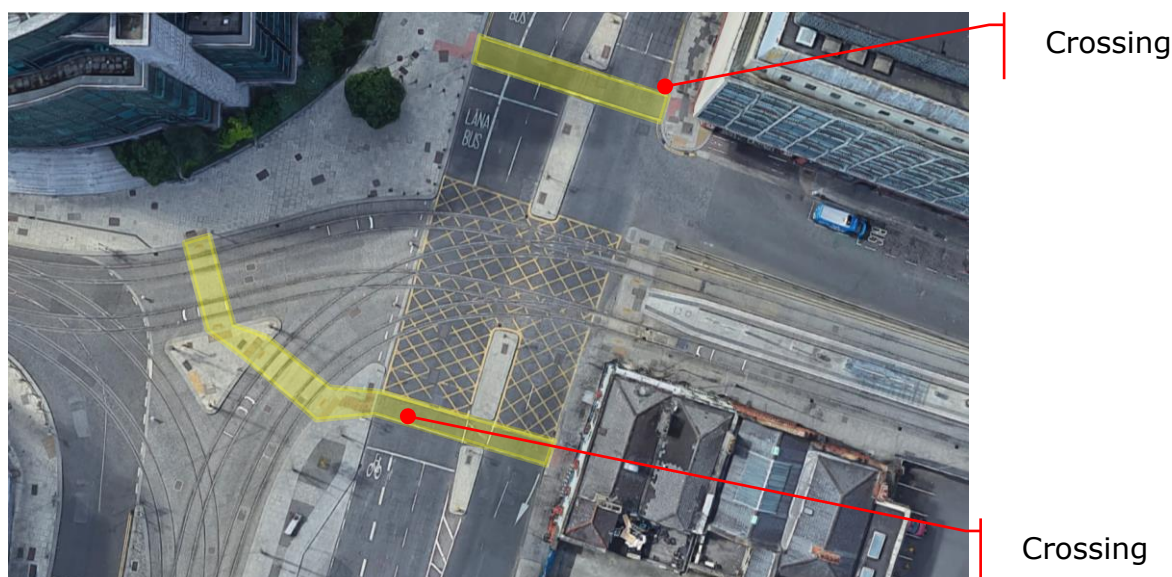
*Figure 10: Pedestrian Crossings at Busárus – Connolly Amiens Street*

**Observation IV:** Pedestrians were observed crossing Amiens Street between Connolly Luas stop and Busárus Luas stop at numerous locations. However, these were able bodied persons. Signal controlled pedestrian crossing facilities are available for the mobility impaired should they choose to use them. As it is anticipated that footfall will increase with the proposed development then the size of the crossing may need to be increased.

**Response:** The designers note the observation and note further the existing crossing points between Connolly & Busárus – Figure 10. Notwithstanding the foregoing the applicants will raise same with the Roads Authority.

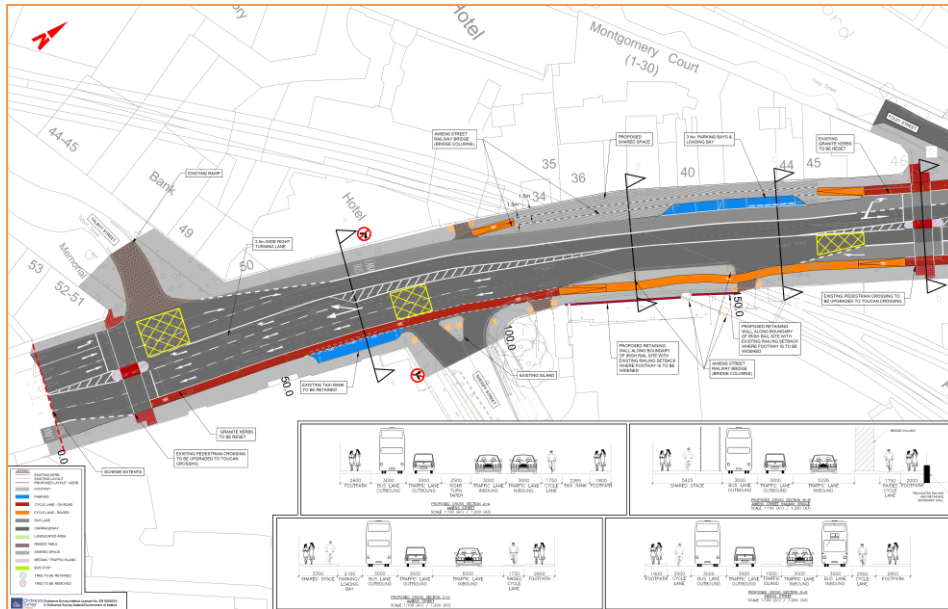
*Figure 11: Proposed Toucan Crossing at Foley Street*

**Observation V:** The pedestrian crossing of Amiens Street at the Talbot Street junction is only on the city centre side of the junction. It is anticipated that with the construction of the proposed development there will be a greater desire line for pedestrians to cross on the north side of the junction to get to Talbot Street and onwards to the O'Connell Street area. Such an upgrade may be included in the core bus corridor scheme.

**Response:** The designers and applicants are aware of proposals under the Clontarf to Amiens Street Cycle Scheme to enhance the stretch of Amiens Street between the junction with Talbot Street and Foley Street (and indeed wider afield as far as

Clontarf). Figure 11 below is an extract from the approved Part VIII proposals for the scheme and shows a new toucan crossing to be provided at the Foley Street junction in addition to the Talbot Street junction. The designers and applicants are of the view that this adequately addresses the audit team's observation.

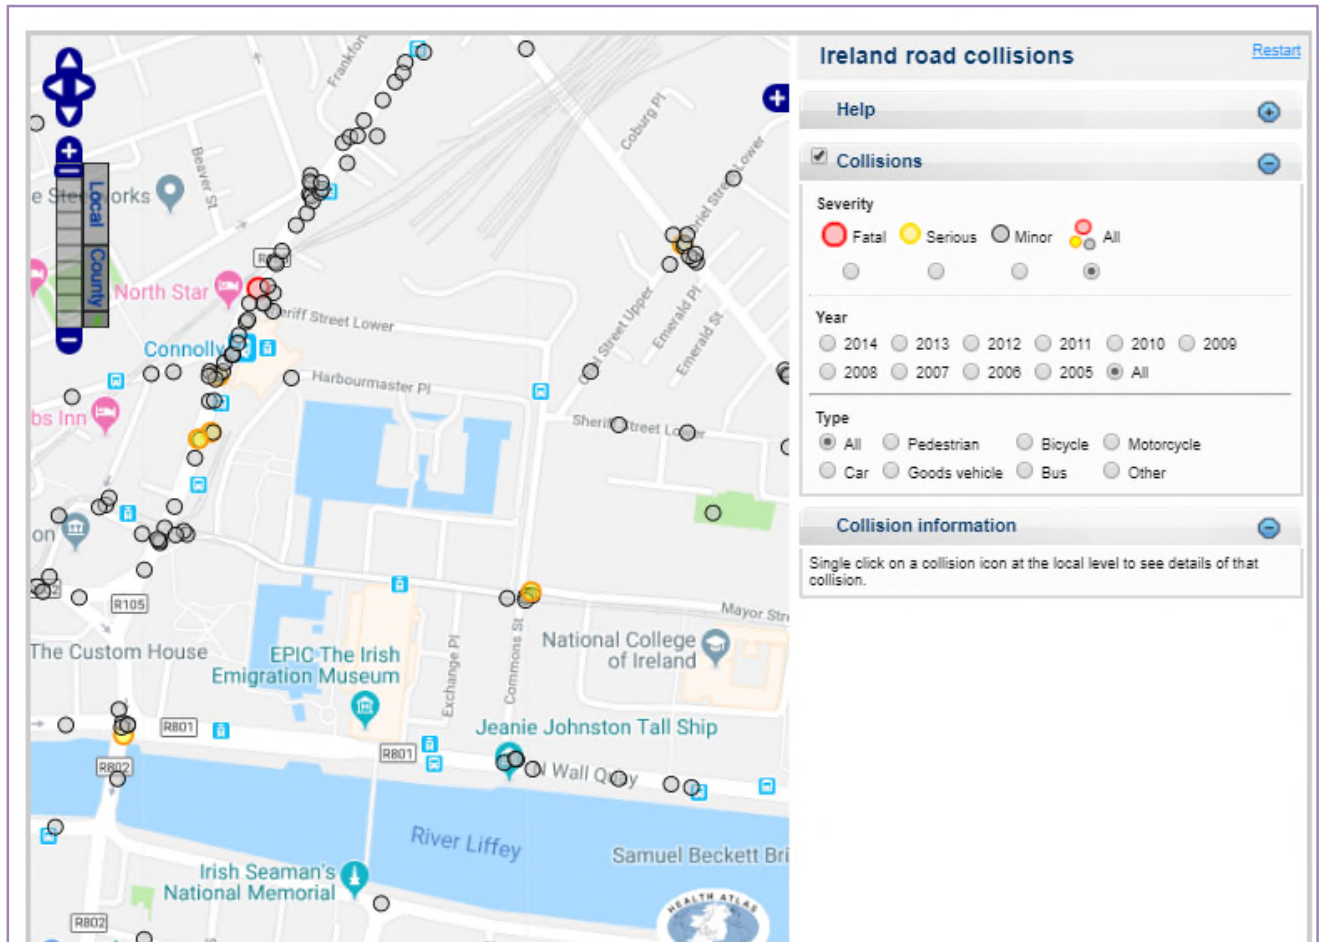
There has been a cluster of minor injury collisions at the Oriel Street Upper/Seville Place/ Oriel Street Lower junction. A number of those collisions have involved vulnerable road users. There was one serious injury at this junction in 2012 which involved a pedestrian.

A map of the collision severity and location is shown below. The number of collisions over the 10-year period is not untypical of roads with similar traffic volumes to Amiens Street.

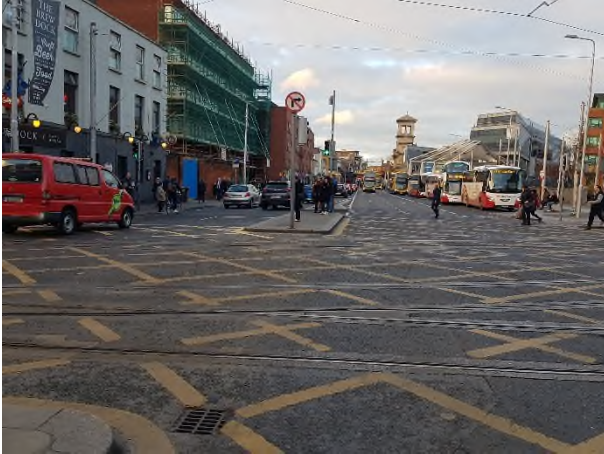
Amiens Street Crossing at Busárus.

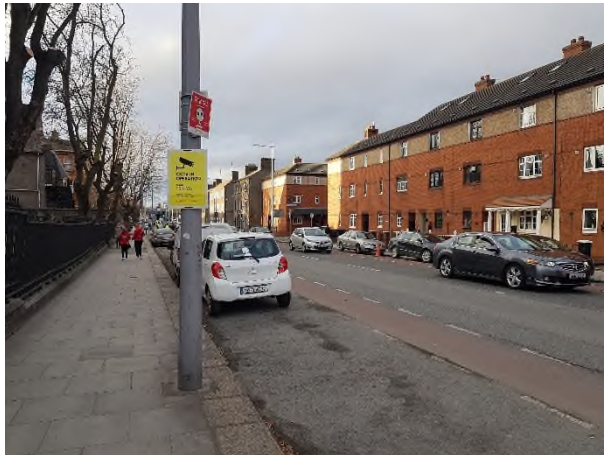
Typical cross section Seville Place

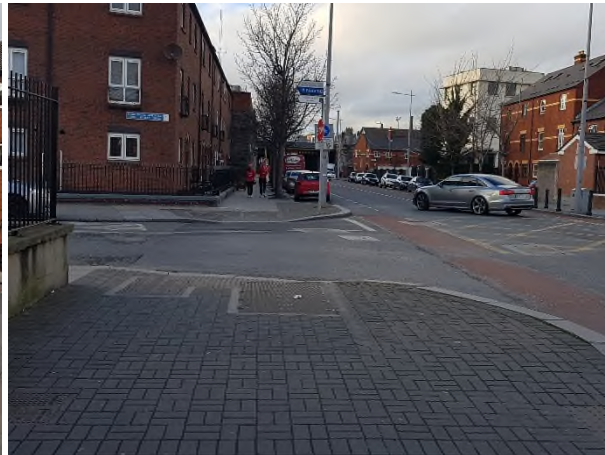
Junction Treatment Seville Place/Oriel St Upper
