Title: **STAGE 1 QUALITY AUDIT**

Sandyford Central.

Report reference: **0653R01**

This report was prepared in response to a request from Mr. Patrick Raggett, OCSC on behalf of Sandyford GP Limited (Acting in its capacity as general partner for Sandyford Central Partnership) for a Stage 1 Quality Audit of the proposed residential development at the former Aldi site, Commonhall Road, Sandyford Business District, Sandyford, Dublin 18.

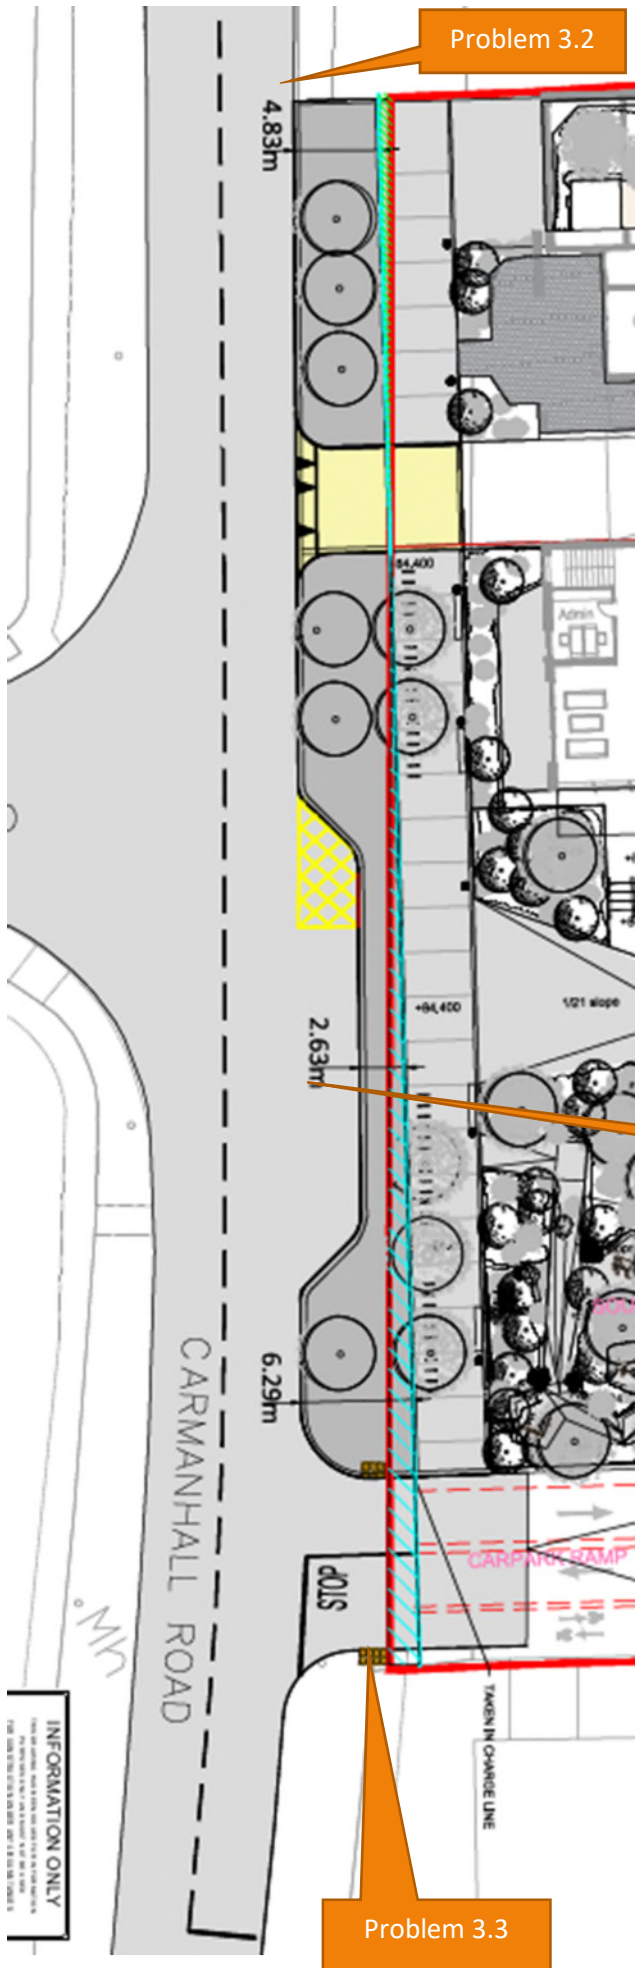
Problem Location Plan.

There is an existing advisory cycle lane on northern side of Carmanhall Road to the West of the proposed development. There are no facilities for cyclists along the site boundary. The lack of cycle facilities will lead to drivers being less aware of the presence of cyclists and a greater risk of collisions between the road user groups.

Problem 3.2

Problem 3.5

Problem 3.3

It is recommended the cycle lane be continued along the front of the development to the existing signalised toucan crossing East of the proposed site.

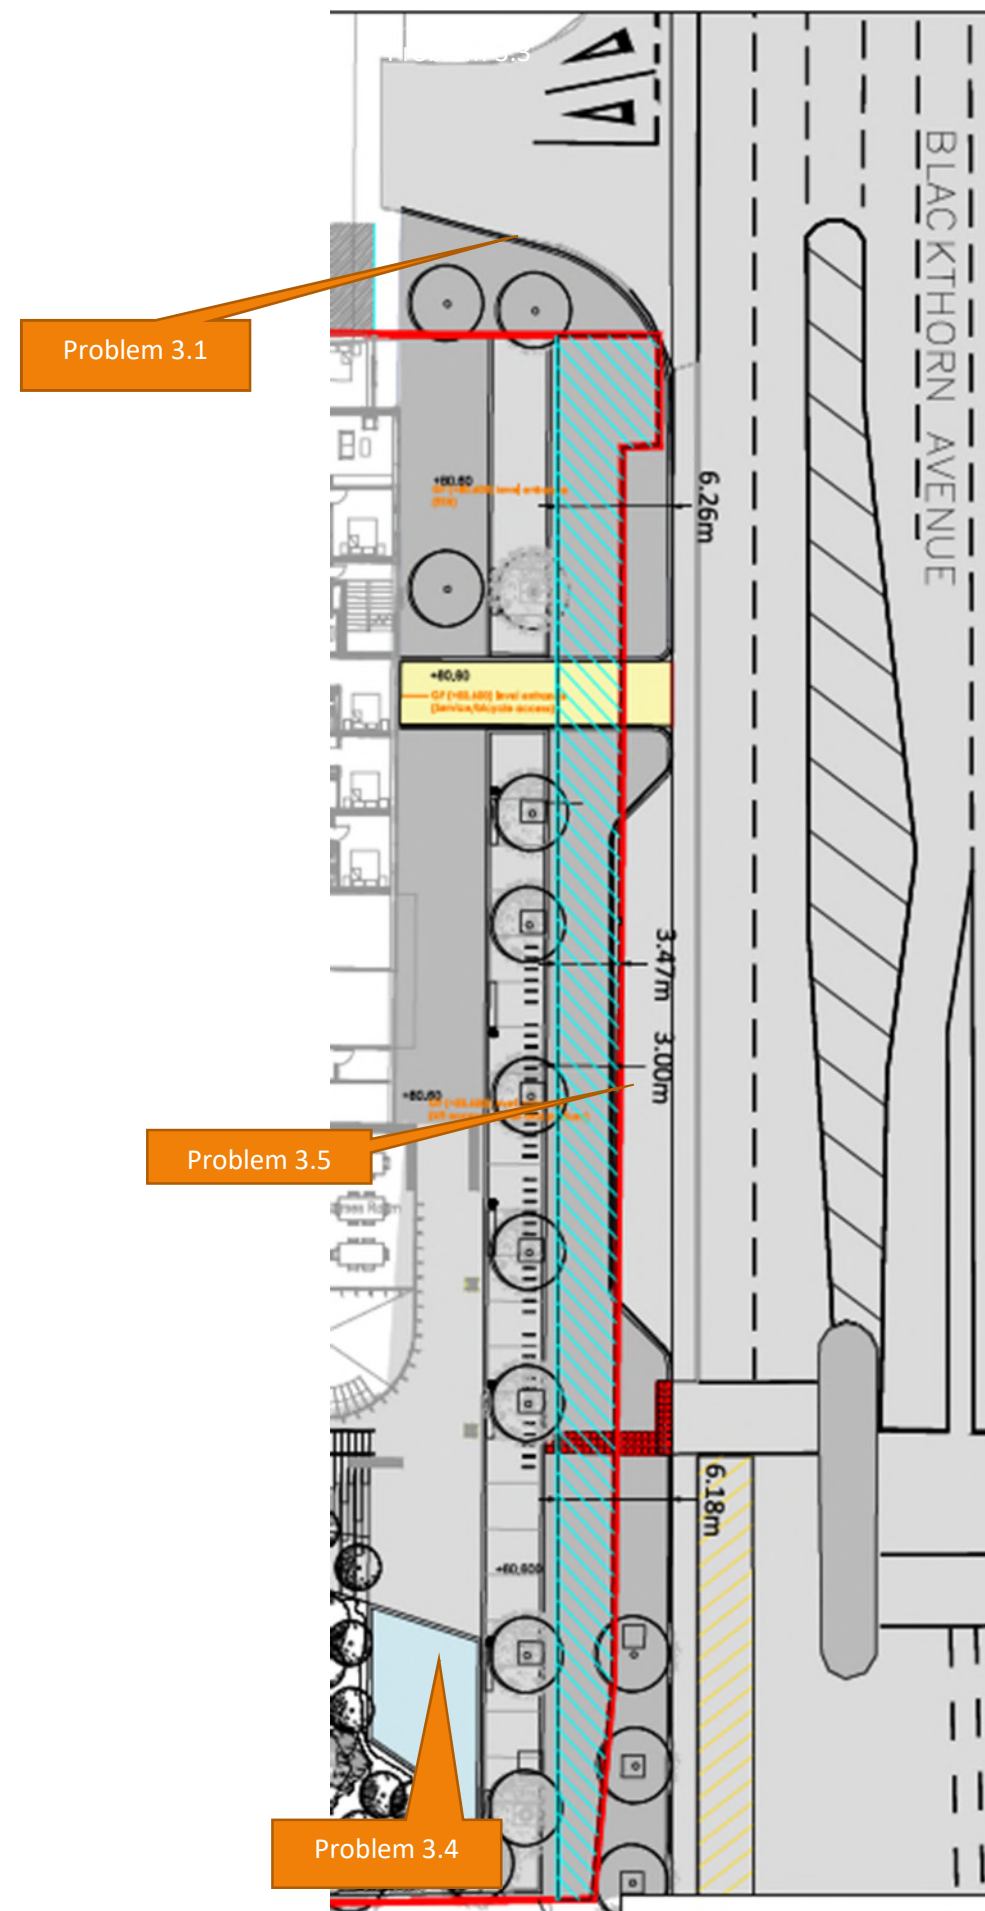
There are inadequate crossing facilities for pedestrians wishing to cross the car park to the West of the proposed development on Blackthorn Avenue. Without suitable tactile paving, partially sighted pedestrians may inadvertently enter the carriageway resulting in a greater risk of a collision with vehicular traffic.

The existing crossing has black (pavement) and white strips that may make it look like a zebra crossing however it is an uncontrolled crossing. This may lead to pedestrians thinking that they have right of way over vehicular traffic and may enter the crossing without due caution.

There are existing tactile paving slabs and dropped kerbs at the Blackthorn Avenue edge of the existing footpath. This may lead pedestrians to cross here where it is not as safe as crossing at a greater setback given the width of the car park access.

Problem 3.1

It is recommended that the crossing is upgraded to a zebra crossing or that the white strips are removed.

It is further recommended that the appropriate tactile paving is provided.

Lastly, it is recommended that the existing tactile paving at the carriageway edge be removed and a full height kerb be provided to deter pedestrians from crossing at that location.
