# Arboricultural Assessment Report

Residential Development,  
Newtownmoyaghy,  
Kilcock, Co. Meath

<b>Project No.</b>	TKIL004	<b>Date</b>	18/11/19
<b>Project Name</b>	Residential Development, Newtownmoyaghy, Kilcock	<b>Revision</b>	D

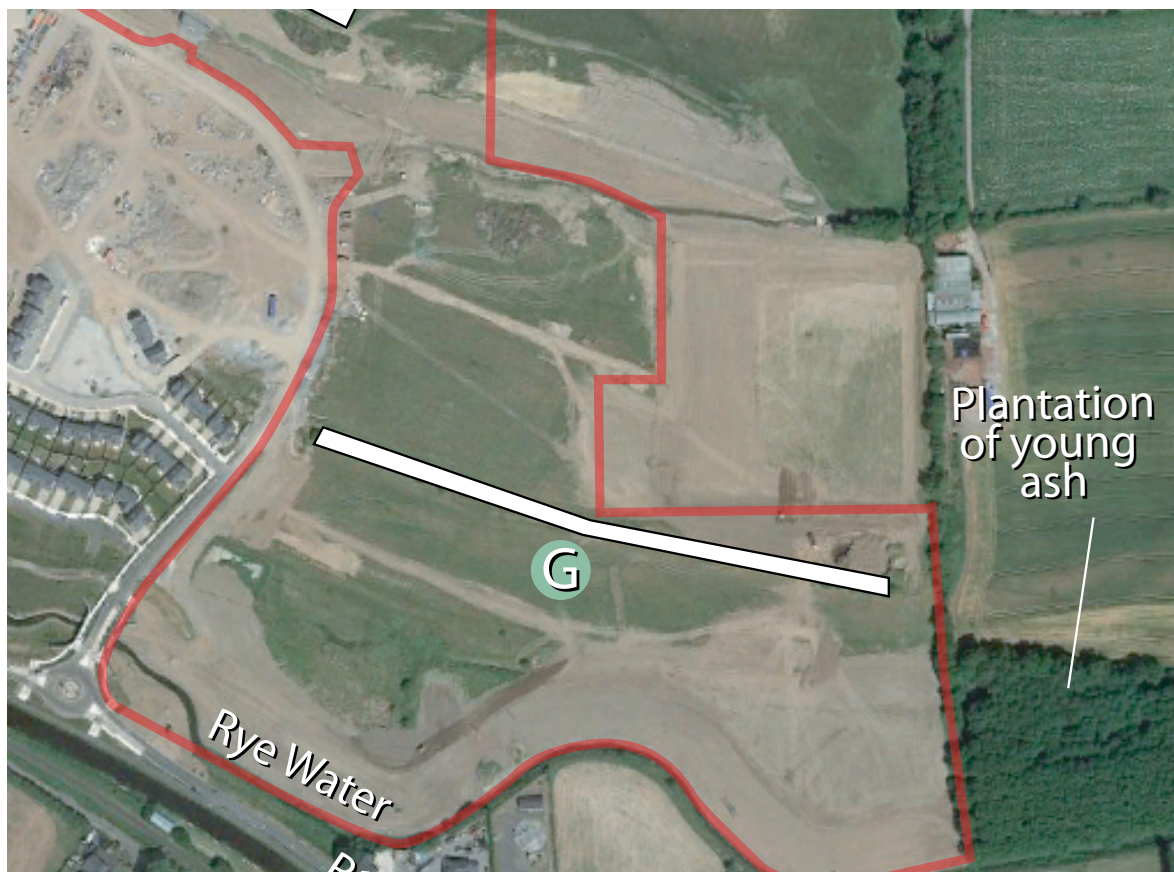
**Description:** A degraded agricultural hedgerow located within southern section of the site which has lapsed due to lack of maintenance. Occasional standard hawthorn present. A plantation of young ash within the neighbouring site to the east providing a degree of shelter and screening to subject site.

**Species present:** Hawthorn, elder and bramble.

**Average height:** 4 meters **Total length:** 341 meters
