Gort Wind Farms Ltd.

# Remedial Environmental Impact Assessment Report Chapter 10 – Soils, Geology and Land

Document No.: QS-000280-01-R460-001-000

Date: July 2020

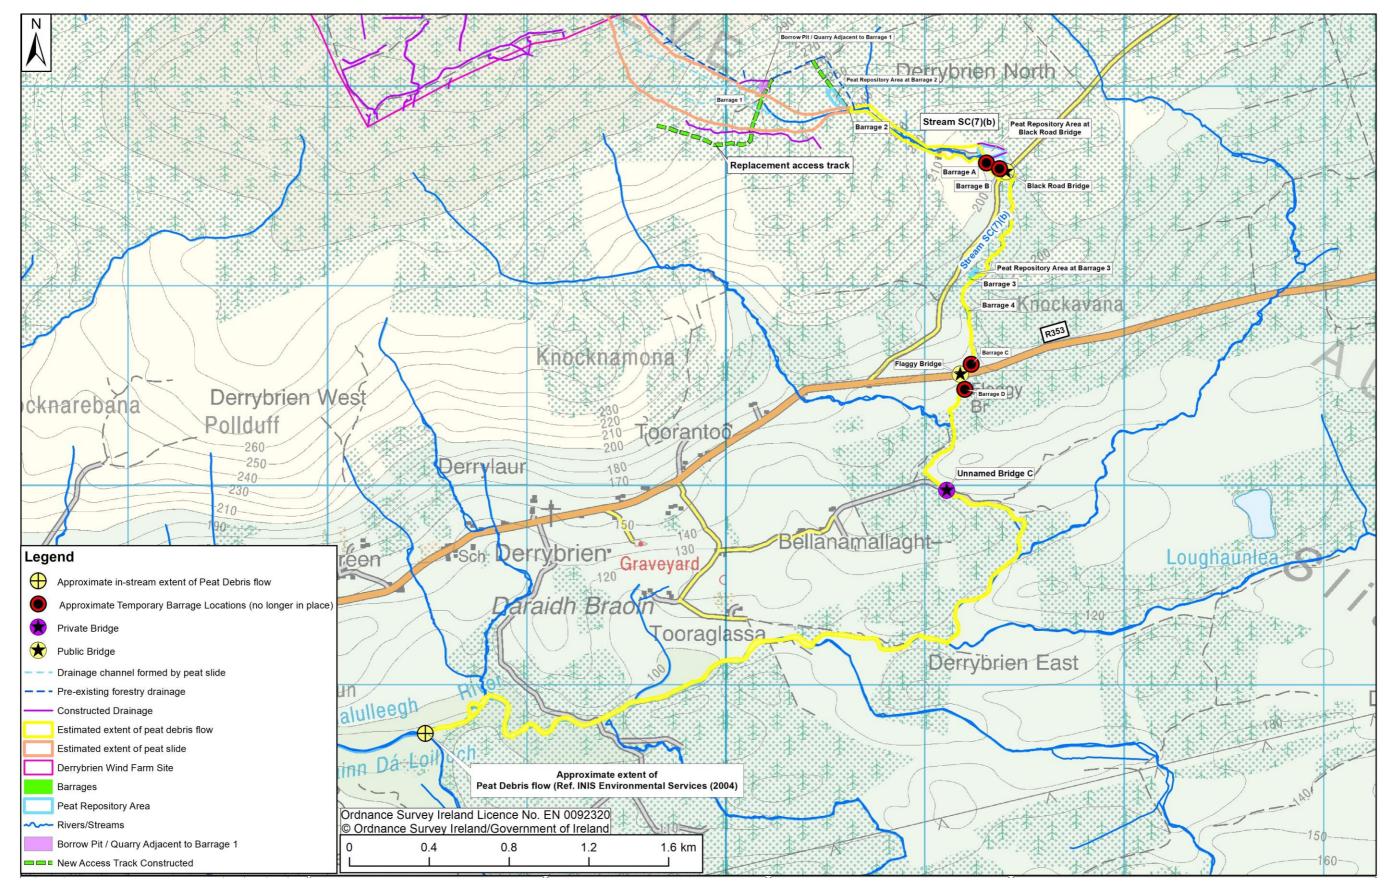
Figure 10-28: General topography – peat slide and associated works

The path of the peat slide debris followed a tributary stream valley (SC7b) of the Owendalulleegh River. From the source area, the peat slide debris passed down the tributary stream valley which narrows to form a steep-sided channel at about 250 m AOD before widening downslope above c.195 m AOD, which is the location of the Black Road Bridge, see Figure 10-28.

Containment barrage 2, which is predominantly constructed from large boulders, is located within the downstream end of a narrow steep-sided channel at approximately 245 m AOD (Figure 10-28). The footprint of the barrage is approximately 17 m long and 20 m wide. The general area comprises level ground, except within the stream channel, which is incised some 3 to 4 m.

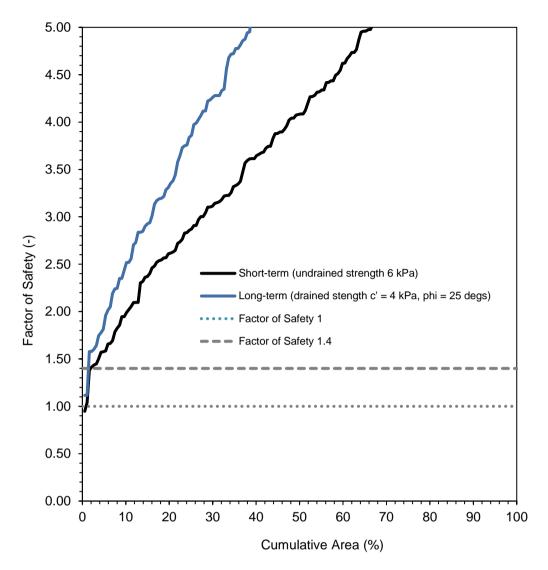
## Figure 10-33: Peat slide source area factor of safety for short and long-term conditions

The above results confirm the findings of the periodic inspections of the source area carried out by ESB, AGEC and FT post the 2003 landslide up to the recent 2019 inspection, which showed that since the time of the peat slide, the debris within the source area had essentially drained and was locally desiccated, which would have increased the peat strength and overall stability. In addition, movement monitoring survey points installed within the source area showed negligible movement within this period.

In general, the FoS's less than 1.4 generated from the analysis are not unexpected as generalised lower bound peat strength values are used in the analysis, which does not take into account areas of higher strength peat. In reality the peat debris within the source area has a significantly higher undrained shear strength than that used in the analysis.

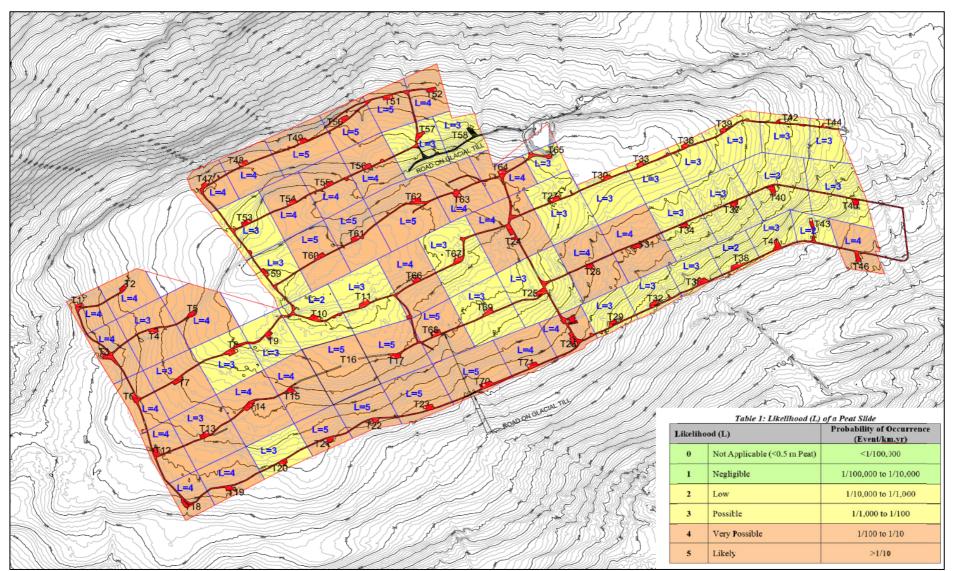
Figure 10-34: Likelihood (L) of a peat slide across the wind farm site for Baseline Peat Stability Risk Assessment based on site conditions in 1998

Significantly, at this stage (Q2 2020), with the improvement of site conditions, the likelihood of a peat slide has reduced to **negligible** across the site for the project activities that are likely to be carried out on site over the remaining operation and maintenance life of the project and during decommissioning.

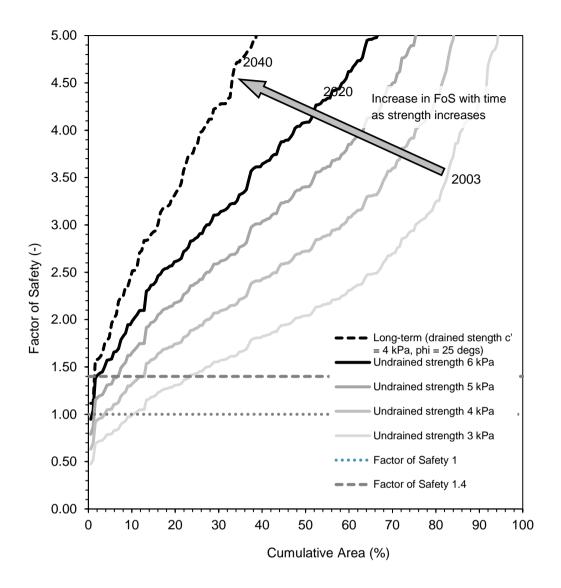
Figure 10-37: Likelihood (in terms of FoS) of a peat slide in source area with improved site conditions from 2003 to 2040 (decommissioning)

The low FoS's are localised within the source area and not unexpected as generalised lower bound peat strength values are used in the analysis, which does not take into account areas of higher strength peat. In reality the peat debris within the source area has a significantly higher undrained shear strength than that used in the analysis. The low FoS's are associated with locally steeper slope inclinations likely as a result of localised undulations in the failed debris or vegetation within the

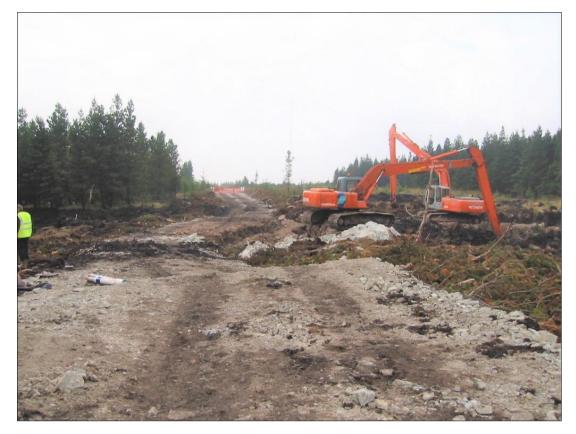
Plate 10-1: Excavation at Turbine T68 at the time of the slide

At the time of the peat slide on the 16<sup>th</sup> October 2003 peat up to 3.5 m deep was being excavated from the site of Turbine T68 and placed on the intact peat slopes on the downslope side of the floating road, opposite the turbine, using 2 No. 20 tonne Hitachi EX200 long-reach excavators. Some of the excavated material was also placed on the slopes to either side of the turbine. The excavators were operating on the floating road and on a small section of granular hardstanding on the glacial till between the turbine and the hardstanding. The excavation had not progressed into the glacial till so only peat was sidecast on the slopes (see Plate 10-1 and Plate 10-2).

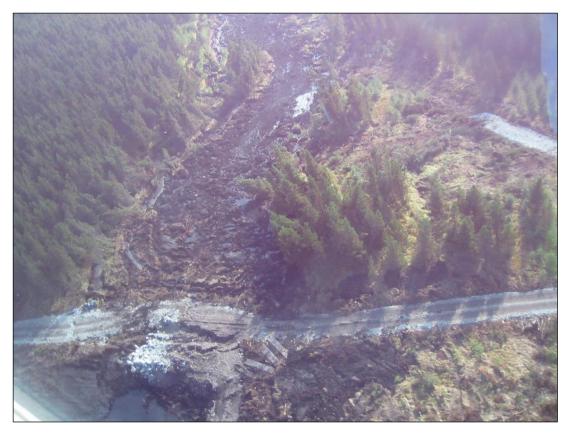
Plate 10-2: Aerial view of the head of the slide at Turbine T68 (October 2003)

AGEC concluded that the construction activity, and particularly the placing of arisings onto the intact peat slopes, most likely triggered the slide. The failure mechanism that they proposed is shown schematically in Figure 10-1.

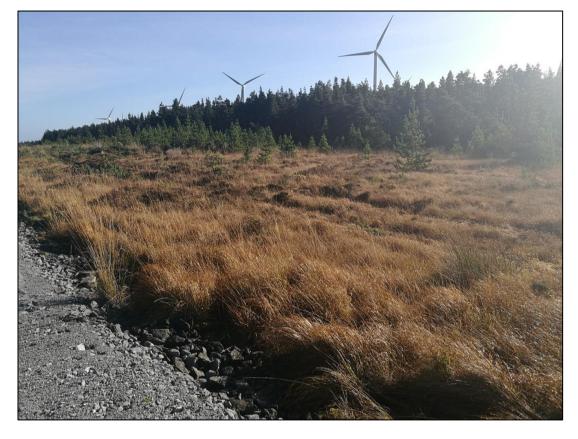
Plate 10-4: Peat Repository near turbine T48 at the end of 2018

Plate 10-4 shows a typical image of the peat repositories at the end of 2018. Since the end of construction, the surface layer of excavated peat has settled significantly into the slope as the underlying intact peat has compressed under the dead load surcharge from the excavated peat. This has partially compensated for the increased rate of decomposition in the excavated peat on the surface of the slope because more of the underlying intact peat has settled below the water table, where the rate of decomposition is significantly lower. Furthermore, the surface of the excavated peat in the repository areas has re-vegetated so that a new rate of carbon flux has been established with the decomposition and accumulation of peat on the slopes. Therefore, the net rate of carbon release has significantly reduced.

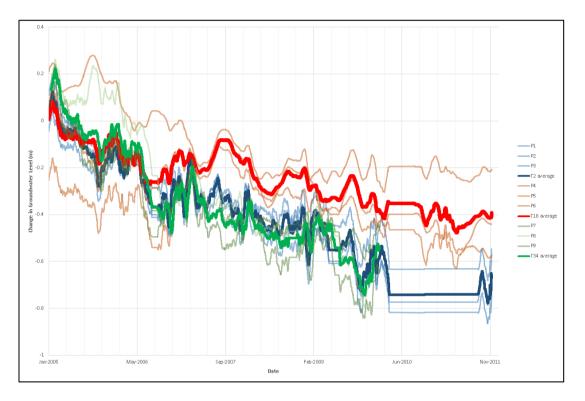
# Figure 10-42: Water level readings from vibrating wire piezometers (January 2005 to November 2012)

Groundwater levels were monitored in the piezometers over a period of 8 years between 2004 and 2012 before the instruments were decommissioned. Figure 10-42 shows the readings from the piezometers at T2, T18 and T34 up to November 2011. The readings from the piezometers at T49/T50 are not plotted because they malfunctioned after installation.

The short-term regular fluctuation in the data reflects seasonal fluctuations in groundwater level as well as changes in atmospheric pressure, which directly affect the water level readings as they are based on pressure. Nevertheless, the results indicate that, on average, between December 2005 and November 2011 the groundwater level in the peat gradually dropped by about 0.40 m at Turbine T18 in the SW corner of the wind farm site, and by about 0.75 m at T2 and T34 in the NW corner of the site and in the turbary plots at the east end of the site, respectively.

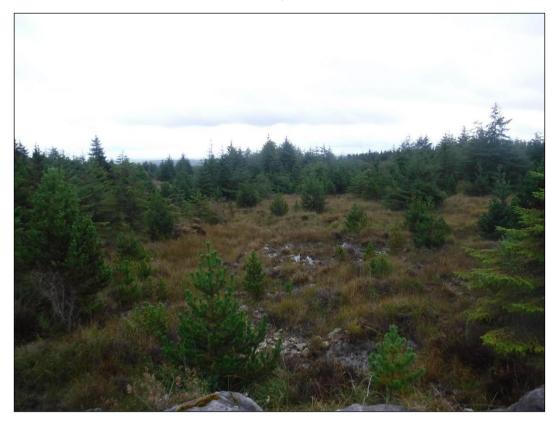
Plate 10-5: Overview of re-vegetated area within the peat slide source area

Plate 10-5 shows a general overview of the revegetated source area in 2019.

The overall significance of these effects still occurring at the end of Q2 2020 is Slight.

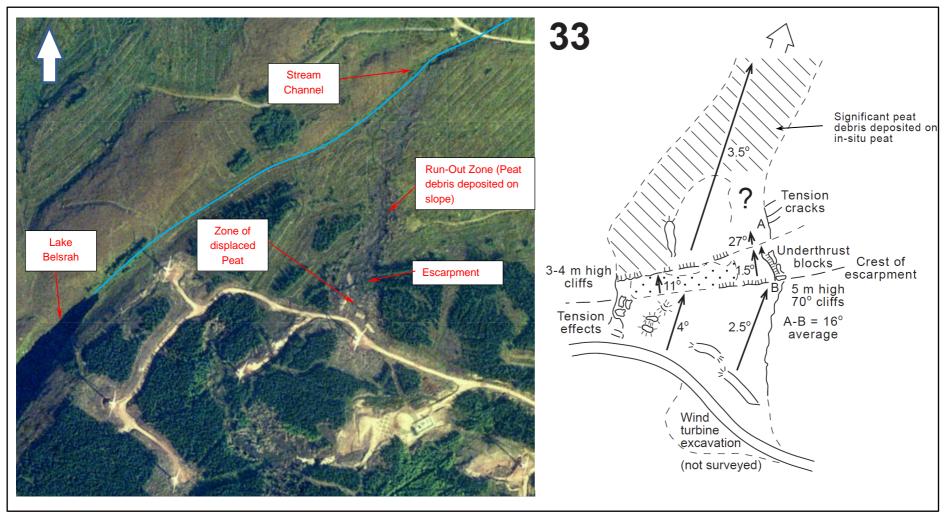
Figure 10-45: Characteristics of peat slide at Sonnagh Old Wind Farm (2005 Aerial Photo (OSI - Geohive Online Portal, 2020) & Geomorphological Map of Slide Area (Dykes, 2009)

An aerial photograph of the site from 2005 showing the location and extent of the slide is presented in Figure 10-45 along with a geomorphological map of the slide area produced by Dykes (2009). Based on this information it appears that the slide initiated in an area of peat on shallow slopes of 2.5-4.0° along the upslope edge of a steep scarp of 3-4 m high cliffs. Peat was displaced to the north over an area of about 0.50 to 0.75 ha from the upper slope and deposited over an area of about 1.25-1.50 ha on the shallow slopes of 3.5° downslope from the escarpment. Debris from the slide appears to have reached the channel for the stream flowing from Lough Belsrah, approximately 450 m downslope. The stream is within a sub-catchment of the Kilchreest River to the north of Sonnagh Old.

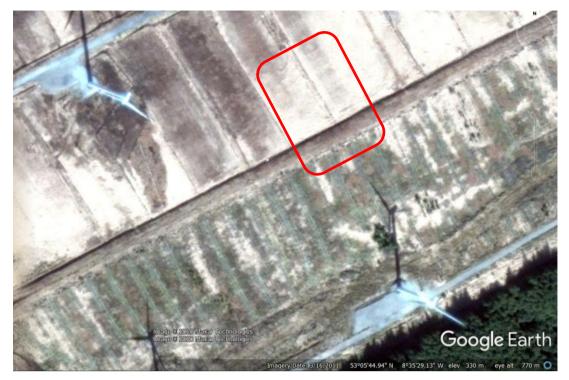
Plate 10-9: Aerial view of slide area - 9th April, 2015 (Google Earth)

Based on historical aerial photographs from Google Earth and the OSI Geohive online portal, the peat slide appears to have initiated sometime between April 2015 (Plate 10-9), when there were no tension cracks visible, and July 2018, when the tension cracks were visible in the peat and the drain on the downslope side had closed over (Plate 10-10). By May 2020 the peat failure had extended further upslope

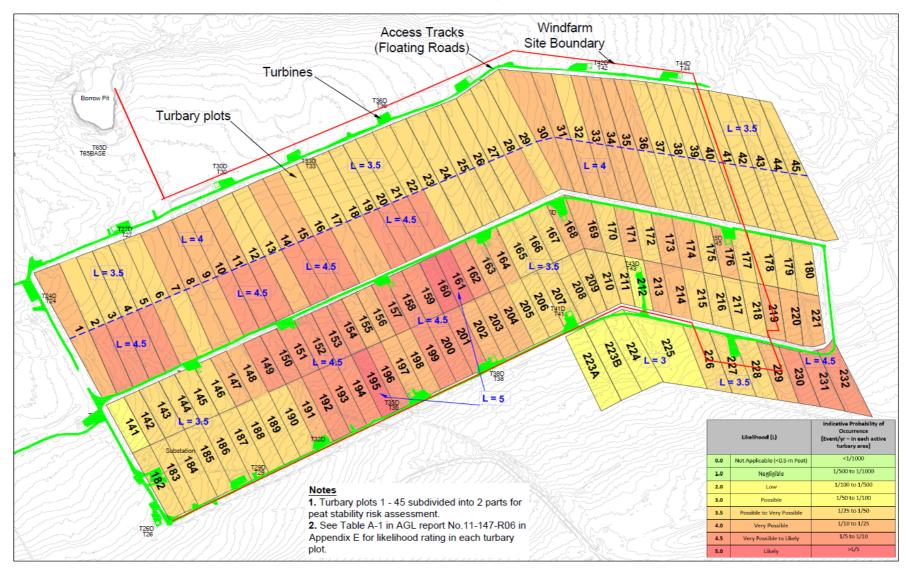
Figure 10-52: Likelihood of a peat failure due to mechanical peat harvesting in the turbary plots prior to mitigation

When this is compared to the significance of the stability impacts of site activities for peat extraction in the turbary plots it can be seen that, due to the increased level of mechanical extraction carried out in the area since 2012, the cumulative effect on the stability of the peat temporarily increased to **Moderately Significant** or **Significant** in the plots where the mechanical peat extraction was being carried out. The highest risk of a peat failure was at the time that the works were being carried out and the effect was brief or temporary, lasting only a few days in each area.

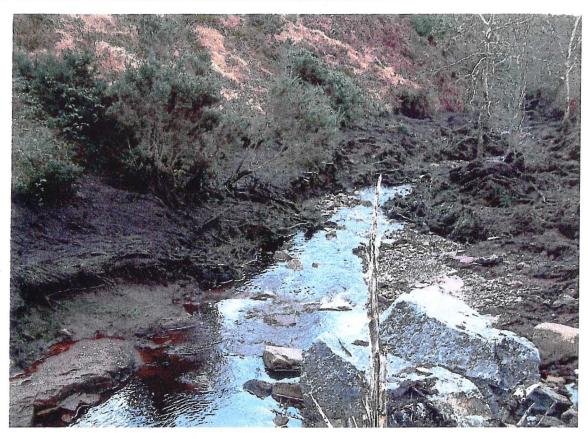
Plate 2 Chainage 198 showing silt deposition and level of peat on the banks.

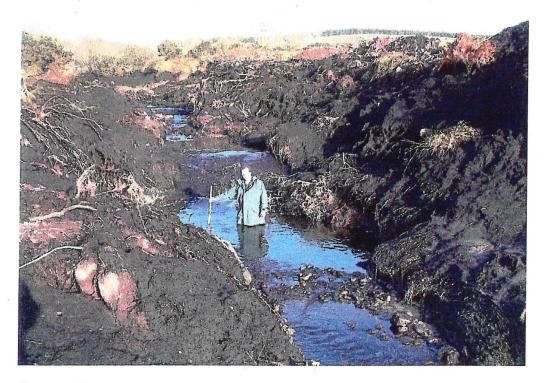
Plate 5 Chainage 199 - just south of Flaggy Bridge (chainage 200) showing peat deposition on the banks.

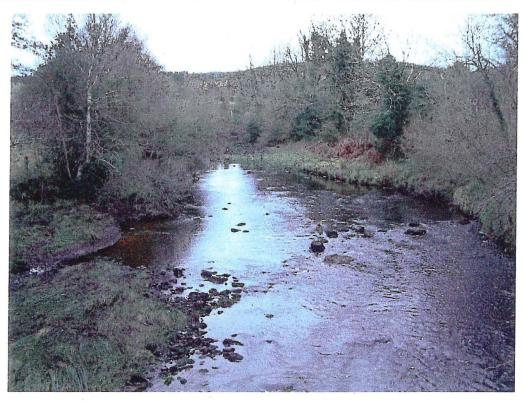
Plate 6 Scene of river from bridge (M 547 990) showing negligible impacts. This is the scenario for most of the lower sections of the river.

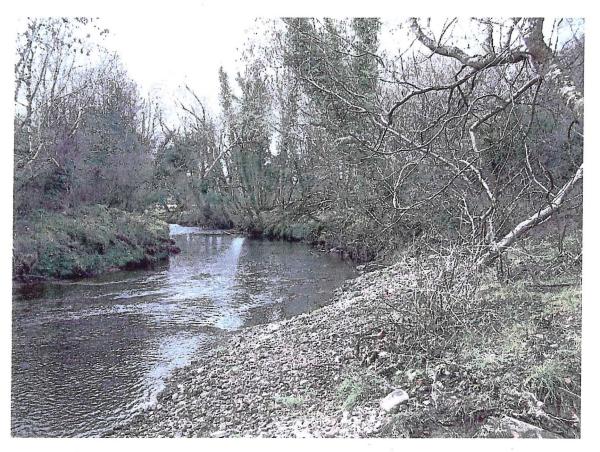
Plate 7 River showing some small light detritus on the banks

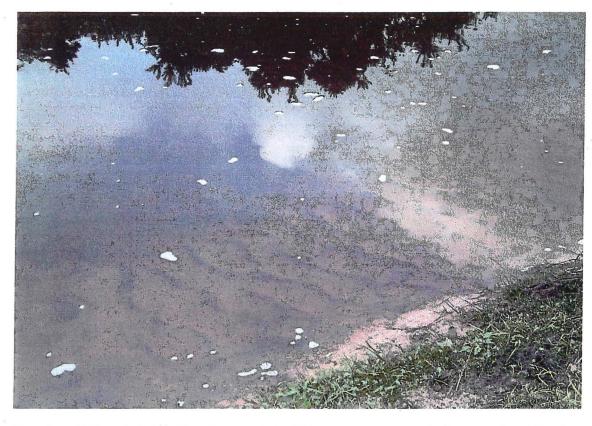
Plate 8 sand/silt washed down from the mountains. This photo was taken in the lower reaches of the river.

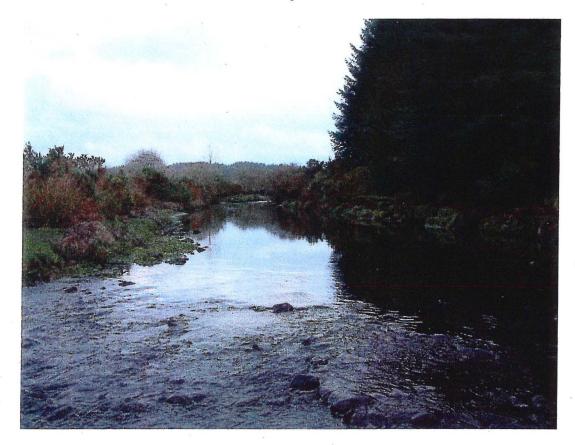
Plate 9 Section of river at confluence (chainage 182) exhibiting very little physical change. Gravels are still in situ here. River has widened considerably and accordingly the power of the slip has dissipated.

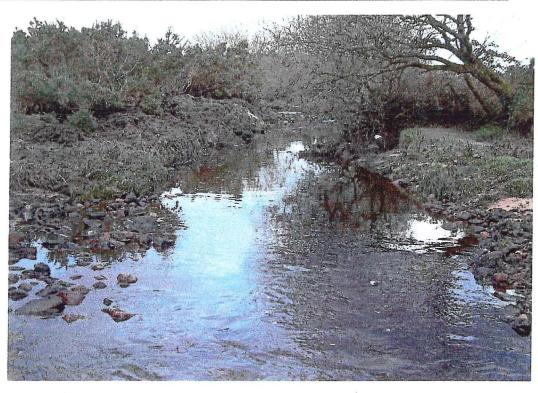
Plate 10 Fish were seen moving upstream in this section (Chainage 184)
