Proposed Strategic Housing Development on the
Former Player Wills Site and Undeveloped Land
Owned by Dublin City Council at South Circular
Road, Dublin 8.

Structural Assessment Report for Planning

DOCUMENT NO: 19.117 – PWFR – 01

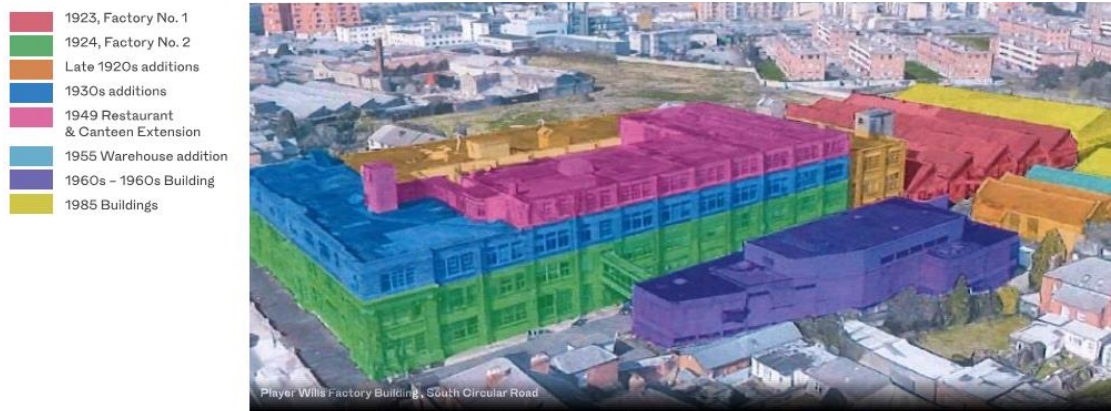
Figure 1.1 – Player Wills Factory – Construction Stages.

The factory building structure consists of a masonry clad steel frame with insitu concrete slabs. The building was constructed in a number of phases dating from 1924-1949. The original building was a two-storey structure, with an additional level constructed in stages between the 1920 and 1930s. The third storey maintains the structural grid of the levels below, with a reduction in the column sizes to that of the lower floors. Also, in the late 1920's the building was extended to the north, with the internalization and removal of a significant portion of the original northern façade. The fourth storey, constructed in 1949, covers only part of the building footprint and does not maintain the same structural grid. This fourth level is proposed to be demolished. Refer to Figure 1.1.

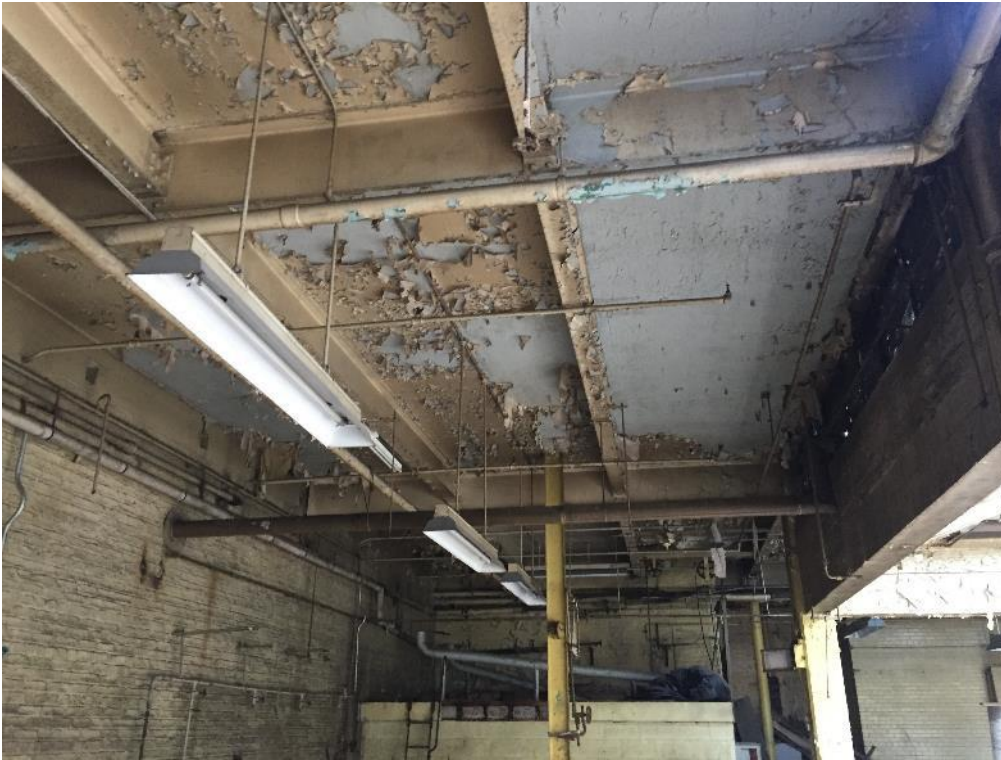
Photo 1: Original Building Condition

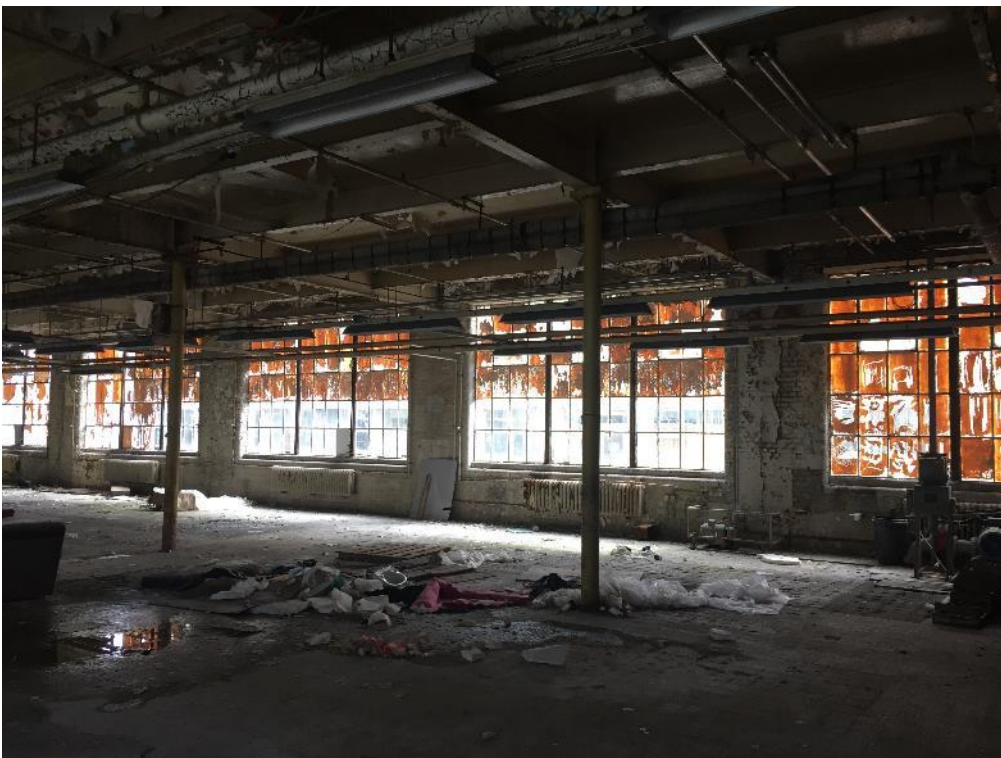
Photo 2: Original Building Condition

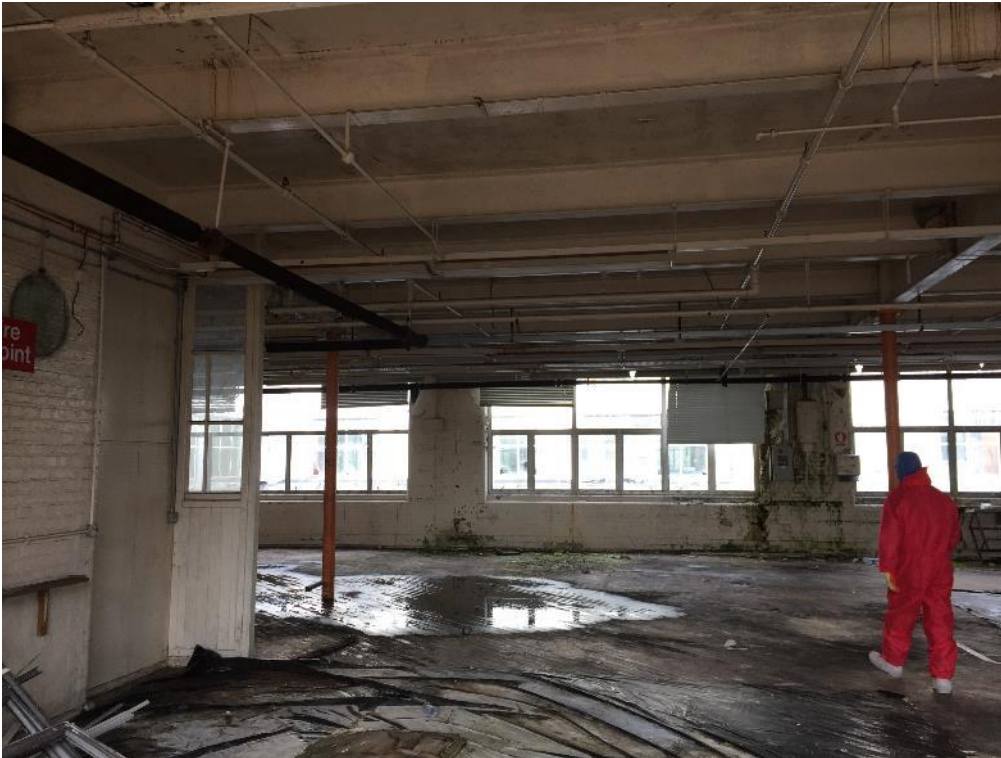
Photo 3: Original Building Condition

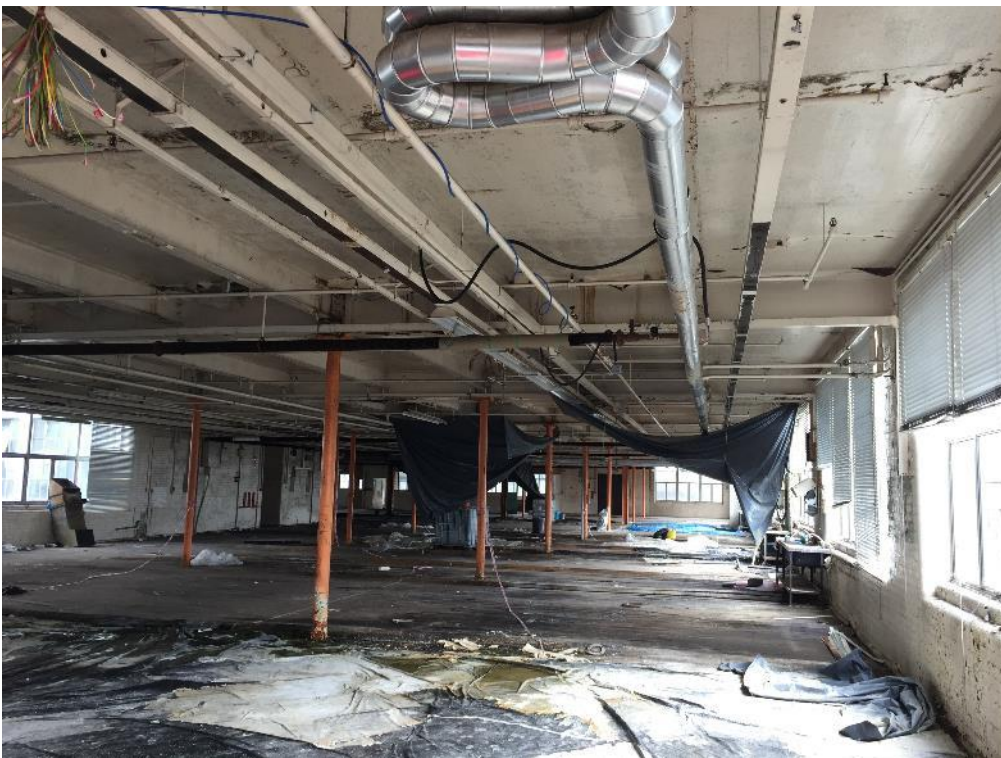
Photo 4: Original Building Condition

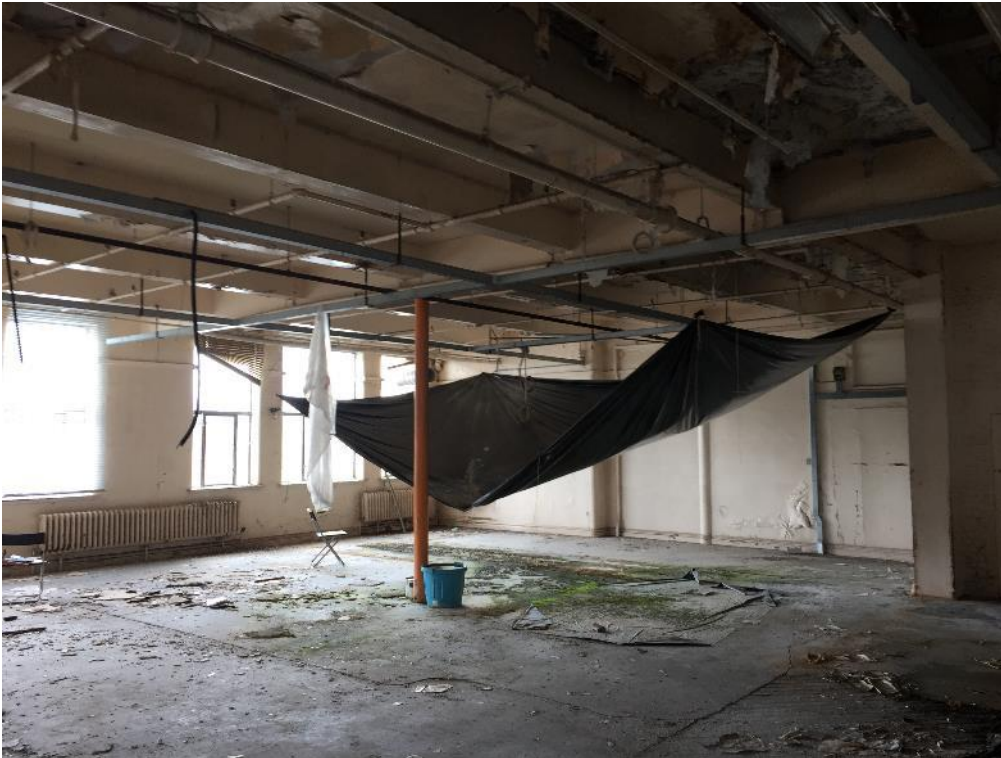
Photo 5: Original Building Condition

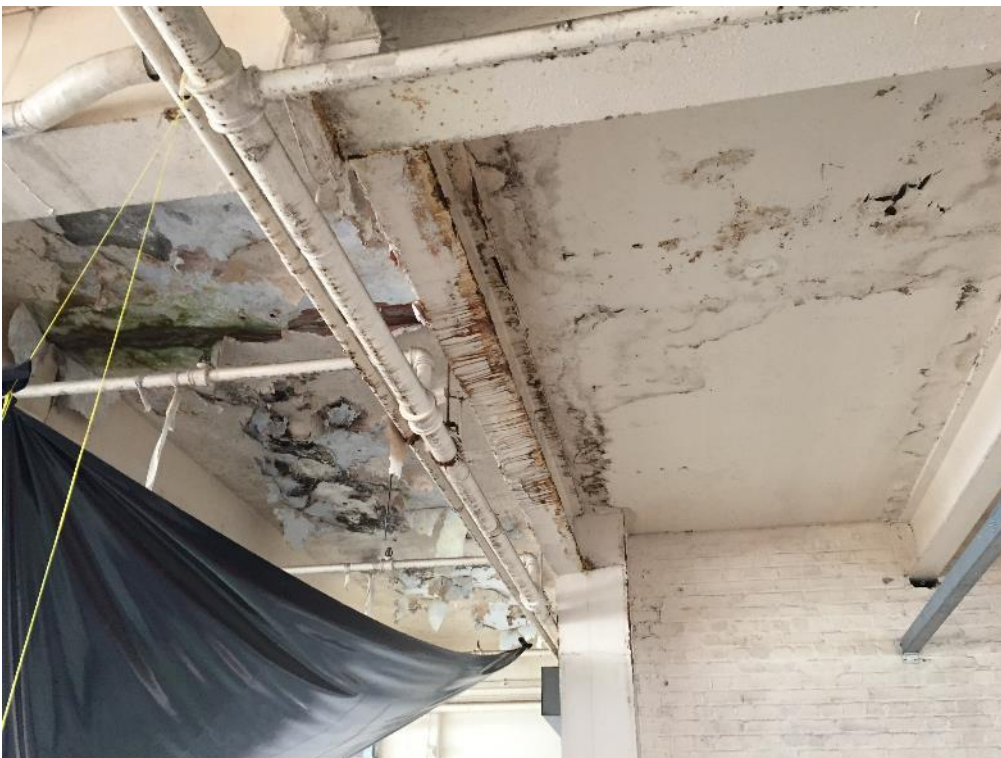
Photo 6: Original Building Condition

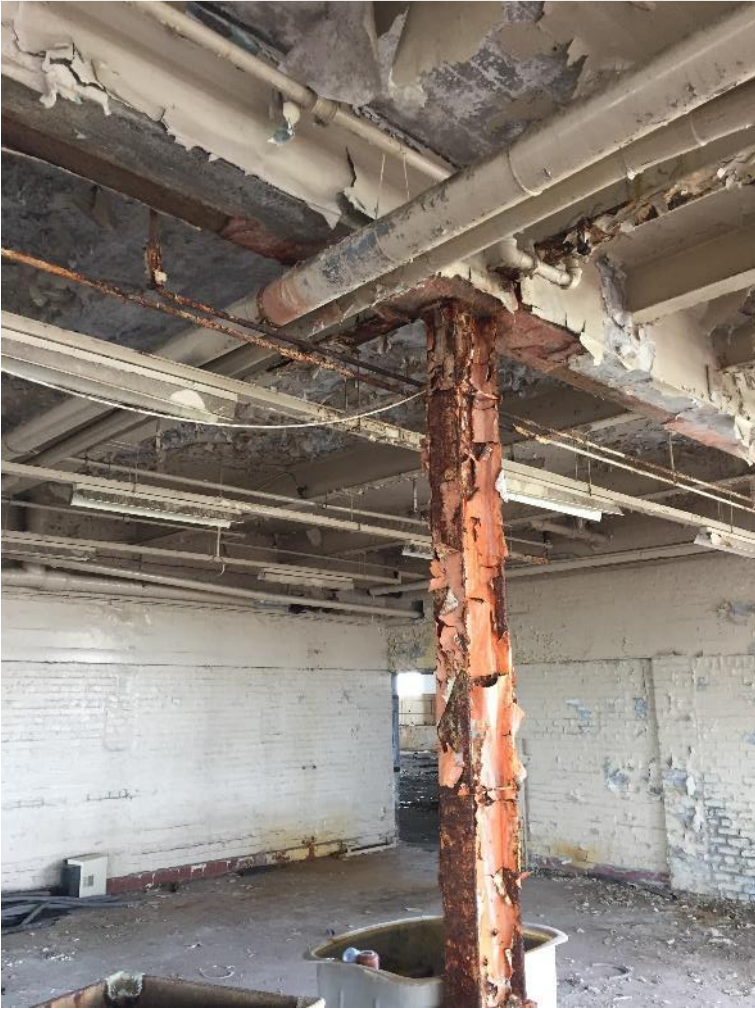
Photo 7: Original Building Condition

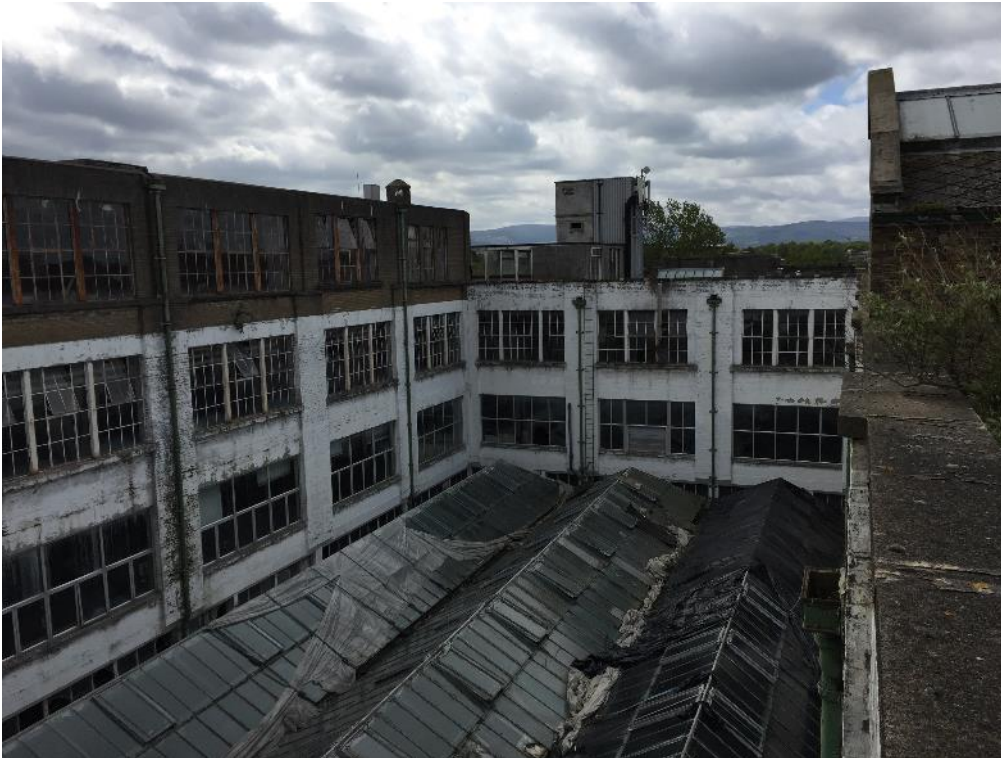
Photo 8: Original Building Condition

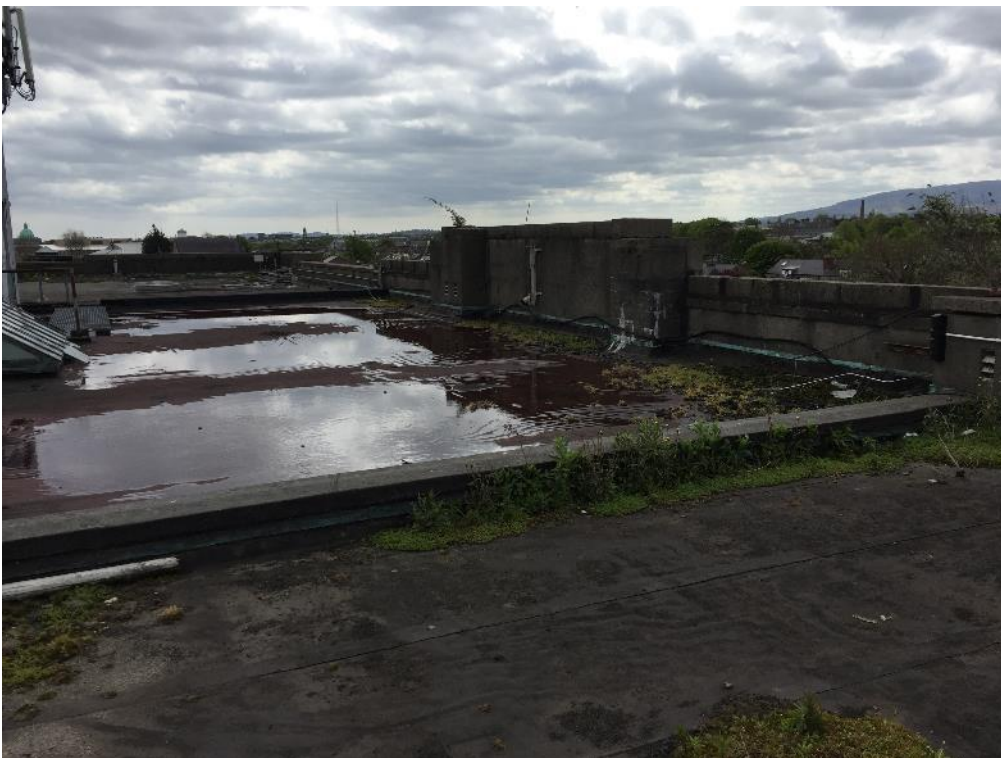
Photo 9: Original Building Condition

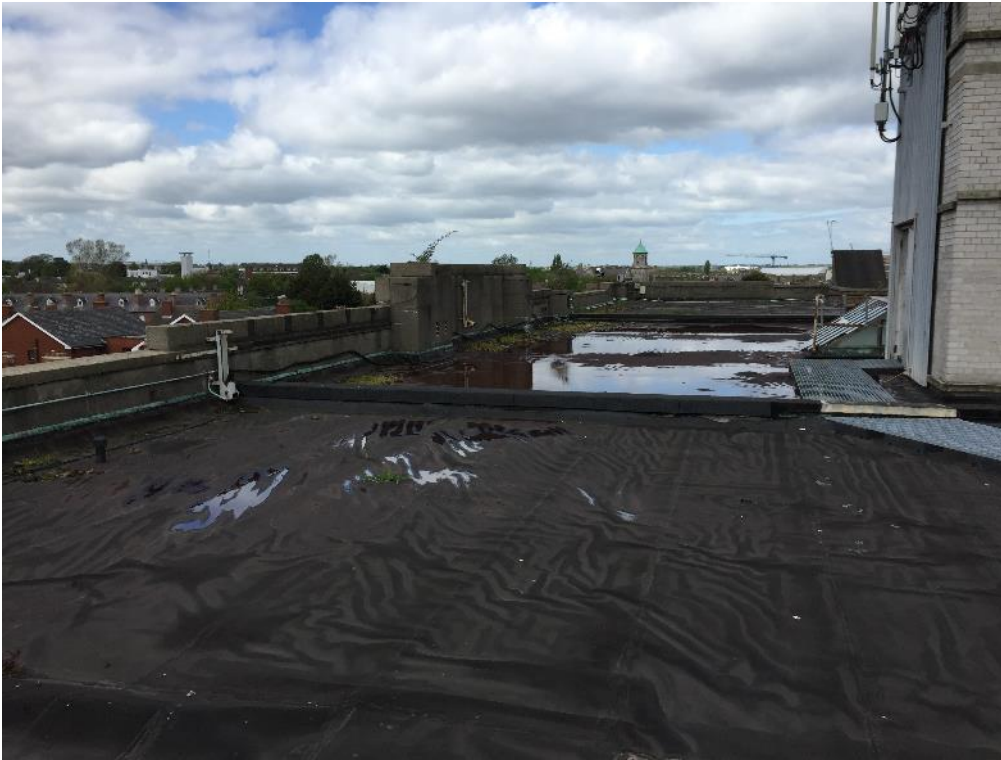
Photo 10: Original Building Condition

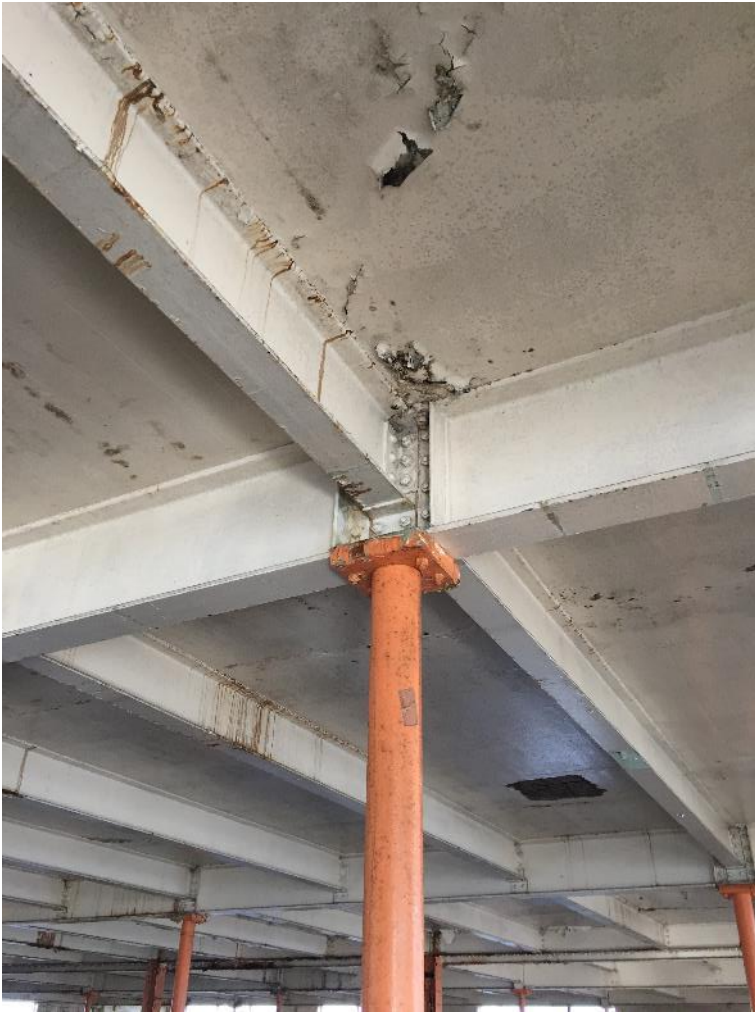
Photo 11: Typical Ground/First Column and beam

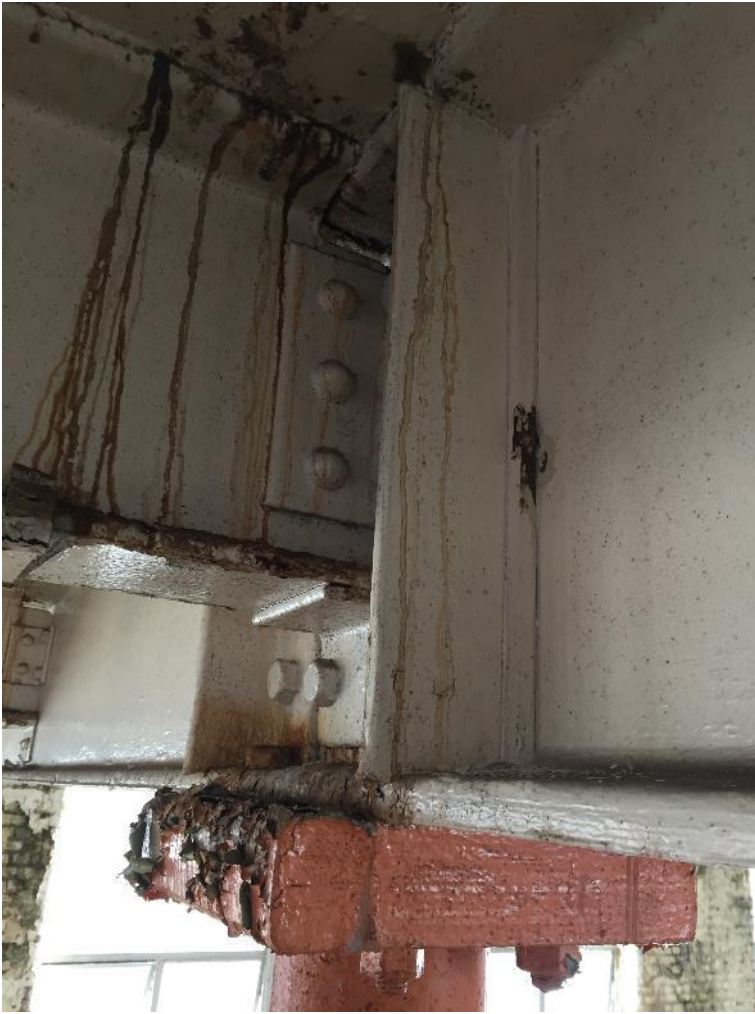
Photo 12: Typical column head connection

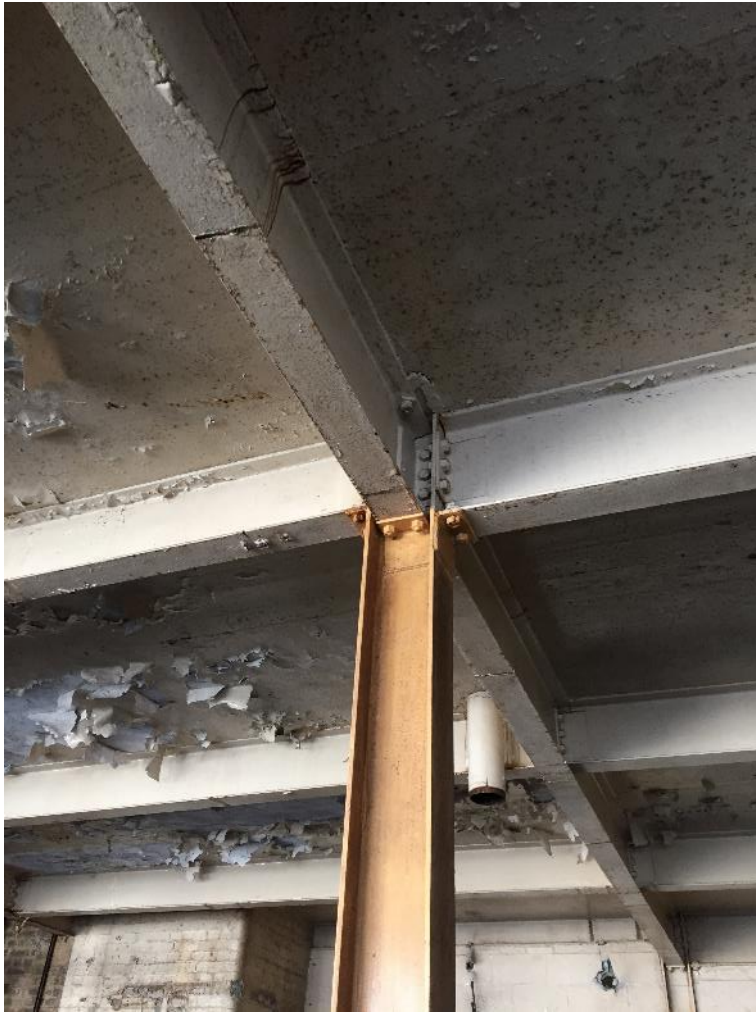
The remainder of the roof over the second floor (third floor) was constructed in the 1930's, and here the columns are universal beam sections to historic imperial section tables. Testing confirms the applicable strength grade as S235. Calculations carried out to date show that these columns are also insufficient in strength to cater for the proposed extended building loads, and they will need to be replaced to provide sufficient capacity for support of the proposed additional floors.

Photo 13: Level 2 column (1930's section) with level 3 beams

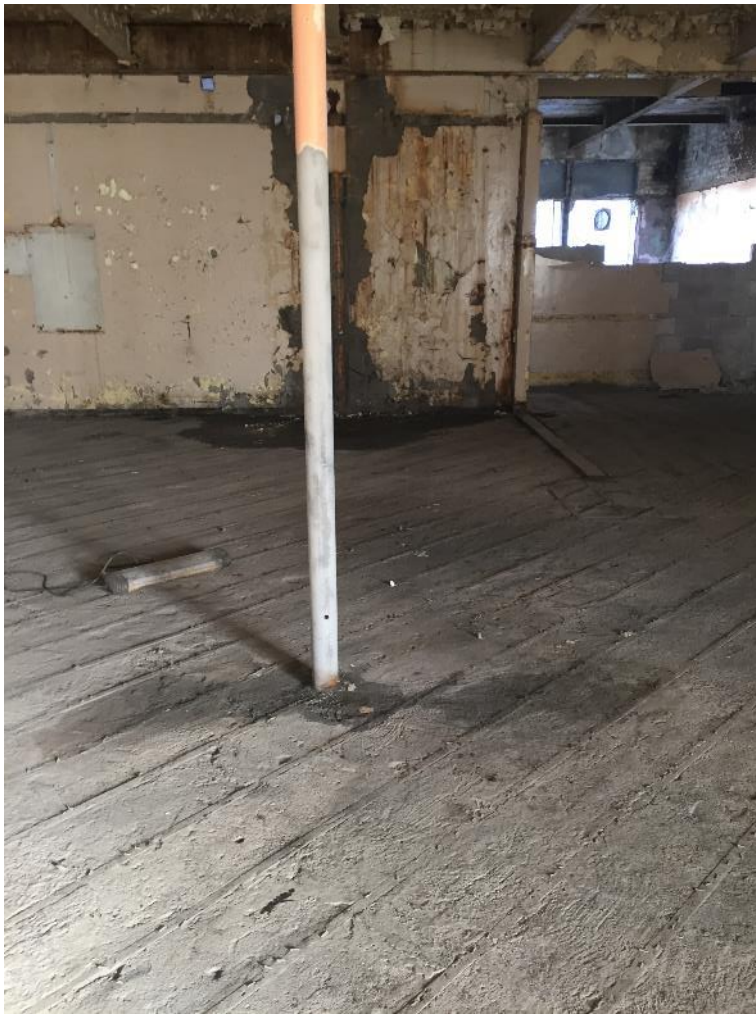
The roof over the second floor (third floor) was constructed in two separate phases. The earlier phase consisted of the west wing of the building north of the first three bays back from the South Circular Road. This was built in the late 1920's and here the columns are 100mm diameter solid steel sections. These columns do not have the capacity to support the proposed additional levels due to their slender cross section. These columns will need to be replaced to provide sufficient capacity for support of the proposed additional floors.

Photo 14: Level 2 column for 1920's section

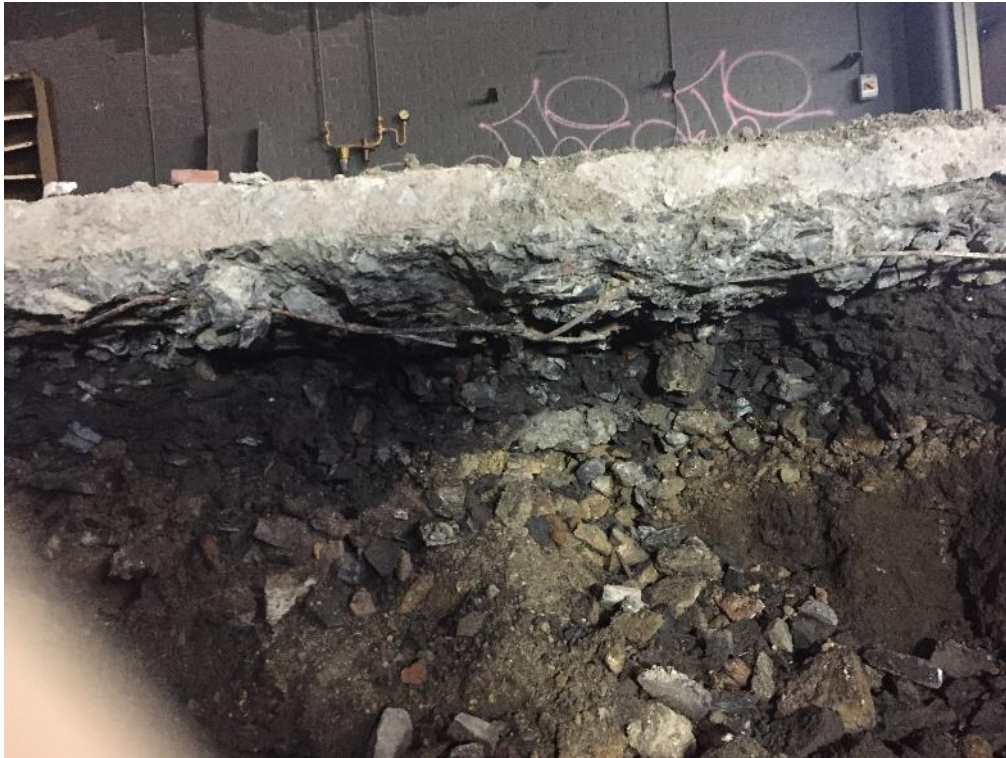
Photo 21: Ground Floor Slab

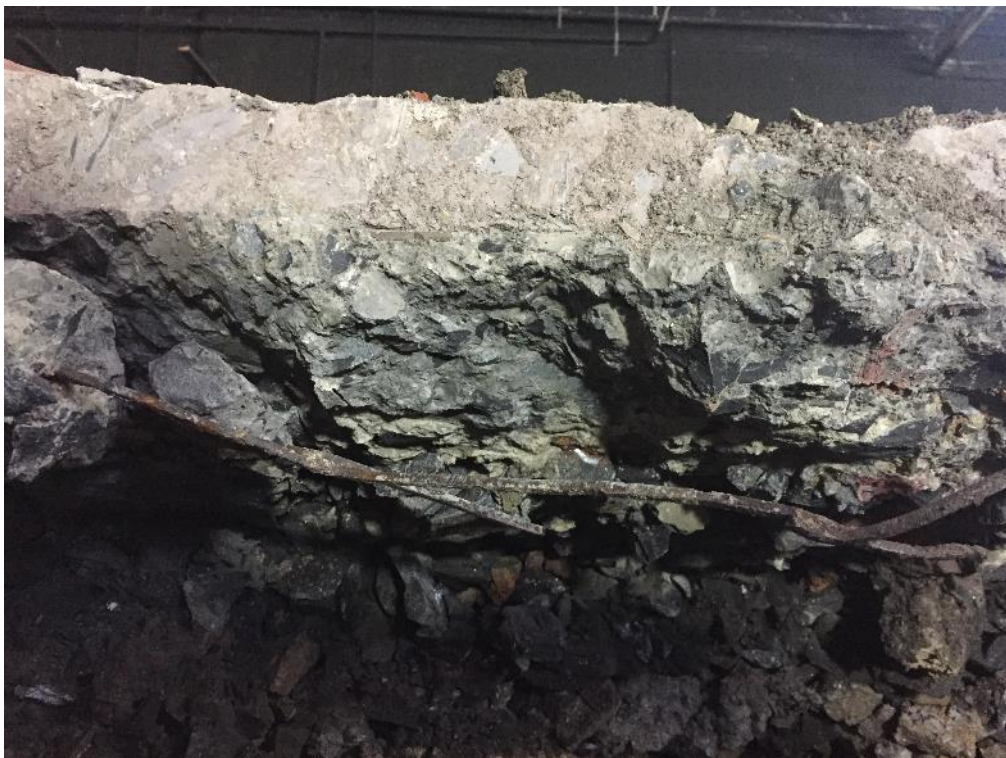
Photo 22: Ground Floor Slab
