Report on Current Condition, proposed repair  
and advice on conservation based alterations for re-use to

## The Walled Garden Walls and corner Bastions at Auburn House, Streamstown, Malahide, Co Dublin

**5<sup>h</sup> March 2021**

**Project 21549**

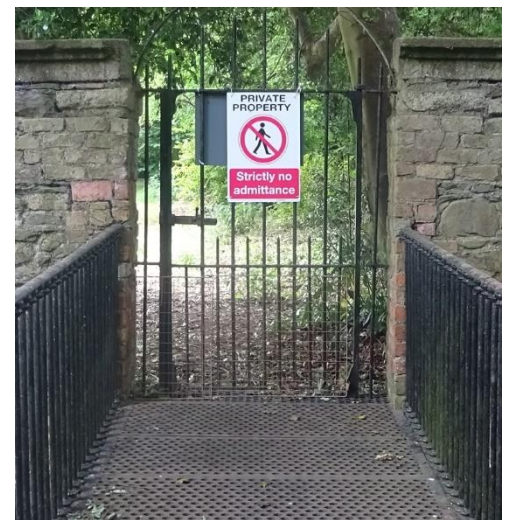
The north wall is interrupted by scooped ends framing the metal gate at the end of the bridge. The gate piers are formed of both random rubble and brick.

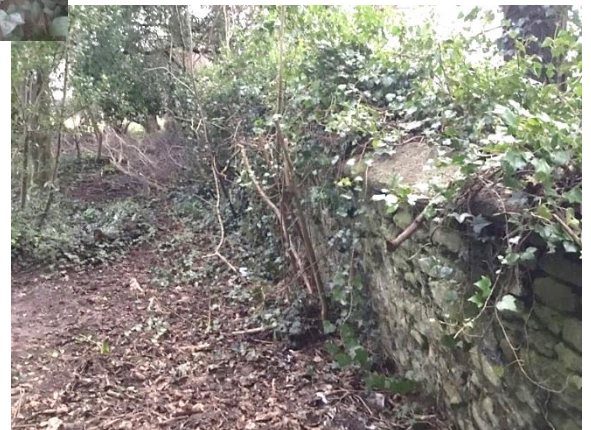
It was noted in two locations that there were more recent blockwork repairs. There may be more interventions

Significant lean to the wall both inwards and outwards was also noted.

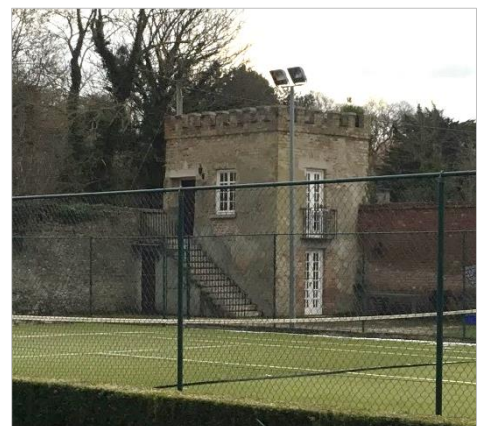
The brickwork has suffered degradation from plant growth and general neglect, the parapet walls are missing in places.

The granite steps are uneven and in places slipped and tilted backwards towards the structure.

It is thought that the original form of the westerly Bastions was more viewing platform rather than fully enclosed structures unlike the larger repaired Turret to the SE corner of the adjoining walled garden.

- Careful control and removal of vegetation
- Back propping as deemed necessary to arches for safety and to allow repair of arches
- Temporary removal of granite steps if deemed necessary to facilitate repair of arches under
- Repair of brick arch vaults using bricks to match set in new lime mortar as specification.
- Reseating of granite steps, including re-bedding / pointing to ensure falls down the steps and limit water penetration into brick vaults.
- Re-establishment of parapet detail to Architects drawings using materials to match existing, set in lime mortars.
- Security fencing / guarding to prevent unauthorised access to platforms.

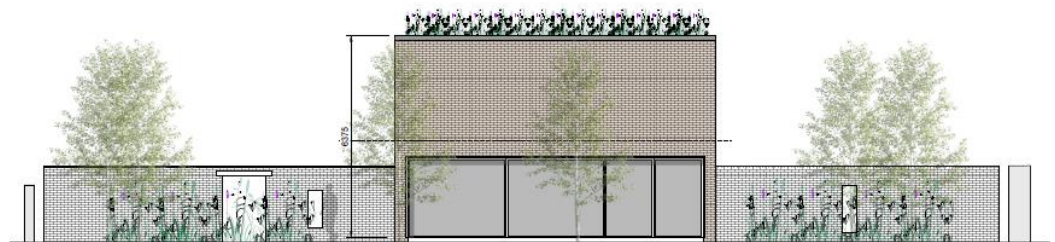
Proposed detail at West Wall

The new community screen wall finishes close to the east and west walls but has been designed such that it does not connect to the existing garden walls.

The detail of the foundation will need to be finalised after localised trial pit excavation and should be designed such that it does not interfere with the garden wall foundations nor encroach within a 45 degree splay of the base of those foundations.

New foundations to details by C&S Engineer for development.  
To be detailed such that no connection or interaction with Walled Garden wall foundations or within 45 degree spread of those foundations.
