Proposed Residential
Development at Howth Road,
Dublin 3

Stage 1 Road Safety Audit

Document Ref: P21-018-RSA-PD-RP-001

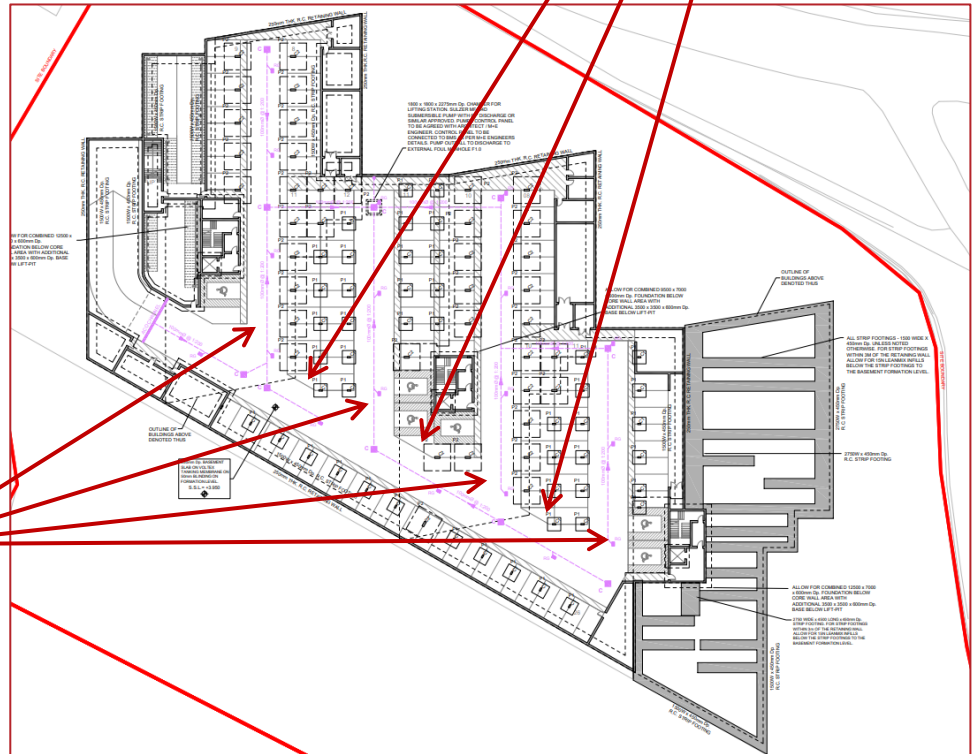
Problem 3.5

Junction control and priority has not been indicated at locations where the aisles within the carpark intersect. This could result in driver confusion and hesitation leading to collisions should drivers assume that they have priority over vehicles in adjacent carpark aisles, leading to low speed collisions and material damage.
