Ruirside Development Limited
42A Parkgate Street
Preliminary Site Assessment

265381-00

Issue | 16 May 2019

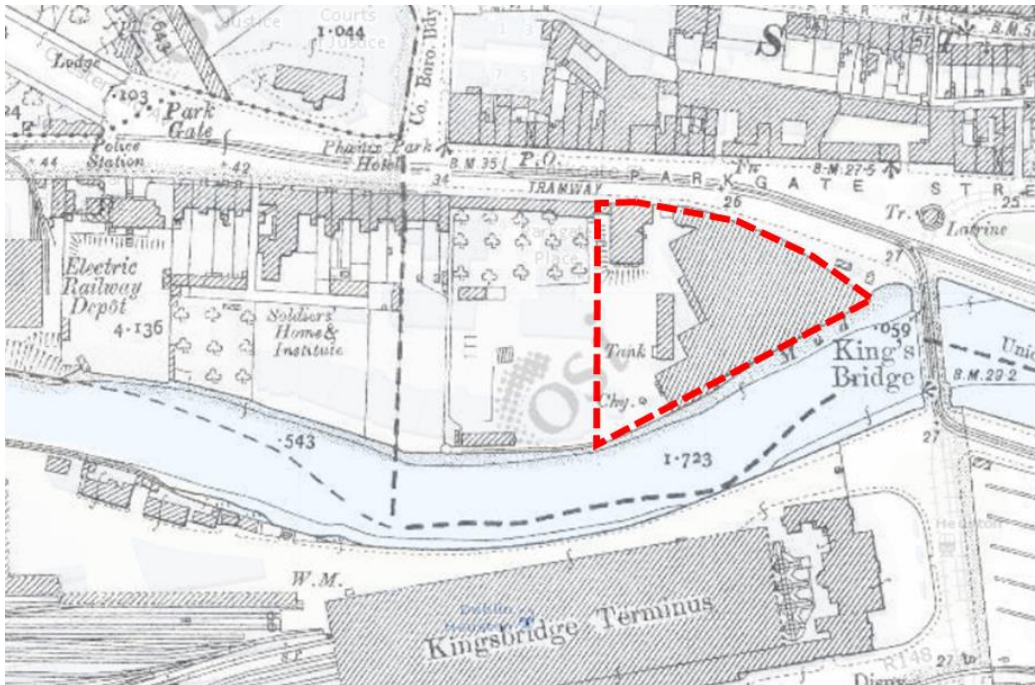
Figure 3: Historic Map 25 inch (1888-1913) showing the approximate site boundary | Source GeoHive, Ordnance Survey Ireland | Not to scale

The Historic 25 inch Map (1888-1913) notes a 'Tank' located in front of the new warehouse. It is not clear whether this is an AST or UST, refer to **Figure 3** below.

Figure 3 shows that in the past, the site was in proximity to several other garages and depots (bus and electric railway), both on Conyngham Road and on the northern side of Parkgate street. Within the site, a tank and chimney are noted on the map.

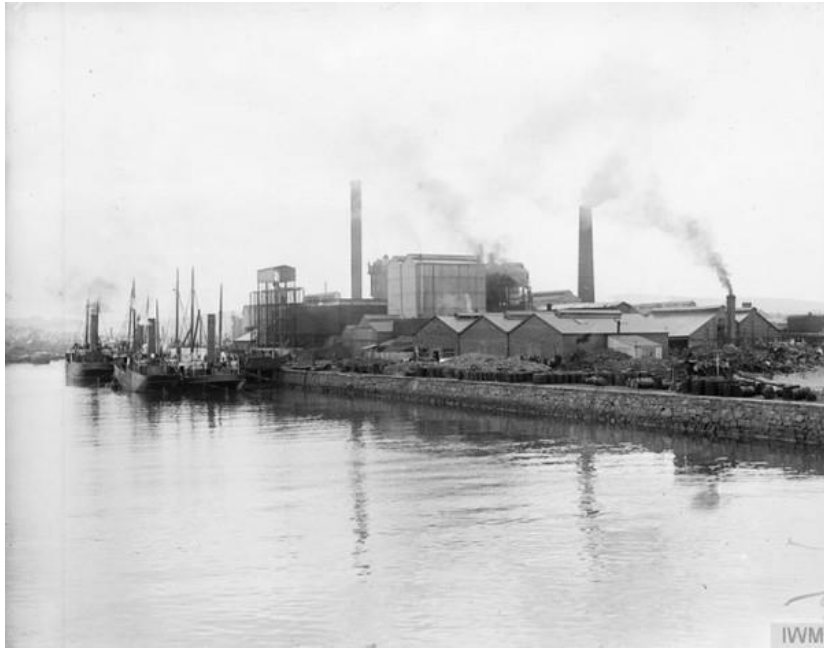
Photograph 1: Photograph of the National Shell Factory on the River Liffey at Parkgate Street, c.1917-1919. | Source Imperial War Museum © IWM

During World War I, the site was used for the manufacture of munitions for the British Army from mid-1915 until 1919 when operations ceased, refer to **Photograph 1** below, from the Imperial War Museum archives. The site was then used as a government store until the 1930s when the printing works began.

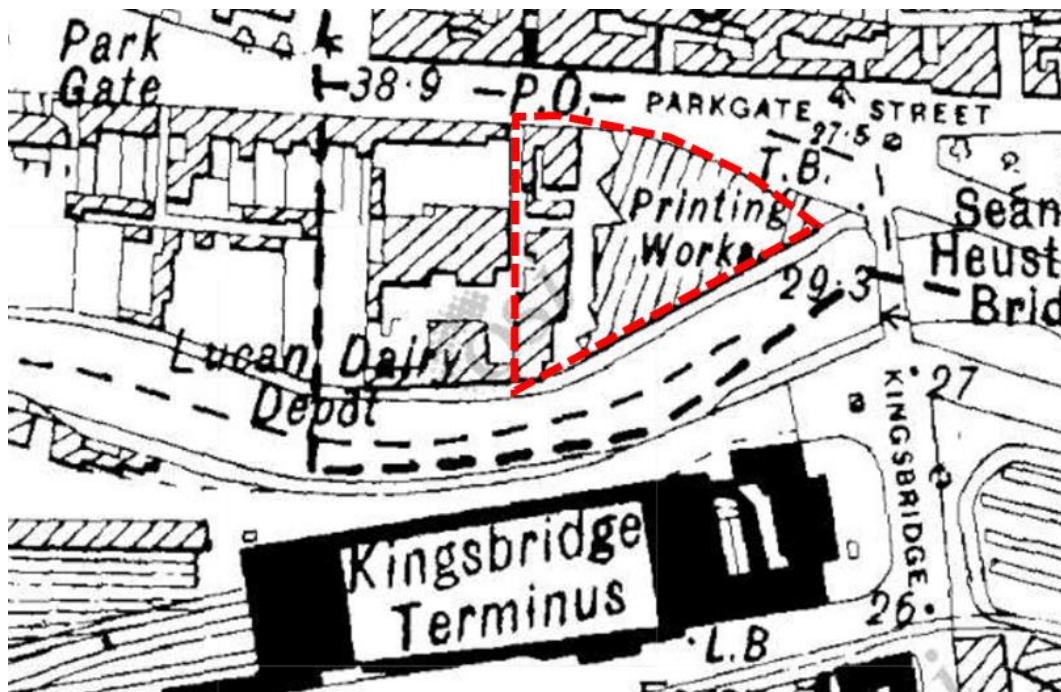
Figure 4: Historic Map 6 inch Cassini (1830s-1930s) showing the approximate site boundary | Source GeoHive, Ordnance Survey Ireland | Not to scale

Figure 4 shows that the warehouse has been extended and the site is used as a printing works (1930s-1970s). The Lucan Dairy Depot is shown to be located west of the site at the time this map was created.

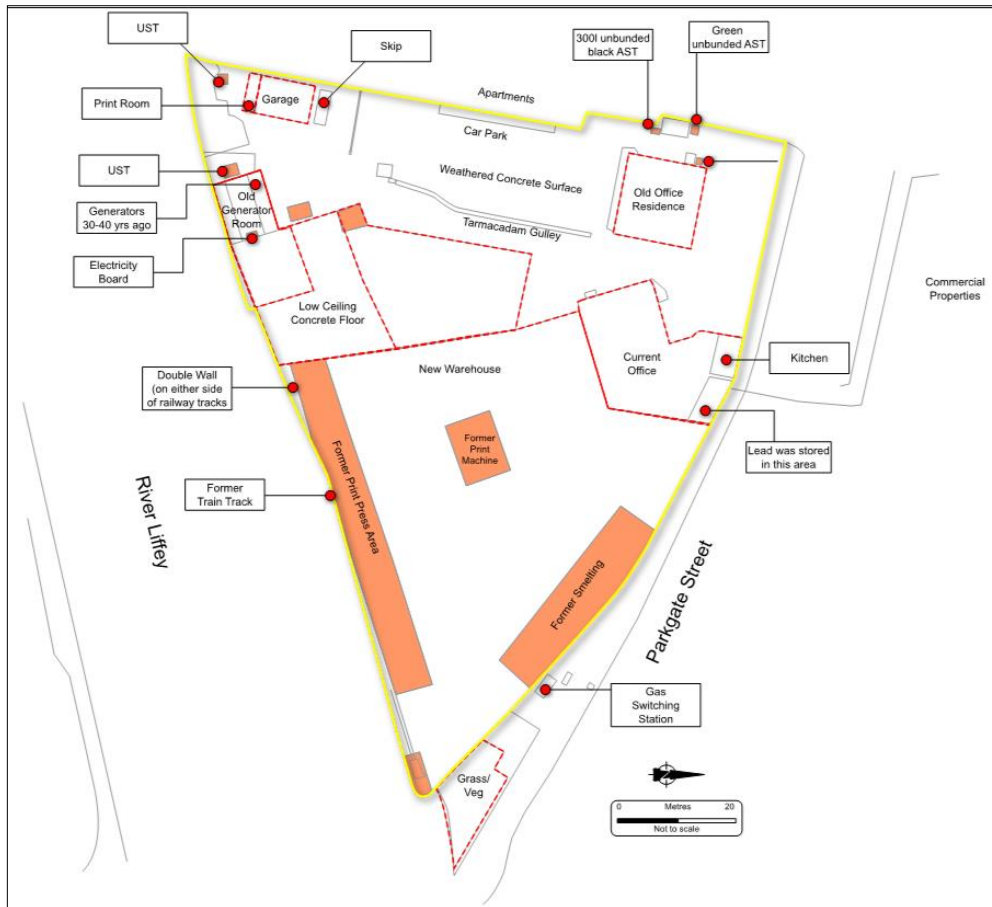
Figure 5: Summary of the location of the historical activities on the site. | Not to scale.

This section summarises the contaminants of concern associated with the previous activities on the site and information gathered during site walkovers, refer to **Table 5**. Refer to **Figure 2 to 5** for the location of the historic activities.

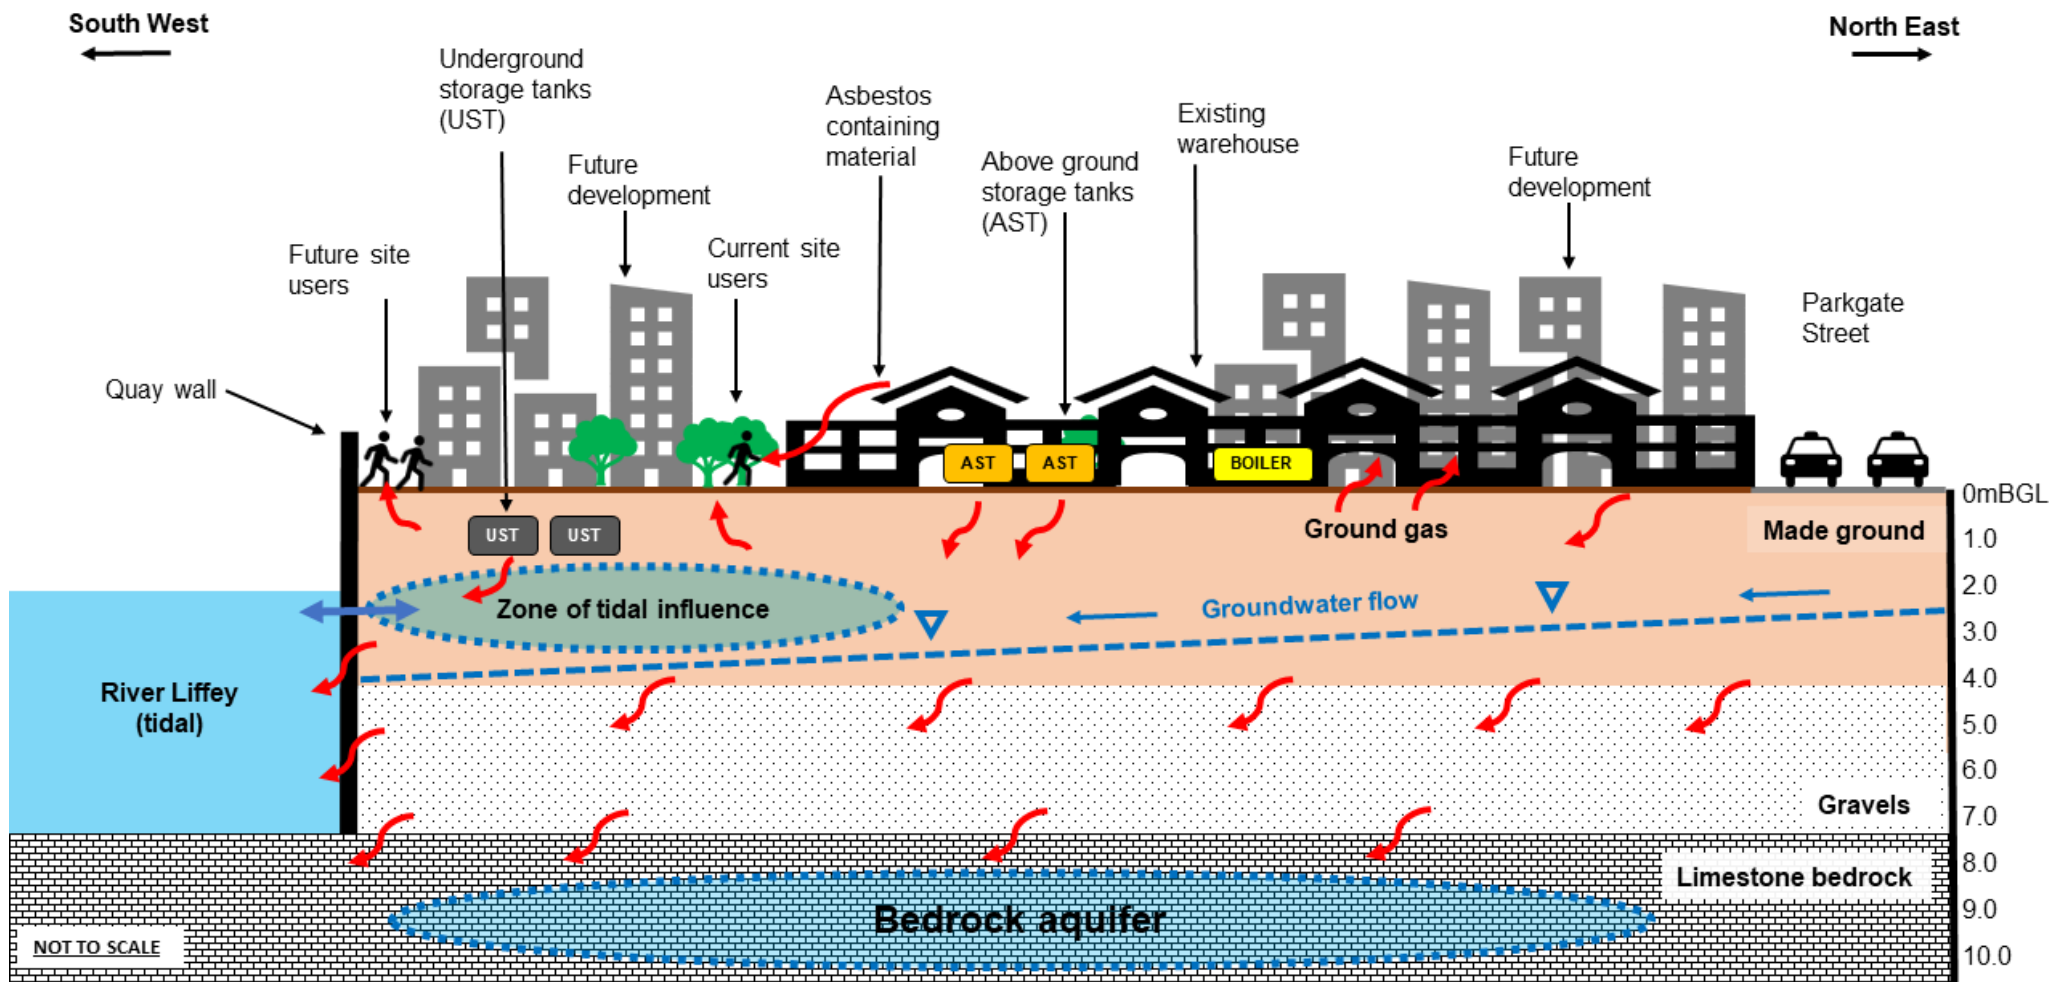
Figure 23: Preliminary Conceptual Site Model for No. 43 Parkgate Street, Dublin 8 | Not to scale

The CSM is presented in **Figure 23** below. The CSM shows a diagram of a cross-section of the site, south-west to north-east between the River Liffey and Parkgate Street. The CSM considers the future development on site which is likely to be mixed-use with commercial or retail on the ground floor and residential or commercial on upper floors. It is assumed that there will be limited green space within the future development that will be used by site users and residents.

Section 6.2.1 to 6.2.3 outlines the potential sources, pathways and receptors on site as illustrated in Figure 23, the preliminary CSM.

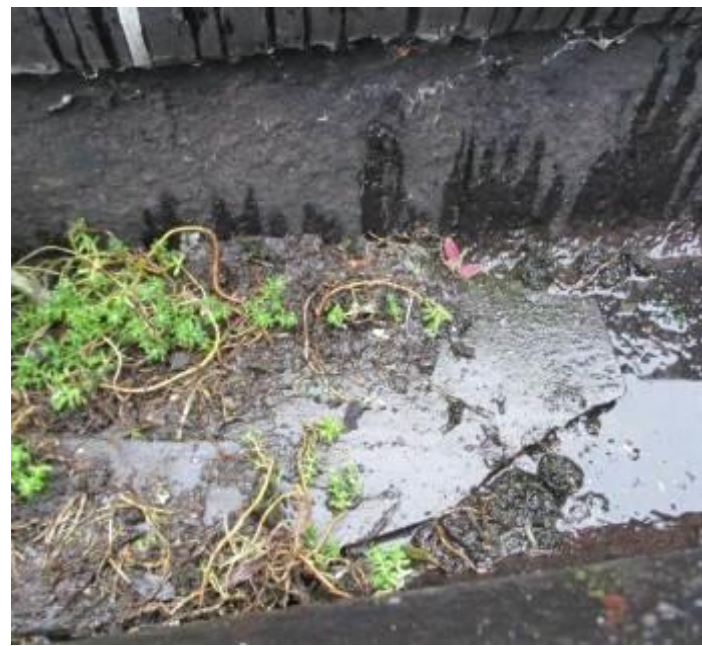
Created By	Jane Hickey
Date	29 th March 2019
Site Details	Parkgate House Site, Parkgate Street, Dublin 8
Client Name	Delaston Limited
Survey Type	R/D Asbestos Survey
Site Ref	PE 19-163
Building Ref.	Main factory
Location	Pitched roof area
Extent/ Amount	Not quantified

Survey Date	24.1.2019	Sample No.	BS 167665
Survey Company	Phoenix Environmental Safety Ltd.		
Testing Laboratory.	G&L Consultancy Ltd.

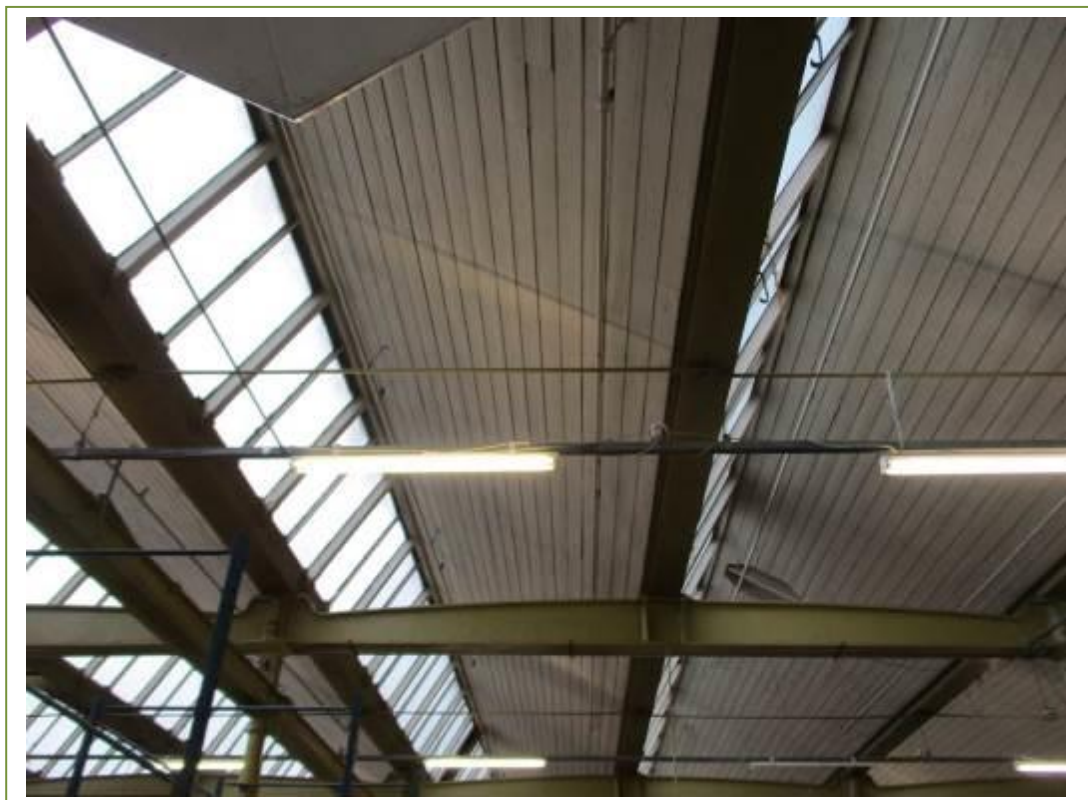
View of the lining boards under the felted pitched roof

DETAIL OF THE ASBESTOS CEMENT REPLACEMENT SLATES & DEBRIS

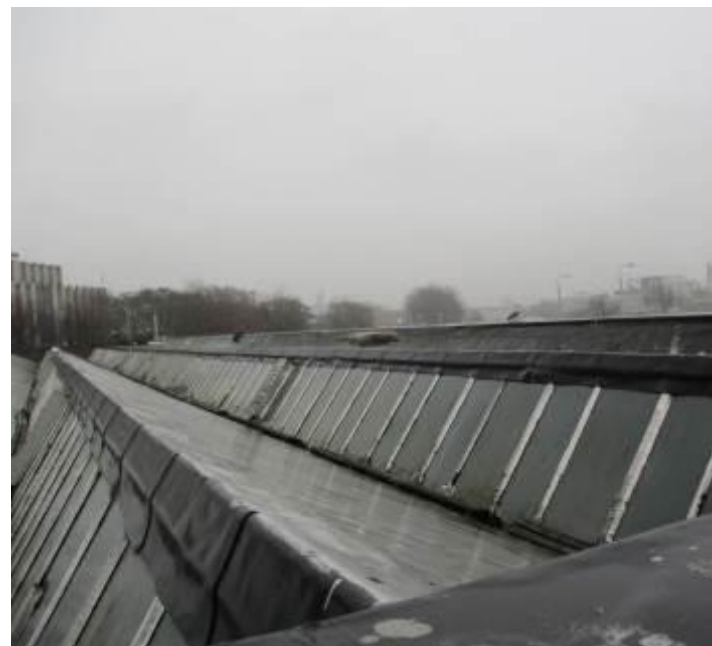
Created By	Jane Hickey
Date	29 th January 2019
Site Details	Parkgate House Site, Parkgate Street, Dublin 8
Client Name	Delaston Limited
Survey Type	R/D Asbestos Survey
Site Ref	PE 19-163
Building Ref.	Main factory
Location	North light windows
Extent/ Amount	Not quantified

All asbestos removal work must be carried out in accordance with S.I. No. 386 of 2006 Safety, Health and Welfare at Work (Exposure to Asbestos) Regulations 2006-2010

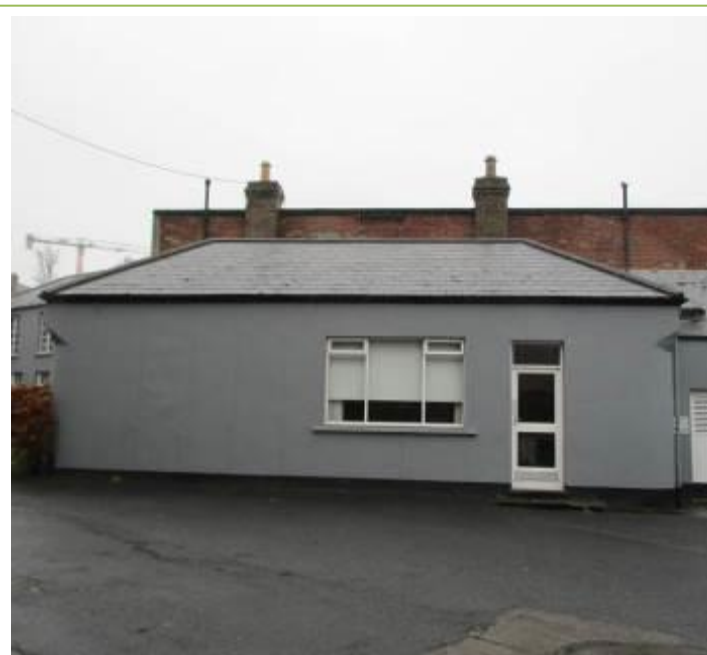
Created By	Jane Hickey
Date	29 th January 2019
Site Details	Parkgate House Site, Parkgate Street, Dublin 8
Client Name	Delaston Limited
Survey Type	R/D Asbestos Survey
Site Ref	PE 19-163
Building Ref.	Meeting room
Location	Roof
Extent/ Amount	40 m ² approx.

Survey Date	24.1.2019	Sample No.	BS 167667
Survey Company	Phoenix Environmental Safety Ltd.		
Testing Laboratory.	G&L Consultancy Ltd.

All asbestos removal work must be carried out in accordance with S.I. No. 386 of 2006 Safety, Health and Welfare at Work (Exposure to Asbestos) Regulations 2006-2010

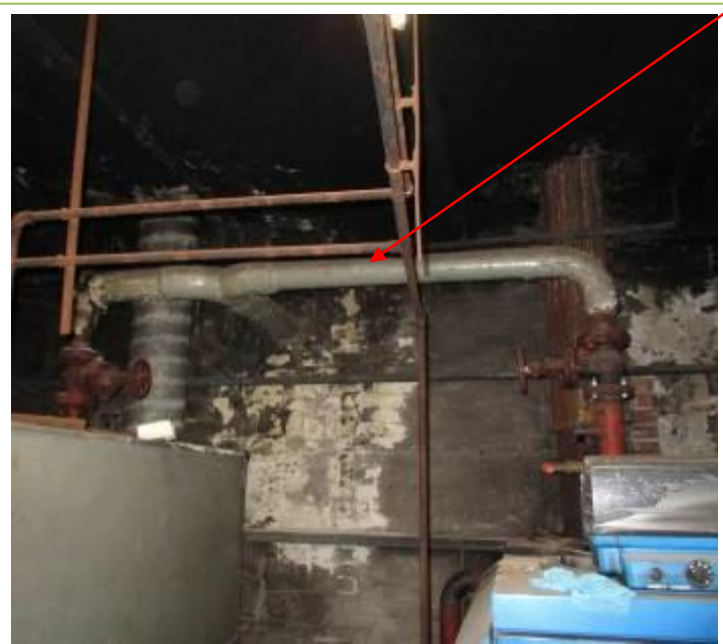
Created By	Jane Hickey
Date	29 th January 2019
Site Details	Parkgate House Site, Parkgate Street, Dublin 8
Client Name	Delaston Limited
Survey Type	R/D Asbestos Survey
Site Ref	PE 19-163
Building Ref.	Boiler room
Location	Pipe work
Extent/ Amount	10 linear meters approx.

Survey Date	24.1.2019	Sample No.	BS 167662
Survey Company	Phoenix Environmental Safety Ltd.		
Testing Laboratory.	G&L Consultancy Ltd.

All asbestos removal work must be carried out in accordance with S.I. No. 386 of 2006 Safety, Health and Welfare at Work (Exposure to Asbestos) Regulations 2006-2010

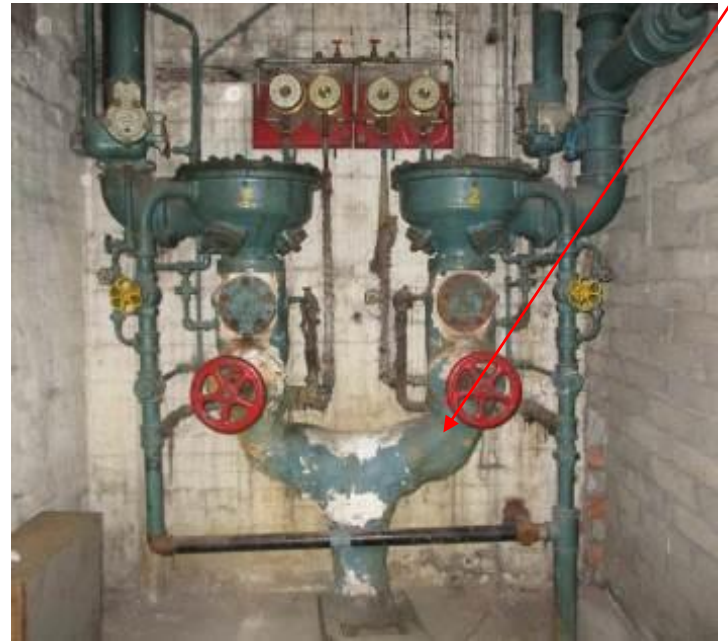
Created By	Jane Hickey
Date	29 th January 2019
Site Details	Parkgate House Site, Parkgate Street, Dublin 8
Client Name	Delaston Limited
Survey Type	R/D Asbestos Survey
Site Ref	PE 19-163
Building Ref.	Sprinkler room
Location	Pipe work
Extent/ Amount	7 linear meters approx.

Survey Date	24.1.2019	Sample No.	BS 167668
Survey Company	Phoenix Environmental Safety Ltd.		
Testing Laboratory.	G&L Consultancy Ltd.

All asbestos removal work must be carried out in accordance with S.I. No. 386 of 2006 Safety, Health and Welfare at Work (Exposure to Asbestos) Regulations 2006-2010

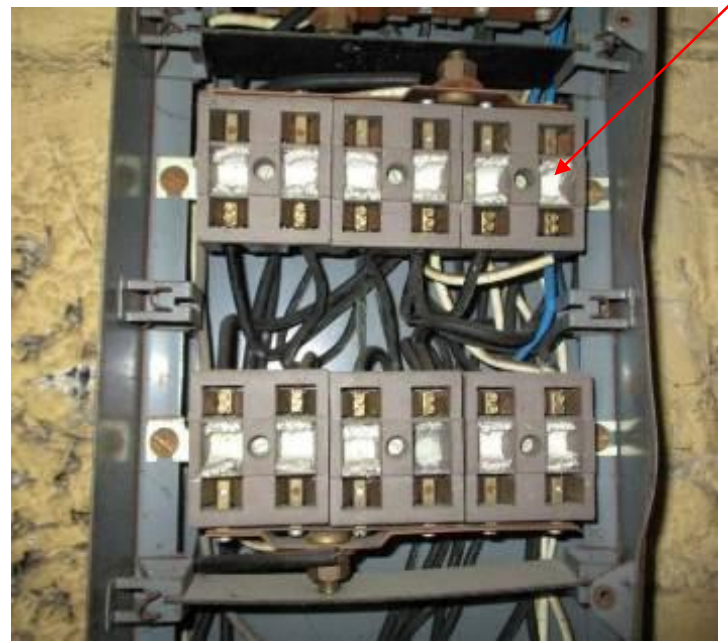
Created By	Jane Hickey
Date	29 th January 2019
Site Details	Parkgate House Site, Parkgate Street, Dublin 8
Client Name	Delaston Limited
Survey Type	R/D Asbestos Survey
Site Ref	PE 19-163
Building Ref.	Main factory
Location	Electrical equipment
Extent/ Amount	Not quantified

Survey Date	24.1.2019	Sample No.	BS 167669
Survey Company	Phoenix Environmental Safety Ltd.		
Testing Laboratory.	G&L Consultancy Ltd.

All asbestos removal work must be carried out in accordance with S.I. No. 386 of 2006 Safety, Health and Welfare at Work (Exposure to Asbestos) Regulations 2006-2010

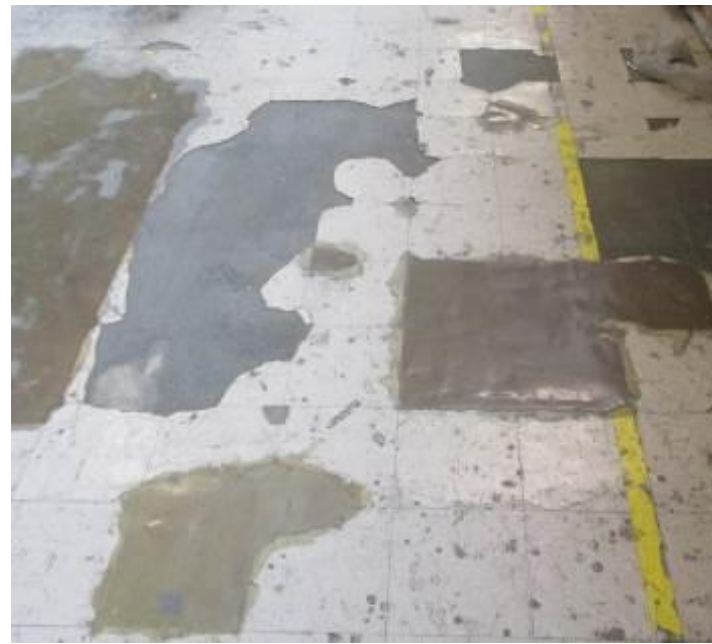
Created By	Jane Hickey
Date	29 th January 2019
Site Details	Parkgate House Site, Parkgate Street, Dublin 8
Client Name	Delaston Limited
Survey Type	R/D Asbestos Survey
Site Ref	PE 19-163
Building Ref.	Main factory
Location	Floor areas
Extent/ Amount	3,200 m ² approx.

Survey Date	24.1.2019	Sample No.	BS 167671
Survey Company	Phoenix Environmental Safety Ltd.		
Testing Laboratory.	G&L Consultancy Ltd.

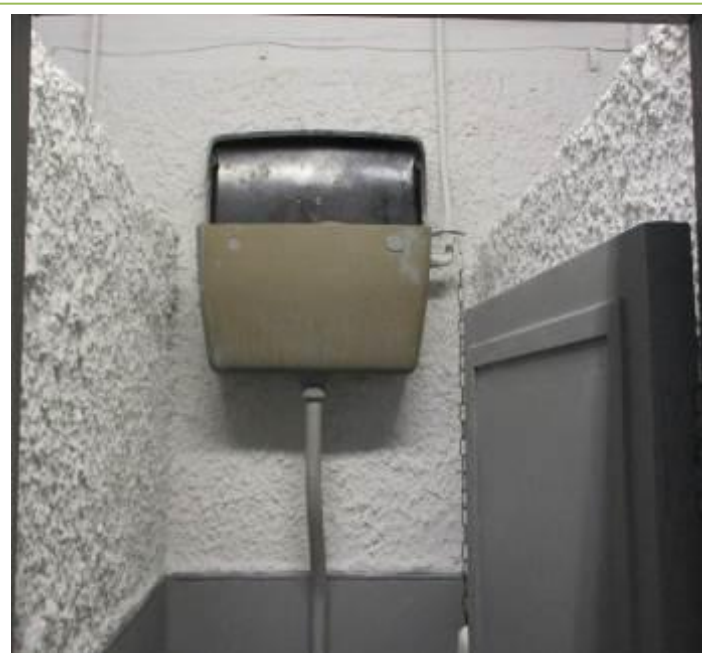
Created By	Jane Hickey
Date	29 th January 2019
Site Details	Parkgate House Site, Parkgate Street, Dublin 8
Client Name	Delaston Limited
Survey Type	R/D Asbestos Survey
Site Ref	PE 19-163
Building Ref.	Main factory building
Location	Male W/C and 1 st floor W/C
Extent/ Amount	6 cisterns

MATERIAL ASSESSMENT		PRIORITY ASSESSMENT
Product type	Toilet cisterns	Normal occupant activity	N/A
Extent of damage	Low damage	Likelihood of disturbance	N/A
Surface treatment	Composite material	Human exposure potential	N/A
Asbestos type	Amosite	Maintenance activity	N/A
Material assessment score: N/A		TOTAL SCORE: N/A	
Priority assessment score: N/A

All asbestos removal work must be carried out in accordance with S.I. No. 386 of 2006 Safety, Health and Welfare at Work (Exposure to Asbestos) Regulations 2006-2010

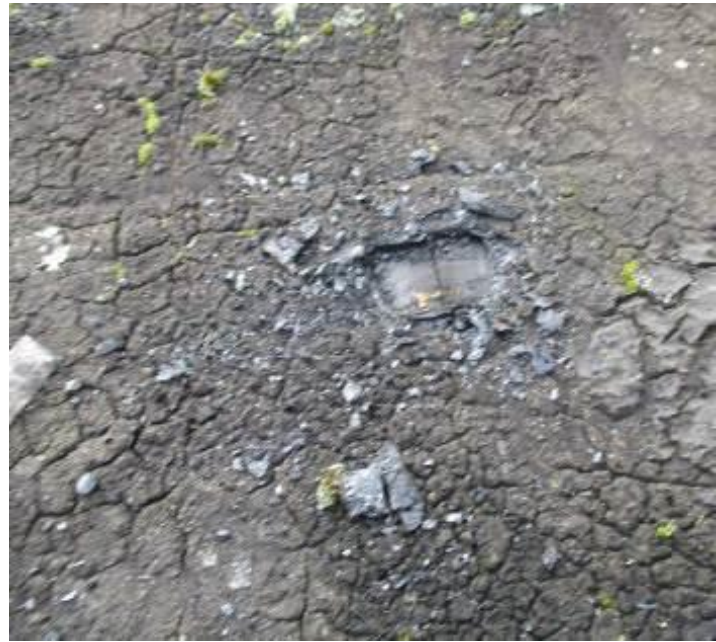
Created By	Jane Hickey
Date	29 th March 2019
Site Details	Parkgate House Site, Parkgate Street, Dublin 8
Client Name	Delaston Limited
Survey Type	R/D Asbestos Survey
Site Ref	PE 19-297
Building Ref.	Matt's Workshop
Location	Roof
Extent/ Amount	80 m ² approx.

MATERIAL ASSESSMENT		PRIORITY ASSESSMENT
Product type	Felt	Normal occupant activity	N/A
Extent of damage	Medium damage	Likelihood of disturbance	N/A
Surface treatment	Unsealed	Human exposure potential	N/A
Asbestos type	Chrysotile	Maintenance activity	N/A
Material assessment score: N/A		TOTAL SCORE: N/A	Priority assessment score: N/A

All asbestos removal work must be carried out in accordance with S.I. No. 386 of 2006 Safety, Health and Welfare at Work (Exposure to Asbestos) Regulations 2006-2010

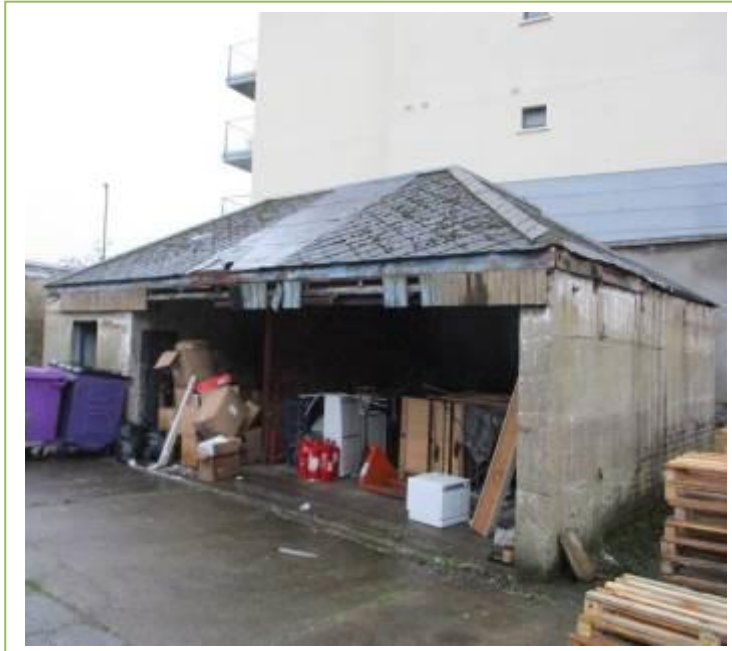
Created By	Jane Hickey
Date	29 th January 2019
Site Details	Parkgate House Site, Parkgate Street, Dublin 8
Client Name	Delaston Limited
Survey Type	R/D Asbestos Survey
Site Ref	PE 19-163
Building Ref.	Rear RHS Storage building
Location	Roof
Extent/ Amount	70 m ² approx.

MATERIAL ASSESSMENT		PRIORITY ASSESSMENT
Product type	Cement slates	Normal occupant activity	N/A
Extent of damage	High damage	Likelihood of disturbance	N/A
Surface treatment	Unsealed	Human exposure potential	N/A
Asbestos type	Chrysotile	Maintenance activity	N/A
	Material assessment score: N/A	TOTAL SCORE: N/A	Priority assessment score: N/A

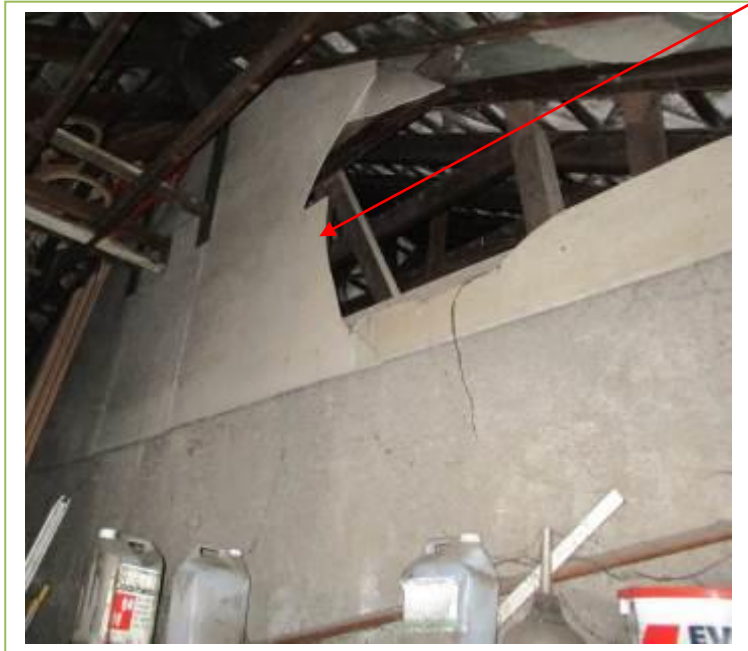
Created By	Jane Hickey
Date	29 th January 2019
Site Details	Parkgate House Site, Parkgate Street, Dublin 8
Client Name	Delaston Limited
Survey Type	R/D Asbestos Survey
Site Ref	PE 19-163
Building Ref.	Rear RHS Storage building
Location	High-level internal wall
Extent/ Amount	20 m ² approx.

MATERIAL ASSESSMENT		PRIORITY ASSESSMENT
Product type	Cement board	Normal occupant activity	N/A
Extent of damage	High damage	Likelihood of disturbance	N/A
Surface treatment	Unsealed	Human exposure potential	N/A
Asbestos type	Chrysotile	Maintenance activity	N/A
	Material assessment score: N/A	TOTAL SCORE: N/A	Priority assessment score: N/A

All asbestos removal work must be carried out in accordance with S.I. No. 386 of 2006 Safety, Health and Welfare at Work (Exposure to Asbestos) Regulations 2006-2010

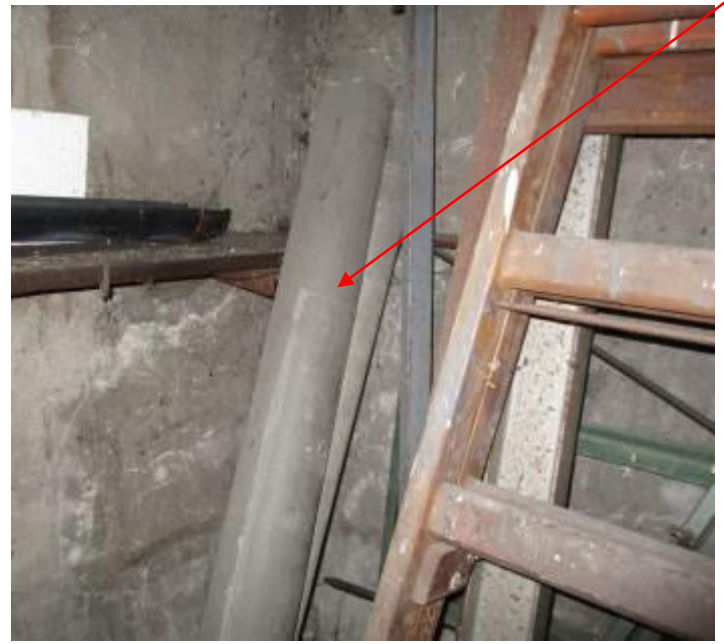
Created By	Jane Hickey
Date	29 th January 2019
Site Details	Parkgate House Site, Parkgate Street, Dublin 8
Client Name	Delaston Limited
Survey Type	R/D Asbestos Survey
Site Ref	PE 19-163
Building Ref.	Rear RHS Storage building
Location	Stored internally
Extent/ Amount	Not quantified

MATERIAL ASSESSMENT		PRIORITY ASSESSMENT
Product type	Cement pipes	Normal occupant activity	N/A
Extent of damage	High damage	Likelihood of disturbance	N/A
Surface treatment	Unsealed	Human exposure potential	N/A
Asbestos type	Chrysotile + Amosite + Crocidolite	Maintenance activity	N/A
	Material assessment score: N/A	TOTAL SCORE: N/A	Priority assessment score: N/A

All asbestos removal work must be carried out in accordance with S.I. No. 386 of 2006 Safety, Health and Welfare at Work (Exposure to Asbestos) Regulations 2006-2010

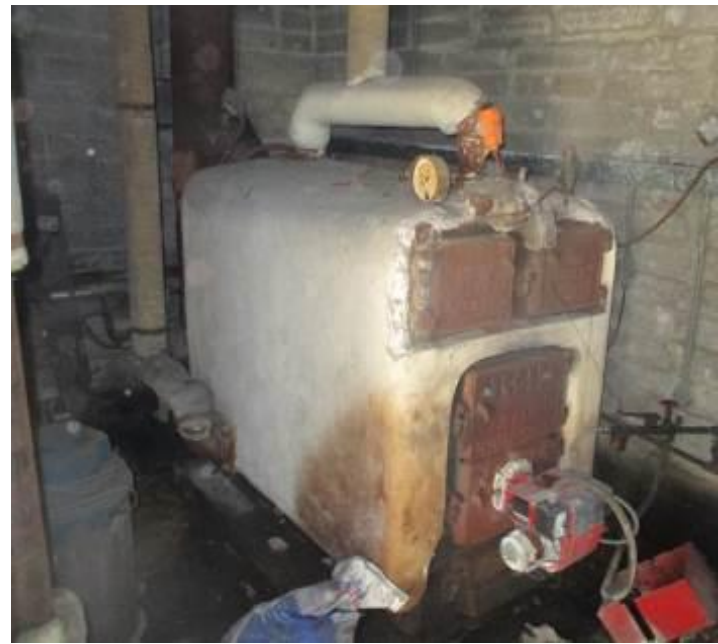
Created By	Andrew Hickey
Date	29 th March 2019
Site Details	Parkgate House Site, Parkgate Street, Dublin 8
Client Name	Delaston Limited
Survey Type	R/D Asbestos Survey
Site Ref	PE 19-312
Building Ref.	Parkgate House
Location	External Boiler Room
Extent/ Amount	Not quantified

MATERIAL ASSESSMENT		PRIORITY ASSESSMENT
Product type	Thermal insulation	Normal occupant activity	N/A
Extent of damage	High	Likelihood of disturbance	N/A
Surface treatment	Unsealed	Human exposure potential	N/A
Asbestos type	Amosite	Maintenance activity	N/A
Material assessment score: N/A		TOTAL SCORE: N/A	Priority assessment score: N/A

The asbestos thermal insulation should be removed under controlled conditions by a specialist asbestos removal contractor and disposed of as asbestos waste before the demolition works commence

All asbestos removal work must be carried out in accordance with S.I. No. 386 of 2006 Safety, Health and Welfare at Work (Exposure to Asbestos) Regulations 2006-2010

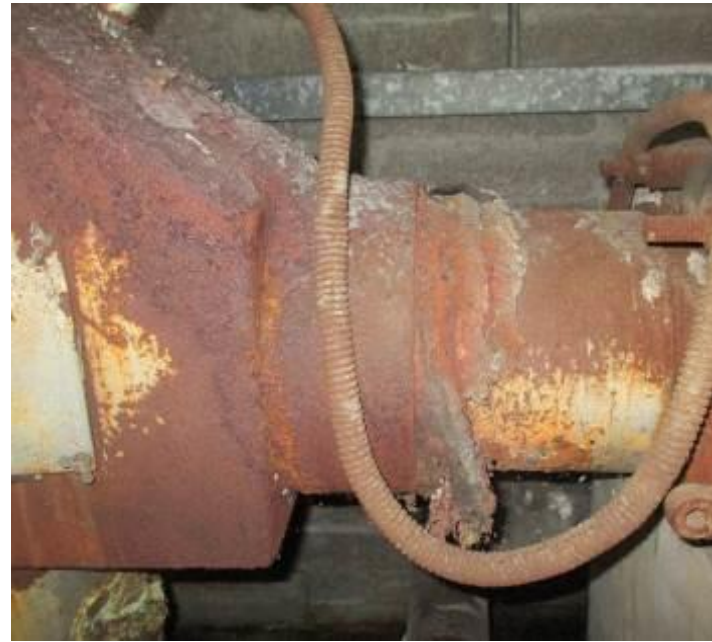
Created By	Andrew Hickey
Date	29 th March 2019
Site Details	Parkgate House Site, Parkgate Street, Dublin 8
Client Name	Delaston Limited
Survey Type	R/D Asbestos Survey
Site Ref	PE 19-312
Building Ref.	Parkgate House
Location	External Boiler Room
Extent/ Amount	Not quantified

MATERIAL ASSESSMENT		PRIORITY ASSESSMENT
Product type	Rope	Normal occupant activity	N/A
Extent of damage	Medium	Likelihood of disturbance	N/A
Surface treatment	Unsealed	Human exposure potential	N/A
Asbestos type	Chrysotile	Maintenance activity	N/A
Material assessment score: N/A		TOTAL SCORE: N/A	
		Priority assessment score: N/A

All asbestos removal work must be carried out in accordance with S.I. No. 386 of 2006 Safety, Health and Welfare at Work (Exposure to Asbestos) Regulations 2006-2010

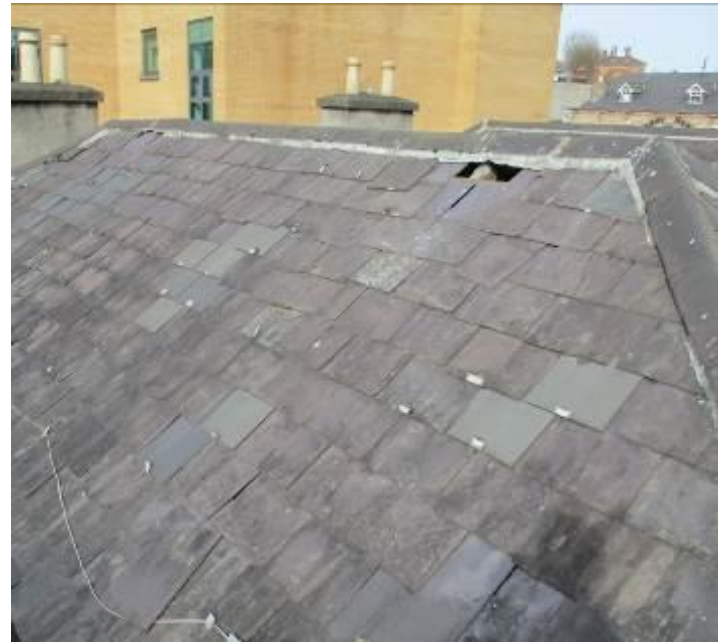
Created By	Andrew Hickey
Date	29 th March 2019
Site Details	Parkgate House Site, Parkgate Street, Dublin 8
Client Name	Delaston Limited
Survey Type	R/D Asbestos Survey
Site Ref	PE 19-297
Building Ref.	Parkgate House
Location	Roof area
Extent/ Amount	Small amounts

MATERIAL ASSESSMENT		PRIORITY ASSESSMENT
Product type	Cement slate	Normal occupant activity	N/A
Extent of damage	Medium damage	Likelihood of disturbance	N/A
Surface treatment	None	Human exposure potential	N/A
Asbestos type	Chrysotile	Maintenance activity	N/A
	Material assessment score: N/A	TOTAL SCORE: N/A	Priority assessment score: N/A

The cement replacement slates identified on the main roof of Parkgate House contains Chrysotile (white) asbestos fibres. Asbestos cement products generally contain 10 to 15% asbestos fibres bounded in Portland cement

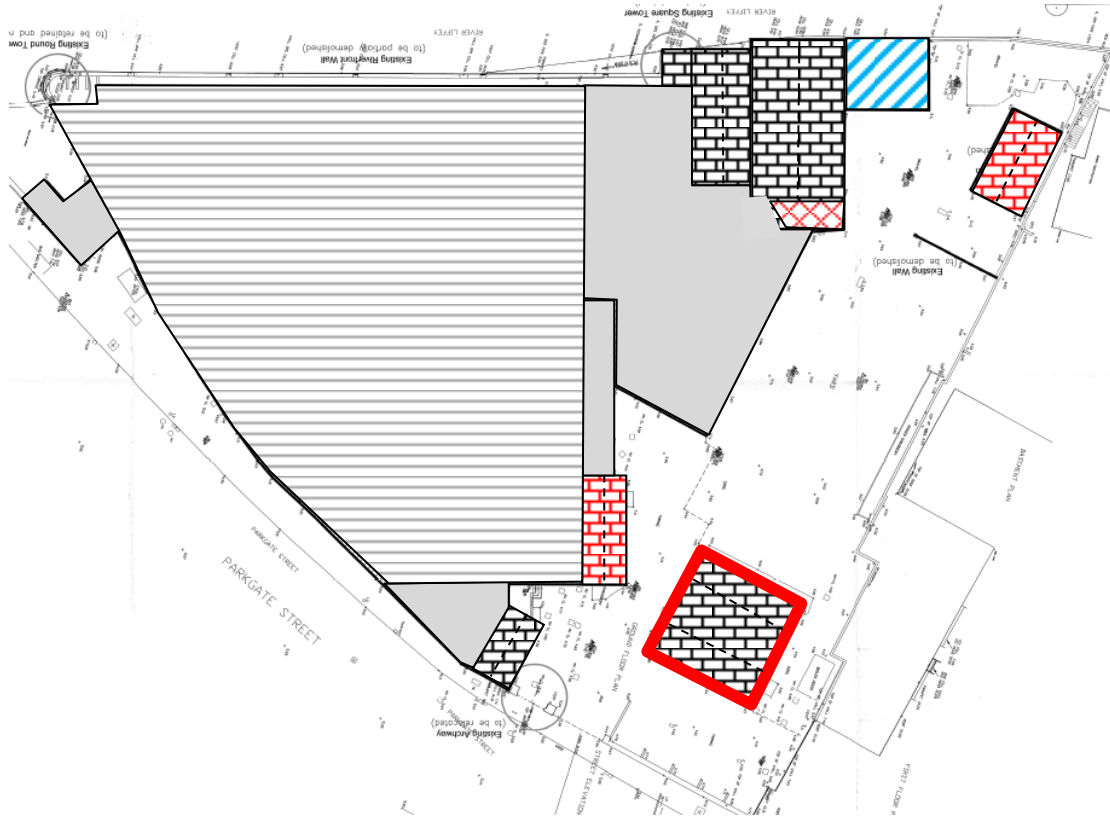
ROOF PLAN

Areas where asbestos cement slates were identified

Area where loose asbestos cement slates were identified

Areas where asbestos cement replacement slates were identified (mainly natural slates on roof)

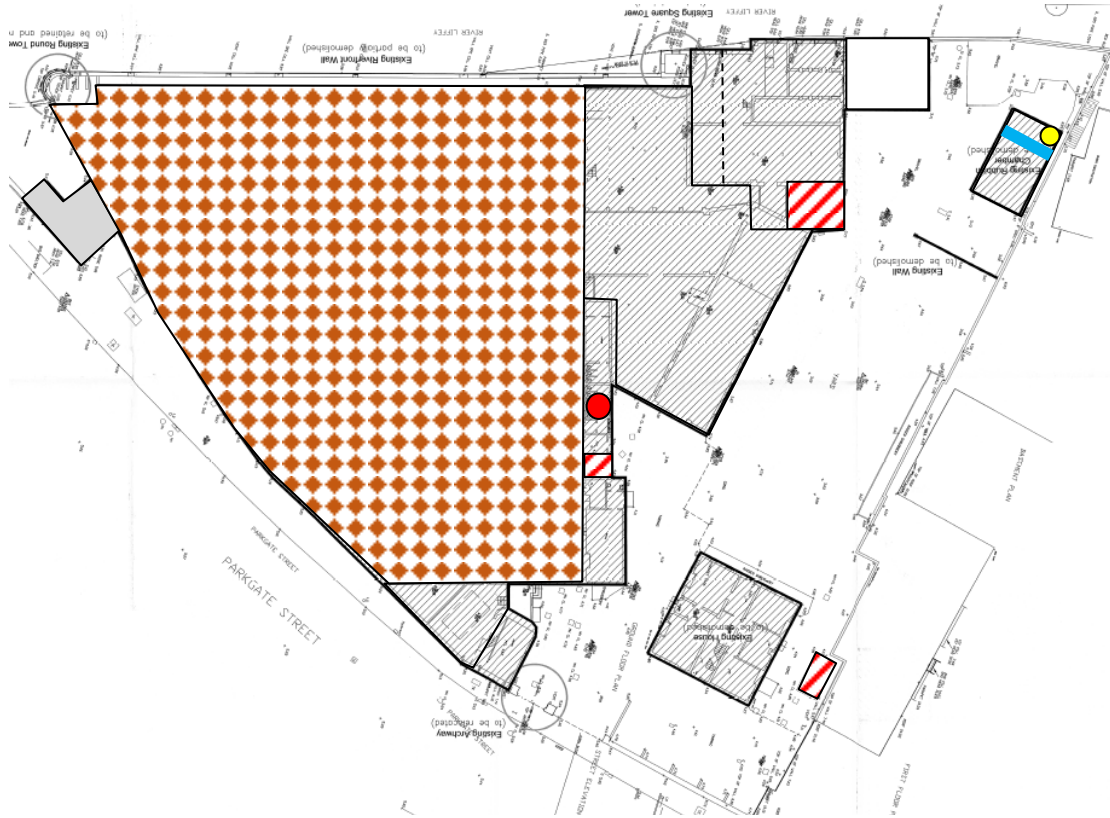
FLOOR PLAN

Area where asbestos floor tiles and bitumen adhesive was identified
