Title: **STAGE 1 ROAD SAFETY AUDIT**

Proposed Residential development at Milltown Park, Sandford Road, Dublin 6.

Report reference: **0995R01**

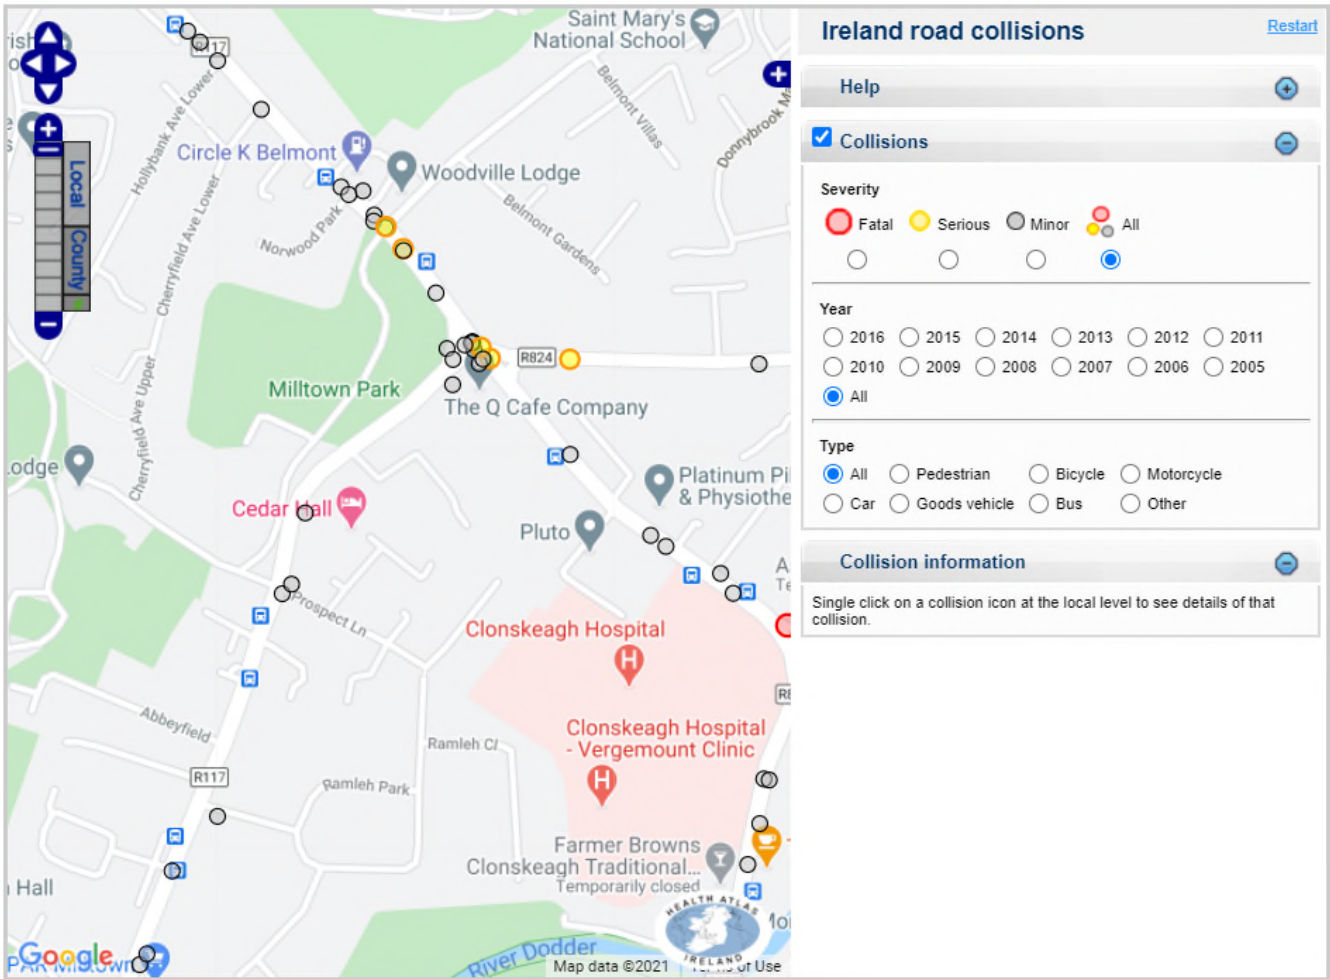
The Road Safety Authority’s website www.rsa.ie shows the recorded injury collisions between 2005 and 2016. There were four serious injury collisions recorded in that period. Two at the Belmont Avenue junction and two at the Milltown Road junction. Three of the four involved vulnerable road users.
