QUINTAIN DEVELOPMENTS IRELAND LIMITED

Portmarnock South Phase 1D

Stage 1 Road Safety Audit

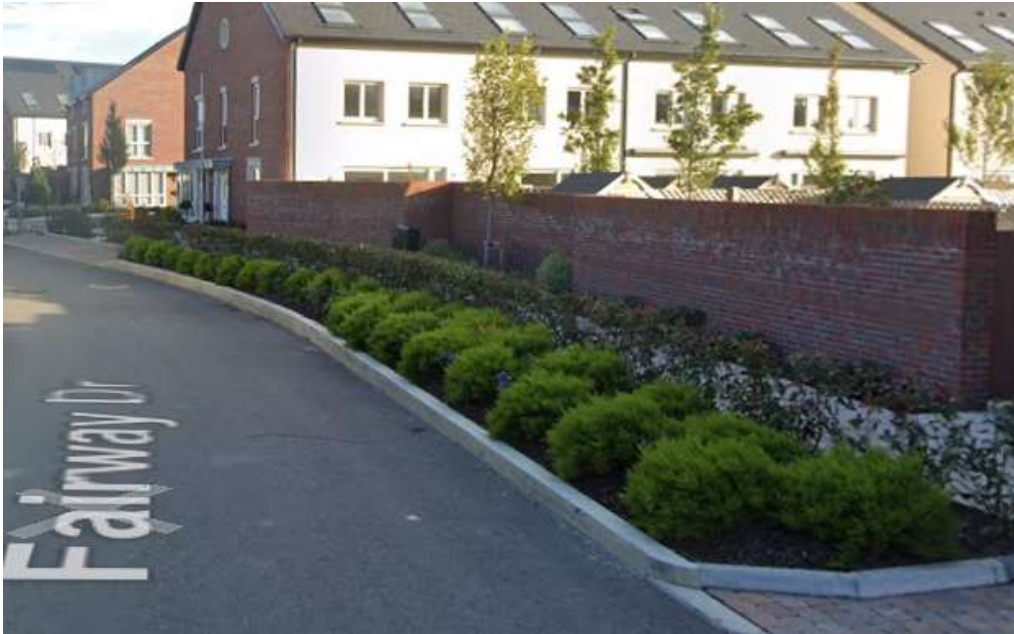
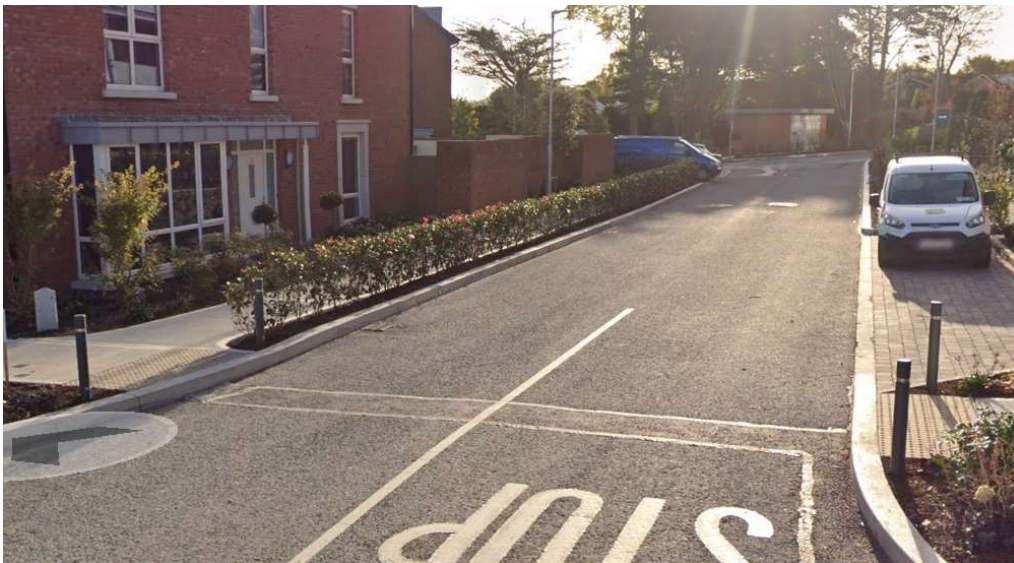
Figure 2.2.2 Examples of vegetation separating the footpath from the carriageway, also acting as a parking deterrent (source: Open-source street view photography)

A limited number of visitors' parking spots should be provided, evenly scattered around the estate.

Where there are no parking spots, footpaths should be separated from the carriageway by means of, for example, a row of vegetation, which will act as a parking deterrent.

Where there are parking spots, footpaths should ideally be run behind parking spots thus ensuring footpaths will remain clear of vehicles and the “temptation” to park parallel is reduced. If this is not possible, a monitoring and enforcement regime should be introduced by the council to ensure footpaths remain clear at all times.
