Tree Management Services

Project: Title: Ashbourne House Residential Development,
Glounthaune Co. Cork

Report Title: Arboricultural Champion and Heritage Tree
Report

Client(s): BARLOW PROPERTIES LIMITED
Planning Ref: 21/05072

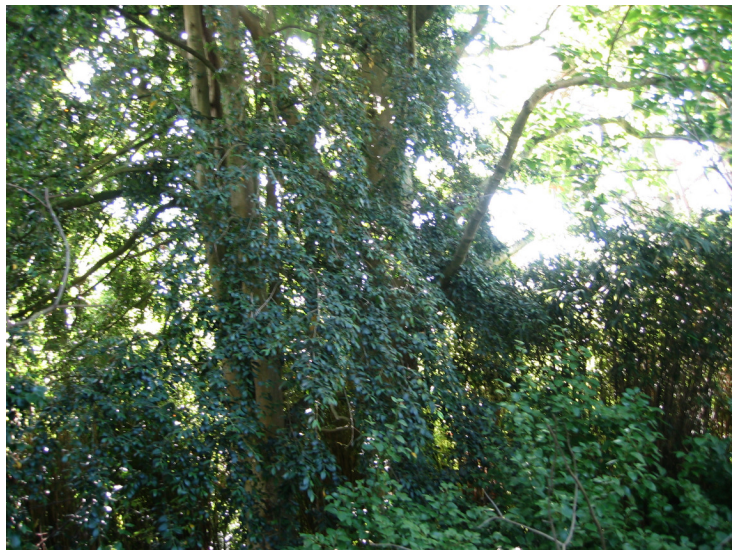
Photo 15: *Tree nos. 950 and 32.*

32	<i>Magnolia campbellii</i>	Campbell's Magnolia	Good	09/09/2021	21.5	87	2.8	✓	✓	Clear stem to about 4m. Upright crown
943	<i>Magnolia grandiflora</i>	Evergreen Magnolia	Good	09/09/2021	15	74	2.4		✓	Large open wound on main trunk east side. Cavity on west side.
29	<i>Magnolia macrophylla</i>	Large-leafed Cucumber Tree	Good	09/09/2021	13	33,28,26	1.2		✓	Species to be confirmed; x 3 stems from base; Orange bark; Could be a Champion tree
956	<i>Nothofagus obliqua</i>	Roble Beech	Fair	09/09/2021	29	116	3.8	✓	✓	Decay at base to 1m. East side. Clear stem to 6m. Possibly topped in past. Compact crown.
