Refurbishment & Demolition Asbestos Survey

Location: *No. 1 & 2 Moore Street.
Dublin 1*

Client: *Dublin Central GP Ltd*

Survey Date: *October 8th, 2020*

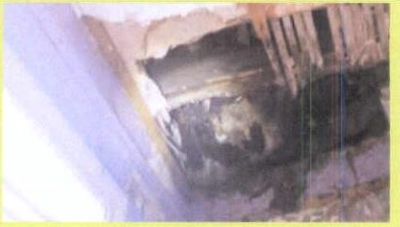
10	No. 1 & 2 Moore St.	No. 2 2 nd floor		Roof not accessible		Presumed to contain asbestos felts						Investigation prior to work likely to cause disturbance.
