Refurbishment & Demolition Asbestos Survey

Location: *No. 20-21 Moore Street
Dublin 1*

Client: *Dublin Central GP Ltd*

Survey Date: *October, 2020*

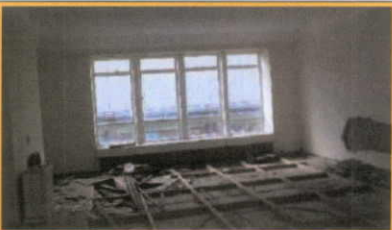
12	No. 20/21 Moore Street	1 st floor	2029209 2029210	Adhesive to VFT under raised floor in big room	60 SM approx.	Chrysotile	1	0	0	1	2	Removal and disposal as asbestos waste by a competent contractor prior to work likely to cause disturbance.
