### **Refurbishment & Demolition Asbestos Survey**

**Location:** *No. 1 & 2 Moore Street.  
Dublin 1*

**Client:** *Dublin Central GP Ltd*

**Survey Date:** *October 8<sup>th</sup>, 2020*

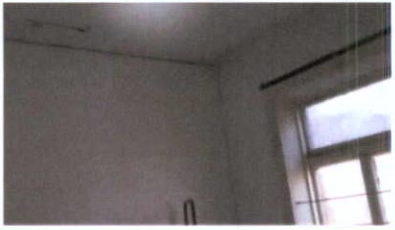
Ref No.	Building or Area of Site	Location or Functional Space	Sample No.	Material Description, surface treatment and condition	Extent	Asbestos identified (presumed, strongly presumed or identified)	Product type	Condition	Surface treatment	Asbestos type	Material assessment score	Recommendations	Photo
9	No. 1 & 2 Moore St.	No. 2 2 <sup>nd</sup> floor Back rooms				No visible asbestos containing materials identified.

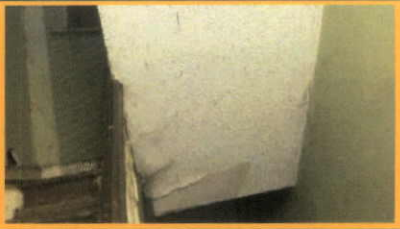
Ref No.	Building or Area of Site	Location or Functional Space	Sample No.	Material Description, surface treatment and condition	Extent	Asbestos identified (presumed, strongly presumed or identified)	Product type	Condition	Surface treatment	Asbestos type	Material assessment score	Recommendations	Photo
9	No. 3 Moore Street	Stairway to 1 <sup>st</sup> floor	2028440	Textured paint to back of stairway		Chrysotile	1	1	0	1	3	Removal and disposal as asbestos waste by a specialist asbestos contractor prior to work likely to cause disturbance.
