Title: **Proposed Strategic Housing Development At Ballymany
Combined Stage 1&2 Road Safety Audit**

Client: **Briargate Developments Newbridge Limited/Muir
Associates**

Date: **May 2021**

Report reference: **1035R01**

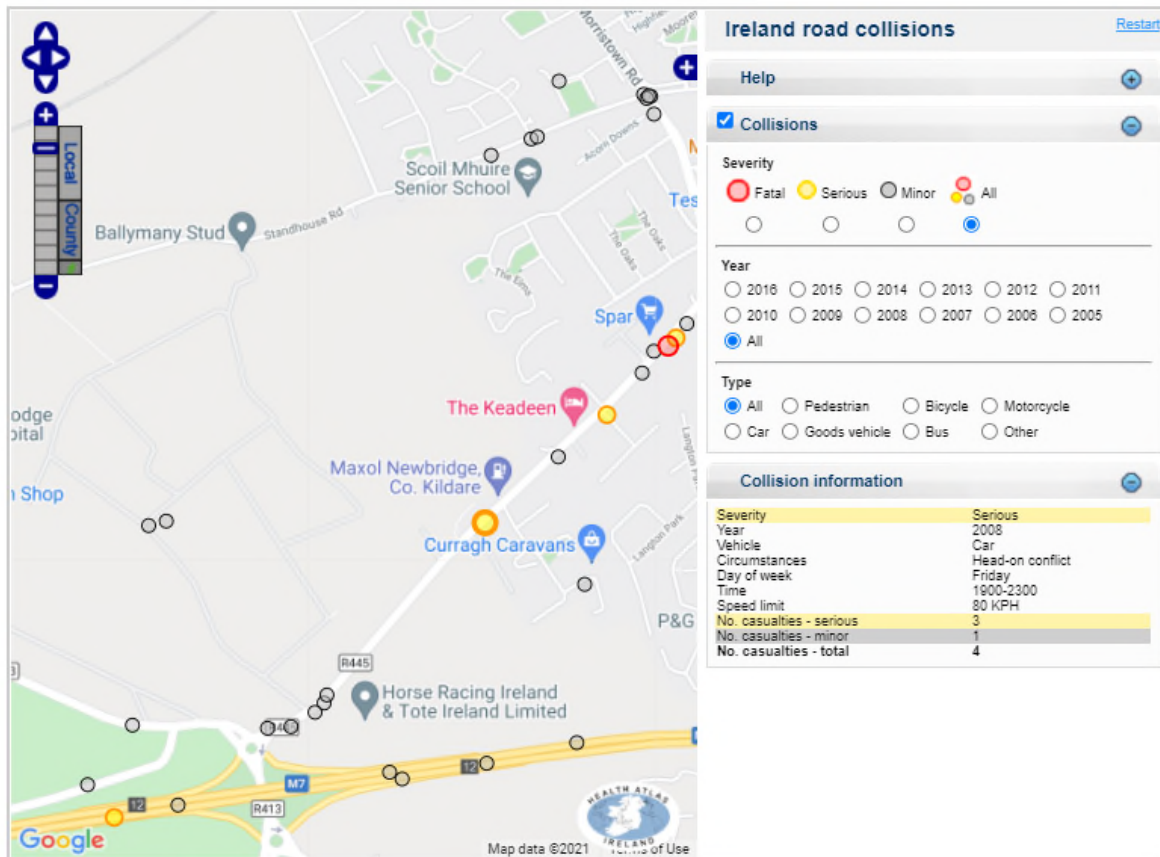
A review of the Road Safety Authority’s website shows that between the years 2005 and 2016 there was one serious injury collision recorded on the R445 just west of the shared site access.
