Arboricultural Survey and Tree Location Drawing

Project: Title: Development Site, Creamfields, Tramore Road,
Cork

Report Title: Arboricultural Tree Survey Report

Client(s): WATFORE LIMITED

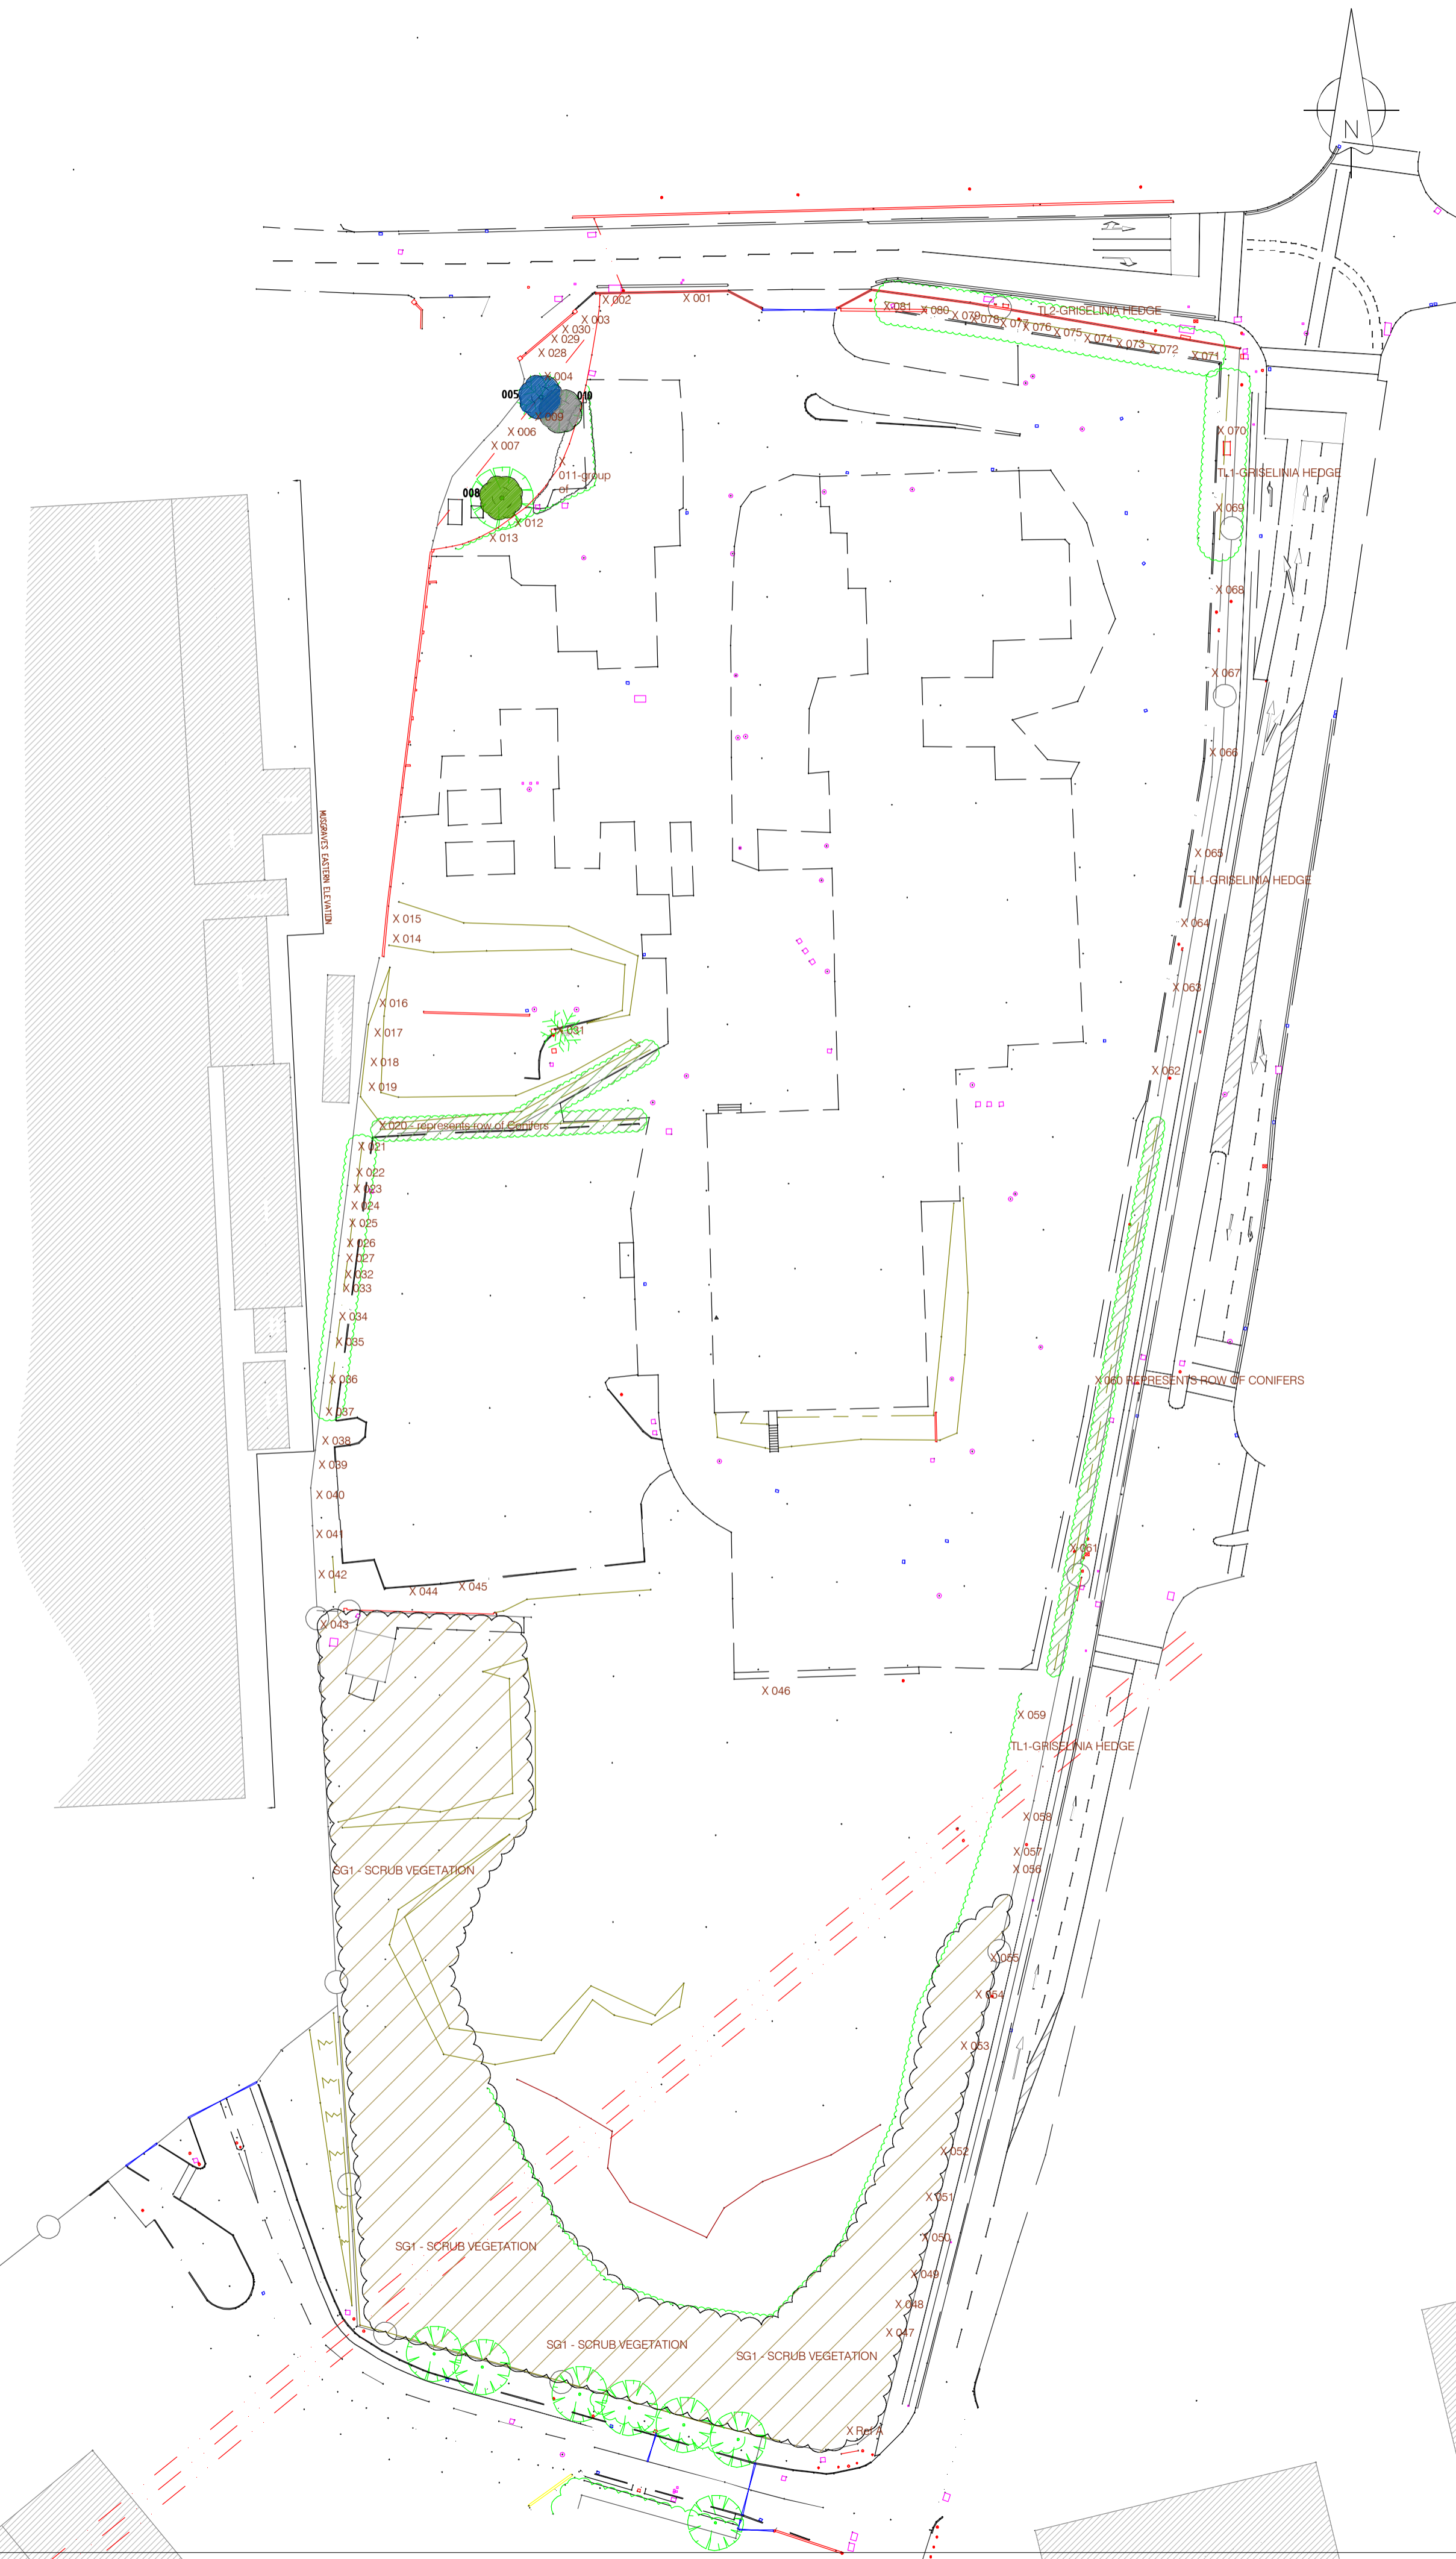
TREE LOCATION MAP

Tree nos. used	001-081
	OUTLINE OF ROW OF LAWSON SCREEN
	OUTLINE OF DENSE SCRUB AREA (MAINLY WILLOW AND BUDDLEIA)
