Arboricultural Report

Tree Survey,
Arboricultural Impact Assessment &
Arboricultural Method Statement

Bridgegate
Rathgory & Mulladrillen
Ardee
Co. Louth

200214-PD-11-D

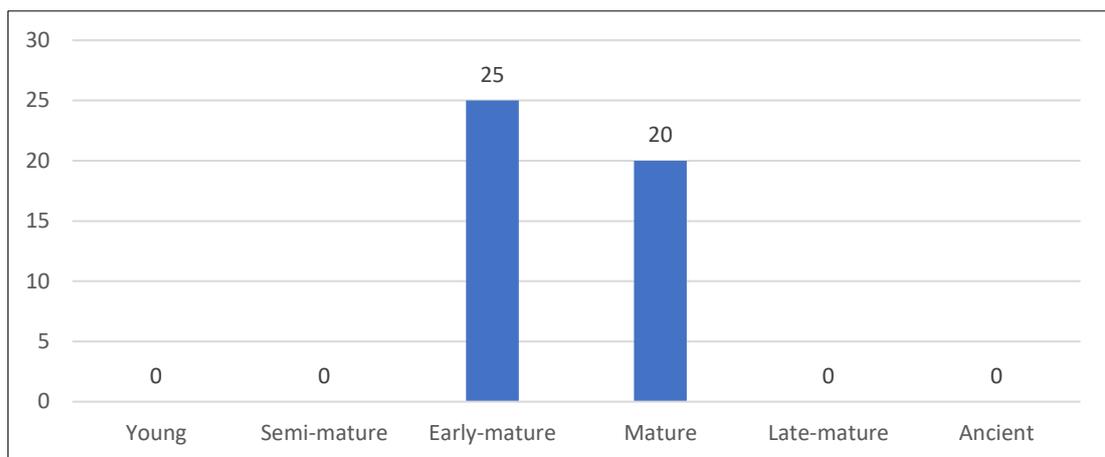
Figure 1: Life stage analysis of the 45 survey entries recorded. The trees and hedgerows on the site are of an early-mature and mature age.

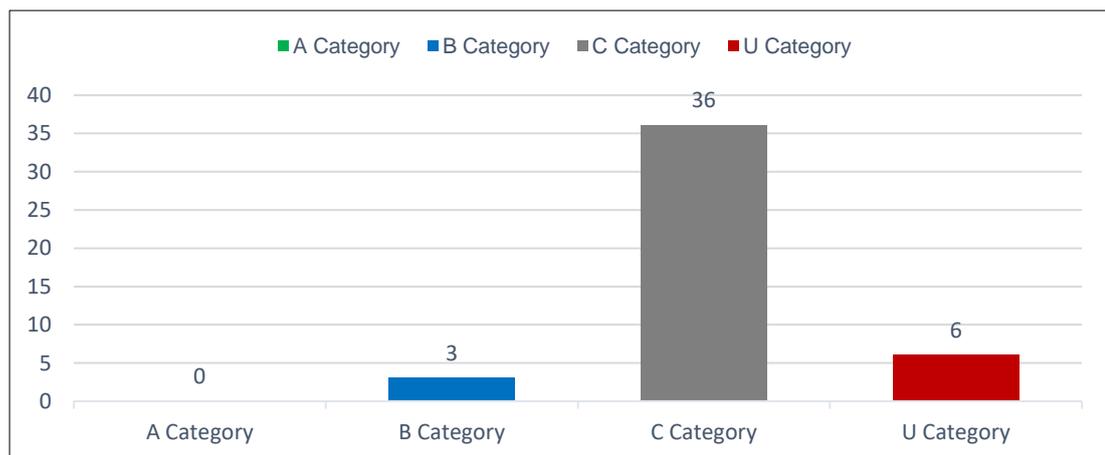
Figure 2: Breakdown of BS5837:2012 categories of the 45 survey entries recorded on site. The majority of trees and hedgerows on the site are of low quality (C Category); however, two hedgerows and one tree group were assessed as being of moderate quality and value (B Category).

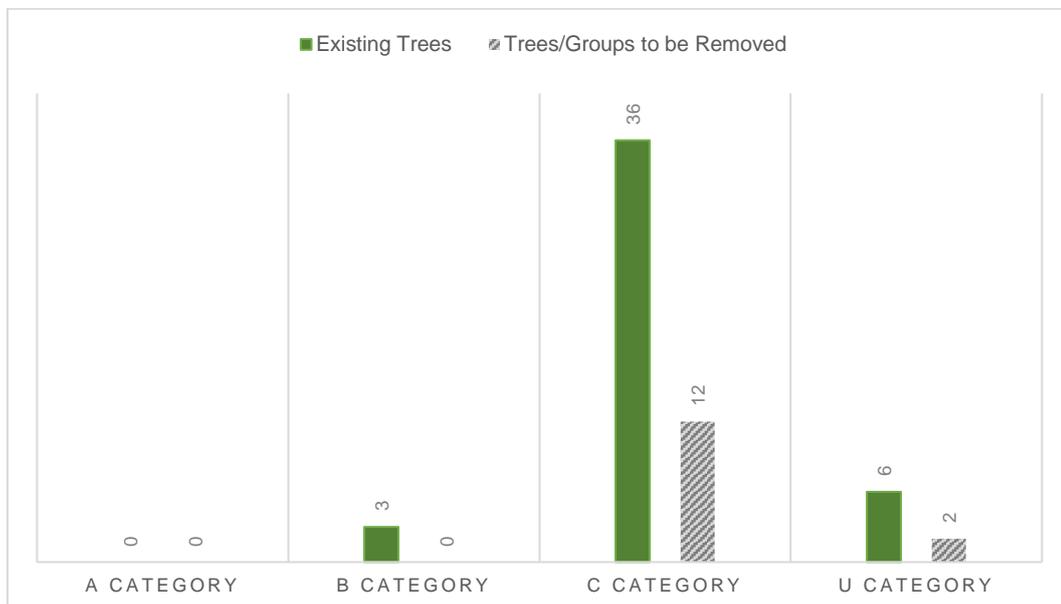
- 6.2 Of the 14 survey entries proposed to be removed to facilitate the development, 12 are of are of low quality and value (C Category) and two are of poor quality (U Category). There are no moderate quality (B Category) trees or hedgerows required to be removed to facilitate the development. A breakdown of tree removals according to their BS 5837:2012 category is outline in Figure 3.

Figure 3: Breakdown of the tree and hedgerow removals required to facilitate the development.
