**Title: QUALITY AUDIT  
INCLUDING ROAD SAFETY AUDIT (Stage 1)  
For;  
Proposed Residential Development and Road Upgrade,  
Boherboy, Saggart, Co. Dublin.**

**Client: Pinnacle Consulting Engineers.**

**Date: September 2021**

**Report reference: 1151R01**

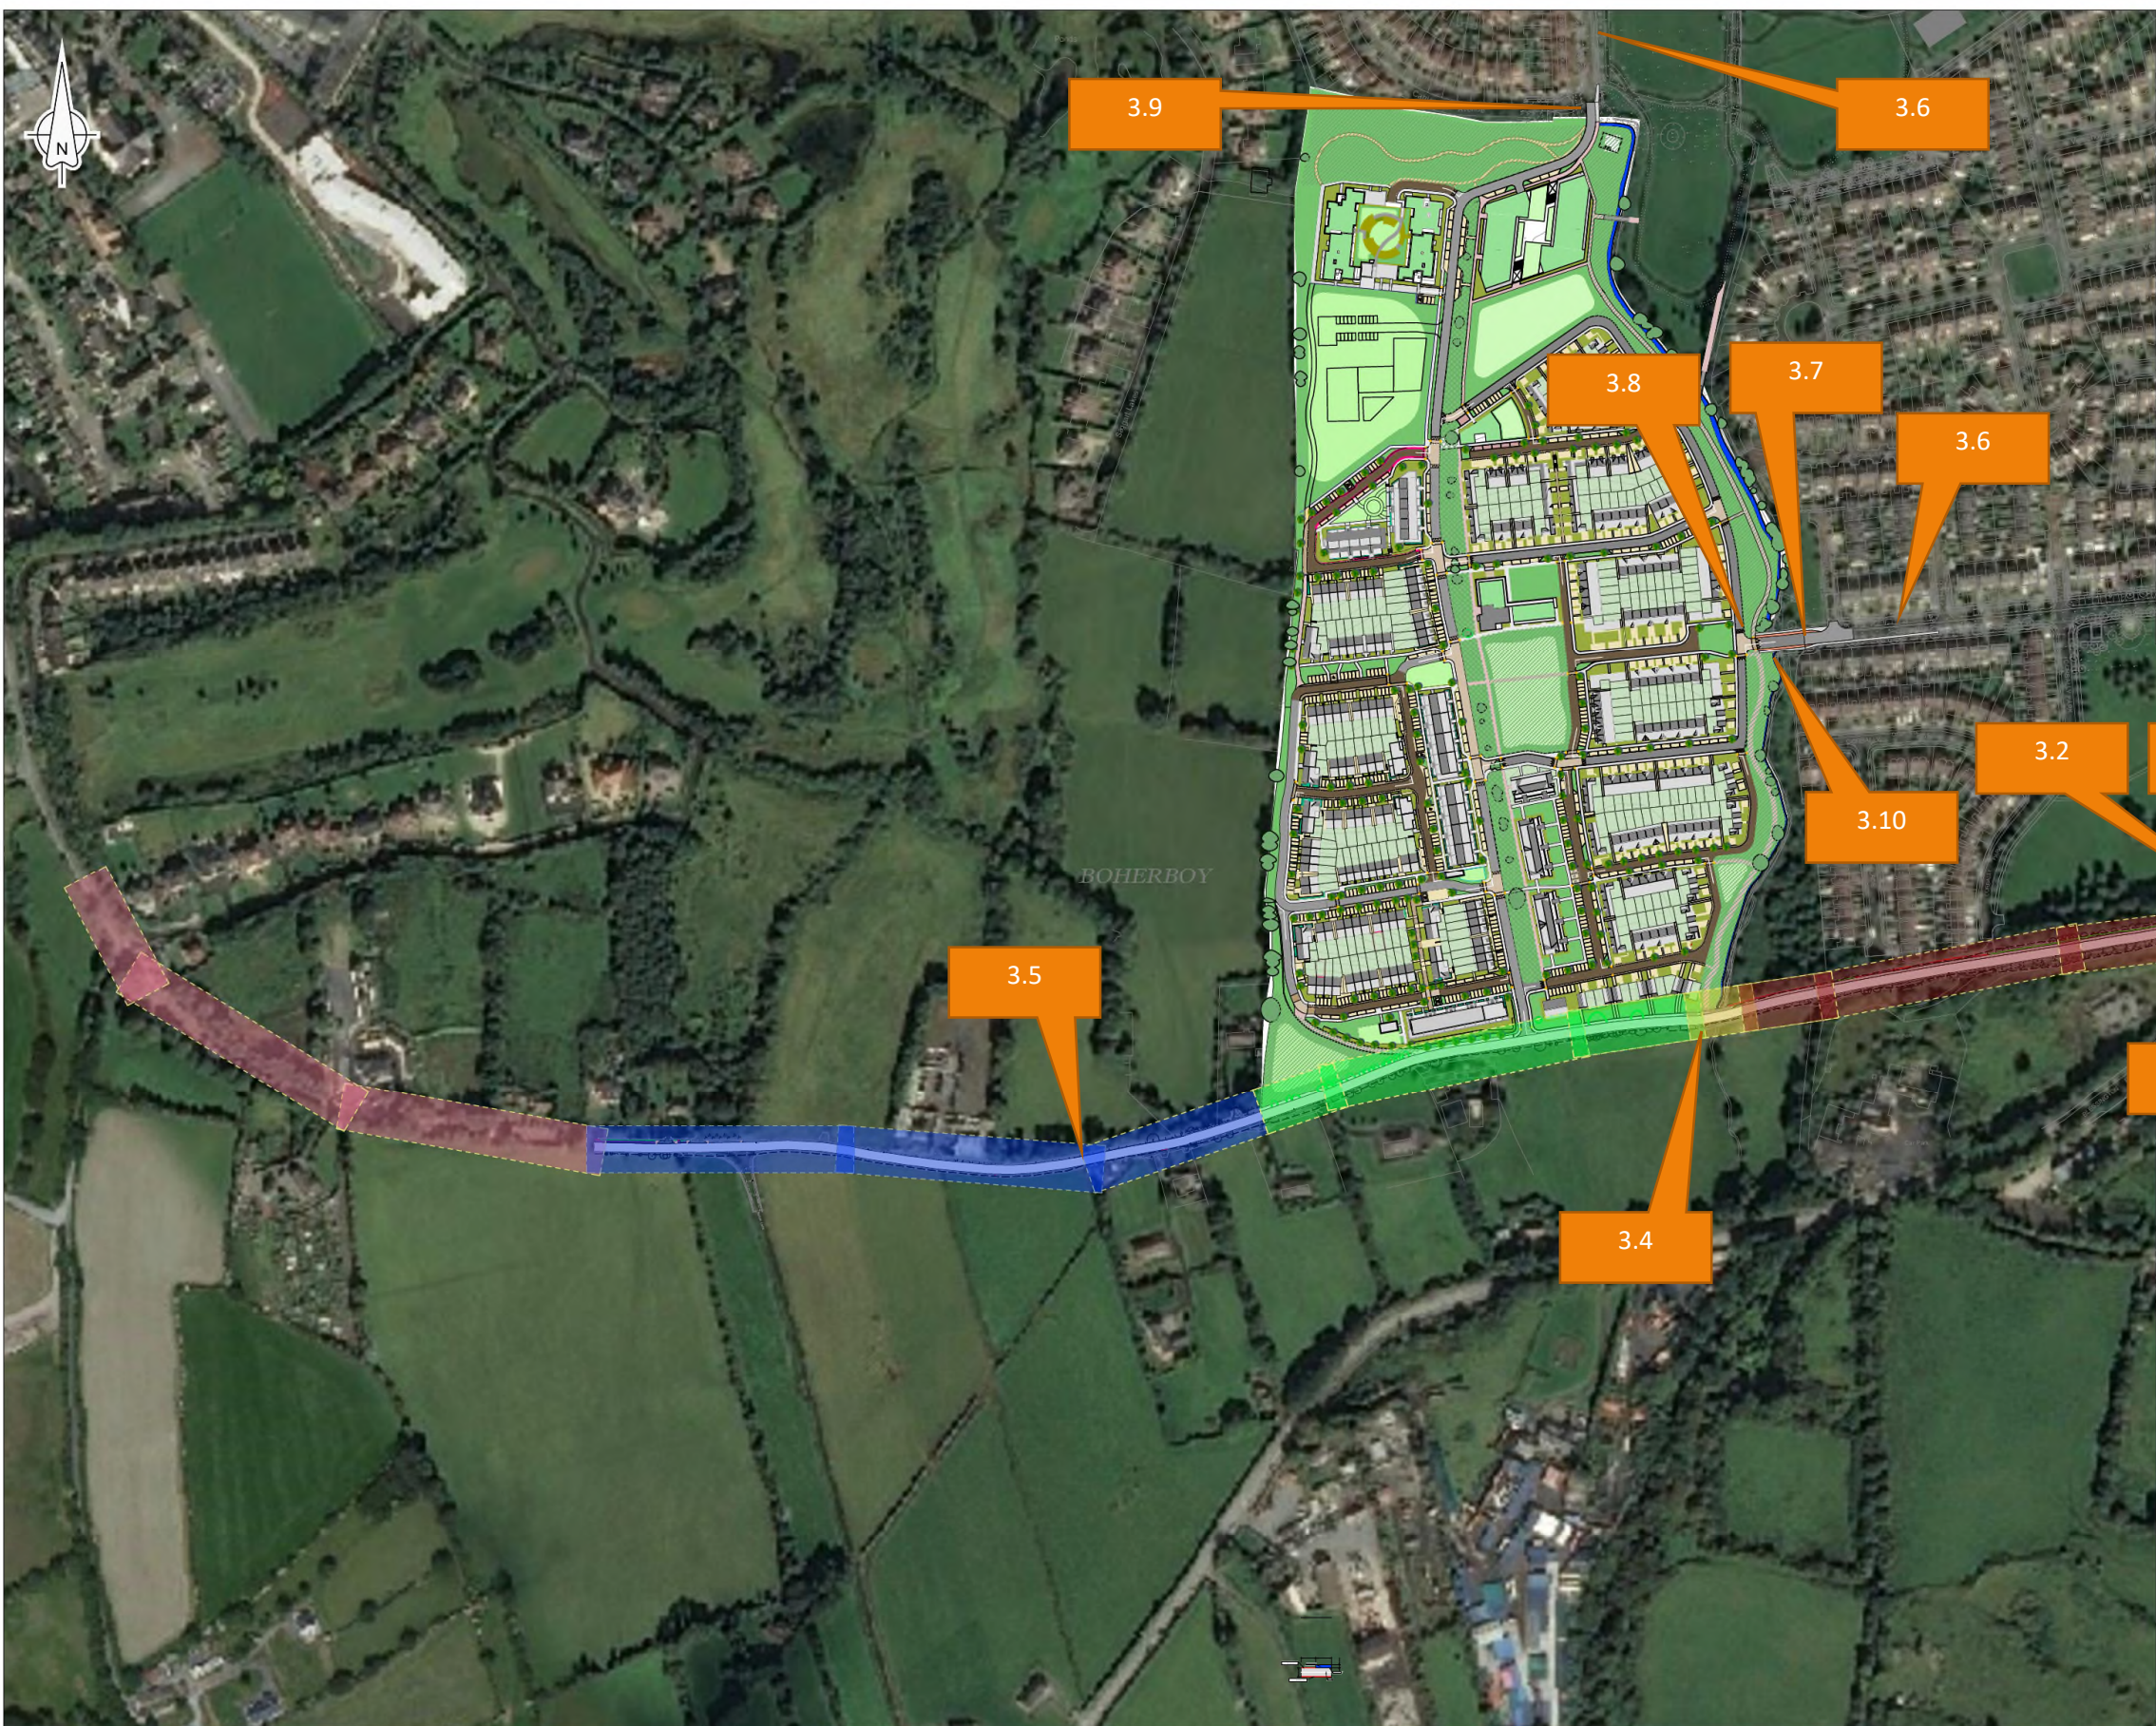
### Problem Location Plan.

There is a risk of overshoot of the stop line at the N81 junction for eastbound drivers on Boherboy Road. This could lead to rear end or side-impact collisions with eastbound traffic on the N81. In addition the proposed straight ahead arrow may suggest drivers have priority to proceed.

It is recommended that a buildout be provided at the existing footpath into which some signage or other feature be provided to alert drivers that it is not a through route and which will force drivers to approach the N81 at a less acute angle. The straight ahead arrow should be removed.
