Appendix 14.1

Scheme Walkover Summary

Appendix A14.1: Scheme Walkover Summary

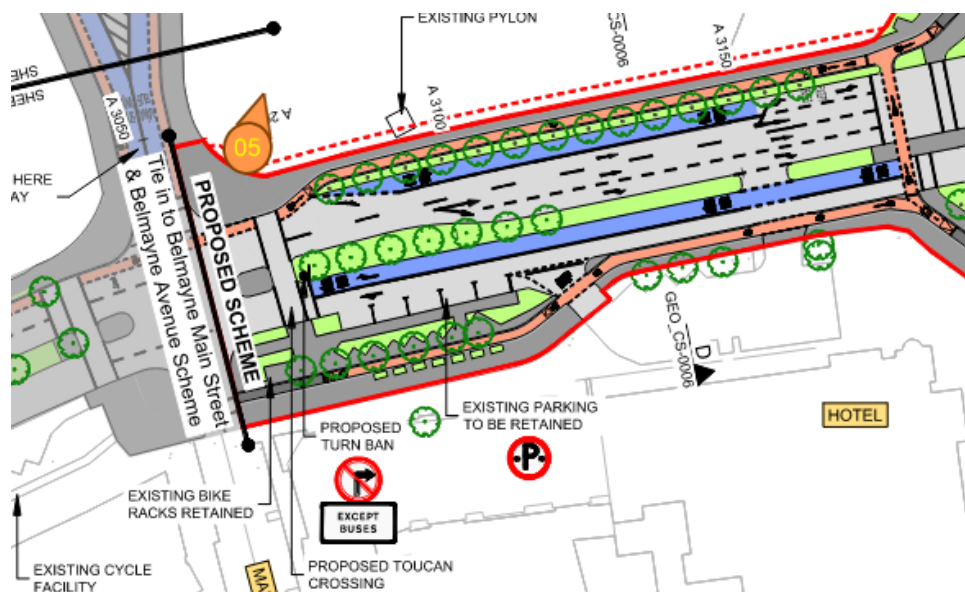
Observation	General Arrangement (GA) Drawing Sheet Number (refer to Volume 3 of the EIAR for GA drawings)	Description	Possible Impact	Photo Number
Bunds of made ground	Sheet 6	At the north-western corner of the junction of Malahide Road with Clarehall road there are made ground bunds immediately adjacent to the road behind the fence.	This may pose an issue for the earthworks balance and waste assessment.	Clongriffin_Image05
Bunds of made ground	Sheet 6	There is a low height bund constructed along the fence line on the western side of Malahide road opposite Tesco, Clarehall. It may contain anthropogenic material.	This may pose an issue for the earthworks balance and waste assessment.	Clongriffin_image06
Raised ground / potentially construction compound	Sheet 8	The ground is raised between Buttercup Park and Malahide Road. A proposed construction compound is to be located within this green area, it is likely that the topsoil will be removed and level changes will be required at this location to accommodate the construction compound.	This may pose an issue for the earthworks balance and waste assessment.	Clongriffin_image15

Photo ID	Caption	Date Taken	Coordinates
Clongriffin_image05	Overgrown area with bunds of potential made ground	14/01/2020	721177, 740715 (ITM)

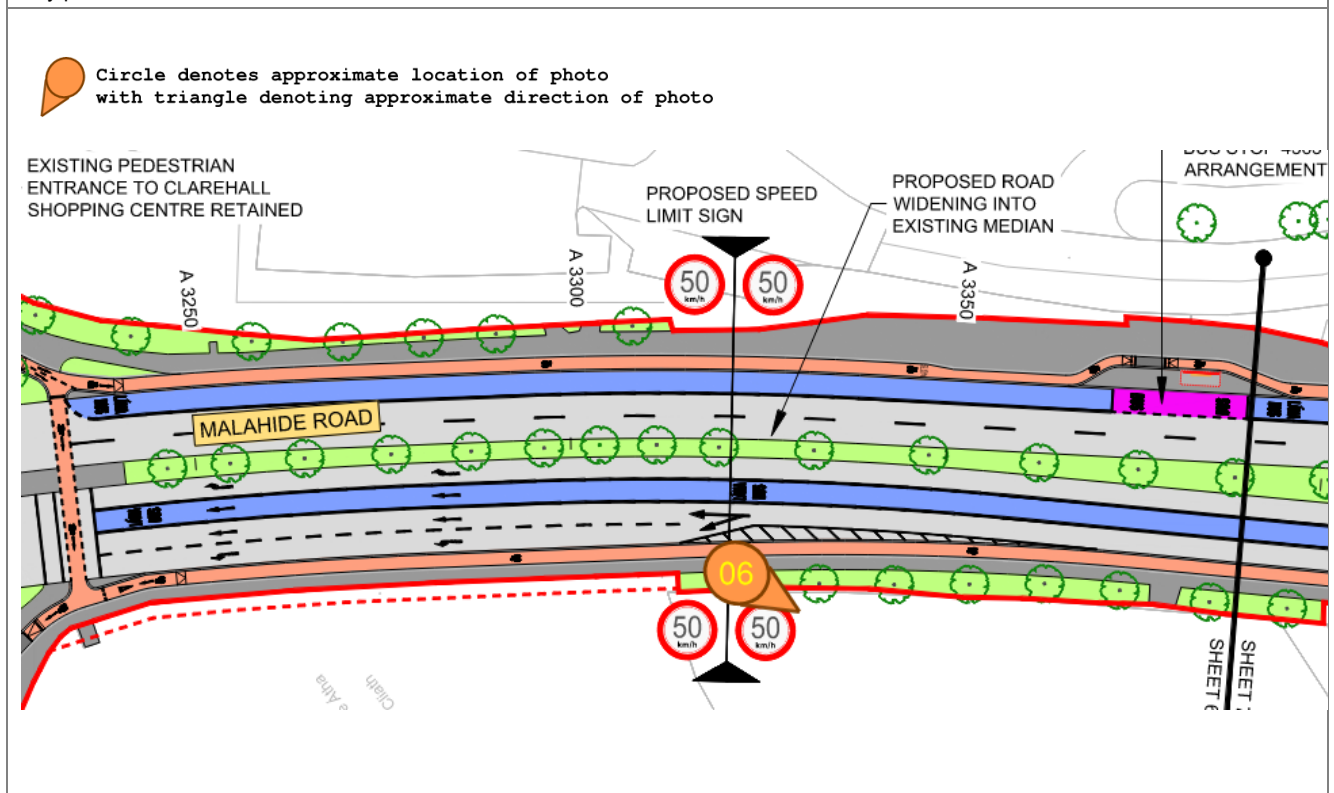
Photo ID	Caption	Date Taken	Coordinates
Clongriffin_image06	Image of raised verge along Malahide Road	14/01/2020	721079, 740717 (ITM)

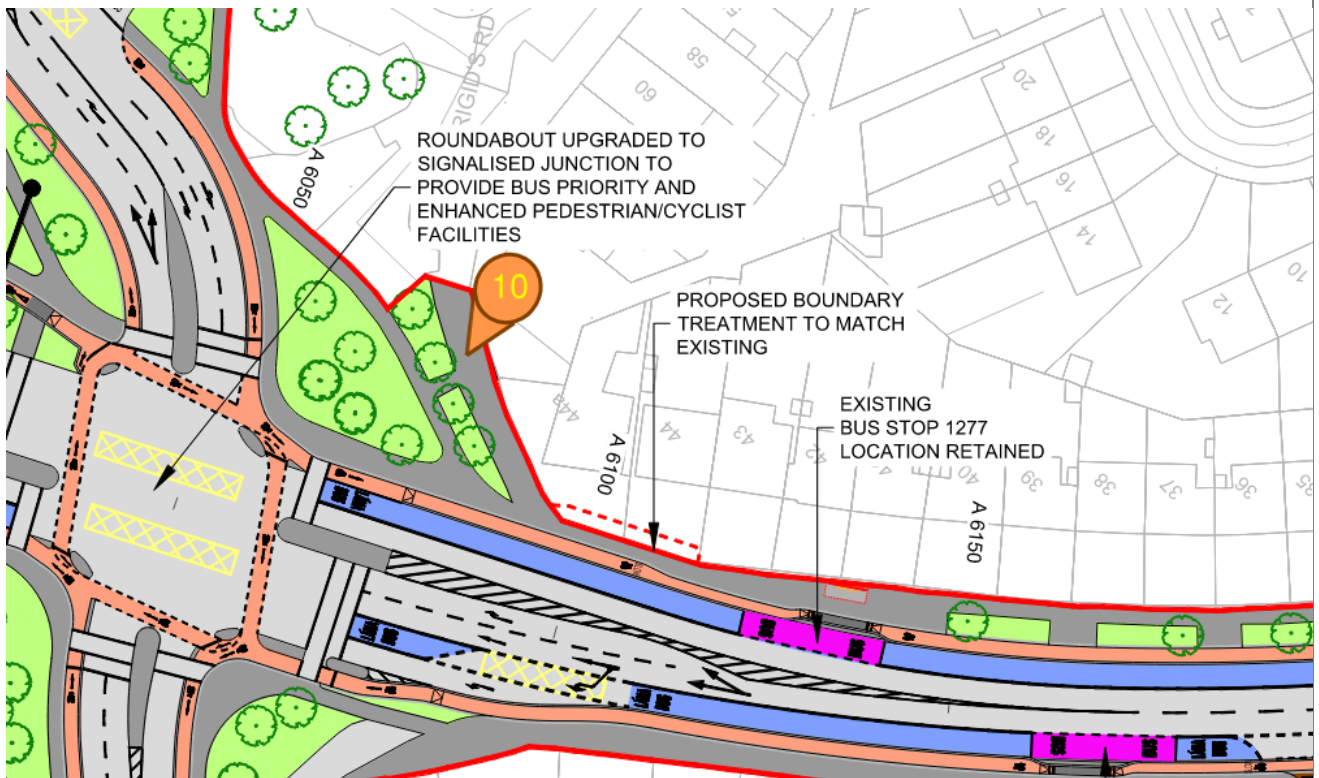
Artane Roundabout	Sheet 13 & 14	There is a notable level change at the roundabout. There will be earthworks required to achieve the proposed road levels.	This may pose an issue for the earthworks balance and waste assessment.	Clongriffin_image10
Old River	Sheet 13 & 14	Old river south of Artane Roundabout, which can be seen on the 25inch Historic Map at present day Mornington Grove. This is associated with a strip of alluvial deposits, so it may impact road design. However, no evidence of this old river was encountered during the site walkover.	This may pose an issue for the earthworks balance due to the requirement to excavate soft ground and creating a pathway to groundwater.	N/A
Donnycarney Bridge	Sheet 17	The proposed scheme passes over the Donnycarney bridge at this location which allows access over the culverted River Wad. In addition, there is a petrol station close to Donnycarney Bridge which may also be a potential source of contamination.	This may pose an issue for the earthworks balance and waste assessment and mobilising contaminants into the groundwater.	Clongriffin_image19 and Clongriffin_image20.

Photo ID	Caption	Date Taken	Coordinates
Clongriffin_image10	Image of raised verge along Malahide Road and surrounding the Roundabout; also note raised mound on roundabout	14/01/2020	719432, 738473 (ITM)

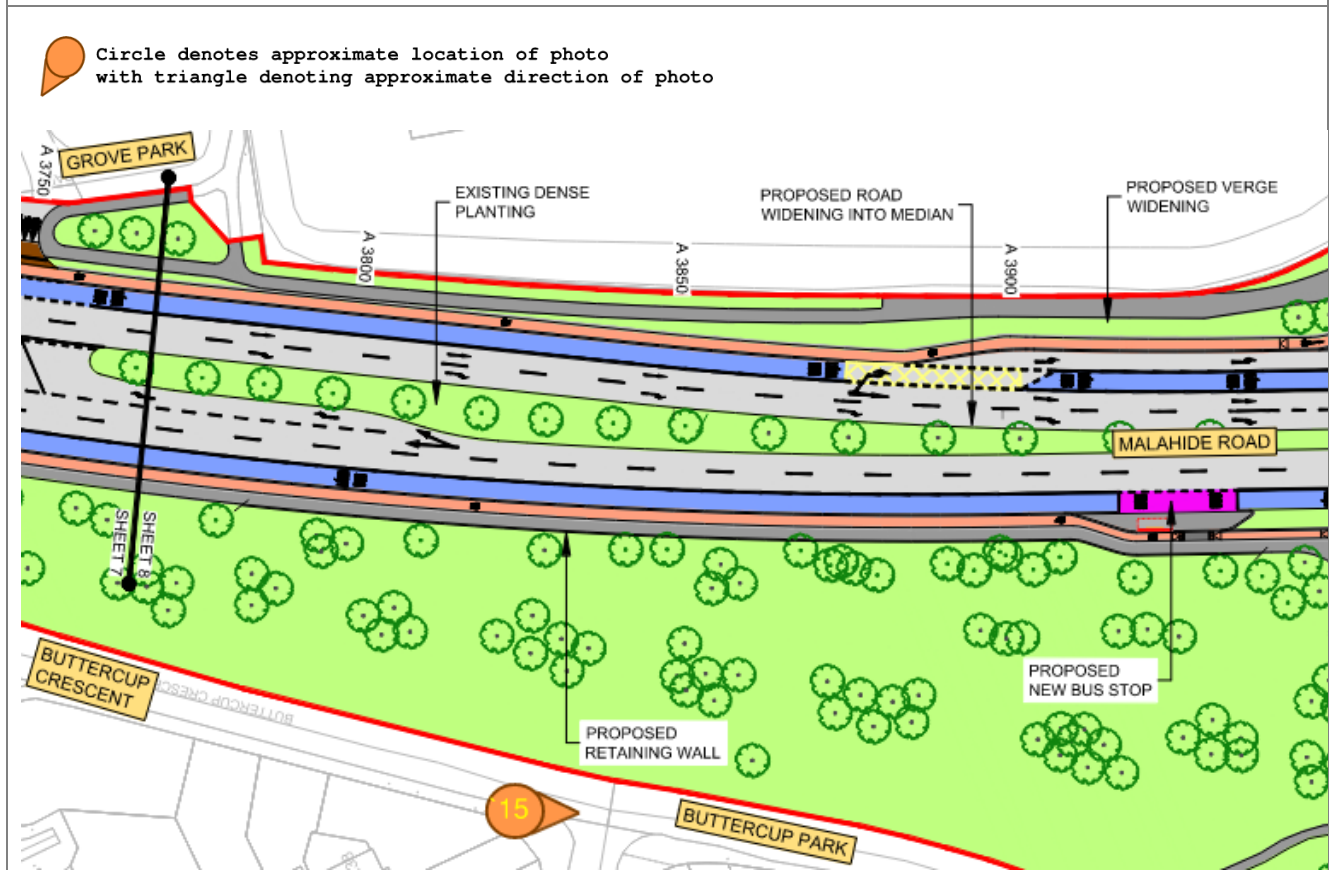
Photo ID	Caption	Date Taken	Coordinates
Clongriffin_image15	Image of proposed location for a construction compound at Buttercup Park.	09/07/2021	720618, 740268 (ITM)

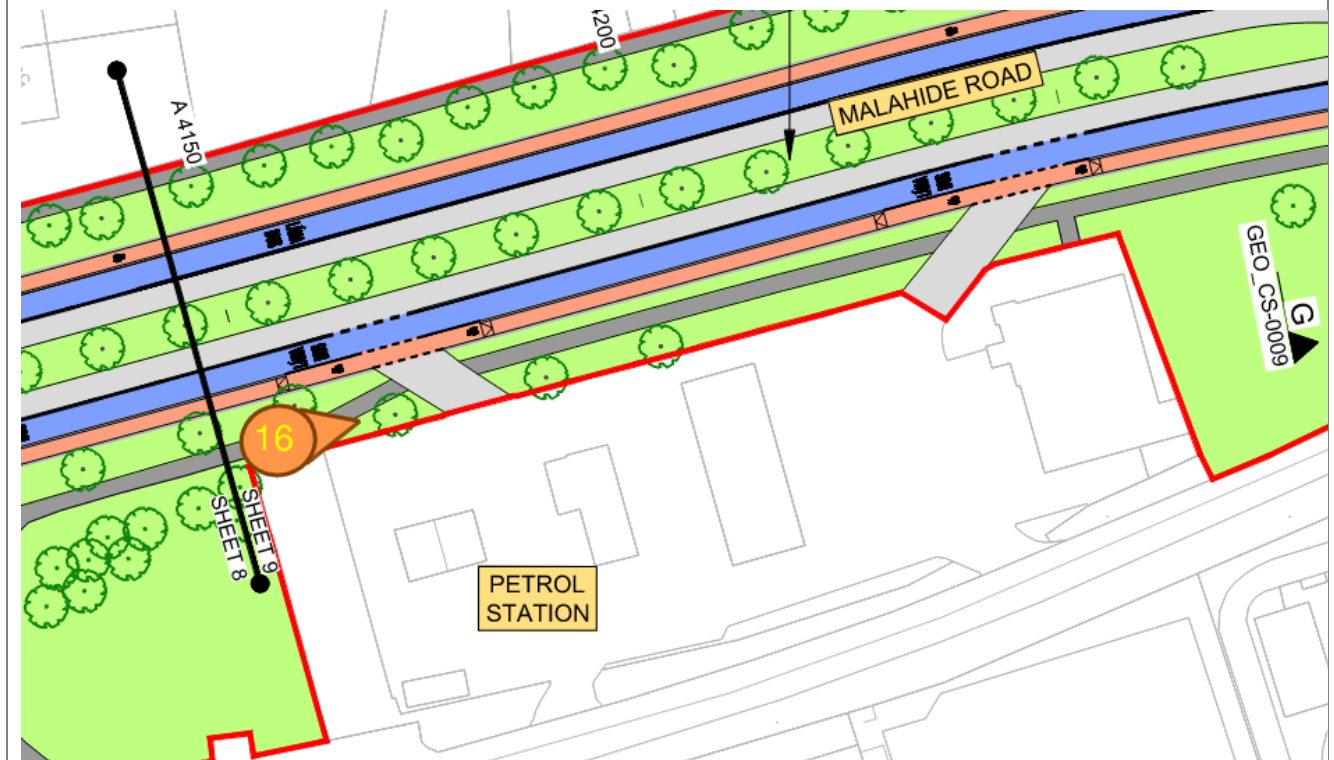
Alternative cycle route	Sheets 20 & 21	This route is considered an alternative to the current cycle route outlined in the drawings.	This may pose an issue for the earthworks balance and waste assessment.	Clongriffin_image21
Petrol stations	Sheet 09, 14 & 17	Two petrol stations are located along the Malahide Road and a third located near Donnycarney. A disused petrol station is also located opposite Belcamp Lane. Historic activities at petrol stations may have resulted in oil leaks into the surrounding soils and groundwater in the past.	This may pose an issue for the earthworks balance and waste assessment and mobilizing contaminants into the groundwater.	Clongriffin_image16, 17 and 18

Photo ID	Caption	Date Taken	Coordinates
Clongriffin_image16	Image of Texaco Service Station on Malahide Road.	09/07/2021	720492, 739951 (ITM)

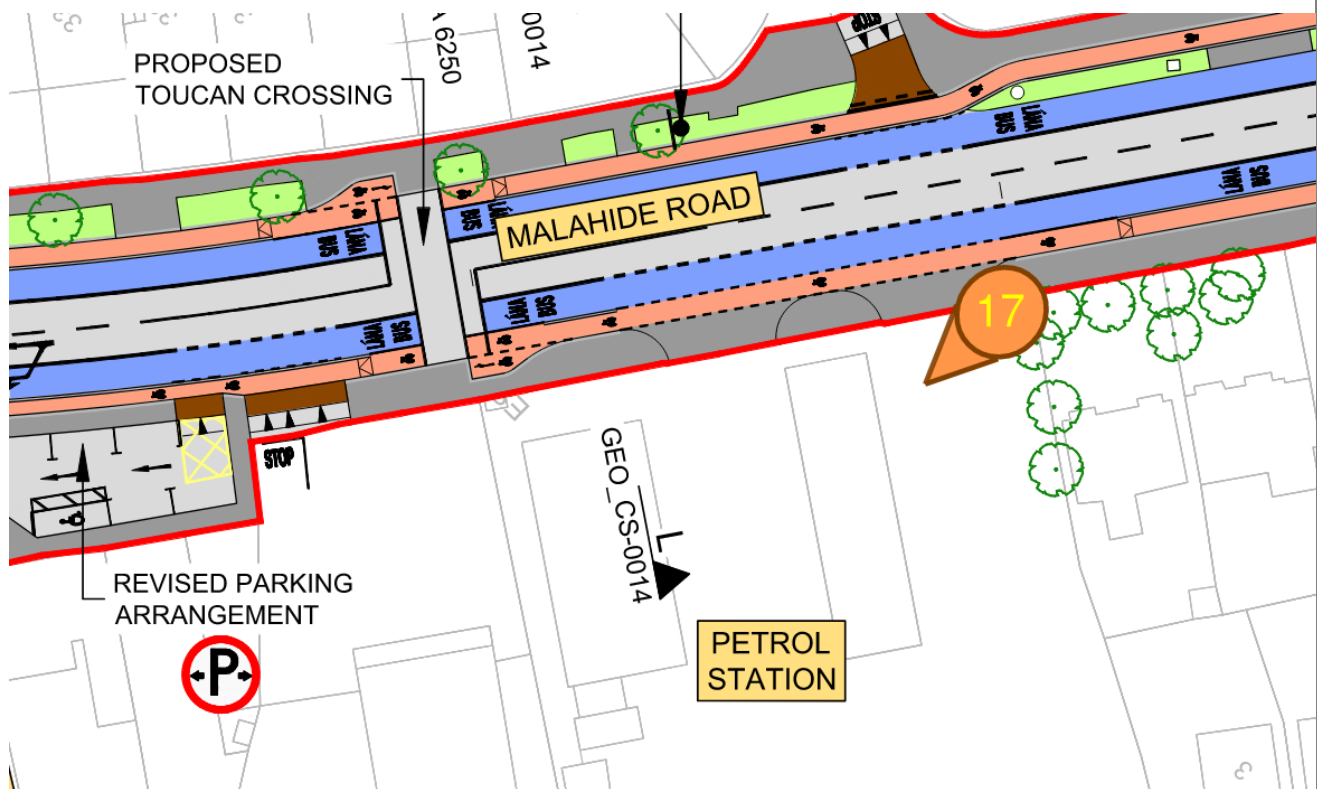
Photo ID	Caption	Date Taken	Coordinates
Clongriffin_image17	Image of Circle K Artane Service Station on Malahide Road	09/07/2021	719210, 738352 (ITM)

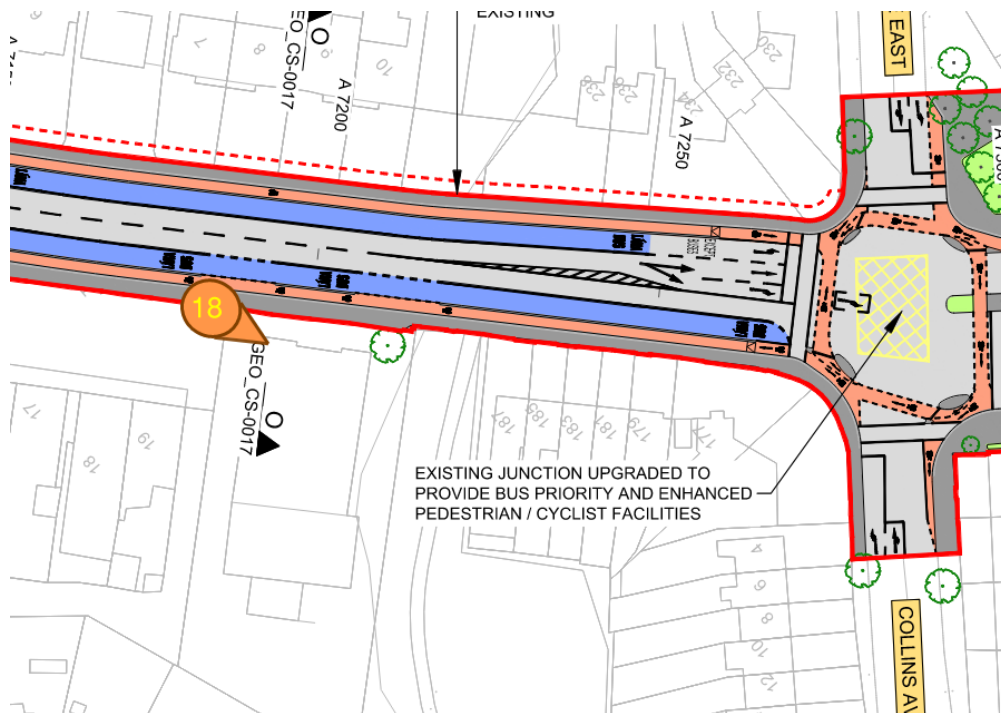
Photo ID	Caption	Date Taken	Coordinates
Clongriffin_Image18	Image of Circle K Maypark Service Station at Donnycarney.	09/07/2021	718565, 737699 (ITM)

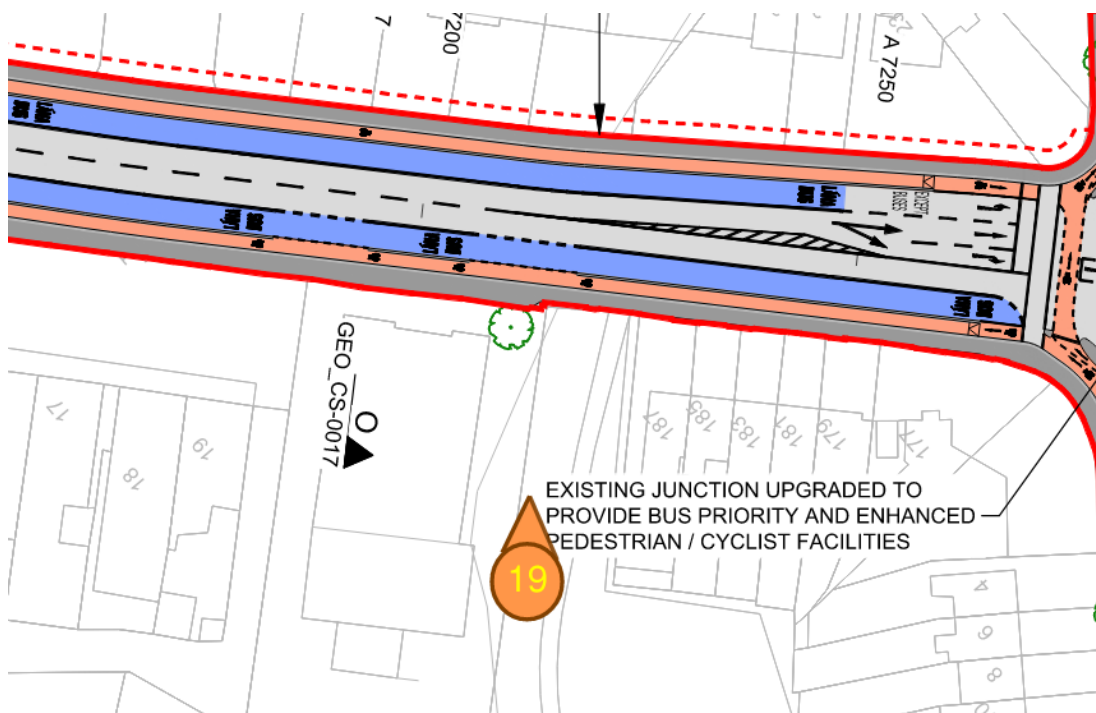
Photo ID	Caption	Date Taken	Coordinates
Clongriffin_Image19	Image of the location of the culverted River Wad at Donnycarney Bridge.	09/07/2021	718544, 737691 (ITM)

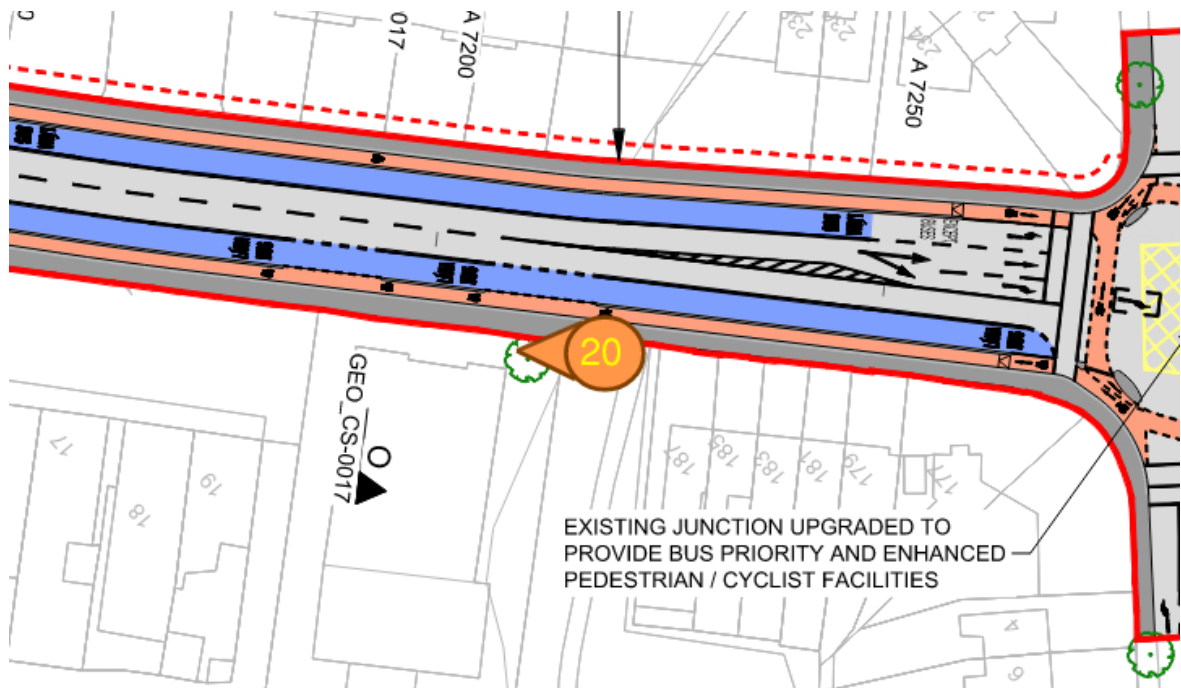
Photo ID	Caption	Date Taken	Coordinates
Clongriffin_Image20	Image of Donnycarney Bridge.	09/07/2021	718564, 737678 (ITM)

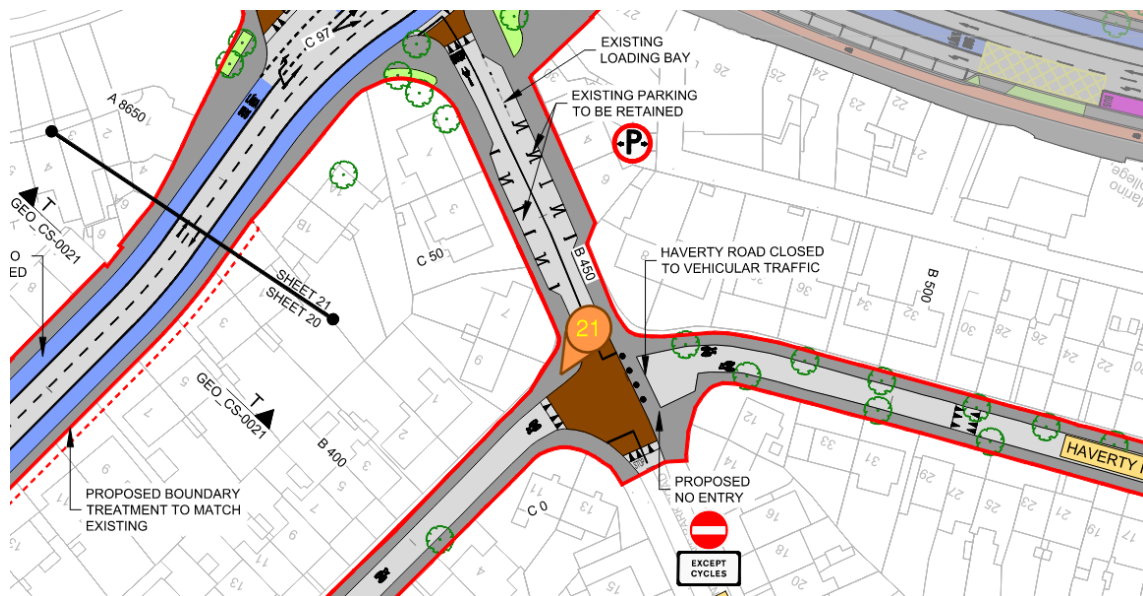
Photo ID	Caption	Date Taken	Coordinates
Clongriffin_Image21	Image of the proposed alternative cycle road near St. Aidan's Park	09/07/2021	717769, 736445 (ITM)
