ASBESTOS R&D SURVEY REPORT

LIMERICK TRANSPORT,
PARK RD, RHEBOGUE,
LIMERICK,
IRELAND

R&D ASBESTOS SURVEY REPORT

Reference: REPORT-230119MG-V1					
Issue		Prepared by	Reviewed by	Verified by	
V1	5 th February 2019

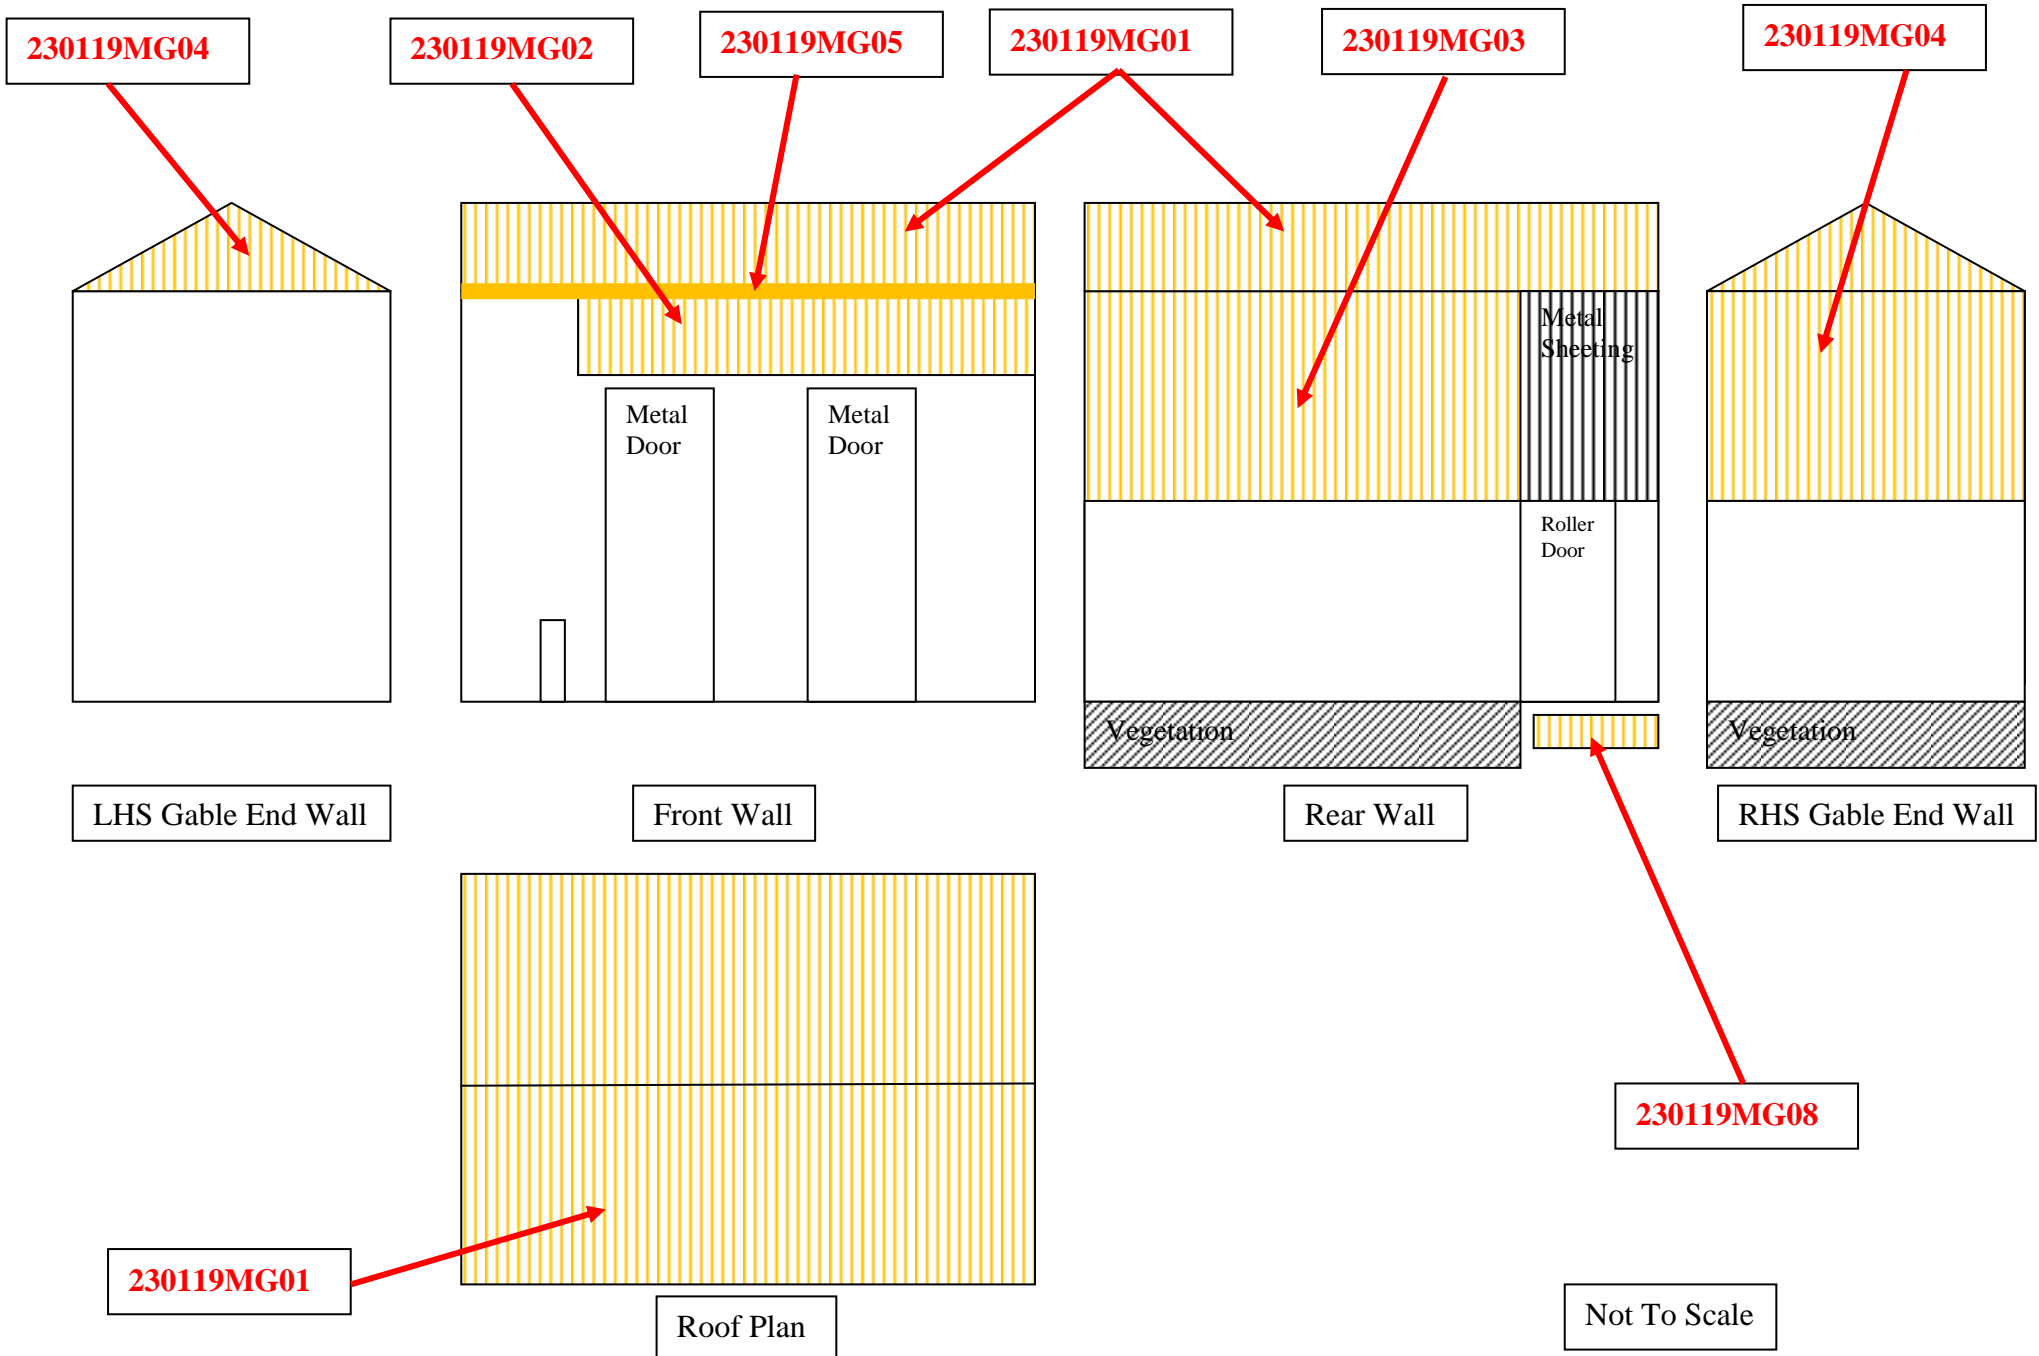
Limerick Transport - Rhebogue		Drawing Title	Date	Client	Survey Report Number	Survey Type
Drawing 1 of 2		Externals	04-02-19	Verde Environmental	23-01-19-MG-V1	R&D
Room/ Area Number	OG01	Sample/inspection/presumed= Asbestos Present 01			Sample/inspection = Not Asbestos Containing 01

Asbestos Cement products containing Chrysotile were identified in six samples/inspections Ref – Inspection sheets 1, 2, 3, 4, 5 & 8 in all of the incidents the cement products were unsealed and in fair condition whilst attached to the building the fragments on the ground externally have exposed fibres on edges.

Precision recommends that all the Cement products are removed by a competent contractor prior to any work that may disturb them, subject to contractor's method statement and risk assessment notification to HSA may be required
