**Arboricultural Report**  
**Trees at Proposed Site at**  
**Coolagad**  
**Greystones**  
**Co Wicklow**

**March 2022**

**The Tree File Ltd**  
**Consulting Arborists**  
**Ashgrove House**  
**26 Foxrock Court**  
**Dublin 18**  
**D18 R2K1**  
**086-3819011**

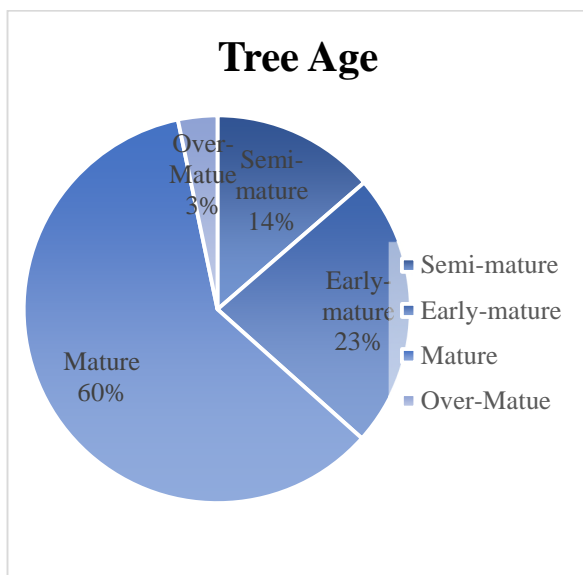
Fig 3

4.8 Sustainability issues are also illustrated by other criteria . We note that 34% of trees have been categorised as being of poor or fair/poor (see fig 2). Similarly, 37% of trees
