Fermoy Housing Development at Cork Rd, Fermoy Co. Cork

Stage 1 Road Safety Audit

January 2022

Client	Cumnor Construction			
Project Title	Fermoy Housing Development			
Document Title Report for Stage 1 – Road Safety Audit				
Job No. 19099TT				
Document No.	19099TT-Doc05

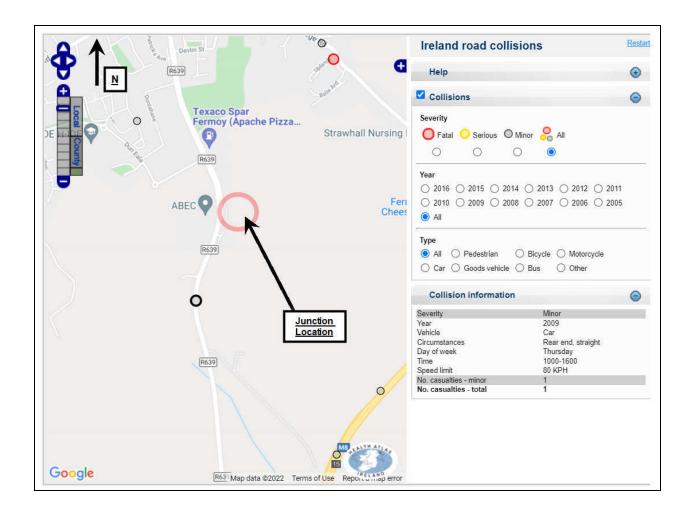
Fig 1 RSA Collision Statistics for Site Location

One minor collision occurred in 2009 at a location approximately 500m to the south of the site entrance. The circumstances were a rear end, straight type collision, resulting in one minor casualty. Refer to Figure 1 in Appendix B for details
