**Title: QUALITY AUDIT
INCLUDING
Road Safety Audit, Access Audit, Cycle Audit and Walking
Audit.
For;
Barrington SHD, Brennanstown Road, Cabinteely.**

Client: Waterman Moylan

Date: March 2022

Report reference: 1432R01

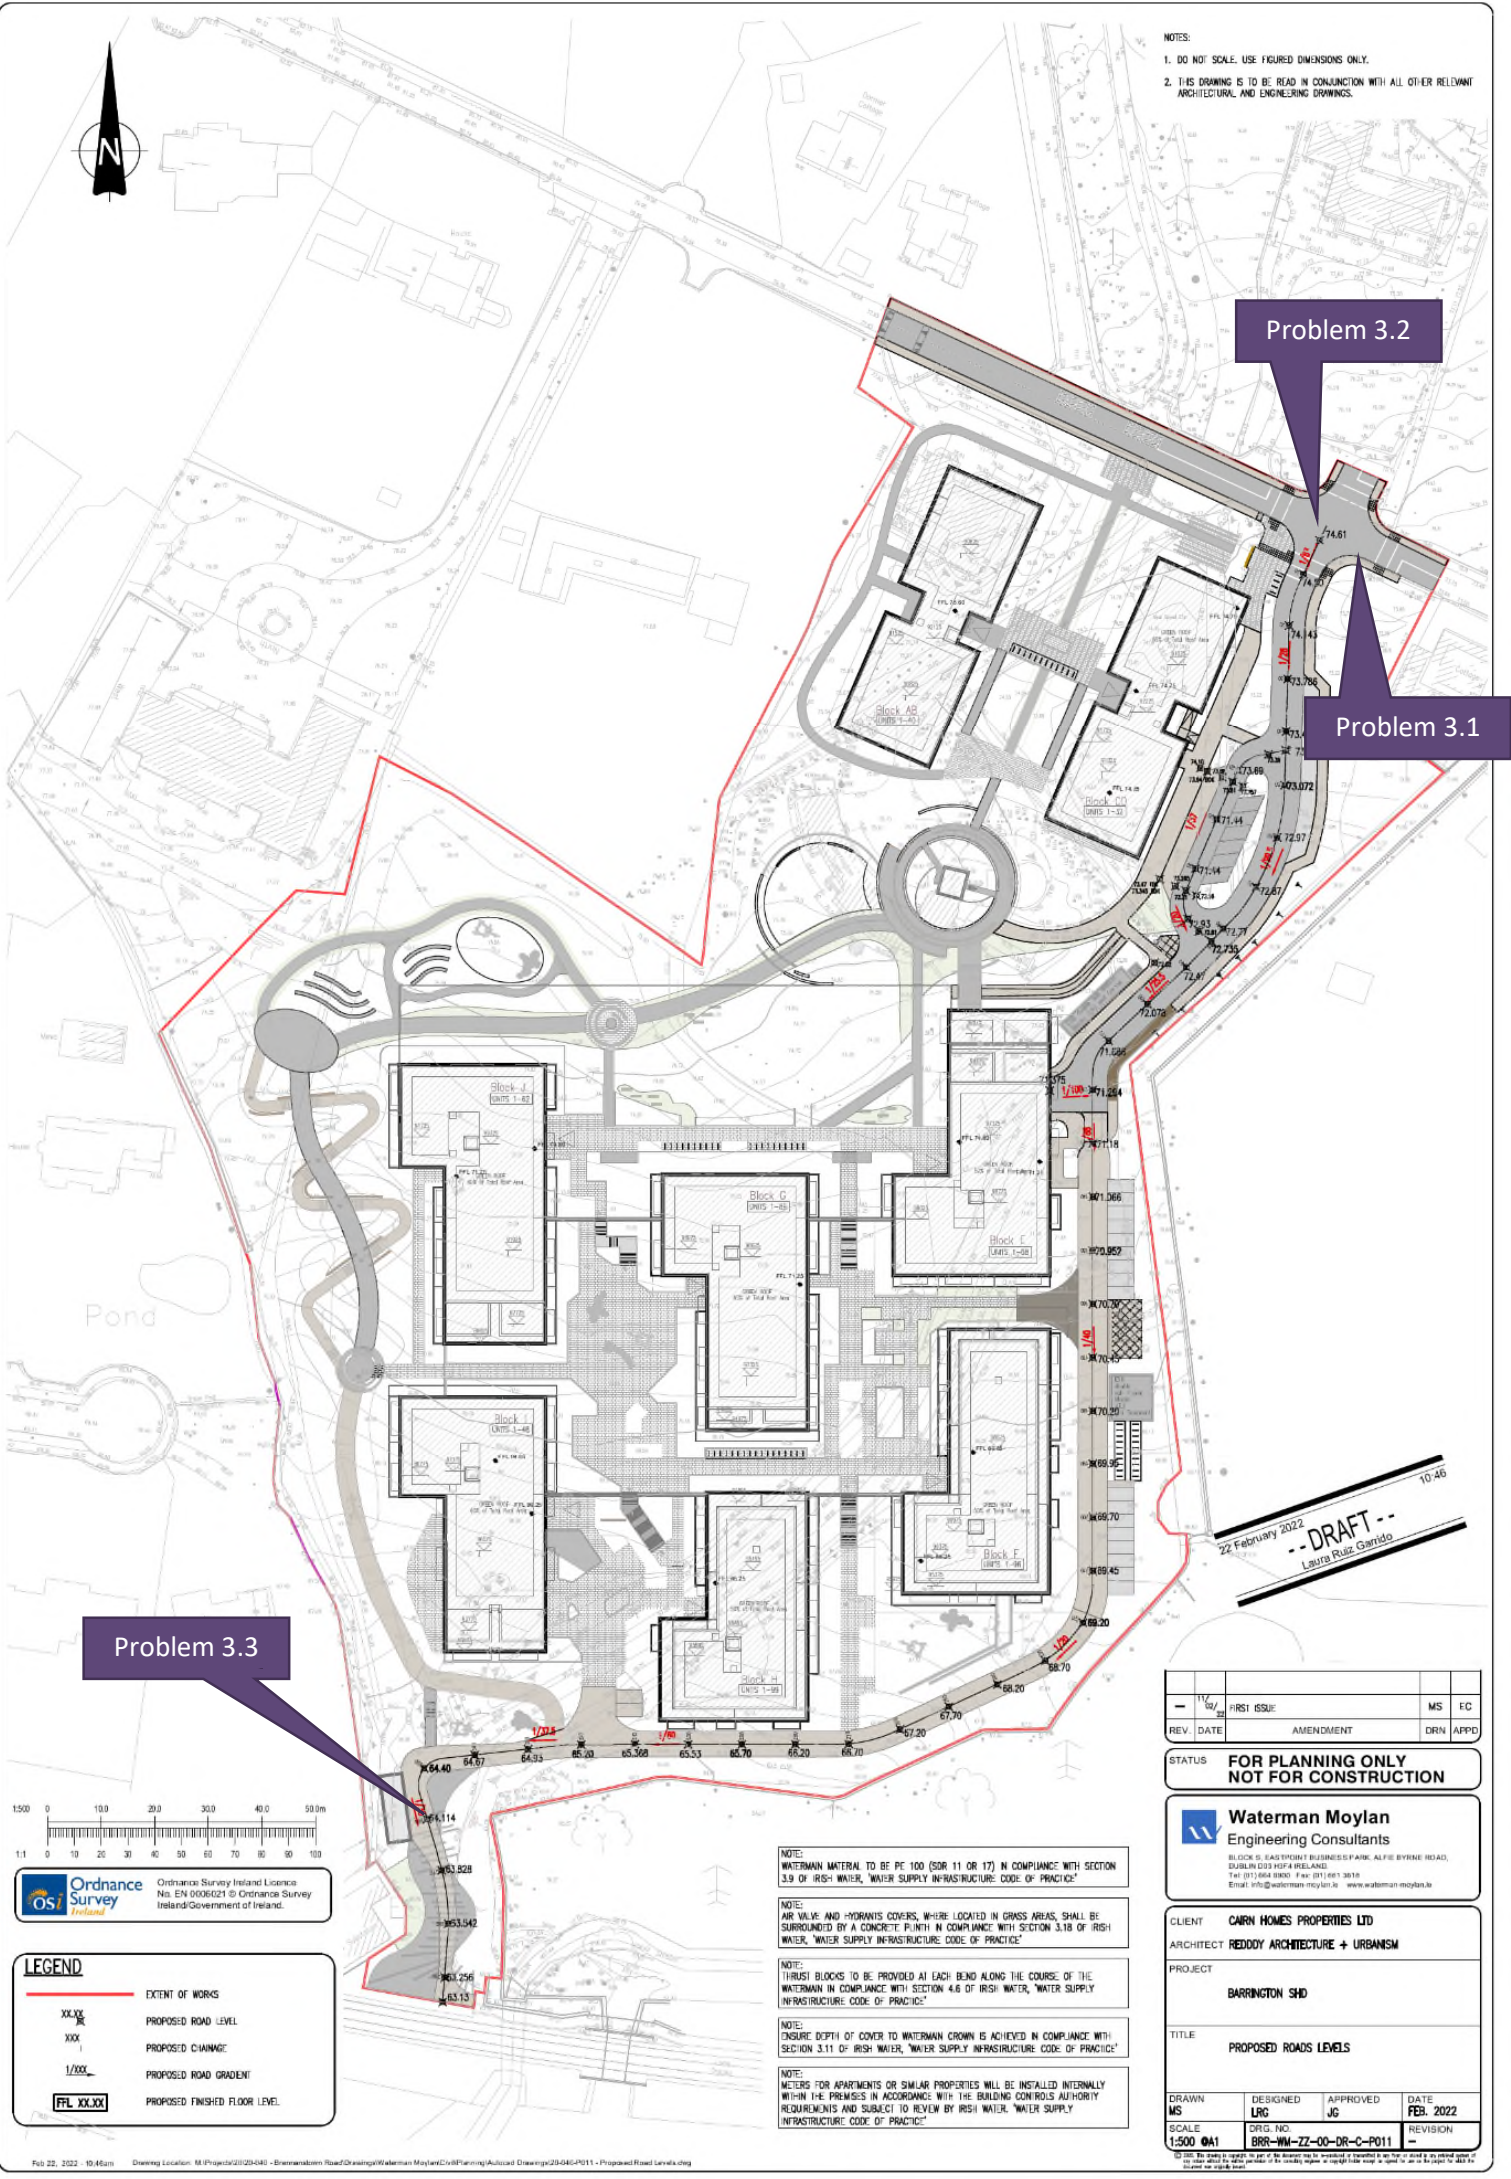
Problem Location Plan.

The swept path of a refuse vehicle is shown on the drawings. The junction will have to cater for large heavy goods vehicles during construction and future upgrades etc. albeit on an infrequent basis. There is a risk that such vehicles will not be able to turn at the junction and will mount the footpaths and possibly damage street furniture and put vulnerable road users at risk.

Brennanstown Road is a narrow road. It is unclear what the overall width of the carriageway will be when the works are complete. At present if two wide vehicles meet they pass using a passing bay type arrangement at private accesses. There is a risk that if two wide vehicles queue at the signals they will not be able to pass when they get the green signal. This could lead to mounting of the footpaths or reversing, both of which could put vulnerable road users at risk.

Ensure that the junction can cater for the turning of large goods vehicles.

Ensure that the carriageway width is sufficient at the junction to allow two wide vehicles pass.
