Tree Survey and Arboricultural Report
Trees at Proposed Site at
Barrington Tower
Brennanstown Road
Dublin 18

March 2022

The Tree File Ltd
Consulting Arborists
Ashgrove House
26 Foxrock Court
Dublin 18
D18 R2K1
086-3819011

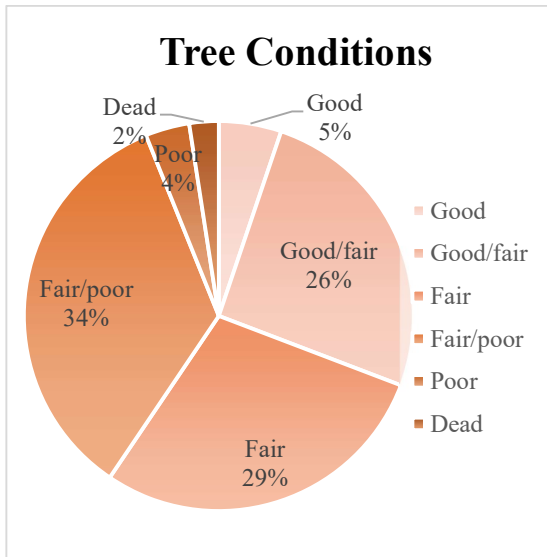
Fig 1

- 4.12 In analysing the surveyed tree population as illustrated in figs 1 to 5, we note a substantial proportion of trees appear to offer notable sustainability. This is well illustrated by the 60% of trees categorised as good, good-fair or fair in fig 1. This in part is borne out by the 39% of category B trees illustrated in fig 2. This information relates to the typically young age of the population, with 48% of trees being sapling, semi-mature or early-mature and a cumulative total of some 57% of trees offering either medium or long-term useful life expectancy.

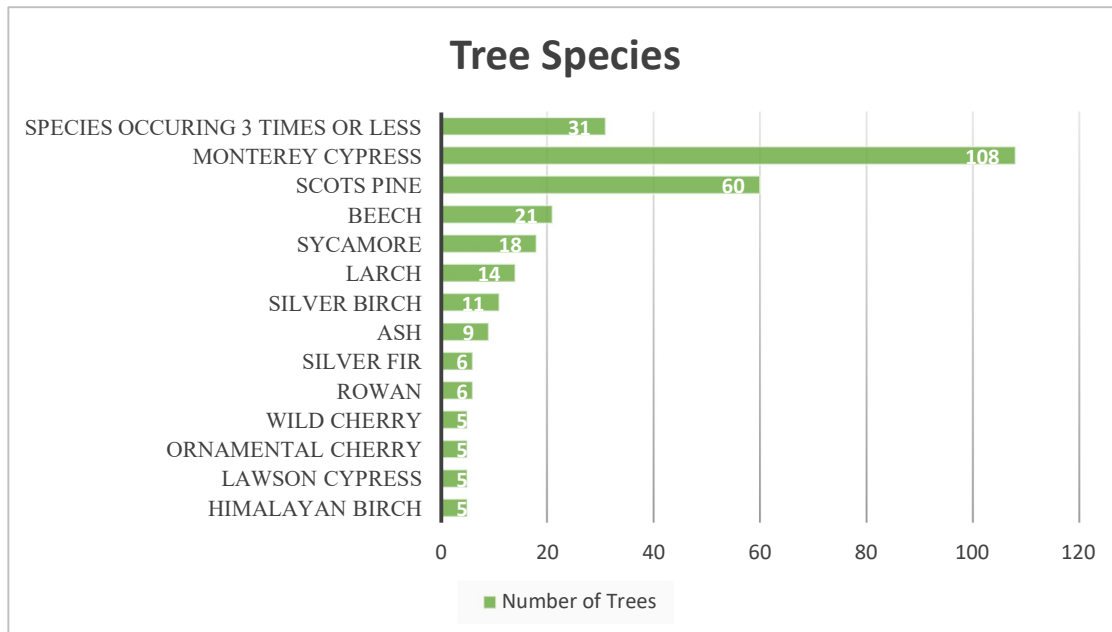
Fig 5

4.13 Review of fig 5 illustrates what is a highly artificial and planted tree population. Both numerically and visually, the site is dominated by conifers including Scots Pine, but particularly by Monterey Cypress. This means that species typical issues must be considered, including mechanical issues and high rates of failure commonly suffered by Monterey Cypress. Considering the number and size of these trees on the site, then issues of contextual compatibility and sustainability cannot be ignored.

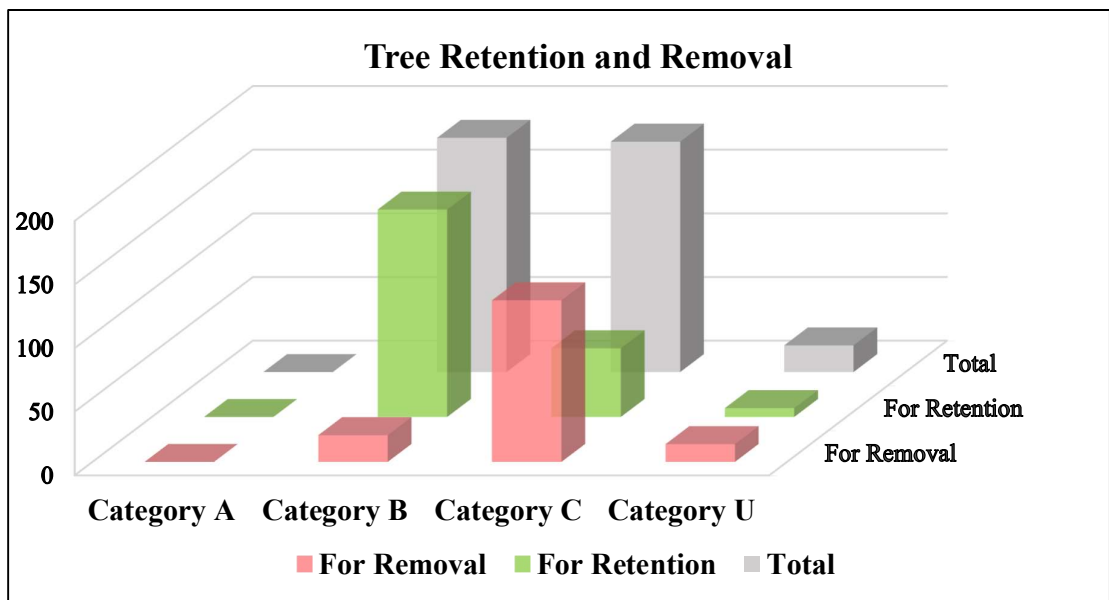
Fig 5 Graphic Representation of Tree Loss/Retention Scenario

- 12.2 While most poor-quality category “U” trees would be removed regardless of development, this development will require the removal of other quality trees as well. Note that not all category “U” trees will be removed, as some are positioned outside of the site’s jurisdiction. The trees for removal are identified by their survey numbers in the list below-
