Arboricultural Report

Tree Survey,
Arboricultural Impact Assessment &
Arboricultural Method Statement

Lands at Fosterstown North

200902-PD-11

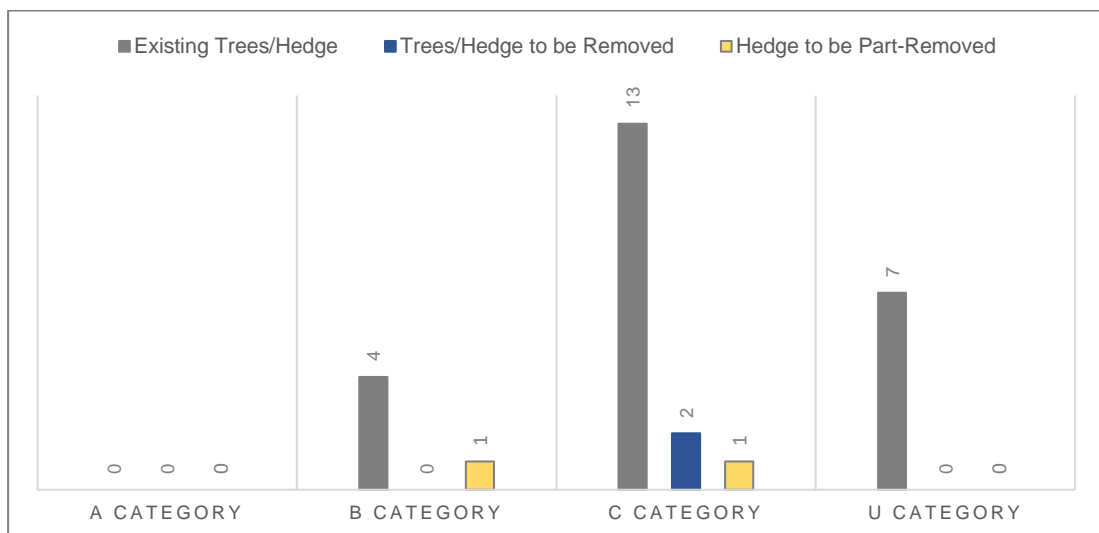
Figure 3: Breakdown of the tree and hedge removals required as part of the development.

- 6.1 **Loss of trees** – The proposed development will require the removal of two low quality (C Category) hedgerows (H1 & H24), the part removal of one low quality (C Category) hedgerow (H8), and the part removal of one moderate quality (B Category) hedgerow (H7).
- 6.2 The proposed removals are specified within the Tree Work Schedule at Appendix A and are highlighted on the Tree Works Plan at Appendix B. A breakdown of trees and groups to be removed / part removed according to their BS5837:2012 category is outlined in Figure 3.

- 6.3 Although of low quality and value, the proposed removal of the eastern boundary hedgerows (H1 & H24) will have an initial visual impact on the immediate surrounding area due to their prominent location. Their loss has been taken into consideration as part of the development design and sufficient space along the same boundary has been provided and new high-quality trees and hedgerows have been proposed to mitigate their loss.
- 6.4 Overall, the proposed development provides a good opportunity to improve the tree and hedge cover across the site and within the local area. Although some hedge removals are required, the extent of the new tree planting proposed will ensure that the local canopy cover and diversity of species are significantly enhanced. This
