Report on Current Condition, proposed repair  
and advice on conservation based alterations for re-use to

## The Walled Garden Walls and corner Bastions at Auburn House, Streamstown, Malahide, Co Dublin

Project 21549

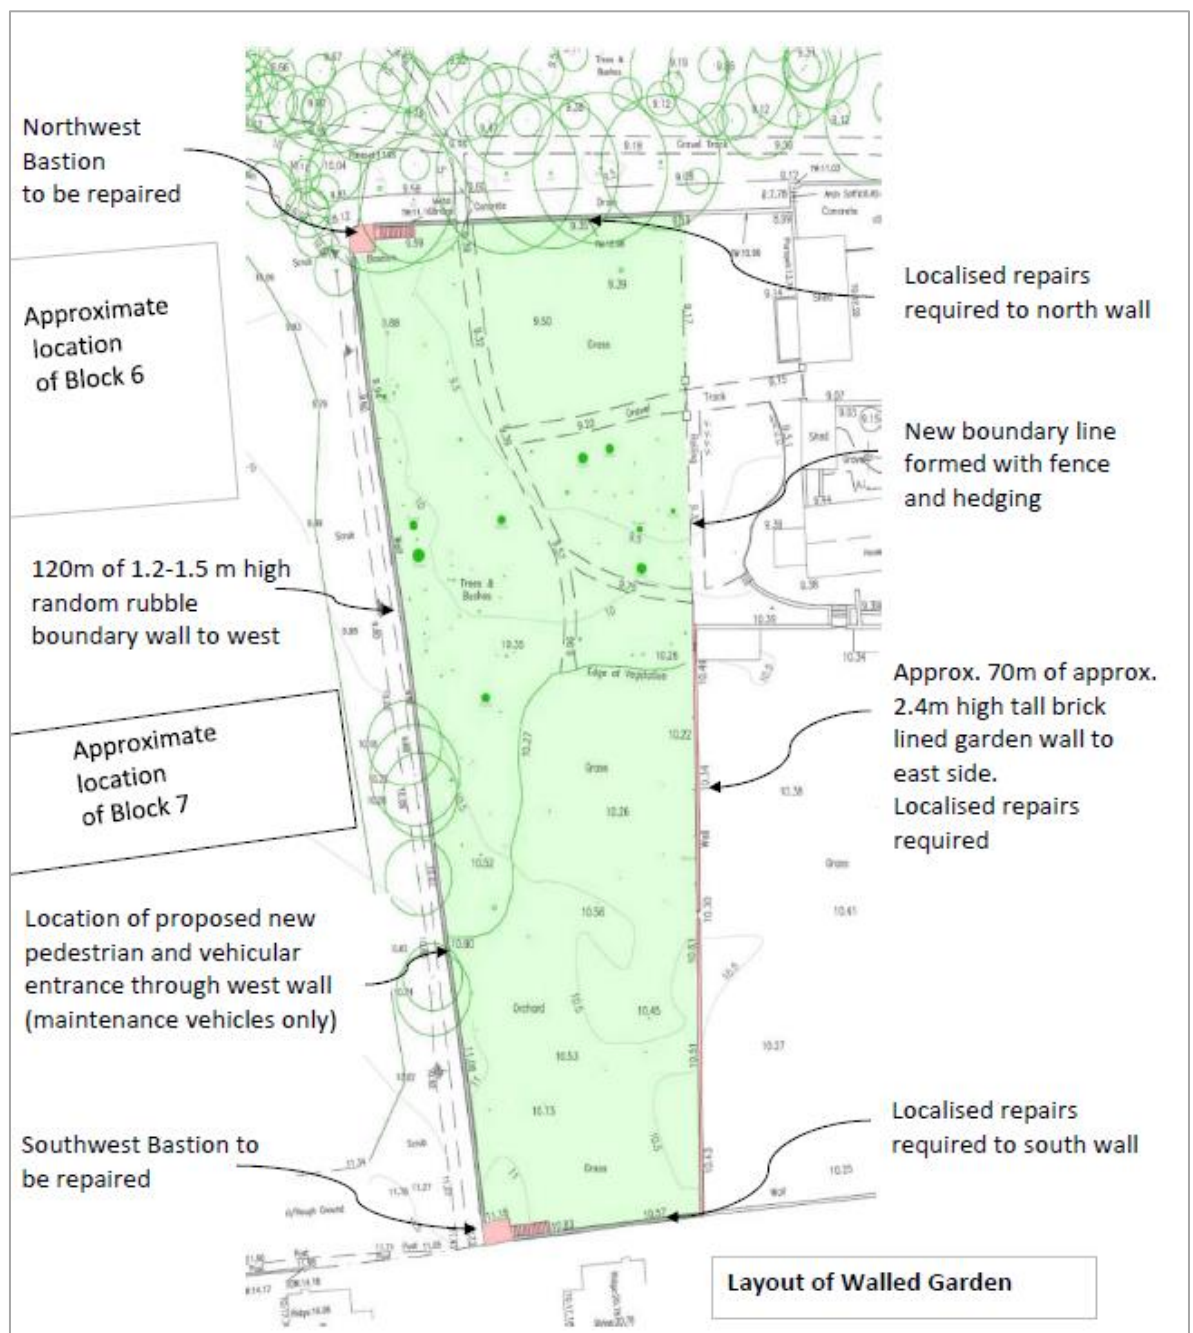
The walled garden is just over 120m long north to south and tapers in width from approx. 30m wide at the southern end to 44m wide at the northern end. It was originally L shaped in plan extending to the northeast but this area is not part of the current curtilage and is to be bounded by a new railing and hedging. Thus the proposed walled garden will be a tapered rectangle with interconnecting path from existing northern gate to proposed new western gate.

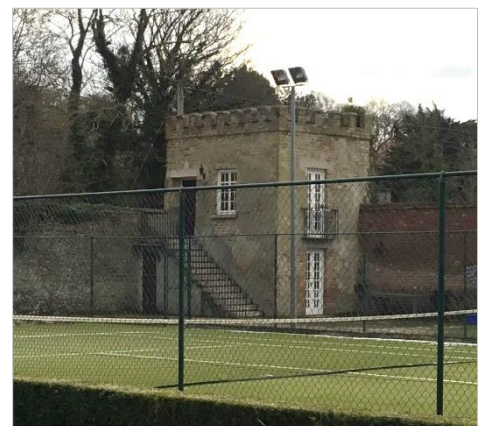
The brickwork has suffered degradation from plant growth and general neglect, the parapet walls are missing in places.

The granite steps are uneven and in places slipped and tilted backwards towards the structure.

It is thought that the original form of the westerly Bastions was more viewing platform rather than fully enclosed structures unlike the larger repaired Turret to the SE corner of the adjoining walled garden.

- Careful control and removal of vegetation
- Back propping as deemed necessary to arches for safety and to allow repair of arches
- Temporary removal of granite steps if deemed necessary to facilitate repair of arches under
- Repair of brick arch vaults using bricks to match set in new lime mortar as specification.
- Reseating of granite steps, including re-bedding / pointing to ensure falls down the steps and limit water penetration into brick vaults.
- Re-establishment of parapet detail to Architects drawings using materials to match existing, set in lime mortars.
- Security fencing / guarding to prevent unauthorised access to platforms.

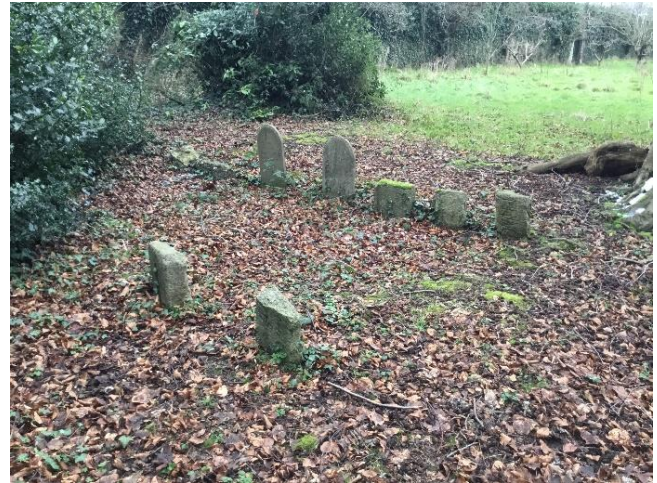
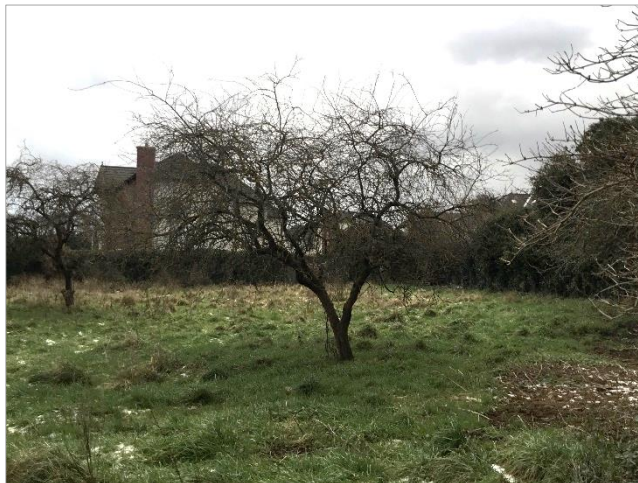
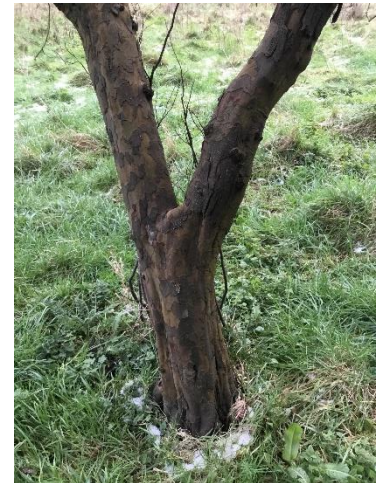
There is a Pet Cemetery approximately in the centre of the garden slightly to the east side.

There are also specimen trees.

There may be other features / plants of note that are discovered when ivy is removed.

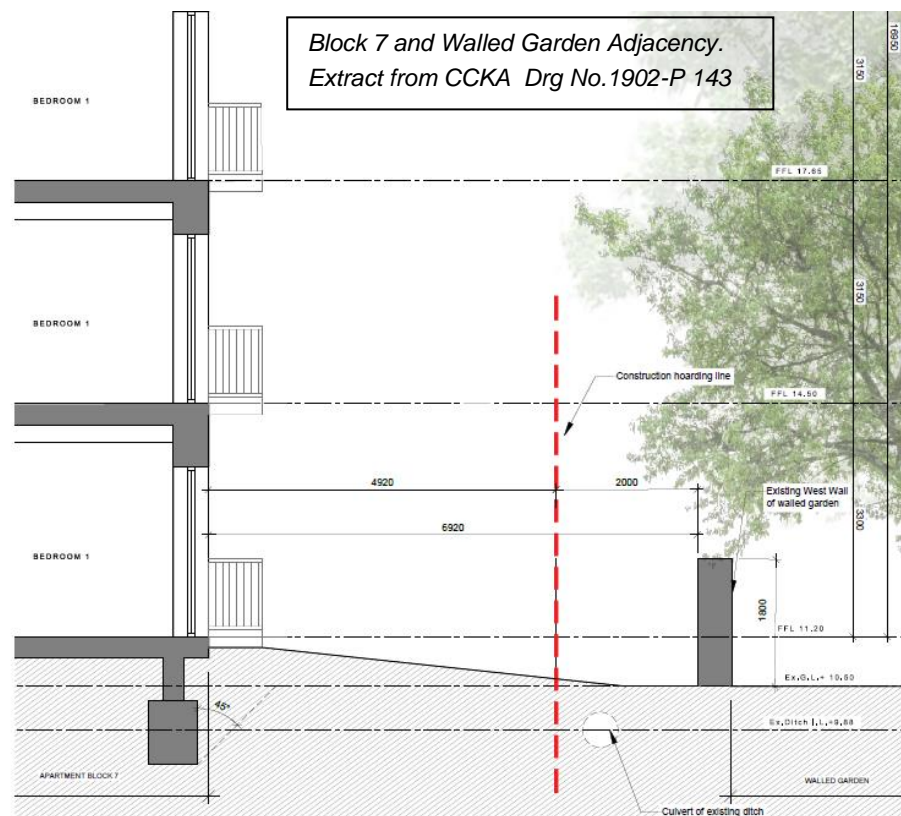
Block 7 is proposed in a location that is at least 6.9m from the Walled Garden Walls and has no basement

The Waterman Moylan Engineers Structural Report outlines the detail of the construction for block 7 and the sequence of works for the construction of the foundations for Block 7 will be as follows:

We believe this to be well considered methodology in close proximity to walls of this nature.

Repairs should be carried out to the Walled Garden Walls prior to the commencement of any groundworks in proximity.
