**Re: An Arboricultural Assessment on the Site Area for a Strategic Housing Development (SHD) at 'Mooretown Phase 3', Swords, Co. Dublin.**

## **An Arboricultural Assessment on the Site Area for a Strategic Housing Development (SHD) at 'Mooretown Phase 3', Swords, Co. Dublin.**

**Prepared for: Gerard Gannon Properties**

**Date: 6<sup>th</sup> April 2022**

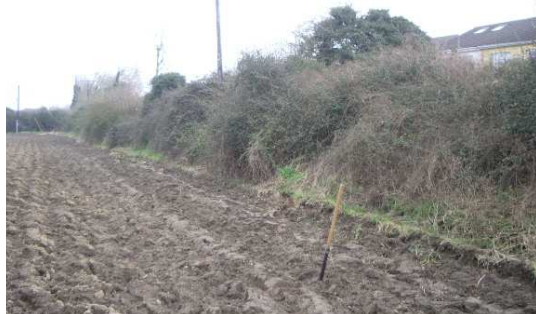
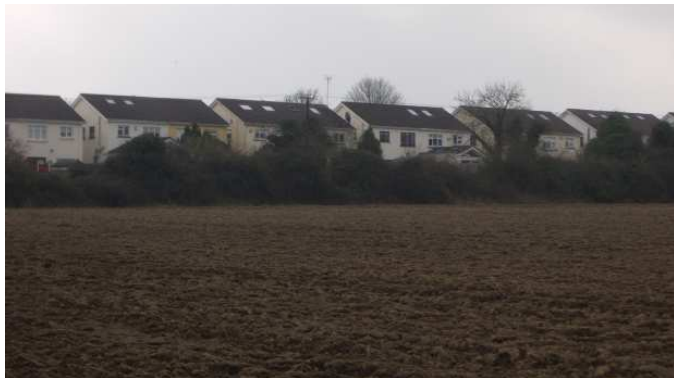
Tree No.	Tree Species	Ht. (m)	Stem Dia. (mm)	Branch Spread (m)				C-Ht. (m)	Age Class	Phys Con.	Structural Condition Other Comments	Preliminary Recommendation	Remaining years	Category Grade						
				N	S	E	W				N-North S-South E-East W-West Ht.- Height C- Crown Phy Con.- Physiological Condition	A- Average Dia.- Diameter Cat.- Category								
No. 7C	<i>Crataegus monogyna</i> <b>Bramble</b> <i>Rubus fruticosus</i> <b>Dogrose</b> <i>Rosa canina</i> <b>Elder</b> <i>Sambucus nigra</i> <b>Blackthorn</b> <i>Prunus spinosa</i> <b>Ash</b> <i>Fraxinus excelsior</i>	<b>of the houses.</b> It is of a mature age class in fair condition both physiologically and structurally. It consists of Hawthorn, Elder, Bramble, Dogrose and Blackthorn with some Ash trees forming part of the upper canopy formation. It is a broad, wide hedge line and is reasonably continuous in length. I suspect that there is vegetation growing from both sides of a deep drainage ditch. Due to the overhead ESB utility line running the full length of the hedge line, it has been cut down low in order to maintain clearance. The bulk of this hedge line would appear to be located on the field side (north side) of the old drainage ditch and a lot of the gardens have used this area to dump garden debris / rubbish and, in some places, have also removed sections of this hedge on their side of the drainage ditch. It has some value for screening along the boundary. <table><tr><th>Average Height</th><th>Average Width</th></tr><tr><td>5m</td><td>6m</td></tr></table> <div>
