Report on Current Condition and advice on conservation based repair to:

The Historic Landscape Features

Structures associated with the two Lakes – Inlet, Causeway and Weir; Bridge over Mayne; Rock House and Icehouse at Belcamp Hall, Malahide Road, Dublin D17

Project 1947 Document Issue Record:

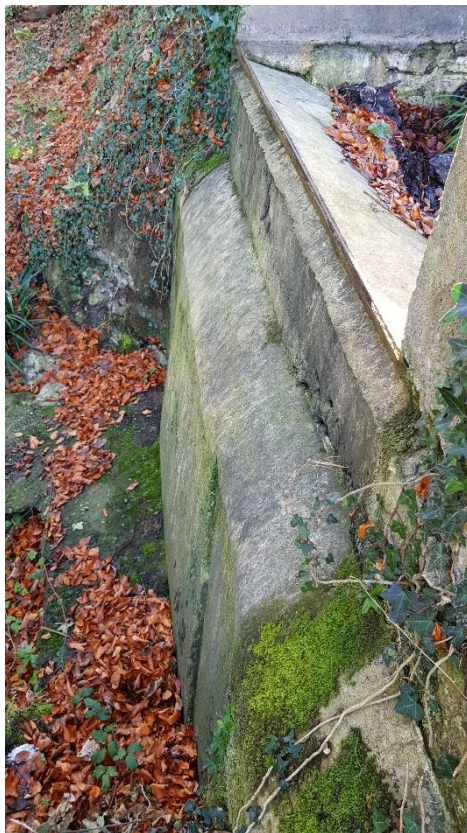
Weir to downstream (east) end of lakes

The most significant intervention will be the downstream hydro brake. Much discussion has occurred around this with a number of iterations being explored. The formulated proposal is to repair the downstream weir and then insert the new Hydrobrake within the lake upstream of, but not interfering with the original weir.

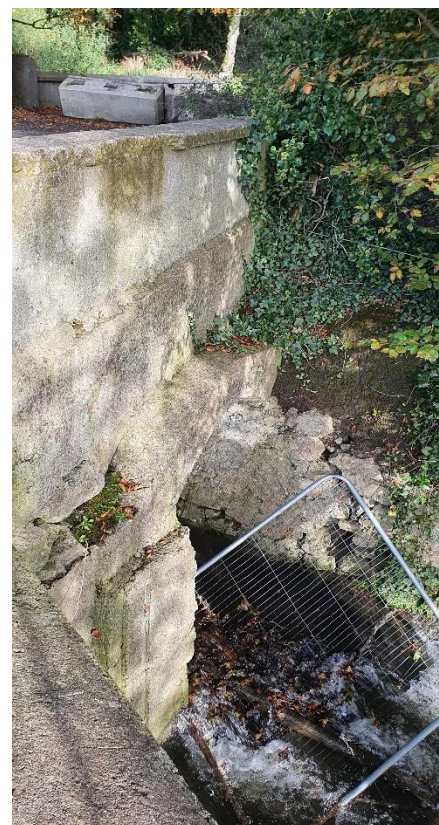
Bridge over river Mayne

The condition of the masonry is generally reasonable albeit the upstream abutments will require stabilisation and the instream debris needs to be removed to ensure unimpeded flows..

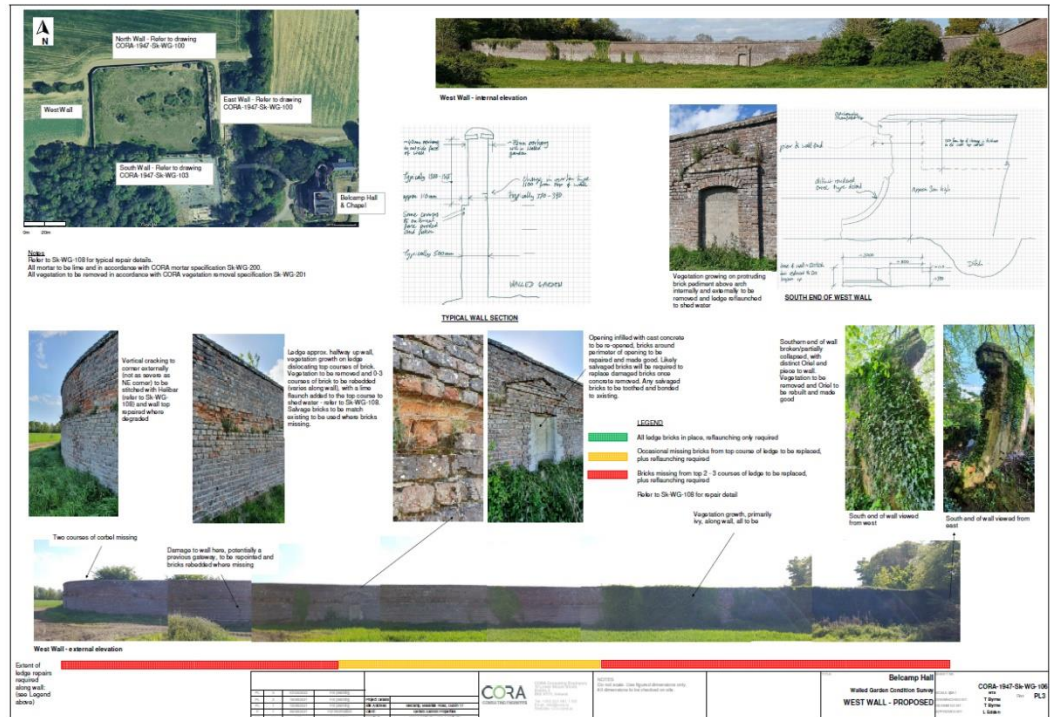
Sample Drawing of Walled Garden set – showing proposed repairs to the West Wall, Drg no. SK-WG-106-PL3

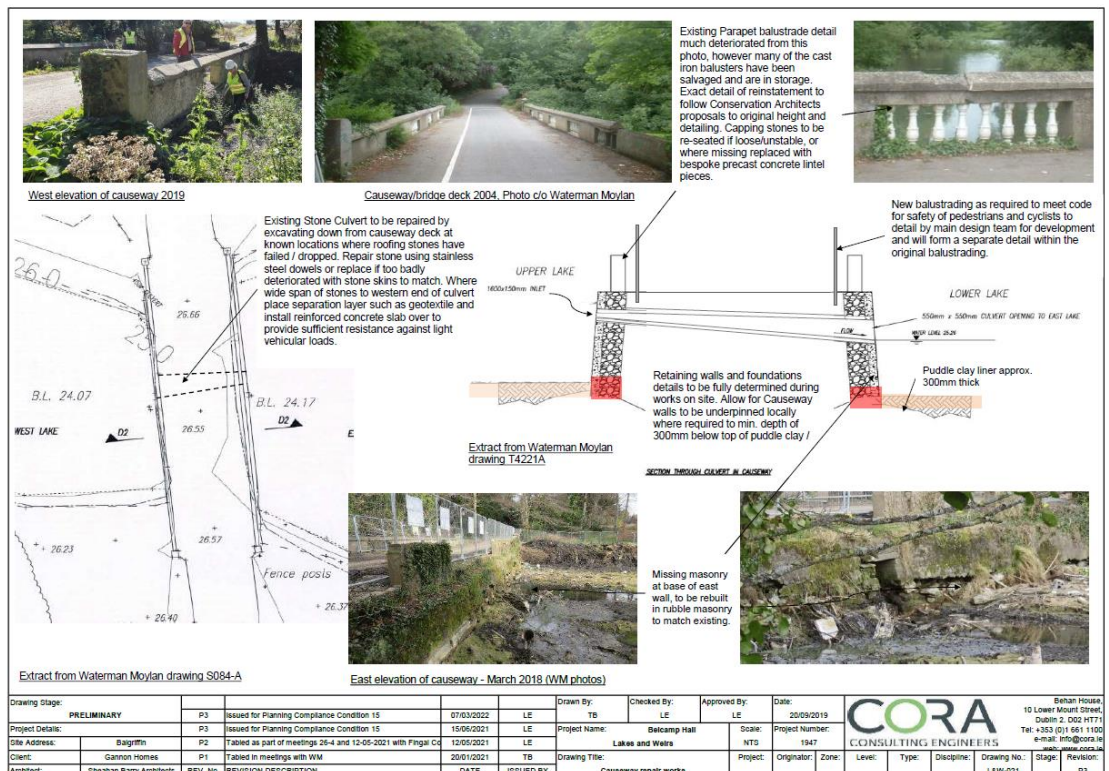
One of the proposed repair works drawings submitted for planning compliance F15A/0607. Including Location Drg 1947-L&W-015 and Repair works L&W 019 - 021

Repair the water features as outlined in CORA Consulting Engineers drawings formulated for planning compliance F15A/0609

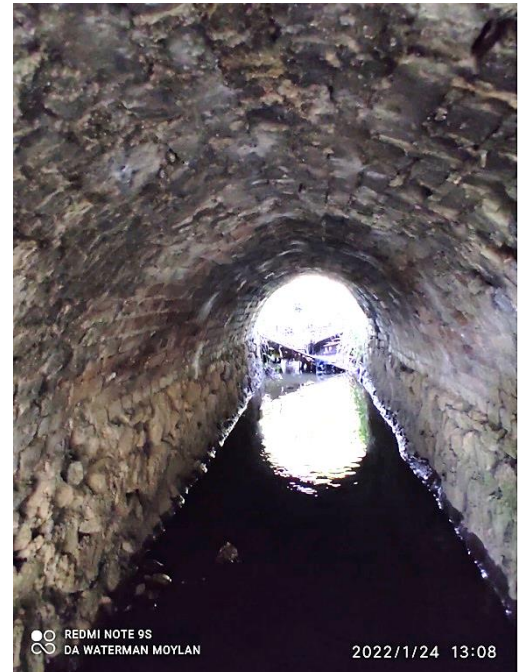
Later flatter, brick arch to upstream side in foreground. This later span is considered as inadequate for Vehicular loading.
