# Appendix I1

## Accessibility Audit Report

National Transport Authority  
**Belfield / Blackrock to City Centre  
Scheme**  
Accessibility Audit Report

Issue | 16 December 2021

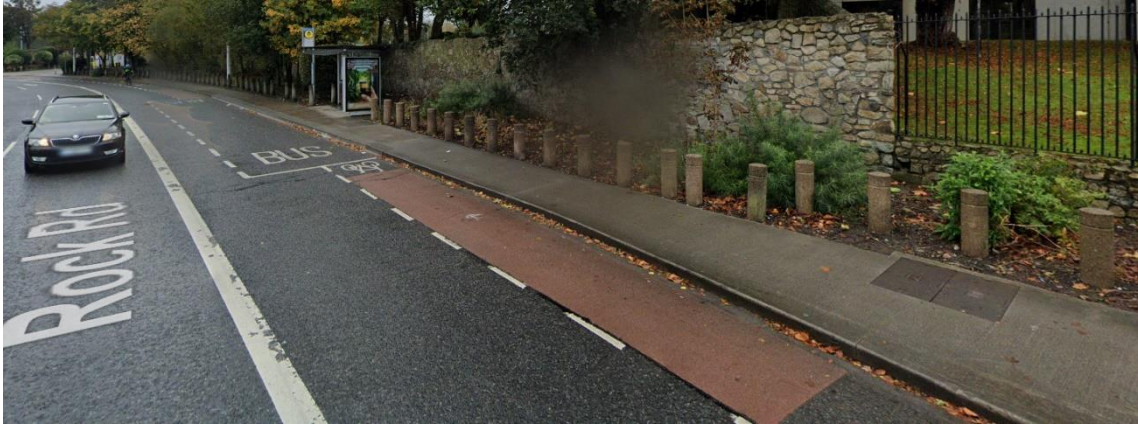
**Figure 13: Street Furniture - Rock Road**

Street furniture was considered to be relatively sparse along this section of the route. The use of bollards along Rock Road, south-east of Booterstown Avenue as shown in **Figure 13** is considered unnecessary but may act as a boundary between private and public lands.

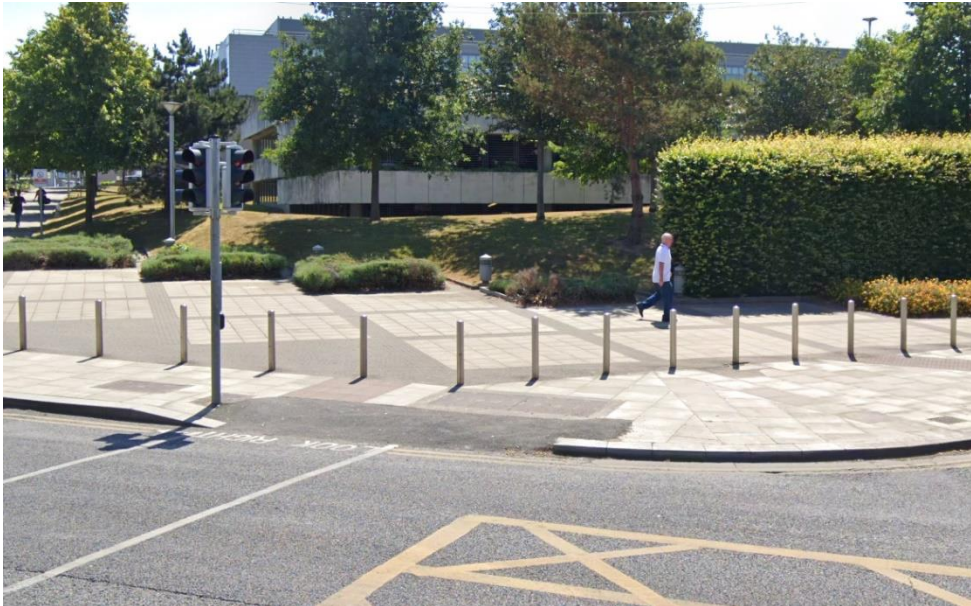
**Figure 20: Controlled Crossing - Merrion Road, Nutley Lane junction**

There are a total of 7 pedestrian crossings along this section of the route, all of which are controlled crossings, fitted with audible pushbutton units and tactile paving. Asphalt patch repair was noted on the tactile paving at the crossing on Merrion Road, near Nutley Lane as shown in **Figure 20**.

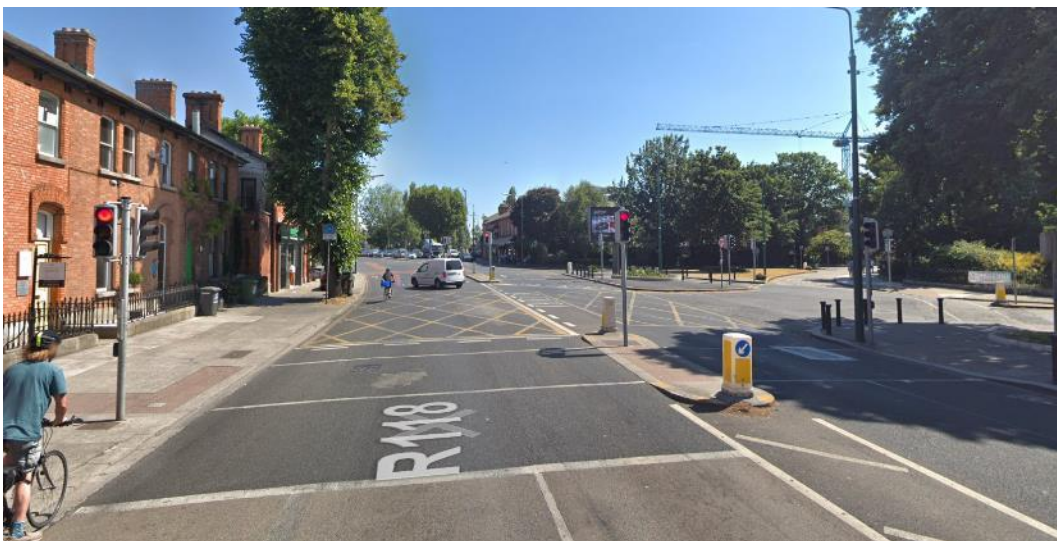
**Figure 32: Pedestrian Crossing Point with Pedestrian Island – Ballsbridge**

At some of the wider crossings along this section of the route, a pedestrian island is provided in the road median. All but three of these pedestrian islands did not have pedestrian guardrails and had limited space for safe waiting to cross the road. Refer to **Figure 32** to **Figure 36** for examples of pedestrian crossing points along Ballsbridge and Merrion Road.

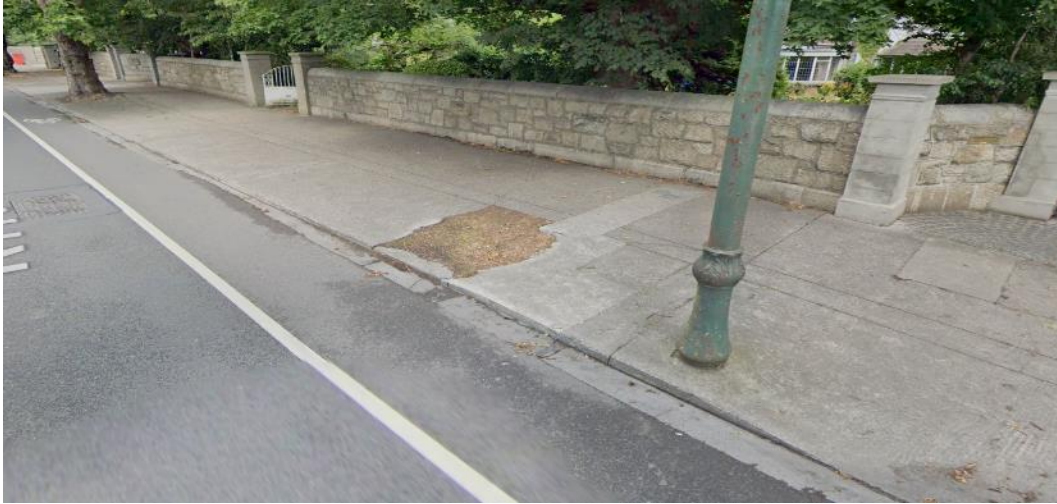
**Figure 43: Surface Material – Footpath along Merrion Road**

Asphalt and concrete have both been used as materials to make patch repairs along both footpaths. In some instance this has led to undulating, uneven surfaces caused by settlement of patch repair material. This is a hazard to pedestrians and cyclists alike. Damage to concrete kerbs and footpaths was also observed at locations where trees were positioned, and this was most likely due to the growth of the tree roots.

Refer to **Figure 42** to **Figure 45** for examples of damaged footpaths and poor-quality surface material.

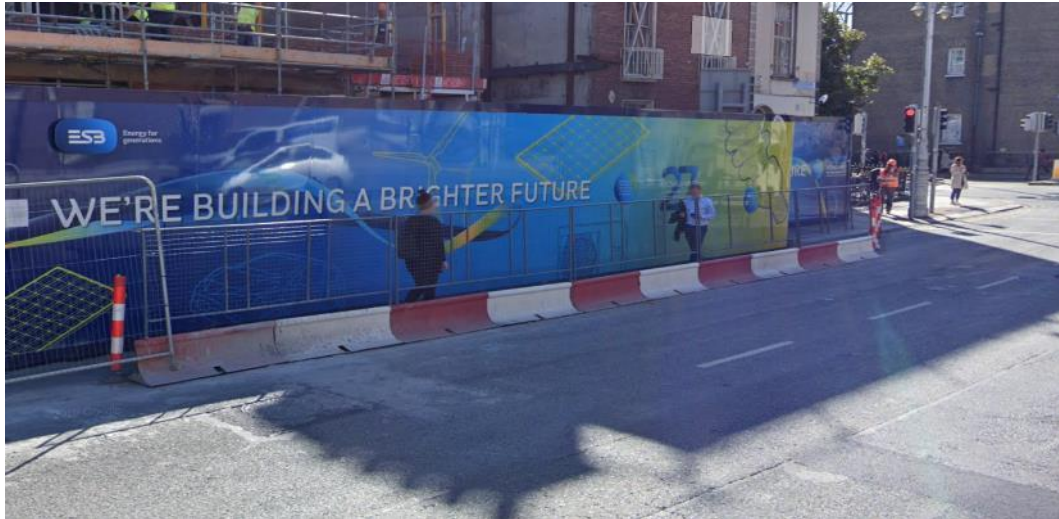
**Figure 55: Temporary Footpath – Fitzwilliam Street Lower**

Along Fitzwilliam Street Lower, the footpath width ranges from 2m to 2.5m. The footpath width along the western side of this street provides adequate space for disabled users. Construction works along the eastern side of this street mean that a temporary, constrained footpath of only 2m width is currently in place. Refer to **Figure 55**.

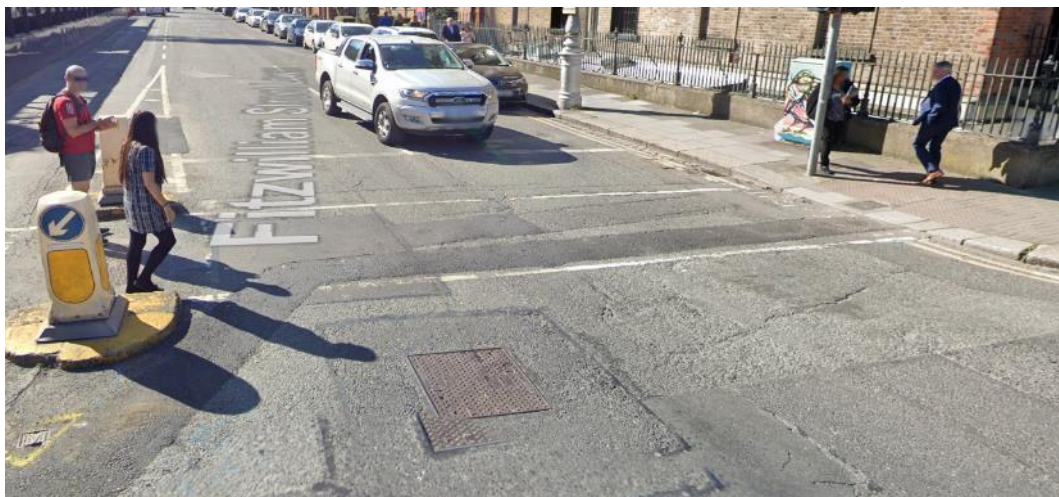
**Figure 61: Pedestrian Crossing Point with Pedestrian Island – Fitzwilliam Street Lower**

At some of the wider crossings along this section, a pedestrian island is provided in the road's median. All but two of these pedestrian islands had no pedestrian guardrails and had limited space for safe waiting to cross the road. Refer to **Figure 61** to **Figure 65** for examples of pedestrian crossing points along Fitzwilliam Street Lower, Baggot Street Lower, Baggot Street Upper and Pembroke Road.

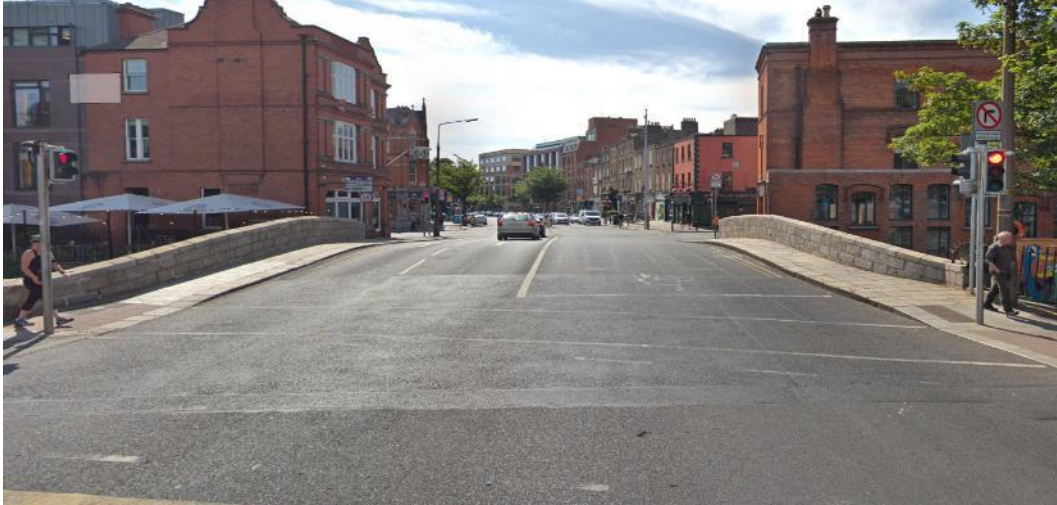
**Figure 69: Level Change – MacCartney Bridge (Baggot Street Bridge)**

However, the MacCartney Bridge (Baggot Street Bridge), where Baggot Street Lower meets Baggot Street Upper, represents a noticeable incline.

Refer to **Figure 69**. The gradient of the slope of this bridge is approximately 1:19 at its steepest point, on the eastern side of the bridge, adjacent to Baggot Street Upper. As per Technical Guidance Document M of The Building Regulations 2010<sup>1</sup>, a slope with a gradient of 1:20 or steeper is considered to be a ramp.

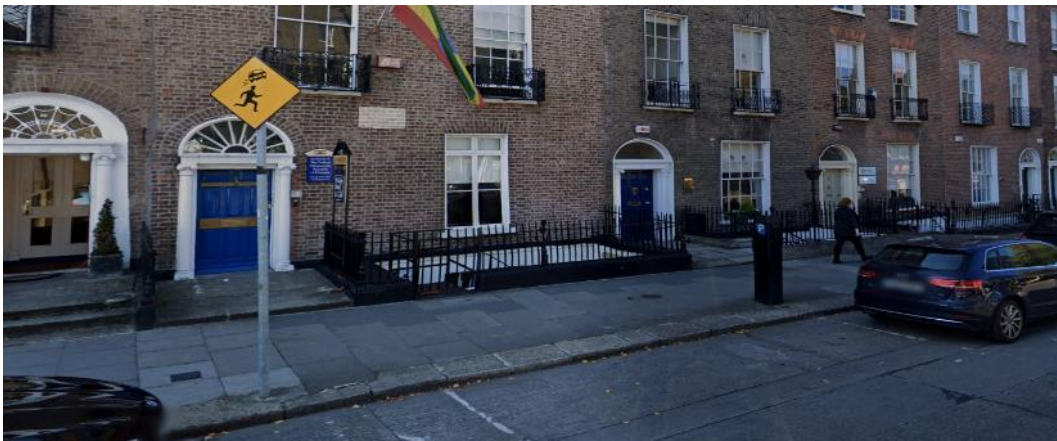
**Figure 74: Street Furniture – Baggot Street Lower**

Street furniture is present at varying densities throughout the length of this section of the route. Street furniture observed included traffic signage and signalling poles, bollards, refuse bins, post office boxes, telephone boxes, bus stops, cycle stands, ‘pay and display’ parking kiosks, electrical kiosks and advertisement boards. The street furniture observed was in most cases located towards the edge of the footpath. Examples of the street furniture observed are presented in **Figure 73** to **Figure 78**.

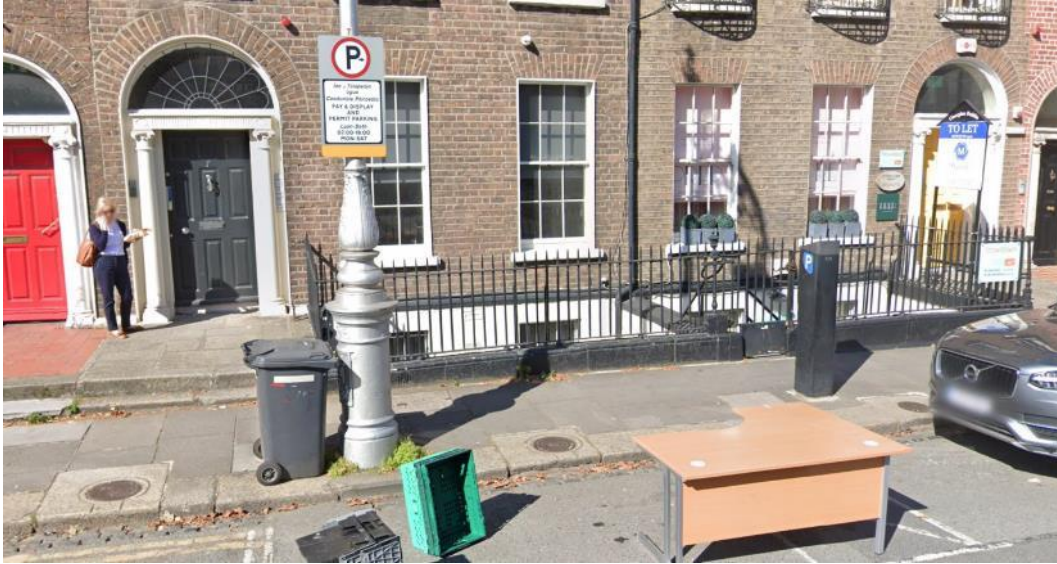
**Figure 79: Street Furniture – Fitzwilliam Street Lower**

In some instances, street furniture did not appear at the edge of the footpath. An example is presented in **Figure 79**, below, where a ‘pay and display’ parking kiosk is positioned almost centrally on the footpath of Fitzwilliam Street Lower. This greatly reduces the effective width of the footpath, making passage difficult for the mobility impaired.

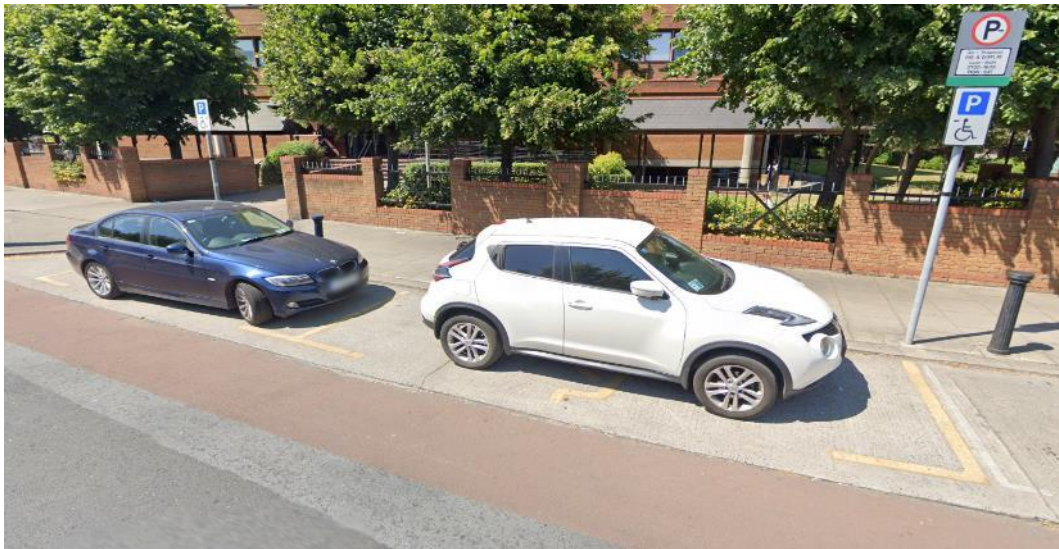
**Figure 82: Disabled Parking Spaces – Nutley Lane**

Along this section of the route, 4 no. on-street disabled parking facilities have been identified on Nutley Lane. Refer to **Figure 82** and **Figure 83**.

These parking spaces are approximately 5m in length and 2m in width. The parking spaces are located in ‘pay and display’ areas and provide access to nearby retail and commercial outlets.

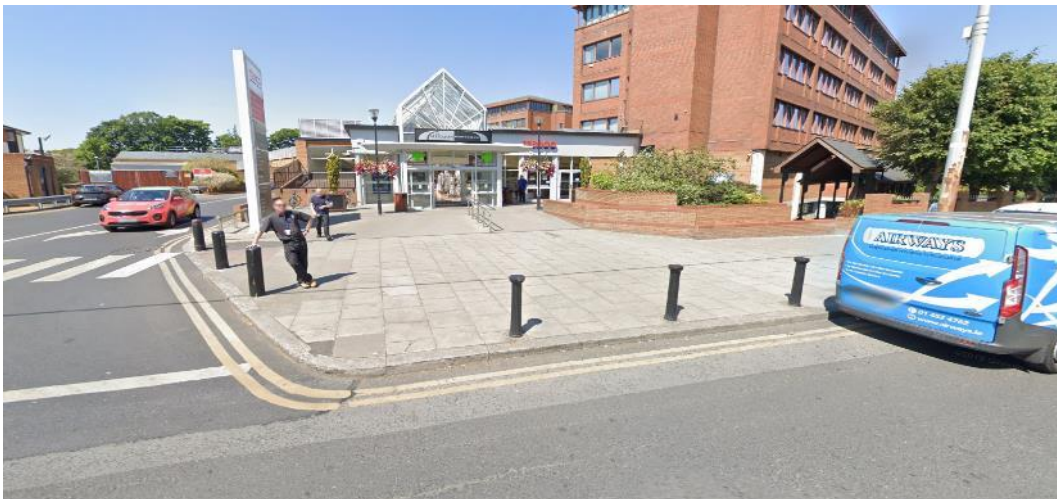
**Figure 84: Wide Footpath – Nutley Lane (entrance to Merrion Shopping Centre)**

Existing footpaths along this section of the route vary depending on the location. They range from 3.25m close to the Stillorgan Road (R138) to 8.5m directly outside the Merrion Shopping Centre (refer to **Figure 84**).

The footpath widths along both sides of the street on this section of the route provide adequate space for disabled users.

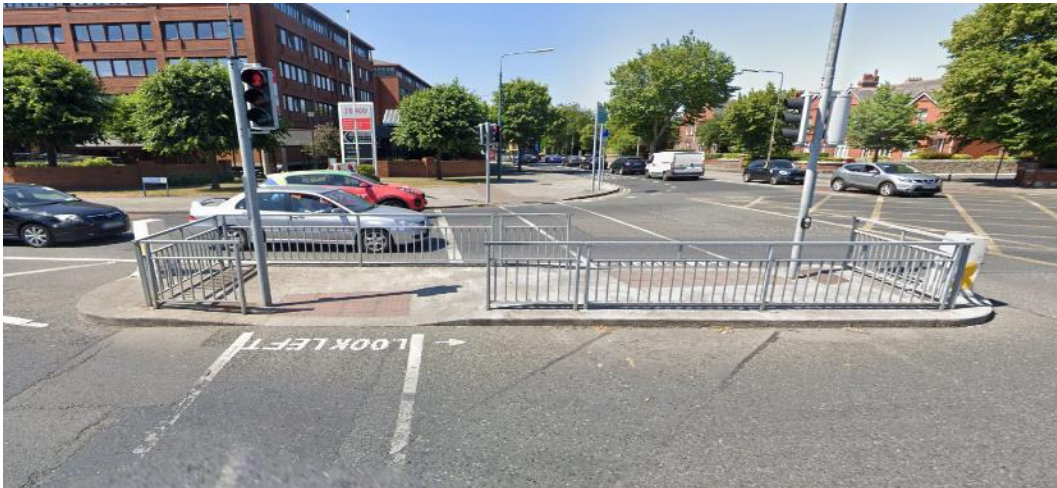
**Figure 85: Guardrails – Nutley Lane**

Pedestrian Guardrails have been observed along this section of the route. 1 no. guardrail was observed at the junction of Nutley Lane and Merrion Road. Refer to **Figure 85**. This guardrail is located at the island of a pedestrian crossing. The width of the footpath in this location is sufficient to accommodate disabled users, even with the reduced effective width caused by the pedestrian guardrails.

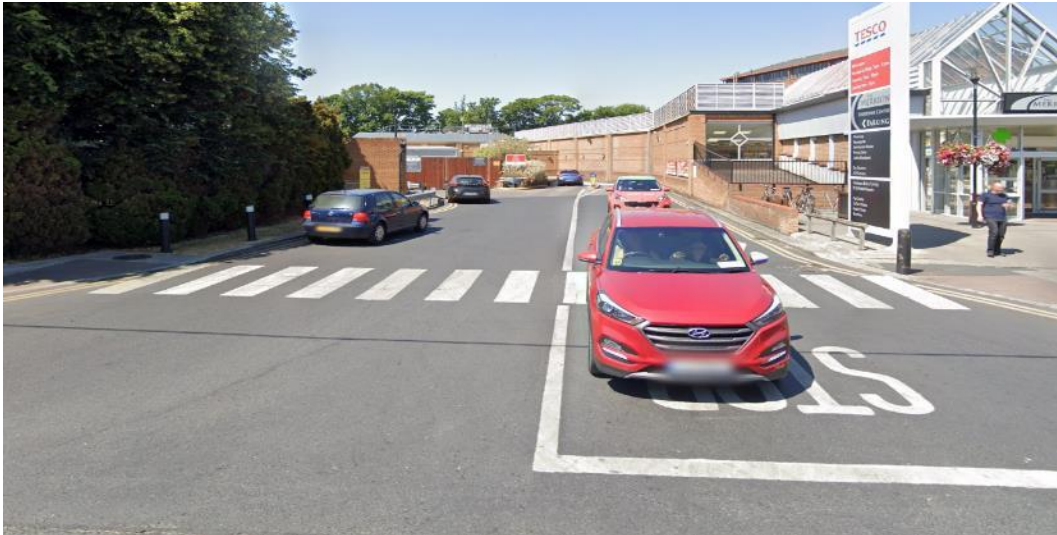
**Figure 86: Pedestrian Crossing Point – Nutley Lane**

At some of the wider crossings along this section, a pedestrian island is provided in the road's median. All but one of these pedestrian islands did not have pedestrian guardrails and had limited space for safe waiting to cross the road. Refer to **Figure 86** to **Figure 88** for examples of pedestrian crossing points along Nutley Lane.

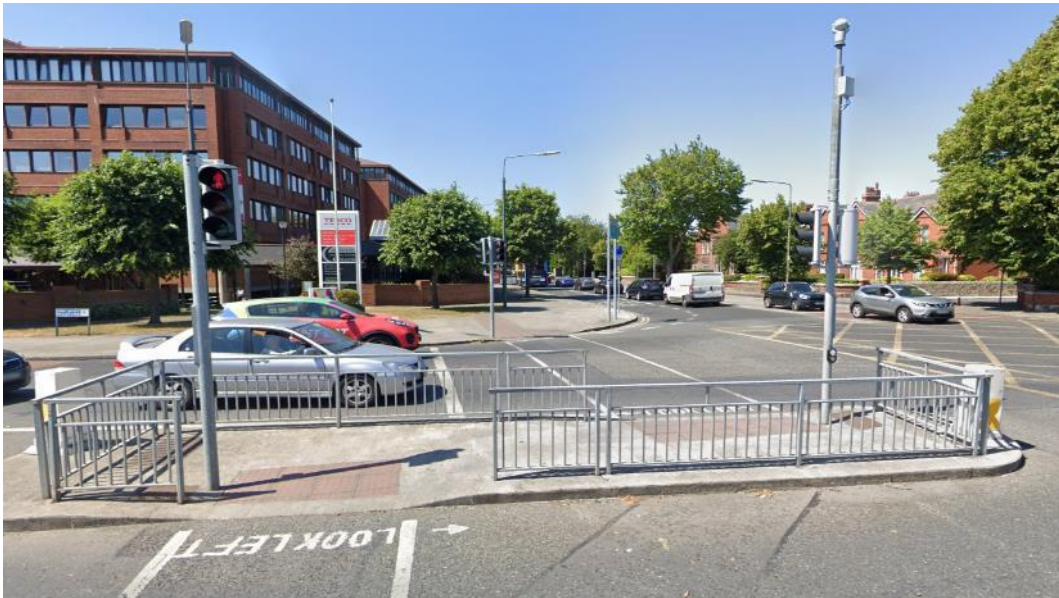
**Figure 90: Tactile Paving Surface at Pedestrian Island – Nutley Lane**

All controlled crossings feature tactile paving surfaces on both footpaths. The pedestrian island at the junction of Nutley Lane and Merrion Road also features tactile paving. Refer to **Figure 90**.

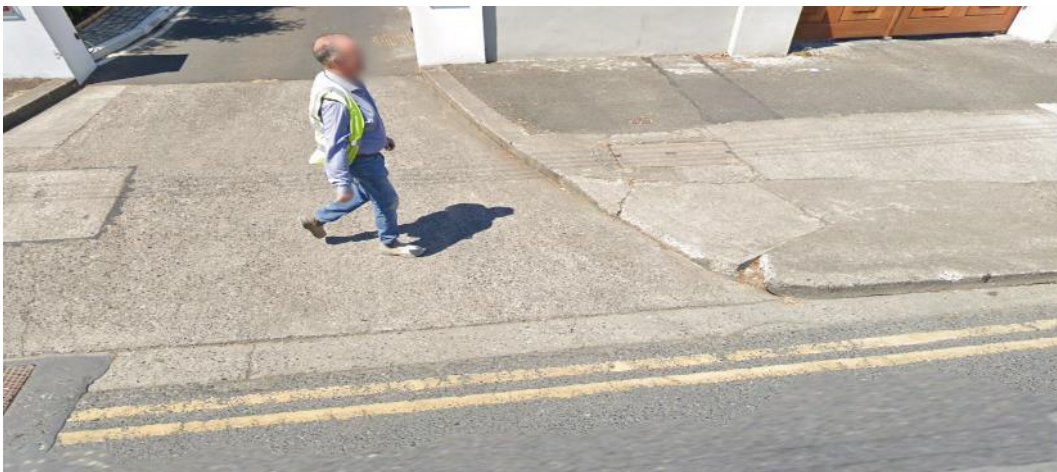
**Figure 92: Surface Material – Nutley Lane**

Asphalt and concrete have both been used as materials to make patch repairs along footpaths. In some instance this has led to undulating, uneven surfaces caused by settlement of patch repair material. This is a hazard to pedestrians and cyclists alike.

Refer to **Figure 91** to **Figure 93** for examples of damaged footpaths and poor quality surface material.

Footpath materials should be selected to ensure surfaces are free of undulations, with no trip hazards where there is a transition between surface materials – or where the Proposed Scheme ties into the existing infrastructure.

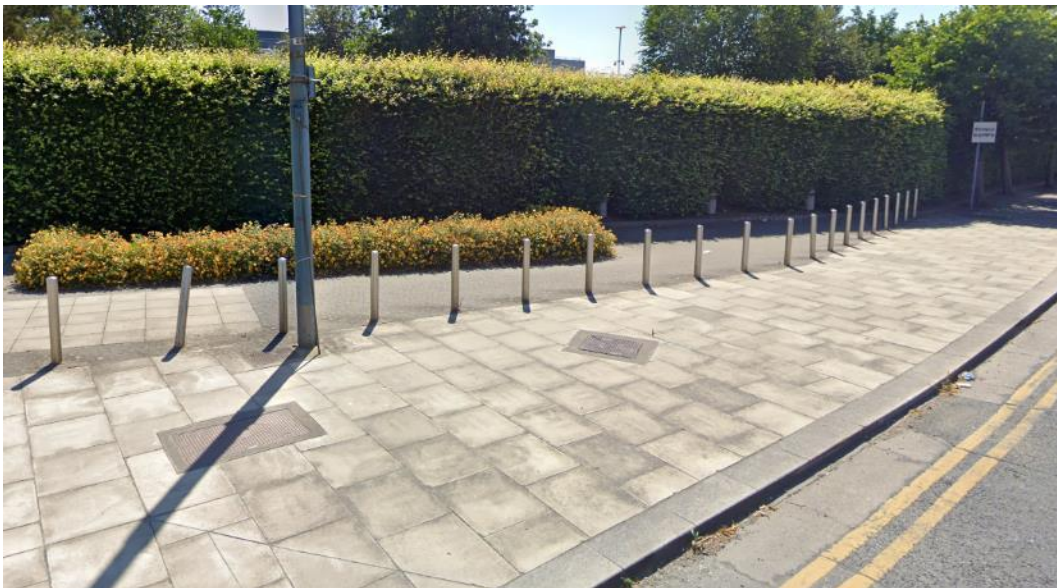
**Figure 94: Street Furniture – Nutley Lane**

Street furniture is present at varying densities throughout the length of this section of the route. Street furniture observed included traffic signage and signalling poles, bollards, refuse bins, post office boxes, bus stops, cycle stands, ‘pay and display’ parking kiosks and electrical kiosks. The street furniture observed was in most cases located towards the edge of the footpath. Examples of the street furniture observed are presented in **Figure 94** to **Figure 96**.

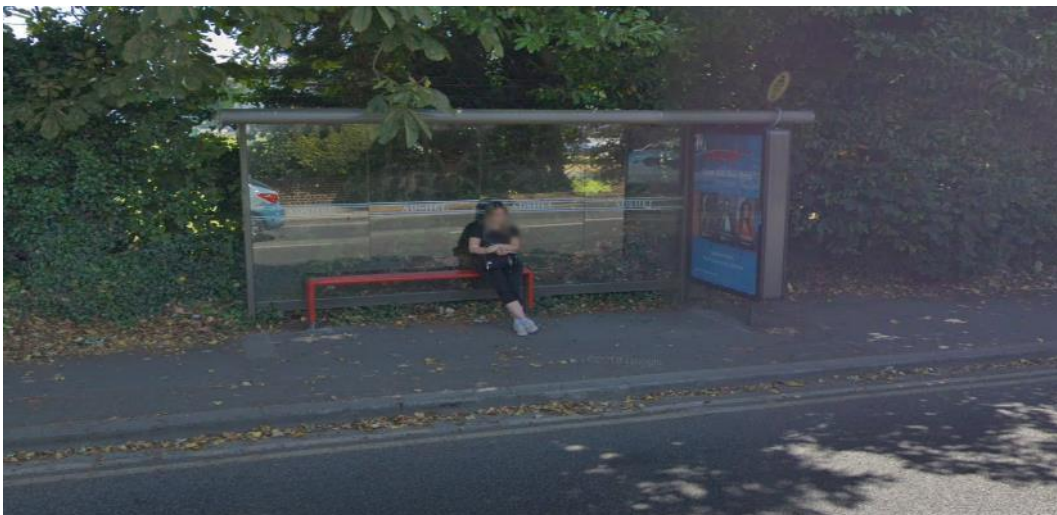
**Figure 97: Street Furniture – Nutley Lane**

Additionally, some of the bus stops located along this section result in a reduced effective width of the footpath, making passage difficult for the mobility impaired. Refer to **Figure 97** for an example.
