An Arboricultural Assessment of the Tree and Hedge Vegetation on 'SHD Lands' at Ratoath South, Co. Meath.

Prepared for: Beo Properties Ltd.

Prepared by: Felim Sheridan F. Arbor. A, RFS Dip, Nat. Dip & NCH in
Arboriculture

Date: 20th April 2022

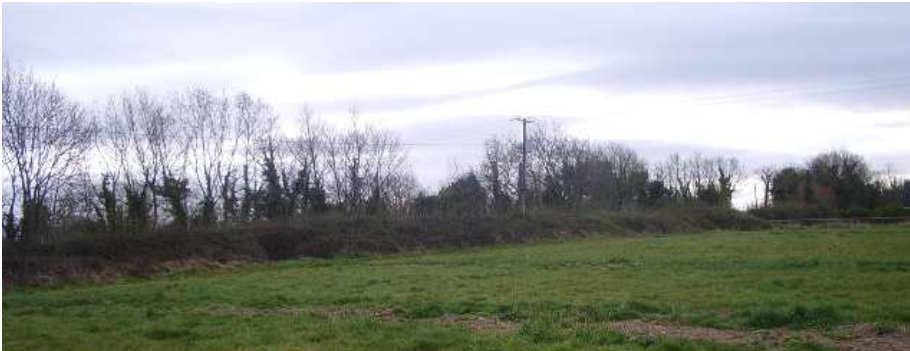
Hedge No. 11	Hawthorn <i>Crataegus monogyna</i> Elder <i>Sambucus nigra</i> Ash <i>Fraxinus excelsior</i> Sycamore <i>Acer pseudoplatanus</i> Bramble <i>Rubus fruticosus</i> Dog Rose <i>Rosa canina</i>							<p>It runs at ninety degrees to Hedge No. 10 and extends in a north-south direction along the east boundary of the site area and is bordering with the lane.</p> <p>It is of a mature age class and in fair condition both physiologically and structurally. It is located on the field side (west side) of a deep drainage ditch cordoning if off from the laneway. The main hedge species consist of Hawthorn, Elder, Ash and Sycamore.</p> <p>It has been cut, clipped and maintained from the lane way which has helped to maintain a good structured hedge. It has been allowed to grow more unmanaged on the field side with scrub species, in particular Bramble encroaching out onto the lands with Ivy dominating some of the hedge plants.</p>	<p>Continue present maintenance.</p> <p>Trim on the field side to contain its width and structure.</p>	-	C2

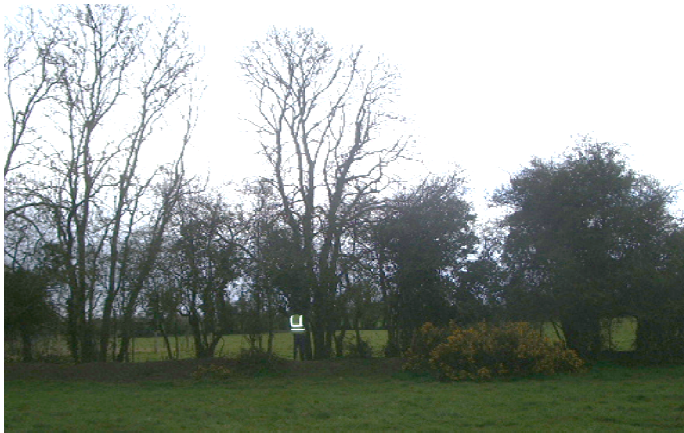
Hedge No. 15	Hawthorn <i>Crataegus monogyna</i> Gorse <i>Ulex europaeus</i> Elder <i>Sambucus nigra</i> Privet <i>Ligustrum sp.</i> Bramble <i>Rubus fruticosus</i> Dogrose <i>Rosa canina</i>	<p>It runs in a north-south direction and forms the boundary between the two fields.</p> <p>The main hedge line is located on the west side of a deep wet drainage ditch with some vegetation located on the east side. It consists of predominately Hawthorn with Gorse, Elder, Privet, Bramble and Dogrose dominating some sections. The lower vegetation has been impacted upon and is being grazed off by the livestock sheltering/ grazing within this area. The hedge plants have been allowed to grow up tall with some sections being suppressed by Ivy.</p>

<p>Make safe large size dead/ unstable growth.</p> <p>Cut Ivy at ground level where it is heavy and trim in all encroaching hedge species.</p>	-	C2

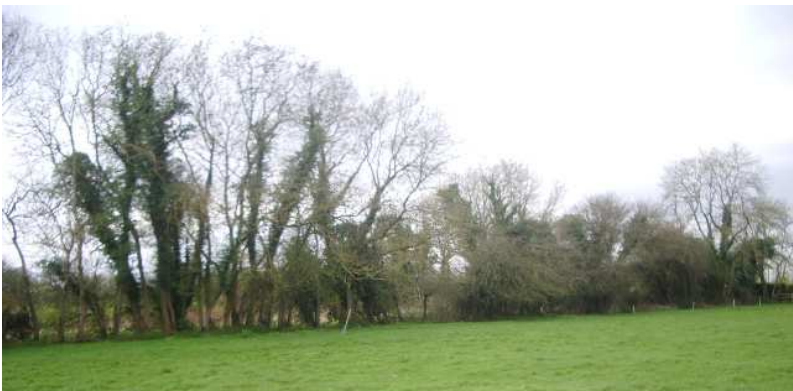
Tree No.	Tree Species	Ht. (m)	Stem Dia. (mm)	Branch Spread (m)	C-Ht. (m)	Age Class	Phys. Con.	Structural Condition Other Comments	Preliminary Recommendation	Remain Contribute in years	Cat. Grade
								N-north S-south E-east W- west Phys.-physiological.	A- average		
The following trees form part of this hedge.											
Tree No. 3	Ash <i>Fraxinus excelsior</i>	15	460	N4 S6 E4 W5	4	Mature	Fair	Fair It is located on the east side of the hedge, on the adjoining landside of the drainage ditch. Multiple-stemmed from base with a lot of soil erosion and compaction being caused around its base by the livestock sheltering/ grazing within this area. Its crown is showing some signs of reduced vigour throughout. There is Ivy cover on the main trunk.	Requires no work at the present time.	10-20	C2
Hedge No. 16	Hawthorn <i>Crataegus monogyna</i> Elder <i>Sambucus nigra</i> Bramble <i>Rubus fruticosus</i> Dogrose <i>Rosa canina</i> Crab Apple <i>Malus sylvestris</i>	It runs in an east to west direction and forms the boundary between the fields running from the southern end of hedge No.15. The main hedge line is located on the north-side of a dry drainage ditch and the main hedge species include Hawthorn with some Elder and Privet, Bramble and Dogrose with some vegetation establishing on the south side of the ditch, consisting predominately of Bramble. Due to lapsed management the scrub species such as Bramble is encroaching out onto the surrounding fields. The upper canopy contains Ash and Crab Apple. As a result of this hedge being allowed to grow up tall and livestock being allowed to graze in this area, it has been left very sparse in lower vegetation and the hedge plants have been allowed to become tall and top-heavy, with some of them prone to failure in winds due to structural issues. It has been reinforced in some places with fencing wire.							Make safe large size dead/ unstable growth. Trim in encroaching hedge species and cut the poorly structured sections of hedge back to help stabilize and to encourage lower growth development. It would benefit from general tidying works.	-	C2

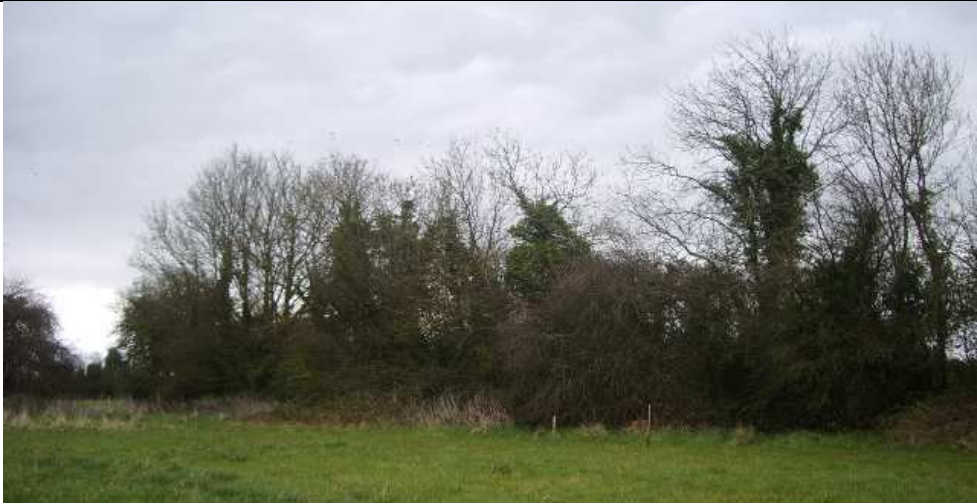
Hedge No. 17	Hawthorn <i>Crataegus monogyna</i> Elder <i>Sambucus nigra</i> Privet <i>Ligustrum sp.</i> Bramble <i>Rubus fruticosus</i> Dogrose <i>Rosa canina</i> Sycamore <i>Acer pseudoplatanus</i>	It runs at ninety degrees to Hedge No. 16 in a north-south direction. It is of a mature age class in fair condition both physiologically and structurally. The main hedge line is located on the east side of a dry drainage ditch and it consists of Hawthorn, Elder, Privet, Bramble and Dogrose with the upper canopy containing some Ash and Sycamore trees. It has been allowed to grow up tall with limited maintenance allowing scrub species, in particular Bramble to encroach out on either side creating a broad scrub hedge on either side. It is a double sided hedge with vegetation growing on both sides of the drainage ditch, however the main hedge would appear to be more continuous and located on the eastern side.						Make safe large size dead/ unstable growth. Trim in encroaching hedge species and cut the poorly structured sections of hedge back to help stabilize, to address structural issues and to encourage lower growth development. It would benefit from general tidying works.	-	C2

The following trees are located within this hedge.											
1902-1903	Ash <i>Fraxinus excelsior</i>	A 14	A 340	A N4 S4 E5 W5	A 3	Early Mature	Fair	Fair They form part of the group canopy formation and are tall, multiple-stemmed trees from base, possibly from where they were cut/ coppiced back into the hedge in the past. They form part of the upper canopy formation with Ivy cover on some stems.	The Ivy will require management in the future.	10-20	C2
1904	Sycamore <i>Acer pseudoplatanus</i>	14	120/ 300/ 340	N5 S6 E7 W6	3	Mature	Fair / Good	Fair Multiple-stemmed from base and forms part of the group canopy formation. There is light Ivy cover on the main trunk with suckers developing from its base.	Requires no work at the present time.	20+	B1

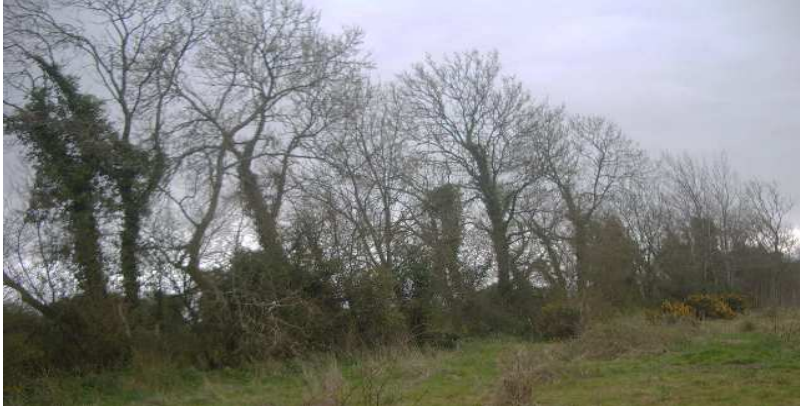
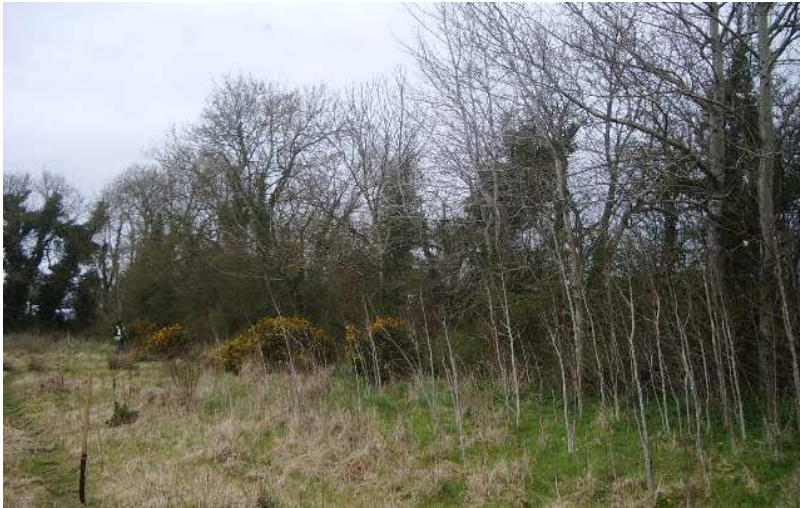
Hedge No. 19	<p>Hawthorn <i>Crataegus monogyna</i> Elder <i>Sambucus nigra</i> Privet <i>Ligustrum sp.</i> Bramble</p>	<p>It runs at ninety degrees to Hedge No.8 and runs in a north-south direction. It is of a mature age class in fair condition physiologically and structurally. The main hedge species consist of Hawthorn with some Elder, Privet, Bramble, Dogrose and Gorse on the outer edges with Ash trees forming the upper canopy, along with some Elm and Poplar. The main hedge line is located on the west side of a deep wet boundary ditch. Due to lapsed management, the hedge species, in particular the Bramble and Gorse have encroached out to create a broad hedge line and scrub areas. Some sections of this hedge have been reinforced with fencing wire.</p>						<p>Make safe large size dead/ unstable growth. Trim in encroaching hedge species.</p>	-	C2

Tree No.	Tree Species	Ht. (m)	Stem Dia. (mm)	Branch Spread (m)	C-Ht. (m)	Age Class	Phys. Con.	Structural Condition Other Comments	Preliminary Recommendation	Remain Contribute in years	Cat. Grade
								N -north S -south E -east W - west Phys. -physiological.	A- average		
1910	Elm <i>Ulmus glabra</i>	14	350	N6 S5 E7 W6	3	Early Mature	Dead	Poor It consists of two stems growing up together and they are becoming decayed and unstable. I suspect that death is due to infection by 'Dutch Elm' disease.	I would recommend its removal as the most appropriate management option.	<10	U
1911	Ash <i>Fraxinus excelsior</i>	12	220/ 340	N7 S3 E4 W5	6	Early Mature	Fair	Fair It is growing up forming part of the upper canopy formation. There is light Ivy cover on the main trunk.	Requires no work at the present time.	10-20	C2
1912	Ash <i>Fraxinus excelsior</i>	12	220/ 340	N6 S7 E5 W5	3	Mature	Fair	Fair Multiple-stemmed from base and forms part of the group canopy formation with an asymmetrical crown as a result. There is evidence of reduced vigour, most likely due to infection by 'Ash Dieback'. The Ivy cover is becoming heavy.	Cut Ivy at ground level at the present time.	10-20	C2
