Arborist Associates Ltd.

An Arboricultural Assessment on the Site Area for 'Ballyoulster SHD (Phase 1), Ballyoulster, Celbridge, Co. Kildare.

Date: 31st May 2022

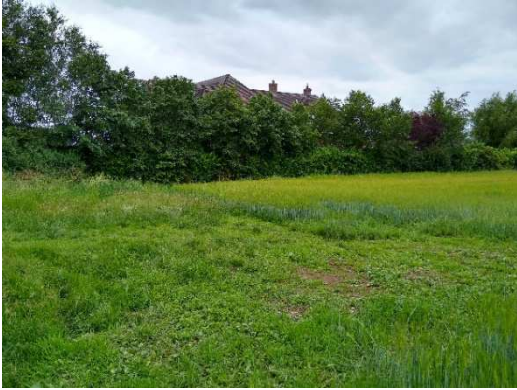
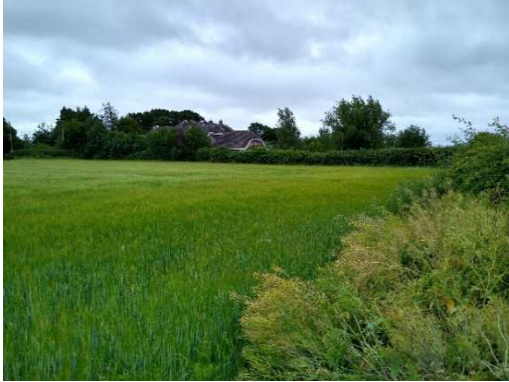
<p>Photo: Hedge No. 1 looking north.</p> <p>Photo: Hedge No. 1 looking south.</p>

Tree No.	Tree Species	Ht. (m)	Stem Dia. (mm)	Branch Spread (m)	C-Ht. (m)	Age Class	Phys. Con.	Structural Condition Other Comments	Preliminary Recommendation	Remain Contribute in years	Cat. Grade
								N-north S-south E-east W- west Phys.-physiological.	A- average		
Hedge No.2	Cherry Laurel <i>Prunus lauro-cerasus</i> Hawthorn <i>Crataegus monogyna</i> Snowberry <i>Symphoricarpos alba</i> Hazel <i>Corylus avellana.</i> Hawthorn <i>Crataegus monogyna</i> Elder <i>Sambucus nigra</i> Dog Rose <i>Rosa canina</i>	<p>This hedge extends at 90 degrees from the southern end of Hedge No. 1 in a broadly east to west direction along the boundary with the adjacent residential property.</p> <p>It is of a mature age class in a fair condition physiologically and structurally. It is growing on the site boundary and screens the adjacent private property. It includes a number of ornamental trees (Tree Line No. 9) planted at c.3m centres along its length which have been allowed to develop above the general hedge height. There is an overhead power line which traverses the hedge at the east end. It is continuous along its length and has been regularly clipped in the past to its current height and spread; this has helped to create a well-structured hedge.</p>							<p>It would benefit from cutting on the site side to contain spread.</p>	C2	
<table border="1"> <tr> <td>A.2</td> <td>-</td> <td>A.</td> <td>-4</td> </tr> </table>		A.2	-	A.	-4

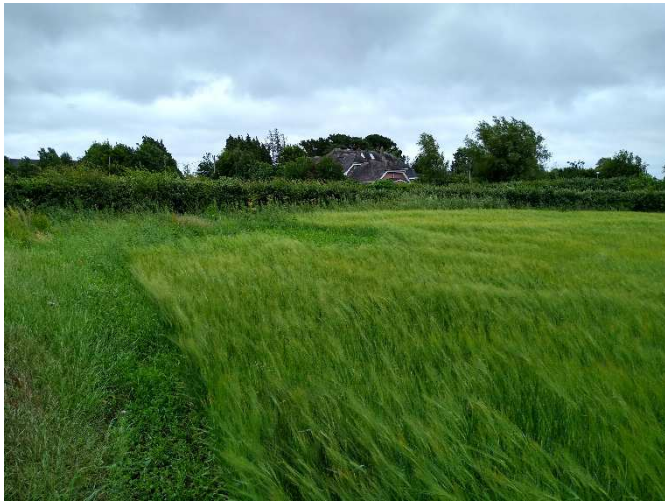
Tree No.	Tree Species	Ht. (m)	Stem Dia. (mm)	Branch Spread (m)	C-Ht. (m)	Age Class	Phys. Con.	Structural Condition Other Comments	Preliminary Recommendation	Remain Contribute in years	Cat. Grade			
								N-north S-south E-east W- west Phys.-physiological.	A- average					
	Lime <i>Tilia sp.</i> (16 trees) Purple Plum <i>Prunus cerasifera</i> <i>Nigra</i> (2 trees)			W3				grown above the hedge line and provide screening along this boundary with the adjoining house. They are mostly single stem trees.						
Hedge No. 3A	Hawthorn <i>Crataegus monogyna</i> Bramble <i>Rubus fruticosus</i>	<p>This hedge extends at 90 degrees from the western end of Hedge No. 2 in a south to north direction. It forms the boundary between two fields within the site area.</p> <p>It is of a mature age class in a fair condition physiologically and structurally. It is a short hedge line forming the northern end of a larger hedge. It has been cut to current height and spread.</p> <table border="1" data-bbox="465 751 1028 813"> <tr> <td>A.1.5</td> <td>-</td> <td>A.2</td> <td>-</td> </tr> </table>						A.1.5	-	A.2	-	Continue present maintenance		C2
A.1.5	-	A.2	-

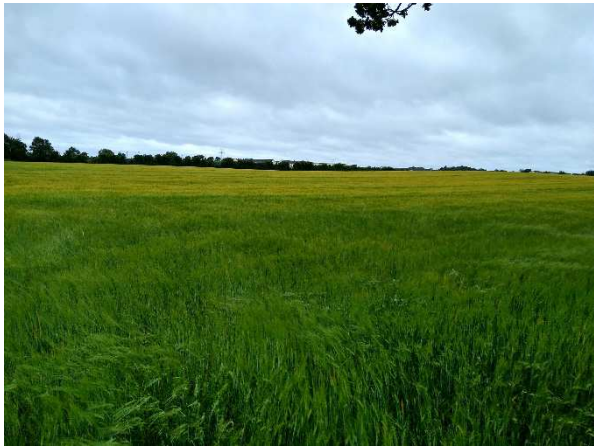
It is of a mature age class and is in fair/ good condition physiologically and structurally. It has been cut over the years which has contained hedge structure but has Bramble and Ivy dominating sections. It is encroaching into the fields on either side.								Control Bramble and Ivy growth.		
		A.2.5	-	A.4	-

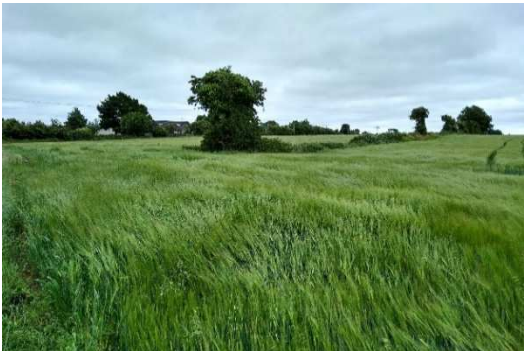
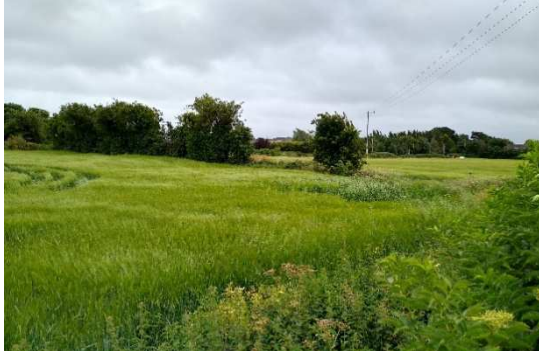
Tree No.	Tree Species	Ht. (m)	Stem Dia. (mm)	Branch Spread (m)	C-Ht. (m)	Age Class	Phys. Con.	Structural Condition Other Comments	Preliminary Recommendation	Remain Contribute in years	Cat. Grade					
								N-north S-south E-east W- west Phys.-physiological.	A- average							
Hedge No. 11	Hawthorn <i>Crataegus monogyna</i> Elder <i>Sambucus nigra</i> Yew <i>Taxus baccata</i> Elm <i>Ulmus sp</i> Privet <i>Ligustrum ovalifolium</i> Bramble <i>Rubus fruticosus</i>	<p>This hedge extends in a broadly east to west direction from Hedge No. 1 to Hedge No. 10. It forms an internal division between two fields within the site area.</p> <p>It is of an early mature age class in fair condition physiologically and structurally. . It is not continuous along its length with sections where Bramble is colonising. The main part of the hedge is located mid-way down the field with either end being more open and sparse in hedging. It has recently been cut back on the north and south sides to contain width but has been allowed to grow up tall. Ploughing has come close on both sides and may have caused soil and root damage, particularly to the trees within.</p> <table border="1" data-bbox="465 683 869 743"> <tr> <td>A.2.5</td> <td>-</td> <td>A. 2.5</td> <td>-</td> </tr> </table>					A.2.5	-	A. 2.5	-					<p>Continue present maintenance.</p> <p>Its top may benefit from being cut in the near future to contain height and structure.</p>	C2
A.2.5	-	A. 2.5	-

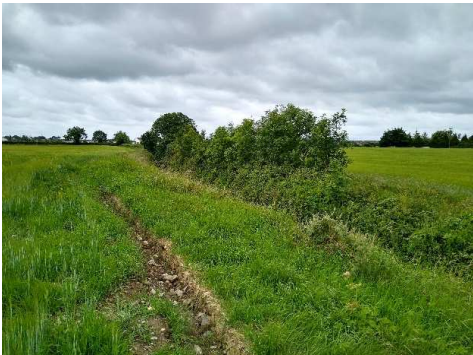
Photo: Hedge No. 14, looking east. Photo: Hedge No. 14, looking west. This hedge line contains the following trees.			
A.2	-	A.2.5	-											
0413 – 0415 (3 trees)	Aspen <i>Populus tremuloides</i>	A.13	A.340	A.N5 S3 E4	2	Early Mature	Fair / Good	Fair A group of three trees close planted and growing up together to form a combined	These trees may be outside the management control of this site. They	10-20	C1

Tree No.	Tree Species	Ht. (m)	Stem Dia. (mm)	Branch Spread (m)	C-Ht. (m)	Age Class	Phys. Con.	Structural Condition Other Comments	Preliminary Recommendation	Remain Contribute in years	Cat. Grade			
								N-north S-south E-east W- west Phys.-physiological.	A- average					
				W5				canopy.	will require management to maintain clearance over the overhead utility line.					
0416	Ash <i>Fraxinus excelsior</i>	8	170 (9 stems)	N4 S2 E3 W4	2	Early Mature	Fair / Good	Fair A multi-stem tree from near ground level growing on top of a small bank. Lower branches have been pruned in the past with re-growth developing from the cut points. It is growing on top of a bank on a deep ditch. There is light deadwood in the crown. Ivy growth is extending high up into the crown.	No works required at the present time.	10-20	C1			
Hedge No. 15	Ash <i>Fraxinus excelsior</i> Elm <i>Ulmus sp.</i> Blackthorn <i>Prunus spinosa</i> Hawthorn <i>Crataegus monogyna</i> Bramble <i>Rubus fruticosus</i> Dog Rose <i>Rosa canina</i>	<p>This hedge extends in a broadly north to south direction from Hedge No. 14. It forms part of an internal division between two fields within the site area.</p> <p>It is of a mature age class in a fair condition physiologically and structurally. It is of uneven structure and is not continuous along its length. It is growing on top of a bank, on the west side of a deep, water filled ditch/ stream. There are a few trees developing above the general hedge line. There are saplings of Ash developing at the northern end. Bramble and Ivy growth are colonising the hedge line.</p> <table border="1" data-bbox="465 975 869 1018"> <tr> <td>A.4</td> <td>-</td> <td>A.4</td> <td>-</td> </tr> </table>						A.4	-	A.4	-	<p>Continue present maintenance.</p>		C2
A.4	-	A.4	-

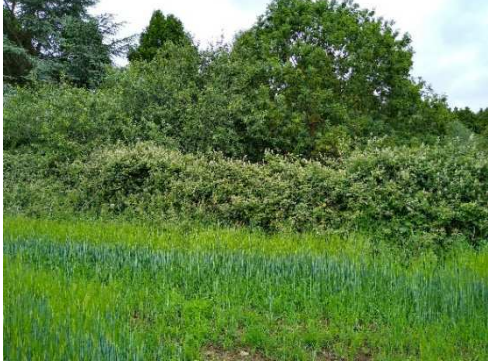
<p>Photo: Hedge No. 18A, looking west.</p>												
Hedge No. 18B	Hawthorn <i>Crataegus monogyna</i> Elder <i>Sambucus nigra</i> Bramble <i>Rubus fruticosus</i>	<p>This hedge extends on from hedge No. 18A extending in a broadly east to west direction and forms the boundary with the adjacent commercial property to the north.</p> <p>It is of a mature age class and is fair condition physiologically and fair/ poor condition structurally. It mostly consists of Bramble with some isolated clumps of Hawthorn and Elder located along the line.</p> <table border="1" data-bbox="465 965 1028 1026"> <tr> <td>A.3</td> <td>-</td> <td>A.6</td> <td>-</td> </tr> </table>					A.3	-	A.6	-			It would benefit from control of Bramble and planting of hedge species to strengthen the line.	C2
A.3	-	A.6	-

Tree No.	Tree Species	Ht. (m)	Stem Dia. (mm)	Branch Spread (m)	C-Ht. (m)	Age Class	Phys. Con.	Structural Condition Other Comments	Preliminary Recommendation	Remain Contribute in years	Cat. Grade
								N-north S-south E-east W- west Phys.-physiological.	A- average		
		Photo: Hedge No. 18B.									
Tree Line No. 7	Western Red Cedar <i>Thuja plicata.</i>	A.11	A.220	N4 S4 E3 W3	0	Early Mature	Fair/ Good	Fair / Good This tree line is located on the adjacent cemetery grounds cordoned off by the boundary wall. They provide screening and privacy. They have been subject to some clipping / pruning in the past on the site side to reduce encroachment.	Management of these trees is outside the control of this site. Remove Bramble on site side.	20-40	B2
Tree Line No. 8 (3 trees)	Beech <i>Fagus sylvatica.</i>	A.10	A.240/ 230	A.N4 S3 E3 W3	2	Early Mature	Fair/ Good	Fair This short tree line is located at the southern end of Tree Line No.6 on the adjacent cemetery grounds cordoned off by the boundary wall. They have been close planted and are growing up with a combined canopy. They are multi stem trees from c.1.5 – 1.8m. The crowns are encroaching over the site boundary wall into the site. There has been recent pruning of lower branches on one of the trees.	Management of these trees is outside the control of this site.	20-40	B2
